TWO MEDIEVAL CHURCHES IN NORFOLK

East Anglian Archaeology

Archaeology and Environment, Norfolk Museums and Archaeology Service 2001

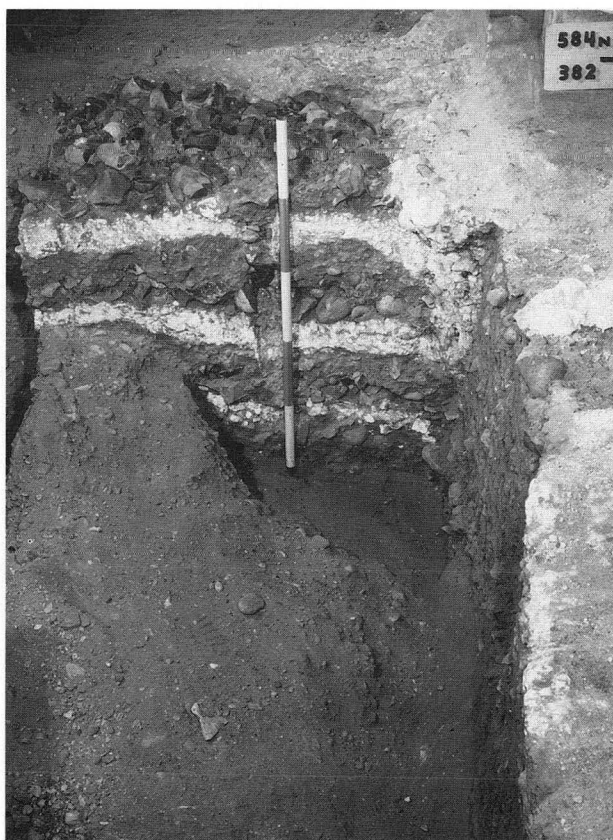
Plate V Trench foundations (382) filled with rammed chalk, flint and gravel. Scale 1 metre

The foundations of Structure C were constructed of trenches filled with alternate layers of rammed flint, chalk and gravel (Figs 13–18, Pl.V). They were detected in the area of the present nave and chancel, as far as the extant chancel steps (Fig.11). Only one edge of the foundations was uncovered during excavation (Fig.11). The other recorded areas were picked up in the watching brief and it is possible that the foundations could have been broader. The internal dimensions recorded from the inner edges were 13.30m west-to-east by 6.20m north-to-south in the nave and 2.90m west-to-east by 6.25m north-to-south in the chancel.

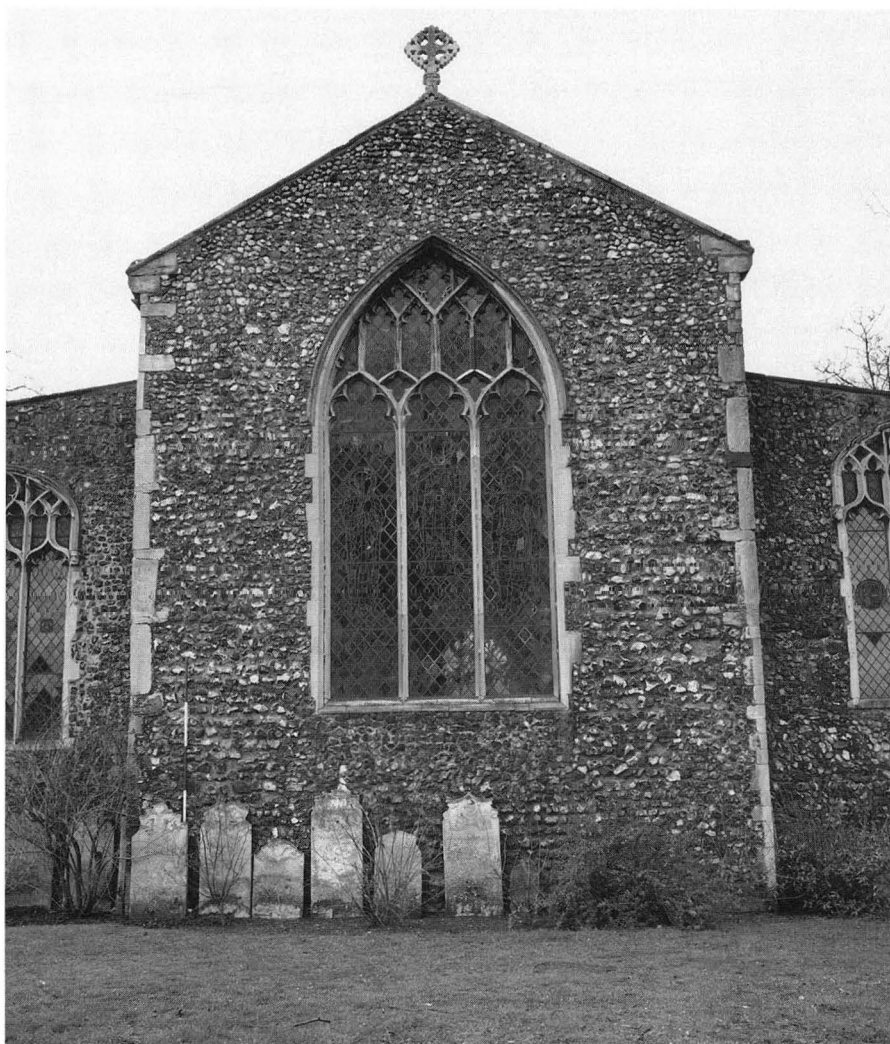
Plate VI East wall of church

The east wall displays what is widely recognised as Anglo-Saxon long and short work on the north-east and south-east corners (Fig.18, Pl.VI); a date of between AD 950–1100 has been attributed to it (Taylor and Taylor 1965). Such a date would make it almost certain that the wall formed the superstructure associated with the foundations uncovered during the excavation. There was, however, no stratigraphic evidence recorded to support this assumption, as the junction of the foundations and the east wall was not within the area of excavation or watching brief.

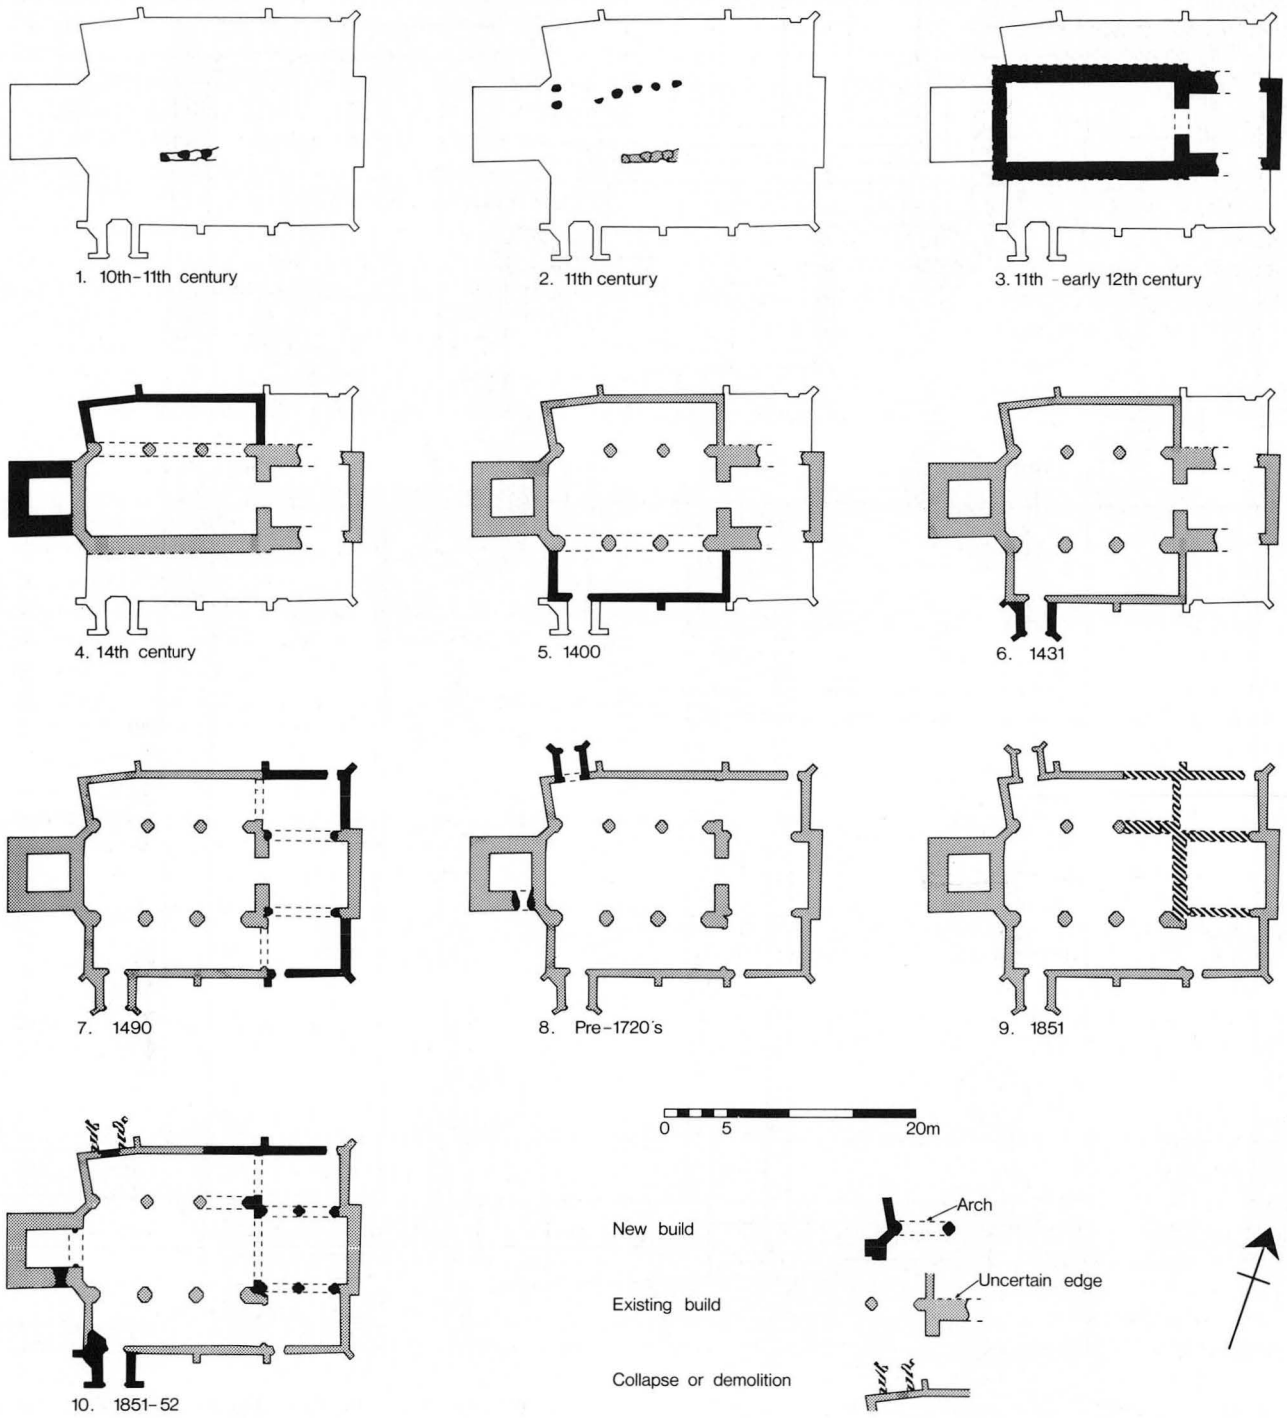
Figure 33 Phases of church development, 10th/11th century–19th century. Scale 1:600

The evidence for the expansion of the church is provided by surviving documentation (pp.49–50). This indicates that the main alterations to the church were made in the late 14th and 15th centuries. The north and south aisles were built as were the choir aisles; in addition the tower and south porch were constructed (Fig.33).

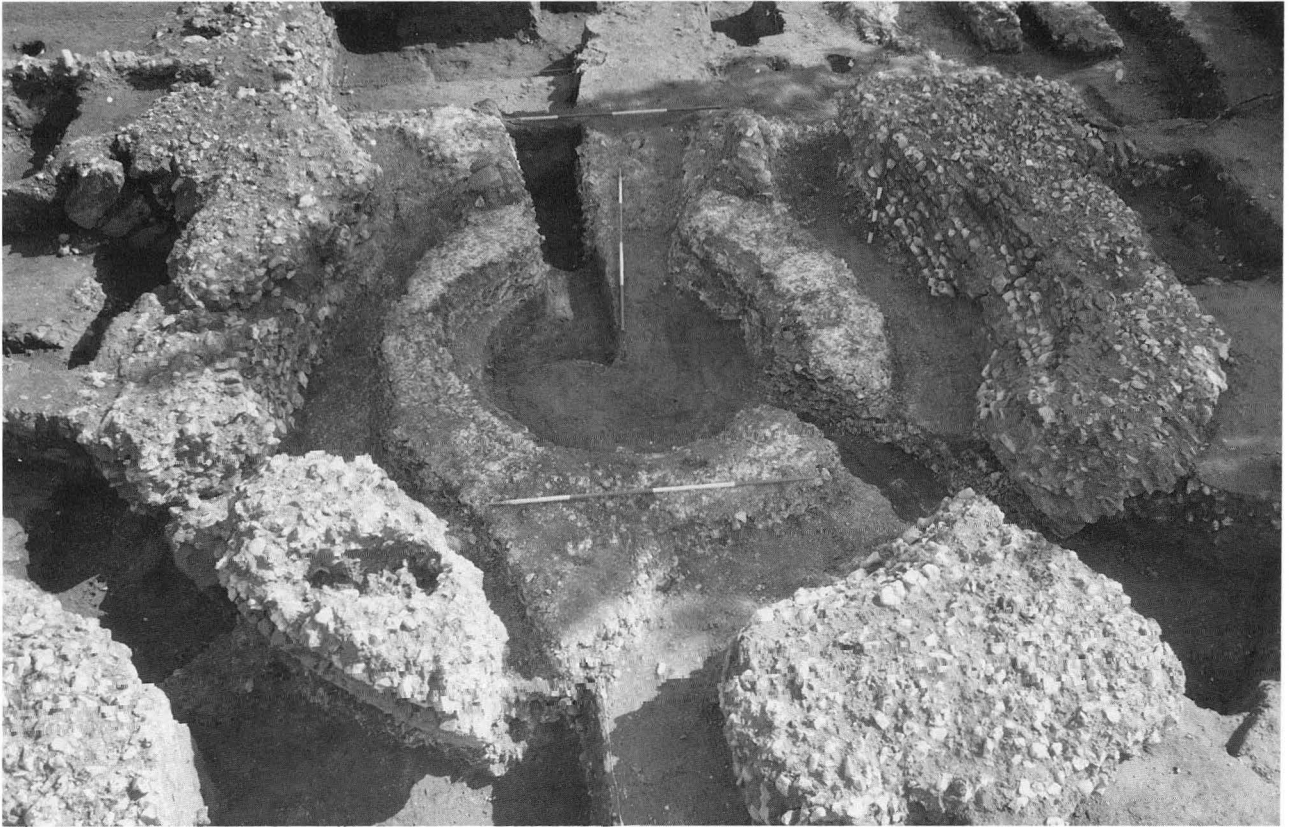
Plate XXV Period I church. Collapsed footings of western round tower with intrusive post-medieval oven feature. View looking east. Scales 2 metres. (Photo: B.S.Ayers)

The tower (Pl.XXV) was constructed of flint with quantities of iron-bound conglomerate. An exterior offset foundation course was observed at the western side of the tower (Pl.XXVI), effected in conglomerate. This stone was also used to create a 'banded' appearance to the interior face of the structure (Pl.XXVII; Fig.42 which is shown at 1:40 for clarity). A collapsed part of the superstructure (1031) was rendered on its exterior face but (where visible) appeared to be only constructed of flint, suggesting the possibility that conglomerate was only used for lower courses. The tower was circular, its original dimensions preserved approximately by the inner edge of its foundation cut (Fig.40) although the tower itself had collapsed outwards around its entire perimeter (Fig.40; p.97). Access was afforded from the nave and probably also via a western door, an unusual but not unique arrangement (p.95). Such a supposition is suggested by survival of a 'tongue' of crushed chalk within this part of the tower
