A Medieval Moated Manor by the Thames Estuary: Excavations at Southchurch Hall, Southend, Essex

by N.R. Brown

East Anglian Archaeology
Report No. 115, 2006

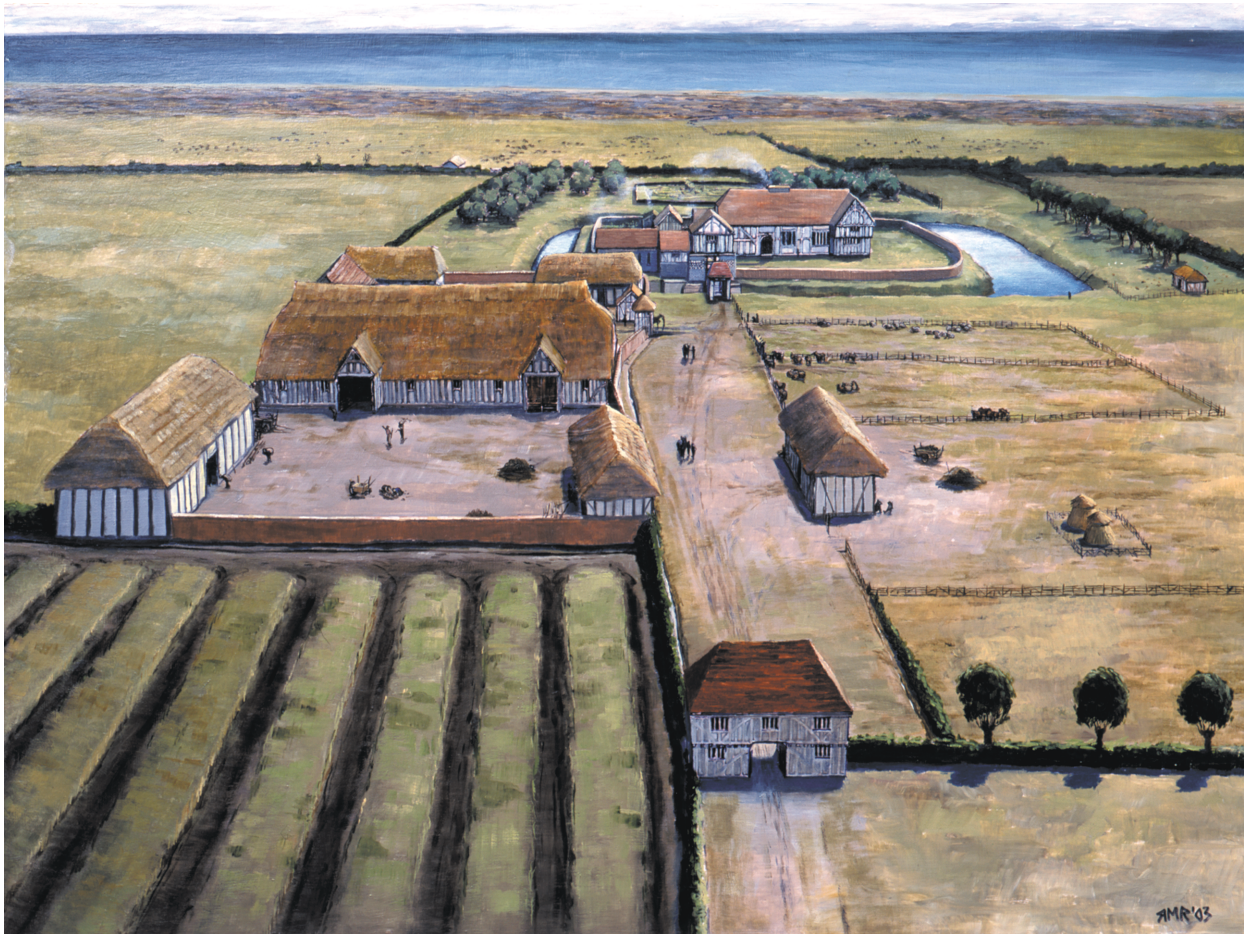
Frontispiece:

Reconstruction painting by Roger Massey-Ryan, of the manorial complex at Southchurch Hall around 1400, based on excavated and documentary evidence (compare Figs 104 and 105, Plate 6). The layout depicted here is described on pp143–5. This picture gives a good idea of the scale of the manorial complex and its relationship with the Thames estuary and marshes which can be seen in the background. The outer gate is modelled on one which formerly stood at Moat House North Shoebury, the barn court to the left of the painting is dominated by the great barn. The Hall, moat and excavated foundations of the inner gatehouses and associated buildings still survive; most of the rest of the area is now covered by housing developments of the 1920s and 30s.

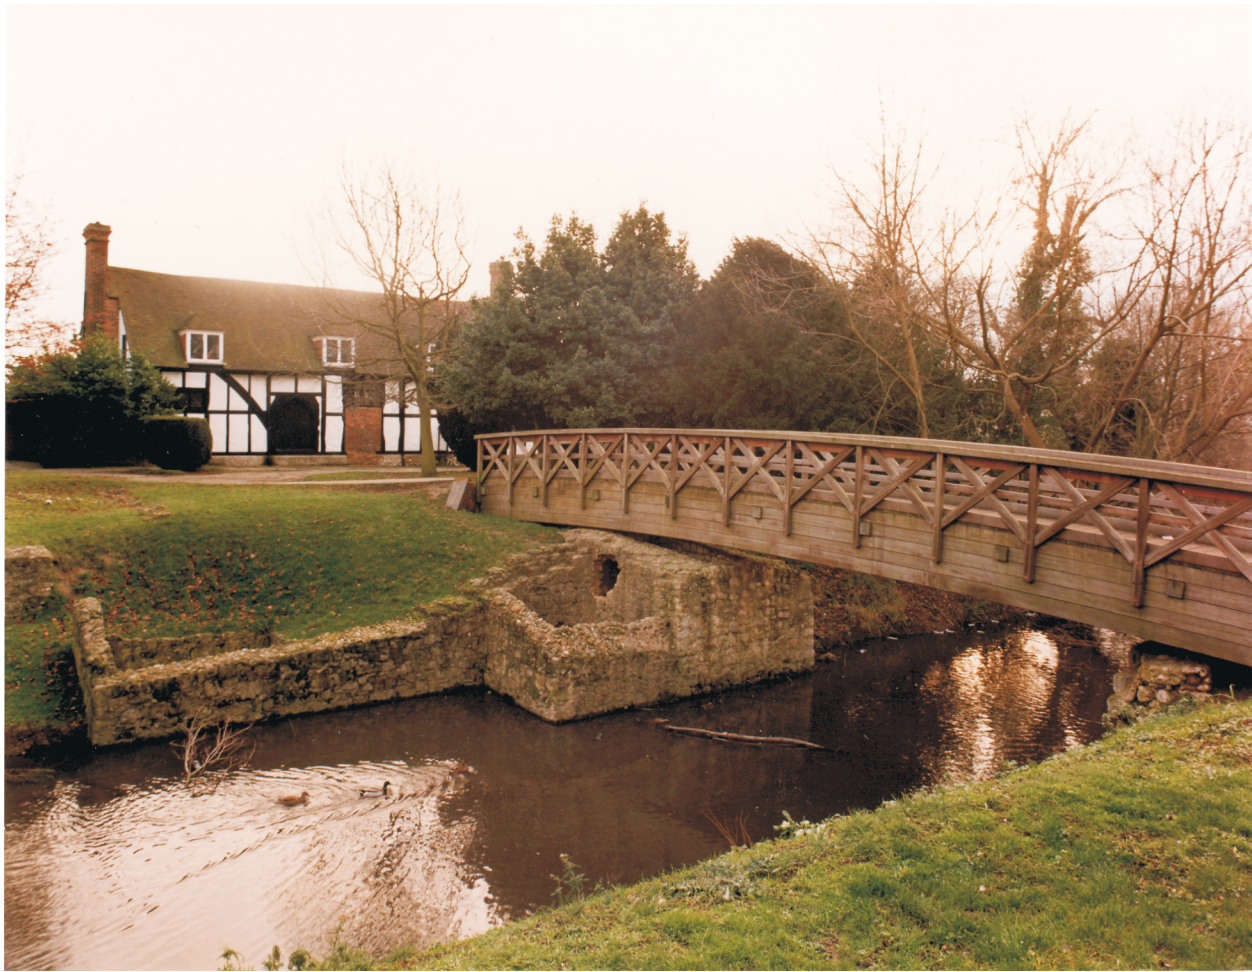
Plate 2 Hall following excavation, consolidation of excavated walls and provision of new bridge. The foundations of the gatehouse (structure III), garderobe (structure V), retaining wall of structure IV with the second garderobe (structure VI) behind, can all be seen on the bank of the moat

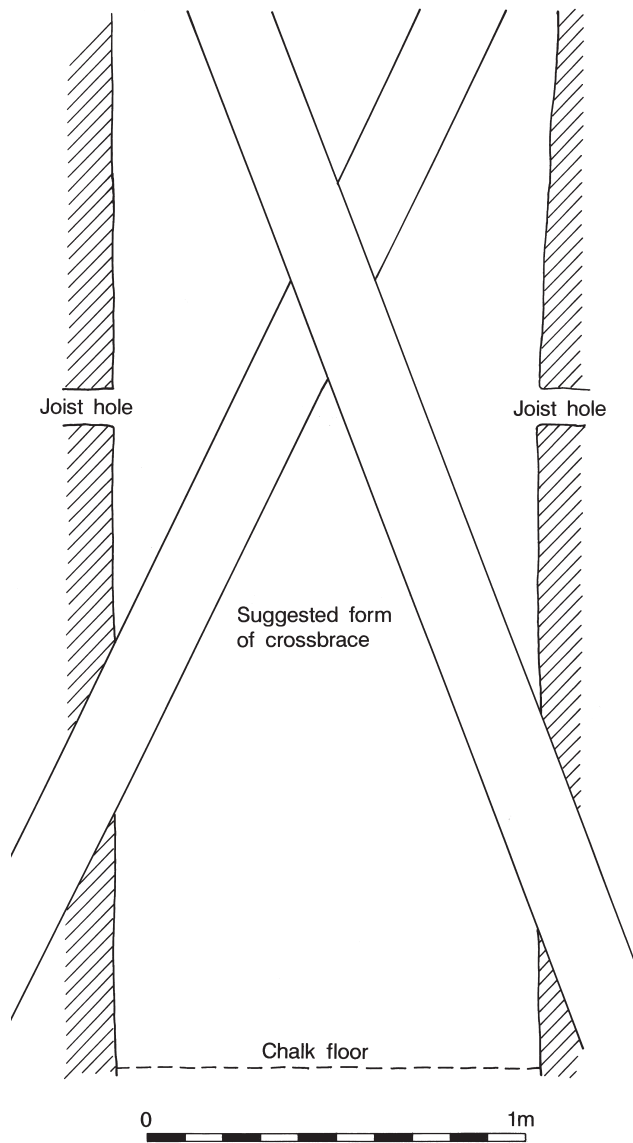
Figure 26 Suggested reconstruction of internal cross brace inside gatehouse

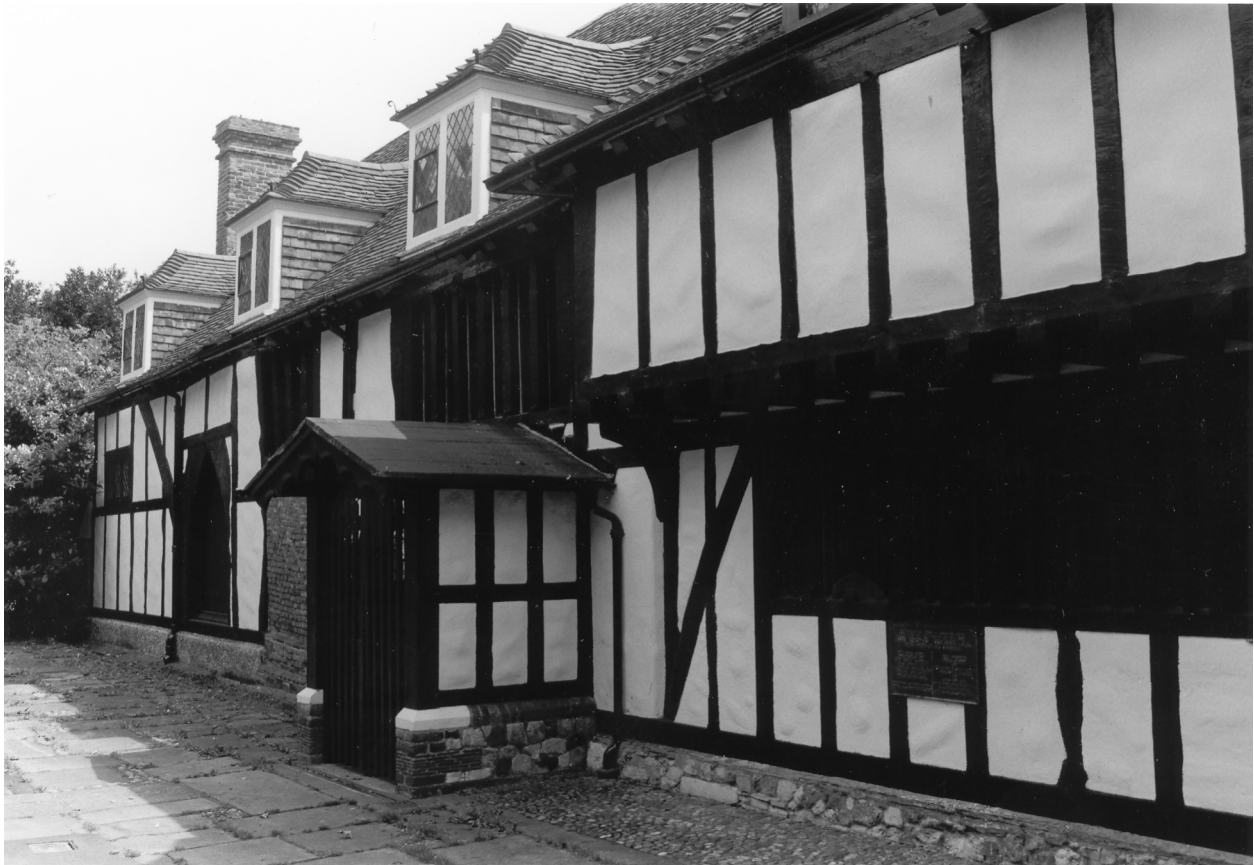
Plate 3 Hall looking east, jettied cross-wing in foreground

The building (Plate 3) comprises a hall of two unequal bays aligned east-west, with in-line service rooms at the east end and a cross-wing at the high end to the west. The restoration revealed the end walls of the hall, the imposing doorways of the cross-passage made of solid pieces of oak or durns, a tie-beam with soffit cusping supporting a handsome crown post, and remains of the large hall windows. If the hall was found to be relatively intact, the original form of the two ends is more problematic, as will be seen.

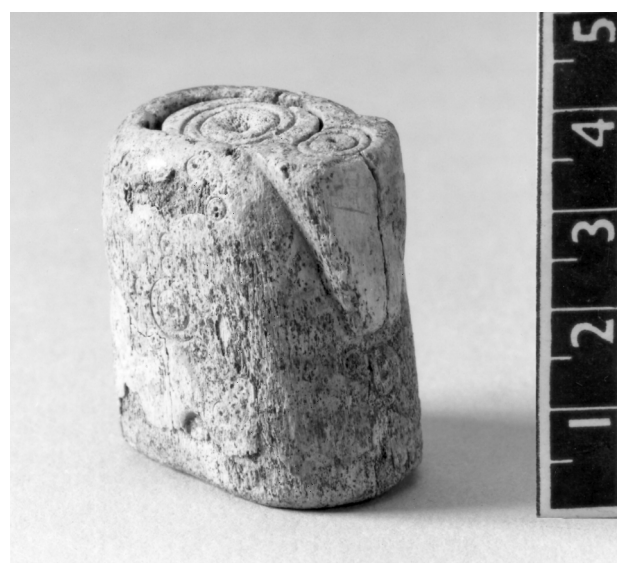
Analysis by FIIR spectroscopy in the British Museum Department of Organics Conservation detected a dark brown porous material between the core and the plugs, probably the clay used in the packing of the plugs within the core.

The form of the chess-piece and the ring-and-dot decoration is repeated on other surviving examples of the mid 11th to 13th centuries, the game of chess being introduced into England at some point at the beginning of this period (MacGregor 1985, 137–139).

Plate 4 Bone chess-piece, scale in centimetres

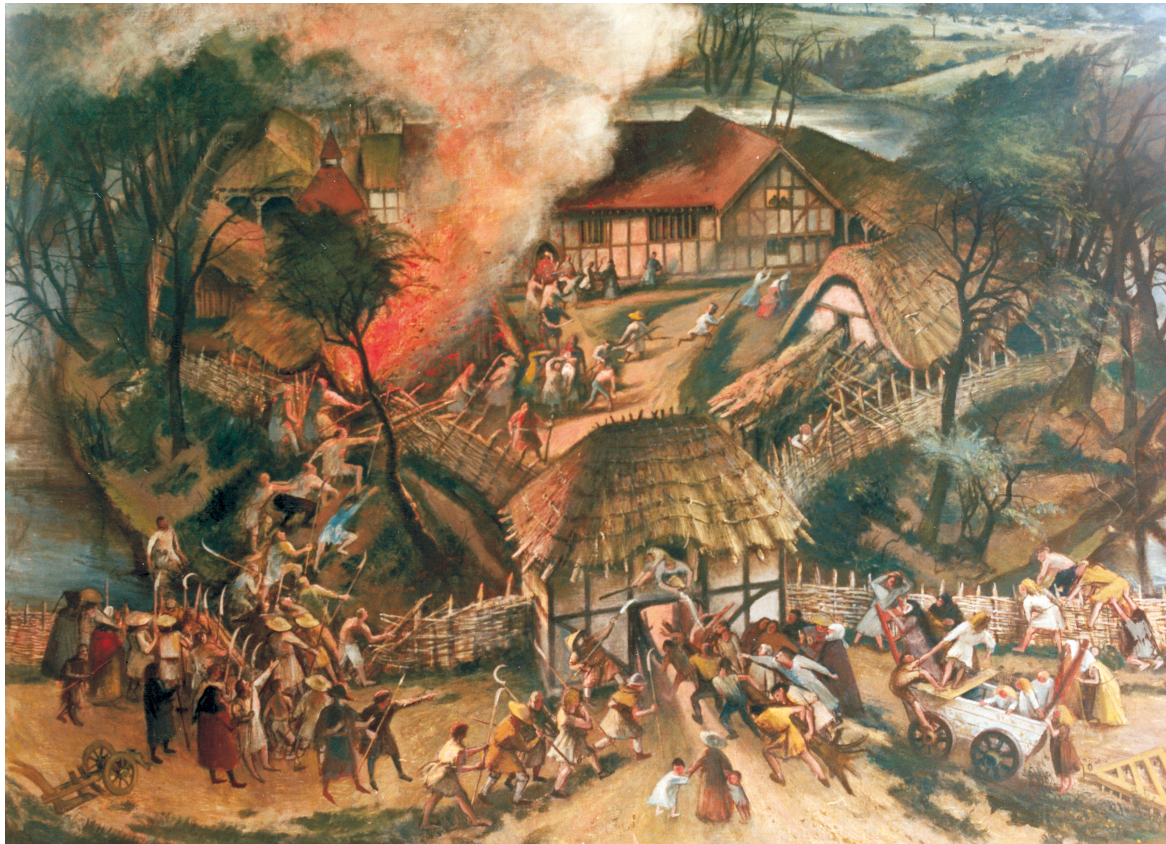
Plate 6 Painting of Southchurch Hall under attack during the Peasants Revolt, by Alan Sorrell. Sorrell's first four reconstruction paintings were commissioned in the 1930s to decorate Southend Central Library, this was his fifth commission also in the 1930s, and the style so familiar from his later works is already apparent. It is clear that Sorrell's depiction of the gatehouse was inspired by the then extant gatehouse at Moat House, North Shoebury a few miles to the north-east of Southchurch Hall. In the early 1930s the Southend Estates Company suggested a scheme to dismantle the gatehouse and re-erect it at Southchurch Hall, the scheme came to nothing and the North Shoebury gatehouse was demolished in the 1960s. Excavation has shown that the gatehouse by the moat at Southchurch was rather different, but the North Shoebury gatehouse has been used as a model for the outer gate in the latest reconstruction of the manorial complex at Southchurch (see frontispiece).
