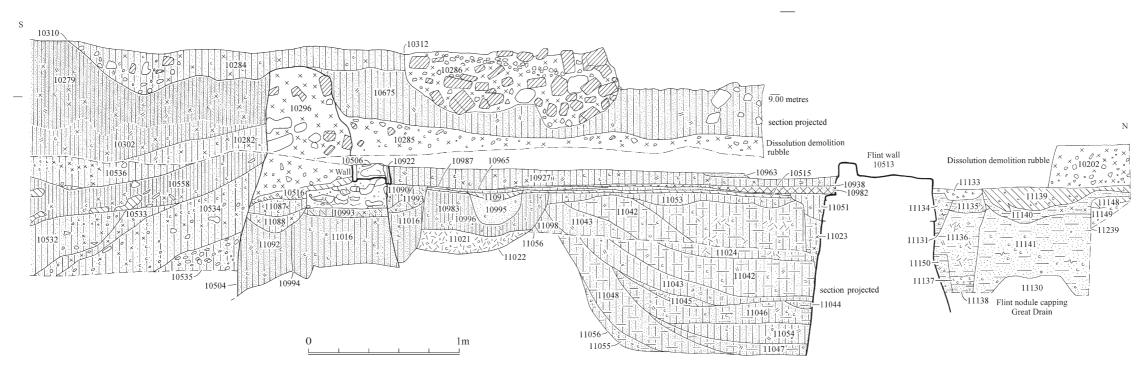
Figure 3.10 East-facing section through connecting passage in west range of cloister, Area A
