Experimental Archaeology and Fire: the investigation of a burnt reconstruction at West Stow Anglo-Saxon Village

by Jess Tipper

East Anglian Archaeology
Report No. 146, 2012

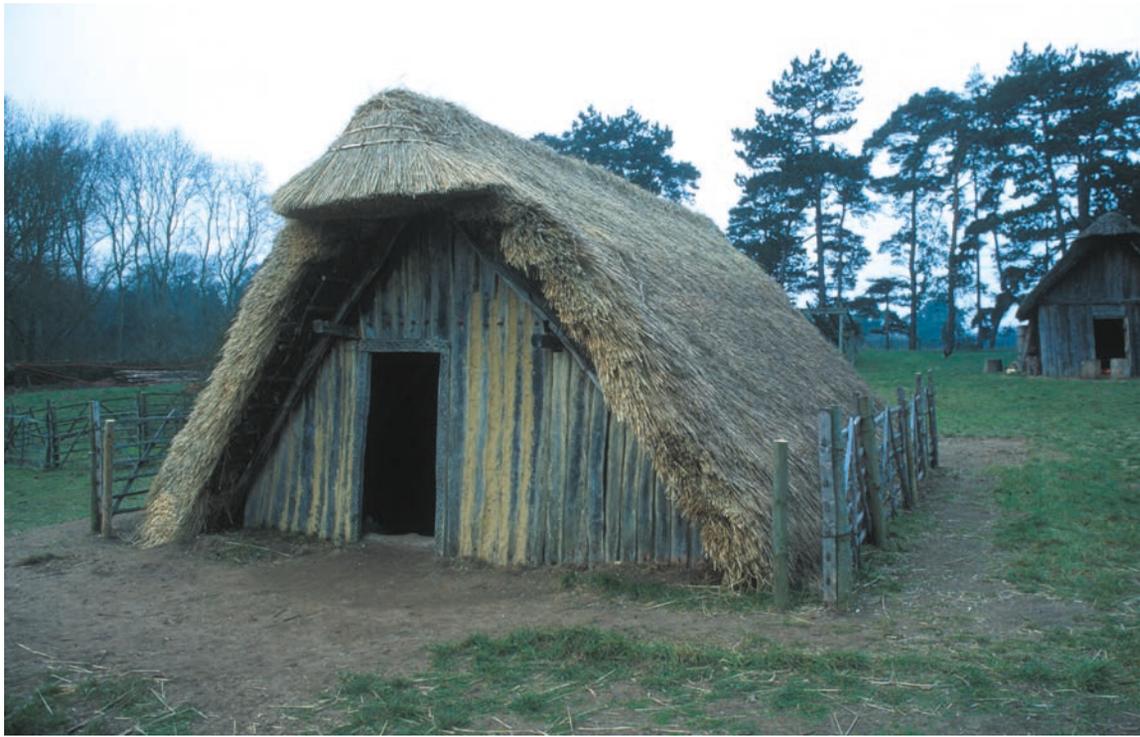
Plate 1.1 Reconstruction of an SFB at West Stow as a traditional sunken-floored building (the Sunken House) with the roof sloping down to the ground surface, with the doorway at the E gable-end and with an internal sunken earth floor (viewed from E)

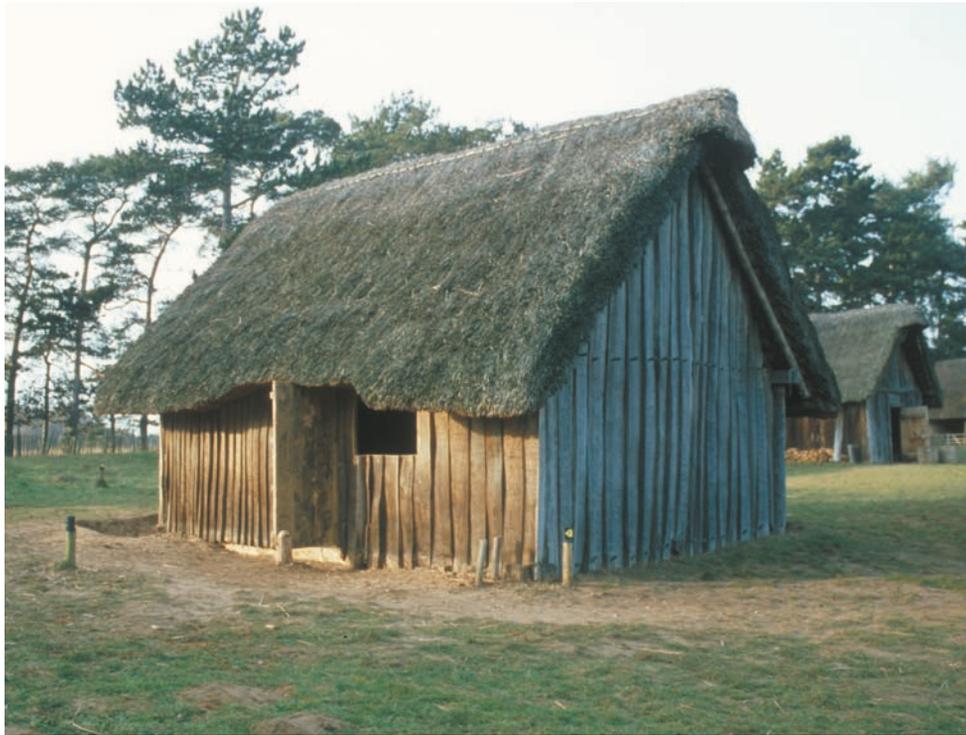
Plate 1.2 Reconstruction of an SFB at West Stow as a substantial ground-level building (the Weaving House), with a suspended floor over the sunken feature, vertical walls and with an internal area that is larger than the sunken feature (viewed from SE)

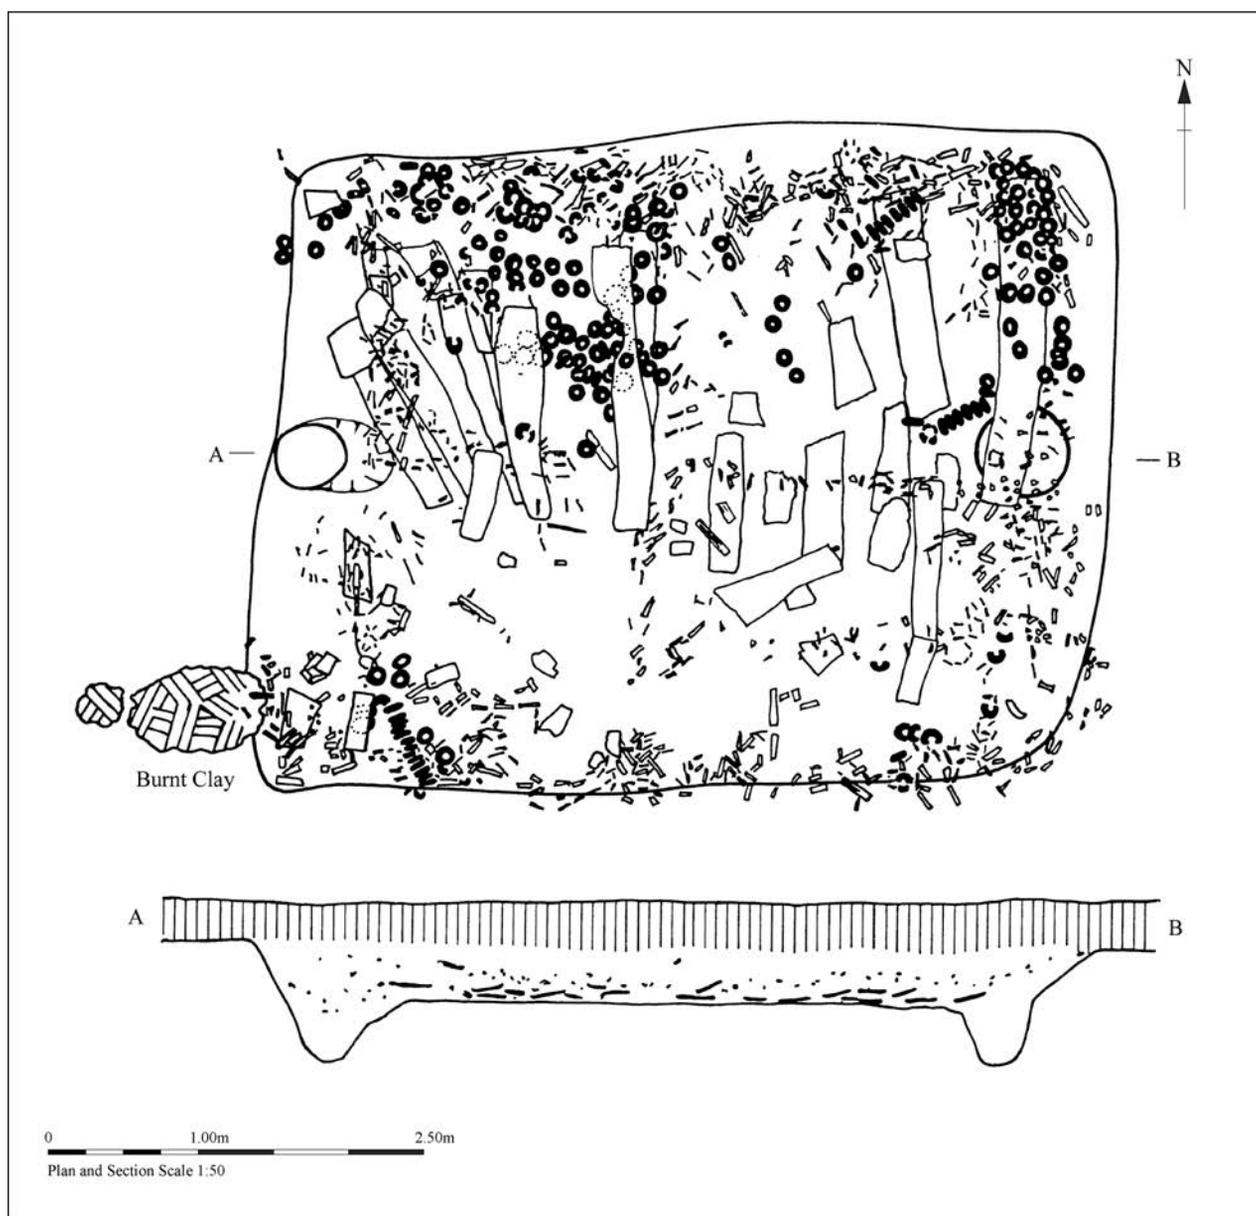
Figure 1.5 Plan and section of SFB 15 that burnt down preserving the evidence of charred planks from the superstructure, interpreted as the remains of floor and wall planks that had collapsed down onto the base of the sunken feature (West 1985, fig. 71)

SFB 15 was one of two that burnt down which, according to West's interpretation, preserved the evidence of both planked floor and walls (West 1985, 119–20 and fig. 71; Fig. 1.5 and Plate 1.3). The remains of over ten charred planks, in two layers, were discovered lying directly on, or just above, the base of the sunken feature. These had a relatively orderly or parallel arrangement, generally aligned N–S across the width, and mainly in the N half, of the sunken feature. However, several of the lower charred planks on the NW side were aligned NW–SE.

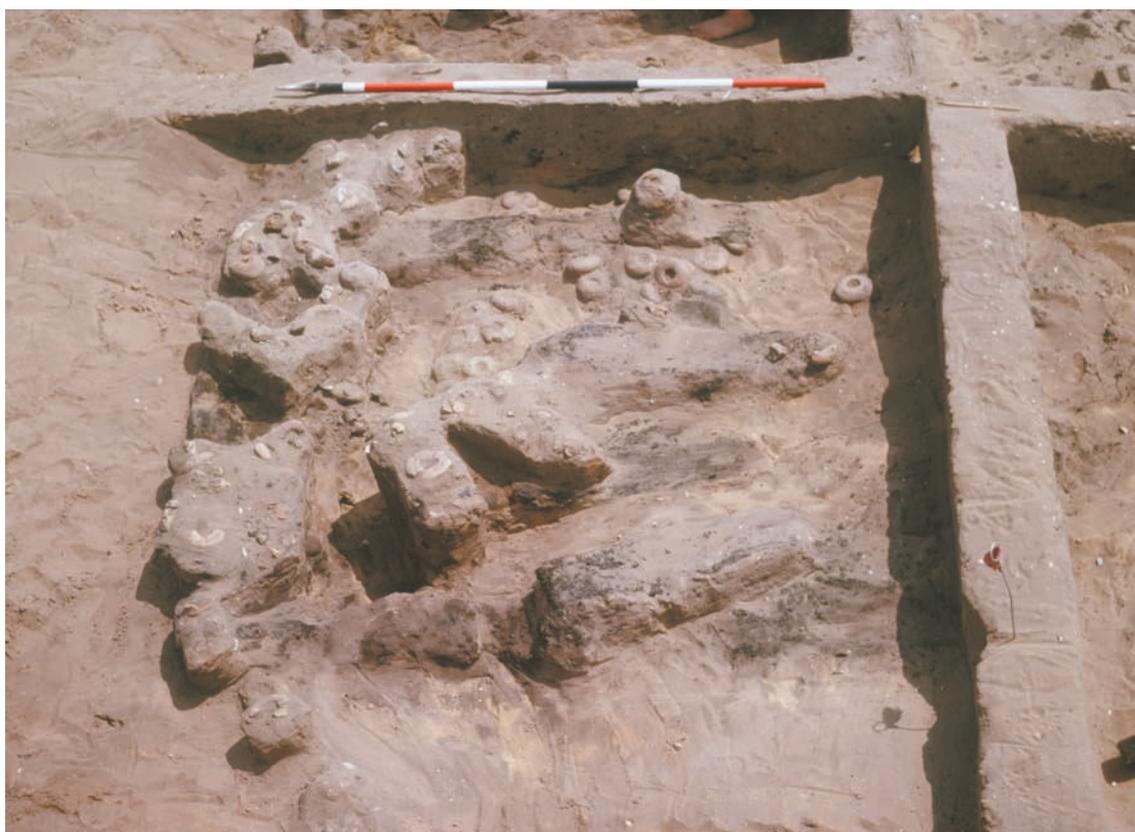
Plate 1.3 SFB 15 during excavation, with the charred planks and loomweights on, and some well above, the base of the sunken feature in the NW quadrant (viewed from NW). Scale at 1ft intervals. *Courtesy of Stanley West*

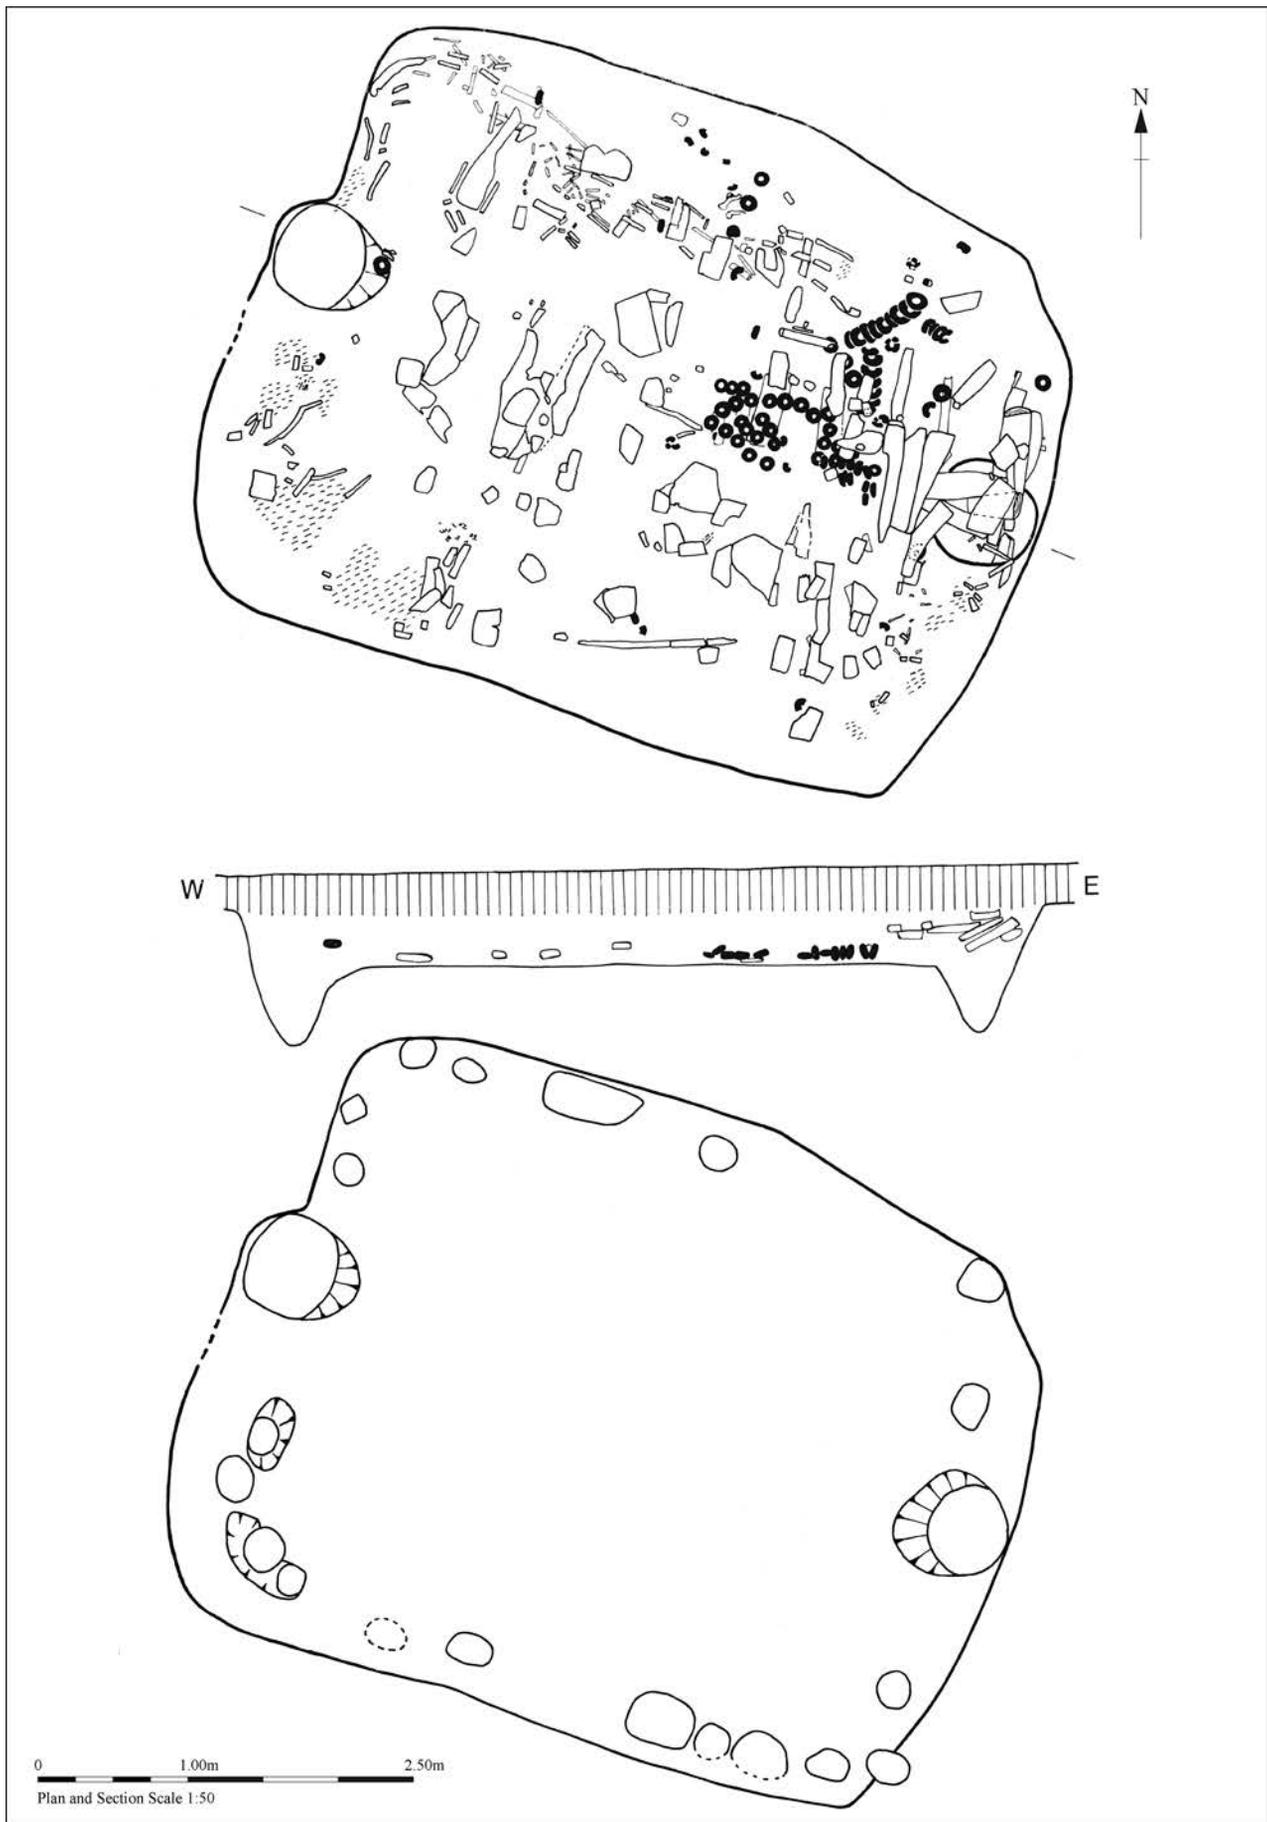
Figure 1.6 Plans and section of SFB 3 showing (top) the charred structural evidence and loomweights on the base of the sunken feature and (bottom) the excavated sunken feature with the post- and stake-holes around the sides (West 1985, fig. 35)

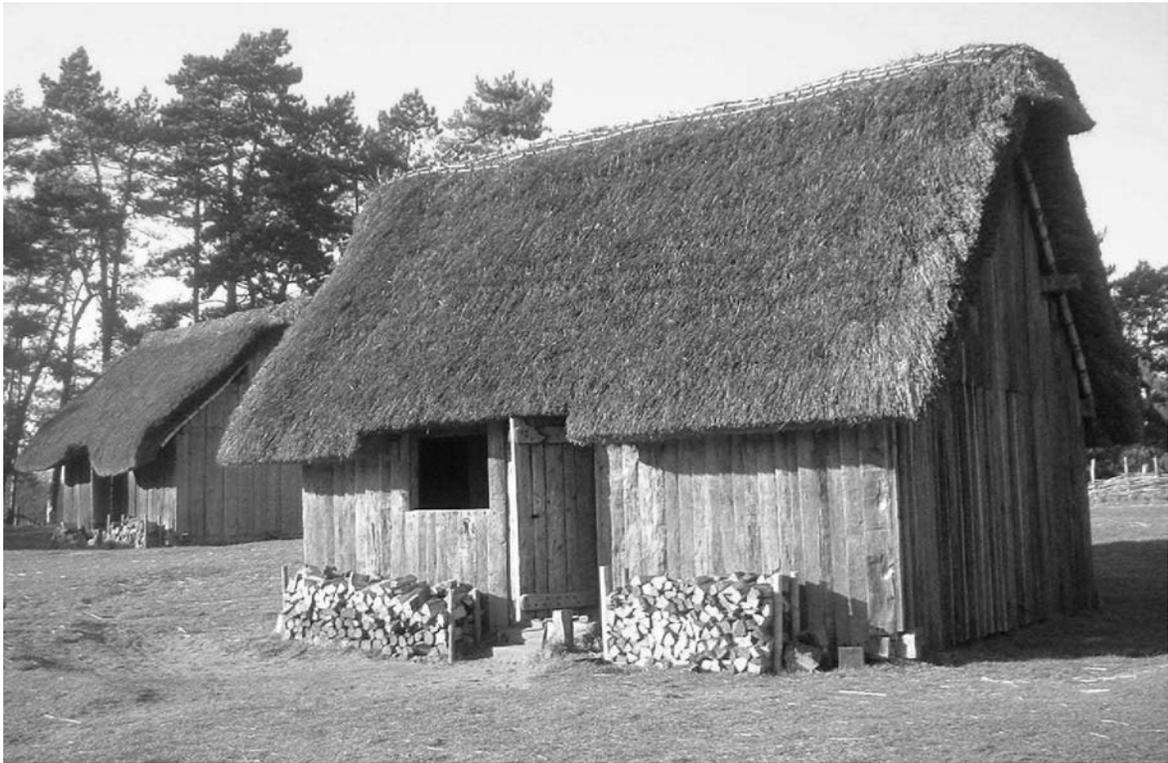
Plate 1.5 The Farmer's House reconstruction at West Stow; the most sophisticated reconstruction of an SFB with a suspended floor over the sunken feature, lined with substantial timber planks, which acted as a cellar (viewed from SE). Notice the log piles stored along the S wall of the building below the eaves and the hollow that has formed in front of the entrance and window

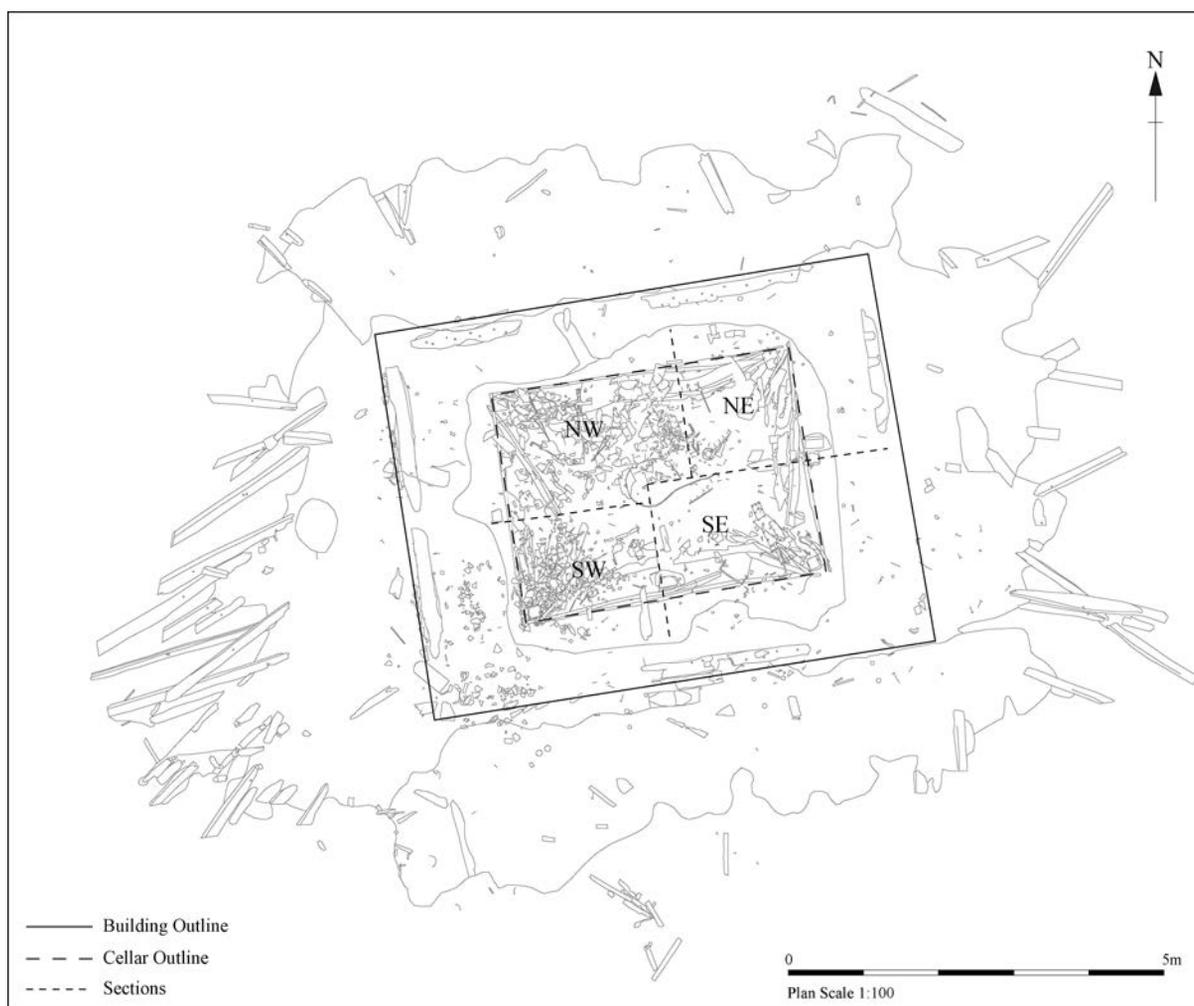
Figure 1.7 Plan of the Farmer's House remains showing the four quadrants of the cellar pit

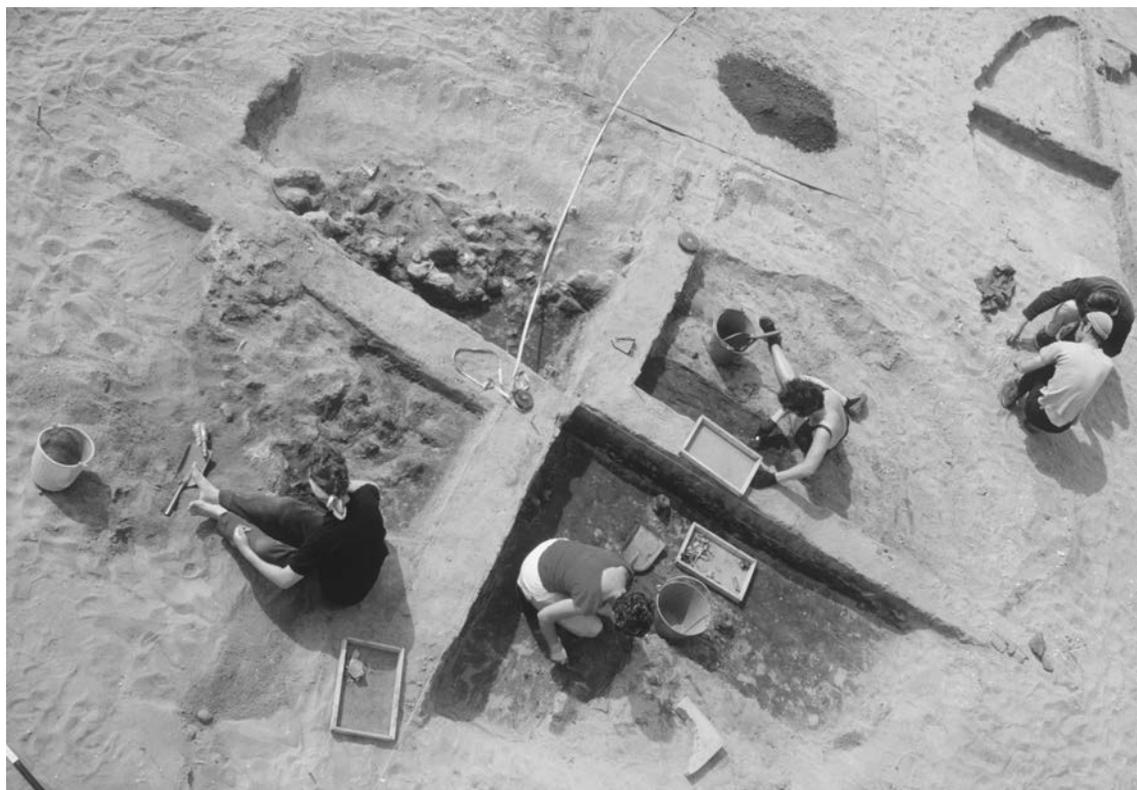
Plate 2.1 SFB 12 at an early stage of excavation. The deposit of clay, tipping down into the sunken feature from the E and sealing the lower fill, has been exposed in the two E quadrants (viewed from N). *Courtesy of Stanley West*

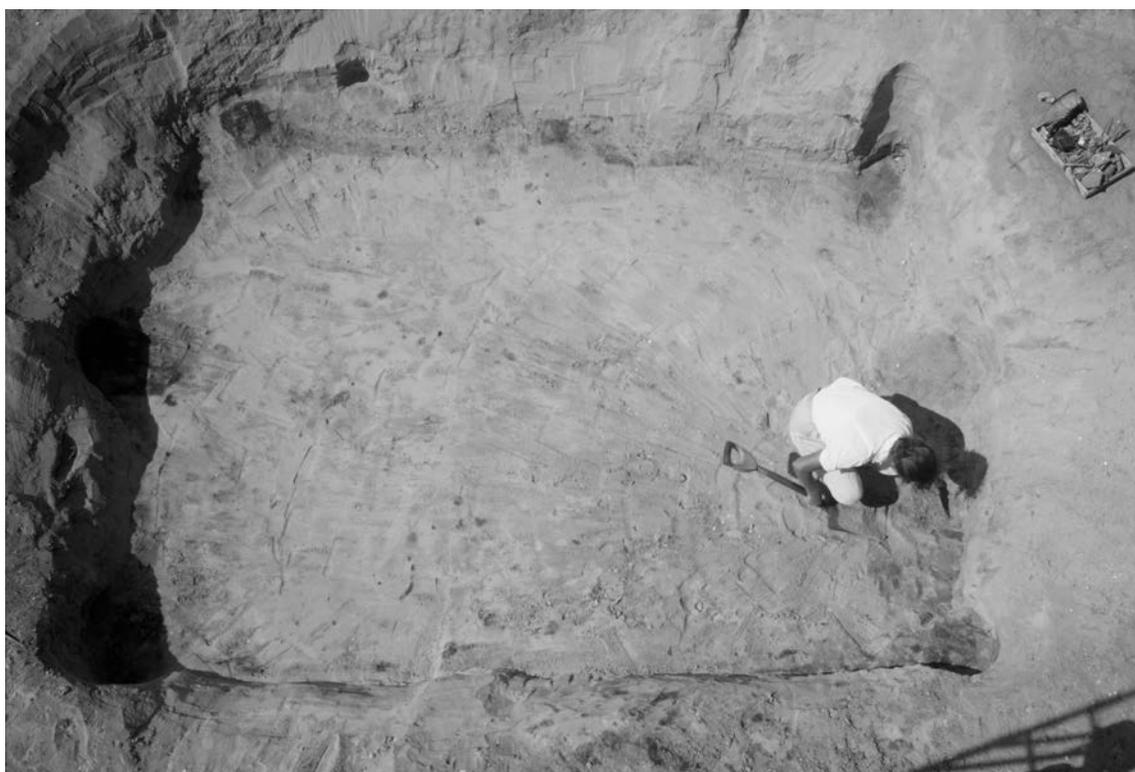
Plate 2.2 SFB 12 towards completion of the excavation, although the post-holes and slots along the base of the sides have not yet been investigated (viewed from S). *Courtesy of Stanley West*

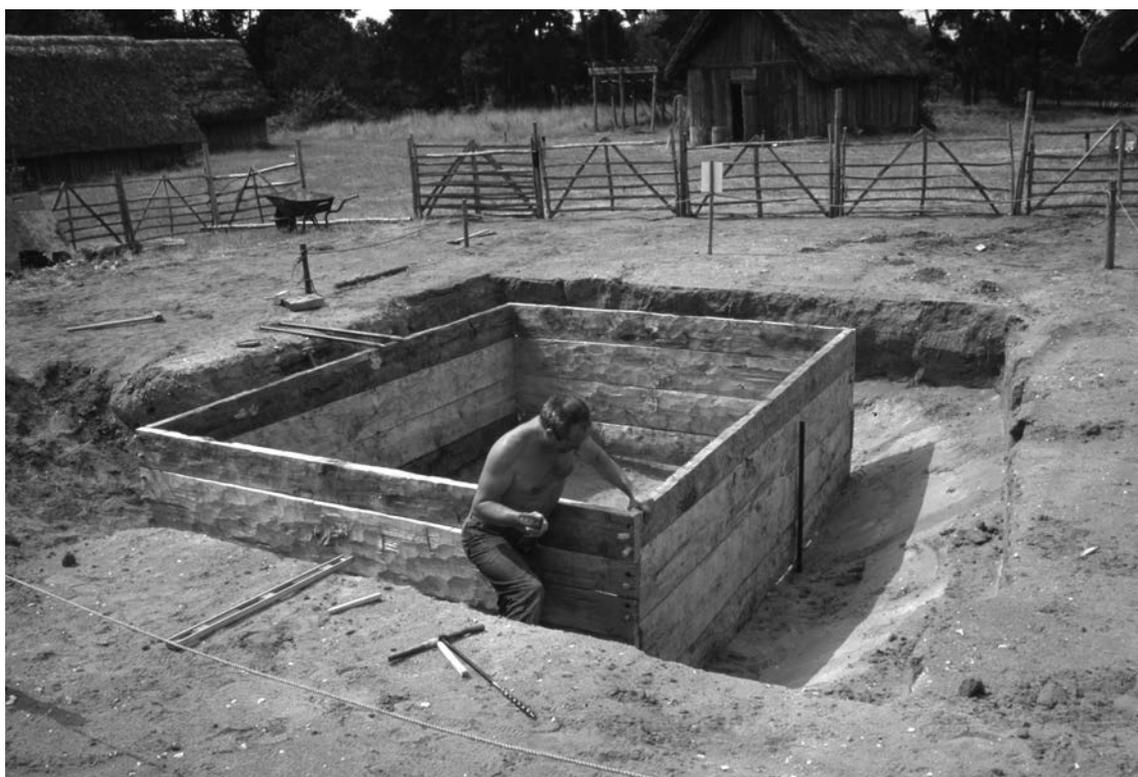
Plate 2.3 The cellar during construction (viewed from NE)

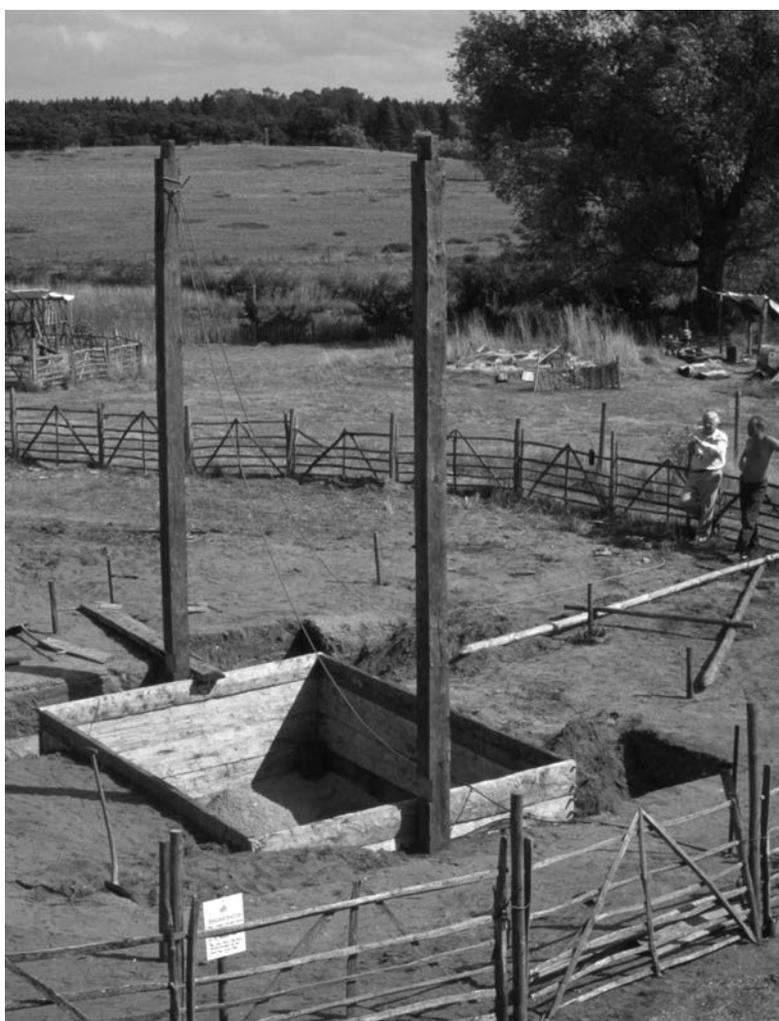
Plate 2.4 After completion of the cellar, erection of the ridge-posts and infilling behind the cellar (viewed from NW)

The Farmer’s House was constructed as a six-post structure with large ridge-posts located centrally along the (short) E and W sides of the sunken feature, each 6.25m long x 0.18m square (Plate 2.4). These were located 4.20m apart and set in post-holes *c.* 0.60m deep below the base of the cellar. The ridge beam, which measured 7.20m long x 0.18m square, was fixed on top of each ridge-post with a mortise and tenon joint. The top of each ridge-post had a central, two-shouldered tenon with rectangular mortises cut into the ridge beam. None of the posts had any form of preservative treatment, before insertion, to reduce the rate of fungal decay. However, the posts were placed on timber pads (*i.e.* flat pieces of oak inserted in to the base of each post-hole), to give greater stability but also to help protect the end-grain of each post.

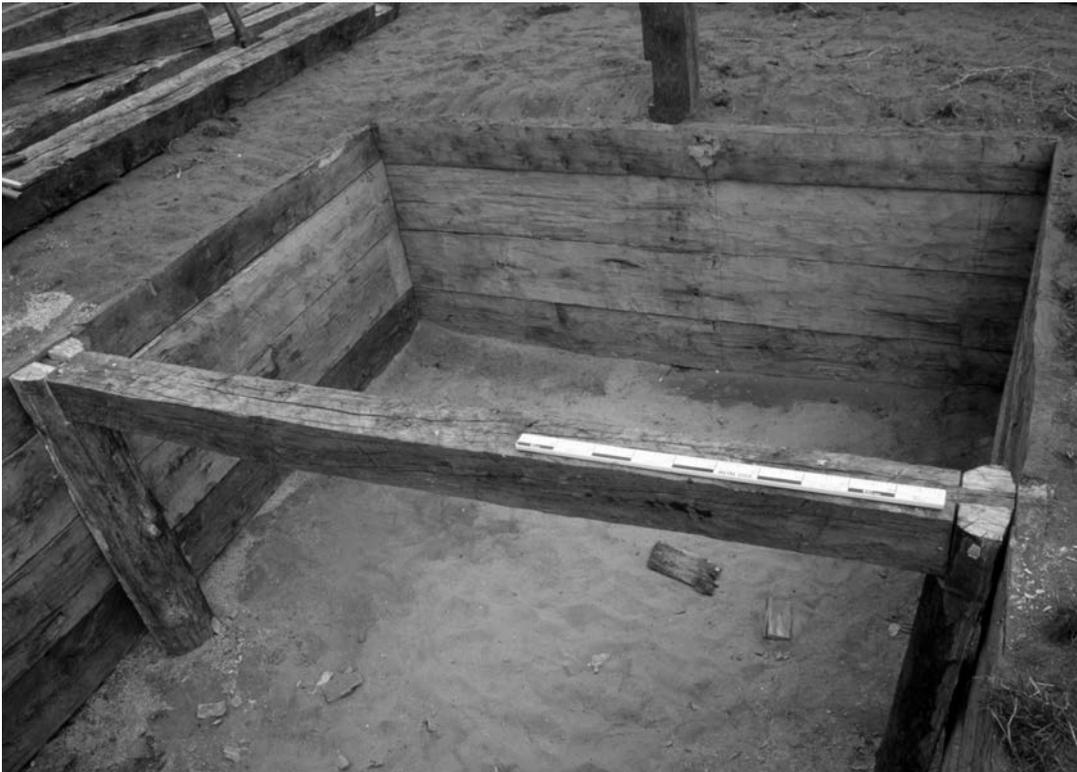
Plate 2.5 The central posts and supporting joist. Notice already the accumulation of fine material around the base of the cellar

The Farmer's House was unique amongst the reconstructions of SFBs with a suspended floor, in that it possessed a lined cellar below the floor. The lined cellar measured 4.00m long x 3.00m wide and was c.1.40m deep from the ground surface. There were four tangentially split boards along each side of the cellar, measuring c.0.36m wide x c.0.06m thick, and pegged at the corners (Plate 2.3). The boards were placed behind and outside the corner-posts, passing in front of the two ridge-posts. However, the lowest boards were set directly on the base of the pit and not in a trench like the original archaeological evidence within SFB 12. Two substantial posts, c.0.20m in diameter and left in the half-round, were inserted midway along the long sides of the pit to prevent the boards bowing inwards, although strictly there was no archaeological evidence from SFB 12 for deep post-holes at this location. These two posts were stabilised by a joist or tie 0.18m square across the width of the cellar, attached with mortise and tenon joints (Plate 2.5).

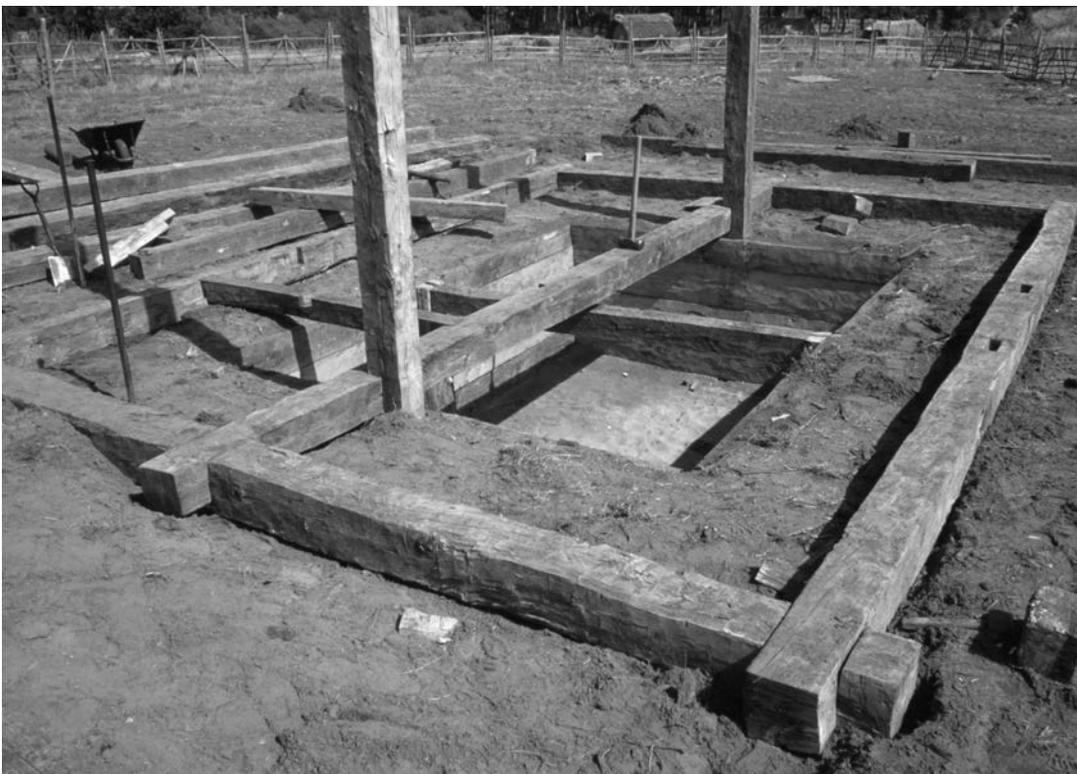
Plate 2.6 The floor joists (viewed from SW)

There were floor joists at ground level along all four sides of the building, each 0.20m square and half-lapped together at the corners, forming an interlocking base for the superstructure (Plate 2.6). The inner edge of each joist was located 1.05m away from the edge of the cellar along the gable sides and 0.80m along the long sides. The N and S joists, along the long sides of the building, measured *c.*6.30m long while the E and W joists, along the gable ends, were both *c.*5.20m long. These provided an internal floor area to the building of 32.50m², over twice the area of the lined pit (12.00m²). There was also a central (E–W) joist (same dimensions as the outer joists), half-lapped to (the N side of) the ridge-posts and also lapped on to the outer joists at the foot of the walls.

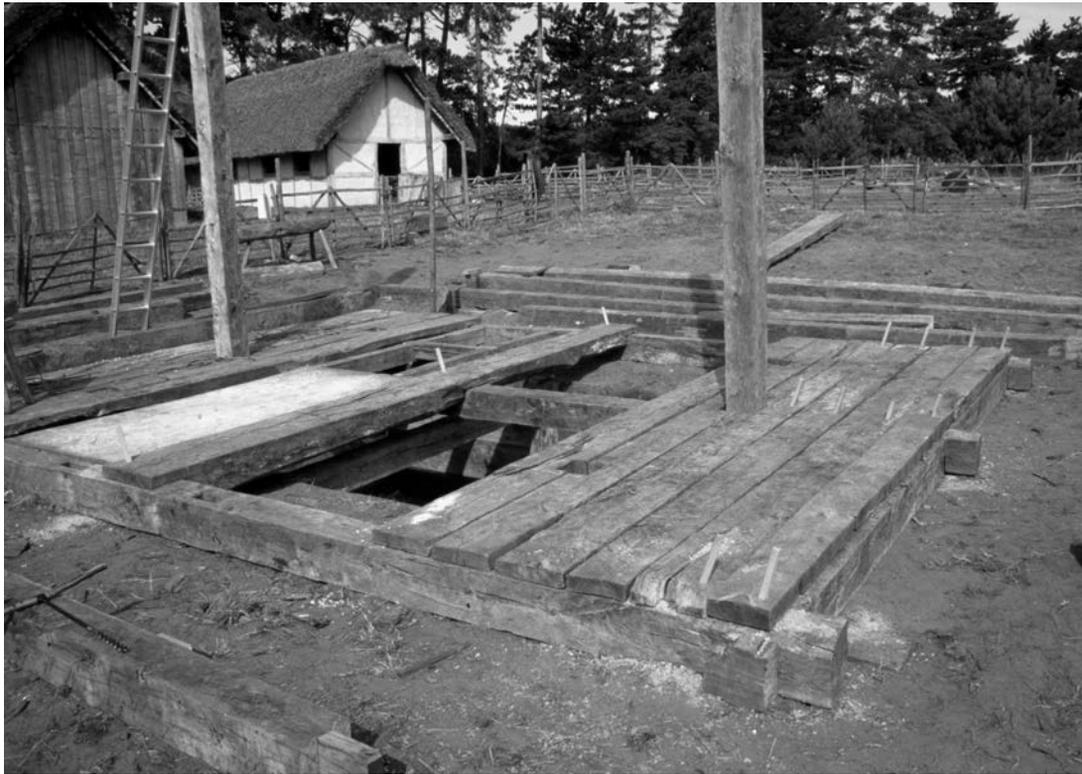
Plate 2.7 The suspended floor during construction (viewed from SE)

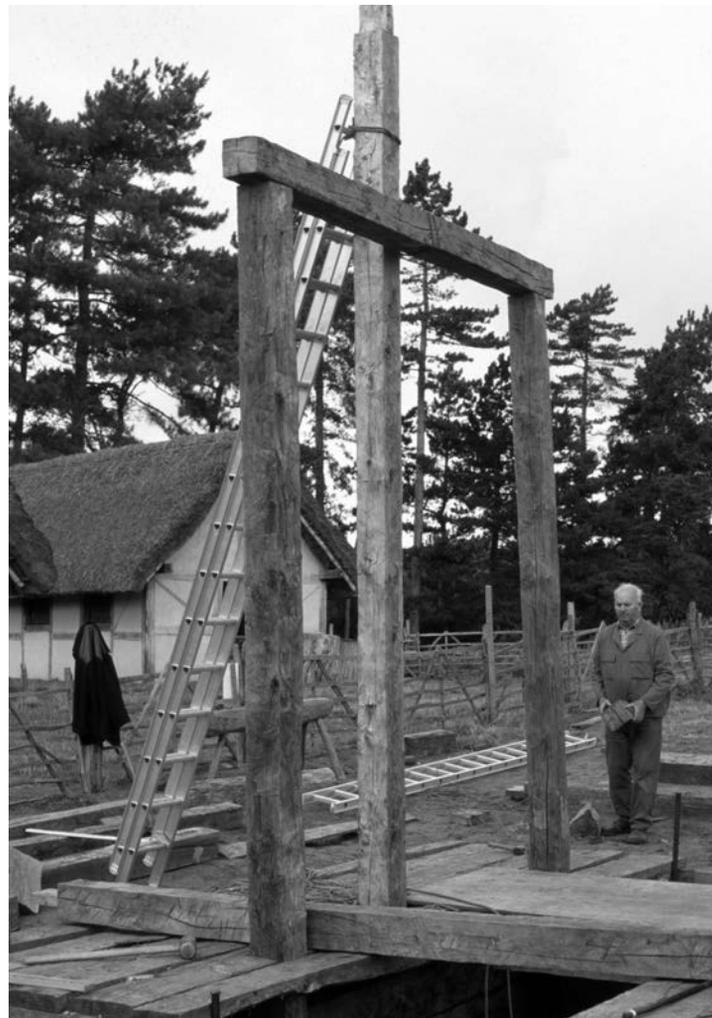
Plate 2.8 The frame during construction, showing the W end of the building after the ridge- and corner-posts have been erected and the upper tie beam fitted to the top of the two corner-posts (viewed from SE)

front of the ridge-posts (the corner-posts were offset in front of the ridge-posts). These were attached to the top of the corner-posts with a mortise and tenon joint (Plate 2.8). Each purlin, measuring 7.20m long x 0.18m square, was lap-jointed on to the top of the upper tie beams, directly above the corner posts (Plate 2.9).

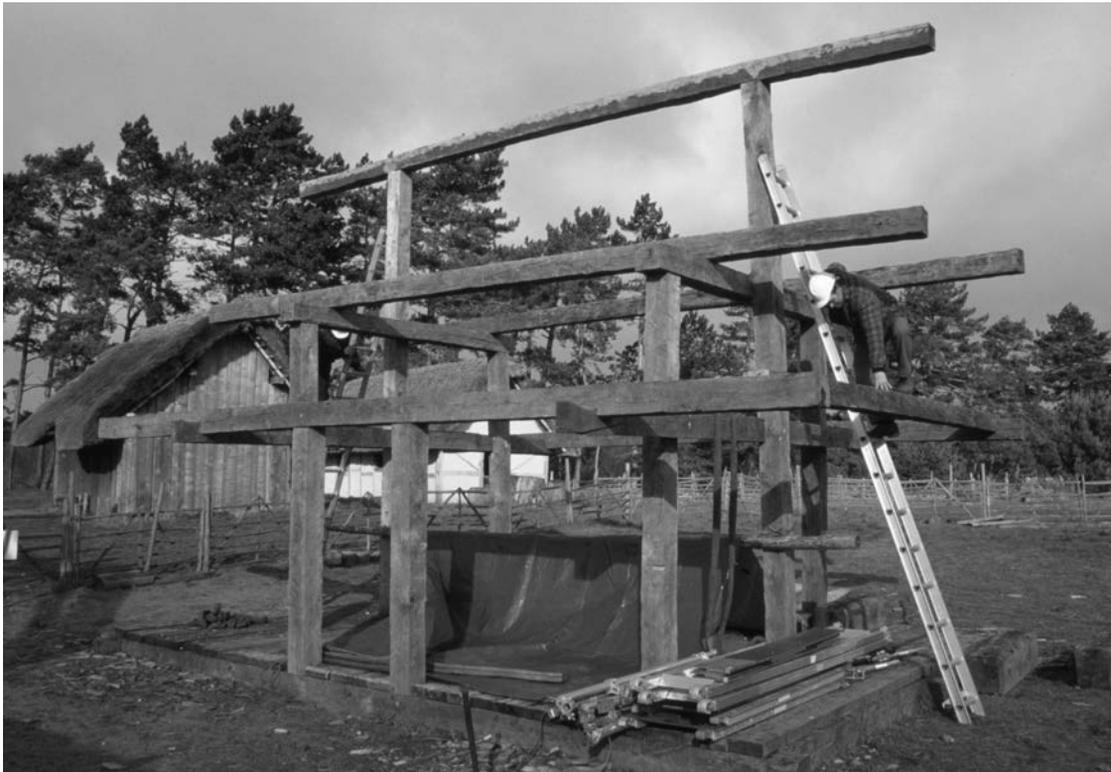
Plate 2.9 The frame near to completion, with upper and lower tie beams supporting the purlins and wall-plates respectively, the ridge beam fitted to the top of the two ridge-posts and with the two door-posts fitted centrally along the S side of the building (viewed from SE)

Two lower tie beams, each 5.20m long x 0.18m square, spanned the width of the building, 2.00m above the ground surface. Each lower tie beam was lap-jointed and pegged onto the corner-posts and the ridge-posts, slotting between the staggered three posts (Plate 2.9). Lower purlins or wall-plates, each measuring 7.20m long x 0.18m square, were lap-jointed on to the top of, the lower tie beams. The S wall-plate was, in addition, fixed directly on the top of the two door-posts, and formed the top of the door and also the window frame. The tops of the wall boards were pegged to the outer side of the wall-plates.

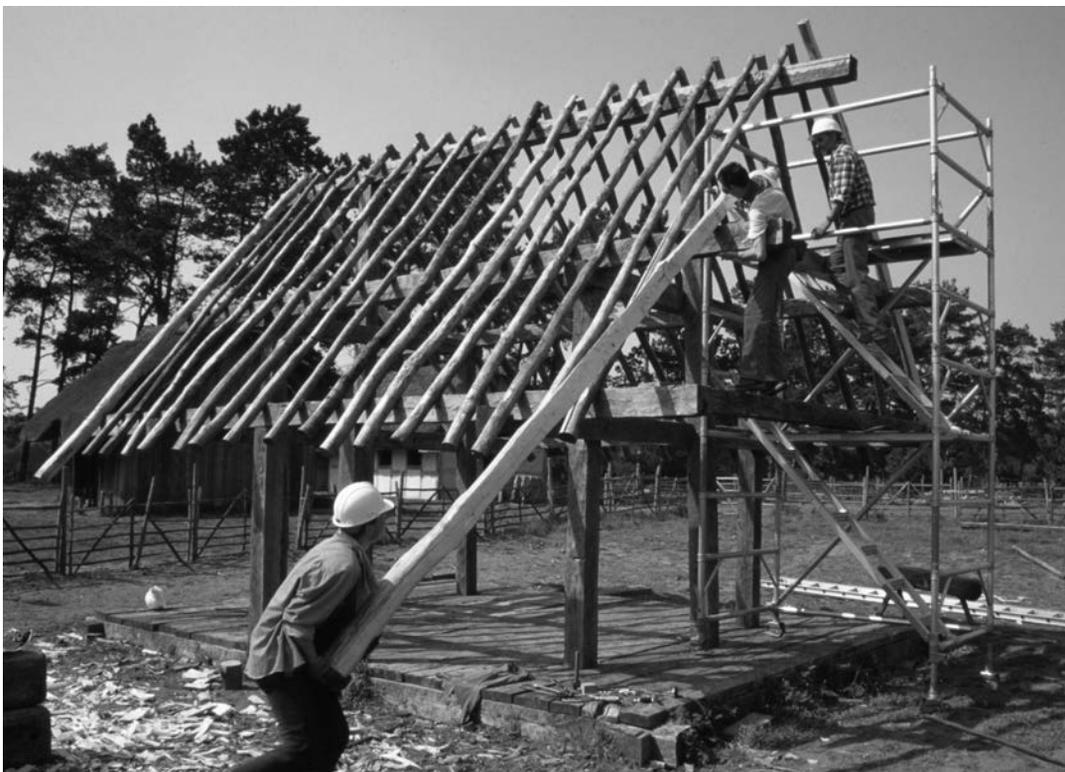
Plate 2.10 The completed frame during the fitting of the rafters. The rafters were attached to the frame before the wall cladding, which was then slotted under and around the rafters. However, the roof was thatched after the wall cladding had been fitted

The roofing consisted of modern wheat straw thatch (an estimated two tonnes) on ash and split ash rafters (Plate 2.10). There were 20 rafters, each c.3.90m long x c.0.10m in diameter, on either side of the roof. The rafters were bird-mouthed, and secured with pegs onto the ridge

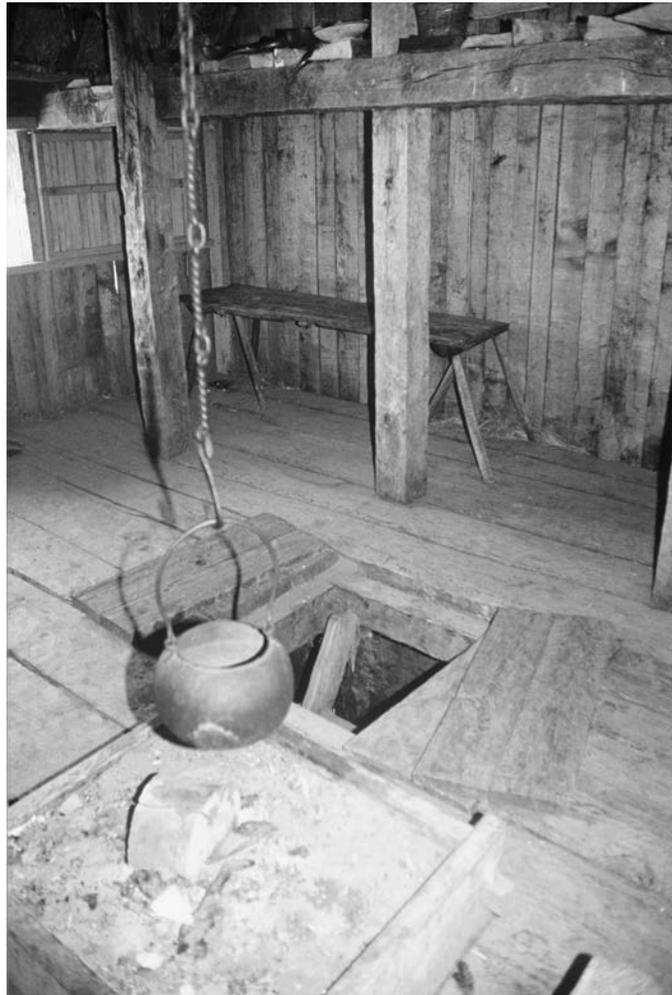
Plate 2.11 The trapdoor and step-ladder after completion, behind the central fire-box and with the cauldron suspended above it (viewed from NE). The image also shows a table in the SW corner, against the W wall of the building

The cellar was accessed through a trapdoor, located W of the central fire-box (Plate 2.11). The central E–W joist formed the S edge of the opening, with additional N–S joists between the N and central E–W joists forming the E and W sides and with an additional E–W joist between these forming the N side. The trapdoor was made from four short planks, aligned E–W (unlike the other floor planks). Eight iron rods, of varying lengths, were subsequently threaded N–S through the planks and a secondary sheet of plywood was fixed to the underside to give additional strength to the trapdoor.

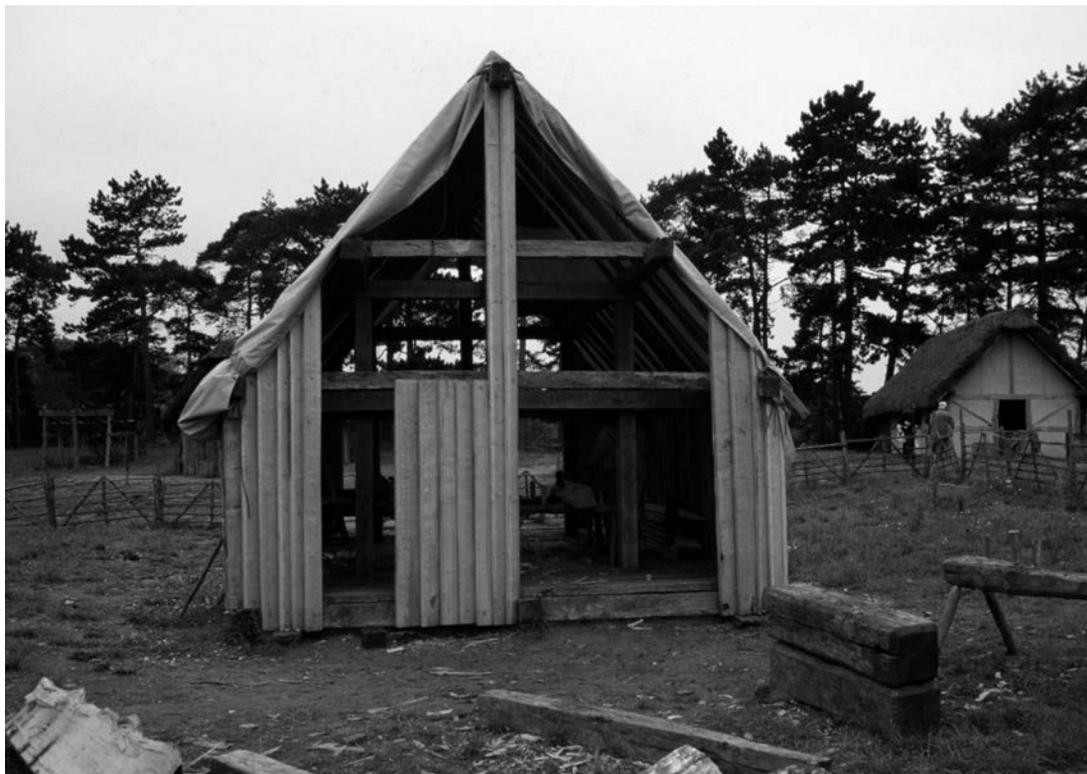
Plate 2.12 The wall cladding being fixed to the E side of the building (viewed from E)

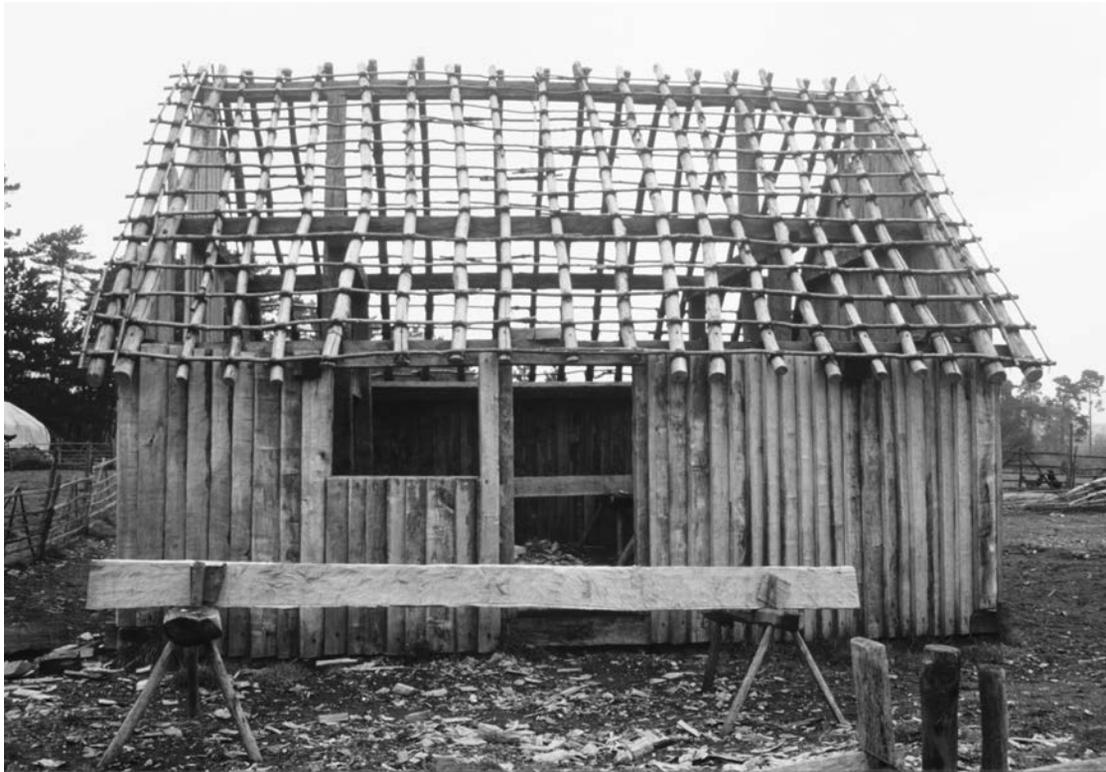
Plate 2.13 The S side of the building after the wall cladding has been fitted, with window and door openings, and after the hazel batons have been attached to the ash rafters with tarred twine. The board in front of the building is one of the final wall boards for the W wall

beam, purlins and wall-plates, with a roof angle of 45 degrees. Hazel rods or batons, each c.0.03m diameter, were tied to the rafters, and also the thatch straw was fixed to the batons, with tarred twine and twisted hazel spares (Plate 2.13). There were 13 rows of batons on either side of the roof.

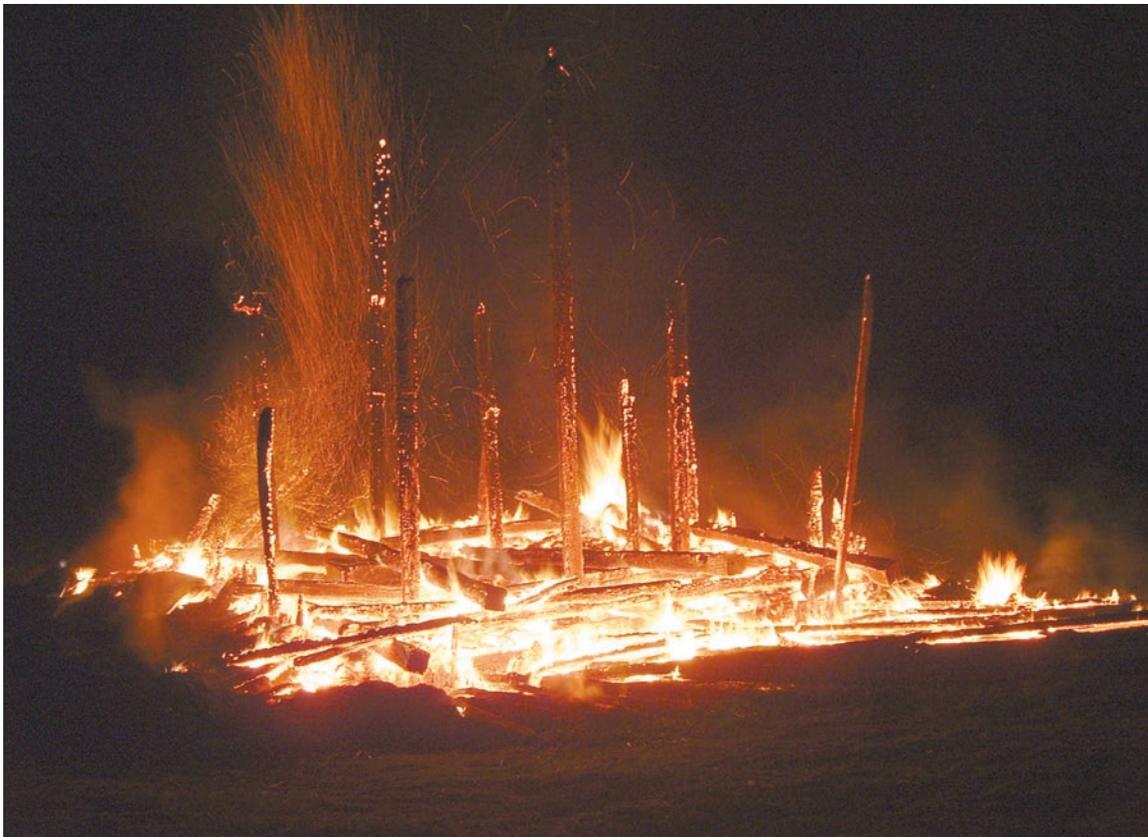
Plate 3.1 Photograph taken during the fire, at 03.30hrs, from the NW corner of the building. Only the posts and several wall boards remain vertical. The wall-plates lie immediately above the outer floor joists, having collapsed. The N wall-plate is sealed below several structural timbers, probably the lower tie beams, and also several wall boards. The two purlins lie E–W across the cellar, resting above other parts of the frame that have also collapsed. Wall boards along the W gable side, which have fallen outwards, lie burning on the ground
