Experimental Archaeology and Fire: the investigation of a burnt reconstruction at West Stow Anglo-Saxon Village

by Jess Tipper

East Anglian Archaeology
Report No. 146, 2012

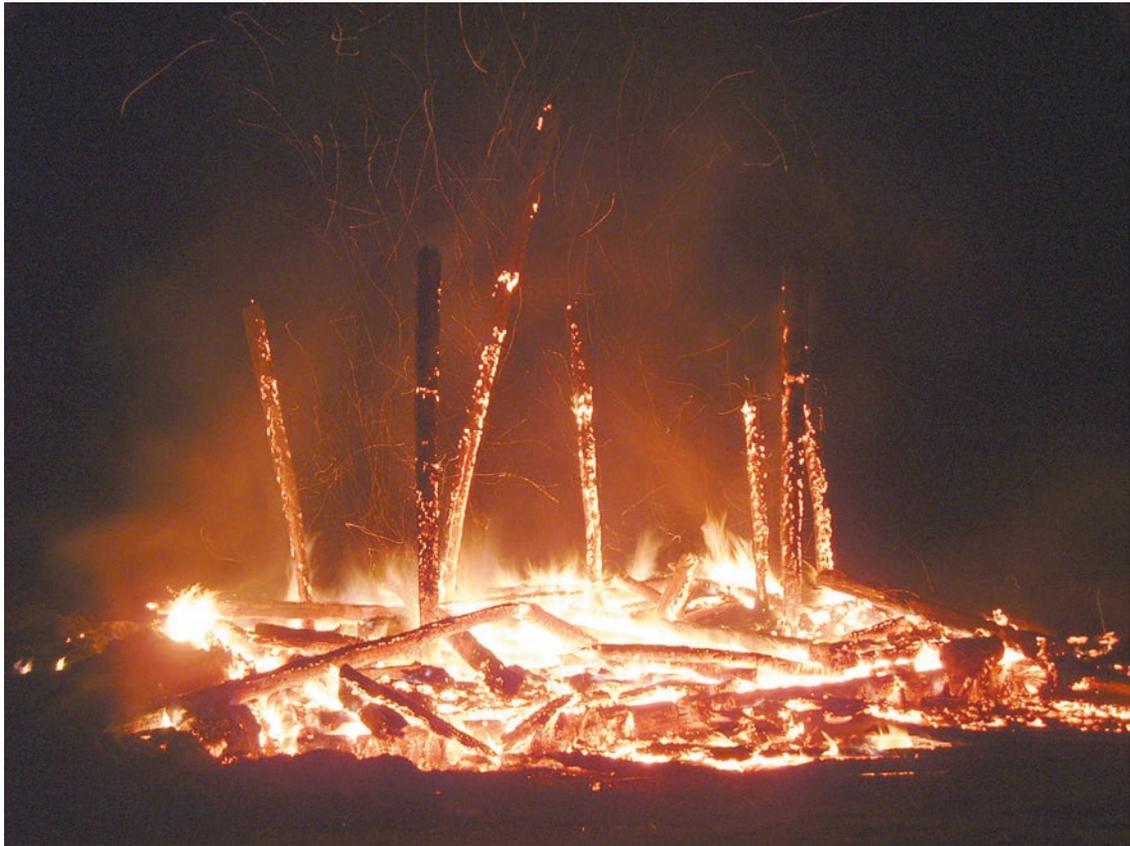
Plate 3.2 Photograph taken during the fire, at 04.24hrs, from the NW corner of the building. The E ridge-post is recorded during the moment of collapse, falling SW towards the doorway. All four corner-posts and both door-posts are still upright, although the NE corner-post has a precarious lean towards the N. The fire-box can be still distinguished on the suspended floor, immediately to the left of the NW corner-post

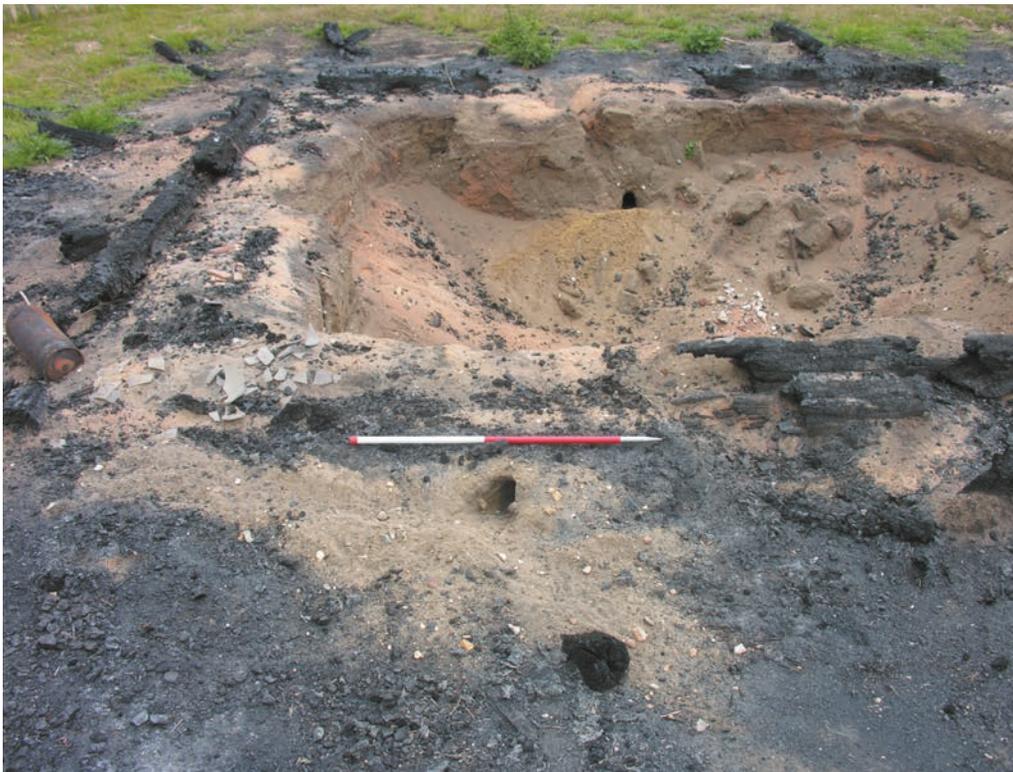
Plate 3.4 The extent of burrowing on 24 June 2005 (viewed from S). There is one burrow outside the wall line on the S side of the building, below the location of the window, and another on the N side of the pit, level with the top of the side collapse

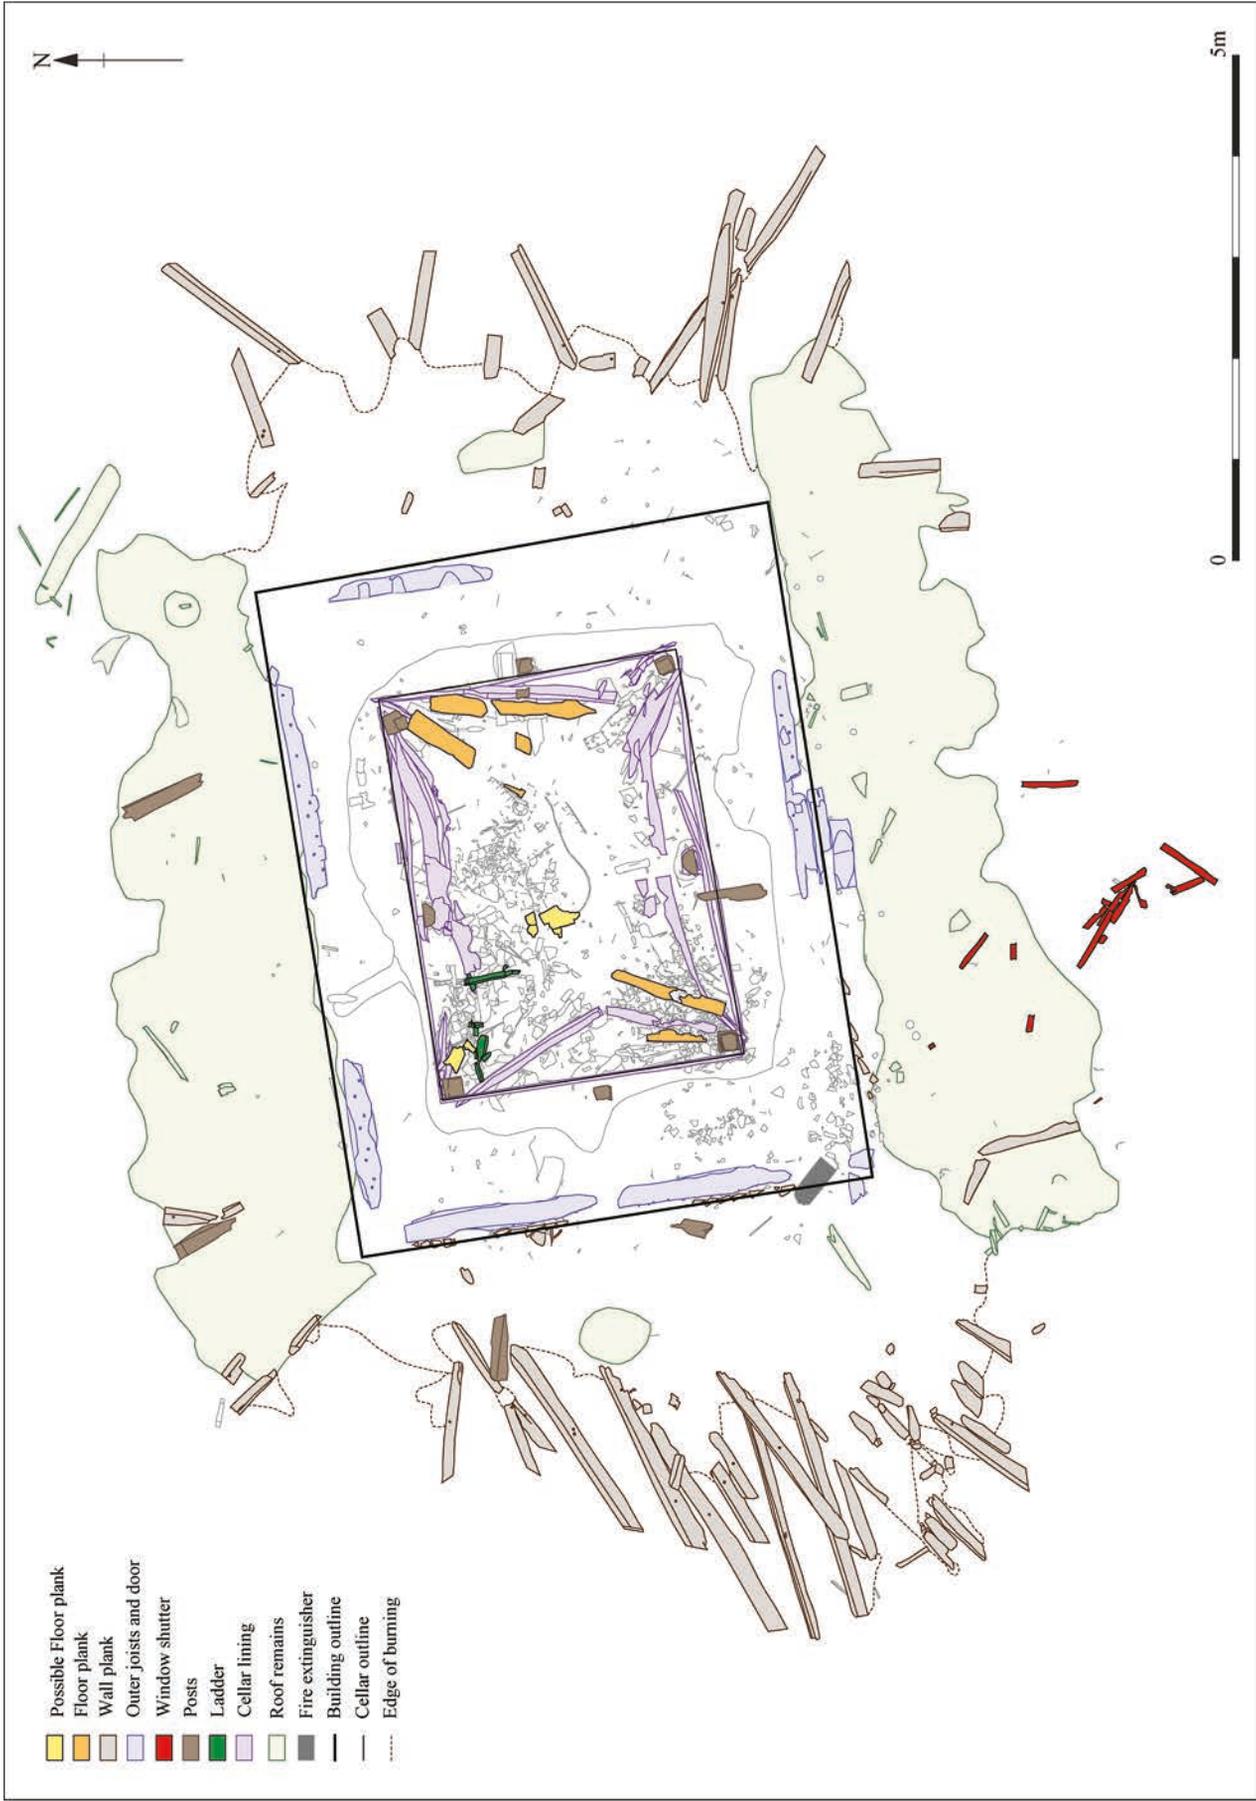
Figure 3.1 Plan of the Farmer's House remains. The limit of burnt ground is indicative because there was no clear edge

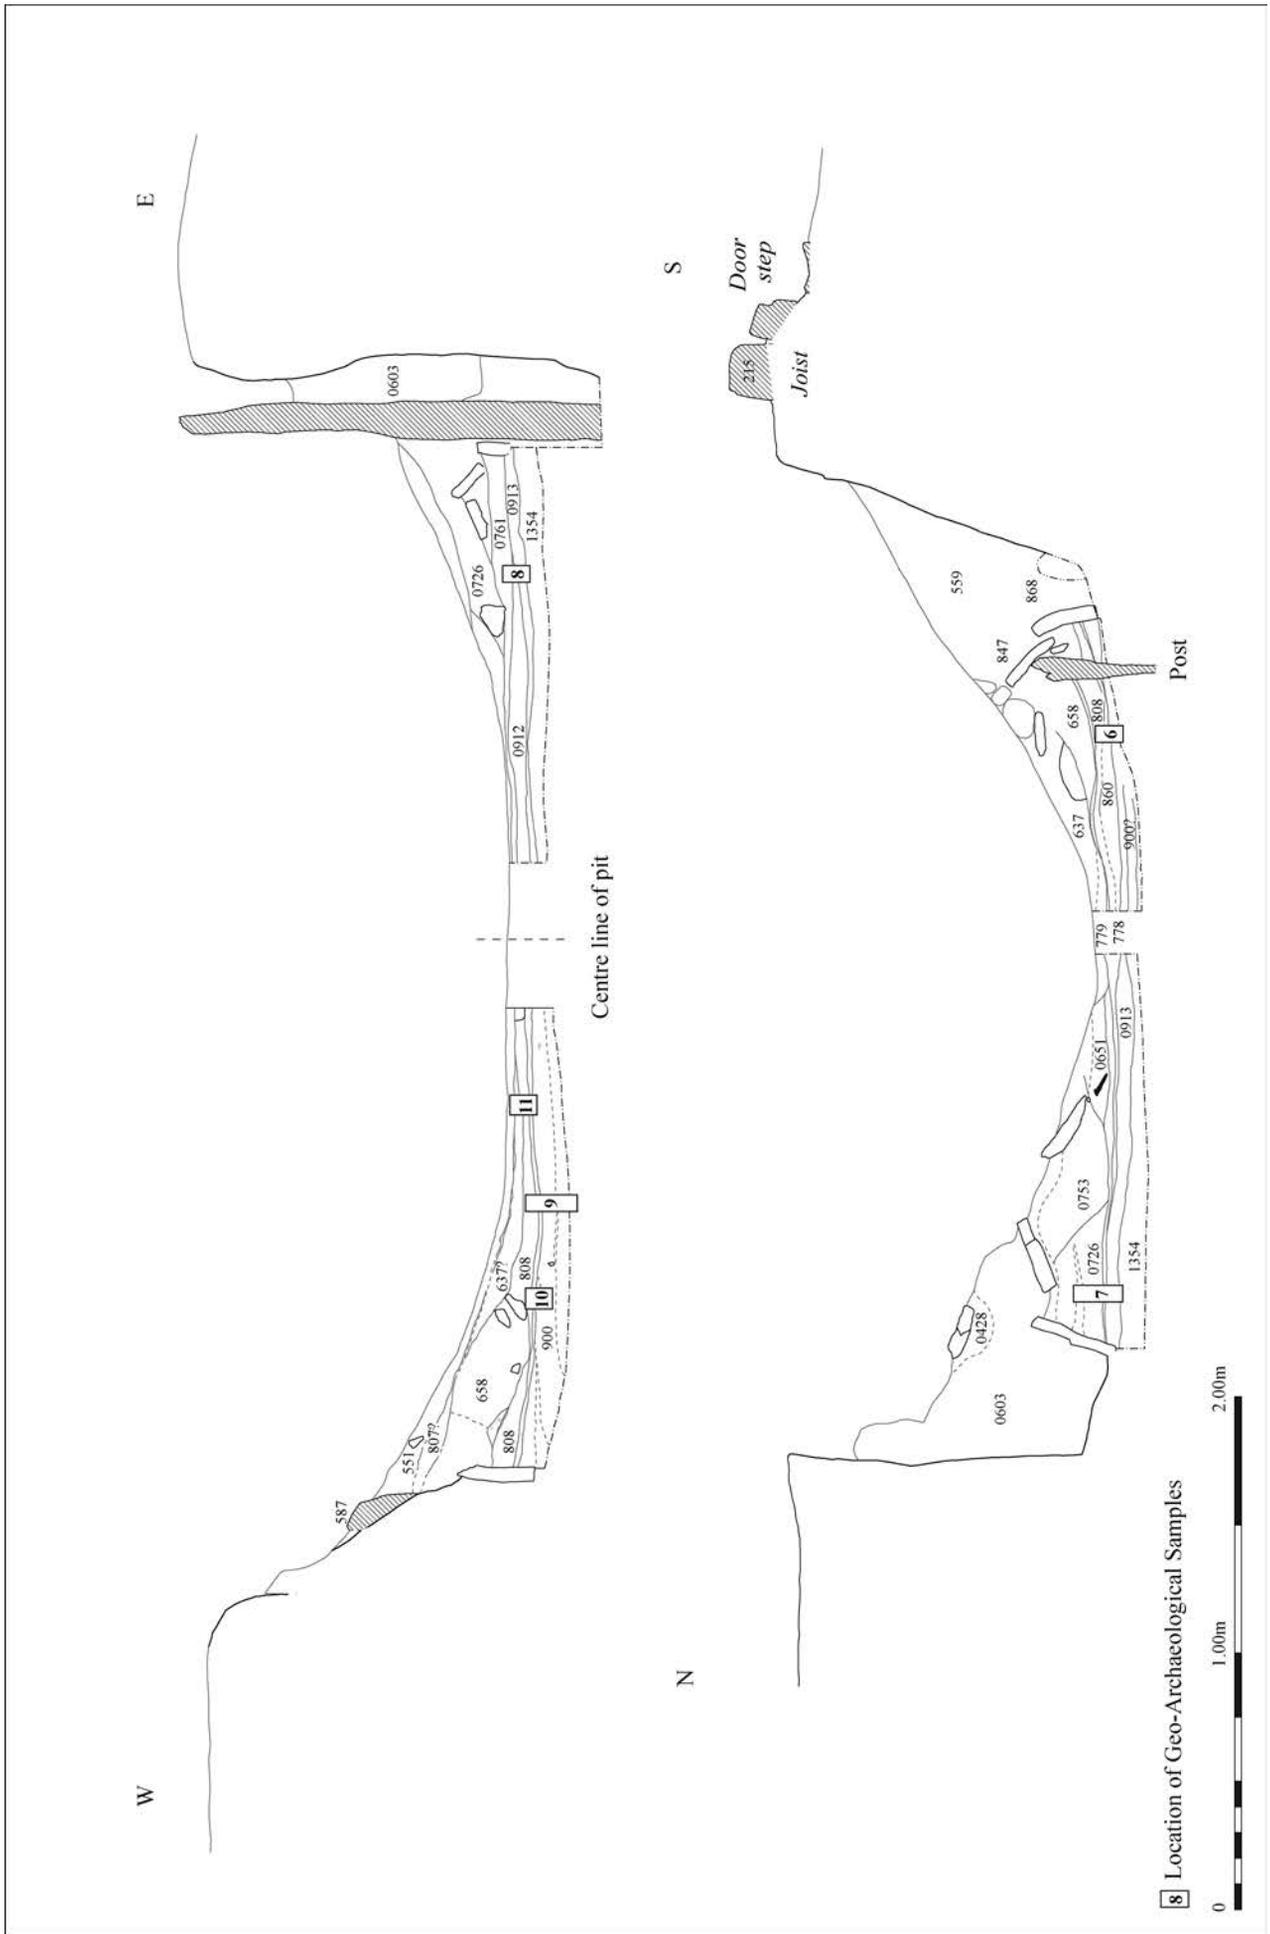
Figure 3.2 Sections across the cellar pit, E-W and N-S (see Table 3.1 for context descriptions)

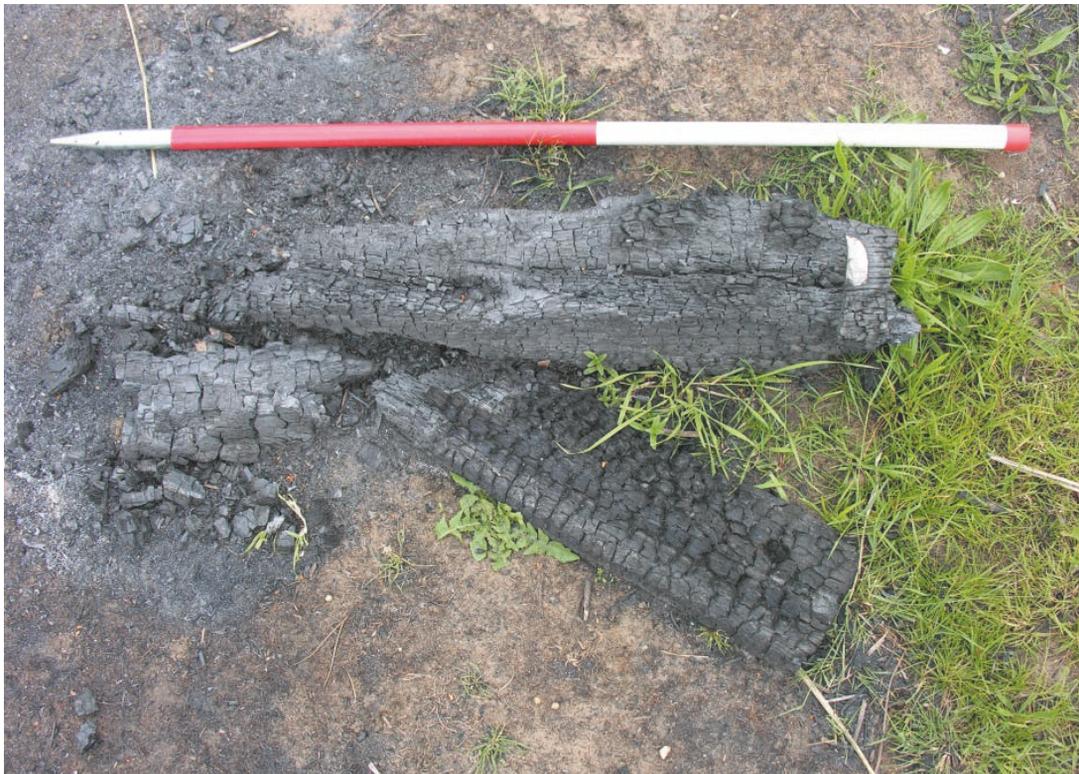
Plate 3.5 The tenon end of the NE corner-post, lying across the flat upper end of a wall board from the N wall

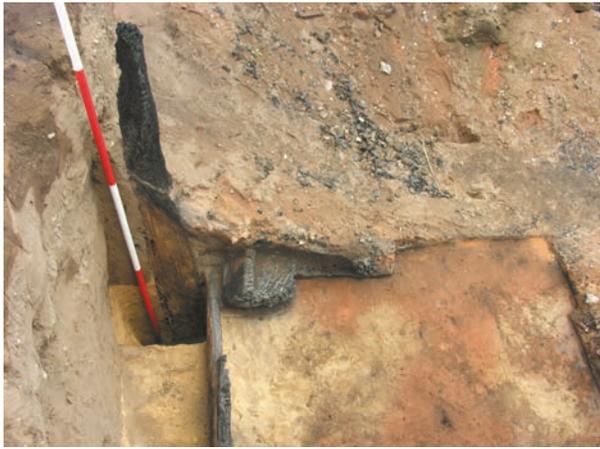
Plate 3.6 The uncharred base of the E ridge-post (top) within the post-hole (viewed from N), behind the lowest *in situ* cellar lining and the burnt sand base of the cellar; (above) after extraction from the post-hole in October 2005

1.82m long (i.e. 29% of the post surviving *in situ*). The top of the post was charred, and roughly level with the ground surface, *c.*1.30m above the base of the cellar lining (Plate 3.6a). In comparison, the top of the W ridge-post was *c.*0.55m below the level of the ground surface and only *c.*0.70m above the base of the *in situ* cellar lining.

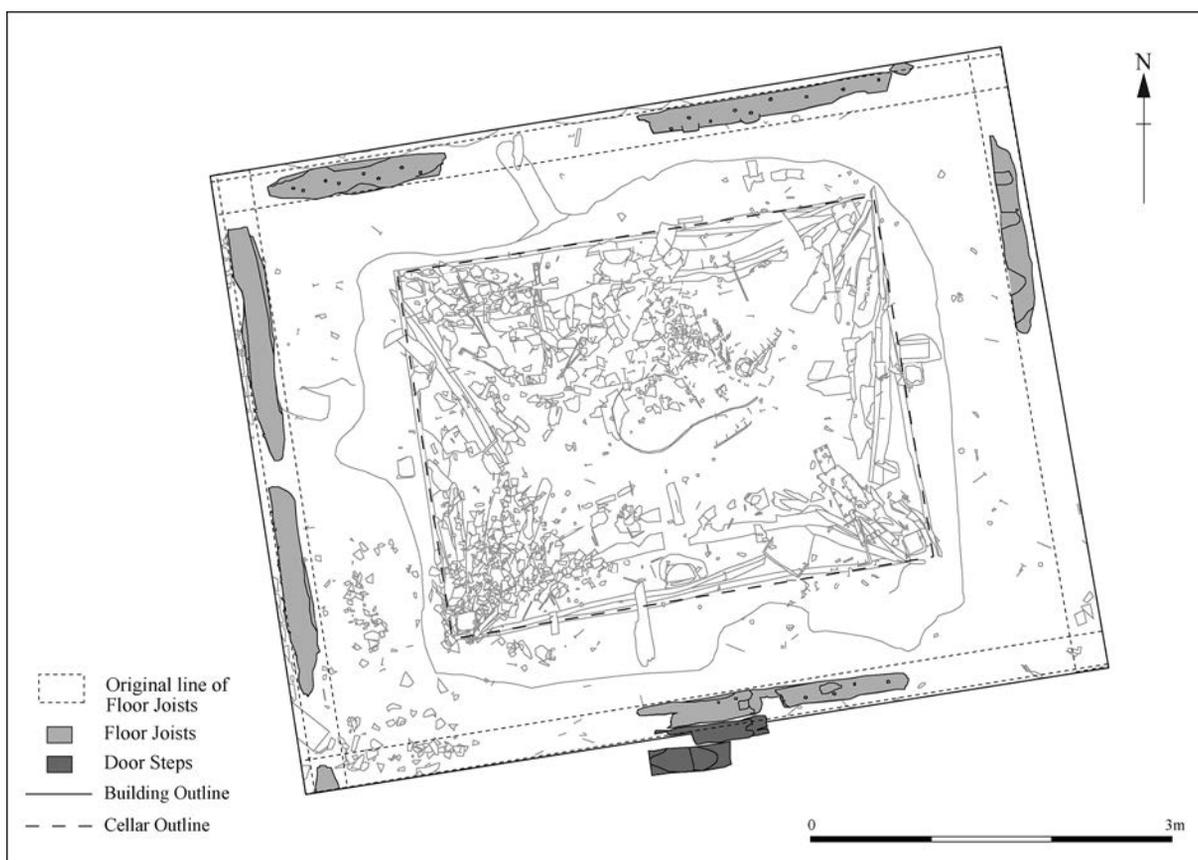
Figure 3.5 Plan of the surviving floor joists and doorsteps

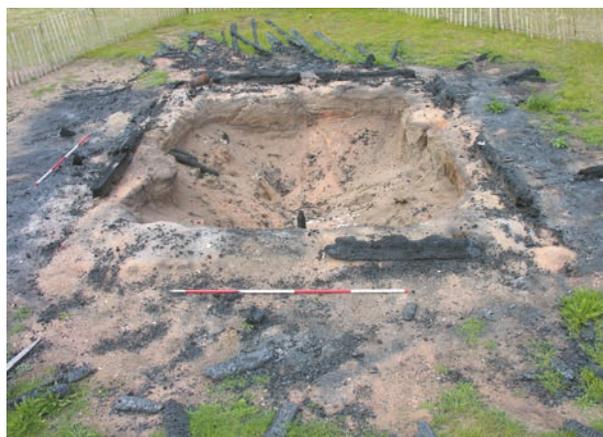
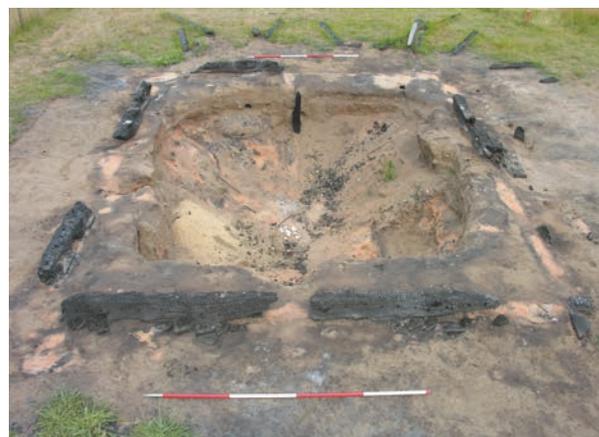
Plate 3.7 The outer floor joists a) before (viewed from E) and b) after removal of surface remains, showing the burnt orange sand below, and marking the position of the floor joists (viewed from W)

was superficial and formed only a thin outer layer. The underside of the surviving joists was uncharred and the ground surface below the surviving joists was completely unburnt (Plate 3.12), except in those areas around the outside of the building where erosion had occurred and the joists had been undercut. Similarly, the area behind (on the N side of) the S floor joist had been protected by the accumulation of soil below the floor planks inside the door, producing a distinctive char pattern (see below).

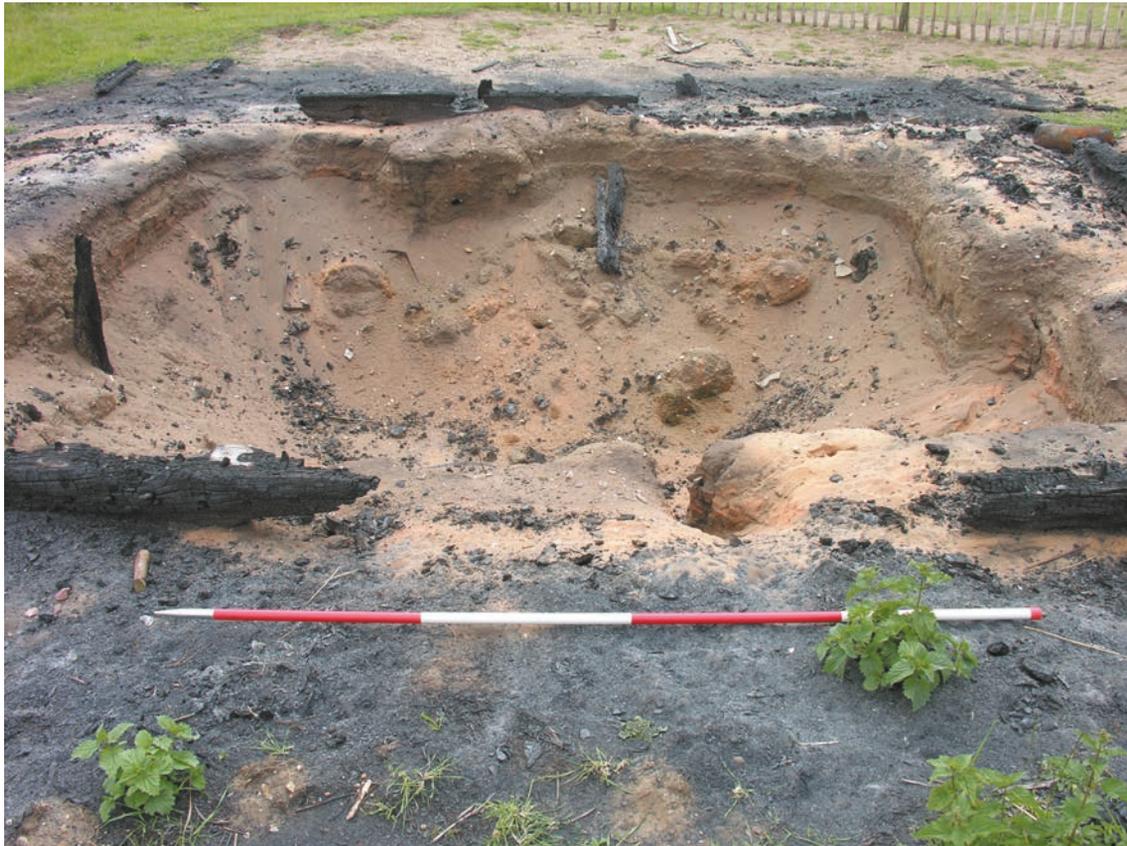
Plate 3.8 The remains of the N floor joist, and the destruction caused by the animal burrow below the central part of the joist (viewed from N)

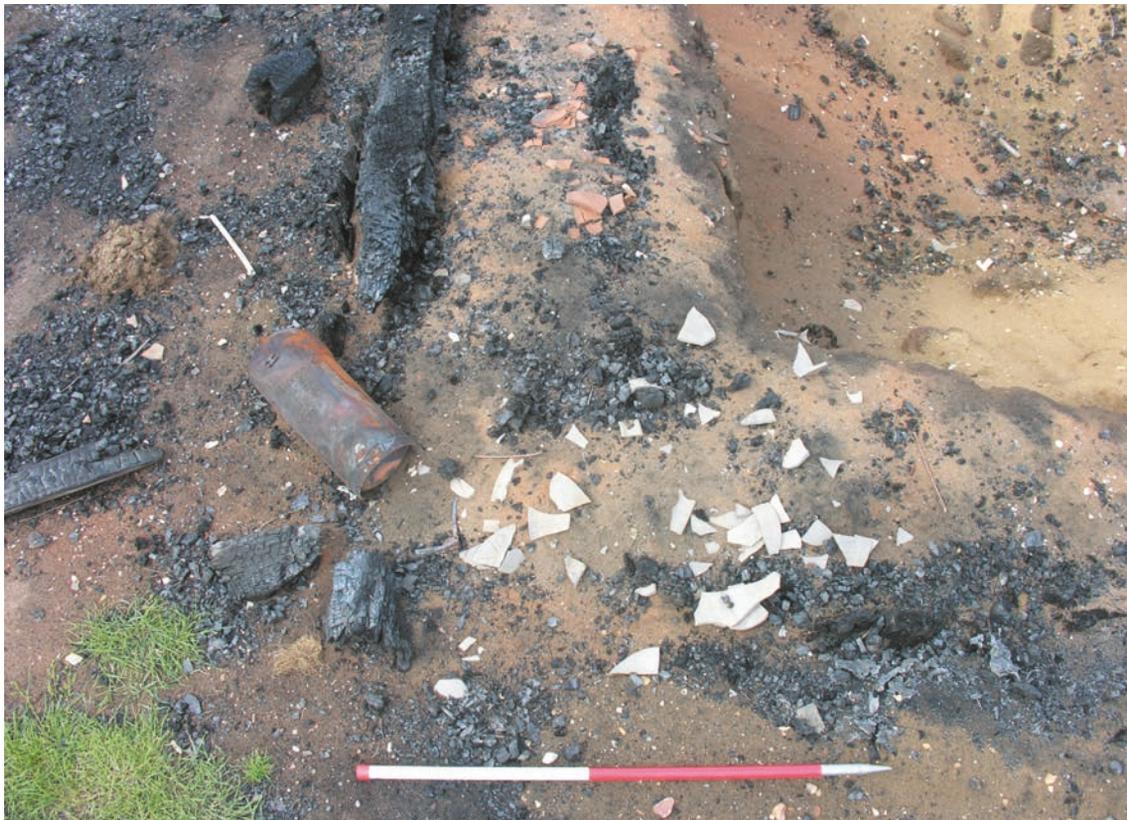
Plate 3.9 The fire extinguisher lying across the wall-line on the W side of the building (viewed from S). Pot-sherds from the vessels stored on the shelf at the W end of the building are strewn across the ground surface within the internal area of the building and across the line of the (destroyed) S floor joist. The pale sherds in the foreground are from Vessel 1 (V1), while the red- brown sherds in the background (to the N) are from V2 and V5

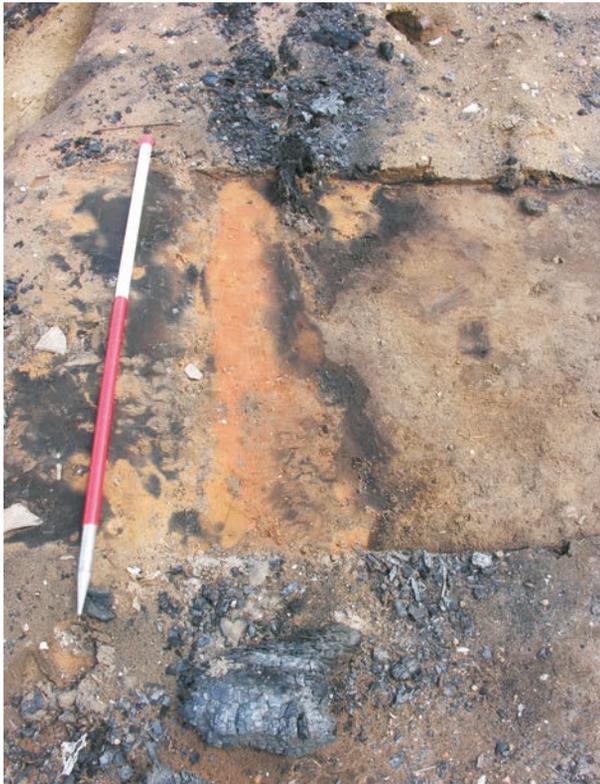
Plate 3.10 The burnt orange sand marking the line of the S floor joist, which had been completely destroyed, after removal of the surface remains (viewed from W)

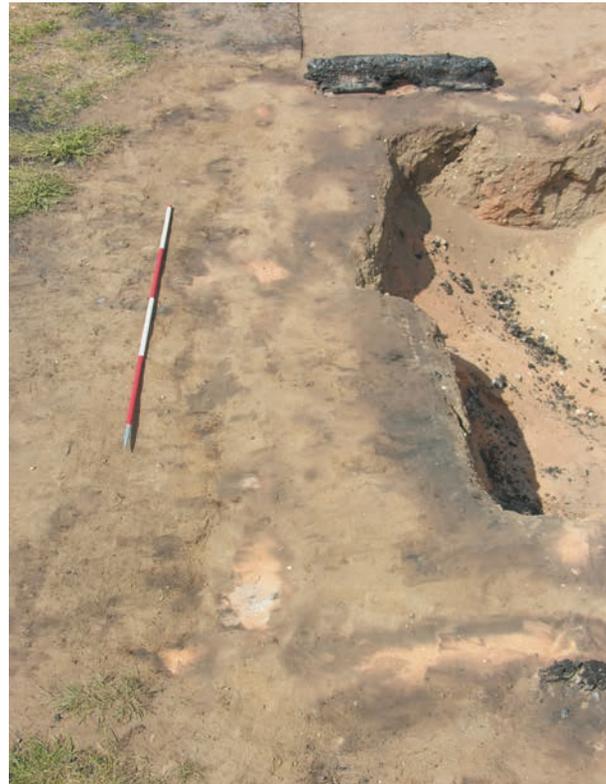
Plate 3.12 The W end of the building after the removal of the surviving floor joists, showing the unburnt areas directly below (viewed from S)

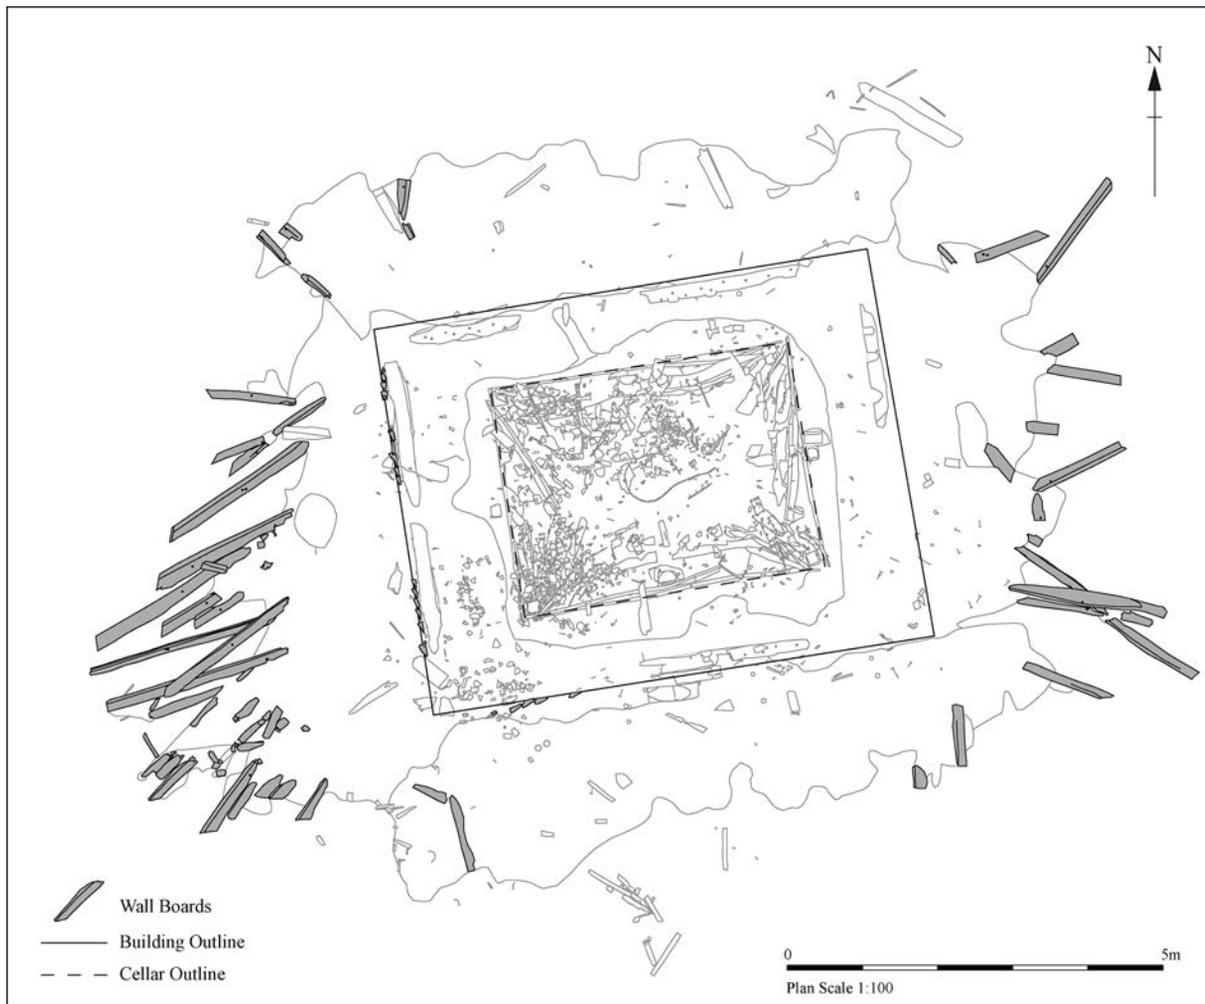
Figure 3.6 Plan of surviving wall boards that fell outwards onto the ground surface, outside the building footprint

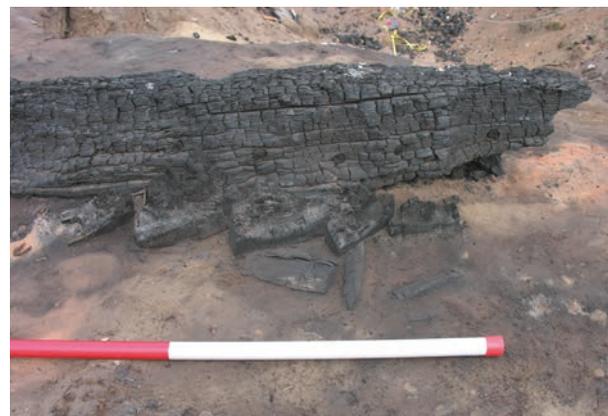
Plate 3.13 The heavily charred base of five wall boards *in situ* along the W side of the building (viewed from W)

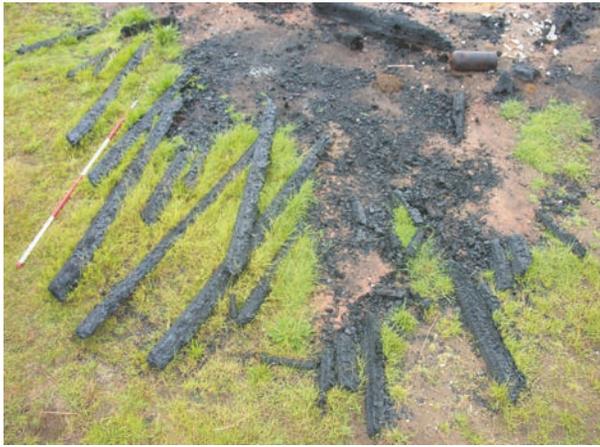
Plate 3.14 The group of wall boards from the W wall that had fallen to the SW, probably collapsing *en masse* (viewed from SW). The fire extinguisher, lying across the line of the W floor joist, is visible in the background

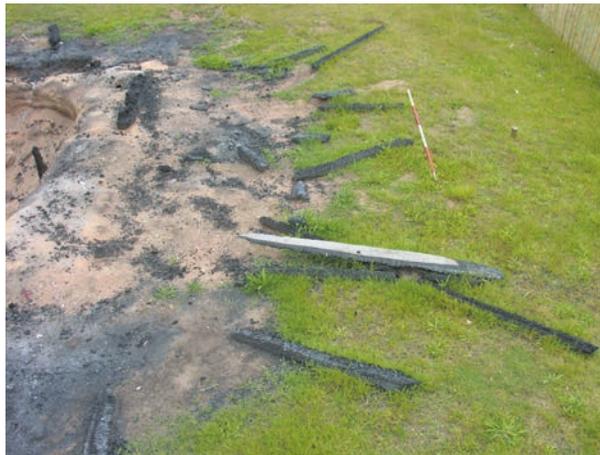
Plate 3.15 The surviving wall boards from the E end of the building (viewed from S)

Less survived of the E gable-end wall and there were the remains of only 13 or 14 partially charred wall boards, although the images of the fire show that many of the E wall boards also fell outwards onto the ground surface (Plate 3.15). These had a total combined length of c.15.25m, which is estimated at c.13% of the original wall. The remains of eight boards were over 1.00m in length, and the longest single surviving board measured c.2.15m, although

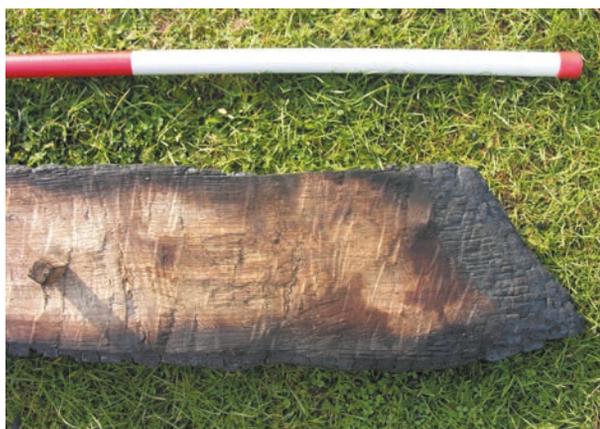
Plate 3.16 Underside (outer facing side when attached to the wall) and top (cut) edge of one of the surviving boards from the W wall. The main face of the board and the protruding end of a peg, which fixed the plank to the outer upper tie beam, are unburnt and the tool marks are clear

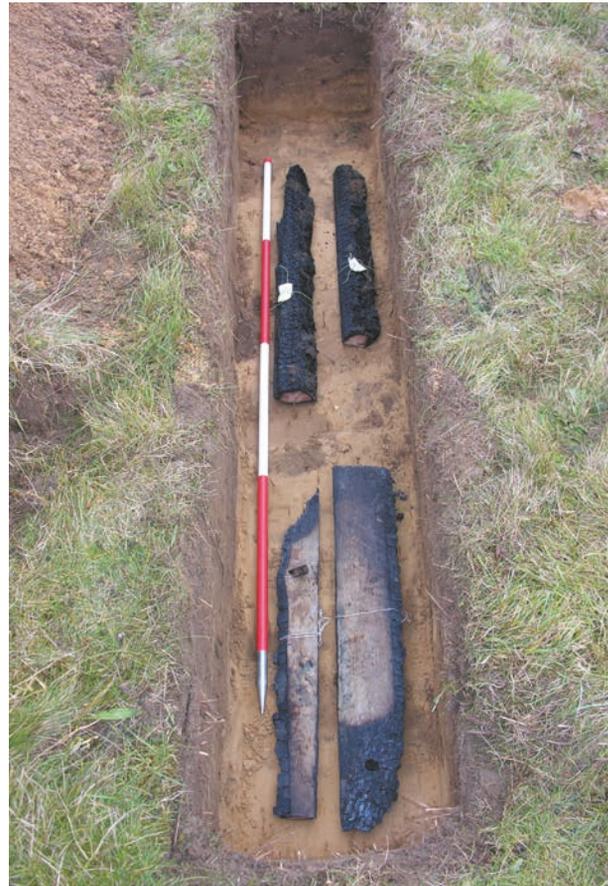
Plate 3.17 Several wall boards buried in a pit (one of four in total) in December 2005, in order to monitor the rate of decay. The boards were sectioned before burial, showing that the char depth was shallow; only the surface and ends of the surviving timbers was charred

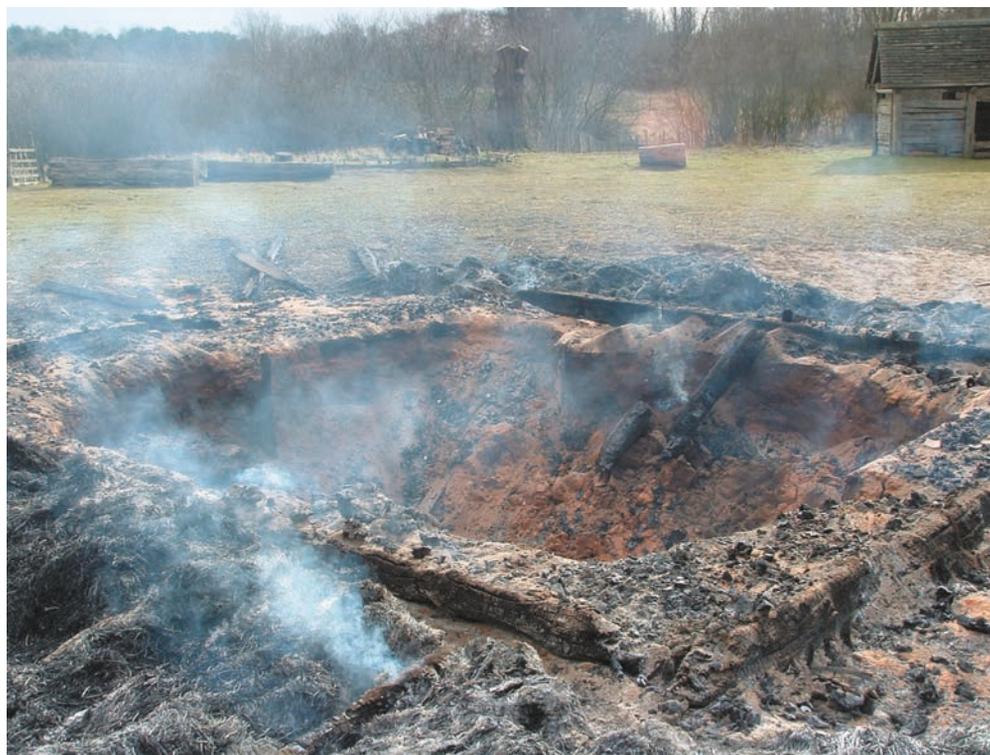
Plate 3.18 The morning after with the remains still smouldering, showing the remains of a substantial squared timber, probably a door-post, sloping down the S side of the pit (viewed from NW). Notice the prominent sand ridges on the ground surface beyond the S side of the pit, which had accumulated below the suspended floor on the surface in the area immediately inside the doorway

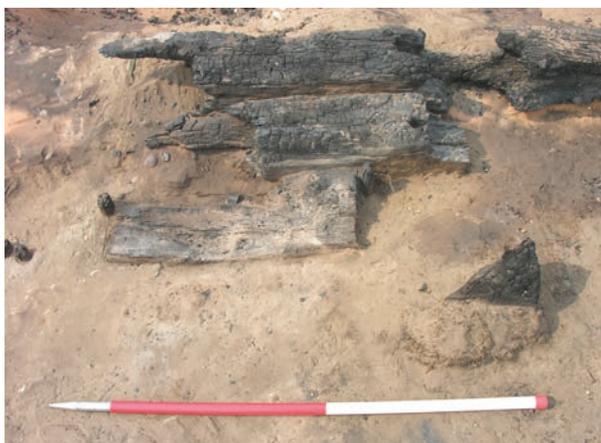
Plate 3.19 The charred doorsteps and (behind) the S floor joist with the remains of the mortise for the tenon end of the E door-post still apparent (viewed from S)

The charred remains of the mortise that held the tenon end of the E door-post was still apparent on the S outer floor joist. The mortise for the W door-post had burnt away leaving a large gap in the joist, but still marking the position of the mortise. There were also the partially charred remains of the two doorsteps, and the remains of

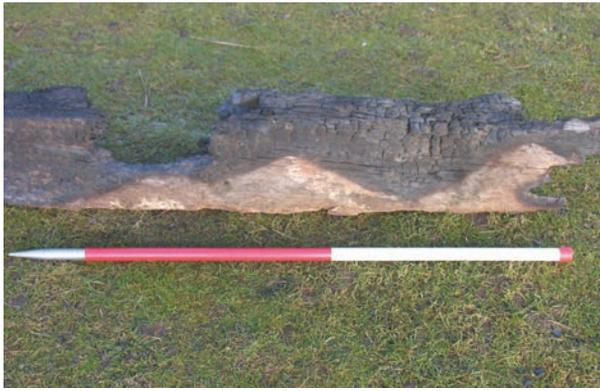
Plate 3.20 The char pattern on the inner (N) face of the S floor joist, showing the location of two ridges of material (marked as uncharred areas) that accumulated below the suspended floor directly below the doorway (taken after excavation in January 2006). The less prominent ridge on the left side was directly below the mortise for the E door-post

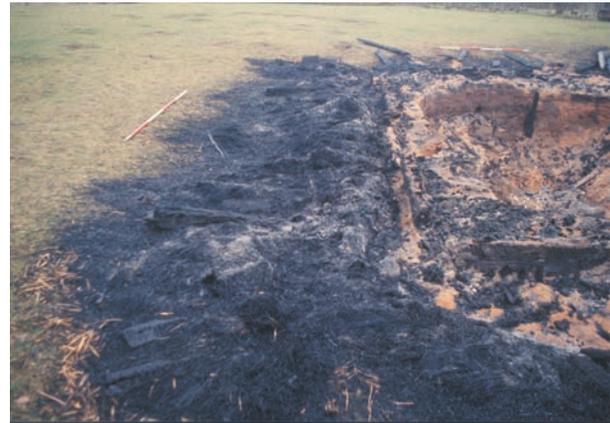
Plate 3.21 A pile of thatch ash along the N side of the building remains immediately after the fire (viewed from W). Notice that the material around the outer edge of the thatch deposit is uncharred. The upper tenon end of the W ridge-post is lying across the thatch

the outer edges of these heaps furthest from the fire, particularly around the NE corner of the building, was only partially charred (Plates 3.18 and 3.21). There were also the remains of smaller thatch ash piles along the gable ends, *c.*0.70–0.80m x 0.40–0.50m in area, where the ridge thatch had dropped down from the eaves. Both were located *c.*0.75–0.80m from the wall-line.

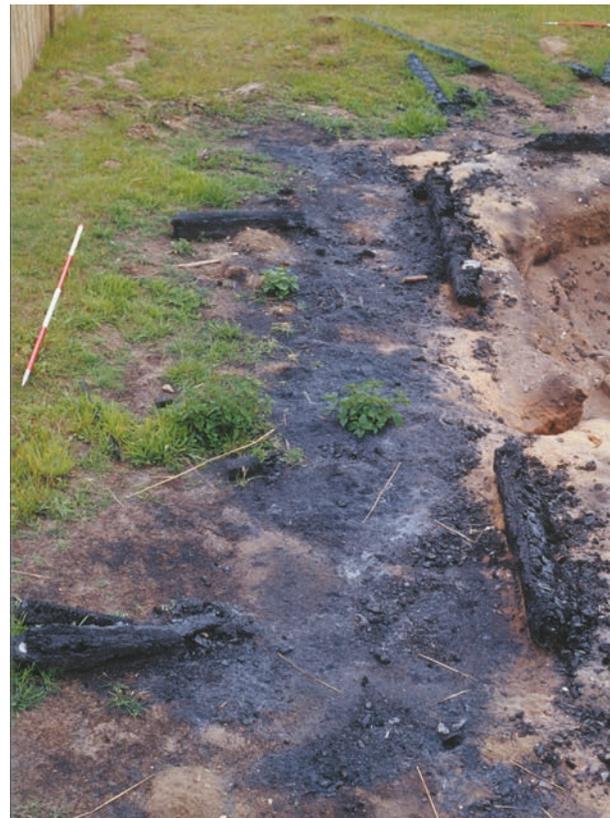
Plate 3.22 The remains of thatch ash along the N side of the building before excavation (viewed from W). The heap that was visible immediately after the excavation has been reduced to a thin and discontinuous layer

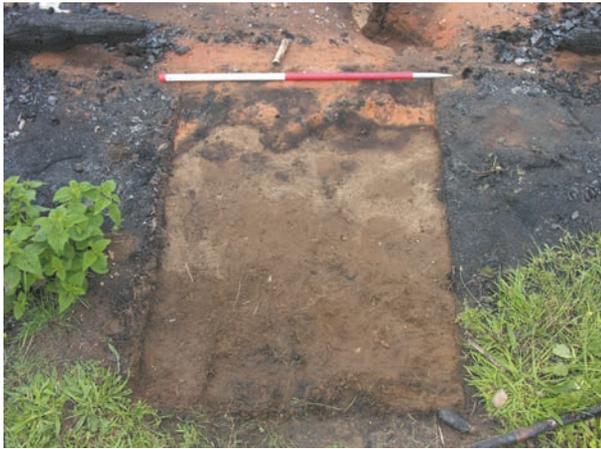
Plate 3.23 An excavated segment across the thatch ash along the N side of the building, which shows both the shallowness of the surviving thatch, originally a mound, and also the lack of burning to the ground surface directly below. Plant recolonisation has already begun, particularly along the edge of the deposit

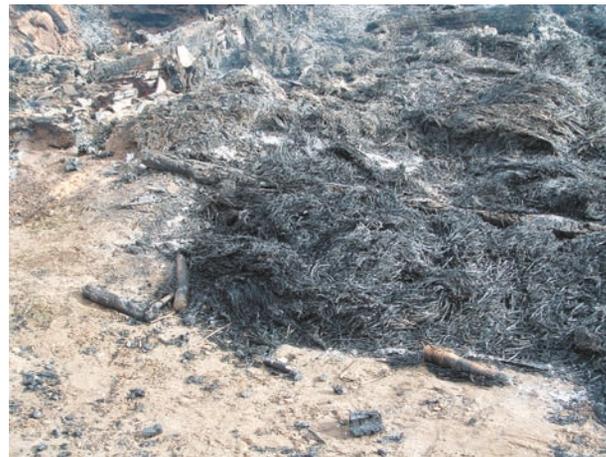
Plate 3.25 Surviving uncharred roof fixings, principally hazel batons and tarred twine, around the edge of the charred thatch ash deposits along the S side of the building remains (viewed from SW)

A small number of roof fixings were recovered from the remains along with several piles of unburnt thatch. All were located around the edges of the burnt area in the SW, NW and NE corners of the remains, up to *c.* 2.00m from the wall-line (Plate 3.25). These consisted of a small

However, in the SW corner and on the very W edge of the charred thatch deposit, *c.*1.00–2.30m from the building, there was a small group of baton fragments, up to 0.28m long, and also several short lengths of twine (Plate 3.25). One piece of twine was still twisted around a short

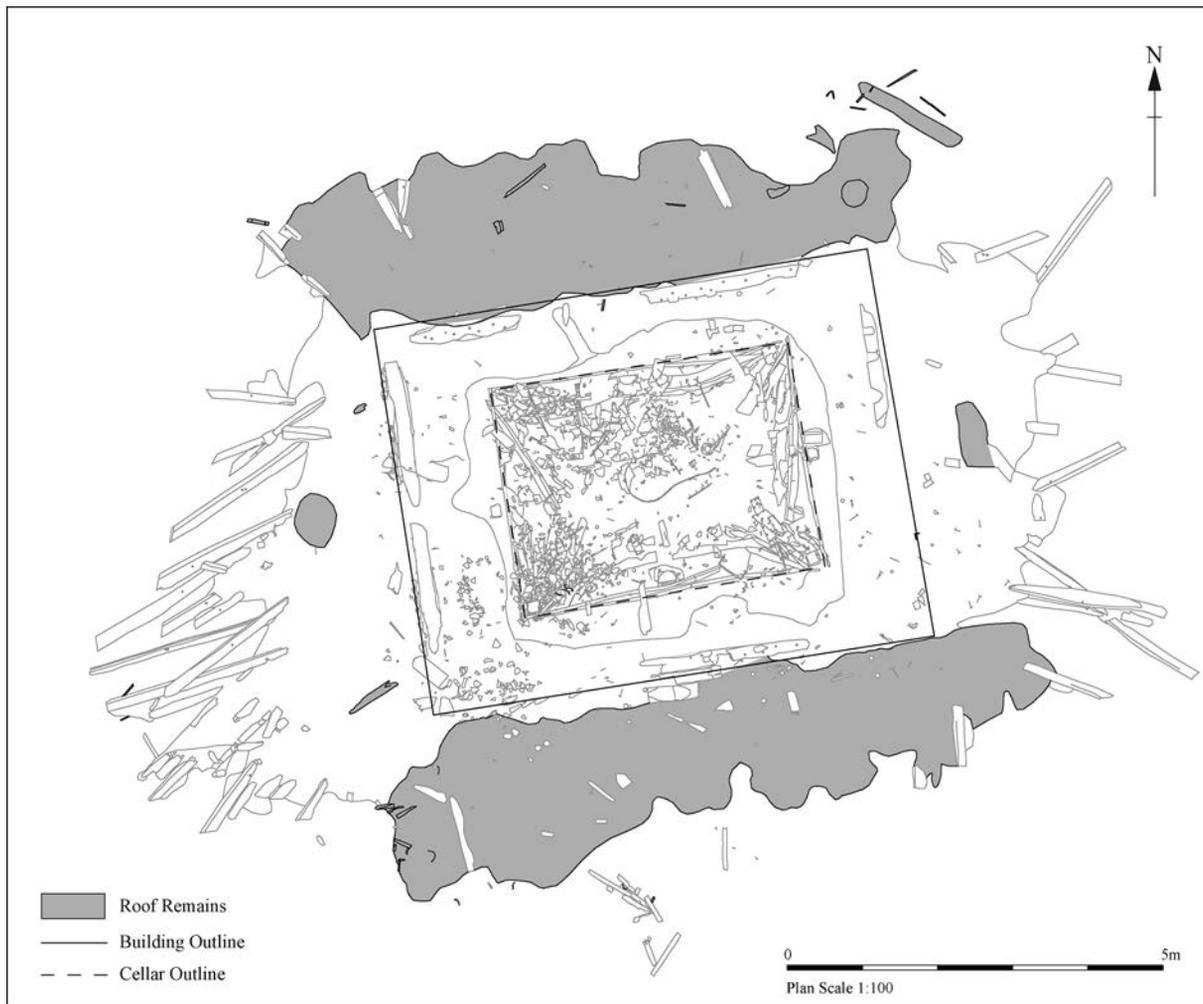
Figure 3.8 Plan of surviving roof remains. Like the limit of the burnt ground, the extent of the thatch ash deposits is indicative because there was no definite boundary

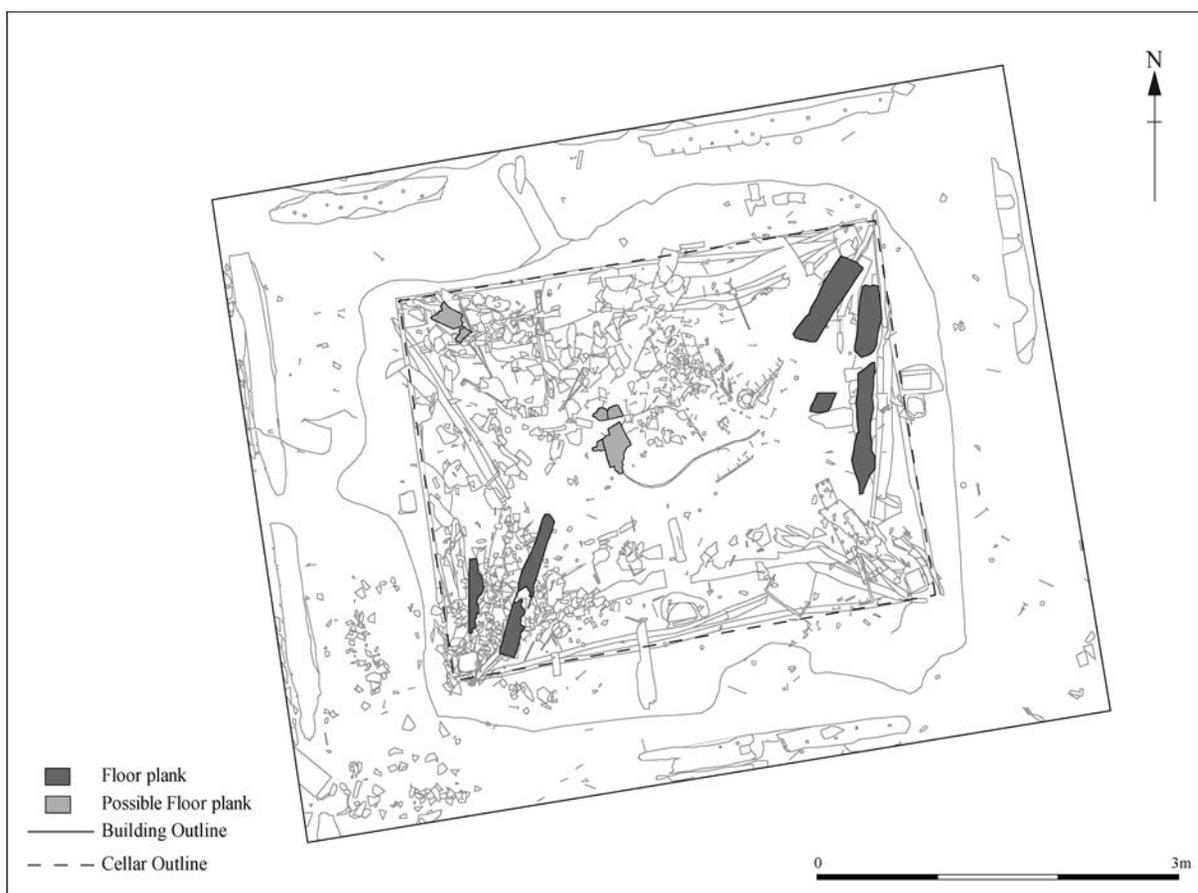
Figure 3.9 Plan of surviving floor planks on the base of the cellar

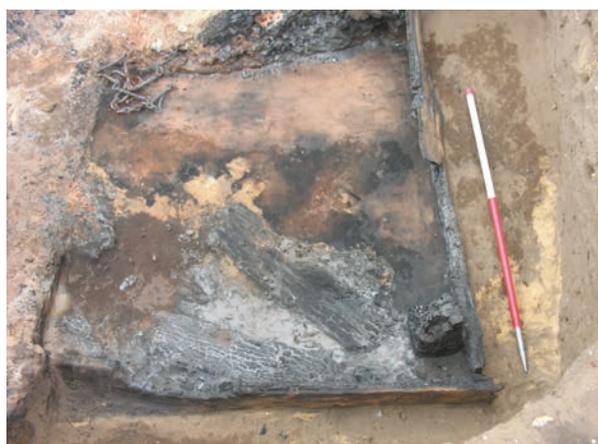
Plate 3.26 The two charred floor planks on the base of the cellar in the NE quadrant, with the lowest *in situ* cellar lining and charred base of the NE corner-post (viewed from W). The cauldron chain is visible in the centre of the pit

The remains of nine (max.) heavily charred floor planks were defined within the pit, less than 5% of the original floor (Fig. 3.9 and Plate 3.26). The longest surviving plank was *c.*1.65m in length. These had fallen *c.*1.40m from their original position suspended over the cellar on the floor joists. No floor planks were defined on the ground surface, around the edge of the pit.
