Experimental Archaeology and Fire: the investigation of a burnt reconstruction at West Stow Anglo-Saxon Village

by Jess Tipper

East Anglian Archaeology
Report No. 146, 2012

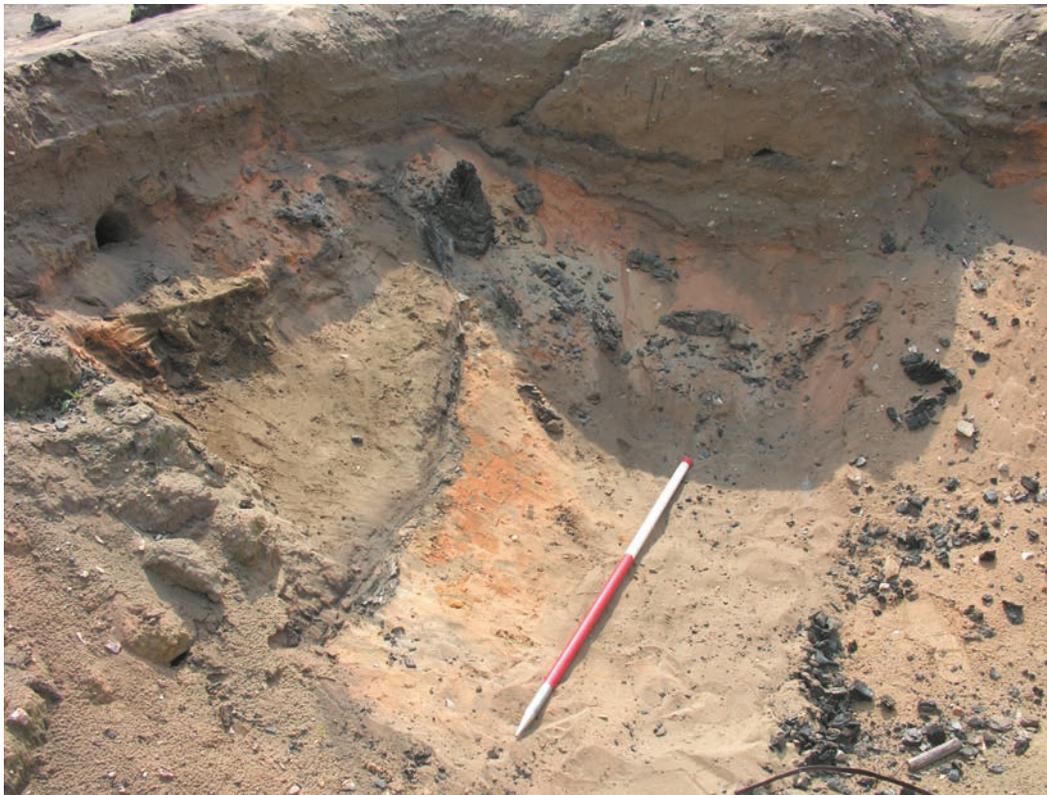
Plate 3.27 The collapsed upper cellar lining within the SW quadrant, with the charred edge of a plank curving from behind the SW corner-post down into the centre (viewed from NE). The charred board marks a clear division between burnt orange sand on the base of the cellar and brown, unburnt sand that has collapsed down from behind the lining

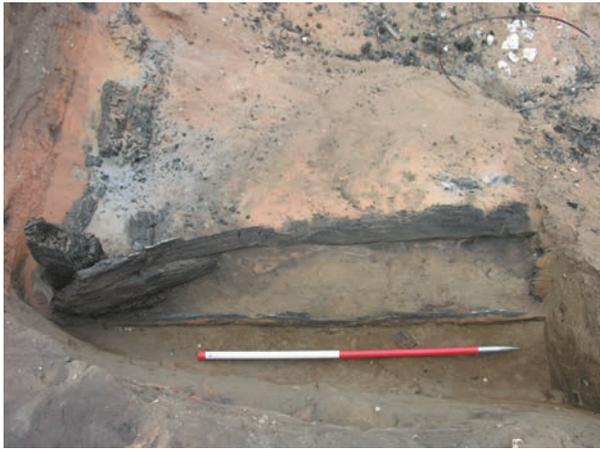
Plate 3.28 The collapsed cellar lining within the SW quadrant (viewed from S). The top of the lowest, and *in situ*, board is below the fragmentary remains of a board that has been forced inwards and downwards, although the W end is still vertical against the SW corner-post

board (in the SW quadrant) was near vertical, resting against the SW corner-post. The board sloped down from beside the corner-post towards the centre of the pit, SW–NE aligned, before curving E (Plate 3.28). The central and main part of the board was roughly parallel to, but *c.*0.45m (max.) to the N of, the *in situ* lining. It was lying flat, inner face down, *c.*0.20m above the cellar floor, and had been forced forwards and down into the pit through the weight of soil behind. The E part of the board was also clearly defined in the SE quadrant, aligned E–W but curving ESE towards the SE corner-post (Plate 3.29). The remains of the board were heavily charred on the inner and under side and in multiple pieces; however, the upper and outer side was only scorched, which indicates that the board was effectively smothered after collapsing down into the base of the pit. A small section of the same board, *c.*0.30m long, was wedged behind (and over the top, charred end of) the central post on the S side of the cellar. The board had simply snapped on both sides of the post. The upper face (originally the outer-facing side of

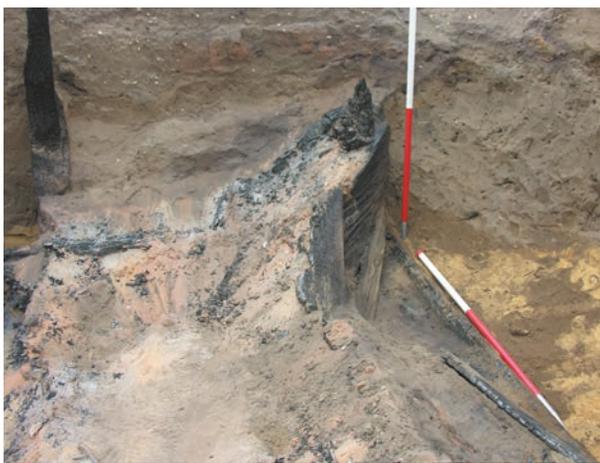
Plate 3.29 The collapsed cellar lining within the SE quadrant, wrapped around the surviving lower part of the SE corner-post (viewed from W). The remains of the E ridge-post is on the left edge of the photograph

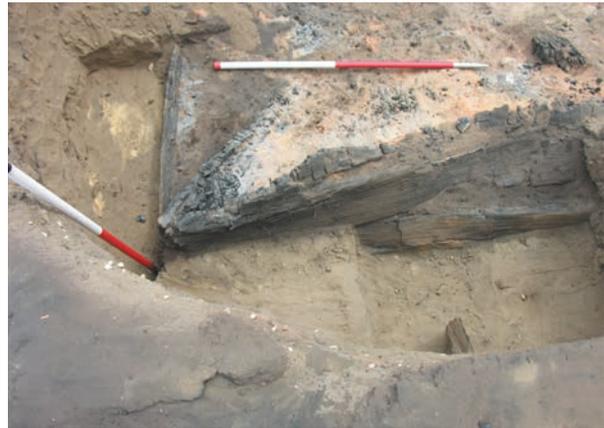
Plate 3.30 The collapsed cellar lining within the NE quadrant (viewed from N). The cellar boards have been forced inwards through the pressure of soil from behind the lining, although both boards from the N and E sides are still resting vertically against the NE corner-post. The top of the lowest and *in situ* boards along both the N and E sides are also visible. Notice how the outer facing sides of the boards are uncharred

The remains of the second lowest board were also defined along the N side. The E half of the board (in the NE quadrant) was in two pieces, and had apparently split along the grain of the timber (Plate 3.30). The E end was still vertical and wedged behind the base of the corner-post. Like those around the other sides, the central part of the board had been forced inwards and down and was lying (inner face down) *c.*0.50m (max.) from the *in situ* lowest board along the N side and *c.*0.20m above the cellar floor level. The board marked the interface of burnt deposits below (various discrete burnt deposits and layers) and unburnt sand above, which is the homogeneous brown sand slumped deposit from behind the cellar lining. It sealed material that had already slumped down into the pit from higher up the side, as the upper two boards presumably gave way before this one.

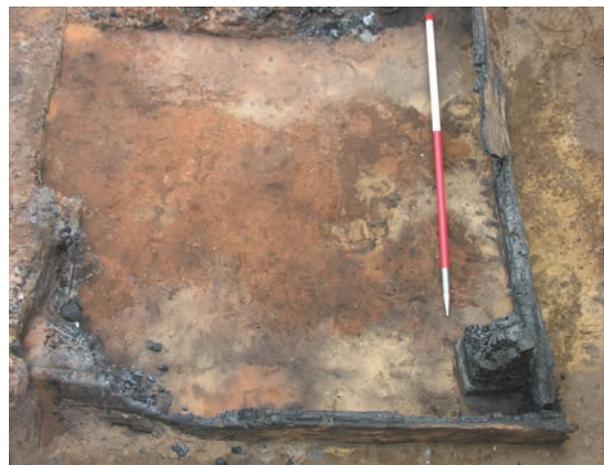
Plate 3.31 The *in situ* cellar lining within the SW quadrant and the charred base of the SW corner-post (viewed from W). The outer face of the board along the S side is entirely uncharred. The sand base is reddened but this is not uniform. Some areas of the base, especially closest to the lining, are unburnt yellow sand, perhaps due to greater accumulation against the boards

The lowest board of the cellar lining, around all four sides of the pit, survived *in situ* (Plate 3.31). The inner-facing sides of these boards (i.e. facing into the cellar) had been heavily charred while, in contrast, their outer faces were unburnt and intact. In places, however, the boards had split longitudinally along the grain of the timber and several had curled inwards as a result of the intense heat and burning on their inner faces, which would have weakened their structural integrity. The top part of the lowest board along the E side of the pit, in the SE quadrant, had simply sheared off; the snapped end was *c.*0.40m from the lower *in situ* part of the same board. Similarly, along the S side, the top part of the lowest board had also split away. Again, the snapped end was *c.*0.35–0.40m from the *in situ* part. A number of other charred timbers in the pit could also have been the remains of cellar lining.

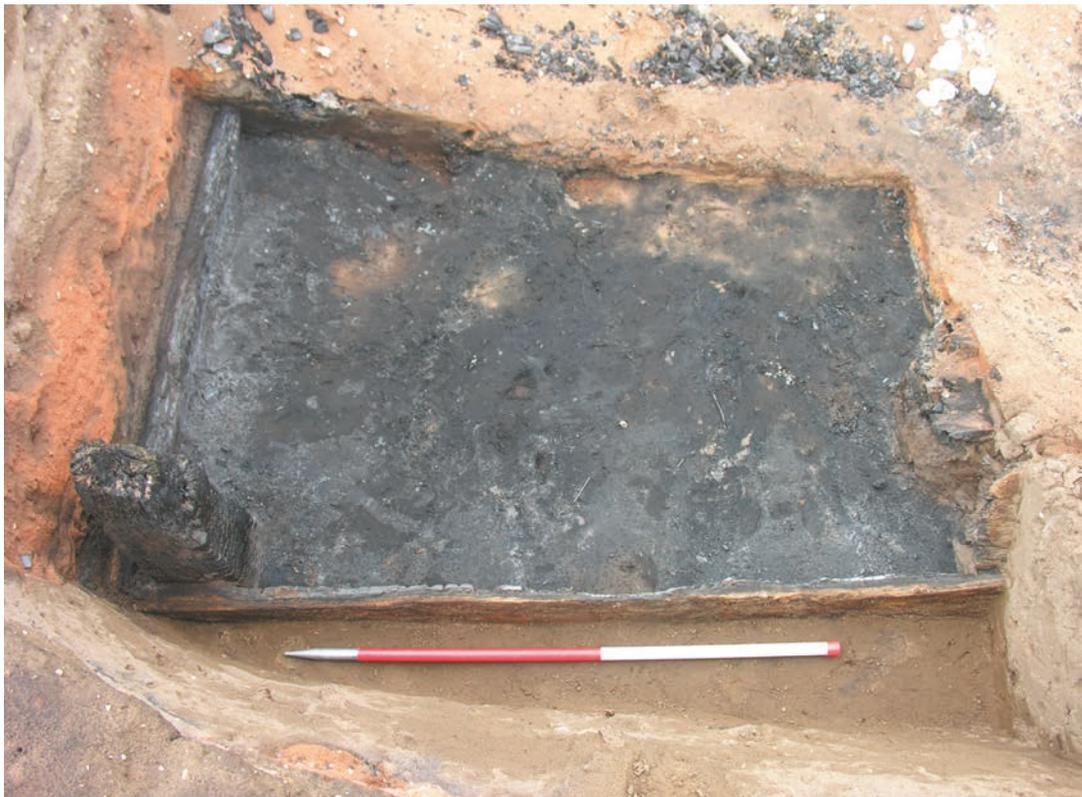
Plate 3.32 The charred pencils on the base of the cellar in the SW quadrant (viewed from S)

In particular, the remains of uncharred and partially charred complete pencils were found within the footprint of the building, on the base of the pit and on the ground surface around the pit (Fig. 3.11 and Plates 3.32 and 3.33). These thin objects would have rolled down the gaps between floor boards, dropped especially by school children. They were unable to retrieve them from the base of the cellar, which was inaccessible to the public. However, their alignment was quite random on the base of the pit and while some were aligned N–S, parallel to the floor planks (and the gaps between these), many were not. In explanation, the pencils near the surface of the accumulation deposit might have been disturbed by the timbers that collapsed down into the pit during the fire while others might simply have been disturbed during use of the cellar itself. It is also possible that others simply landed at an angle. There were also many others incorporated within or above the collapsed remains of the cellar lining. These pencils must originally have been on the surface around the upper edge of cellar, brought into the pit with the collapse of the lining.

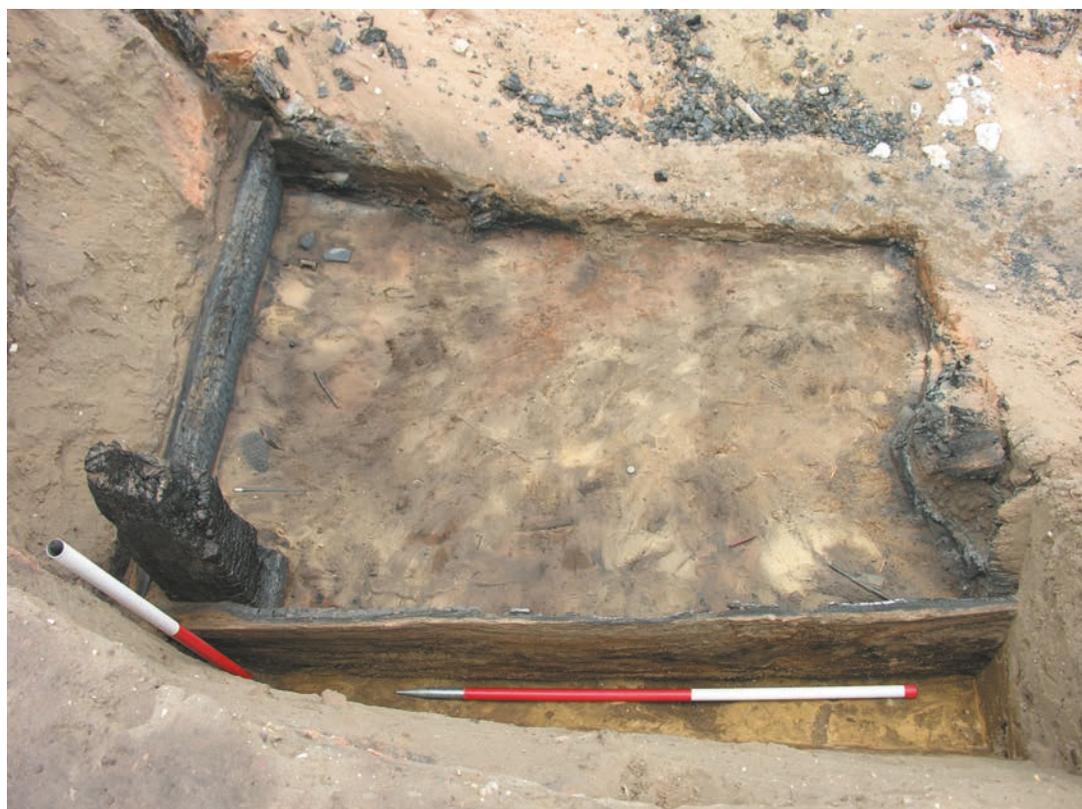
Plate 3.33 The uncharred pencils protected by subsequent accumulation below the level of the burning on the base of the cellar in the SW quadrant (viewed from S). There was a Desktop HB pencil complete with rubber located close to the W side (<0.10m) of the *in situ* cellar lining. There was an 'Independent on Sunday' pencil against the S side of the *in situ* cellar lining and also a 'Disco Nite' pencil close to the same side; this pencil was scorched and broken into several pieces but otherwise complete. In addition to the three uncharred pencils from the SW quadrant, there was the remains of a heavily charred but otherwise complete pencil, also on the base of the cellar in the same quadrant but recovered in the sieve

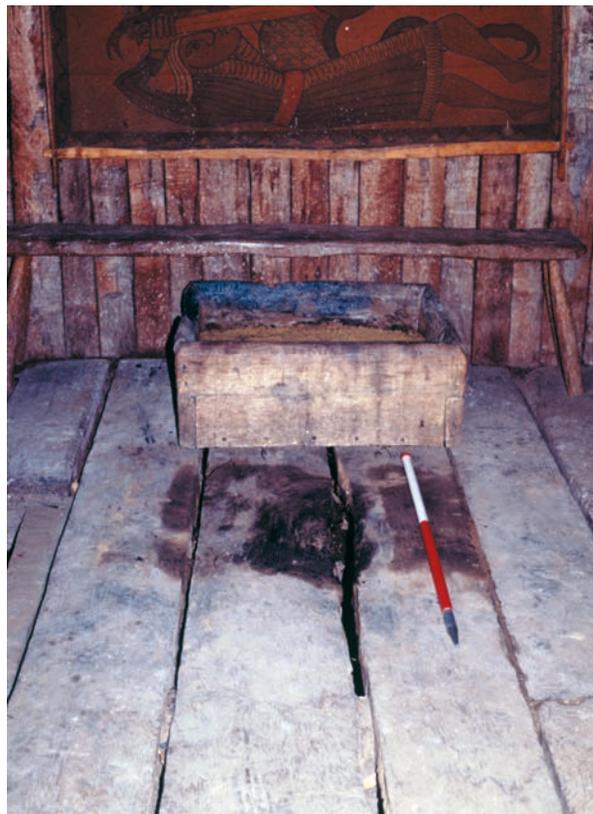
Plate 3.34 The charred floor planks below the fire-box as a result of a fire in September 2004. Notice the gaps between the planks through which small objects fell

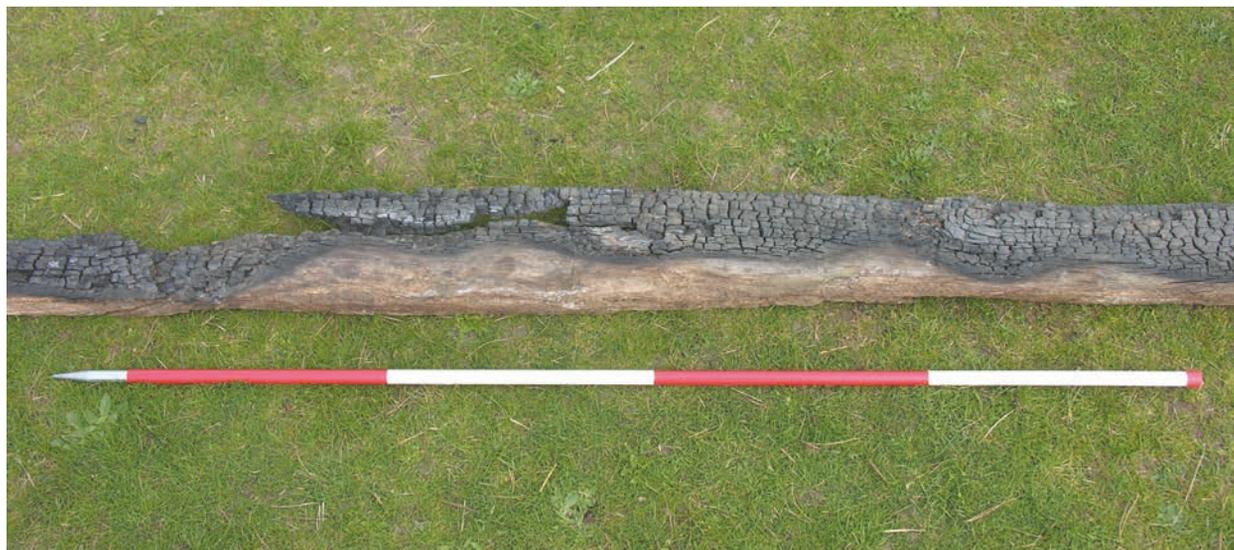
Plate 3.35 The char pattern on the lowest plank lining on the S side of the cellar, which had been in line with the doorway

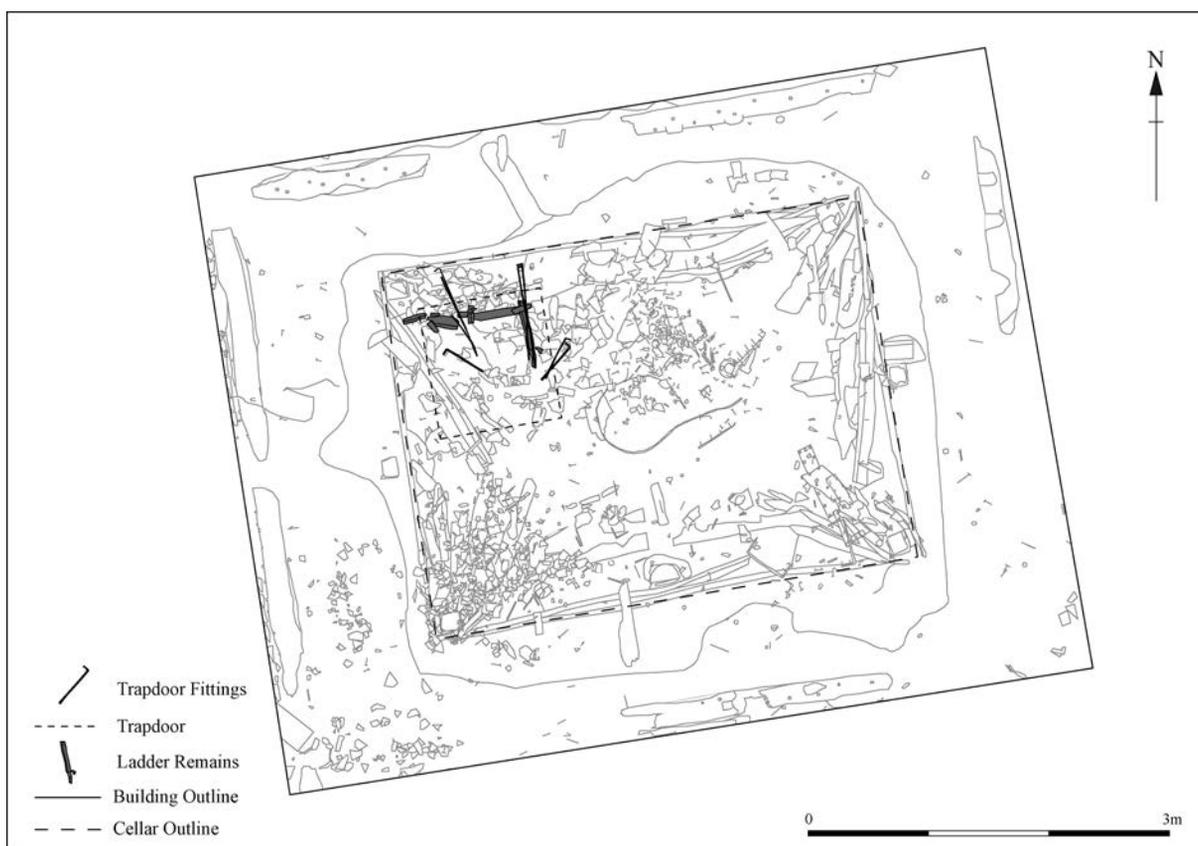
Figure 3.12 Plan of surviving charred step-ladder remains and trapdoor remains on the base of the cellar

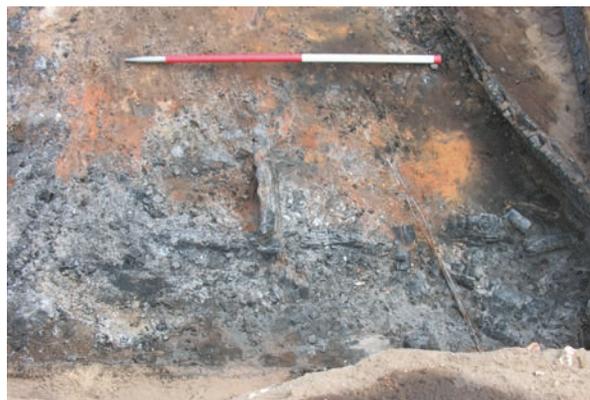
Plate 3.36 The remains of the cellar ladder lying on the base of the cellar (viewed from N). The remains of the lowest step, aligned N–S, is clearly visible along with most of the N leg, aligned E–W. Several of the iron fixings from the trapdoor are lying across the top of the ladder remains immediately to the W of the position of the central step, demonstrating that the trapdoor simply collapsed down on the ladder. In addition, the collapsed cellar lining, from the W side, lies at an angle across the top of the ladder

The fragmentary and heavily charred remains of the step-ladder and trapdoor were defined on the base of the cellar. The N side of the ladder was best preserved because it had been sealed below the collapsed cellar lining while the S (inner) side had been almost totally destroyed (Fig. 3.12 and Plate 3.36).

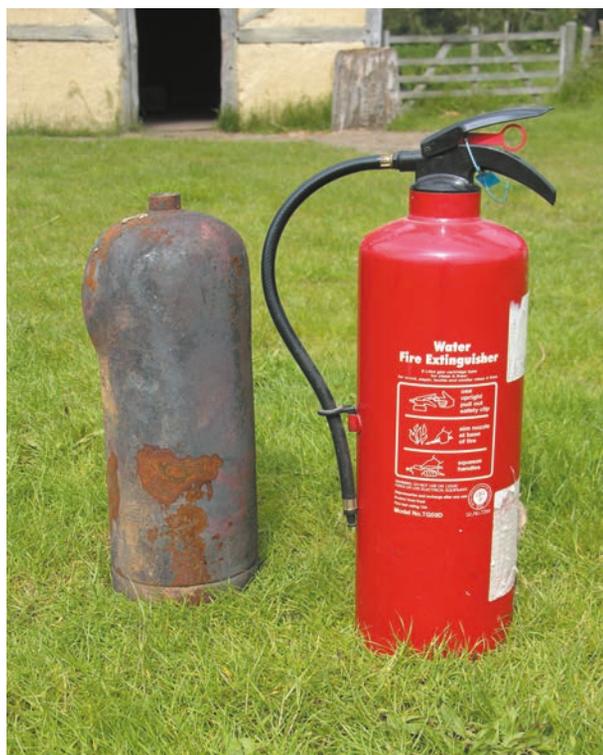
Plate 3.37 The mis-shapen fire extinguisher in relation to a reference example

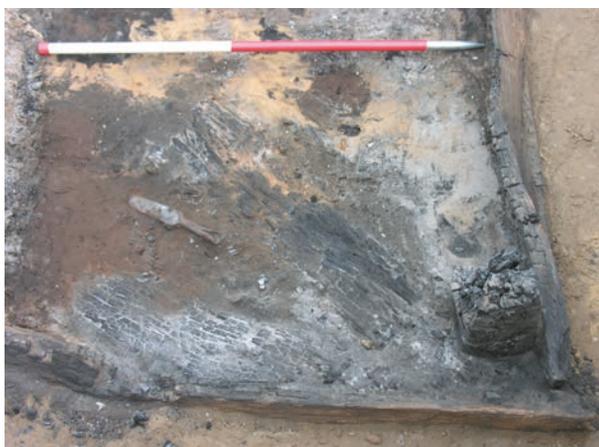
Plate 3.38 The spearhead on the base of the cellar, at the level of the charred floor planks (viewed from W).

The charred NE corner-post and the *in situ* lowest planks lining the N and W sides of the cellar, and also the remains of two charred floor planks aligned NE–SW, are clearly defined

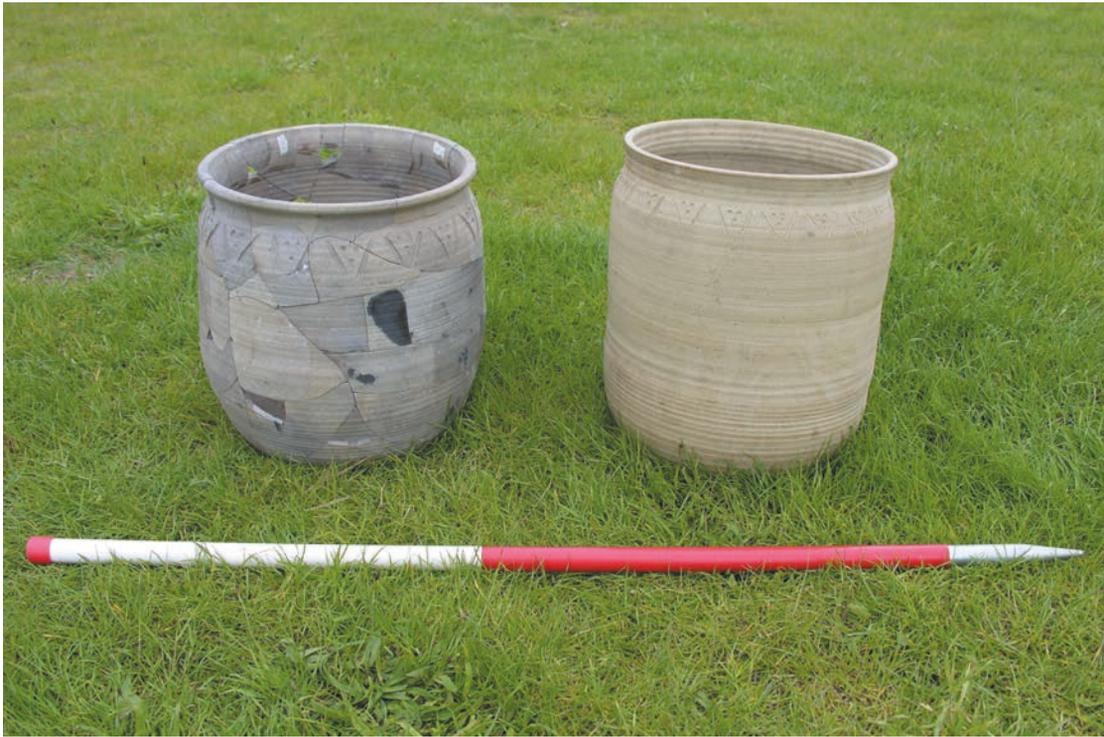
Plate 3.39 Pottery vessel V1 after refitting (left), which was one of a pair of large storage vessels. The complete example is located in the Weaving House

V1 was a large pale grey wheel-turned storage vessel, with incised line and dot decoration around the shoulder

(Plate 3.39). There were 151 sherds (c.8.60kg) in total recovered from this vessel, of which 128 sherds were plotted three-dimensionally.

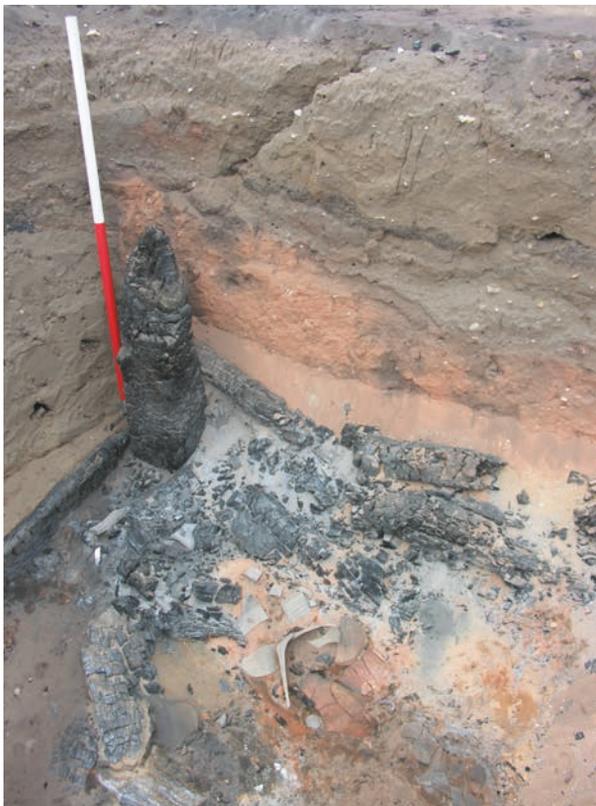
Plate 3.40 The location of pot-sherds (from V1, V2 and V5) amongst the burnt structural remains on the base of the cellar in the SW corner (viewed from NE towards the *in situ* SW corner-post). The sherds must have been deposited before the cellar lining collapsed in because they were sealed below the remains of the lining

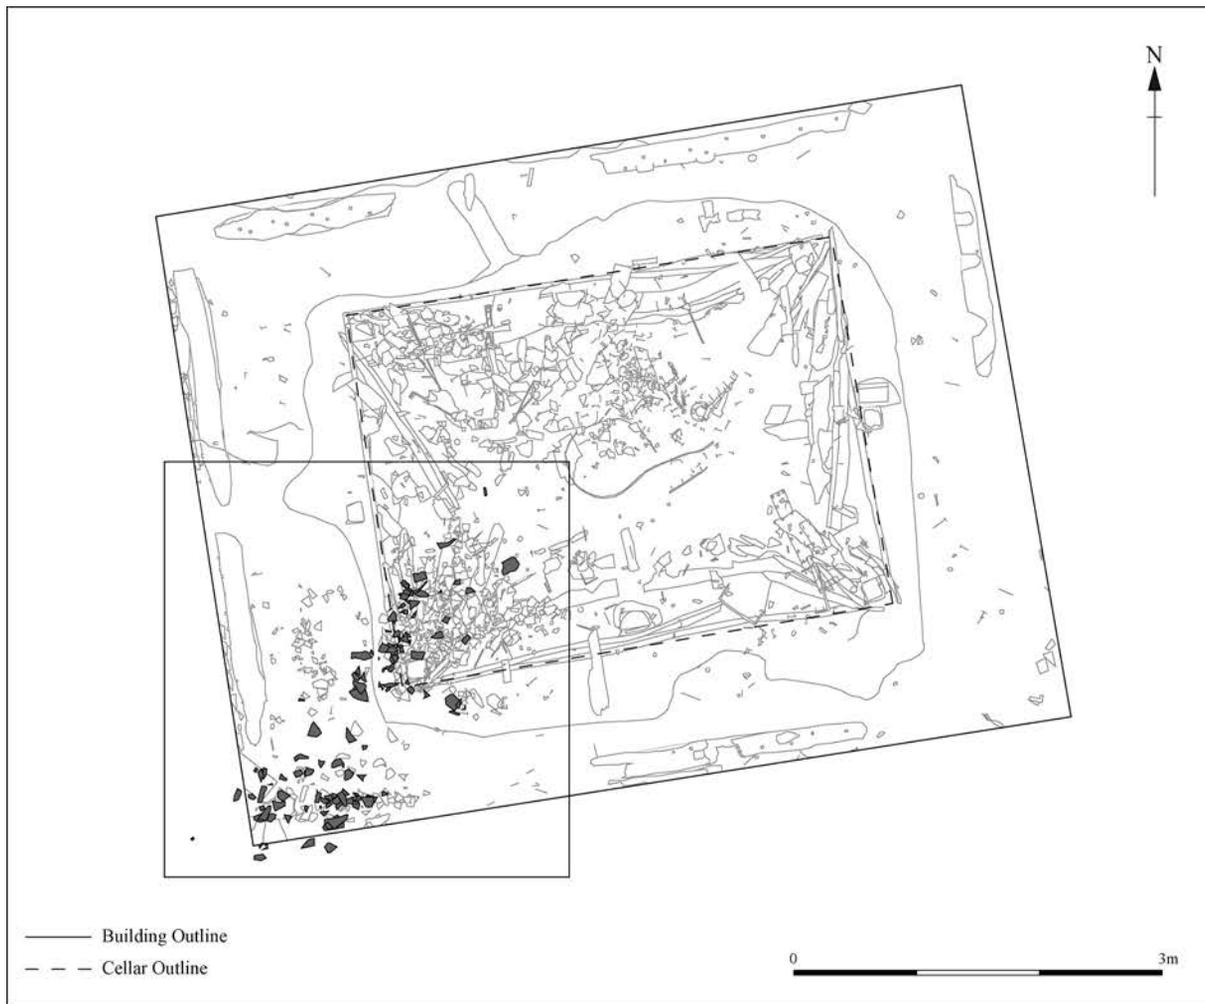
Figure 3.15 Plan of (above) pot-sherds and (below) refitting (lines linking joining sherds) V1, a large storage jar 350mm tall and with a rim diameter of 340mm (base diameter 270mm)

The sherds from this vessel were separated c.3.70m horizontally (max.) and had a pronounced SW–NE alignment (Fig. 3.15). Most joining sherds were close together but some were over 2.00m apart and there were many joins between sherds within the pit and on the ground surface around it. 63 sherds occurred on the surface around the SW corner of the pit, mainly within the wall-line and directly below the original location of the vessel but several were on or outside the wall-line along the S side of the building.

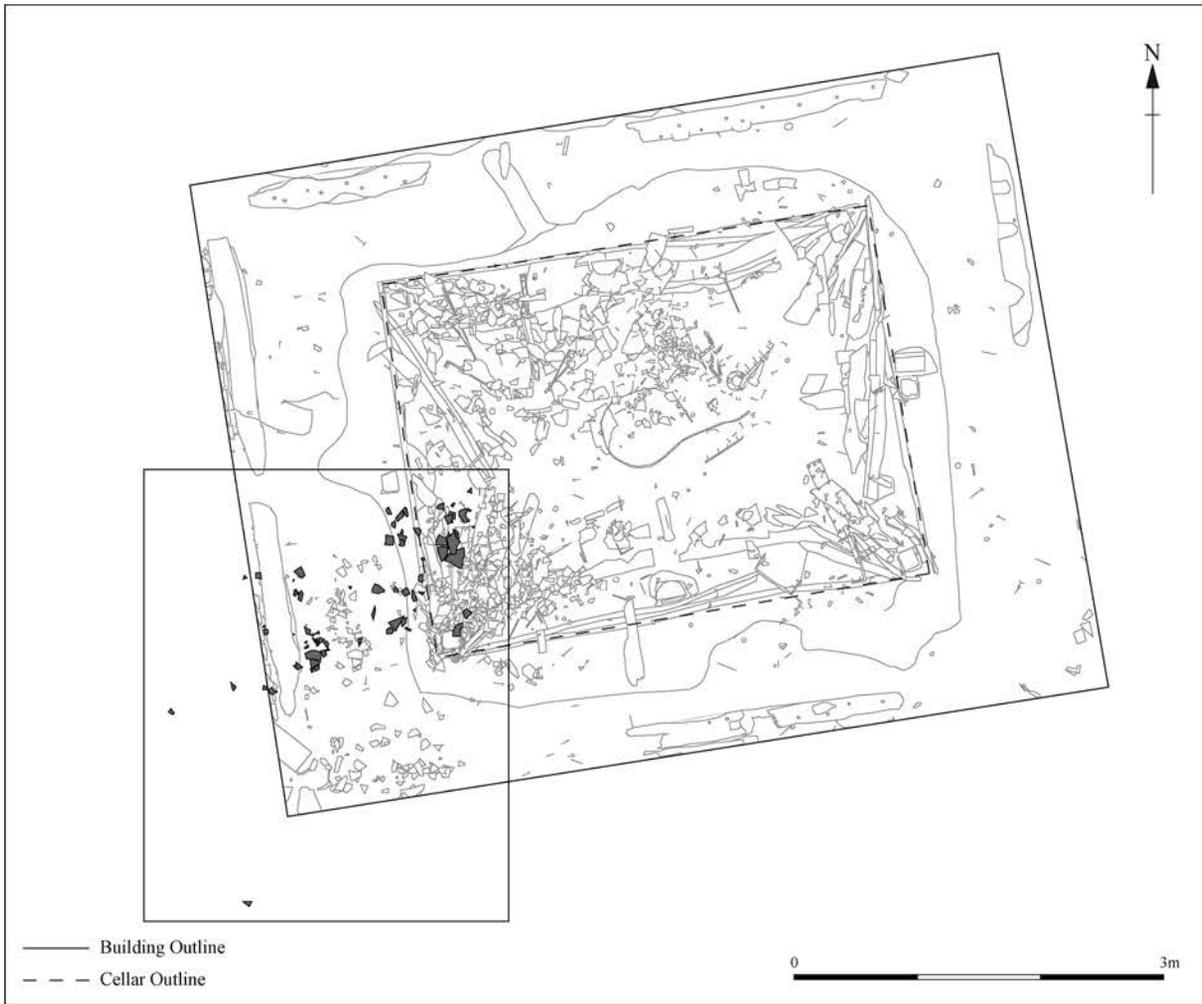
Figure 3.16 Plan of (above) pot-sherds and (below) refitting (lines linking joining sherds) V2, a large storage jar 240mm tall and with a rim diameter of 240mm (base 160mm)

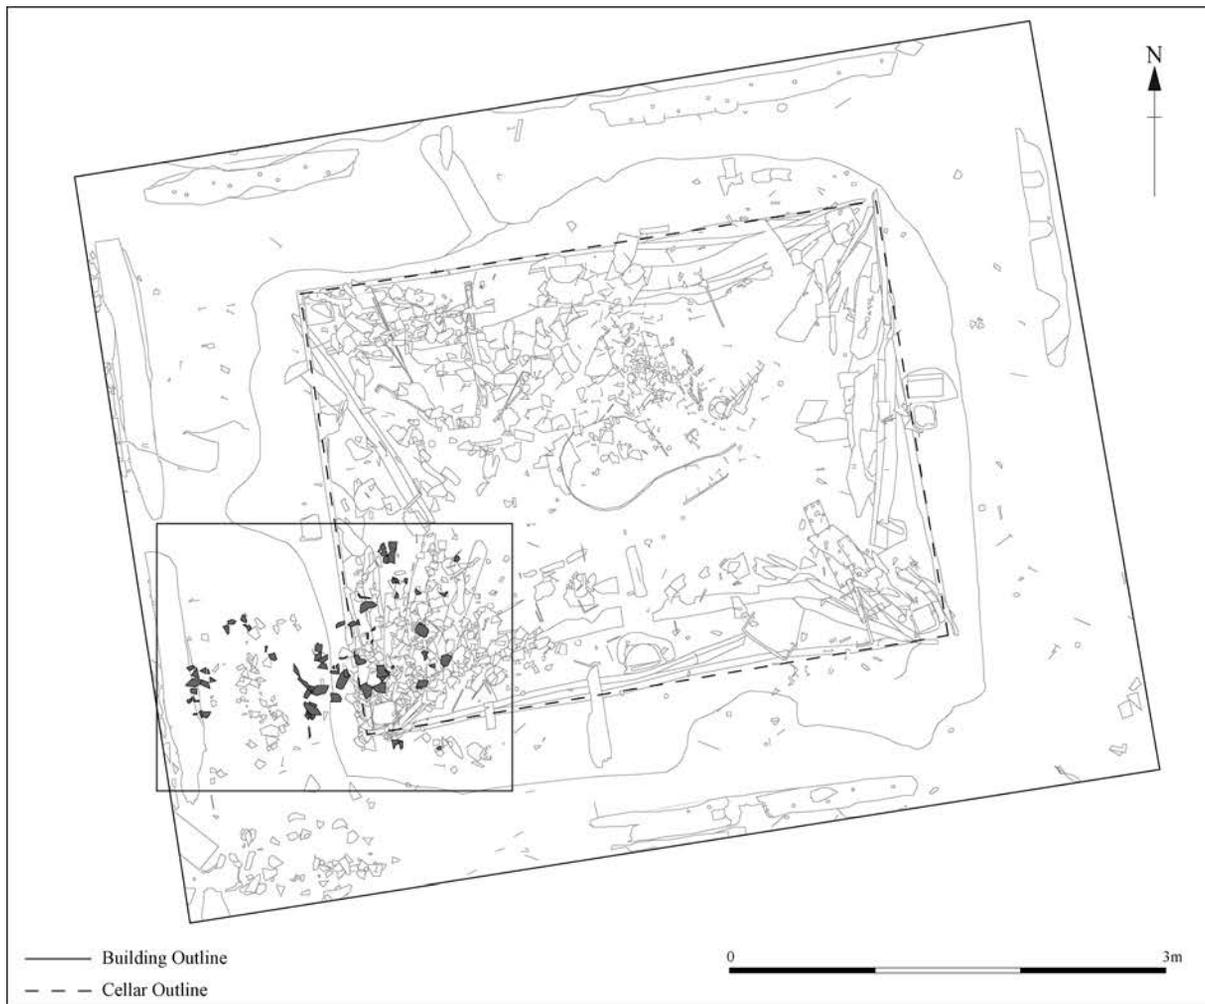
Figure 3.19 Plan of (above) pot-sherds and (below) refitting (lines linking joining sherds) V5, a large storage vessel very similar to V2, 240mm tall and with a rim diameter of 240mm (base 140mm)

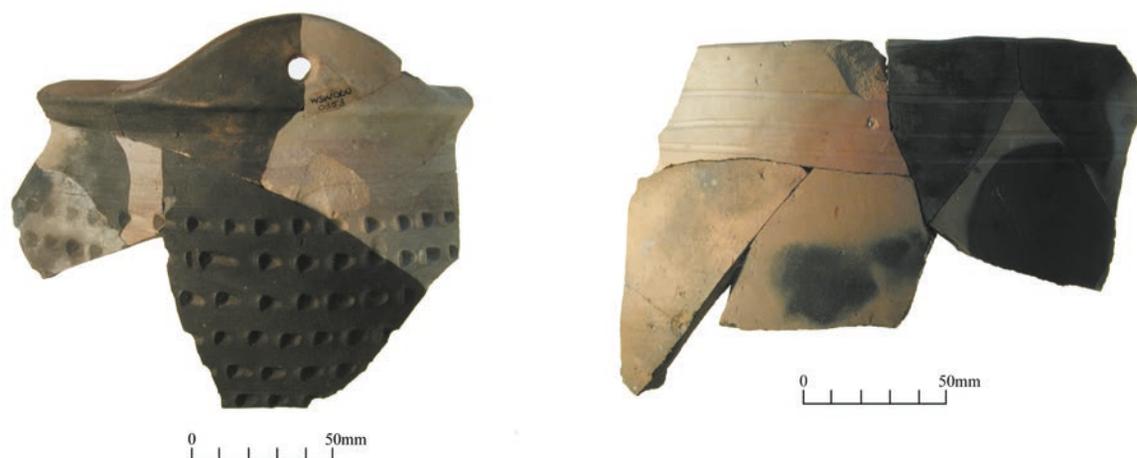
Plate 3.42 Conjoining pot-sherds from (left) V2 and (right) V3, showing the effect on individual pot-sherds of localised conditions of temperature and oxygenation within the fire

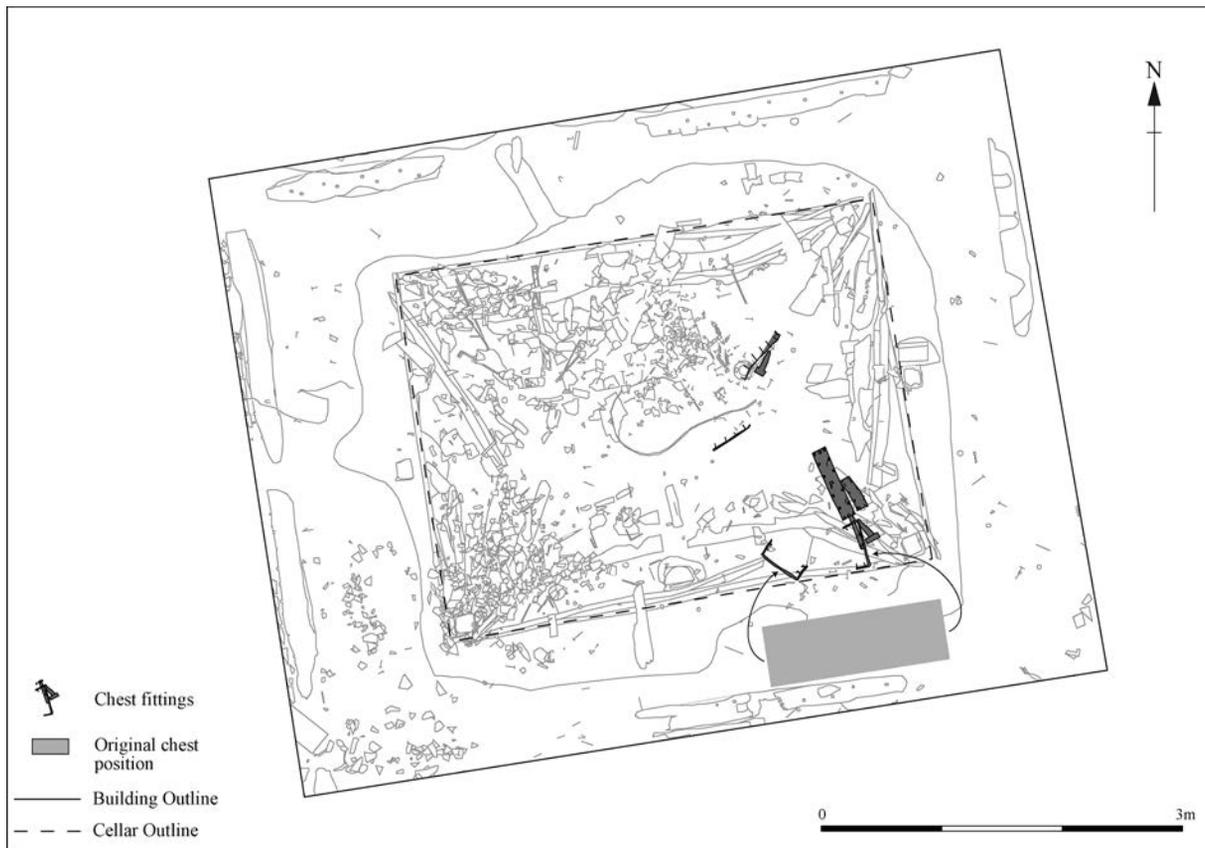
Figure 3.20 Plan of metal chest fittings in the SE part of the cellar pit (with the original position of the chest against the S wall-line marked)

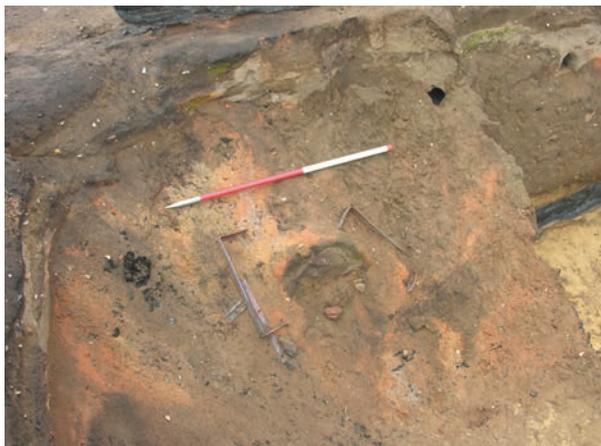
Plate 3.43 The distribution of several metal chest fittings (principally the two base straps) on the surface of the side collapse and sloping down towards the centre of the pit, within the SE quadrant (viewed from N). The top of the charred SE corner-post is just apparent level with the top of the collapse, below the point of the scale bar

presumably separated by the force of collapsing timbers that struck the chest and also by subsequent collapse and erosion (Fig. 3.20, Plates 3.43 and 3.44).

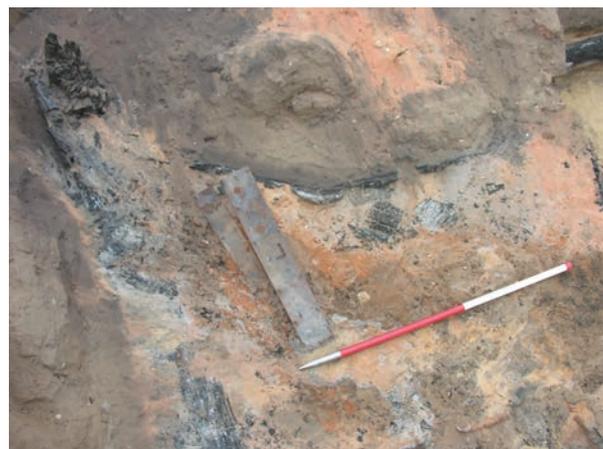
Plate 3.44 The distribution of chest fittings (including the lock plate) lying over the collapsed cellar lining (from the S side) in the SE quadrant and sloping down towards the base, and centre, of the cellar. The collapsed lining from both the S and E sides of the cellar is clearly visible, and also the top of the SE corner-post. The planks form a clear division between orange burnt sand to the N and W within the centre of the pit and unburnt sand to the S and E, which collapsed inwards from behind the lining

the cellar. One of two base straps was lying directly over a lid strap and hinge, *c.* 1.05m from the original wall-line of the building against which the chest had been placed. The other base strap was at the same level and *c.* 0.75m to the W; however, this strap had been hanging down from the top of the collapsed pit side immediately after the fire and only fell into the pit through subsequent side erosion^x. The lock plate rested against the collapsed cellar lining slightly further inside the pit, sloping down steeply S–N, and next to the first reinforcement base plate (Plate 3.44). The lock plate was also originally on the surface of the collapse, directly below the lid strap, but had been buried by subsequent side collapse.

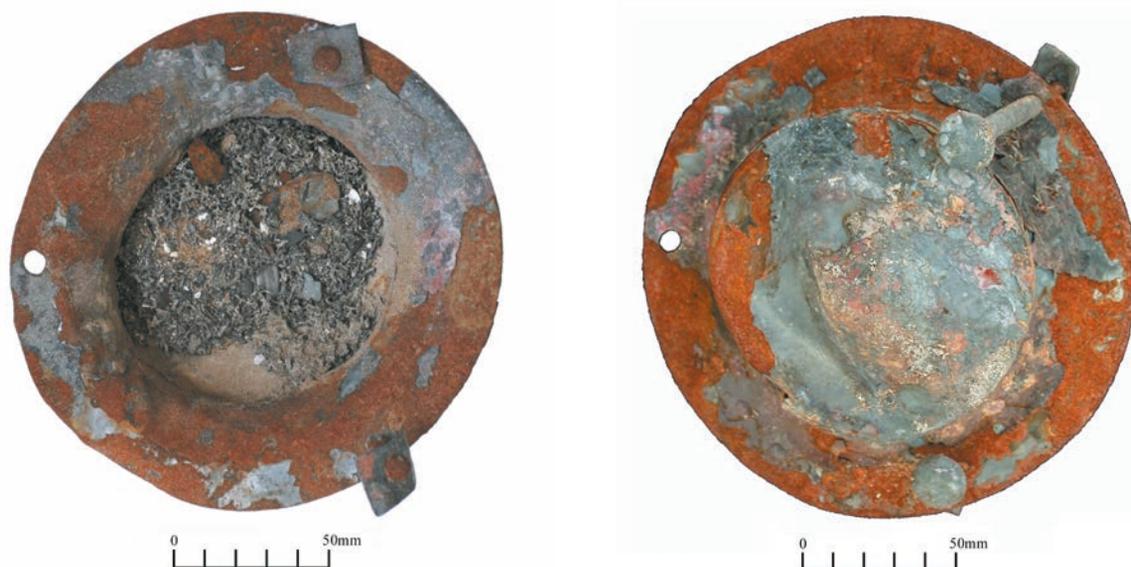
Plate 3.45 Shield boss. Left, inside the boss; right, outer side

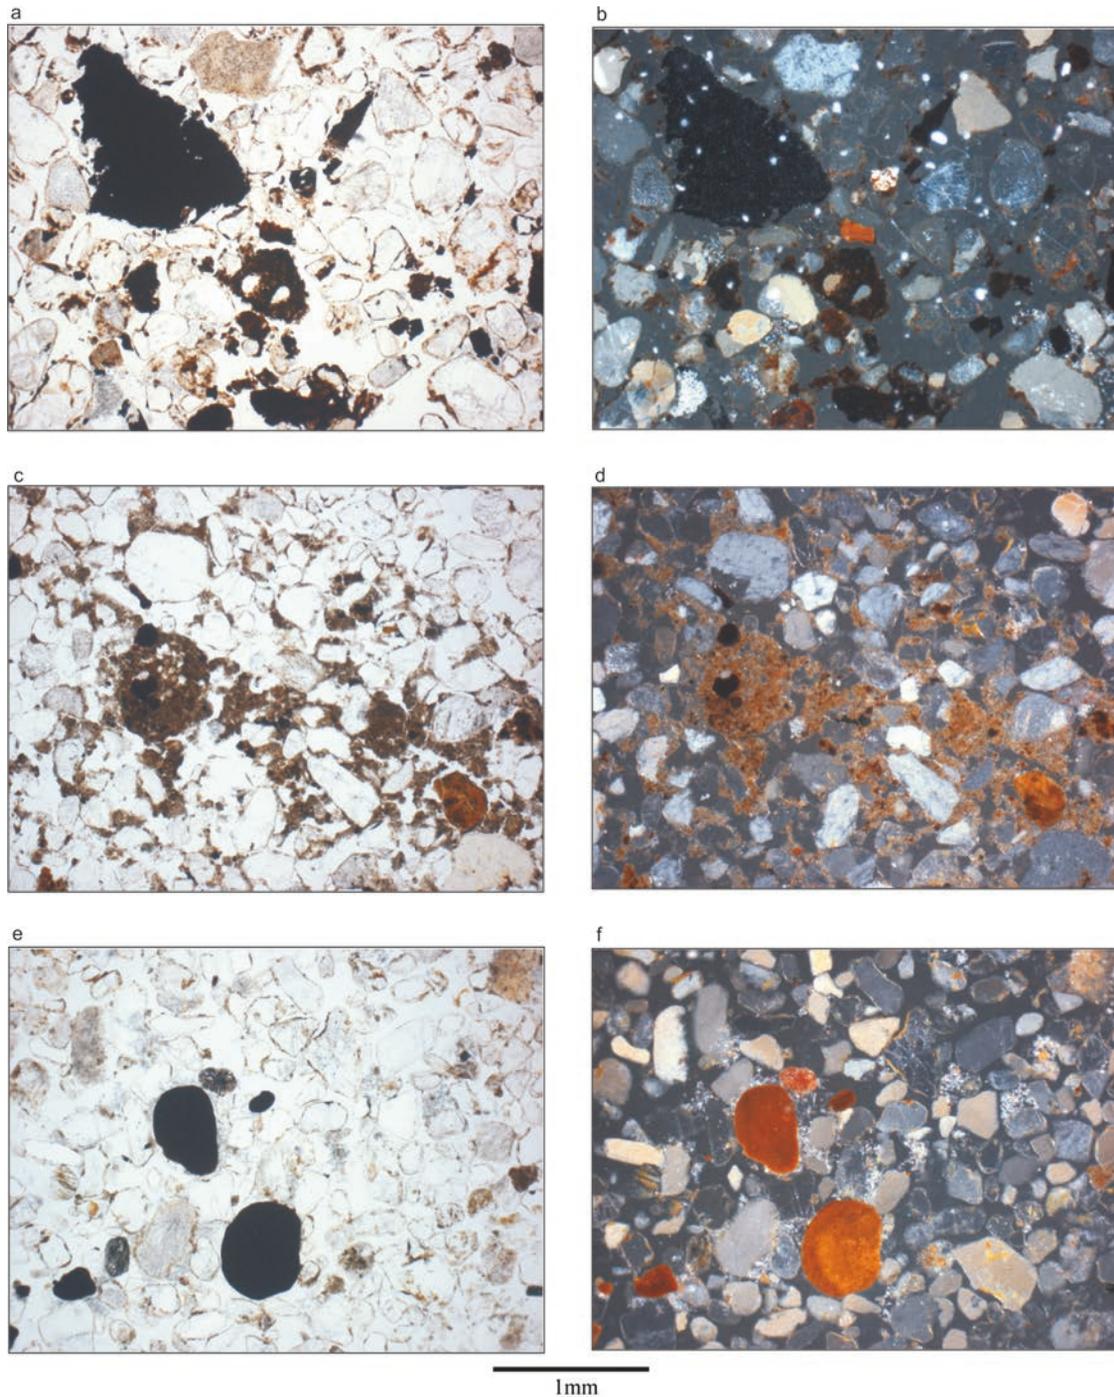
Plate 4.2 The three main fabric types observed in thin section, shown on the left in PPL, and on the right in partial XPL and OIL. These examples are taken from sample 6

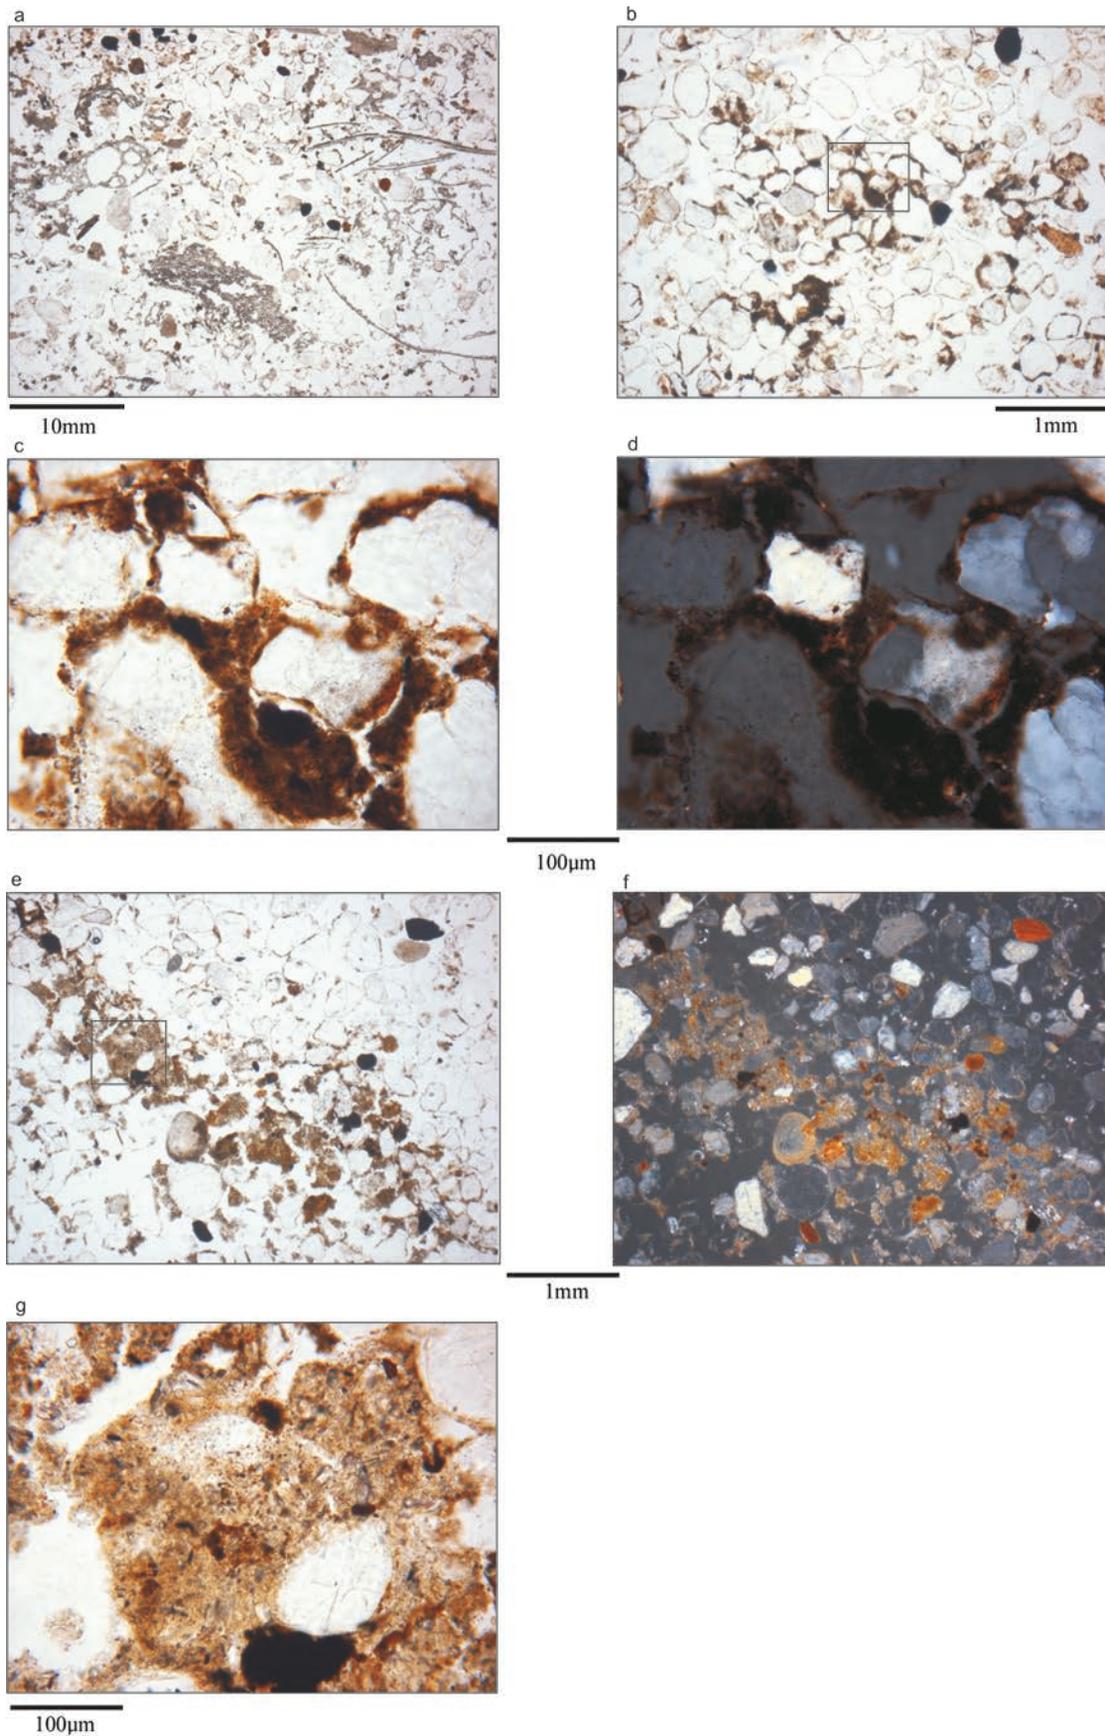
Plate 4.4 The sediment fabric associated with collapse following the burn event (a) contrasted with the fabrics created during the occupation of the building (b–g)

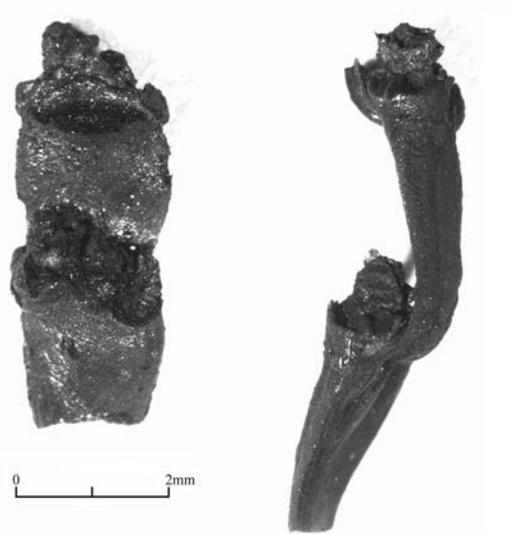
Plate 5.6 Charred bread wheat rachis fragments from sample 76 showing near perfect preservation
