Experimental Archaeology and Fire: the investigation of a burnt reconstruction at West Stow Anglo-Saxon Village

by Jess Tipper

East Anglian Archaeology
Report No. 146, 2012

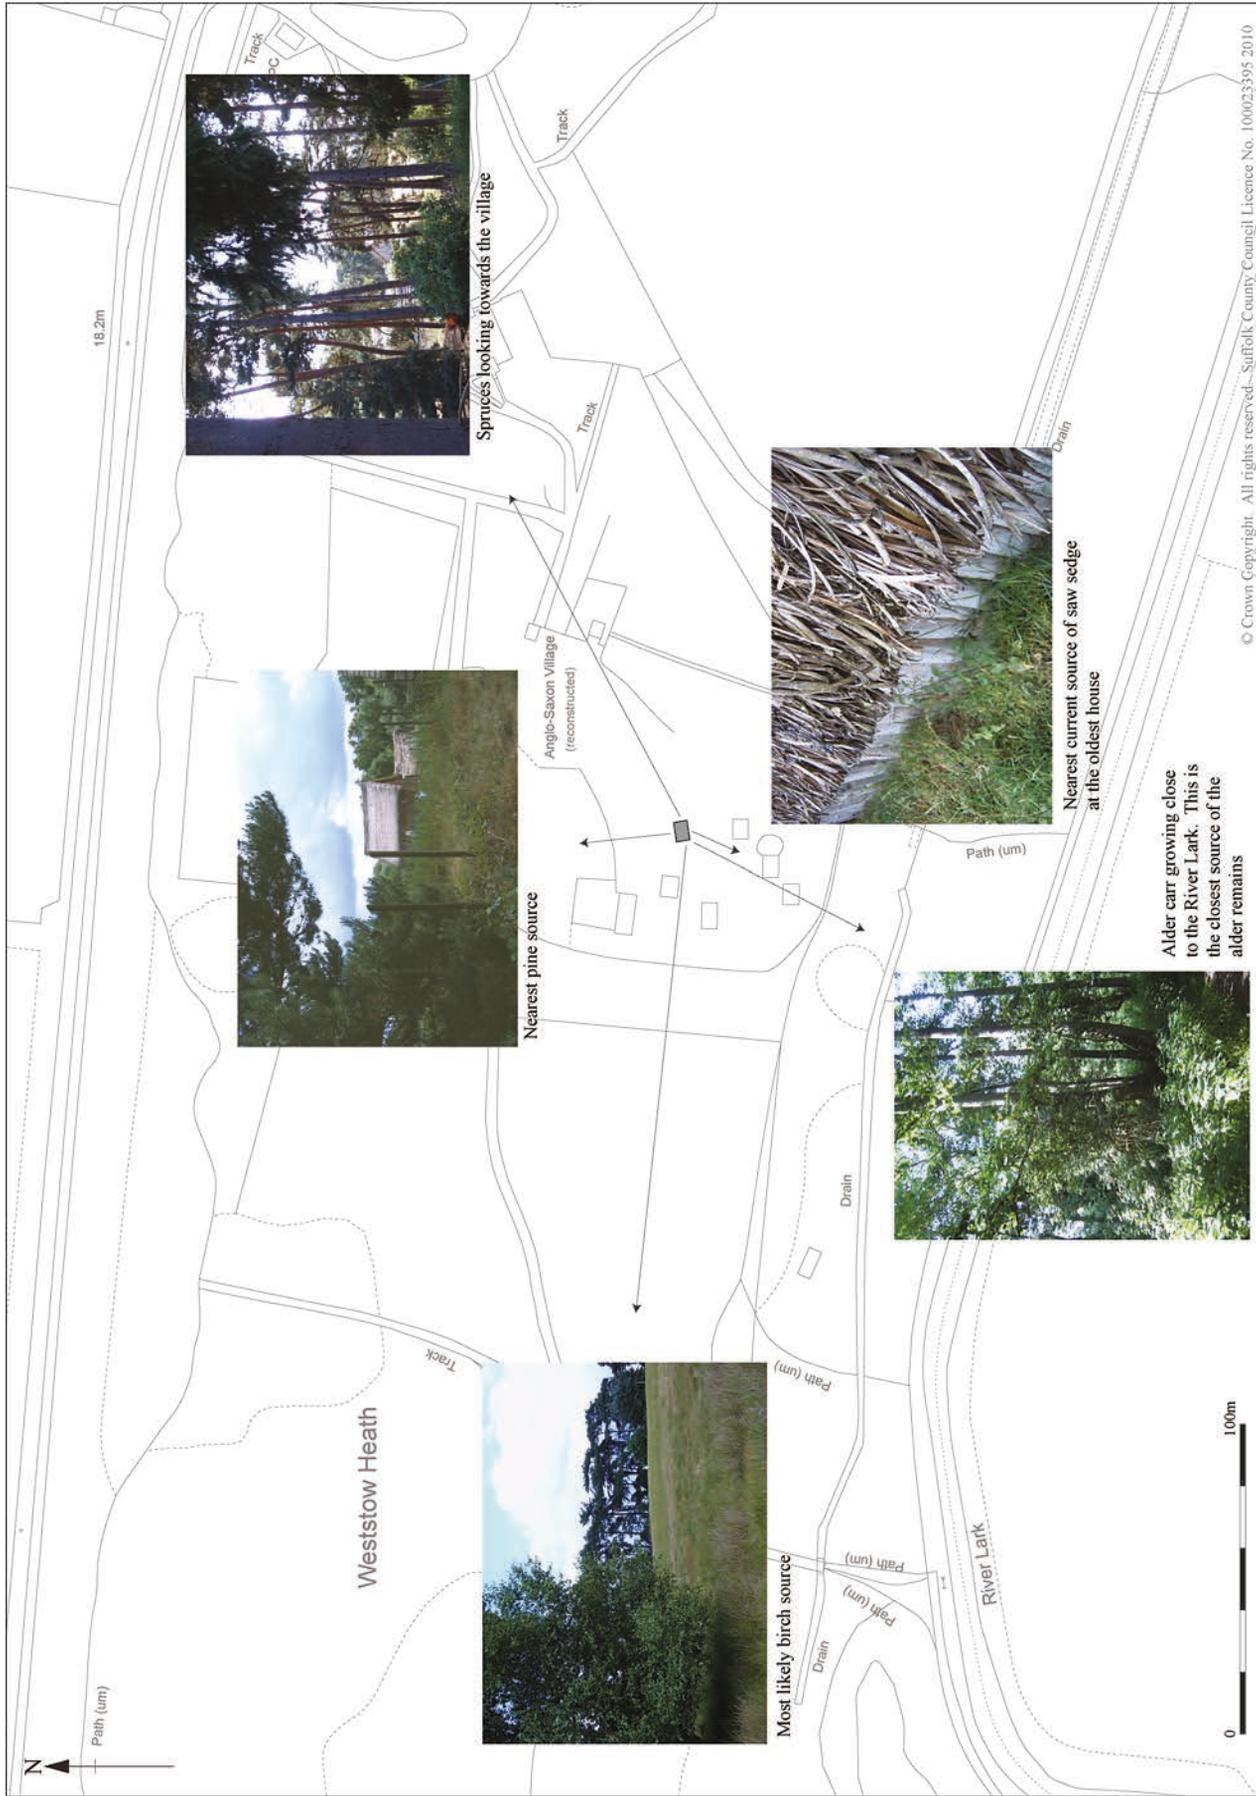
Figure 5.2 Plan showing the Farmer's House in relation to the nearest current sources of some of the plant remains recovered from the samples (June 2010)

(see Fig. 5.2 for the nearest current source of some of these plant remains).

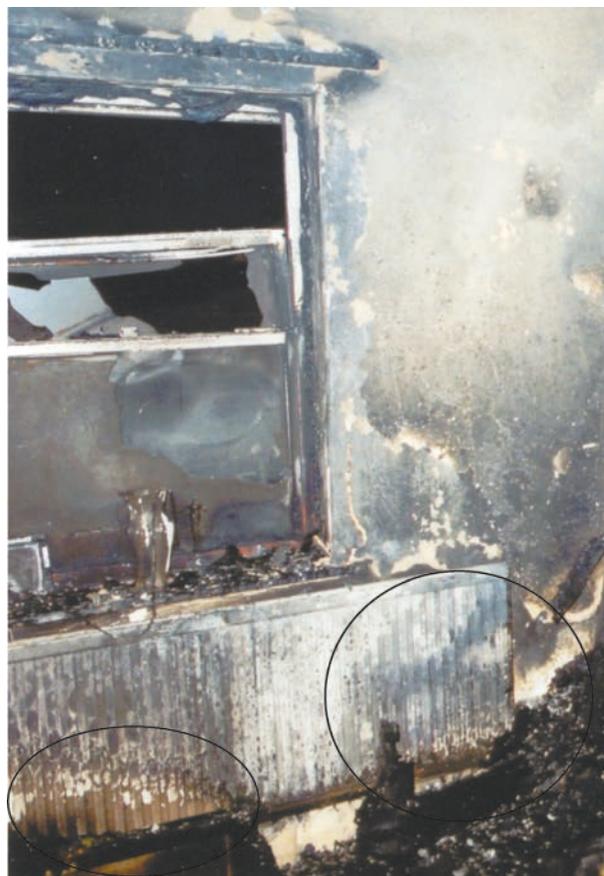
Plate 6.1 A contemporary fire. Circled areas highlight 'V' pattern and low burning (left), and heat shadowing from furniture (right)

In general terms, a fire investigator will conduct an excavation of the suspected 'seats' or points of origin of the fire in question. Such an examination will aim to recover potential evidence associated with the ignition, as well as to identify characteristic signatures of burning, such as the lowest examples of heat damage within a room, or characteristic 'V' patterns of scorching, both of which are suggestive of early involvement in structural fires (Plate 6.1).

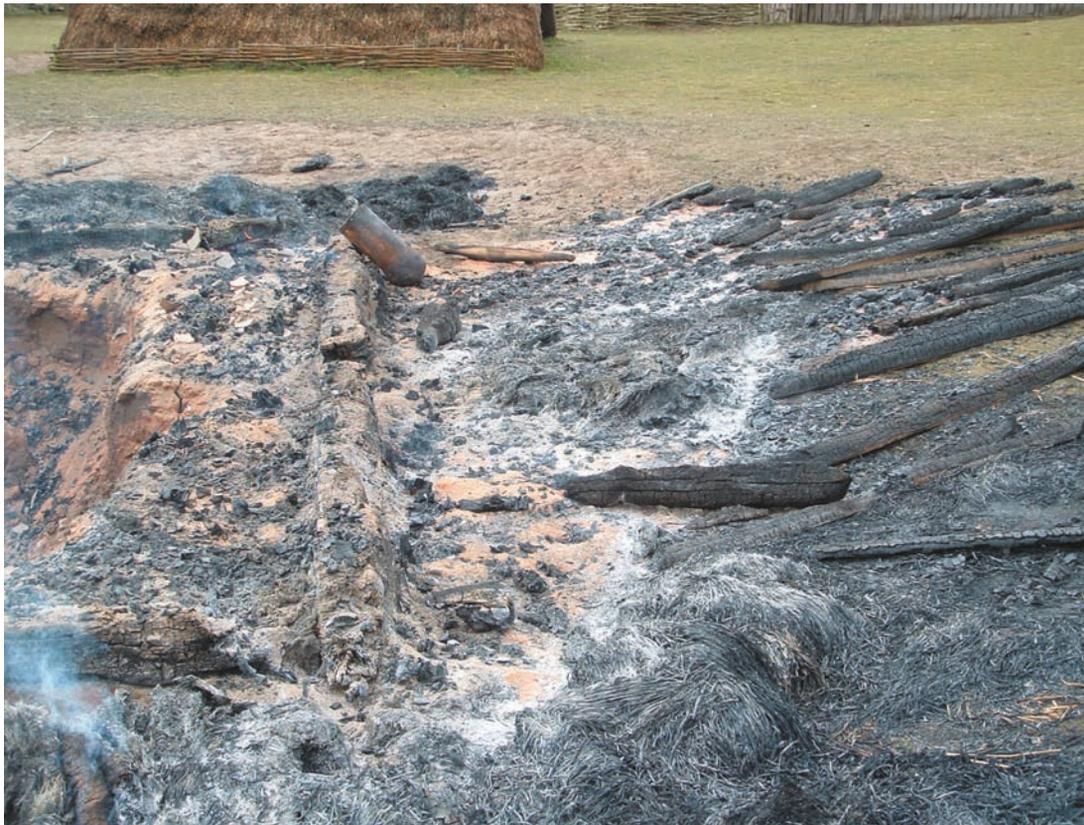
Plate 6.2 Photograph taken the morning after, looking S from the NW corner of the building down the remains of the W (gable-end) wall-line. The charred remains of the wall boards lie on the ground surface away from the building. Varying combustion of thatch reveals smouldering *in situ*

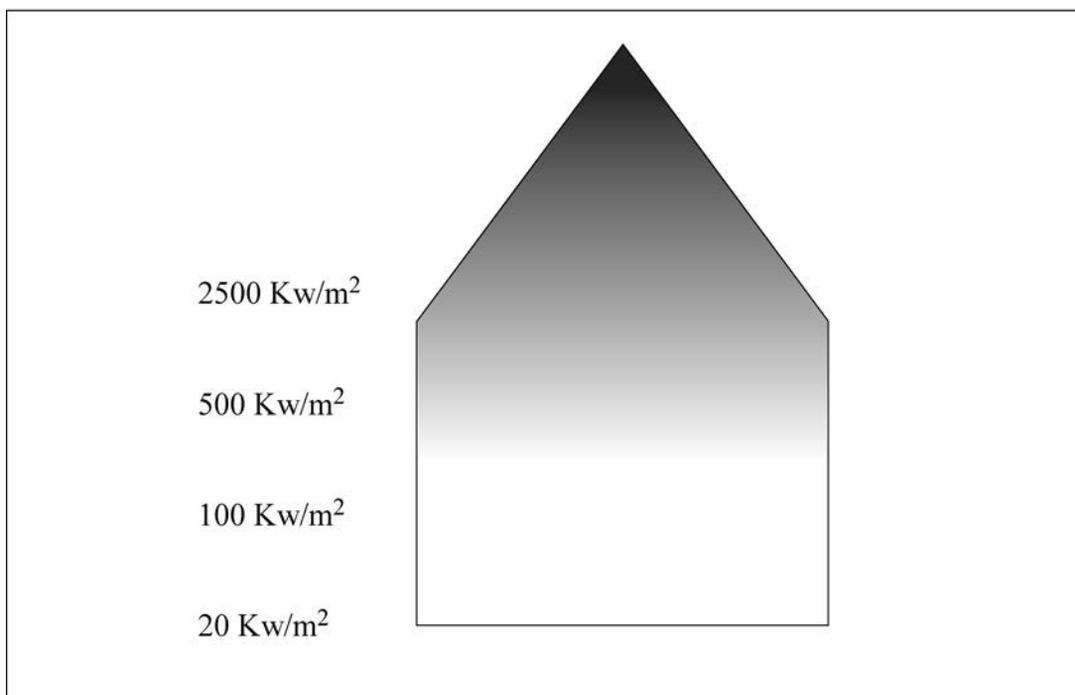
Figure 6.2 Schematic view through the building during combustion. Even with a two metre column of pyrolysis products burning, the fire would have to emit an impossible intensity of energy in order to generate the 20Kw/m at floor level required to initiate combustion there by radiation alone

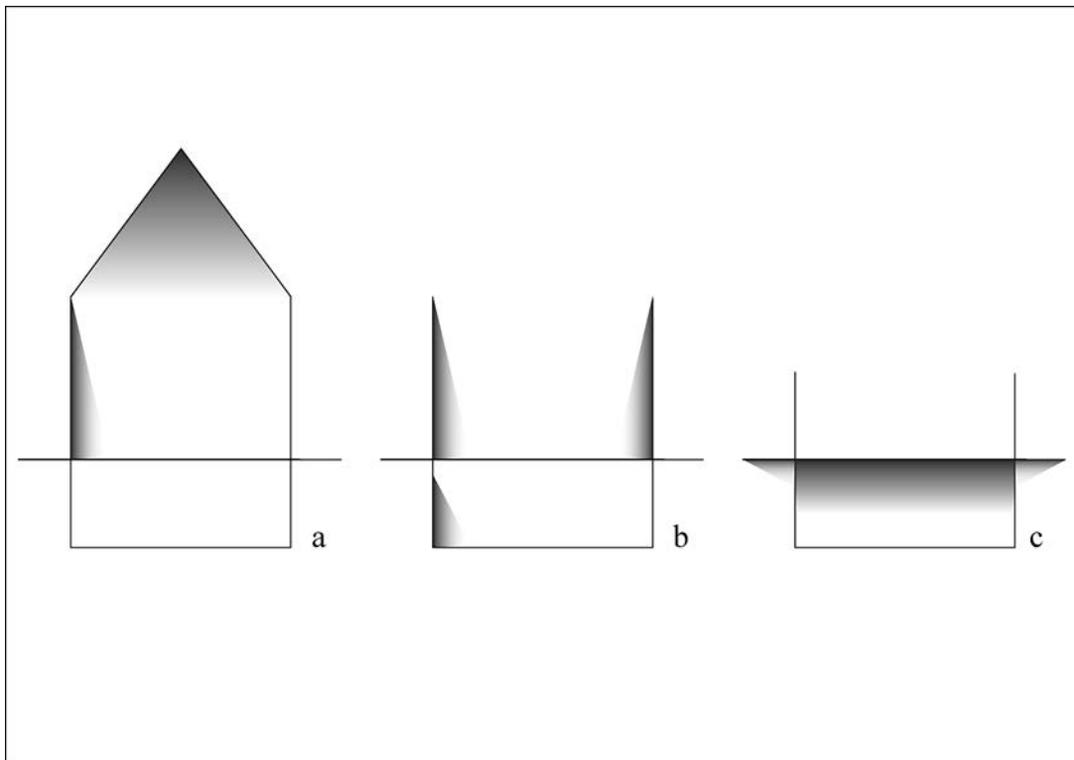
Figure 6.3 Schematic views through the building to show the suggested pattern of destruction and two distinct stages of burning

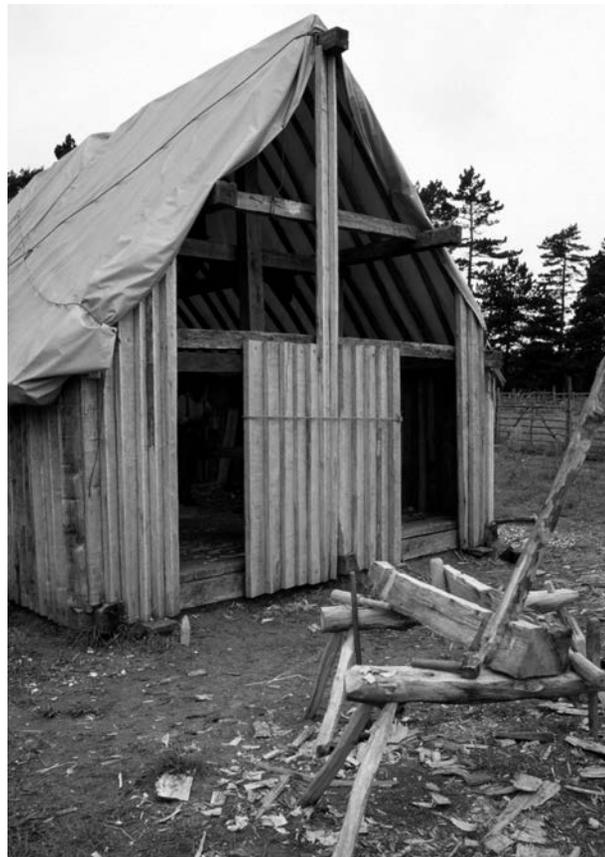
Plate 6.3 The E gable-end of the building during the fitting of the wall boards, with a vented area (i.e. slight gap) apparent beneath outer joist (viewed from the SE)

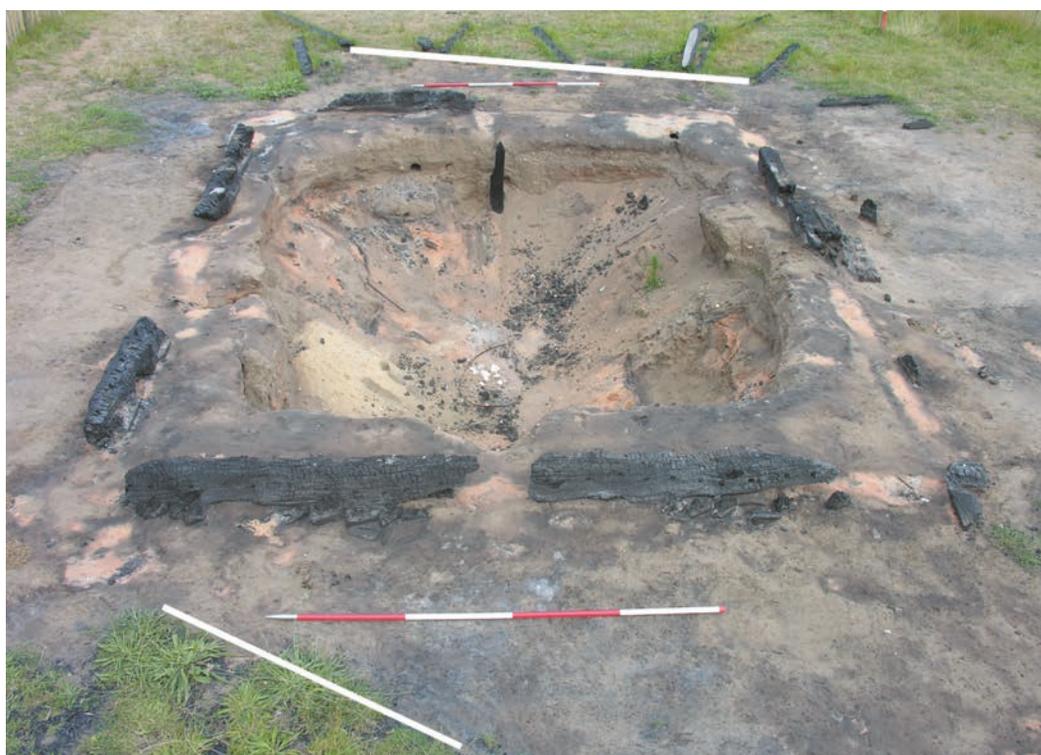
Plate 6.4 The *in situ* remains of the outer joists (viewed from W end of building) following clearance of the remains that collapsed outwards around the building, with linear patterns of destruction marked with white lines. The heat-shadowing along the S side of the building, below the position of the (destroyed) S joist is particularly clear

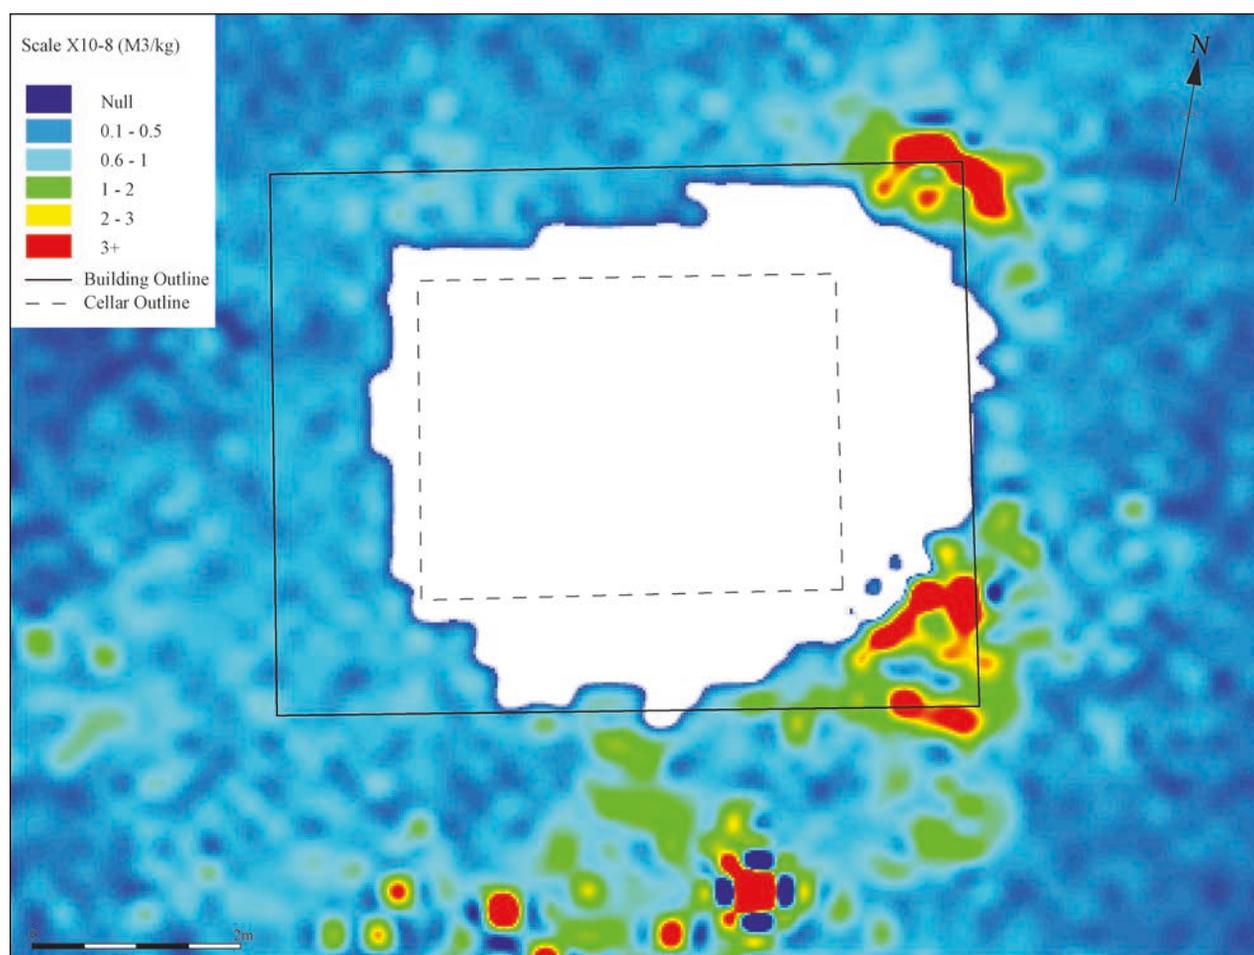
Figure 6.4 Graphical representation of magnetic susceptibility data at the site of the Farmer's House undertaken on the ground surface within and outside the wall-line (but not within the cellar pit) after the clearance of the surface remains in July 2006

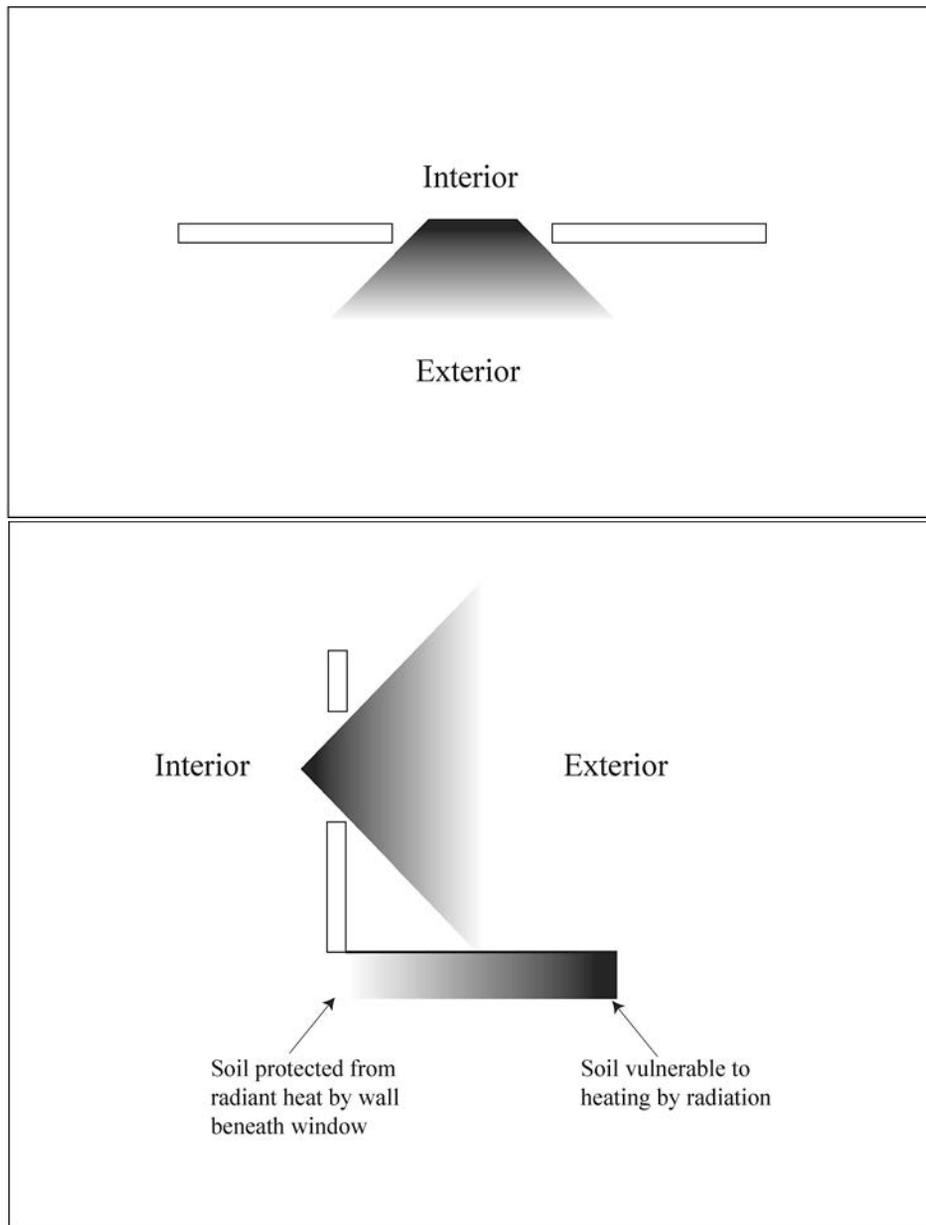
Figure 6.5 Schematic illustration to show the spread of radiated heat through doorway (top, in plan) and window (above, in section)

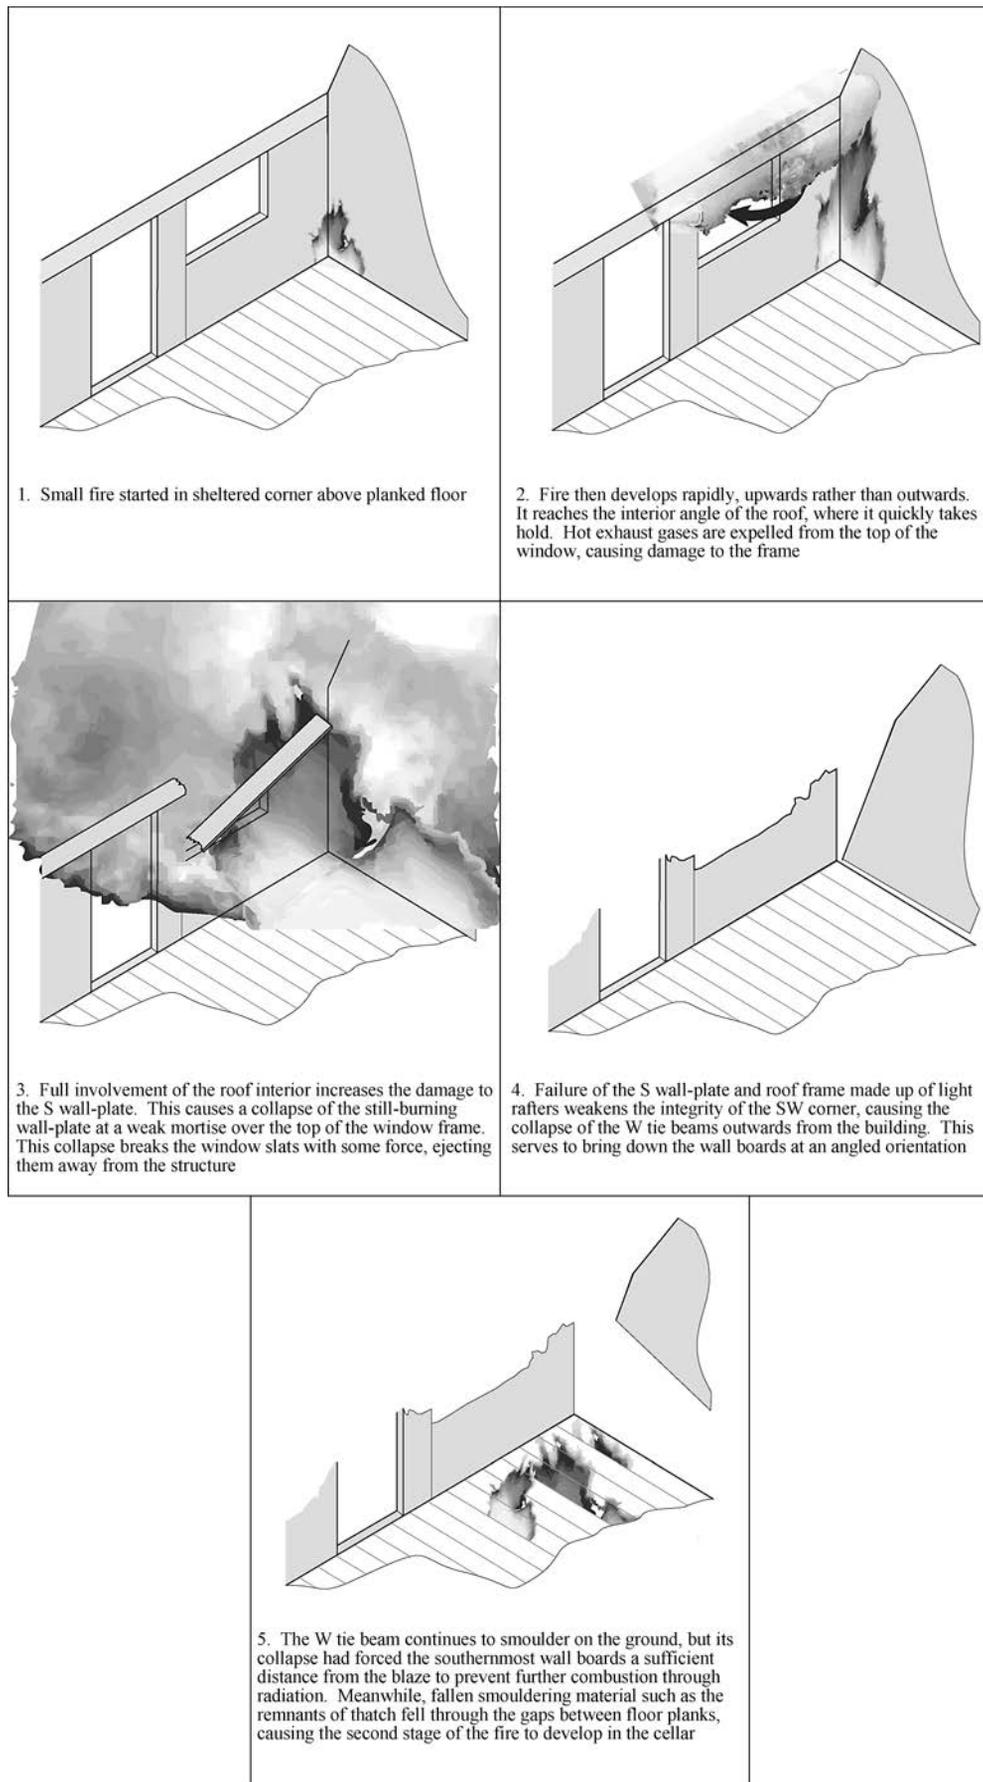
Figure 6.6 Schematic illustrations of the building to show the projected development of the fire from its initial seat in the Farmer's House

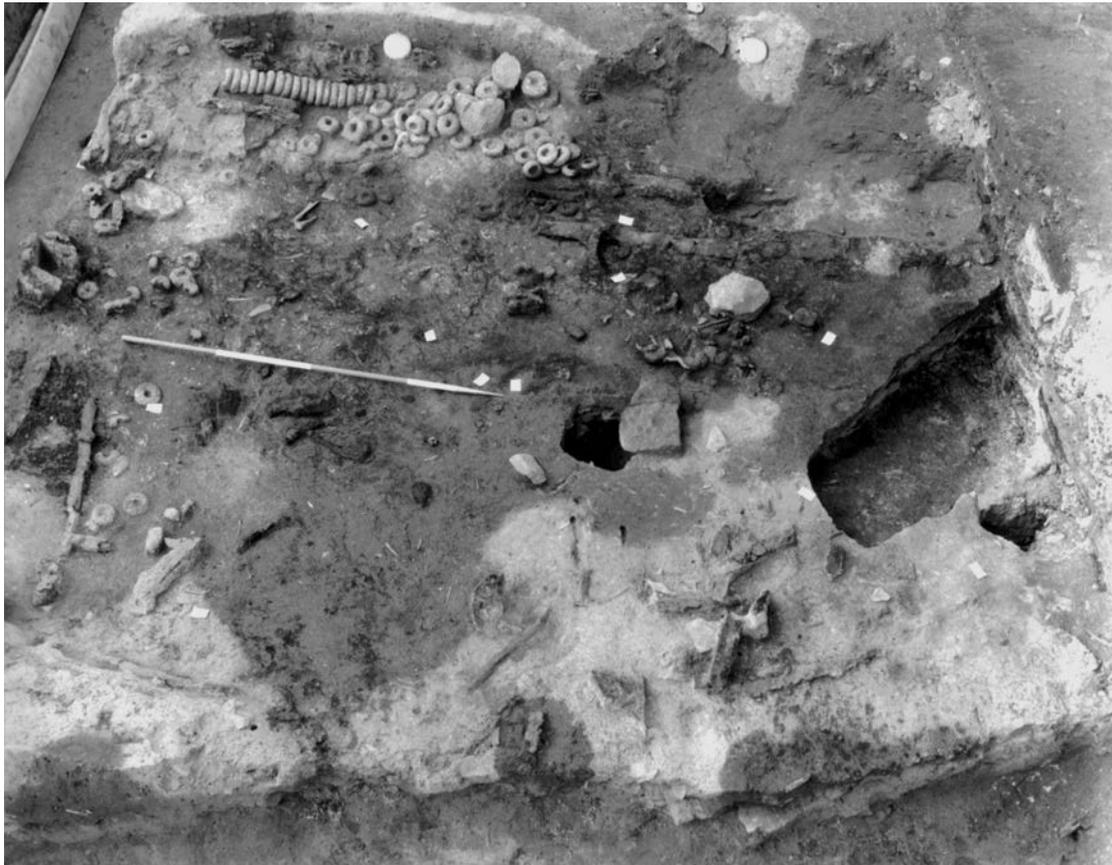
Plate 7.1 The large sunken-floored building destroyed by fire at Old Swindon (viewed from E). The row of loomweights on the base and against the (S) W side of sunken feature are mainly unburnt. The burnt remains seem to be concentrated to the N of these and in a NW–SE zone across the base of the building. Scale at 0.50m intervals.

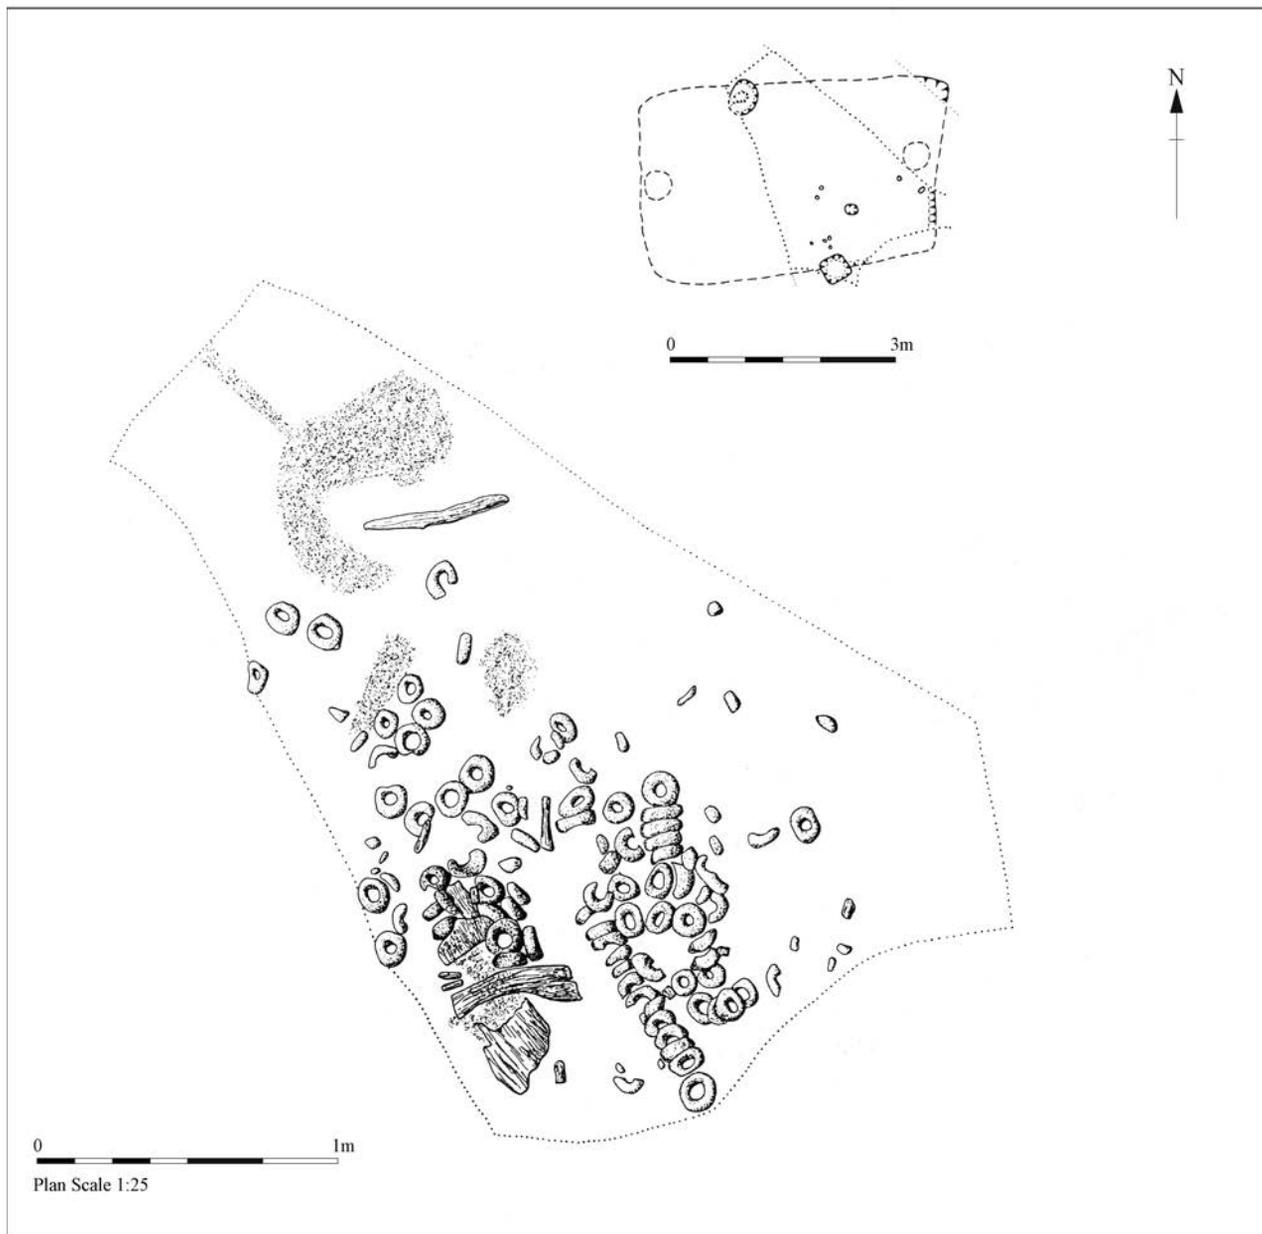
Figure 7.5 Plan of the burnt remains within SFB 2 at Hinxton Hall, Cambridgeshire. *Courtesy of Paul Spoerry and Oxford Archaeology East*

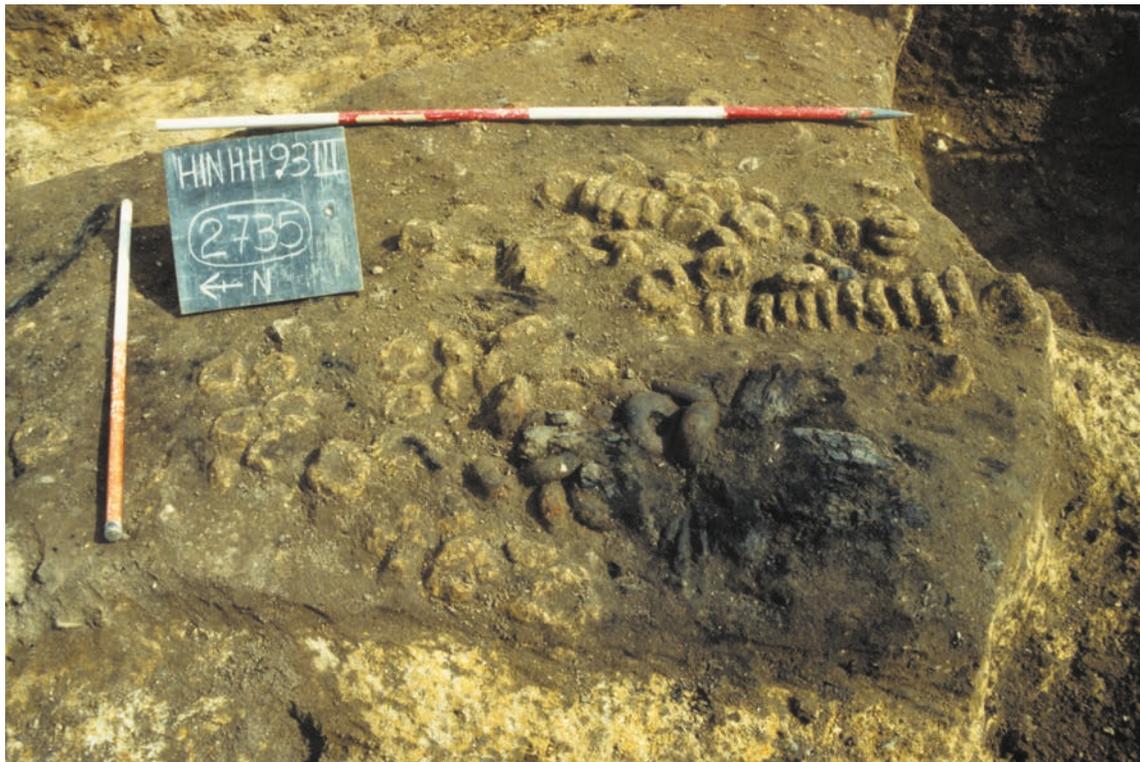
Plate 7.2 The burnt deposit on the base of SFB 2 at Hinxtton Hall, Cambridgeshire (viewed from W; scale at 0.50m intervals). The burning is localised and the majority of loomweights, and soil matrix, are entirely unburned.
Courtesy of Paul Spoerry and Oxford Archaeology East

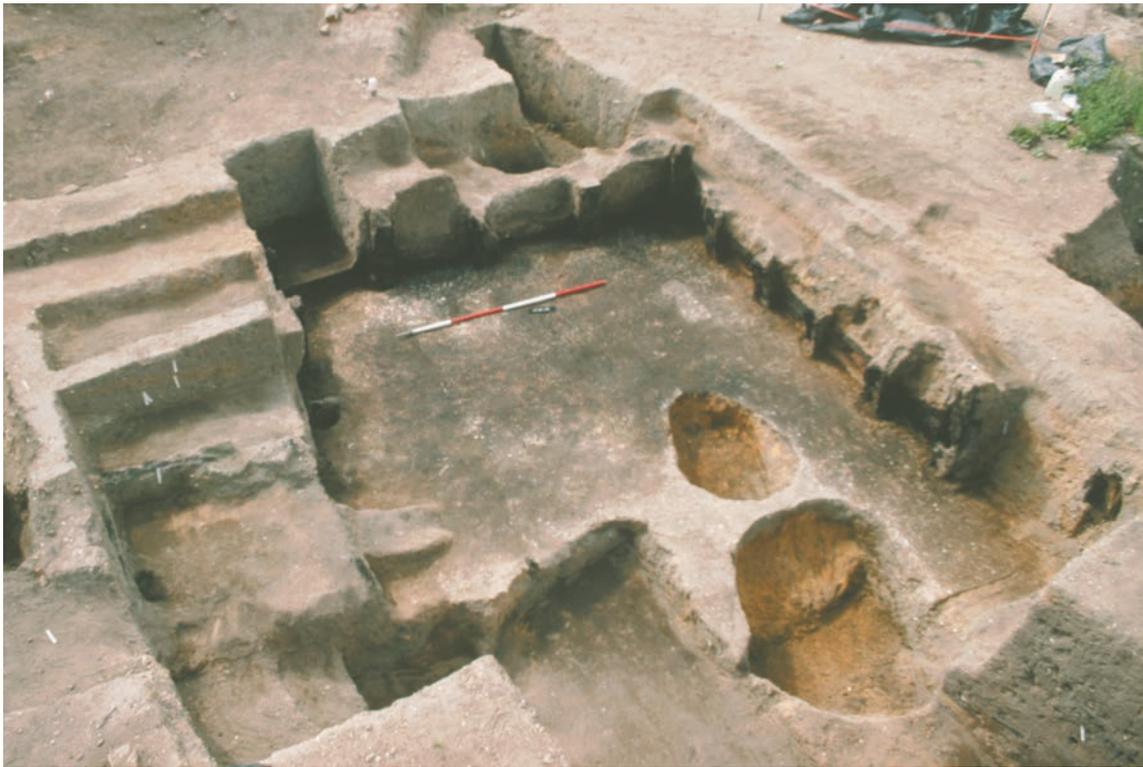
Plate 7.3 Building 2140 from St Stephen's Lane (IAS 3104), Ipswich (viewed from NE; scale at 0.50m intervals). The image shows the cellar after excavation and removal of the charred debris (and later infill) with the *in situ* charred posts and plank lining clearly preserved along the W and S sides. The entrance was on the E side of the cellar. The N part of the cellar has been cut by a number of later pits. *Courtesy of Keith Wade and the Archaeological Service, Suffolk County Council*

In IAS 3104 Building 2140 (IAS 3104, St Stephen's Lane), dated to the late 11th century, the vertical posts were preserved up to *c.*0.90m high above the cellar base, which measured 1.20m deep (Fig. 7.6, Plates 7.3 and 7.4). The lower part of the cellar lining also survived and in places the charred remains of the two lowest planks survived (with the base of the third) *c.*0.80m high (max.). The building had two phases: the first measured 5.10 x

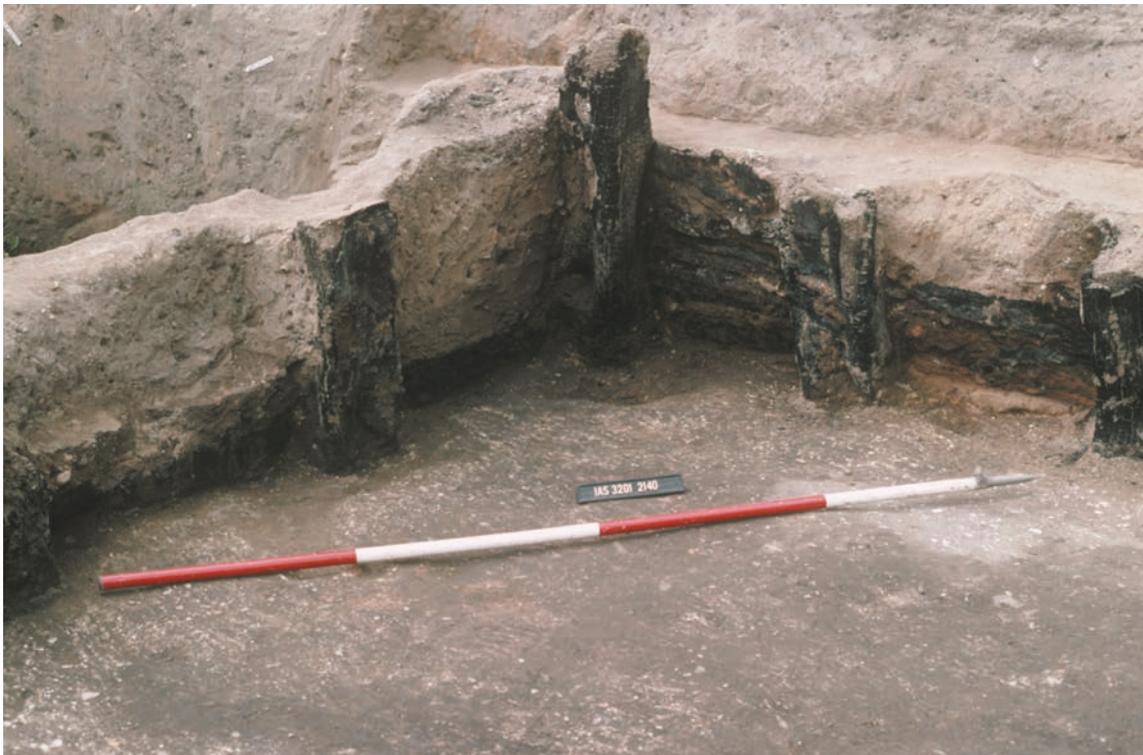
Plate 7.4 Building 2140 from St Stephen's Lane (IAS 3104), Ipswich (viewed from NE; scale at 0.50m intervals). Detail of the *in situ* charred posts and the lowest two planks of the cellar lining (wedged behind the posts) preserved in the SW corner of the cellar. The post and plank surfaces survive as thin veneers of charred material on the three outer facing sides. *Courtesy of Keith Wade and the Archaeological Service, Suffolk County Council*

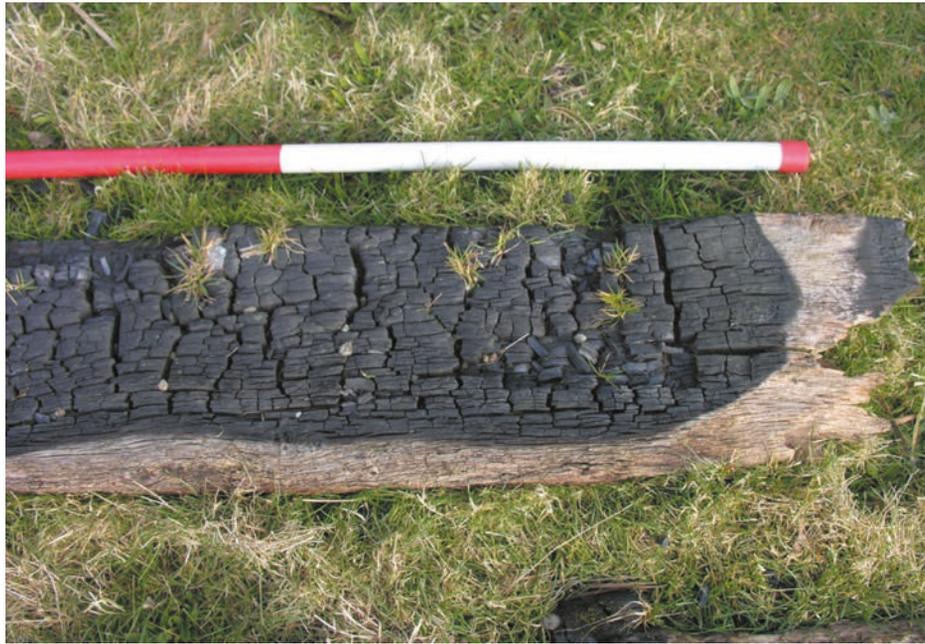
Plate 7.5 A (partially) charred board from the cellar lining, photographed over two years after the fire in March 2007, after removal from the excavation and laid on the ground surface around the excavated cellar pit (and fenced off). It was the lowest board, which remained *in situ*, along the S side of the cellar. The uncharred area on the right side was protected behind the SW corner-post while the lower part of the board was protected by accumulation below the suspended floor (two slight ridges are also just apparent). Notice how grass has begun to colonise the cracks

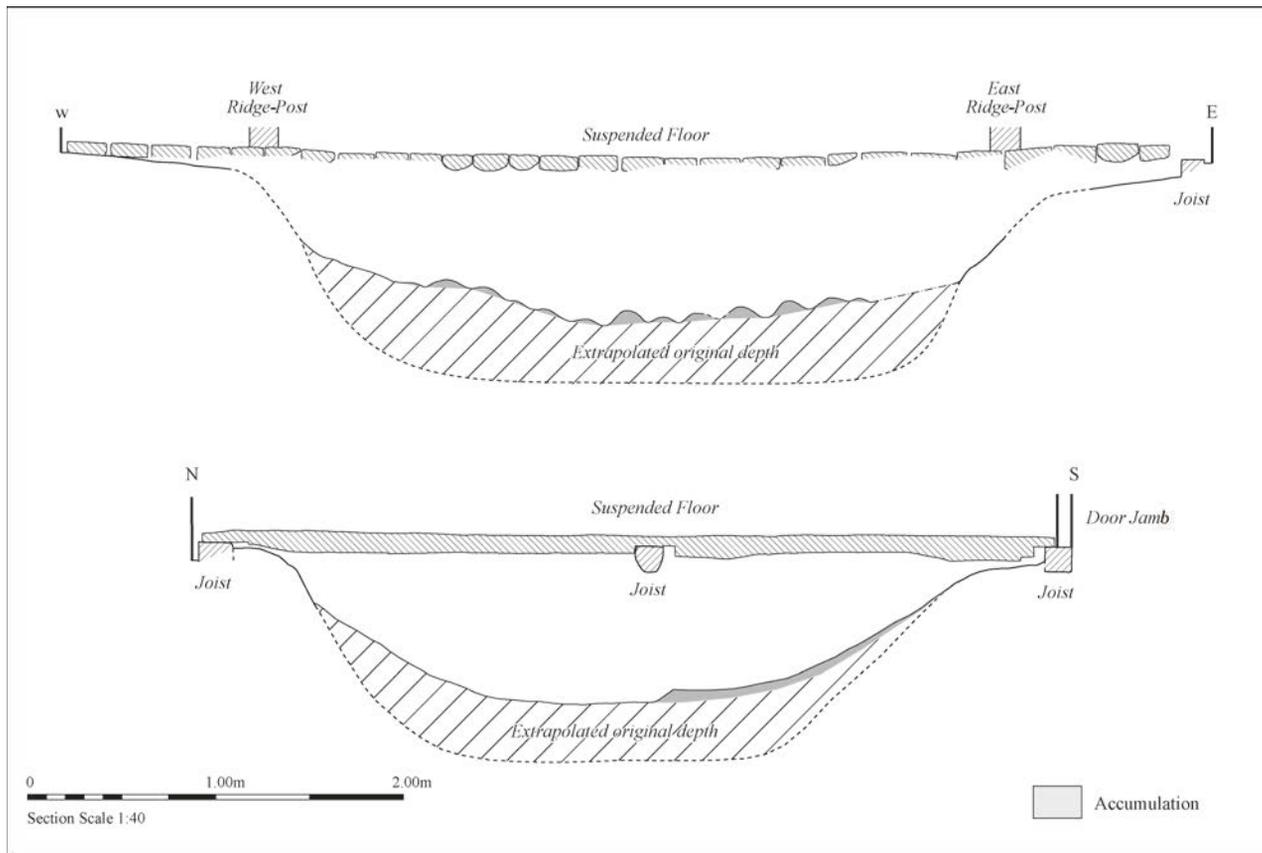
Figure 7.9 Profiles to show the ridges of accumulation on the base of the sunken feature, below the suspended floor, of the Weaving House (recorded in October 2004). The original depth of the cut is an approximation (and, therefore, the amount of accumulation below the suspended floor is also an estimate), based on the estimated reconstructed depth of SFB 20 which was 1.10m (West 1985, 26)

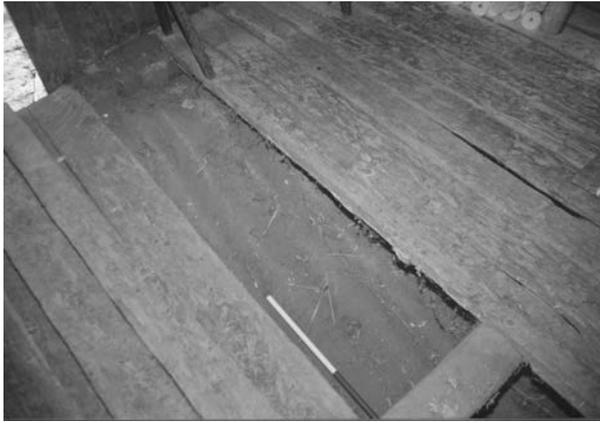
Plate 7.6 The ridges of material (at least four visible within the photograph) that have formed below the suspended floor, across the base of the sunken feature, within the Weaving House (taken in October 2004). The doorway is in the top-left corner of the image

Unsurprisingly, the location and extent of the ridges in the reconstructions reflects the size of the gaps between floor planks, with prominent ridges directly below the widest gaps. Within both the Living and Weaving Houses, the gaps between floor planks are slightly more irregular, up to 35mm wide in the former and 40mm in the latter but generally less than this. The gaps were considerably smaller, however, when the floors were originally laid, and this is the result of subsequent shrinkage of the green oak planks. Like the Farmer's House, the extent of the accumulation was also considerably greater below the doorways in both the Weaving and Living Houses.

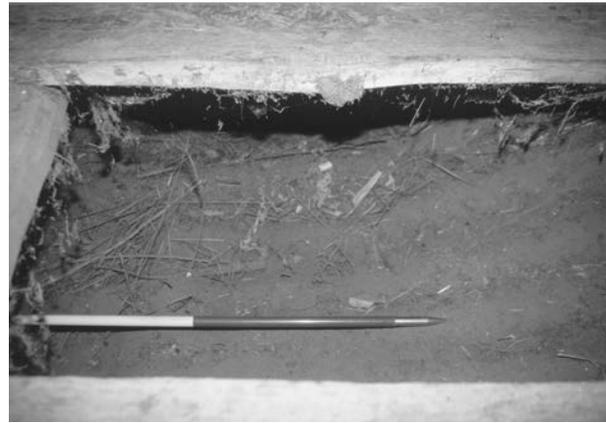
Plate 7.7 The ridges of material that have formed below the suspended floor, across the base of the sunken feature, within the Weaving House (taken in October 2004). The central E–W joist is on the left side of the picture, supporting the suspended floor planks. As well as fine sand, the material includes hazel batons, bark, straw, paper and pencils

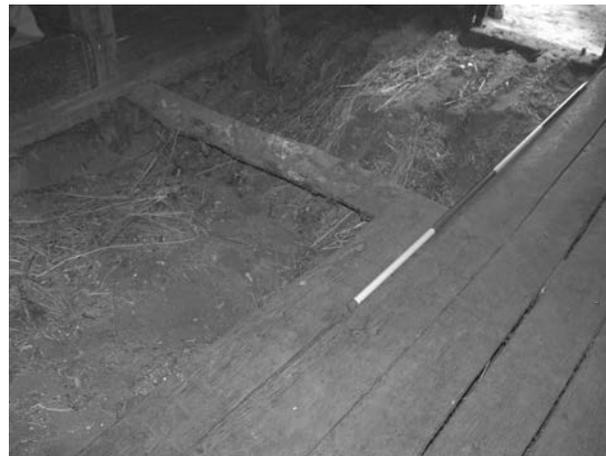
Plate 7.8 The ridges of material that have formed below the suspended floor, across the base of the sunken feature, within the Living House (taken in April 2008). The ridges are particularly clear on the ground surface inside the doorway. The sunken feature contains a considerable amount of straw, much of which has fallen between the gaps during thatching repairs earlier in the year (although a plastic cover was placed over the floor to prevent this)

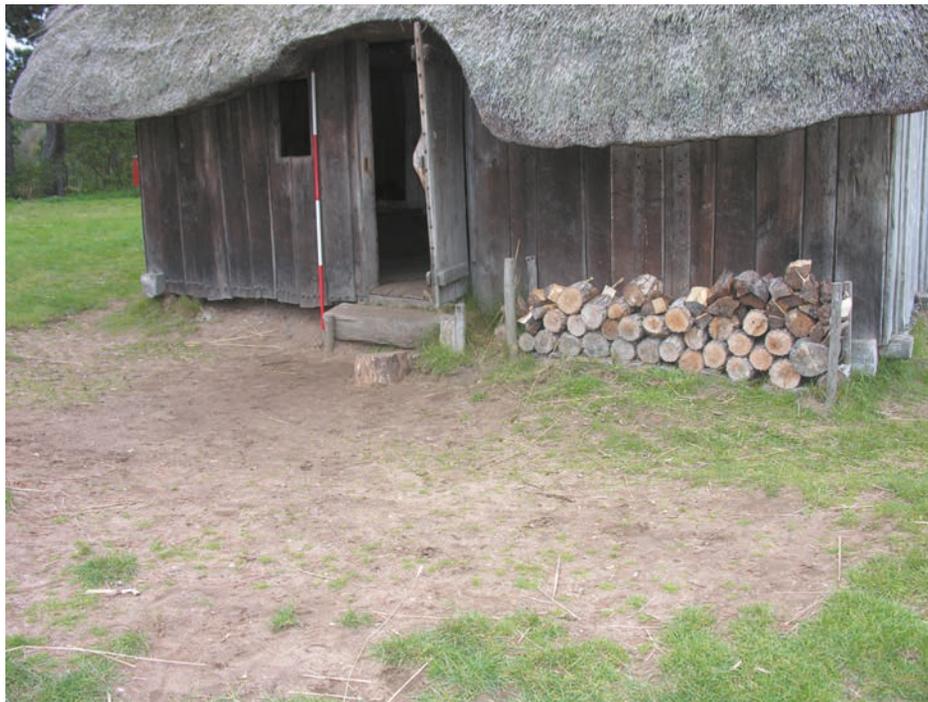
Plate 7.9 The erosion hollow that formed in front of the Living House door, before the hollows were infilled (in November 2005). There is a prominent hollow of bare sand in front of the entrance and below the window. Notice the extent to which the outer floor joist and wall boards, directly below the window, and also the lowest step, have been undercut through wear and erosion

In comparison to the accumulation of material inside, prominent erosion hollows have developed outside the doorways of all the buildings from visitors which, from time to time, have to be infilled by staff (Fig. 7.10 and Plate 7.9). There was no such evidence from the original excavations, around any of the sunken features, although the volume of foot traffic is likely to be considerably higher within the reconstructed site, which has *c.*20,000

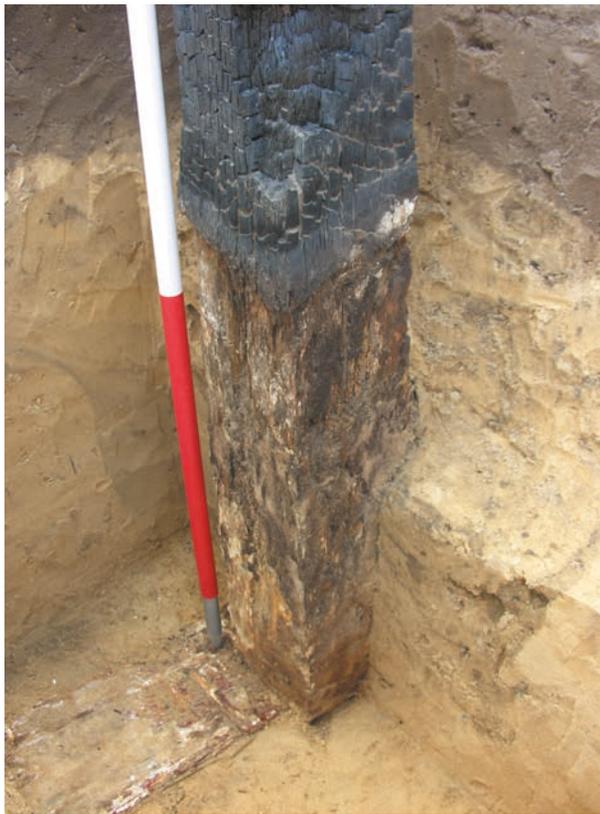
Plate 7.10 The base of the SW corner-post, investigated in May 2006. The line of charring stops at the level of the accumulation on the base of the cellar. The post is entirely unburnt below this level. The level of decay to the lower part of the post is also clear

It is probable that the extensive decay of the W ridge-post has taken place after the destruction of the superstructure, rather than during the life of the building, given the considerable difference between the two ridge-posts and the two-year timelag between the investigation of the two posts. This is presumably as a result of the increased (and more variable) moisture content of the surrounding soil without the protection of the building, and thus greater fungal attack, during the interval between the fire and investigation, and during the interval between the extraction of the different posts. The light sandy soil conditions at West Stow are favourable to water movement and, therefore, high bacterial decay of timber and other organic remains. This does not entirely explain the considerable difference in preservation between the SW corner-post and the W ridge-post. However, as previously stated, the degree of fungal attack will vary and it should not necessarily be assumed there will be equal decay between posts.

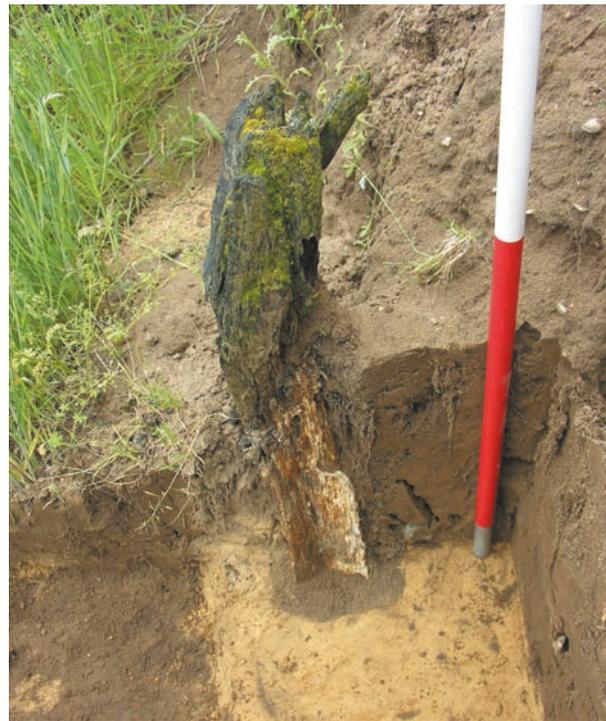
Plate 7.11 The base of the W ridge-post, investigated in May 2007. Notice, again, the line of charring also stops at the level of accumulation on the base of the cellar. The post is entirely unburnt below this level. There is considerable decay to the lower part of this post in comparison to both the E ridge- and SW corner-posts
