0. NON TECHNICAL SUMMARY

0.1 A programme of archaeological works was conducted at Alva House, Clackmannanshire on 4<sup>th</sup> and 5<sup>th</sup> November 2009. The works comprised building recording of the largely demolished Alva House and a machine excavated evaluation by trial trenching. Structural remains associated with Alva House, as well as sediments associated with levelling the site prior to the construction of the house were recorded. A second phase of archaeological works was undertaken from 28<sup>th</sup> February 2011 and comprised the machine excavation of a large open area within the confines of the demolished Alva House. Further structural remains associated with Alva House were recorded in addition to a dump of midden that overlay a demolished stone wall. Below the midden, but later than the demolished wall was a bright red silt from which a piece of pottery dating to the 14<sup>th</sup>/15<sup>th</sup> century AD provides a *terminus post quem* date for this deposit and the overlying midden material and *terminus ante quem* for the demolished wall. This wall may be the remnants of a former tower house reputed to have once stood on the site prior to the constru

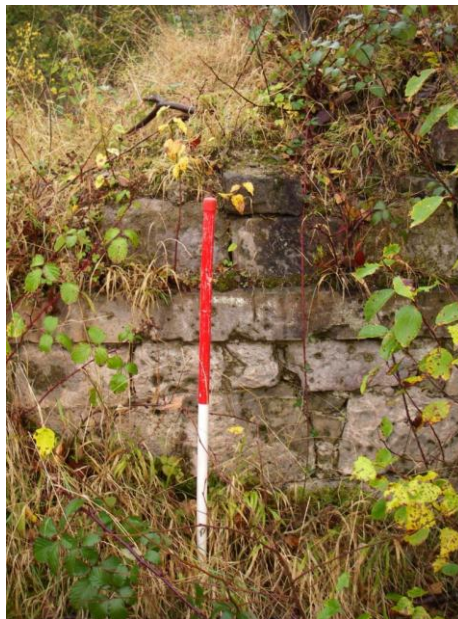
*Plate 1. Wall construction of central pedimented bay of south facing façade, showing band of dressed sandstone blocks, Alva House (Photo 36).*

- 4.1.3 The central pedimented bay projects 0.60 m from the main wall (W1), with a further central projection, some 4.40 m long and some 0.20 m southward of the latter (Photos 1, 4, 5, 36 & 37) (Fig. 2). On the south-eastern side, the corner block work of the central pedimented bay is chamfered and steps back slightly with increased height (Photo 2); the south-western corner is not visible (Photo 5). The central pedimented bay is constructed from roughly shaped rectangular blocks of igneous stone with a line of neatly cut, elongated (1.60 m x 0.14 m), rectangular sandstone blocks which occur three courses above (0.80 m) the current ground surface (Plate 1). Above this the stone blocks are darker in colour (igneous), with occasional slates between to maintain level. The wall survives to approximate 2 m above the current ground surface. Where visible the central projection is harled.

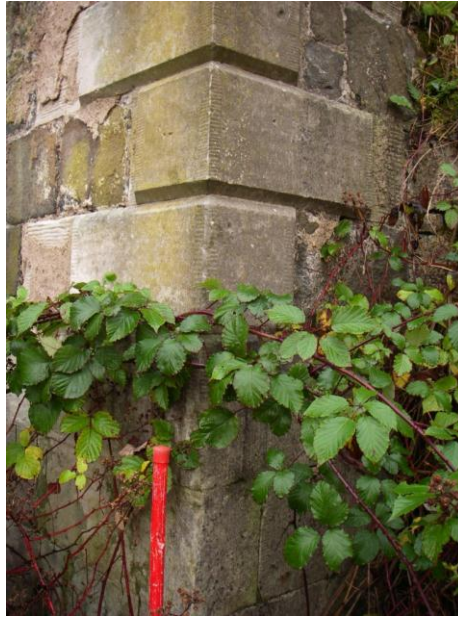
*Plate 2. Rusticated quoins of west wing, south facing façade with flat, dressed stone 'simple stylobate' visible at the base, Alva House (Photo 39).*

- 4.1.4 The western wing, south facing elevation (W2) projects 0.90 m from the main façade wall. The corner stone work comprises rusticated quoins above a lower panel of dressed cream sandstone that was once plastered ('simple stylobate') (Photos 38, 39 & 40) (Plate 2). The stone work of the main wall comprises rectangular blocks that were originally harled. 2.5 m from the south-eastern corner of this western wing the wall above the dressed stone 'simple stylobate' is inset; this is possibly a blocked, three framed window (A4) (Fig. 3 & Photo 8). The wall at this location survives to around 4 m and is approximately 8 m in length.

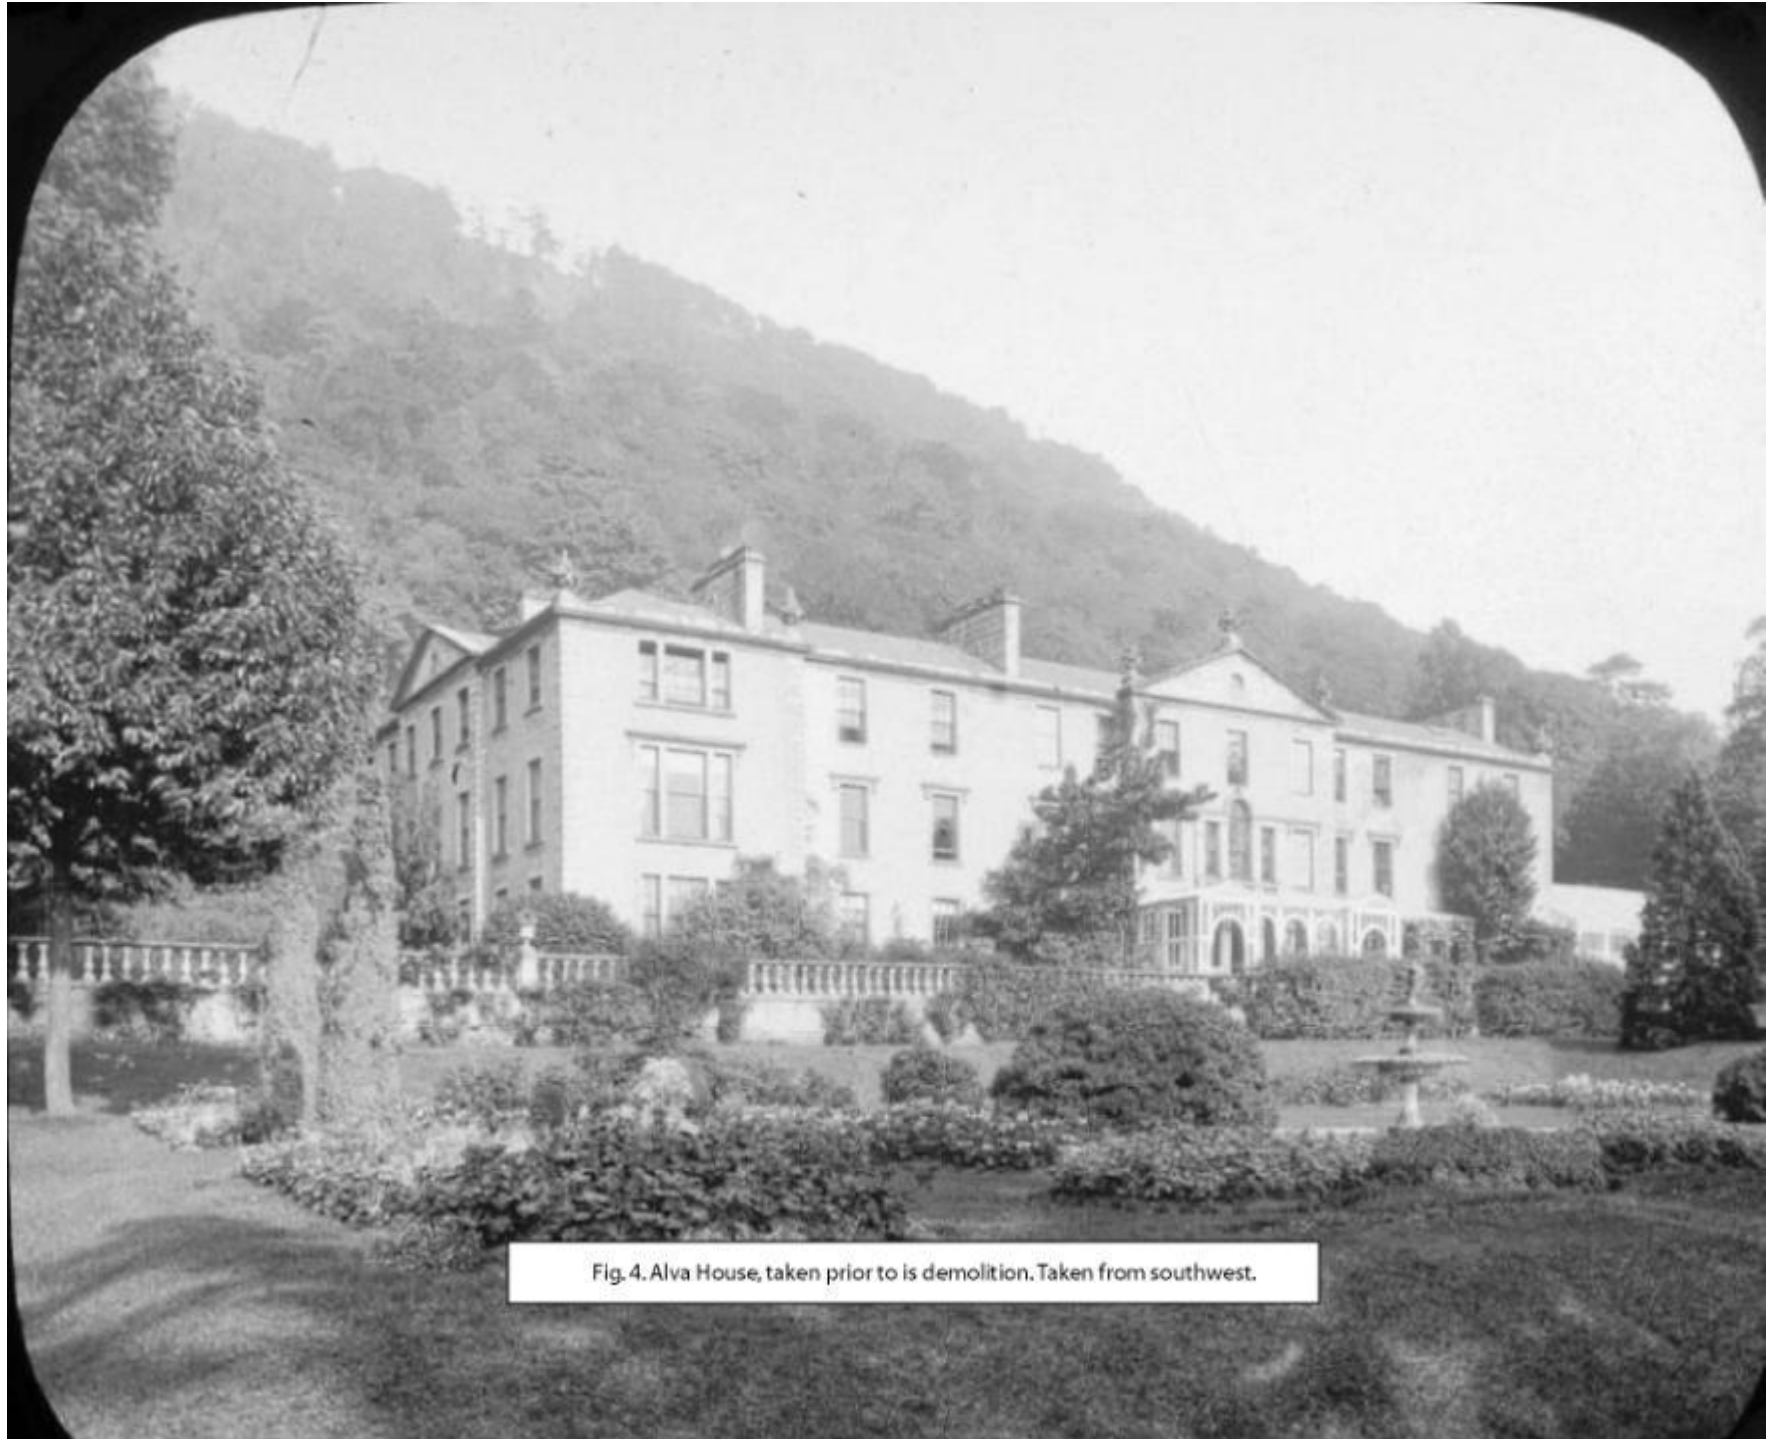
Fig. 4. Alva House, taken prior to its demolition. Taken from southwest.

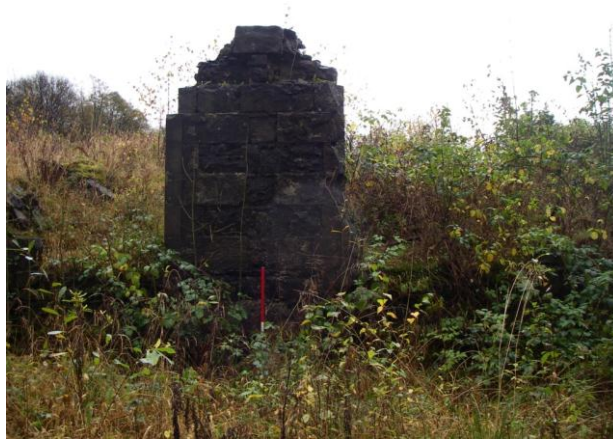
*Plate 3. Western façade, window jambs either side of surviving wall, Alva House (Photo 11).*

- 4.1.5 The southern half of the west facing elevation (W3) is largely obscured by thick scrub (Photo 10). The slight projection of the pedimented bay (0.40 m) occurred approximately 7 m from the south-western corner of the building (Fig. 2). The wall (W3) survives to approximately 3 m height (Plate 3). There are three windows that reduce in size towards the back of the house; (A5) 1.80 m, (A6) 0.80 m and (A7) 0.70 m wide respectively. All three windows have dressed stone jambs and sills. The largest window, which is set within the pedimented bay, widens into the interior, with a wall width of 1.10 m. At the northern end of the west façade is an inset wall (W4) (inset by 0.40 m) which marks the end of the pedimented bay; this wall can be traced for around 4 m northwards, although the northwest corner of this façade was not visible.

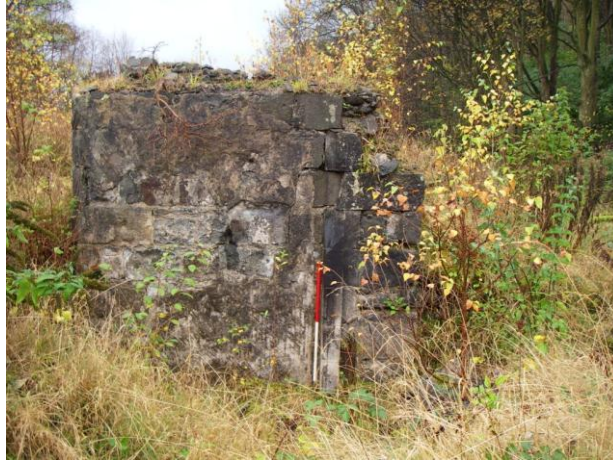
*Plate 4. East facing plastered/harled wall with stone door jamb at its northern end, Alva House (Photo 15).*

- 4.1.7 An east facing, plastered wall (0.60 m wide), with a dressed stone door jamb at its northern end lies to the south of the above and forms the eastern wall of Room 2 (W6) (Fig. 2) (Plate 4 (Photos 29 & 15)). A window (A8) in this wall has dressed stone jambs and is 1.5 m wide; it widens into the interior (Photo 30). A further dressed stone door jamb occurs at the southern end of this wall, with a matching stone door jamb on the opposite north facing wall (W11) (Photos 16 & 31). The door opening is 1.10 m wide. On the other side of this east facing wall, roughly opposite the door, an inner wall, (W7), 0.70 m wide, spans the width of the west wing. The line of the east facing wall (W8) extends southwards, although it is slightly off-set and appears to abut a fragment of wall running in an eastwardly direction (017) (W9). Abutting the latter is a further north/south oriented wall (W10) that appears to be keyed in with the wall of the south facing façade (W2).

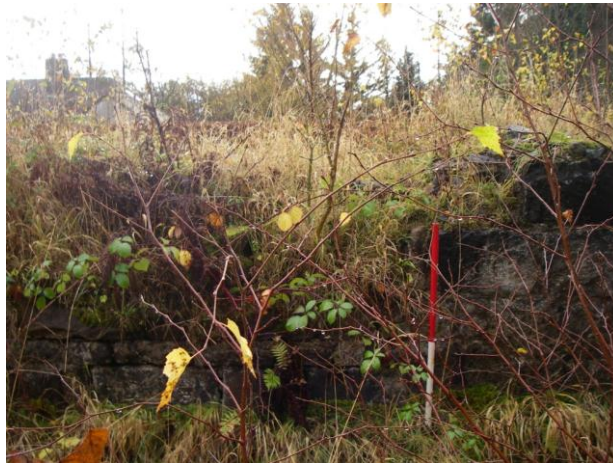
*Plate 5. Northernmost, north facing wall with window aperture, Alva House (Photo 18).*

4.1.8 An additional north facing stone wall runs from the doorway (described above) eastwards for approximately 12 m (018) (W11) (Photos 18, 19 & 20) (Fig. 2). The wall is 0.70 m wide and survives to a height of 1 m above the current ground surface. The blocks of stone are more uniform (0.45 m x 0.35 m) than those of the south facing elevation (except for the west wing). Fragments of harling are visible on the north facing side of W11. Within this wall three window apertures are just discernable (A9, A10 & A11) (Plate 5). Two of the windows are 1 m wide (A9 & A11), one side of the third (A10) is not visible. All the windows have dressed stone jambs and sills.

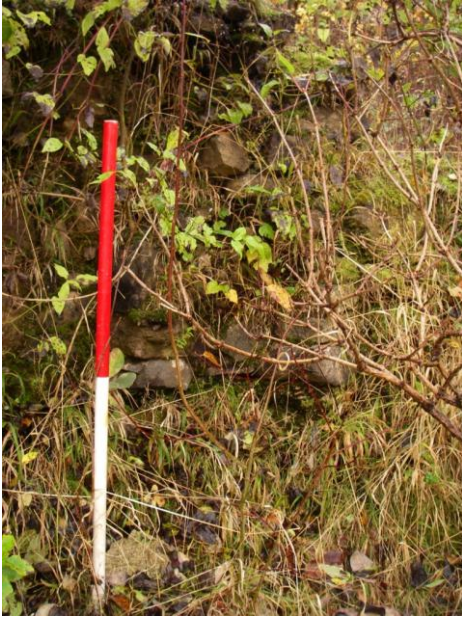
*Plate 6. Curvilinear wall, Alva House (Photo 28).*

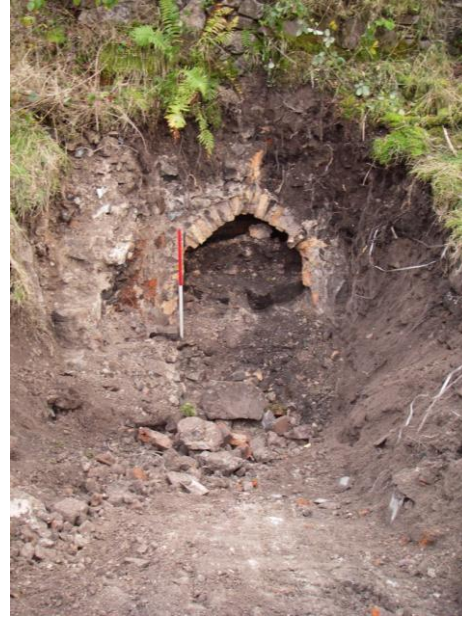
*Plate 7. Brick barrel vaulted niche, Alva House (Photo 65).*

- 4.2.7 A brick barrel vaulted niche (015) was revealed in Trench 3, (Fig. 2 & Plate 7). The vault is 1.20 m deep, 1.10 m wide and 0.60 m high. It has a stone floor, upon which is a considerable amount of soot. The brick work abuts the east/west oriented structural wall (017), extending the wall width at this point by 1 m. A further stone barrel vaulted cellar (016) (Plate 12) was recorded to the north of (015). The machine cleared back rubble from the collapsed entrance. This cellar is partially collapsed and was not entered, although the back (eastern) wall was discernable. The cellar is 3 m wide, with 3 brick built compartments at its eastern end. A lower brick barrel vault was just visible below the northernmost brick compartment; the depth of this was not ascertained.

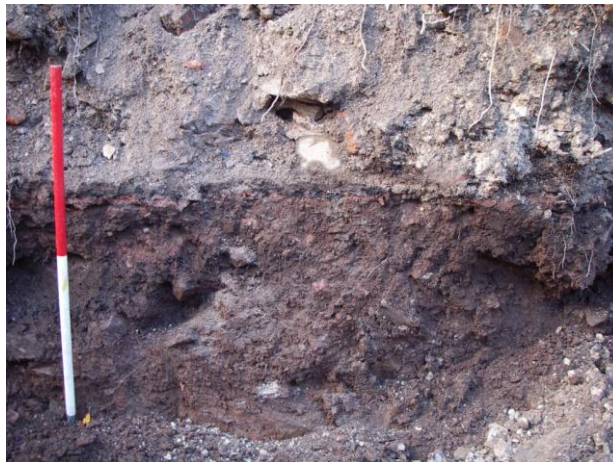
*Plate 8. East facing section showing natural silt (007) and various sedimentary deposits above, Alva House (Photo 47).*

4.2.2 Trench 1 was oriented north to south. The southern end of the trench comprised the inner face of the south facing elevation. The stone foundations of this wall comprise two stepped tiers of stone blocks; the lowermost extends some 0.40 m from the main wall. The foundations rests upon natural red silt (007) and in one section brown silt (006). The east facing section revealed an interesting sedimentary sequence (Fig. 4). At the base, some 0.20 m of natural red silt (007) is overlain by 0.40 m of brown silt (006) in which are mixed numerous fragments of coal (approximately 30%) and rare fragments of animal bone. There are occasional short, discontinuous bands of coal fragments within this deposit. The brown silt (006) is capped by a series of thin bands of sediment. The first is (005), a thin band (0.02 m) of bright red clay with occasional small pebbles. This is capped by a thin (0.01 m) brown sandy silt with charcoal fragments (004). On top is another red clay (003) some 0.03 m thick, which is very similar to (005). Directly below the rubble back fill is (002) a dark brown silt with coal fragments; this layer is 0.03 m at its thickest. Above this lies 2.28 m of rubble back fill (001). On the western side of Trench 1 the made ground of re-deposited silts extends back to (009), a thin wall. On the eastern side of Trench 1 the natural silt (007) extends back to (009), some 5 m north of the inner face of the wall of the south façade.

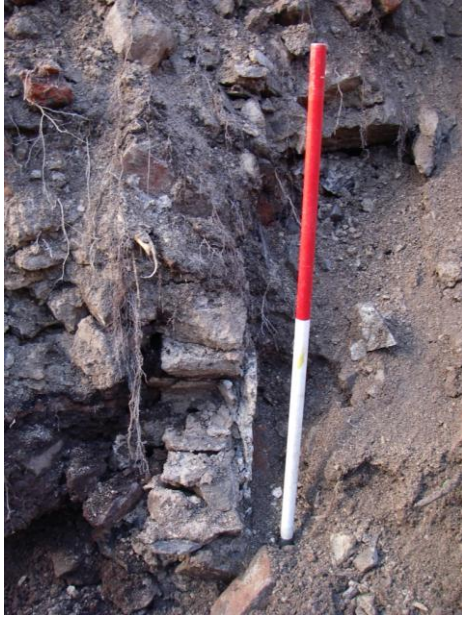
*Plate 10. Thin wall of passage, Trench 1, Alva House (Photo 48).*

4.2.4 Trench 2 was oriented east to west and led off Trench 1 in an eastwardly direction. A thin wall (009) was seen in the east facing section and in plan at the north end of T1 running into T2 (Fig. 2). The wall is thin, 0.20 m wide, and stone and brick built; its northern side is lined with plaster (Plate 10) and at the base of the trench its southern side by natural silt (007). The wall curves northwards leading towards a wall of stone (010), the eastern end of which is curved (Plate 11); this structure is interpreted as an elongated stone newel post. Beneath the newel is a stone arch, thought to be a supporting arch for the rising newel. This arch and the newel post are constructed from sandstone; each block about 0.20 m thick, 0.50 x 0.26 m long. The newel was originally plastered and survives to a height of at least 1.80 m. The thin wall (009) forms part of a passage leading from the western side of T1 to the supporting stone arch.

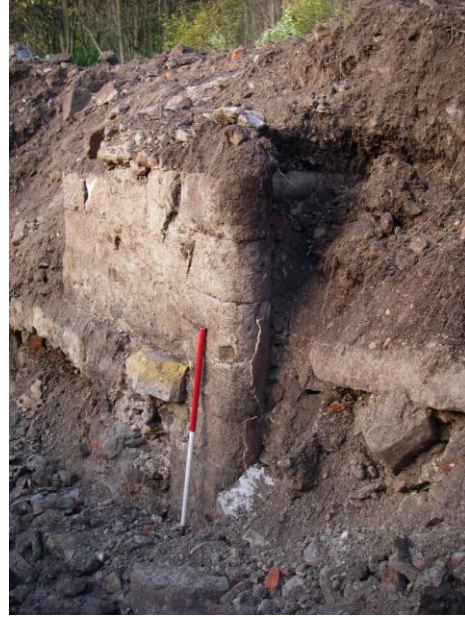
*Plate 11. Stone newel post with Supporting arch, Trench 2, Alva House (Photo 52).*

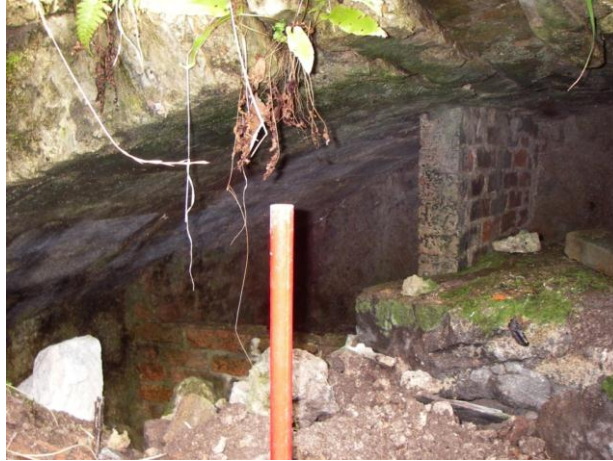
*Plate 12. Stone barrel vaulted cellar with brick compartments, Alva House (Photo 61).*

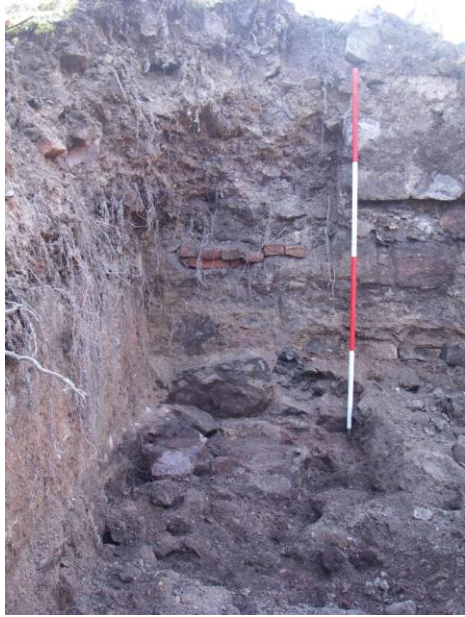
*Plate 13. Blocked doorway in (W11) and levelling layers (033), (034) and (035) below. (Photo 87)*

- 4.3.4 In the corner where (W11) met (W1) a layer of sandstone blocks (033) formed the northern side of the ventilation gap (036) (Plate 13). Below (033) was a brown silt midden (035) which had clearly been disturbed and sandstone blocks added to it.

- 5.7 The corner of W1 and W11 are keyed in, demonstrating that they had been constructed at the same time. The blocked doorway in W11 as well as a brick lined chimney are shown on Adam's plan of the first storey of the house. (008) is as depicted on Adam's plan but wall (030), only seen in section, is not; it is likely that this wall belongs to a later phase of construction and alteration of the house. The stair (027) coincides with that shown on Adams' plans, and clearly extended to quite a depth to allow access to the cellar down the subterranean passage (009).

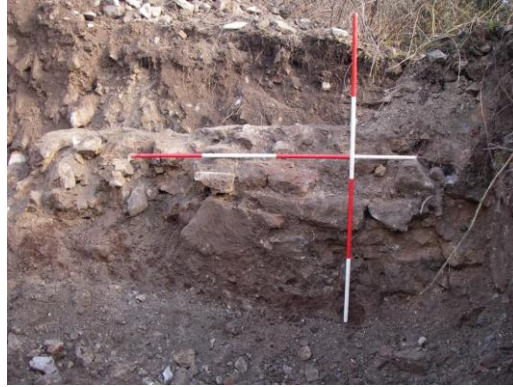
*Plate 14. Wall (008). (Photo 89)*

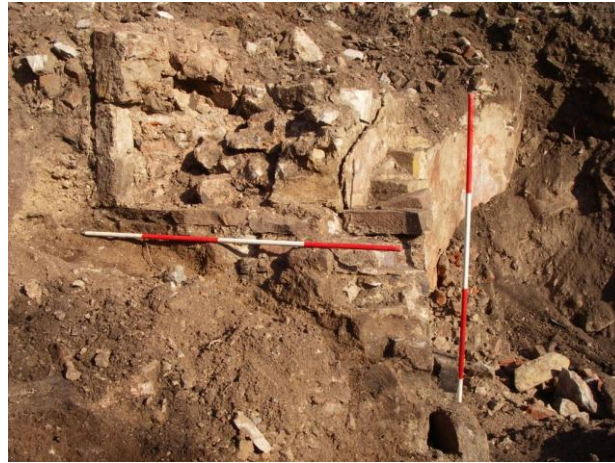
Plate 15. Stone staircase (027). (Photo 96).

- 4.3.2 The stone stair (027) revealed in the evaluation was re-revealed, with broken sandstone treads of a curving (spiral ?) staircase ascending in a clockwise direction and with a lower curving concave wall extending to the east (Fig. 3). The stair was supported by a substantial stone supporting wall (028), with a cement mortar; the stone work of the western side of this supporting structure was dressed. To the north of (028) there appeared to be a rubble filled doorway. The construction trench for (028) was clearly visible cut into (025) a red silt. The passage (009) revealed in the evaluation was also re-exposed. The passage clearly cut the red silt (025) and the overlying midden deposit (021). The walls of the passage were roughly constructed from cobbles and stone with a weak cement mortar. The walls had been built up against the silt and midden deposits on the north side and natural red silt on its south side. To the west was a large, deep cellar. The south, east and northern walls of the cellar were exposed. The walls were constructed from sandstone and originally plaster, although later repairs were apparent as red brick had been utilised to fill gaps left by collapsed sandstone blocks. Holes for thin joists were visible near the top of the cellar wall. The remnants of a possible brick built cupboard was recorded on the southern wall. To the south of this the over thickened wall of the brick oven (015) revealed in the evaluation was just visible.

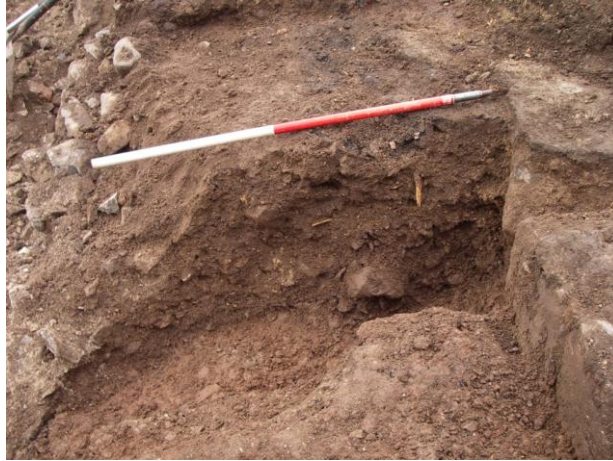
*Plate 16. Sondage through middens (023), (021) and material (022), with wall (026) visible on the right. (Photo 112)*
