**Tetcott Methodist Chapel
Bone Lane
Tetcott
Devon**

Historic Building Record

National Grid Reference: SX34050 96500
OASIS reference: deborahl1-305273
Planning application No: 1/0940/2017/FUL

February 2018

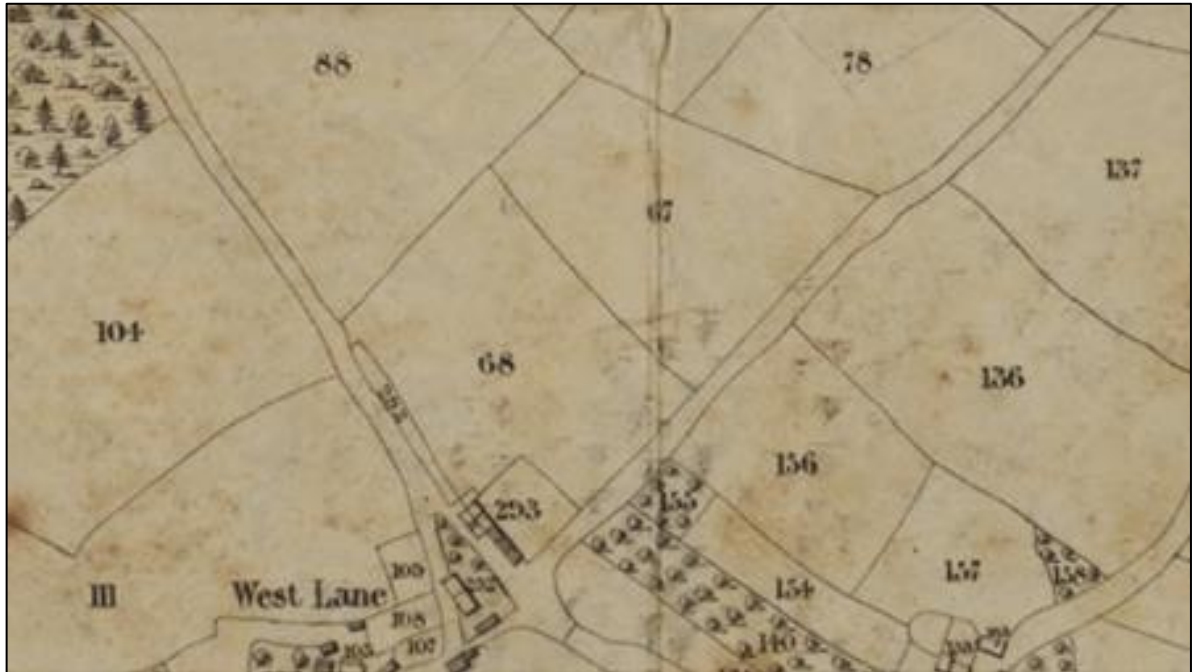
Figure 2: Extract from the 1837 Tithe map of Tetcott. The field now containing the chapel within the east corner is No. 67.

The Tithe map (Fig.2) and Apportionment tells us that in 1837 the field now containing the chapel was owned by Sir William Molesworth, the owner of the Tetcott estate. At this time the only lands on the estate occupied by Sir William, some 89 acres, included 'woods', 'downs' and stables and yard which suggests that he was not resident but retained an interest in hunting on the estate. The field in question was tenanted by the 'Messieurs Courtice' and formed part of the Moor Town holding. The field Numbered 67, named 'Middle Close' is empty of buildings and there is nothing within the eastern corner where the chapel now stands. Francis Chappel was tenant of the Barton at this time and clearly remained so for some years.

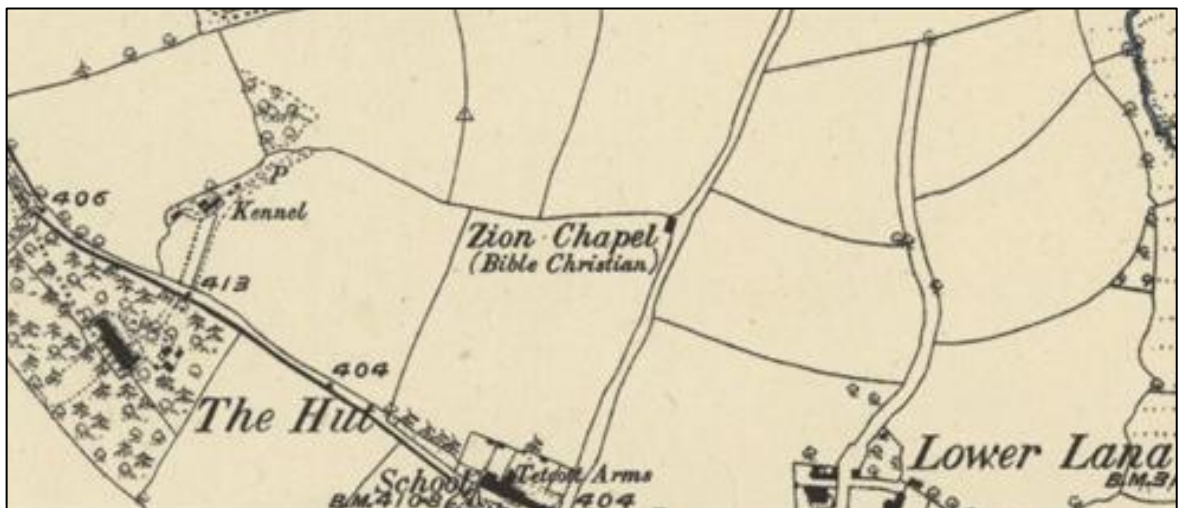
Figure 3: Extract from the 1st Edition Ordnance Survey map surveyed 1883, published 1885 (scale: 6inch – 1:10560).

of 1885 (Fig. 3) depicts the chapel; built at the same location as the existing building, aligned roughly north-south against the road. This rectangular building appears to be a far more simple building than the later chapel with its larger meeting hall, side school room and rear service rooms (see Fig. 4). The name Zion was commonly used by the Bible Christians for their places of worship; other sites include Langtree and Plymouth.

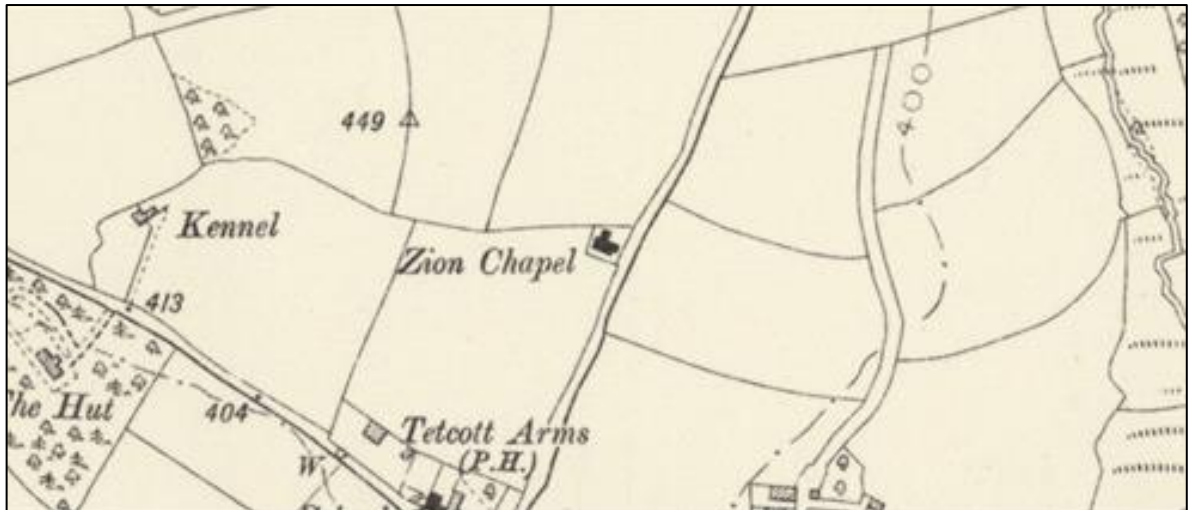
Figure 4: Extract from the Second Edition OS Map surveyed 1905, published 1907 (scale: 6inch – 1:10560).

The Second Edition OS map (Fig. 4) appears to show the building much as it is today, although it is not at a scale to detect any minor differences to the building.

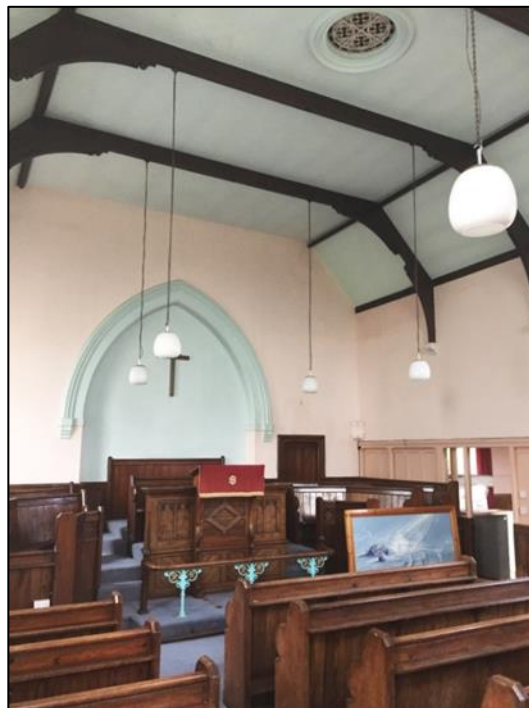
Figure 5: Former interior west end of Chapel, showing congregation pews, Choir or Leader pews, raised Rostrum and Communion rail (Courtesy of A. Pett).

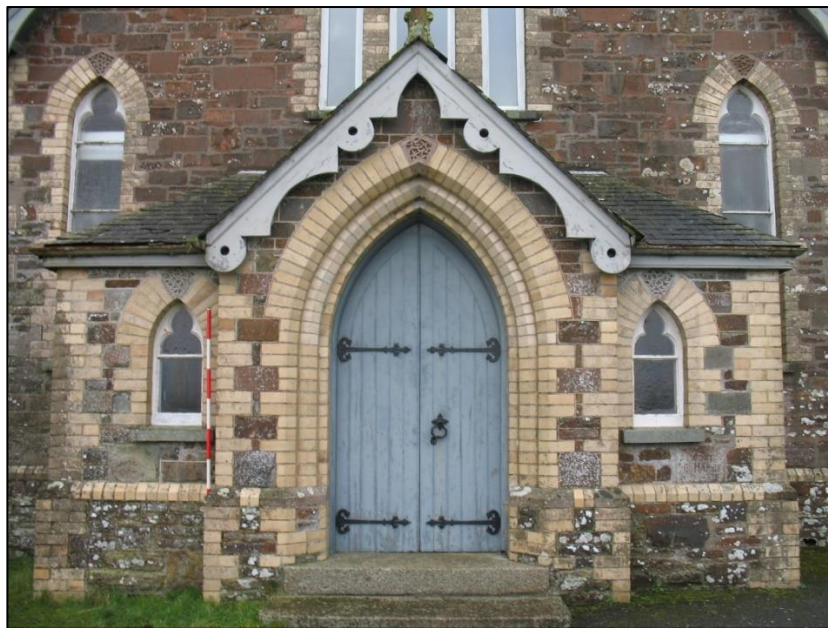
Figure 6: The east entrance vestibule of the Chapel Hall, viewed from the east (2m scale).

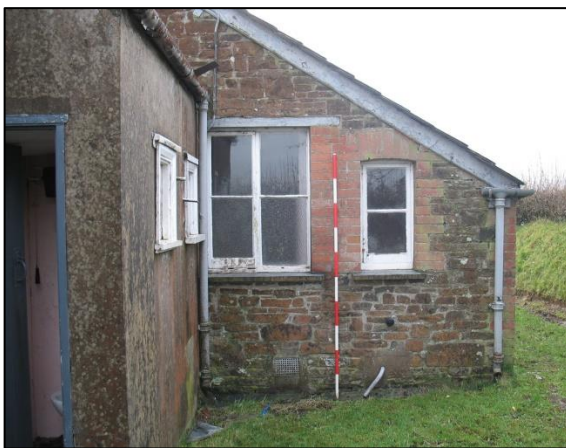
Figure 7: Left. The north elevation of the Vestry, viewed from the north (2m scale).

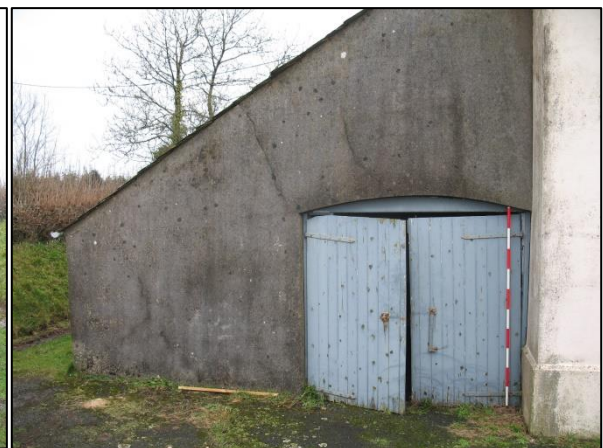
Figure 8: Right. The south elevation of the Stable, viewed from the south (2m scale).

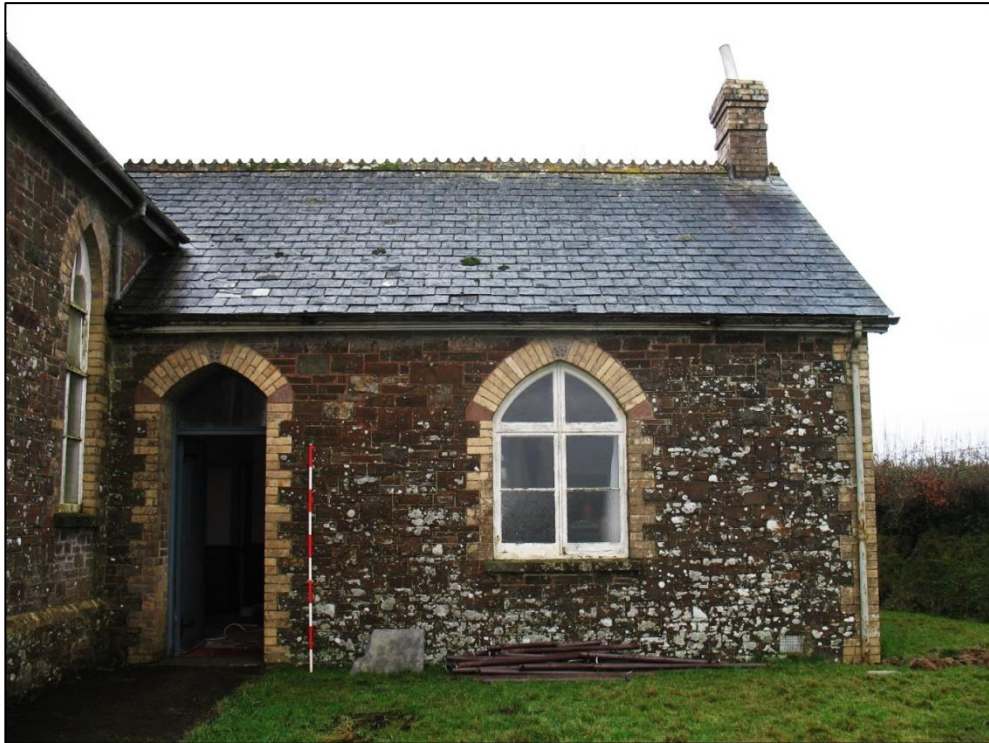
To the northwest end of the Hall is a single storey former School Room, with a pitched slate roof and with a brick chimney at the north gable (Fig. 9). To the rear southwest of the School Room is a later brick built toilet extension with a mono pitched metal sheet roof, set within the angle between the School Room and the Vestry (see Fig.7).

Figure 9: East elevation of School Room, viewed from the east (2m scale).

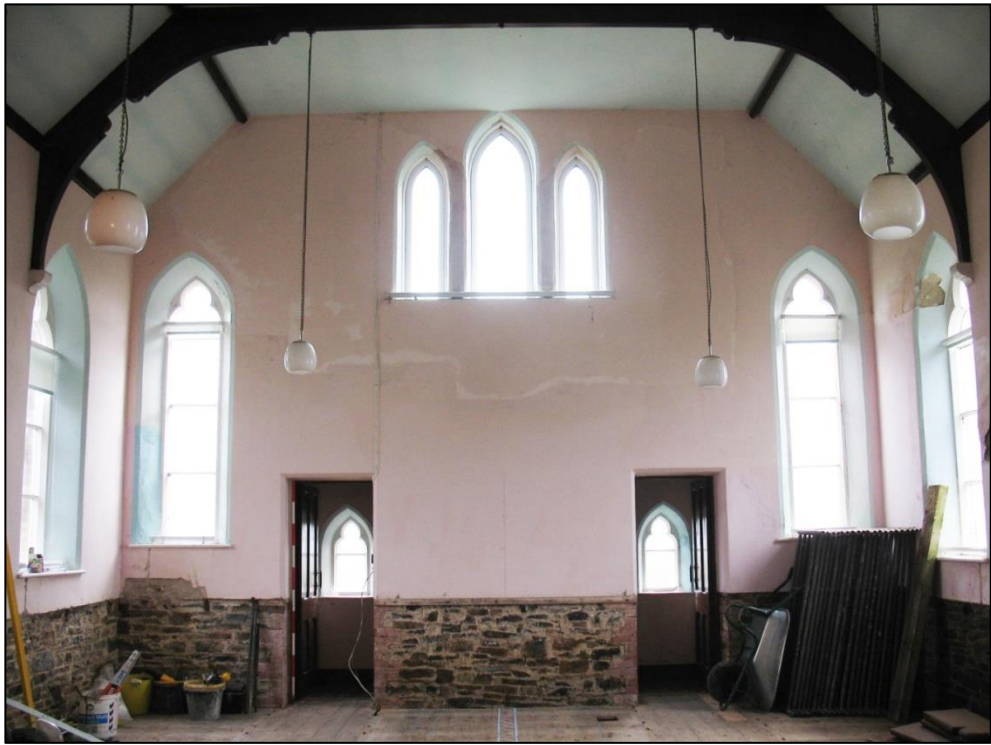
The five bay Chapel Hall interior walls are plastered and painted with masonry exposed at lower levels where former panelling has been removed (Figs. 10 & 11). All structural elements within the

Figure 10: The Chapel Hall east wall, also showing ceiling with timber bracing below structural roof timbers, viewed from the west (2m scale).

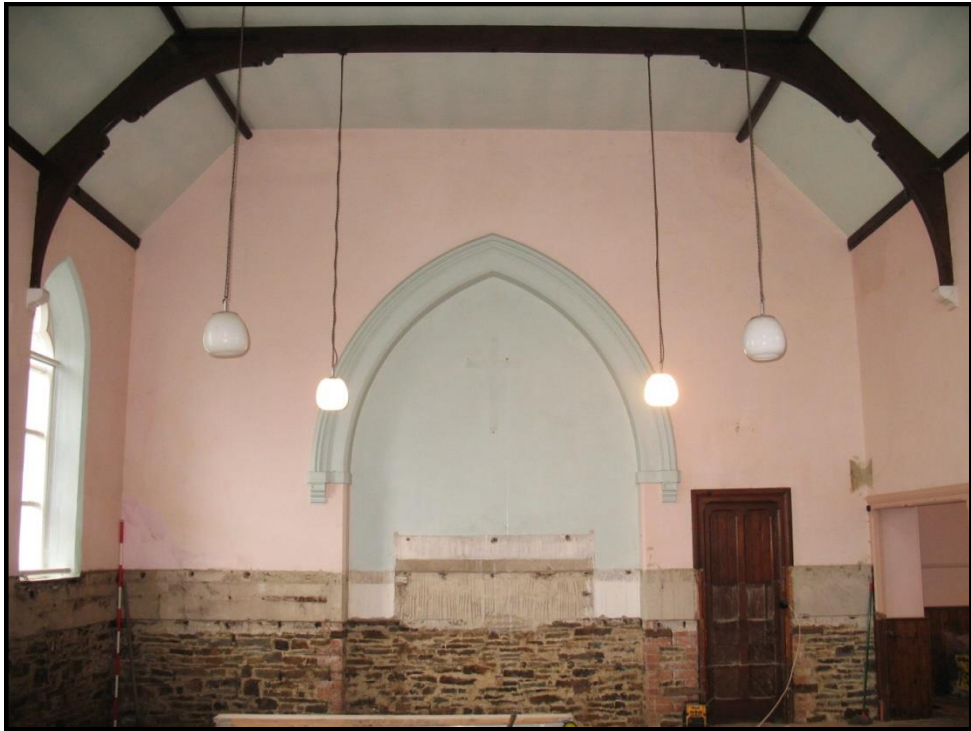
Hall, including a moulded arched recess in the centre of the west wall (Fig. 11), all arched window openings, door openings and the ceiling and visible roof structure are original to the building. The four bolted pine A-frame trusses of the roof structure have raised tie beams/collars and pairs of timber braces, the lower set into wall and resting on masonry corbels. The lathe and plaster ceiling rises with the angle of the roof pitch to north and south and ceils the roof space above the cross beams. The ceiling has a central moulded roundel containing a painted cast iron grill of quatrefoil design and there are pairs of pendant light fittings, hung from chains fixed to the cross beams.

Figure 11: Interior west wall of Hall, showing central arched recess, ceiling detail and Northern portion of opening into School Room, viewed from the east (2m scale).

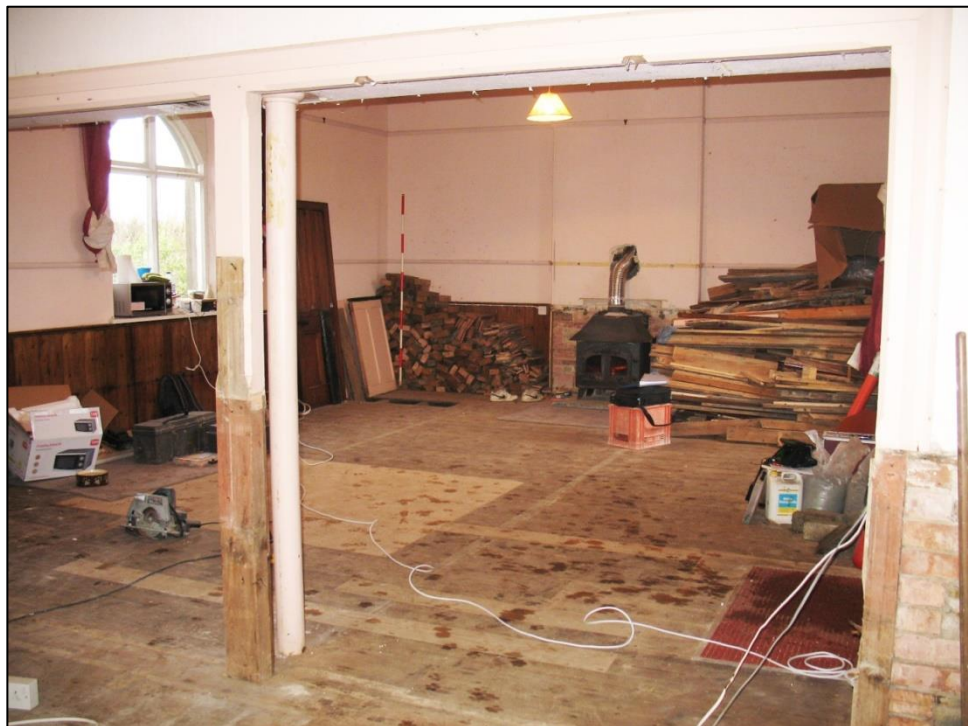
In the northwest corner of the Hall is a wide opening into the School Room to the north (see Figs. 11 & 12).

Figure 12: The interior of the former School Room, viewed through the opening in the western end of the north wall of the Hall, from the southeast (2m scale).

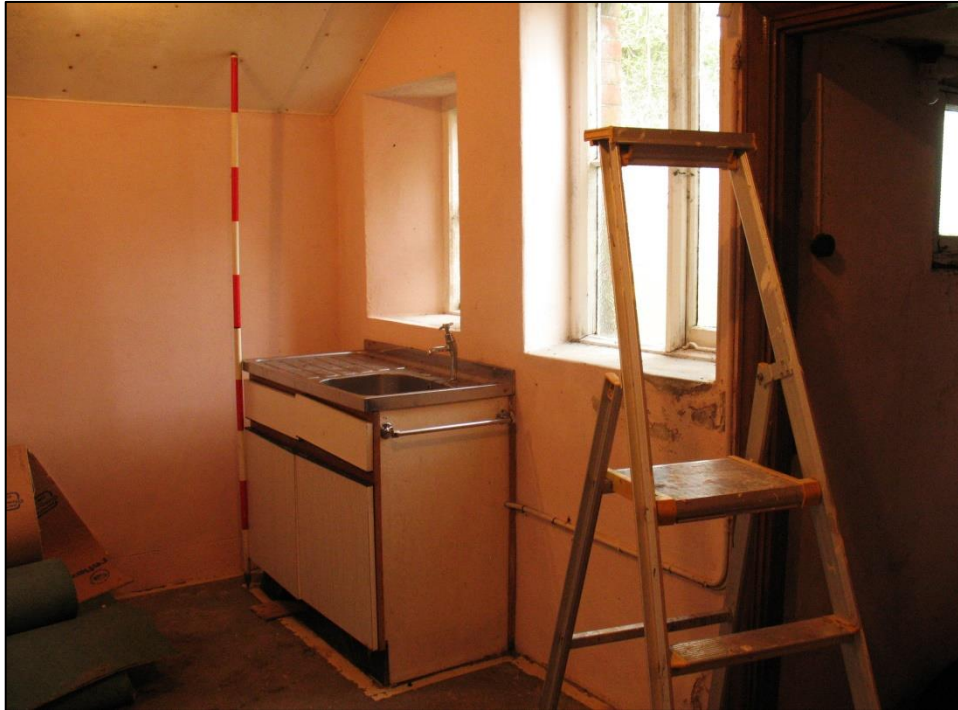
from the Hall to the east (see Fig. 11), the opening now forming a store cupboard. There is a forced door opening in the north wall into a small toilet, with two window openings to the west with modern sink unit below. The window arrangement is awkward, and the eastern, larger opening has been altered with the splay now reversed. The smaller opening to the west is probably a later insertion.

Figure 13: Interior north wall of Vestry, showing window openings and forced door opening into toilet, viewed from the southeast (2m scale).

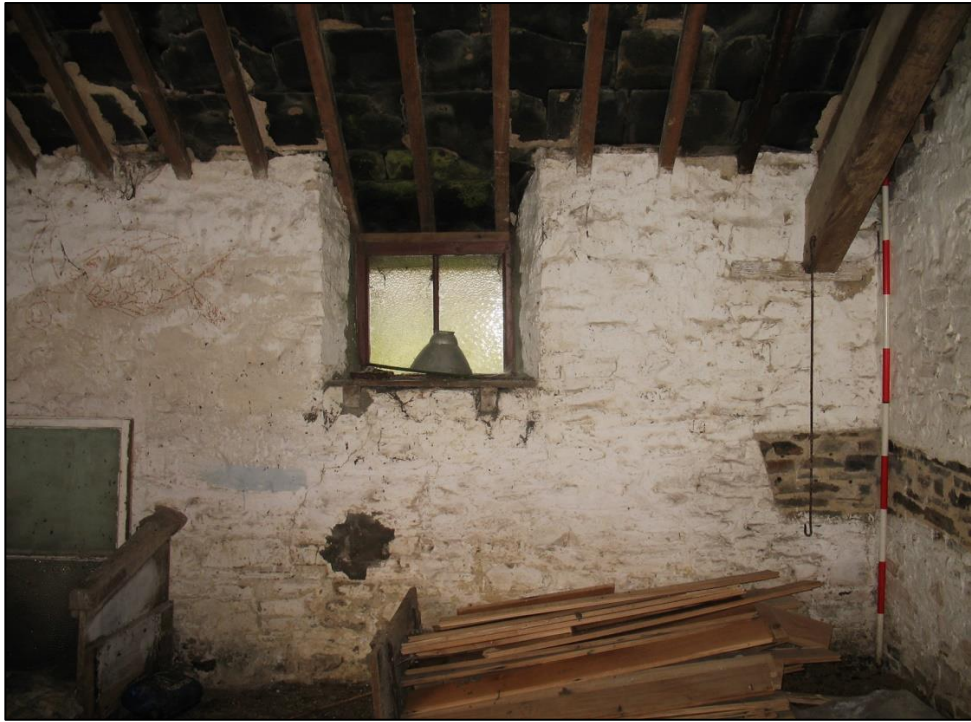
The unheated former Stable or Trap House to the rear (southwest) of the Hall is accessed from the exterior at the eastern end of the south wall. The walls are of whitewashed rubble stone and the floor is cobbled. The room is open to the rafters which slope down steeply from the east, with a single principal rafter set just to the south of the north wall which divides the Stable and Vestry. There is an opening into a loft space set above the Vestry to the northeast and a small window in the centre of the low west wall.

Figure 14: Interior west wall of Stable/Trap House, showing window opening and foot of principal rafter, viewed from the east (2m scale).

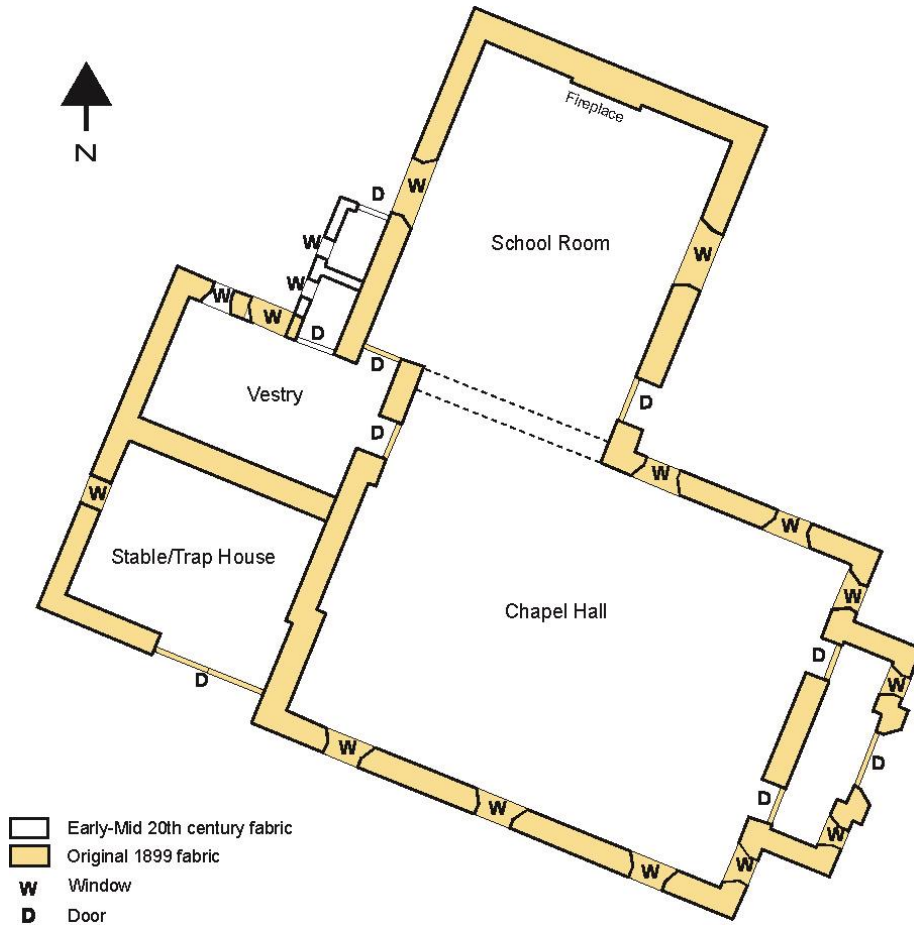
Figure 15: Tetcott Chapel schematic plan (not to scale).

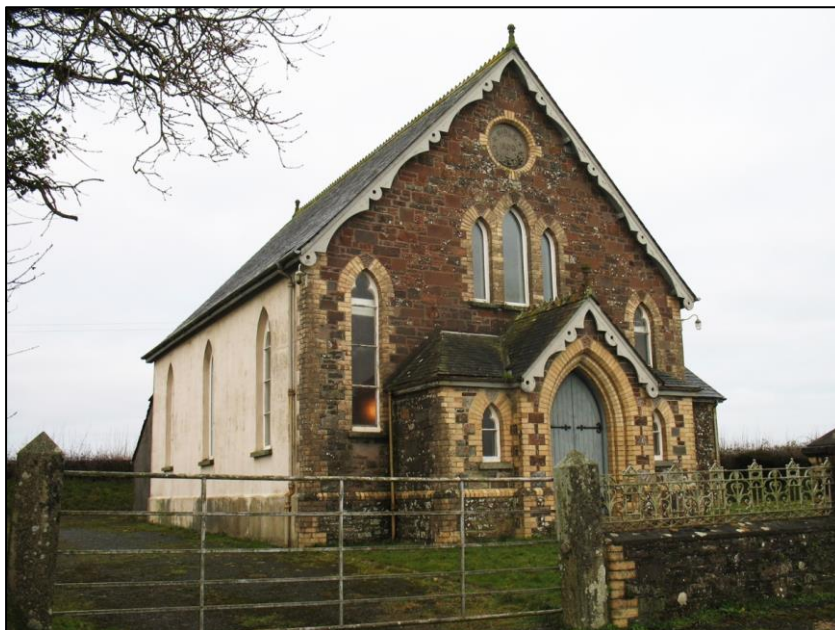
Figure 16: The Chapel Hall, viewed from the southeast.

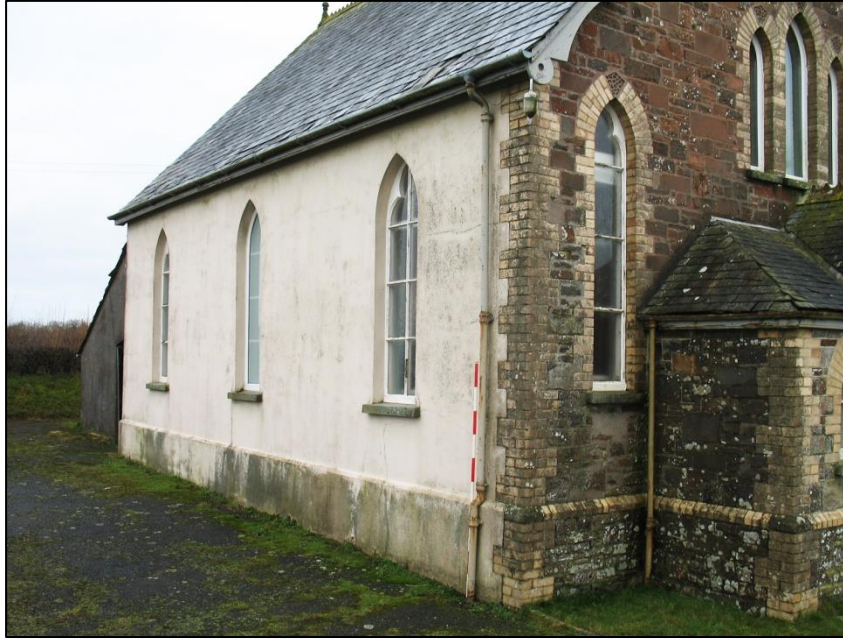
Figure 17: South elevation of the Chapel Hall, viewed from the southeast (2m scale).

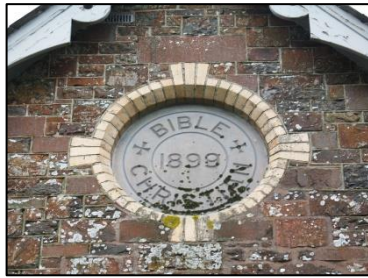
Figure 18: Left: Detail of roundel at east gable.

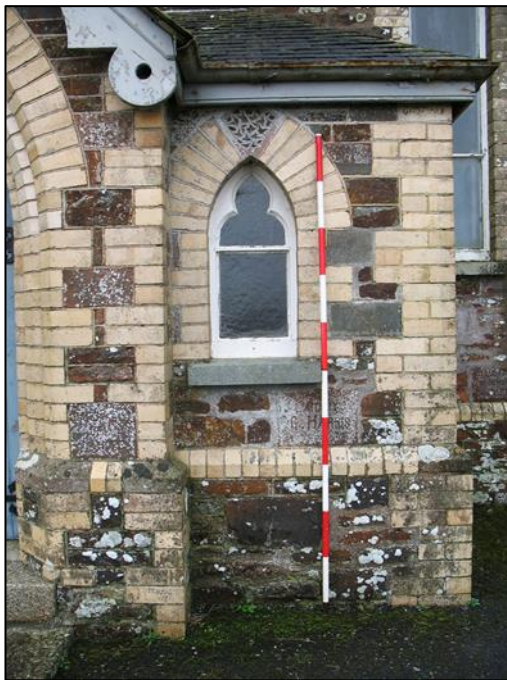
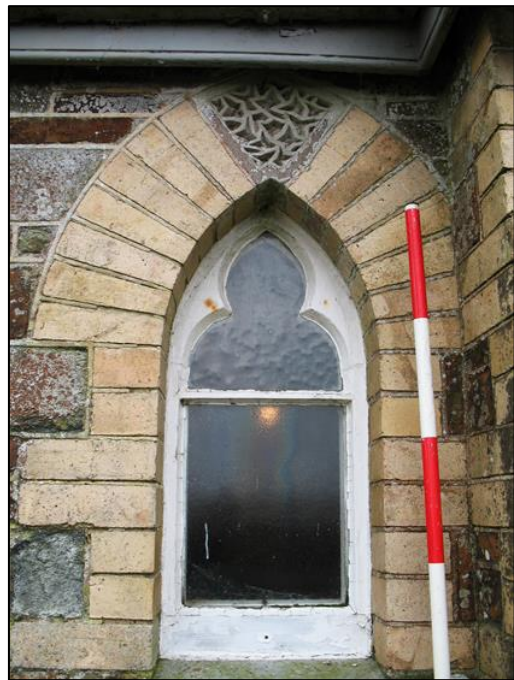
Figure 20: Left: Northern portion of east wall of Vestibule, viewed from the east (2m scale).

Figure 21: Right: Detail of window to south of entrance door, viewed from the east.

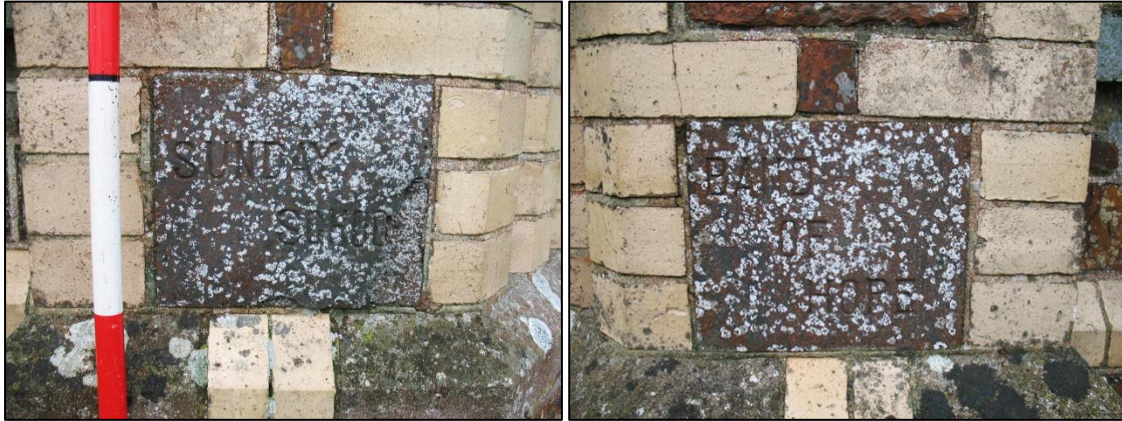
Figure 22: Left: Detailed of inscribed stone to left of entrance.

Figure 23: Right: Detail of inscribed stone to right of entrance.

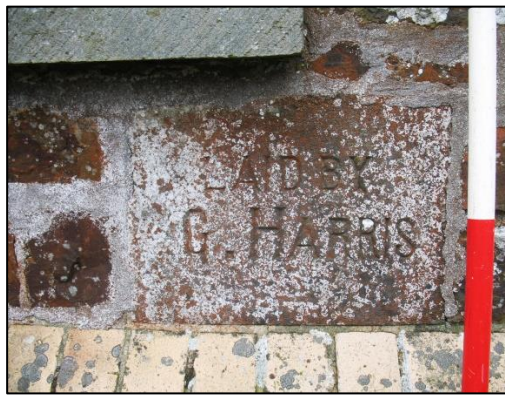
Figure 24: Detail of inscribed stone beneath northern window in east wall of Hall.

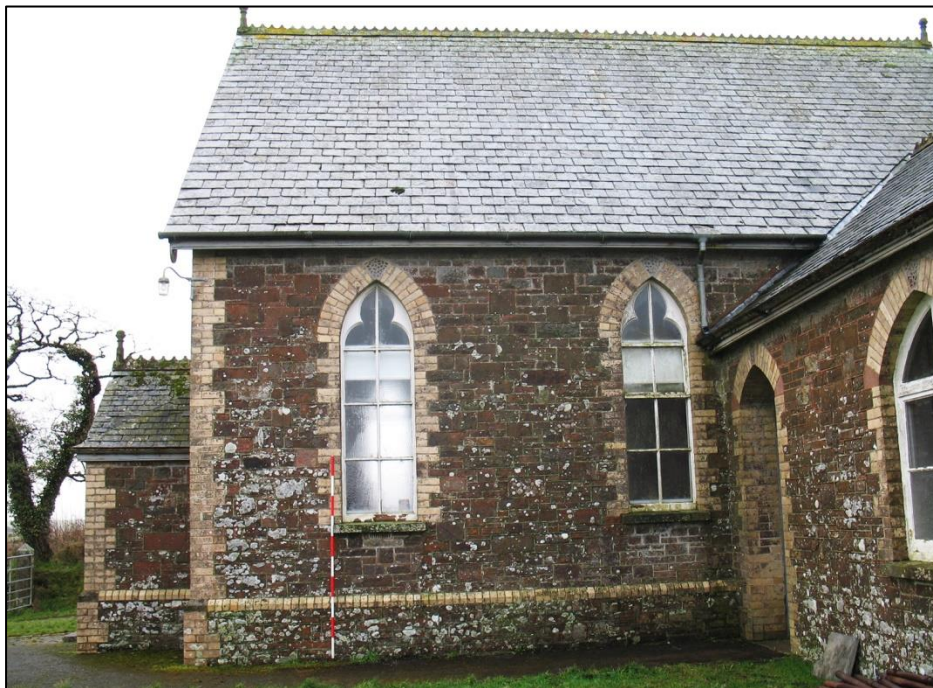
Figure 25: North elevation of Chapel Hall, viewed from the north (2m scale).

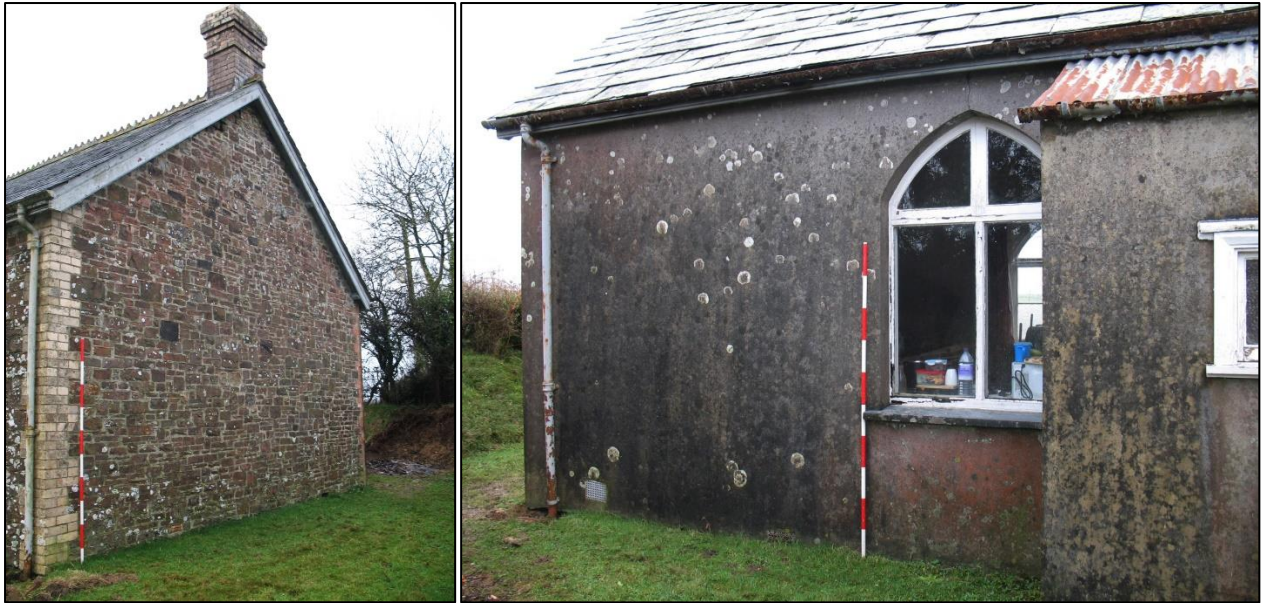
Figure 26: Left: North wall of School Room, viewed from the northeast (2m scale).

Figure 27: Right: West wall of School Room, viewed from the southwest (2m scale).

The three bay single storey School Room is set to the north and at a right angle to the Hall. The room is heated with a fireplace at the north end and is accessed from the exterior to the east, the Hall from the south and the former Vestry to the southwest. The walls are plastered and painted with stained pine panelling to the lower portion, with window openings to east and west. The room is ceiled above the cross beams of two A-frame trusses, as the Hall, with a central cast iron vent, and is floored with pine planks.

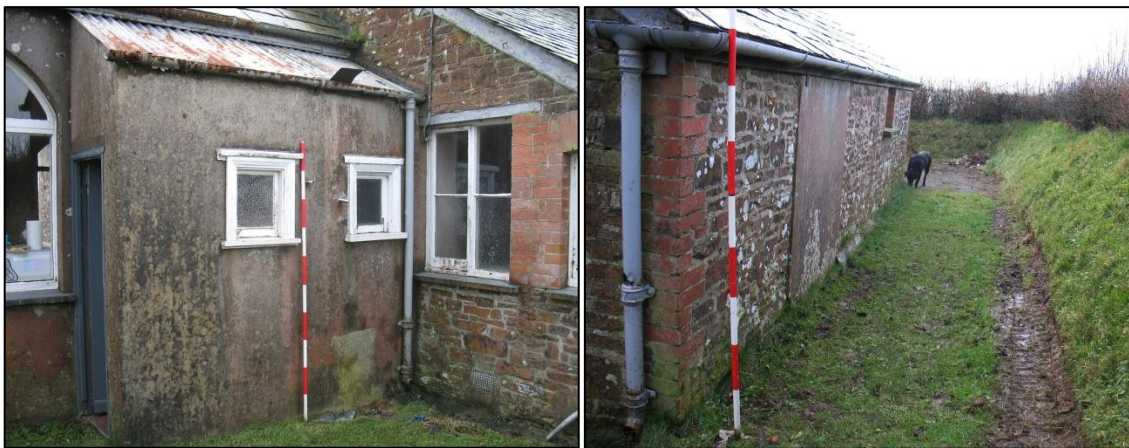
Figure 28: Left: Toilet Block, viewed from the northwest (2m scale).

Figure 29: Right: West elevation of Vestry & Stable, viewed from the northwest (2m scale).

The fabric of the majority of the building is unchanged with the exception of the addition of the toilets to the rear, contemporaneous with alterations to the north wall of the Vestry, including the forcing of a door opening into the southern toilet cubicle and an alteration to the window arrangement in the north wall to accommodate a partition wall across the western end of the room, lit by an inserted small window. It is likely that the Vestry ceiling was replaced at this time and the cement render applied to some exterior walls.

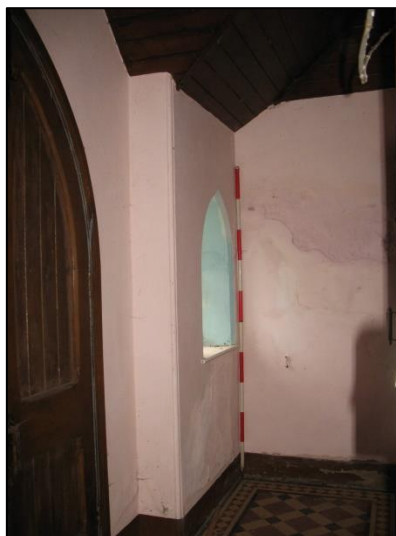
Figure 30: Left: Southern interior of Vestibule, viewed from the north (2m scale).

Vestibule: Single storey narrow room giving access to Main Hall. East wall plastered and painted, with recessed central portion with timber dowels to returns with central opening. Timber arched two leaf vertical plank door, with two panels per leaf with chamfered and stopped edges in arched chamfered timber frame, both stained brown. Door with timber rim lock to left lock rail with applied painted metal decoration at corners and decorative keyplate, with plain metal latch above, with added slim chamfered timbers to base of each leaf. Vestibule lit by fixed foiled and chamfered two pane timber framed windows, with 'bathroom' glazing, in splayed arched openings, with painted timber sills, flanking door opening. North and south walls plastered and painted. West wall, plastered and painted with symmetrically placed door openings into main Hall at north and south ends. Doors, flush to wall, timber plank four panel with chamfered and stopped edges, bottom panels with angled planks, set in chamfered and stepped frames, with fluted brass upright handles and brass hook loops to shutting stile and decorative sprung hinges to lock rails. Ceiling of stained timber planking, angled to follow exterior roof line, with central early-mid 20th century light fitting. Floor original cream, black and terracotta coloured tiles laid in a geometric pattern with border flush to wall contours.

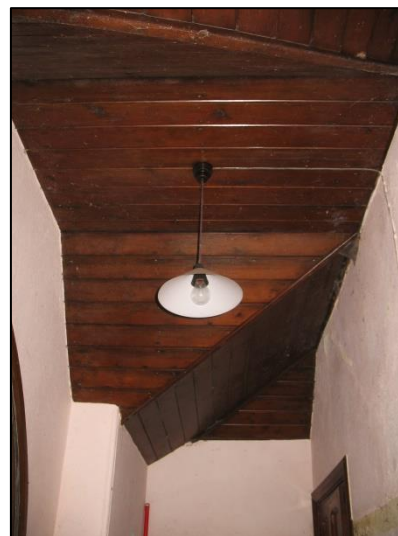
Figure 31: Right: Vestibule plank ceiling, viewed from the north.

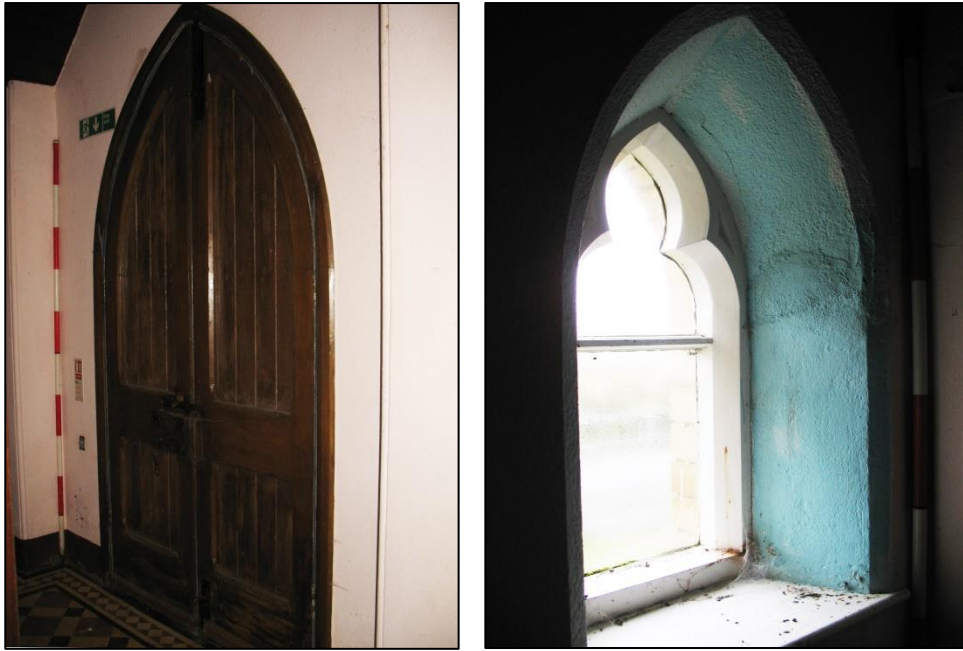
Figure 32: Left: Entrance door into Vestibule, viewed from the southwest (2m scale).

Figure 33: Right: Detail of window opening to south of Entrance door, from the northwest.

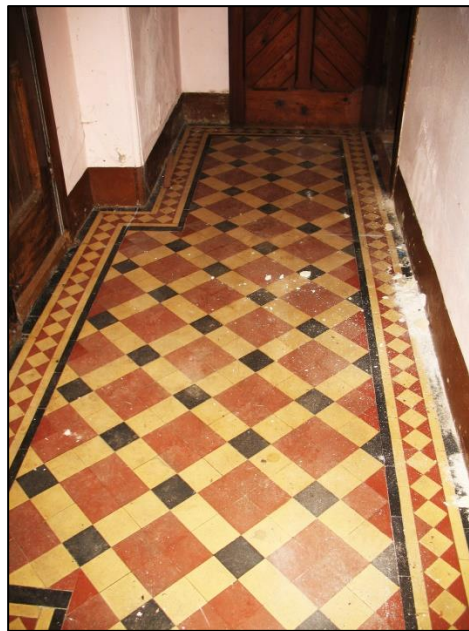
Figure 34: Detail of Vestibule floor, viewed from the north.

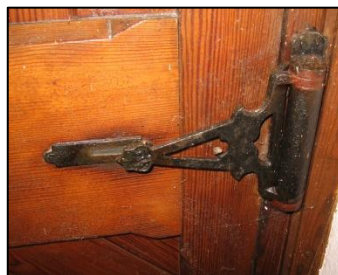
Figure 36: Centre: Detail of sprung hinge on doors into hall from Vestibule.

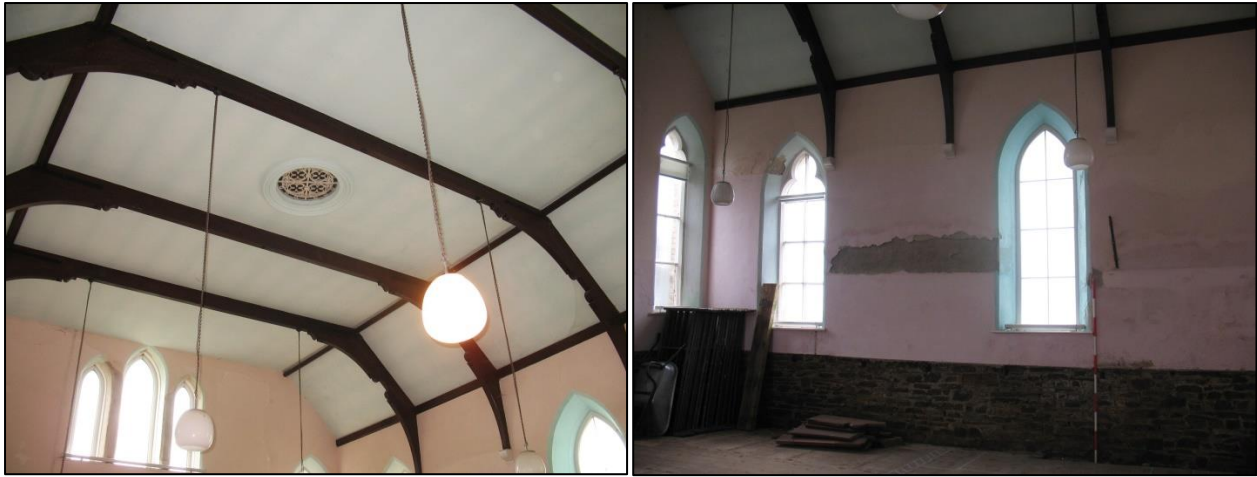
Figure 38: Left: Hall roof structure, with central vent, viewed from the northwest.

Figure 39: Right: Hall south wall, viewed from the northwest (2m scale).

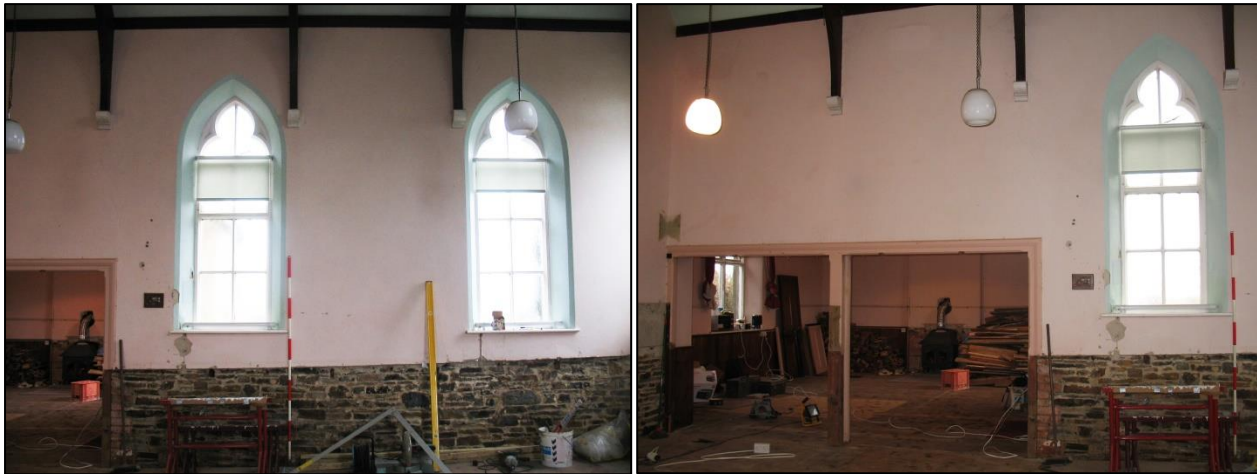
Figure 40: Left: Windows in north wall of Hall, showing ramped sills, viewed from the south (2m scale).

Figure 41: Right: West end of Hall north wall, showing opening into School Room, viewed from the south (2m scale).

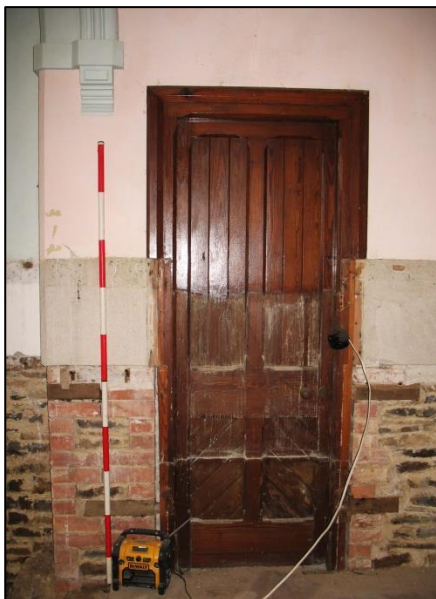
Figure 42: Left: Blocked door opening into Vestry in west wall of Hall, viewed from the east (2m scale).

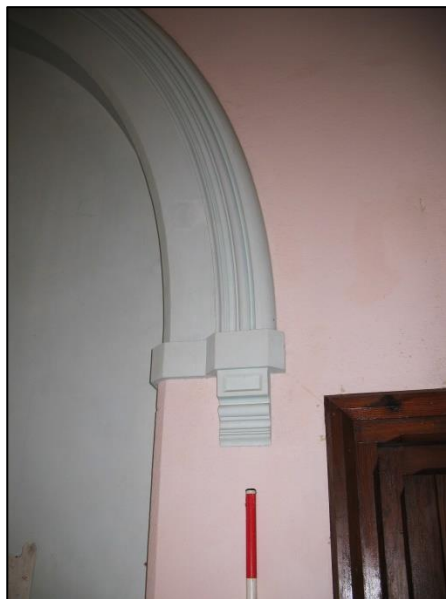
Figure 43: Right: Detail of moulded arched recess in west wall, viewed from the east.

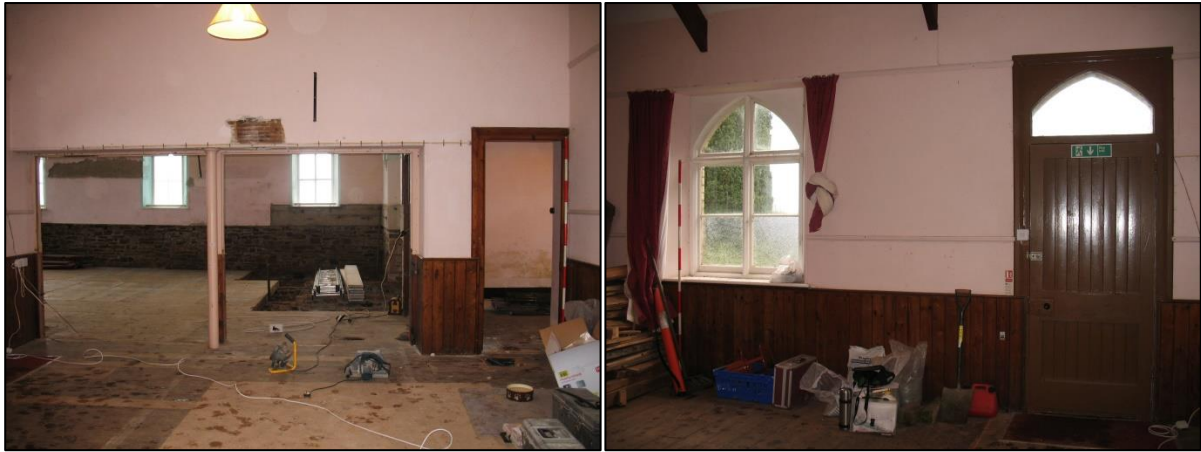
Figure 44: Left: School Room south wall, with openings into Hall and Vestry, viewed from the north (2m scale).
Figure 45: Right: East wall of School Room, viewed from the west (2m scale).

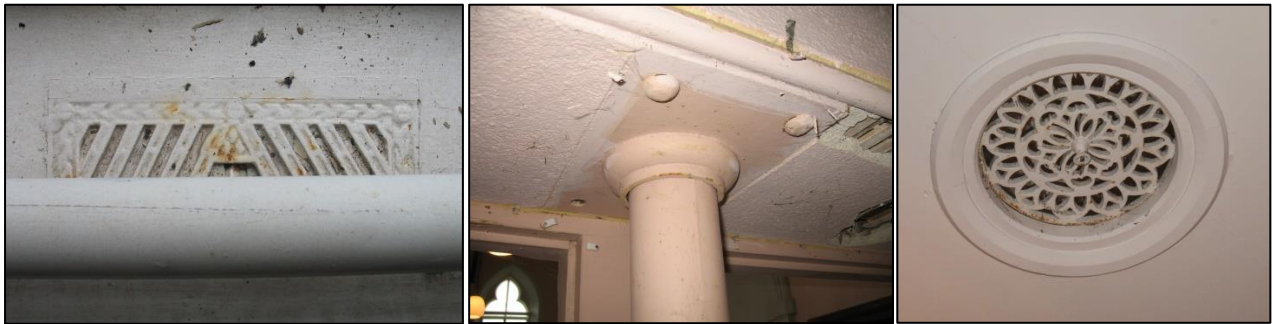
The building was originally lit by gas, with metal vents sunk within the timber of the window sills and cast iron vents in the ceilings of the Hall and the School Room, to give ventilation. The School Room was heated by a fireplace in the north end, formerly containing a late Victorian register grate, but the main Hall probably had free standing oil heaters.

Figure 46: Left: Detail of vent example (partially obscured by modern pipe) in window sill in Hall.
Figure 47: Centre: Detail of top of metal support in centre of opening between School Room and Hall, viewed from the northeast.
Figure 48: Right: Detail of central circular vent in School Room ceiling.

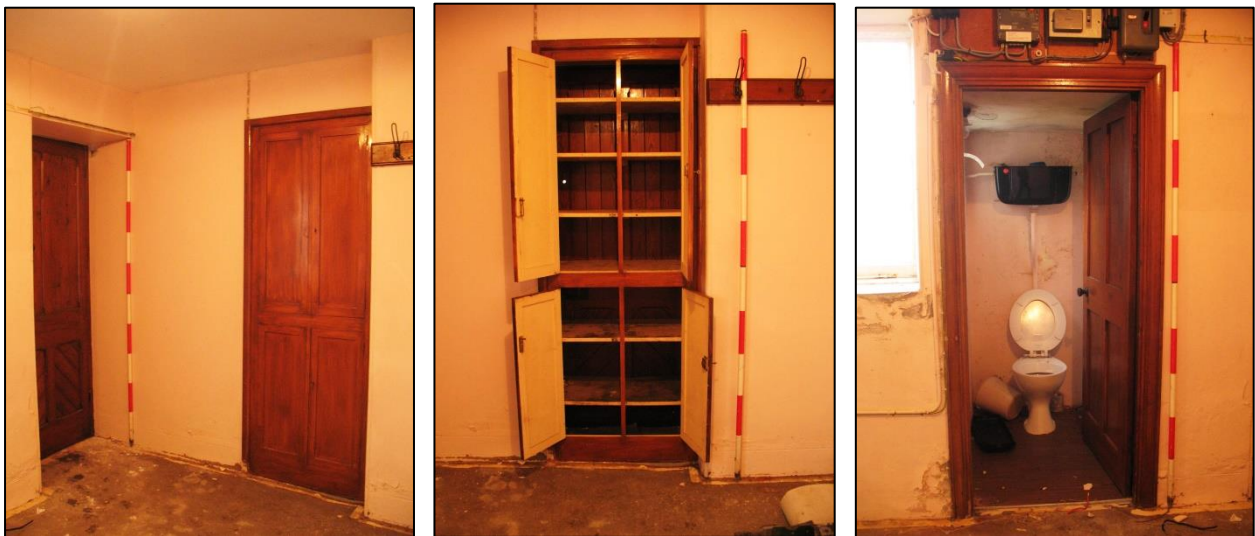
Figure 49: Left: Northeast corner of Vestry, showing door to School Room and former to Hall (2m scale).
Figure 50: Centre: Former door from Vestry into Hall, now forming cupboard, viewed from the west (2m scale).
Figure 51: Right: Door into Toilet from Vestry, viewed from the south (2m scale).

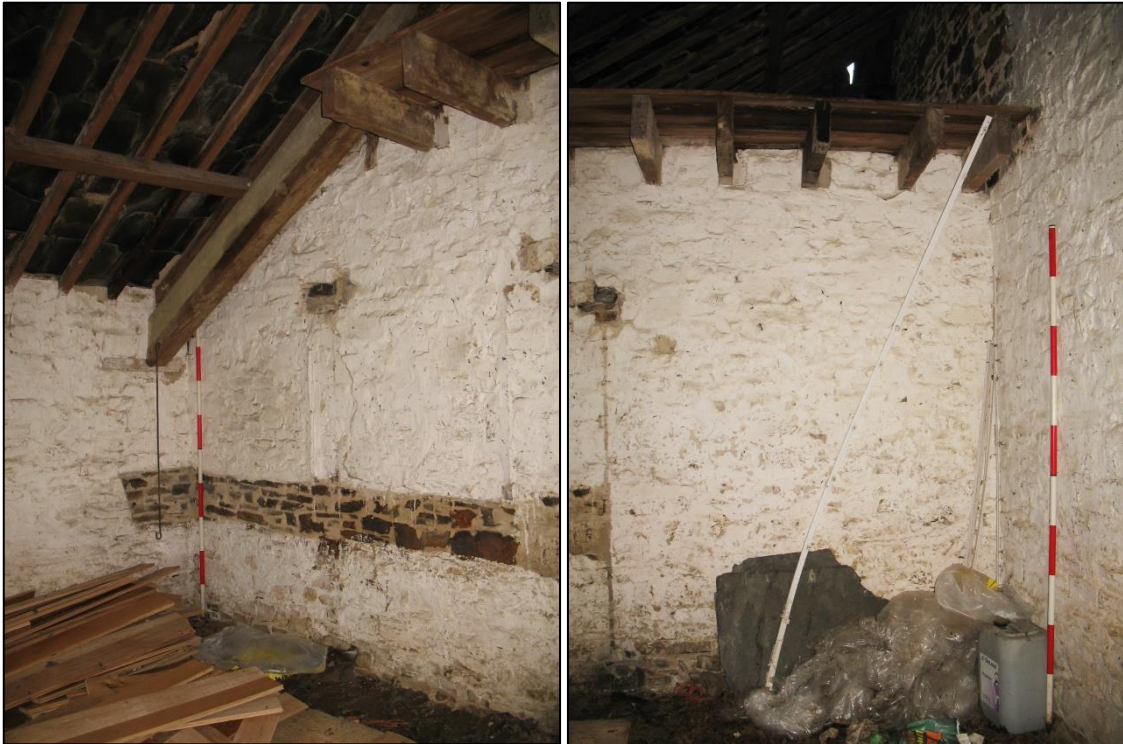
Figure 52: Left: Northwest corner of Stable/Trap Room, showing scars of former stalls, viewed from the southeast (2m scale).

Figure 53: Right: Northeast corner of Stable/Trap Room, viewed from the south (2m scale).

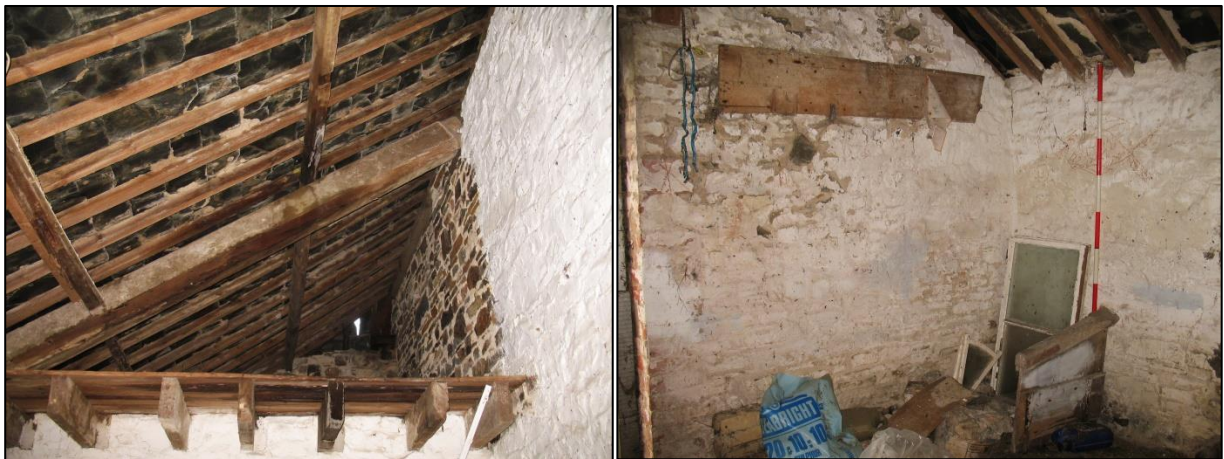
Figure 54: Left: Loft above Vestry accessed above north wall of Vestry, viewed from the south (2m scale).

Figure 55: Right: Southwest corner of Stable/Trap Room, with brick door jamb to left, viewed from the northeast (2m scale).
