A Community Excavation in the Churchyard of St. Mary's Reepham, Norfolk

Archaeological Site Report of the Community Excavation in the Churchyard of St. Mary's Reepham, Norfolk

HER Number: ENF141052

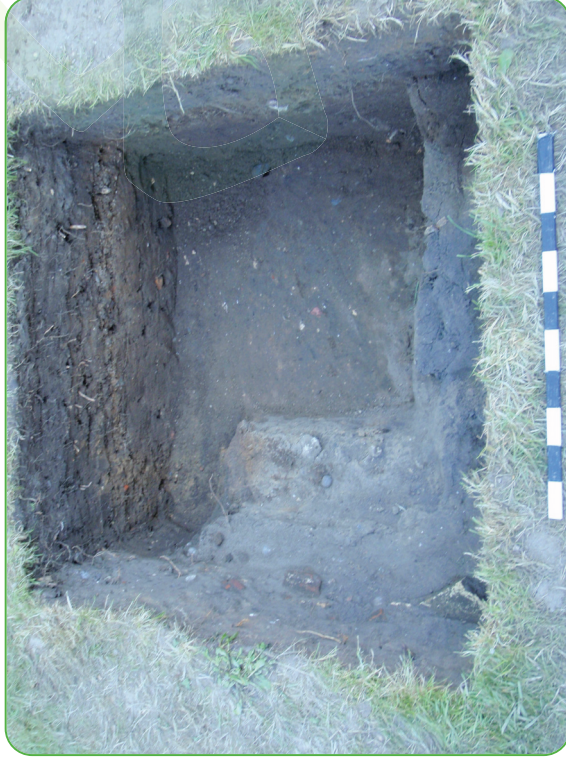
Figure 5.3 - Post excavation photo showing excavation limit

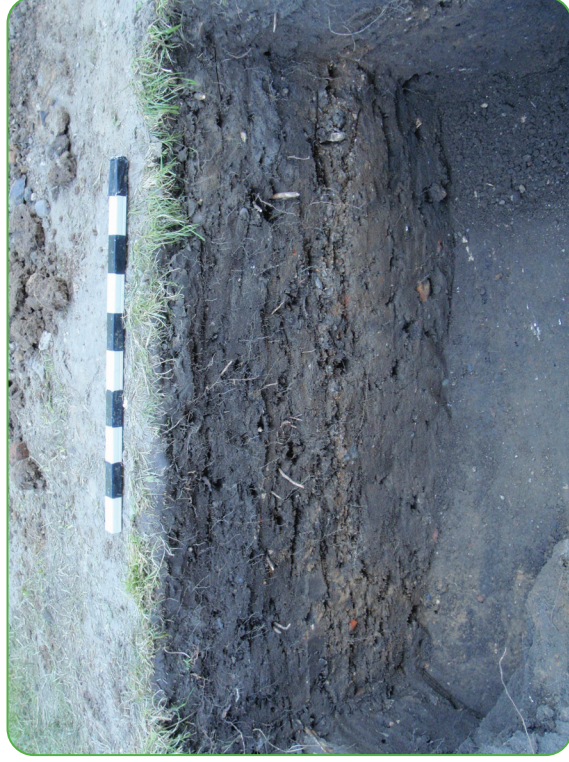
Figure 5.4 - Photo of W Facing Section

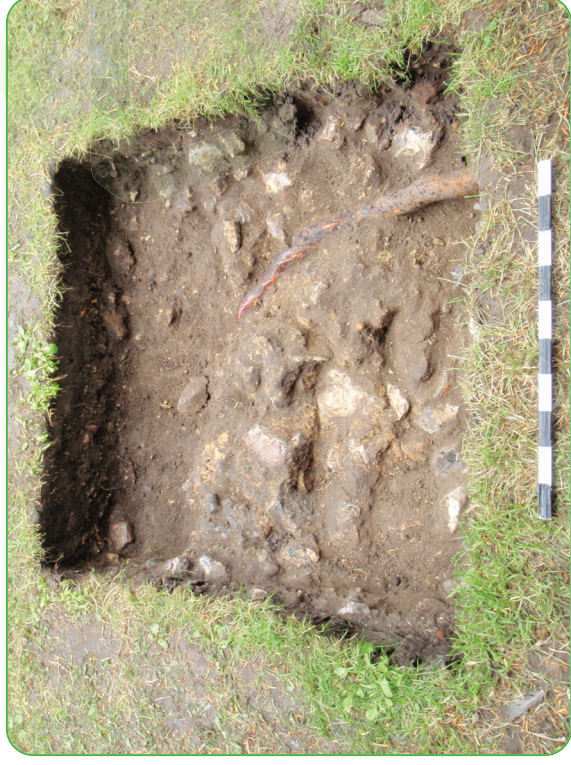
Figure 6.4 - Post excavation photo showing flint masonry (2004)

- 4.1.8 The composition of the masonry (2004) is similar to that of the standing west wall of All Saints' porch (See Fig. 6.1). This finding is consistent with the positive feature that the results of the geophysical survey suggested. The finds from the subsoil (2002), surface (2003) and masonry (2004) included charcoal, vitrified and burnt metal, and fragments of stained window glass suggesting these contexts probably relate to the burning and destruction of All Saint's church. (See Fig. 6).

- 5.1.3 Test Pit 2 was placed over a geophysical anomaly that suggested an intact wall foundation would be found. Excavation revealed an area masonry composed of flint nodules bonded in buff-coloured mortar. This was in a N-S orientation and most probably comprises a section of wall foundation for All Saints church. Finds of vitrified metal and stained window glass serve to relate the excavated layers to the burning of All Saint's.

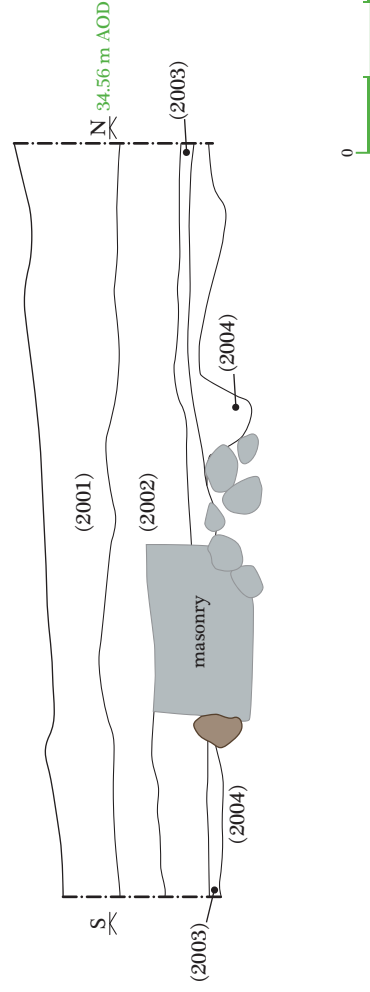
Figure 6.2 - Post excavation section facing E showing dressed masonry block in (2004)

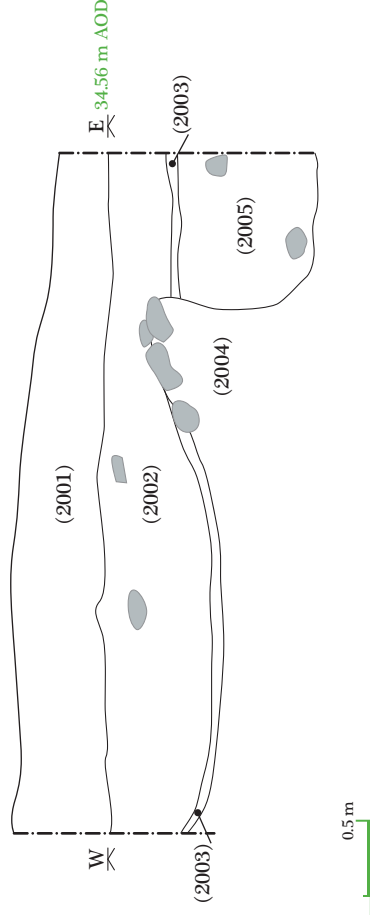
Figure 6.3 - Post excavation section facing S showing masonry (2004) and interface layer (2003)

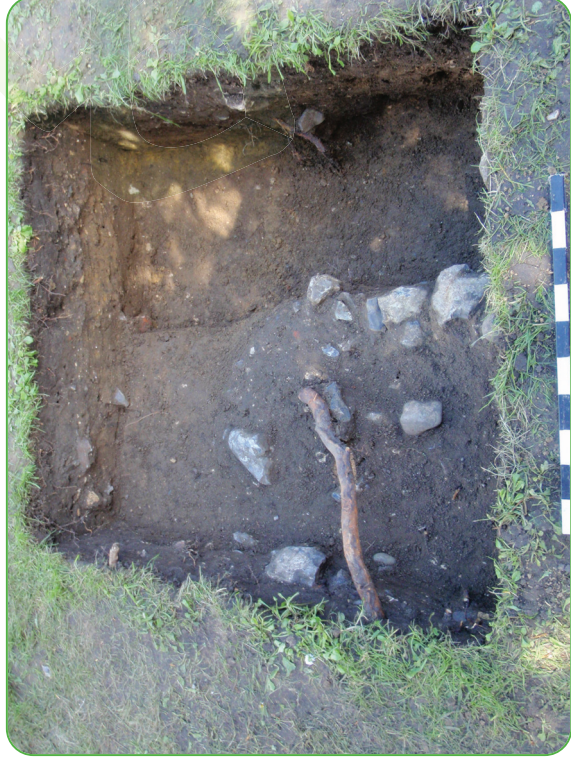
Figure 7.3 - T3 Post excavation photo showing E facing section

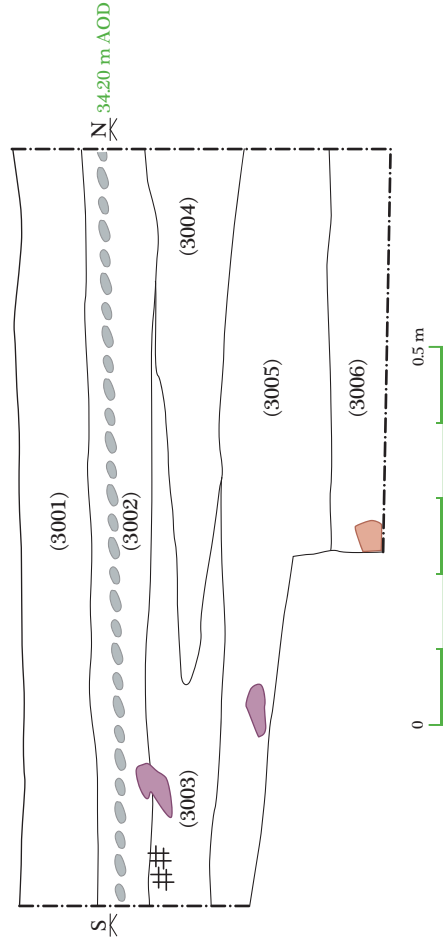
Figure 7.2 - Post excavation section facing E showing extent of excavation

- 4.1.11 The wall material found in layer (3005) is consistent with the geophysical report which proposed a negative feature like a robbed out wall would be found in this area. The bulk finds of burnt flint in subsoil (3003) as well as SF8 of stained window glass in subsoil (3002) help relate the rubble found in the test pit to the burning of the church.

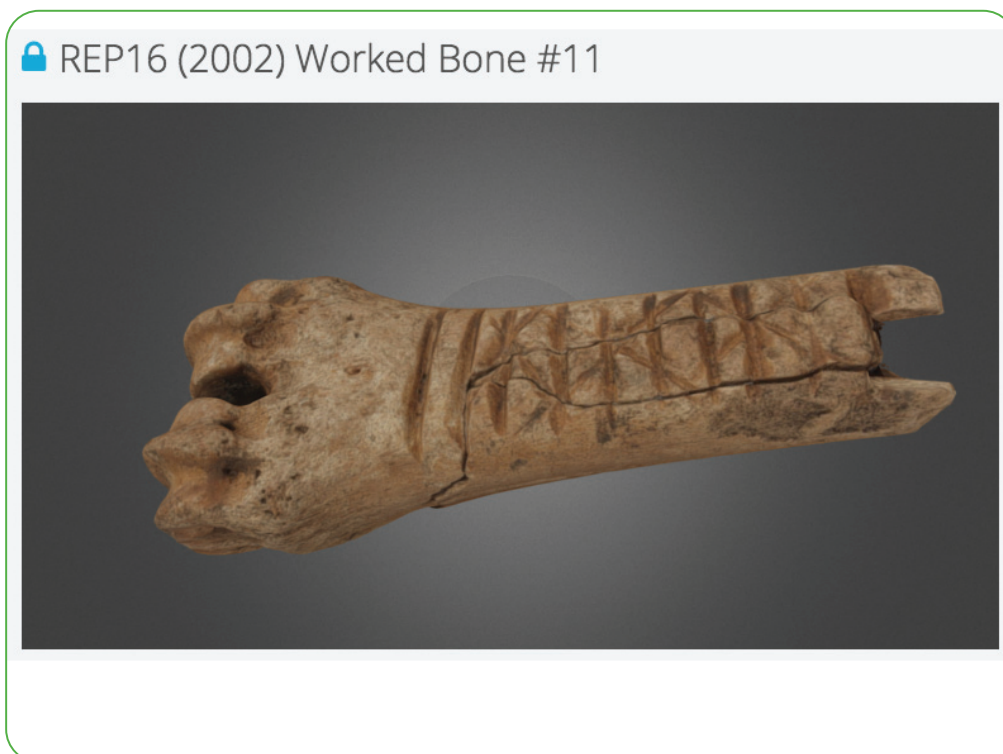
Figure 8.4 - 3D Model made of Small Find 11 - Worked Bone Fragment. <https://skfb.ly/RTZT>

- 4.2.4 One notable find is the worked bone fragment, SF11, recovered from (2002). The worked sheep/goat metapodial forms a handle, probably from a scoop or apple corer. The shaft has been carved with linear incised decoration on the front, including lines cut across the shaft, with some zig-zags over the top (see Fig. 8.4 and 8.5, and 3D model <https://skfb.ly/RTZT>). Similar examples are recorded on the Portable Finds Scheme database (eg Record LIN-997216), interpreted as a

- 5.2.4 A 3D Model of the worked bone SF 11 has been made to allow the public a closer look at one of the most interesting finds of the excavation (found here: <https://skfb.ly/RTZT>).

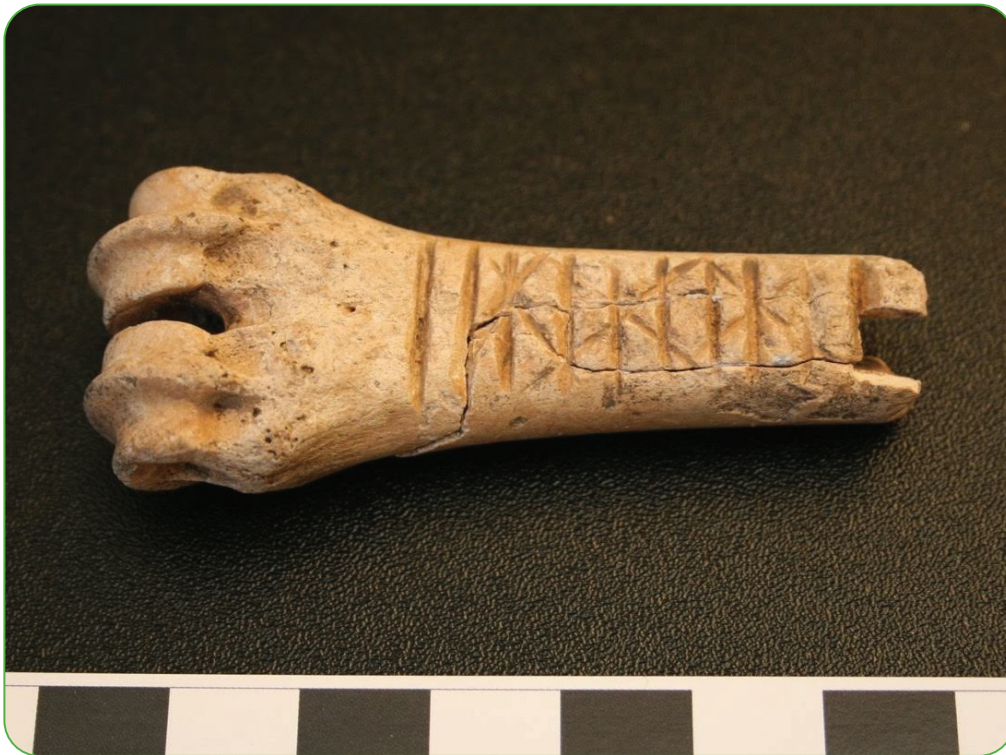
Figure 8.5 - Studio photograph of Small Find 11 - Worked Bone Fragment
