Rear of 42 Horsemarket, Barnard Castle  
Phase 2 Archaeological Watching Brief

Archaeological Watching Brief  
Rear of 42 Horsemarket  
Barnard Castle (Phase 2)

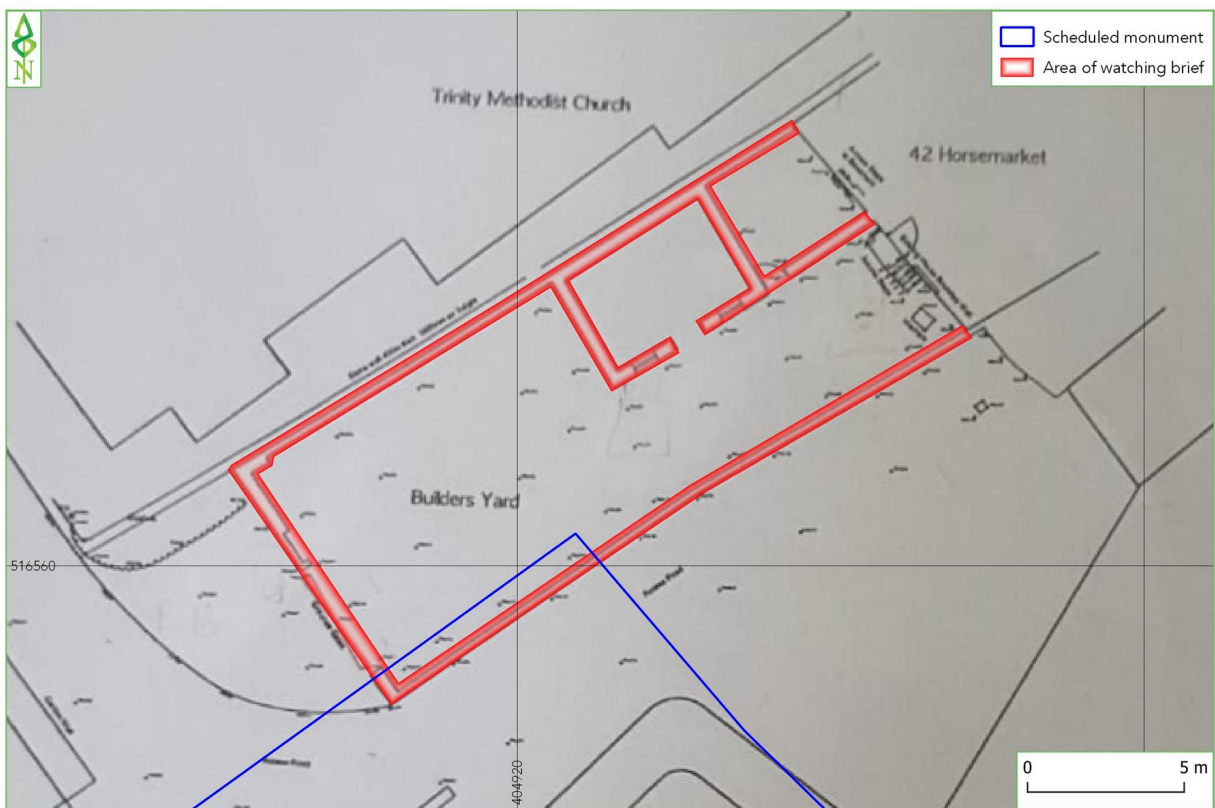
Figure 2 - Area of watching brief, showing location of scheduled area and structures being demolished

2.1.2 To the west of the site the medieval castle (SAM List entry number 1007505) is a ringwork developed into a shell keep. One of the largest castles in the of north of England, the boundary of the scheduled Ancient Monument area lies adjacent to the site and in one area on the southern side of the development site, the proposed works encroach slightly into the scheduled area (see Figure 2 for the boundary).

- 4.1.1 On attendance to the plot at the rear of 42 Horsemarket, Barnard Castle, it was observed that no below ground deposits were extant within the scheduled area, and that the walls that had been located within the scheduled area had been demolished to ground level. Below ground foundations have been preserved in situ.

3.2.1 The demolition of stone outbuildings and walls comprised the removal of an external wall adjacent to the access road by hand using mobile lift/hoist, removal of metal roof structure to wall plate level by hand, external/internal brick walls removed by mechanical excavator with grab attachment and ground levelling. Grubbing out of the existing foundations was undertaken using a mechanical excavator. Where walls were located within the scheduled area (Figure 2) these were removed to ground level only.

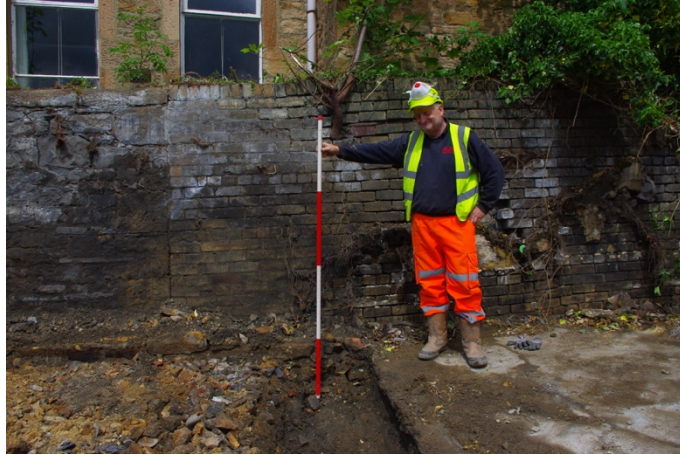
- 4.2.1 Outside of the scheduled area, existing foundations for the structures associated with the builder's yard were re-excavated using a toothless ditching bucket under archaeological supervision. The foundation trenches had been excavated to a depth of around 0.5m and the footings constructed of sandstone (Figure 3). Some of the blocks appeared to be dressed, and were potentially reused ex-situ building materials sourced from disused/ruined structures in the local vicinity – possibly Barnard Castle itself.

Figure 3.1 North-west facing showing existing above ground boundary wall and grubbed foundation

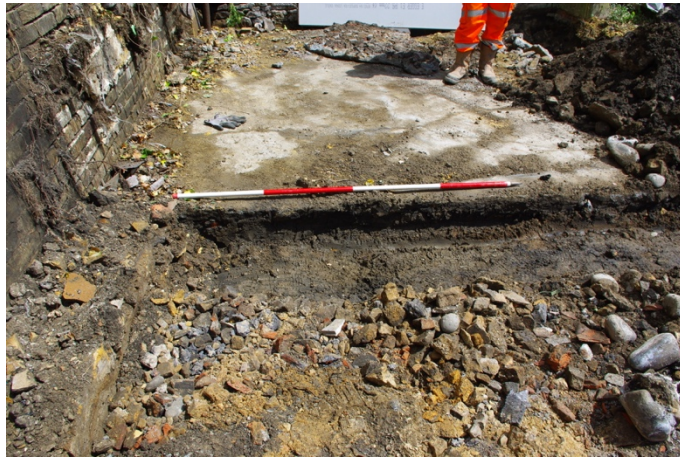
Figure 3.2 North-east facing showing north-eastern existing grubbed foundation running north-west/south-east

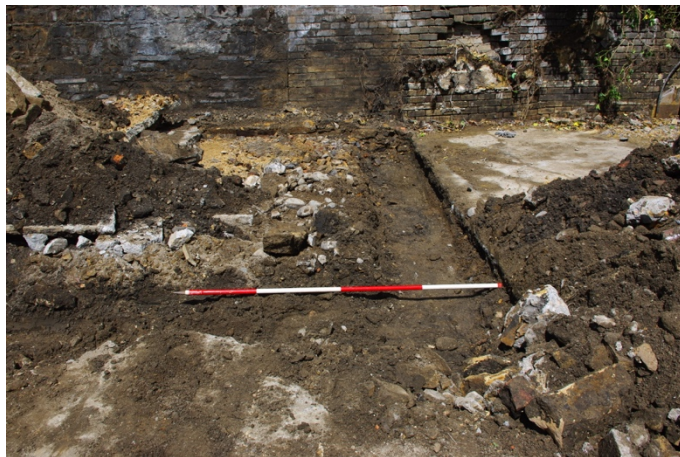
Figure 3.3 North-west facing showing three existing foundation trenches after completion of the grubbing works

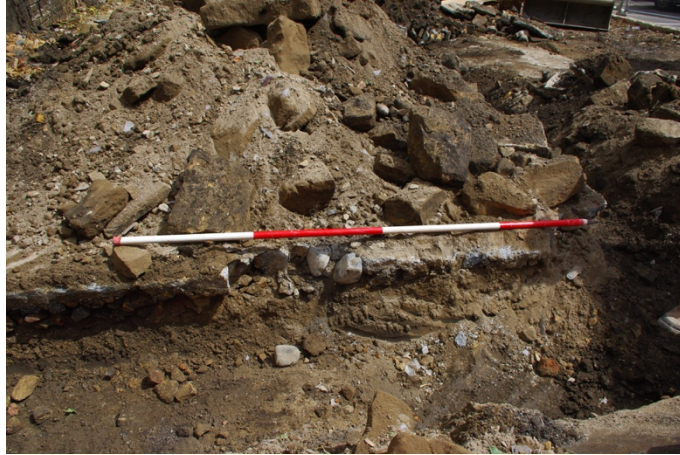
Figure 3.4 North-west facing showing existing south-eastern foundation trench after completion of the grubbing works

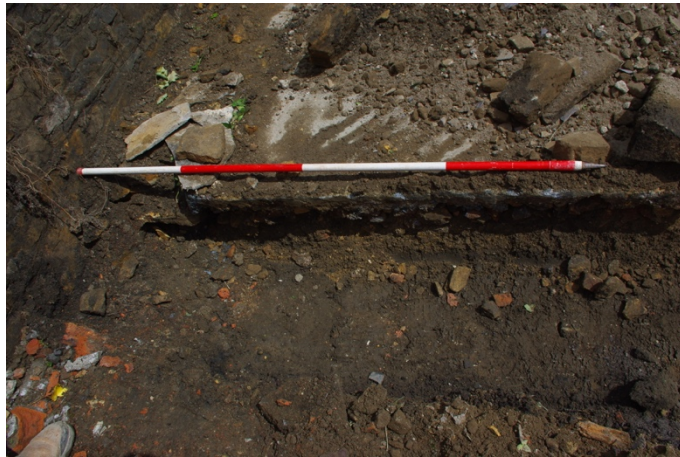
Figure 3.5 North-east facing showing above ground boundary wall on the left and north-west/south-east running existing south-western foundation trench after completion of grubbing works

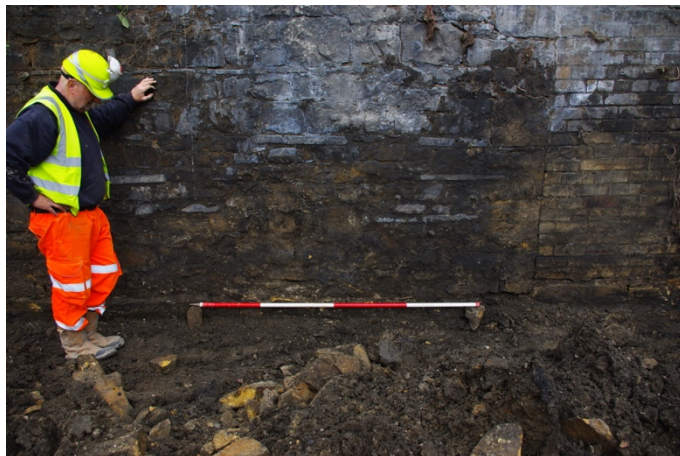
Figure 3.6 North-west facing showing above ground boundary wall and existing foundation trench after completion of grubbing works
