Gatehouse Project, Pontefract Castle Community Archaeology Project

Assessment Report

Gatehouse Project, Pontefract Castle
Community Archaeology Project
Archaeological Assessment Report

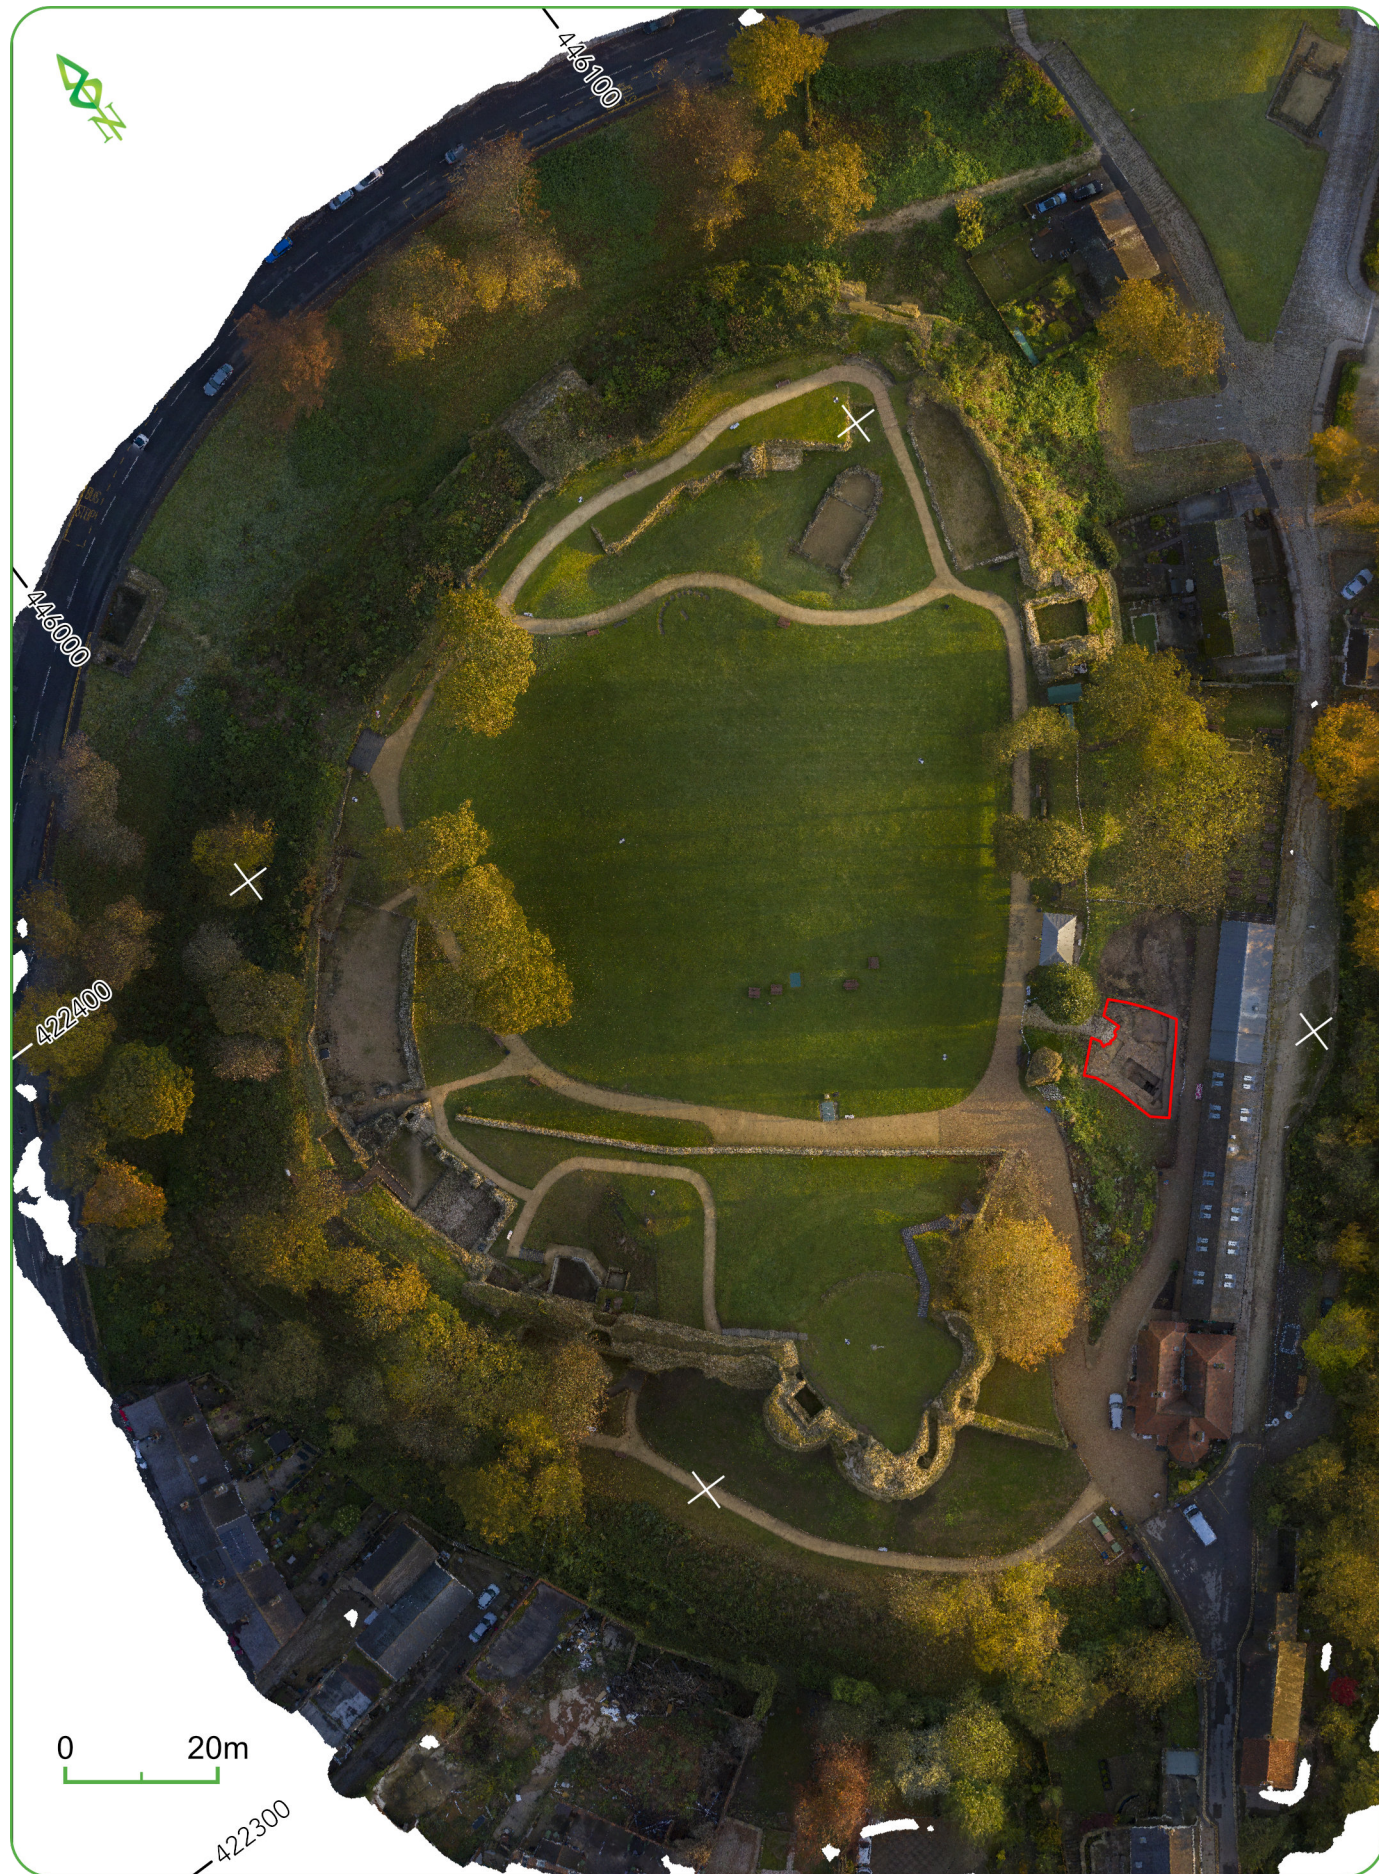
Figure 2: Remote sensing results

Aerial ortho-image

Digital Surface Model

2 and addresses Aim 1 Questions 1–3 of the Project Design (Casswell et al. 2019) by mapping the physical extent and condition of the site.

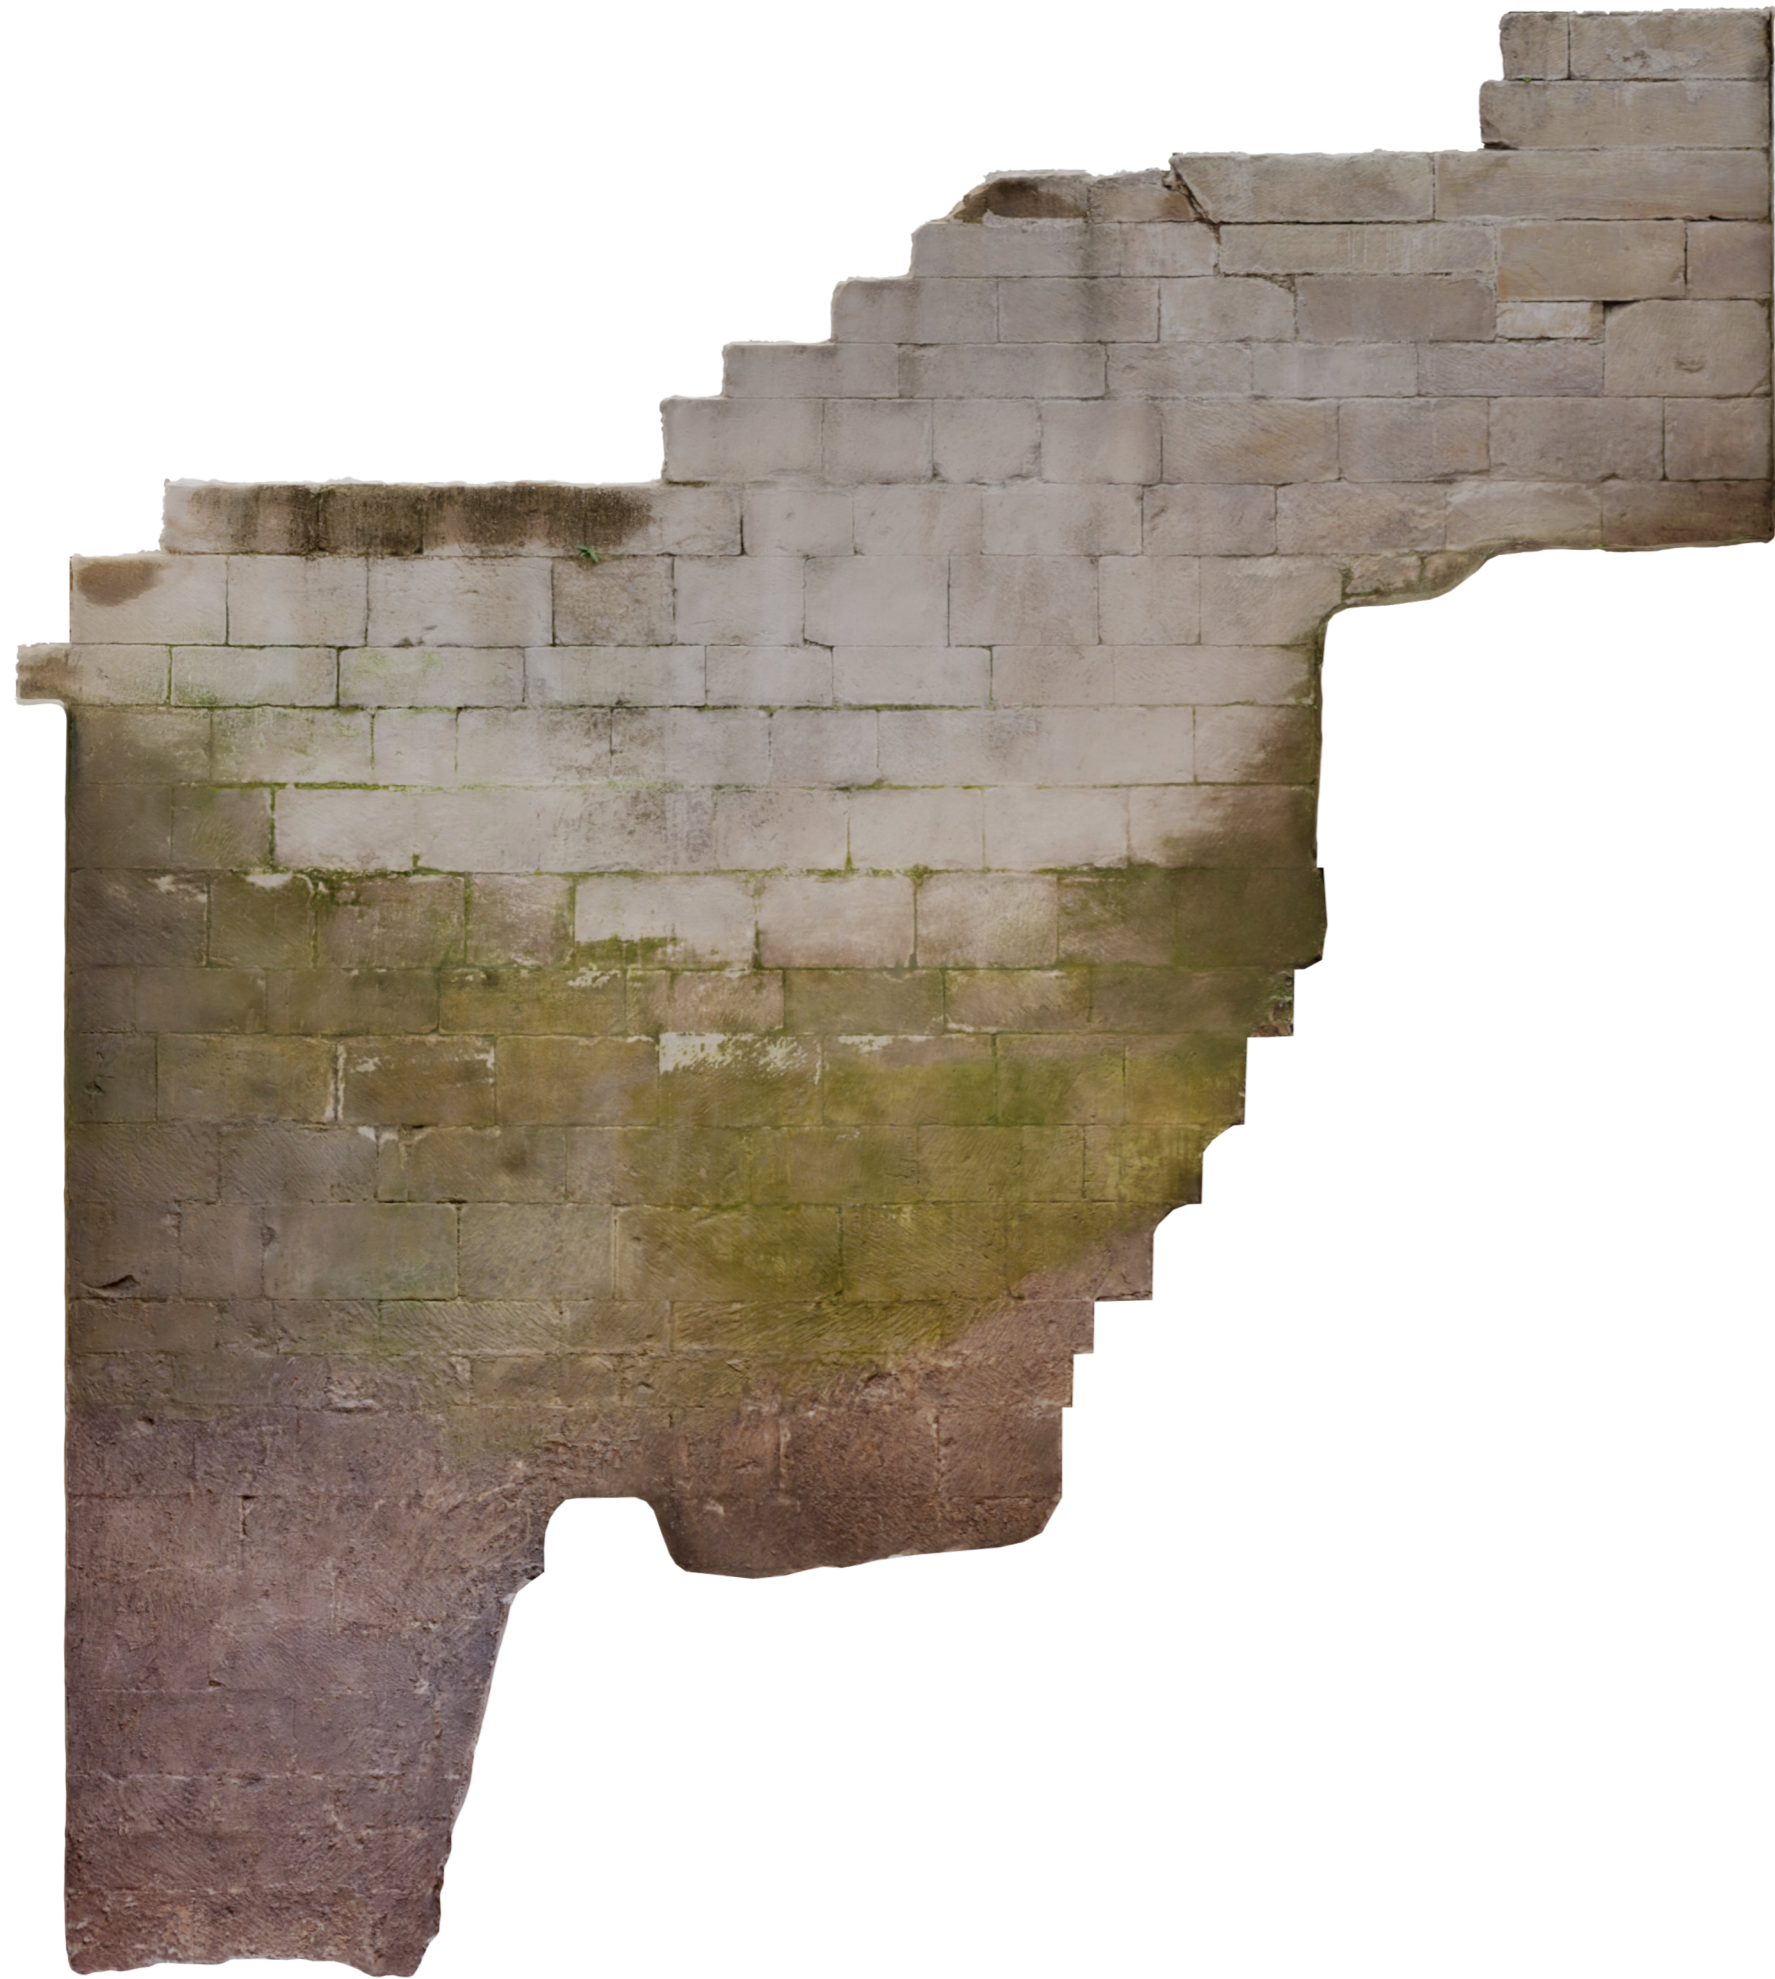
Ortho-image

Mason's marks

6.3.5 Mason's marks were found on each of the faced walls relating to the construction of the gatehouse; 22 in total. The east wall contained 15 unique marks, the west wall 13, the south wall four, north wall six, and external wall two. Many of these marks were found on more than one wall, and there were two instances in the east wall where blocks of masonry were found with two marks. There appeared to be no pattern to the placement of marked stones from the base of the drawbridge pit to the top, suggesting that the gatehouse was constructed as one scheme of work.

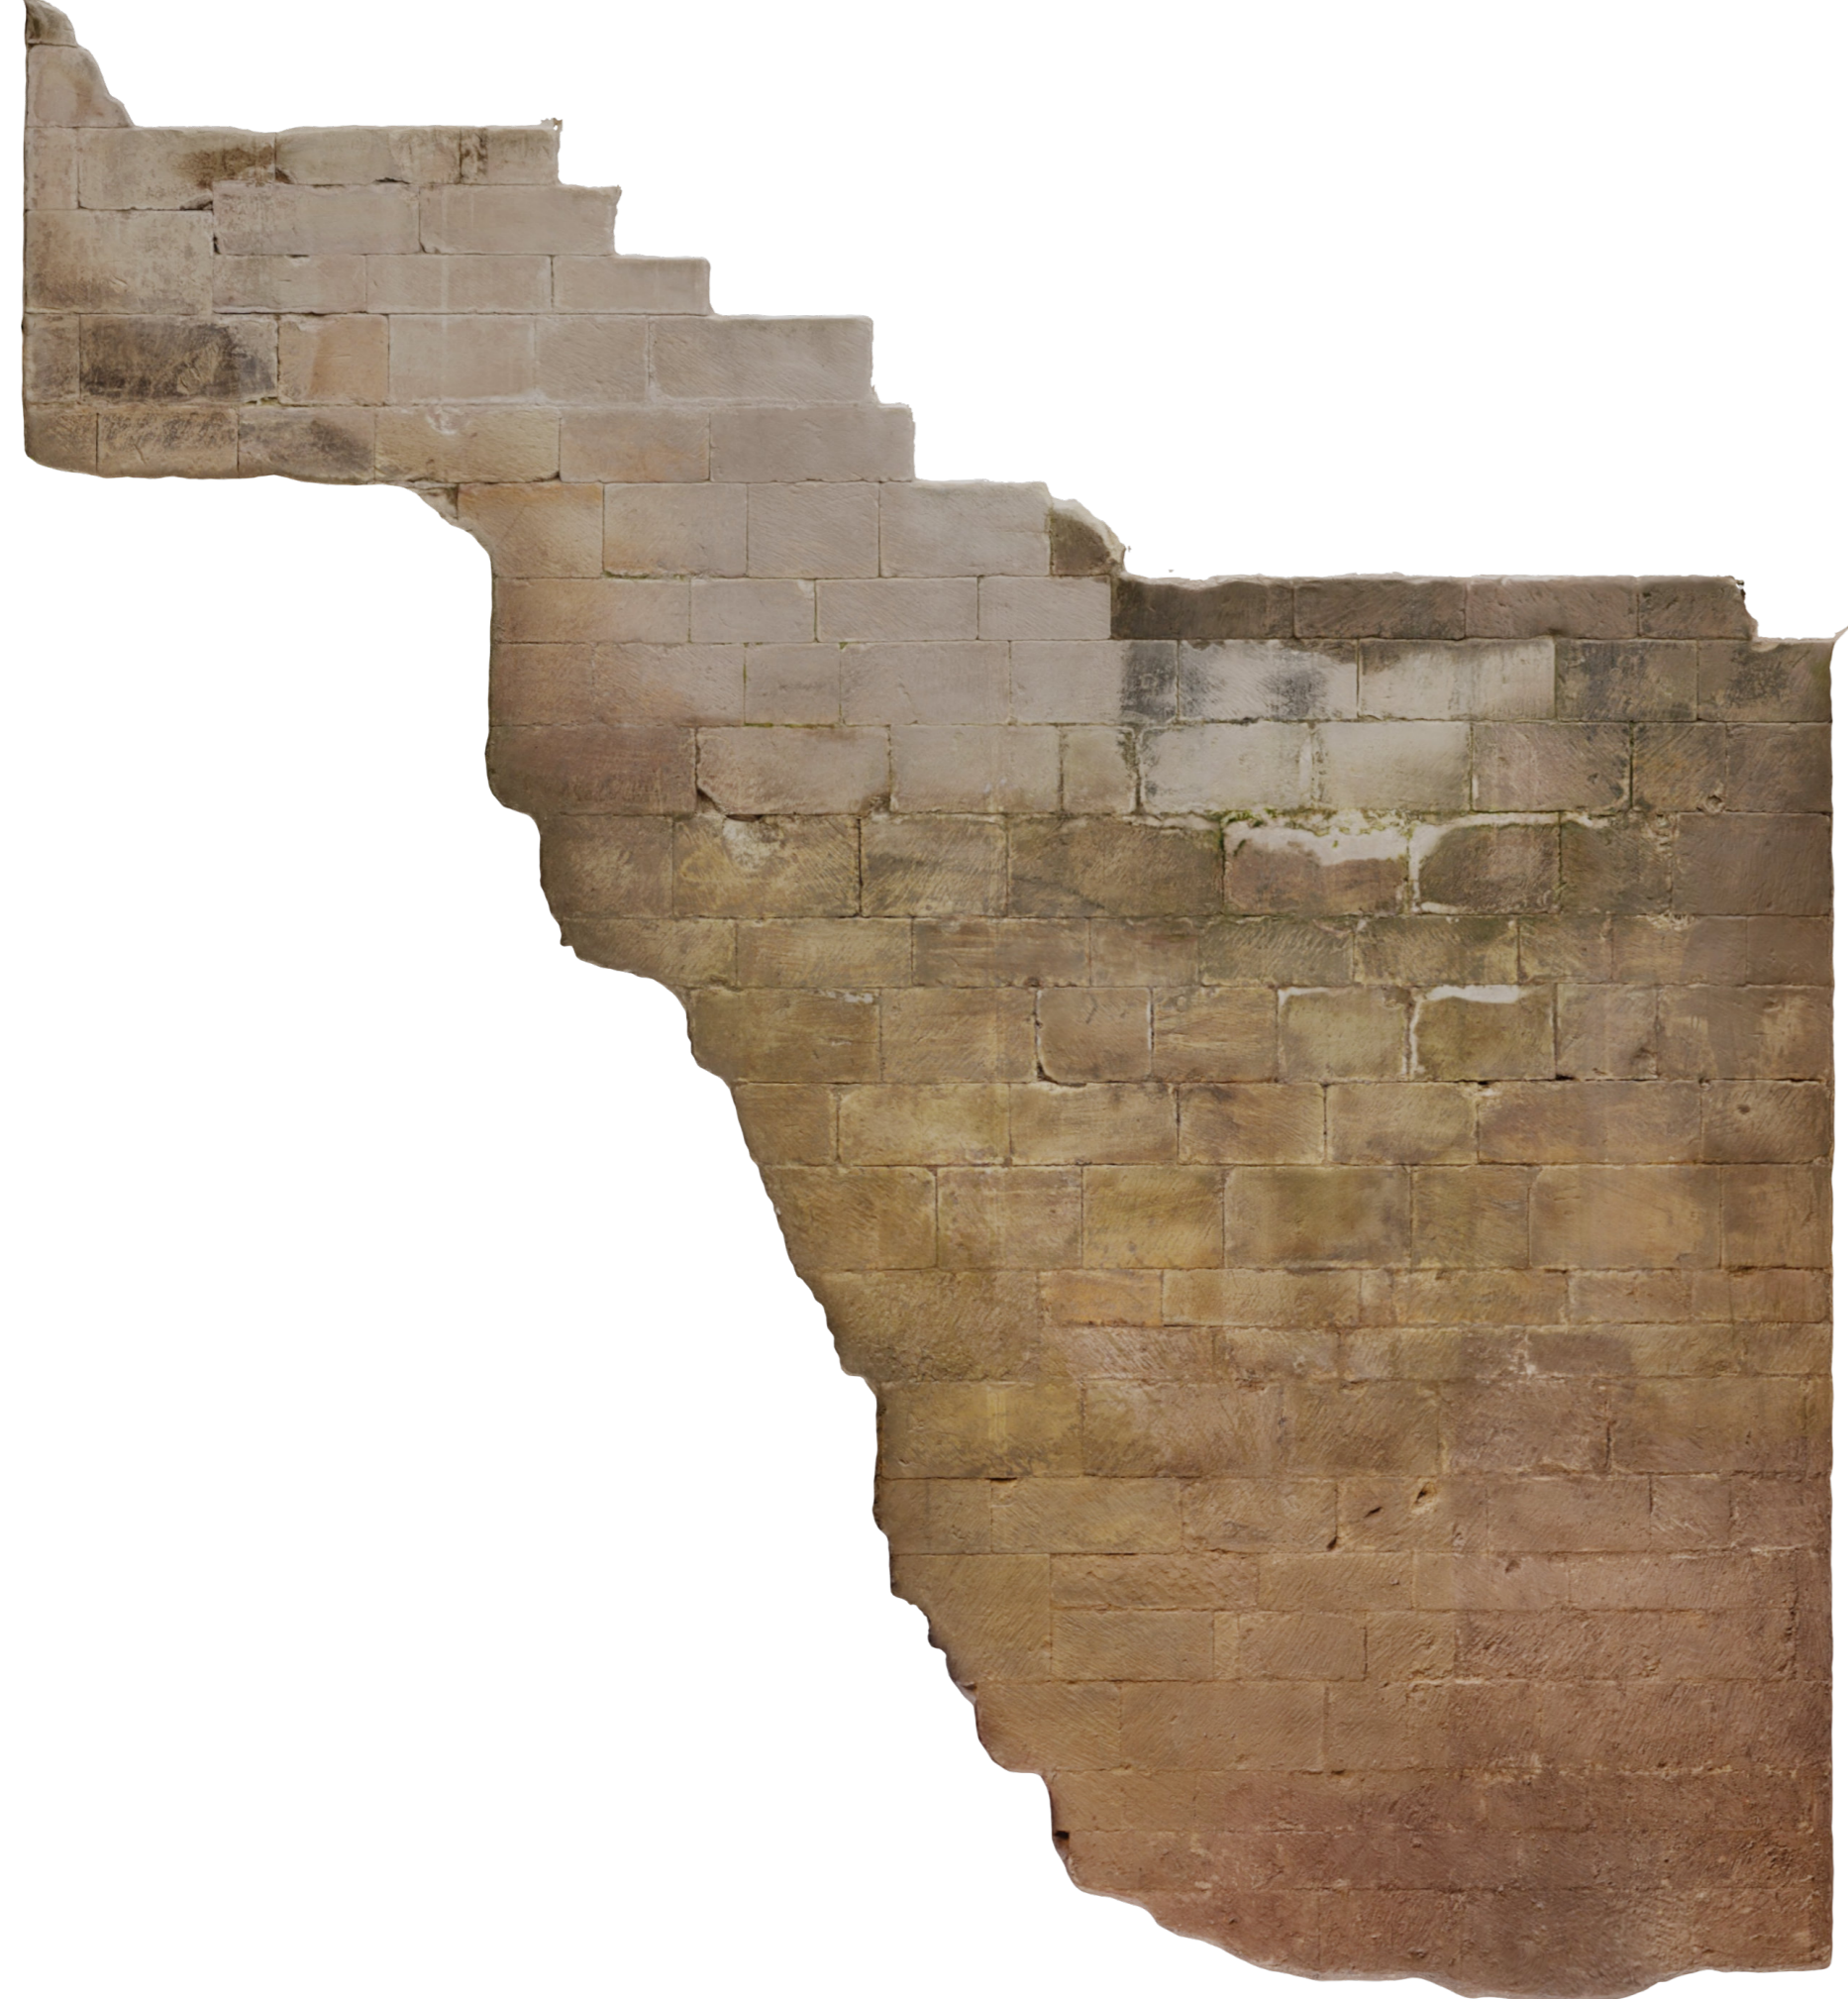
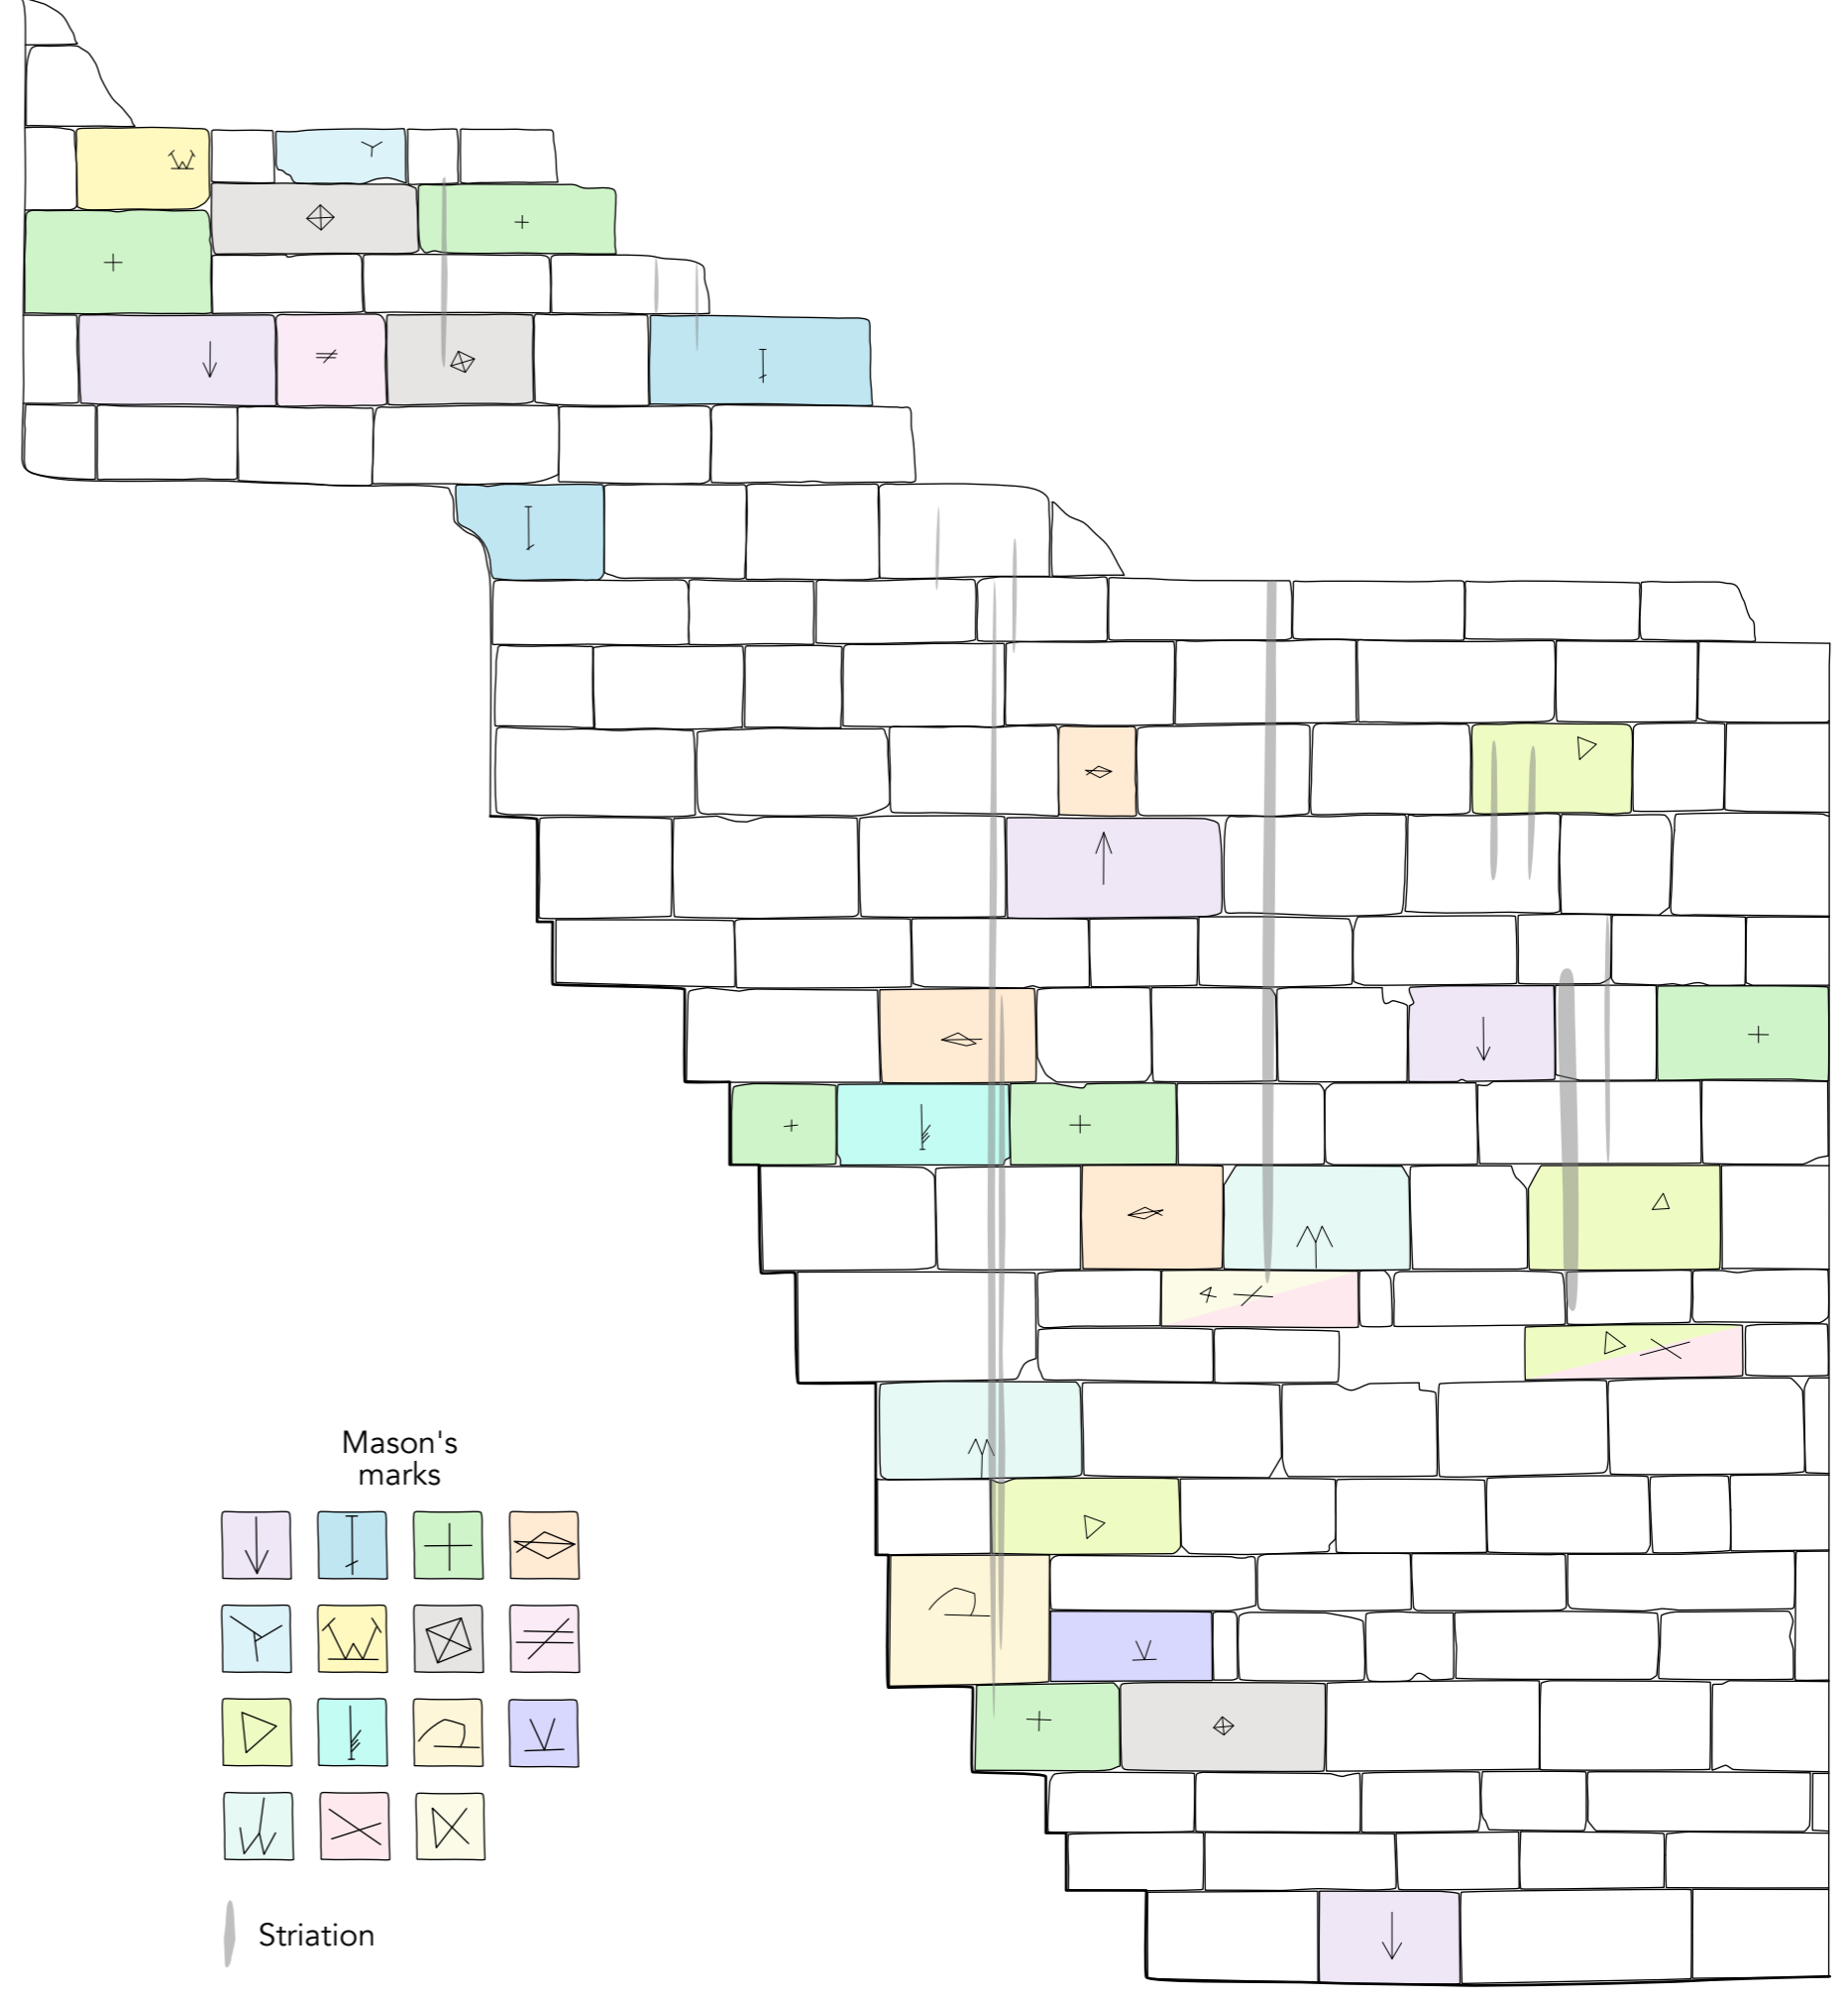
Ortho-image

- Mason's marks
- | | | | |

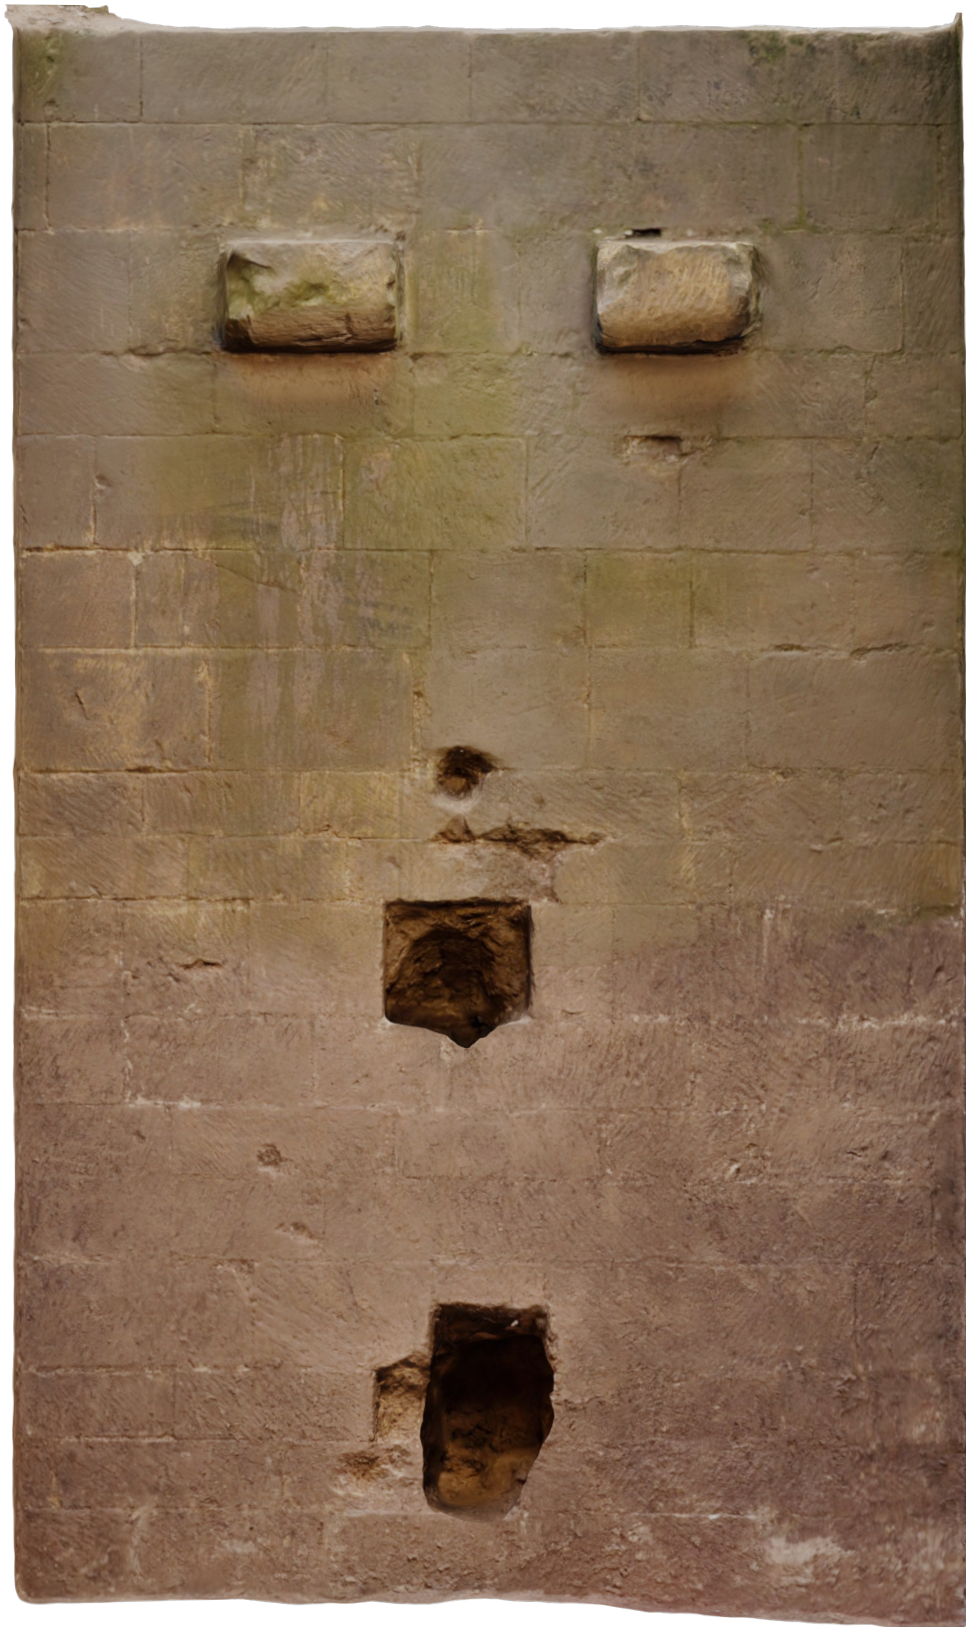
Ortho-image

Mason's
marks

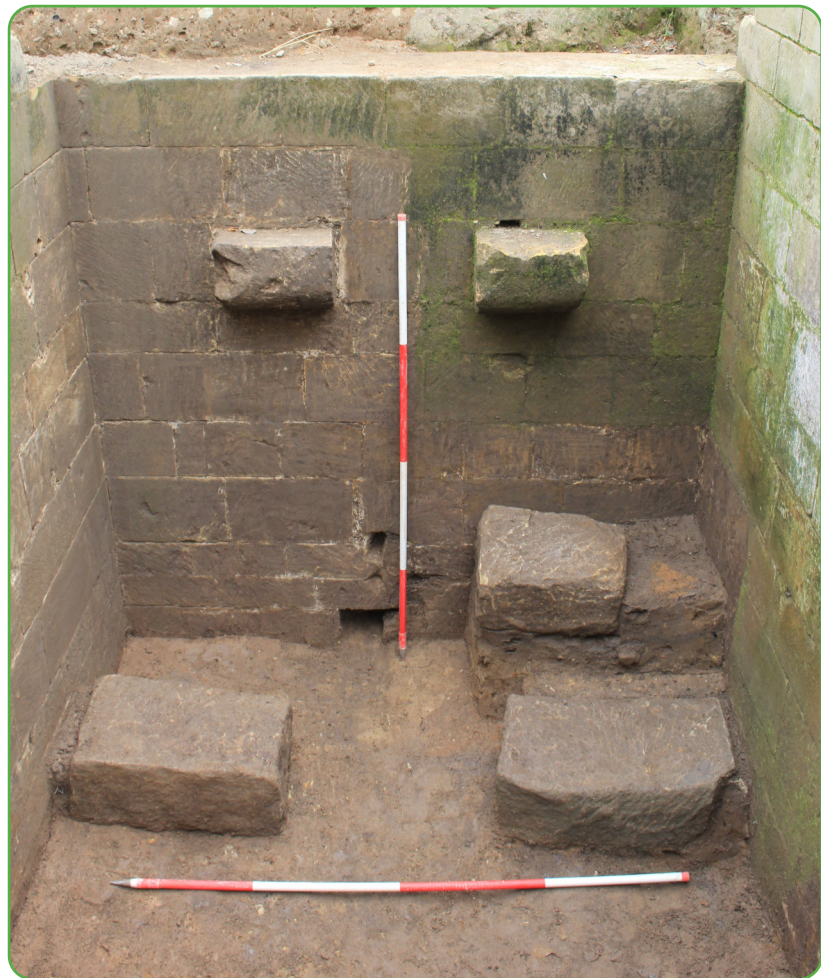
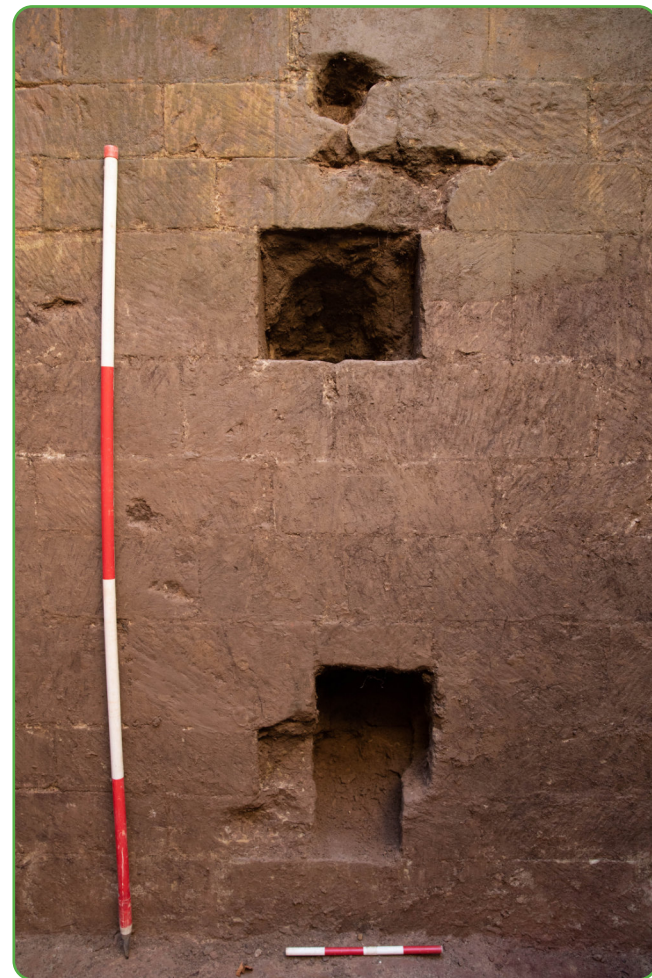
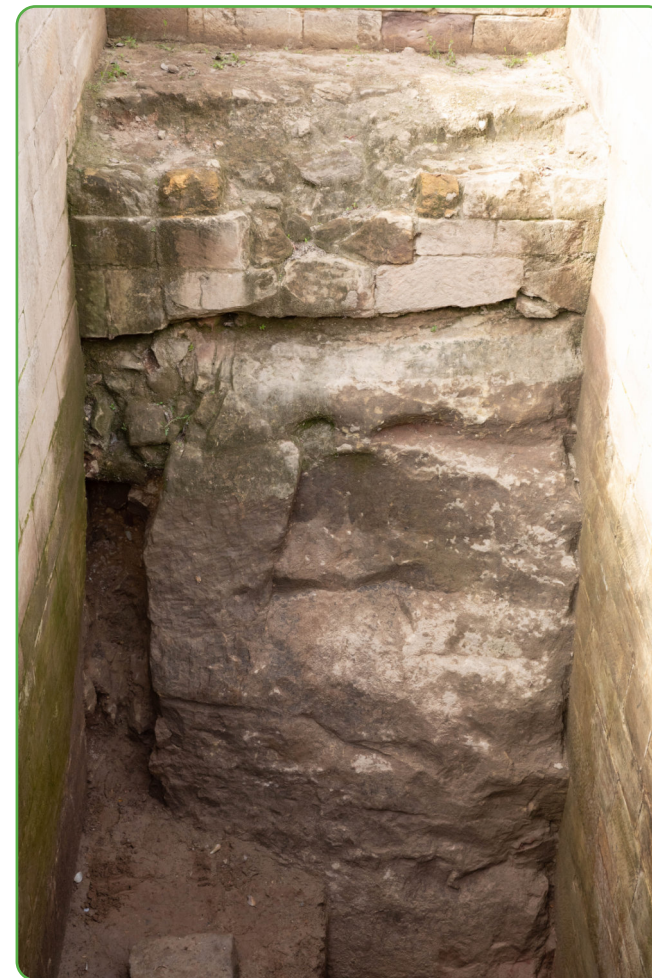
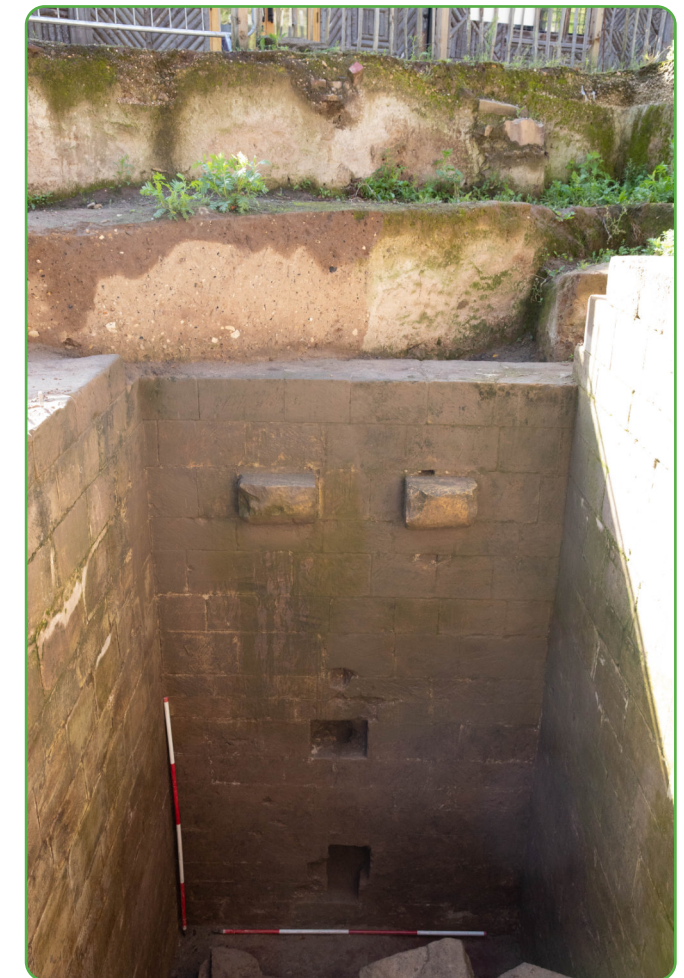
Figure 12: Excavation photographs

Mid-ex photo of south wall, showing large masonry blocks in the fill of the drawbridge pit

Recesses in the south wall

Post-ex photo of bedrock and casing wall

Post ex photo of south wall of the drawbridge pit

- 6.2.1 The earliest remains encountered during the excavation was a heavily degraded limestone wall F120 fronting the natural sandstone edge within the drawbridge pit (Figure 5). It comprised four courses of degraded ashlar to a maximum height of 0.8m mortared in a single 0.3m wide skin to the outer facing edge of the moat. The upper two courses had suffered from significant erosion, particularly towards the centre, and

architectural elements had evidently been placed during the initial construction of the wall and probably formed brackets upon which timber uprights were positioned, possibly related to the function of the drawbridge. Three recesses were observed further down the wall. The uppermost depression was roughly circular, measuring 0.12m diameter and 0.1m deep, slightly off-centre and had evidently worn through repeated motion of an object in this space. Below this was a larger, 0.35m deep recess on a similar vertical alignment that also appeared to have formed through repeated striking of a roughly circular object, leading to the removal of the masonry facing. The angle at which the hole had formed suggested striking had occurred from an elevated position. The lowest recess was found three courses from the base of the drawbridge pit and was positioned more centrally. Unlike the other two, this appeared to have formed through the deliberate removal of a square section of wall, possibly to support a horizontal beam; however, no working was found into the bedrock opposite to suggest it spanned the base of the pit. No structural elements were found within the recesses and none contained layers unique to their situation.

- 6.4.4 The late 15th to 16th century fill of the drawbridge pit was initially represented by two large rectangular masonry blocks (1088 and 1089) that had been placed 0.7m from the south wall against the east and west walls. They were found at the same level on opposite sides of the pit and shared similar dimensions, each measuring approximately 0.75m long, 0.45m wide and 0.3m thick. The apparent deliberate placement of these substantial masonry pieces 1.7m from the base of the drawbridge pit indicates a new phase of construction, with each one likely serving as foundations upon which large timber vertical supports were placed. This may have been required to either provide additional support for the drawbridge or could represent the establishment of a more permanent superstructure. Layers overlying these foundation stones produced notably later pottery than those beneath them, dating to the late 15th and 16th century. Although no clear cut was observed during excavation, it is possible that the drawbridge pit was cleared to a specified level before these stone blocks were placed and the pit began to fill again.

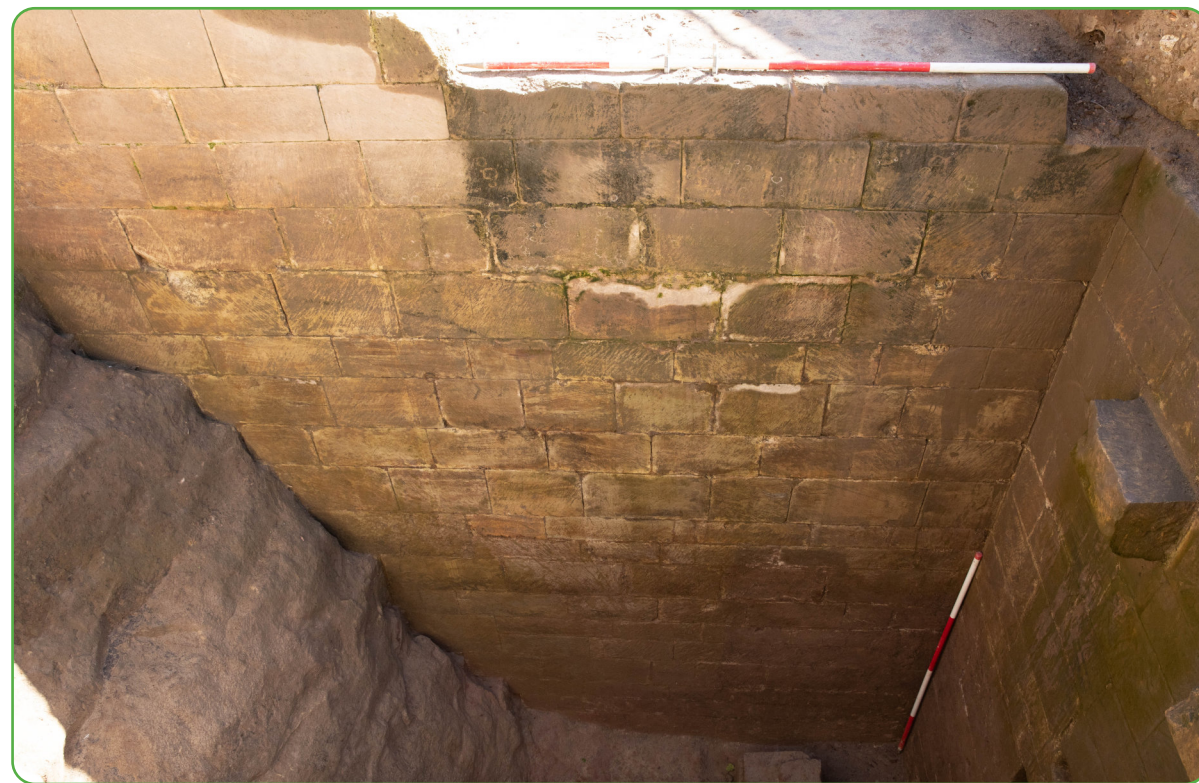
Post-ex photo of east wall of the drawbridge pit

6.3.6 Vertical striations were found on both the east and west walls, appearing as very faint pale stripes from the top of the walls down towards the base. This pattern was most noticeable on the east wall where three were spaced at 0.75-0.9m intervals from the south wall. These stripes were not cut into the ashlar walls, had not formed through weathering and were observed down almost the full elevation of the walls. It is possible that they were areas of the wall less exposed and

6.5.1 Bonded to the outer face of the eastern gatehouse tower and the circular tower in front was a later piece of masonry F118 (Figure 12). No attempt had been made to tie the masonry into the Phase 2 gatehouse structure, rather it had been cemented onto the outside. It extended to the east, at right angles to the curve of the circular tower but was in poorer condition than the earlier remains having been truncated by later landscaping activity. The coursing was much thinner, comprising eight courses to a height of 1.36m, but just the southern side of the structure lay within the trench. Dating this feature was difficult but it seems likely this angular addition to the outside of the gatehouse tower was a redans relating to Civil War fortifications.

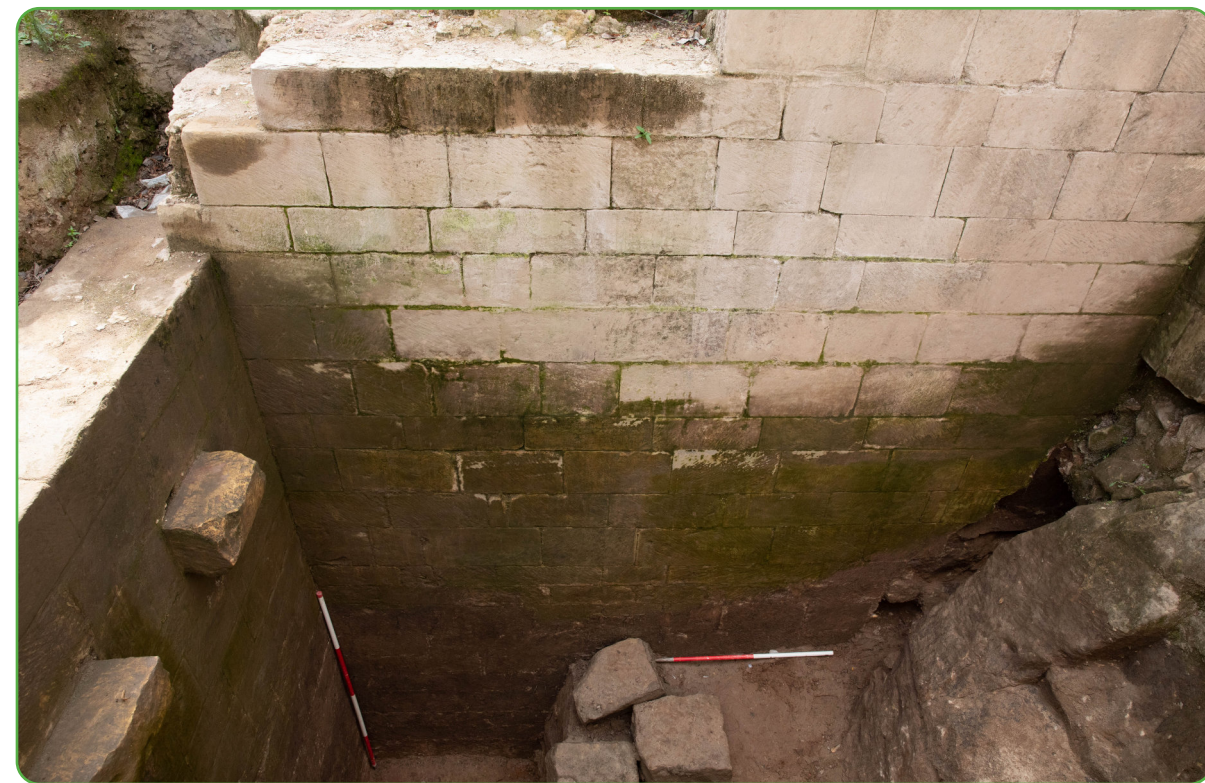
Post-ex photo of west wall of the drawbridge pit

6.7.2 The earliest and most extensive stone-robbing event was found over the south wall of the drawbridge pit and along the inside edge of its west wall F111 (Figure 12). On the south side a cut had been made directly over the wall for the removal of masonry, whereas on the west wall a 0.45m wide trench had been tunnelled down into the demolition layer within the drawbridge pit deeper than the that of the robbing event. Pottery found within the backfill of the robber trench suggests that this activity was undertaken in the latter half of the 17th century, conceivably very soon after the demolition phase.
