Gatehouse Project, Pontefract Castle Community Archaeology Project

Assessment Report

Gatehouse Project, Pontefract Castle
Community Archaeology Project
Archaeological Assessment Report

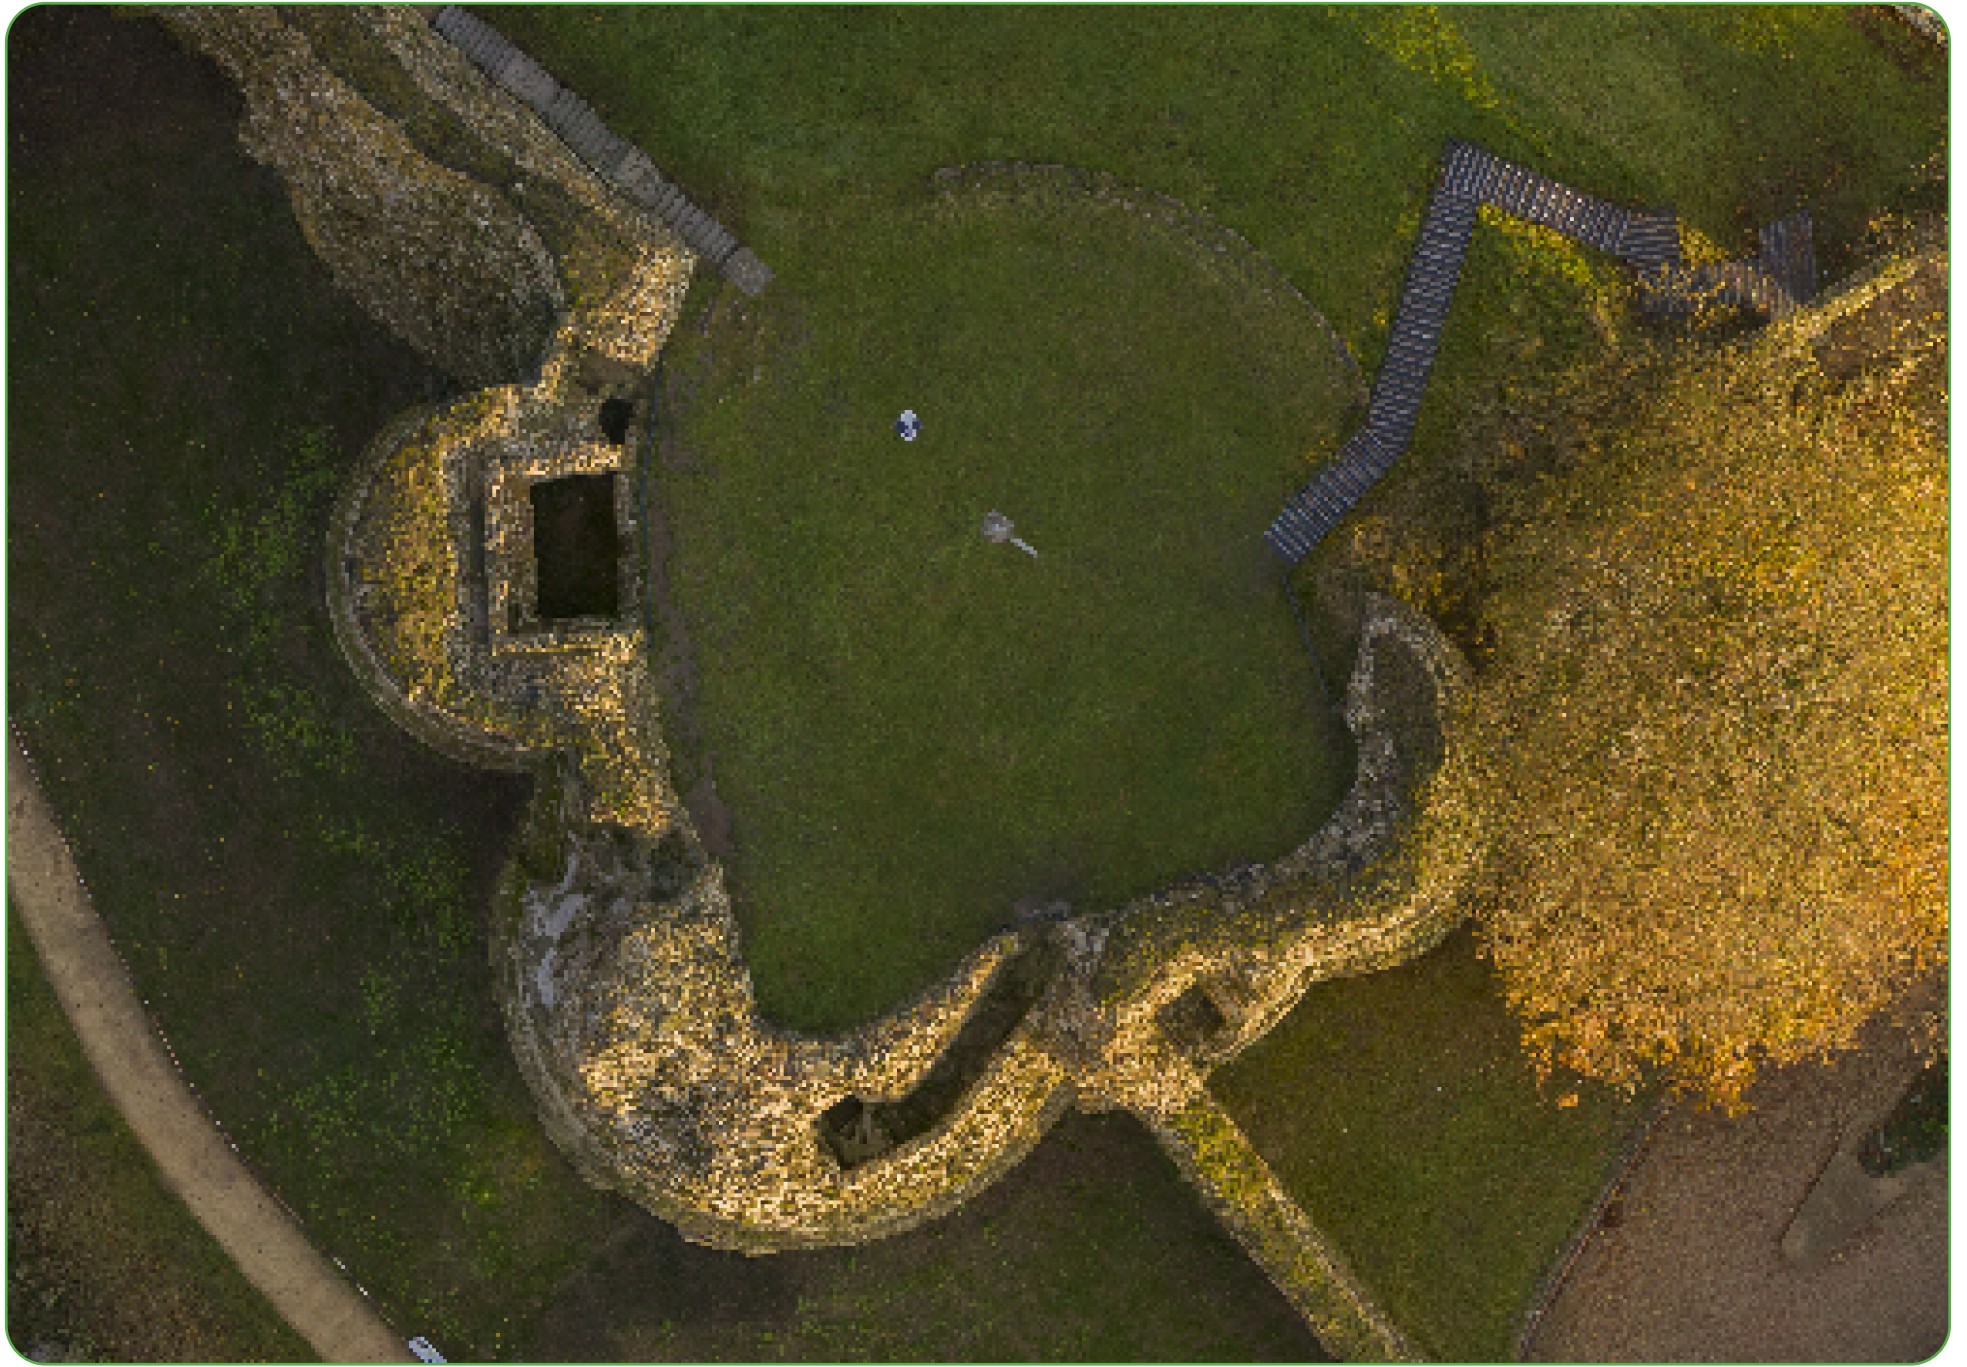
Figure 21: Projected elements of the Great Tower

Ortho-image

Plan
