Croxdale Medieval Chapel

Archaeological Watching Brief Report

Croxdale Chapel

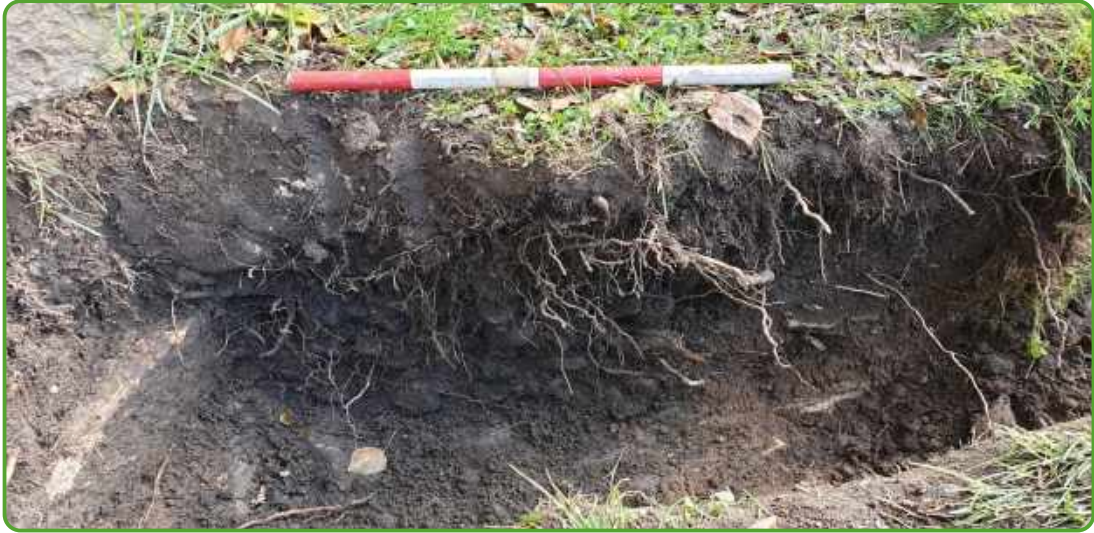
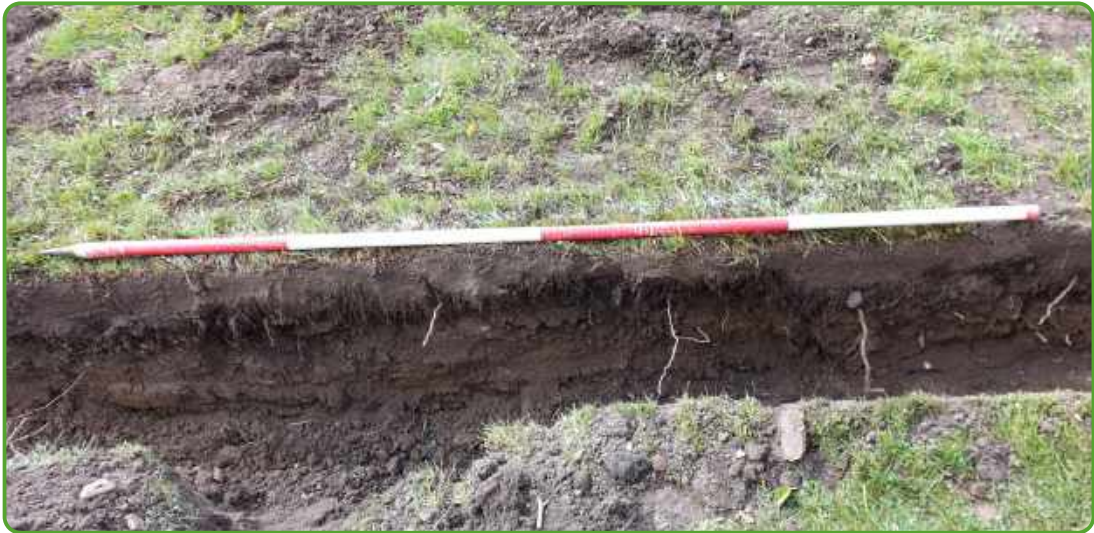
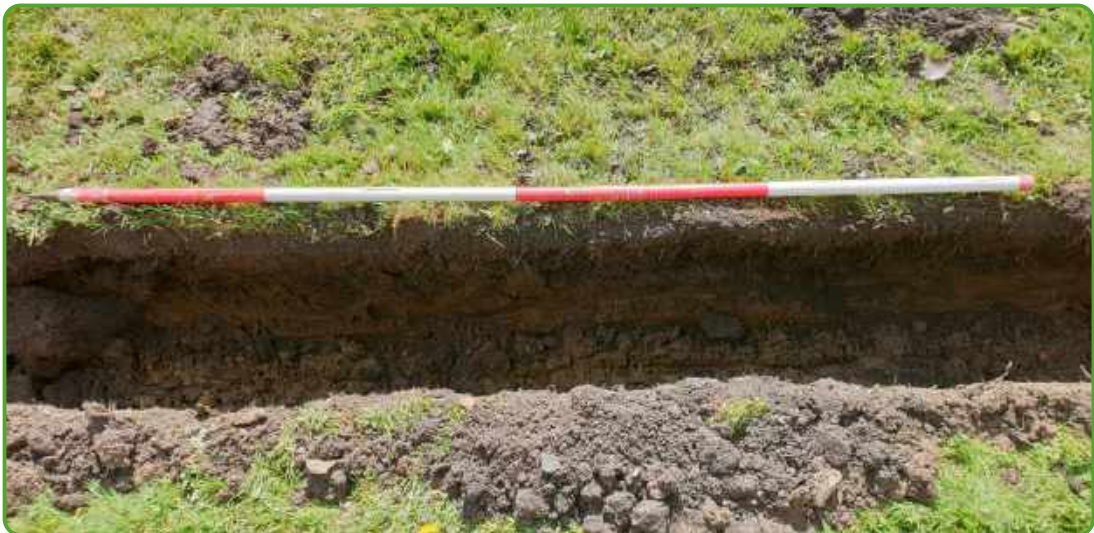
Figure 3. Representative photographs of excavation areas (location and direction indicated on Figure 2)

5.1.1 Excavation revealed a common stratigraphic sequence consisting of a dark greyish brown sandy silt topsoil with occasional small and medium sized sub-rounded stones to a maximum thickness of 0.15m (1001). Underneath this was a layer of mid yellowish grey silty clay (subsoil) with occasional small to medium sized sub-angular sandstone fragments, with charcoal and mortar flecks (1002) to a maximum thickness of 0.30m. In areas of work further away from the chapel to the east, the natural horizon (1004) was encountered at a depth of 0.35m and excavated to a final depth of 0.50m with the maximum thickness being 0.15m. (Figure 3)

5.1.2 Close to the chapel itself and below each of the lead waterspouts built into the walls above, a localized purposefully laid concentration deposit of well sorted tightly packed small to medium sized rounded stones (1003) was observed, measuring 0.55m in length and 0.35m thick to the limit of excavation. This deposit likely represents a relatively modern rudimentary drainage aid or primitively constructed soak-away for the waterspouts above.
