## **2 Old Mill Lane, Edinburgh**

### **Archaeological Watching Brief**

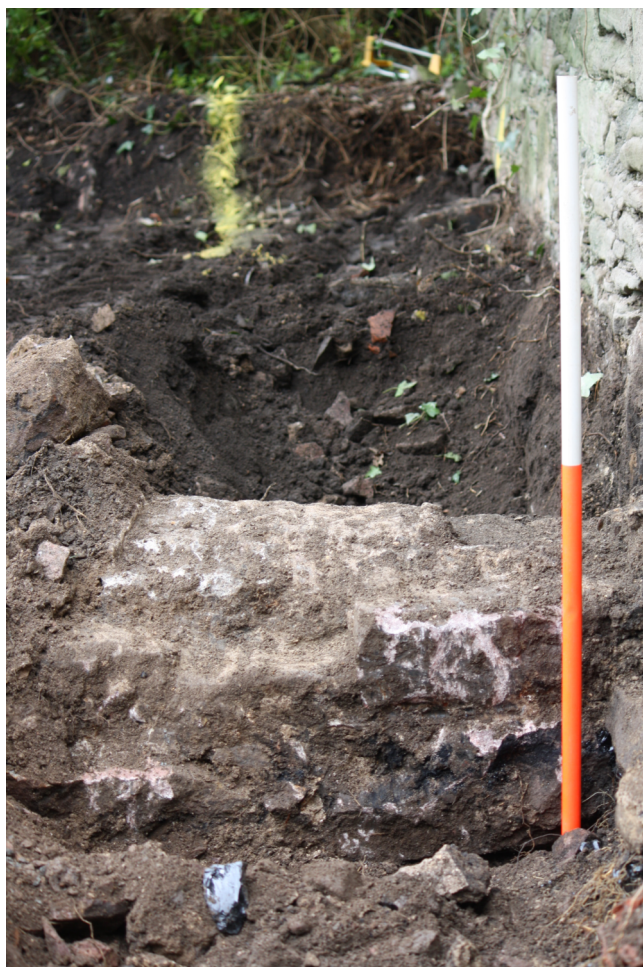
**Plate 1 – South West Facing Elevation of Wash House Foundations (004)**

3.1.5 The only feature of note uncovered during excavations was the foundations for a mortar bonded stone built wall **(004)** running north west to south east. The wall remains were 0.5m thick, 0.37m and three courses high and a length of 0.8m (see Plate 1), the remains continued beyond the edges of the

trench. The remains however were part of the foundations of the washhouse that had been demolished previously.

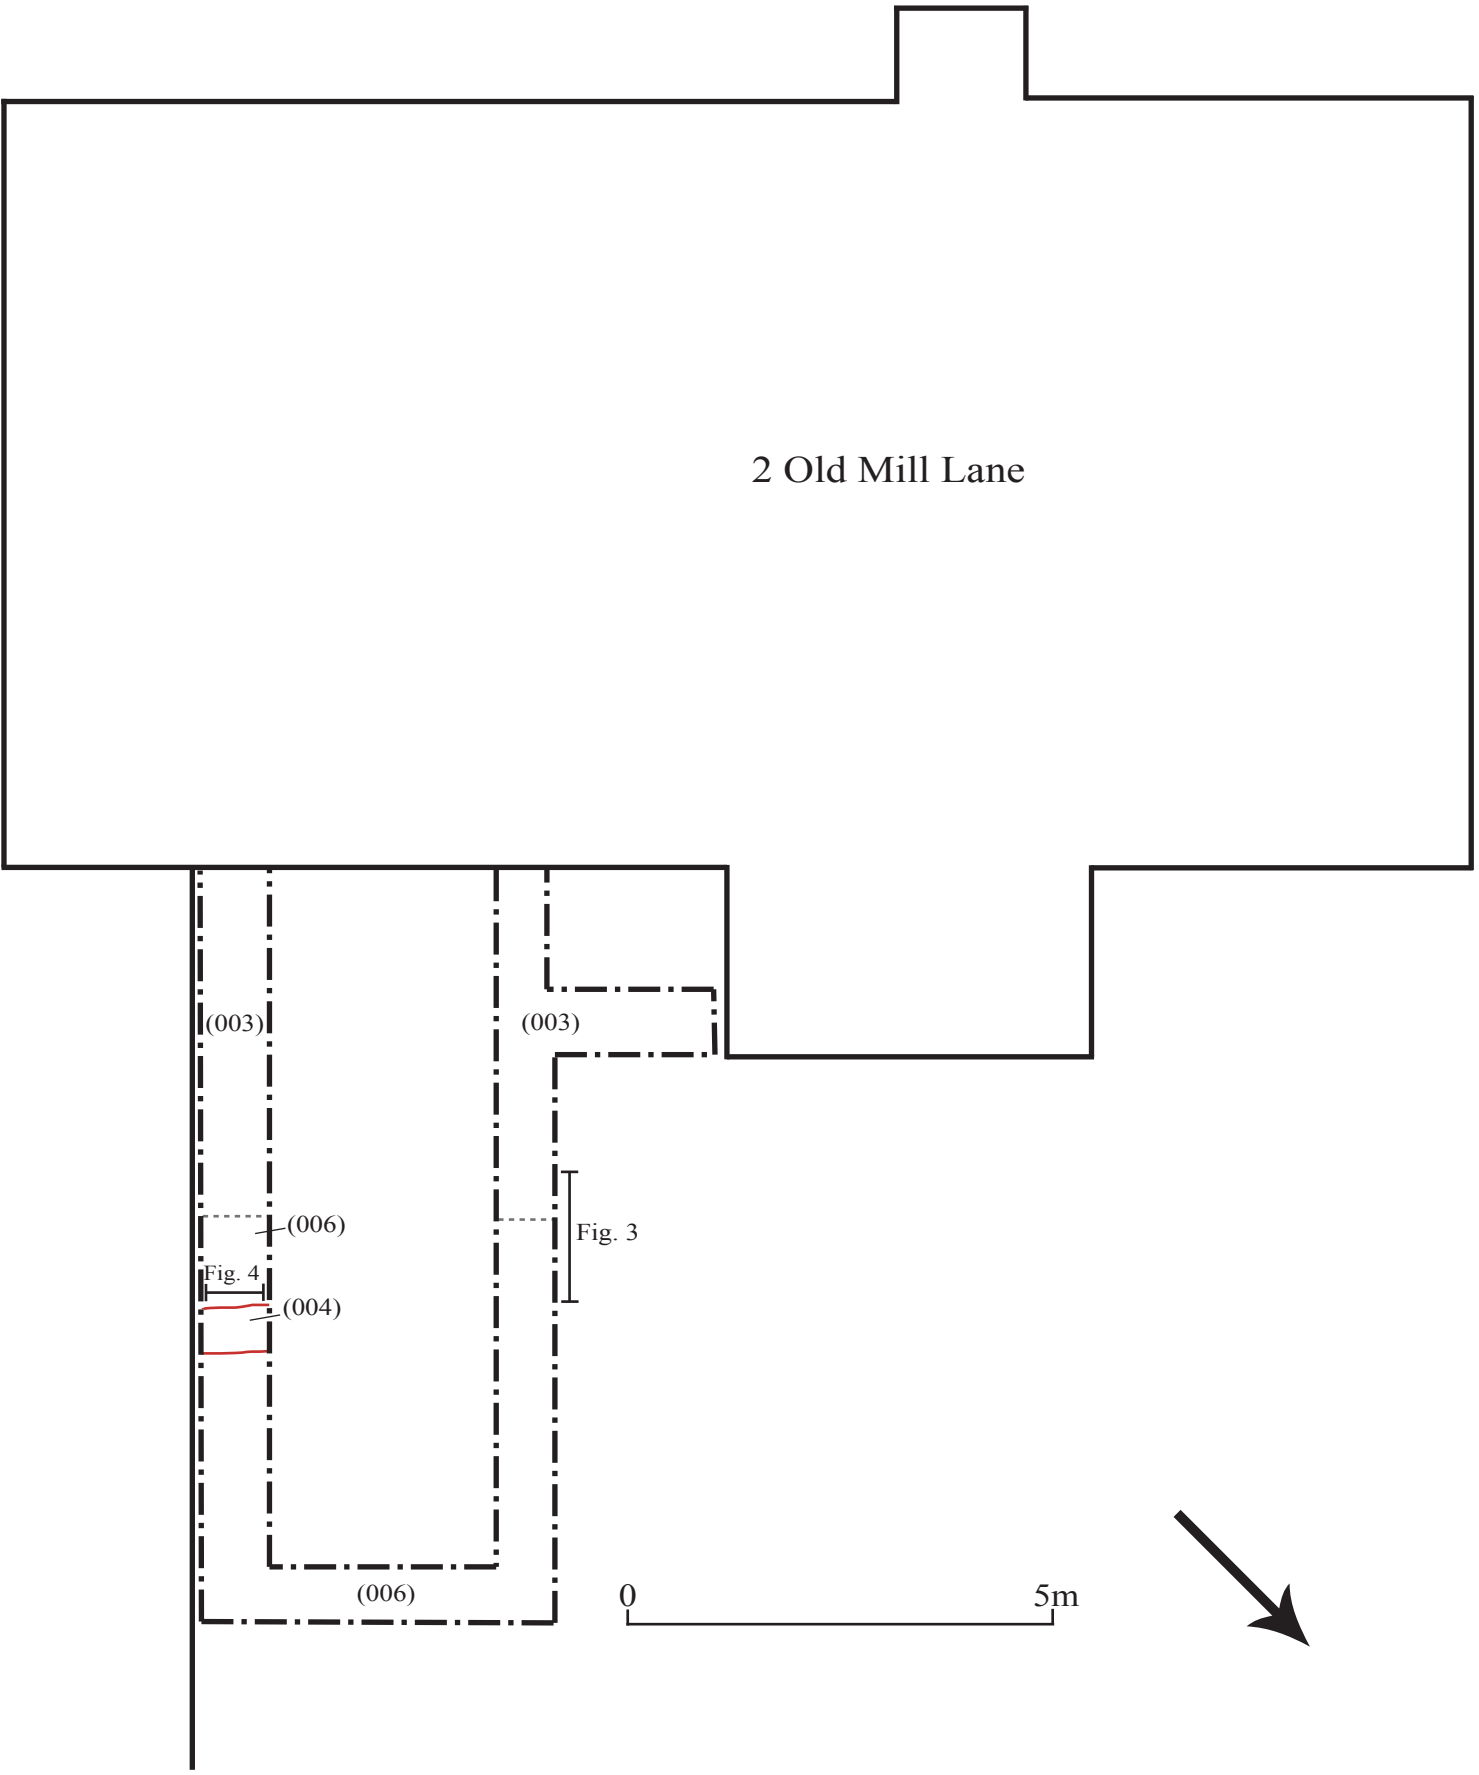
3.1.3 Excavation revealed two distinct deposit types within the garden, split into the north east and south west halves of the foundation trenches (Figure 2). The north eastern half consisted of a rich grey-brown garden soil **(005)** that contained occasional modern debris and pipes associated with the wash house that had been previously demolished. This generally continued to a depth of 0.4m deep. It overlay a dark brown silty clay subsoil layer **(003)** that continued to a depth of 0.3m. **(003)** overlay a mid orange-brown clayey sand natural **(006)** (see Figure 3).

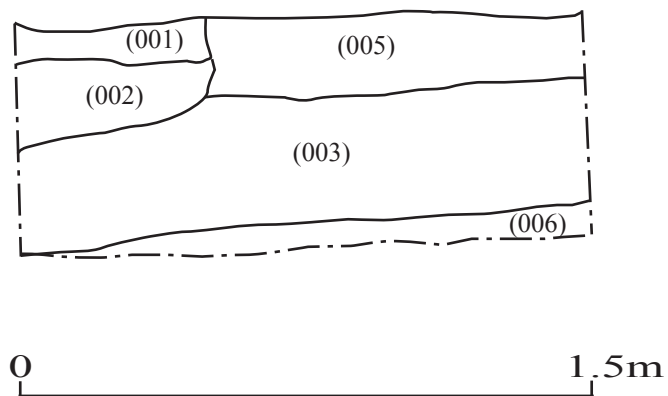
Fig.3 - SE Facing Section Showing Transition from Garden Soil (005) to Rubble Deposit (002)

3.1.4 The south western half of the foundation trench consisted of modern concrete paving **(001)** overlying a rubble bedding deposit **(002)** for the paving, which consisted of small and medium stones with occasional bricks and mortar fragments. This deposit continued to a depth of 0.3m and overlay the garden soil **(005)** noted in the north eastern half of the foundation trench (see Figure 3).
