**Peterborough Cathedral Precincts**

**ARCHAEOLOGICAL RECORDING**

**ON 'WALL 17', EAST WALL OF BISHOP'S GARDEN, NORTHERN HALF**

Archaeological Contractor's Site Code: PC W17

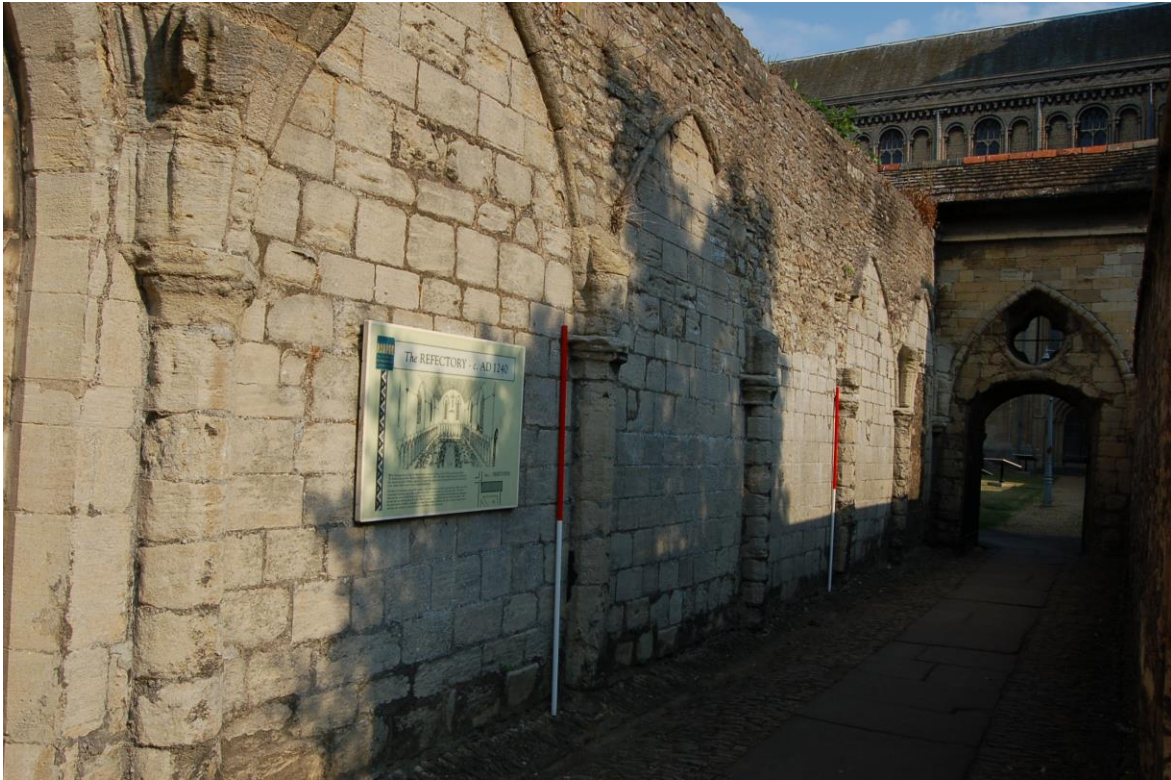
Fig 2: Northernmost five bays of 'Wall 17', east side, with 13th-century vault responds and wall ribs, looking north-west (taken July 2006)

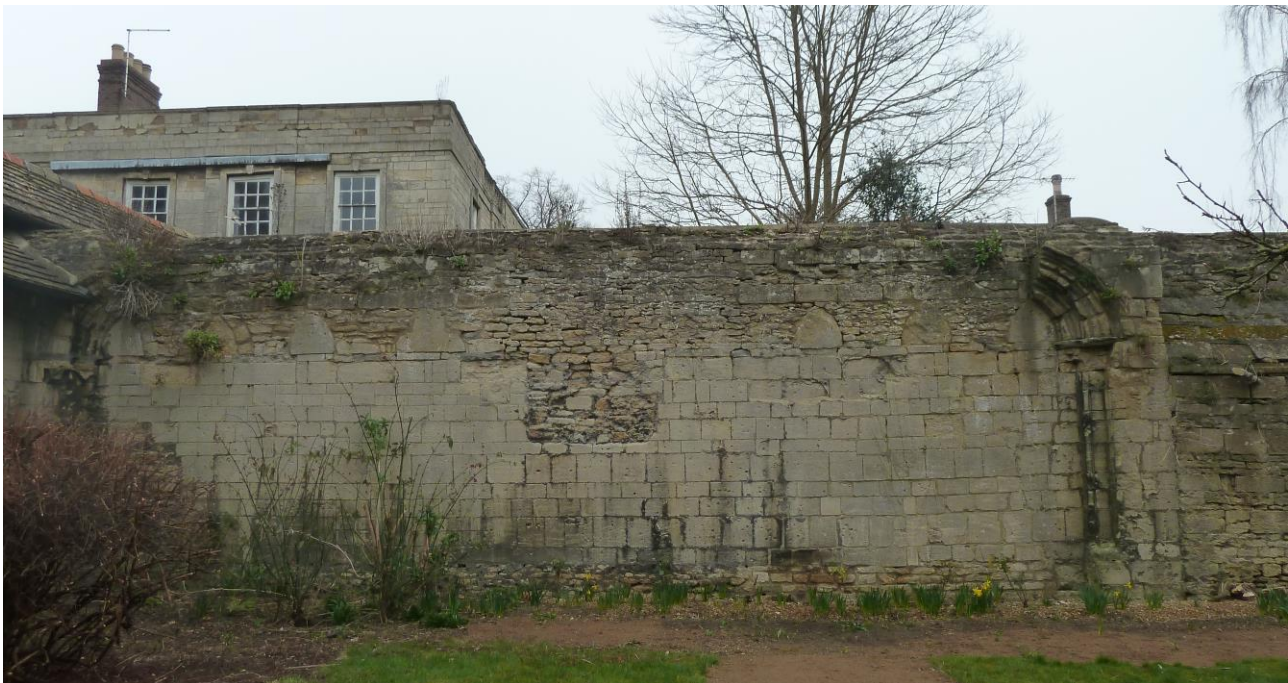
Fig 3: Northernmost section of 'Wall 17', west side, interior of medieval refectory with details of blind arcade and later refacing and repairs (taken March 2015)

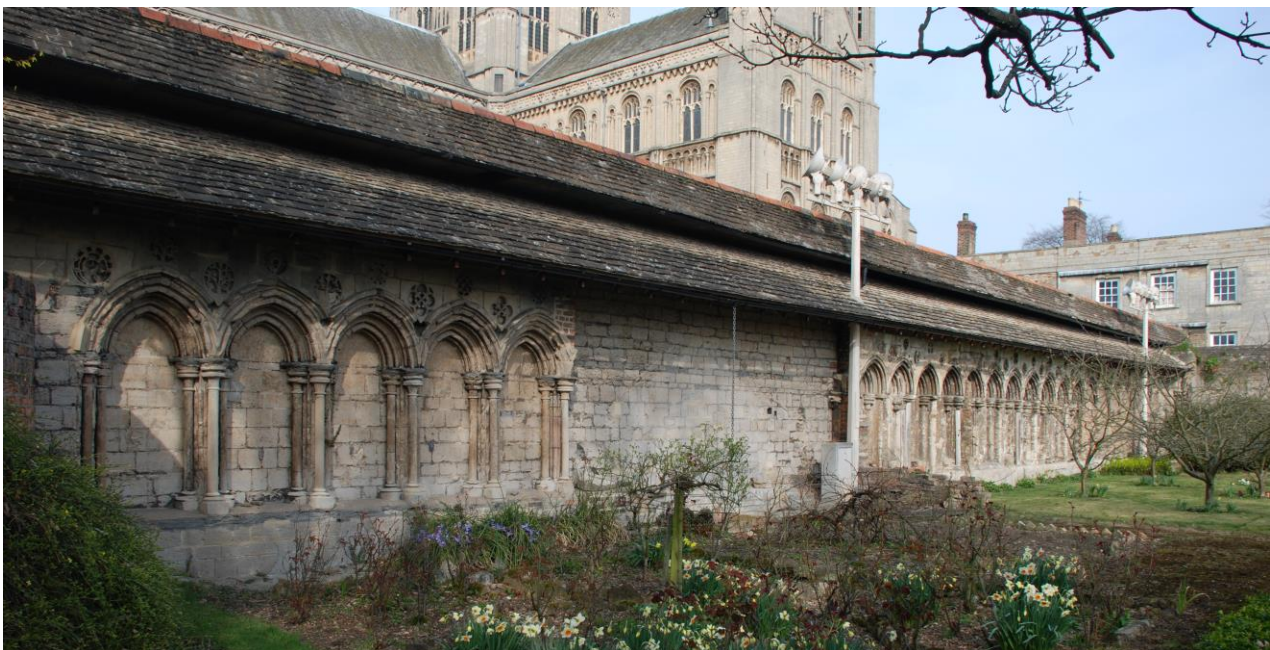
Fig 5: North wall of refectory (taken March 2009)

implying two further missing trefoiled arches. This was investigated further (below). Unlike some of the nearby monastic buildings, such as the cloisters, chapter house and library, the refectory is not recorded as having been sold during the Commonwealth period. In the early 18th century, it is shown roofless, but with its west wall still extant; Eayre's map of 1721 (Fig 4) confirms that the south wall is by now missing (Bailey 1996, 161; PCCHER, Image 1526, Image 1065). The north wall still retains most of its wall arcade, along with finely carved sunk roundels (Fig 5).

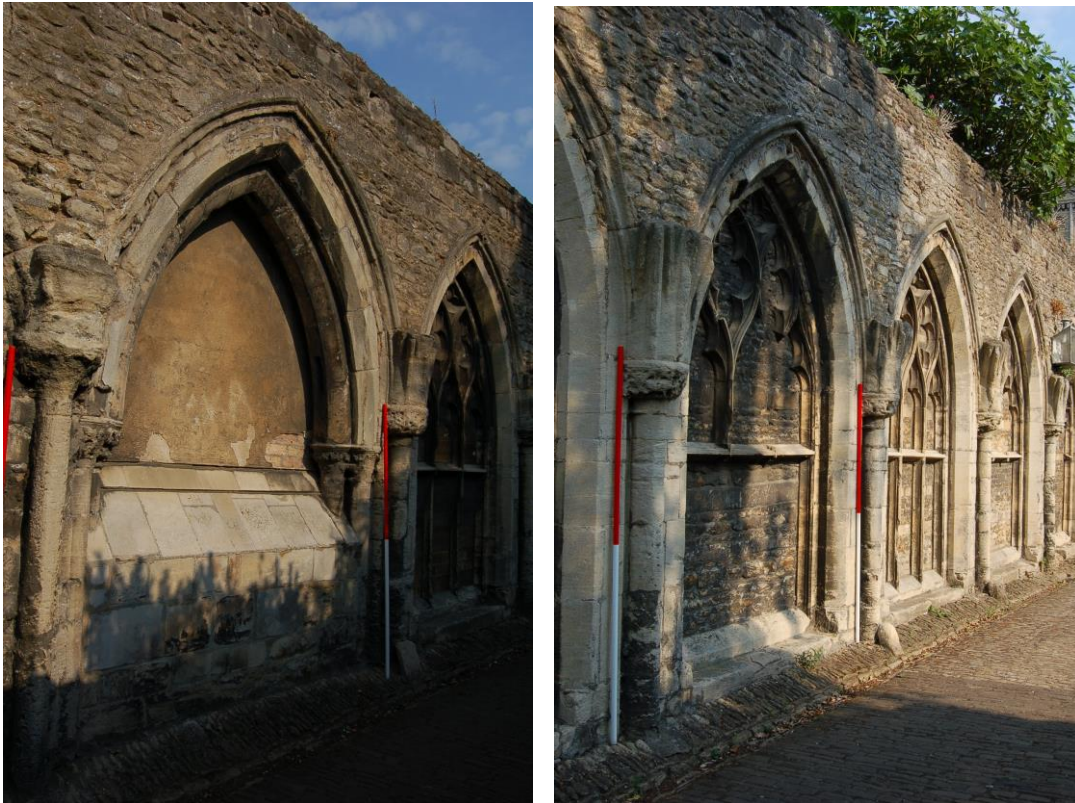
Fig 6: Bays 12 and 11–9 bays of ‘Wall 17’, showing 14th-century door and tracery, looking north-west (taken July 2006).

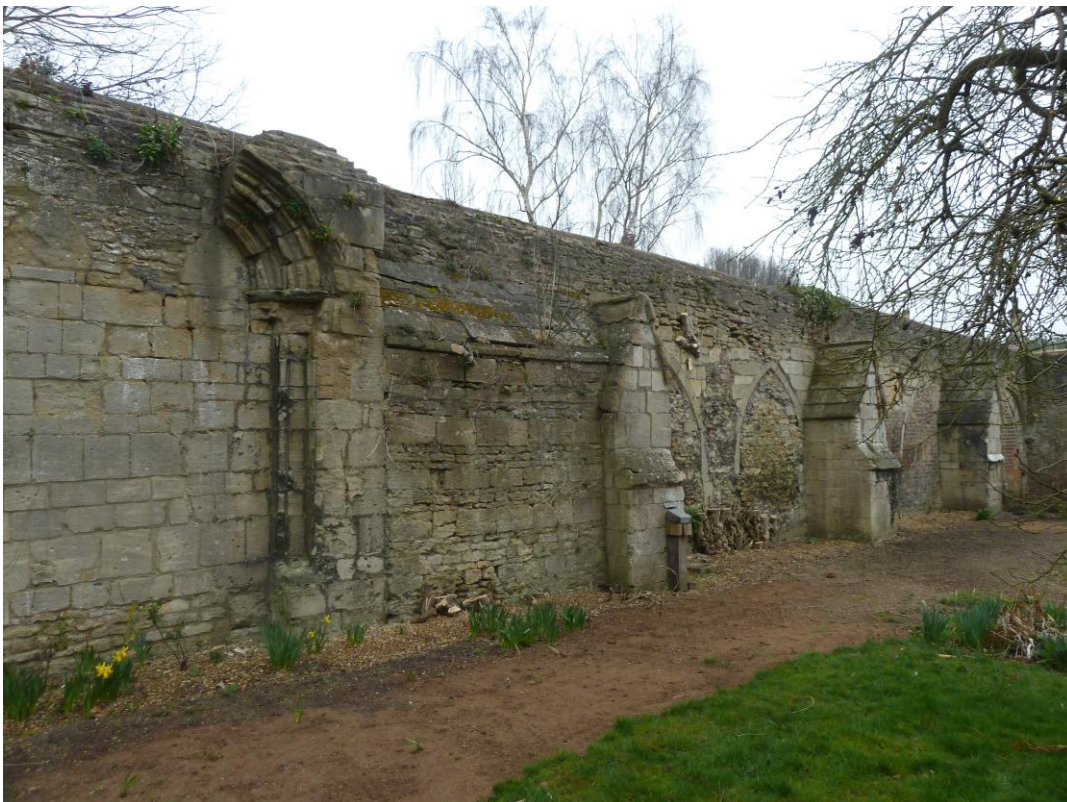
Fig 7: General view of west side, with 13th-century refectory in foreground, then bays 6–12, 14th-century covered way with gabled buttresses and numerous blockings and refacings (taken March 2015).

Externally, the most prominent feature of the covered way are the gabled buttresses (Figs 7, 16, 18). Three of these survive, each with a single sloping offset. The southernmost example projects less than the others

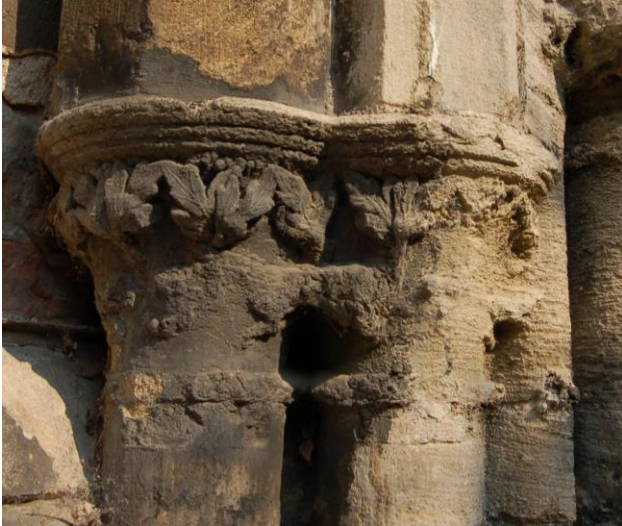
Fig 8: Naturalistic foliage capitals of doorway from Hostry Passage, north of Little Dorter (north side of doorway)

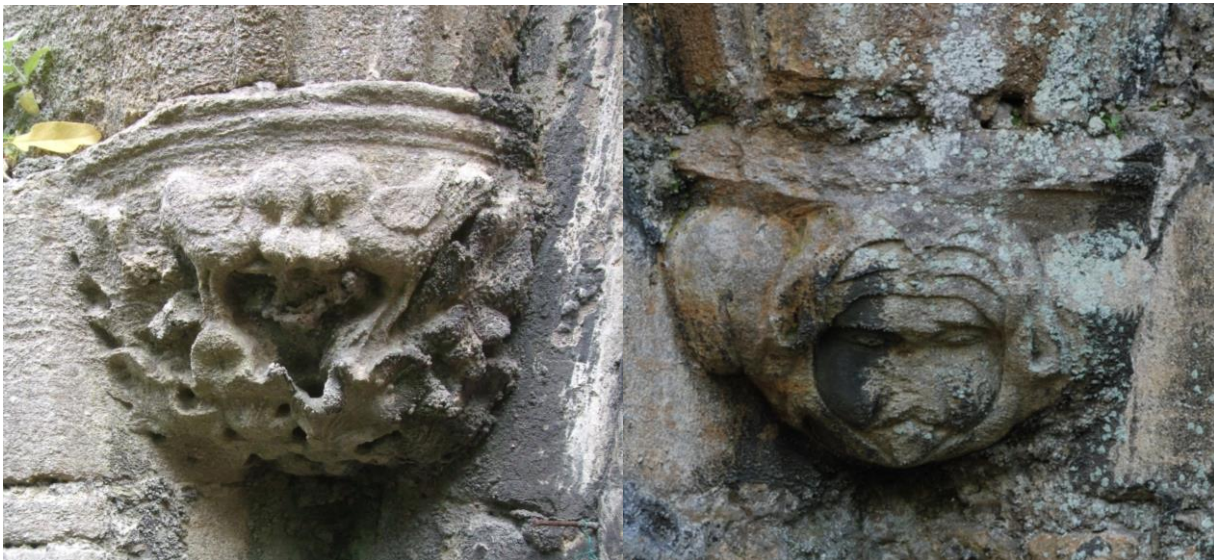
Fig 9: Vault corbels of east-west covered way north of Little Dorter, on west side of Hostry Passage

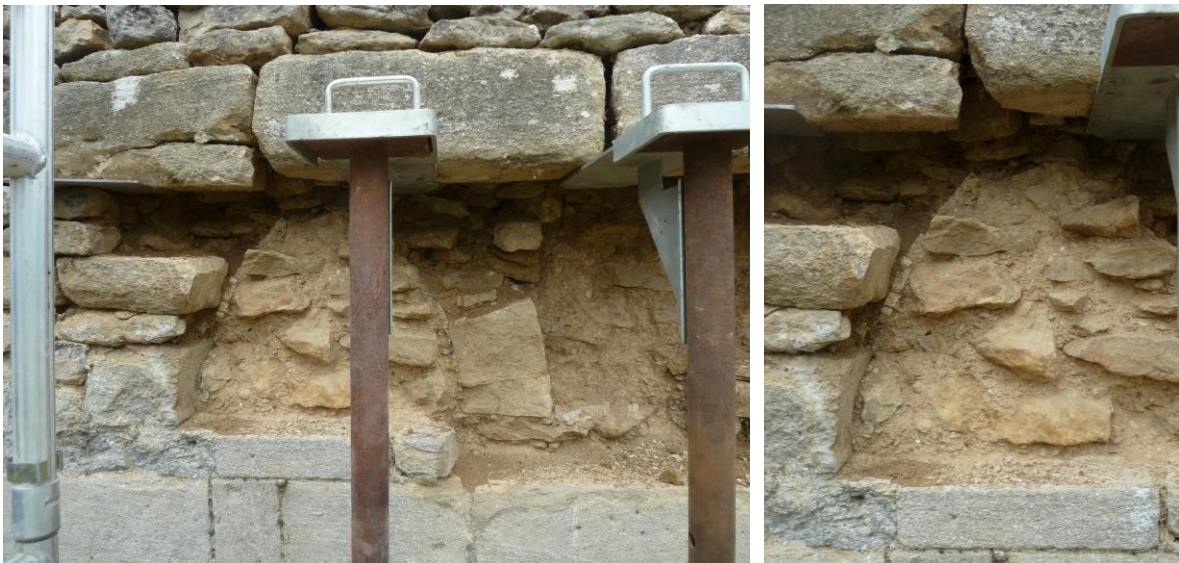
Fig 10: Third lancet from north, showing mortars behind facing. The pale lime-based mortar of the lancet is clearly visible against the darker, clay-based mortar of the re-facing.

Removal of one of the lancets (Fig 10) clearly showed the off-white lime-based mortar of the original build, as against the dark clay-based mortar of the post-dissolution re-facing (Table 1 and Appendix 1). It was also possible to see cut-back voussoirs of the blind arcade. Some voussoirs were turned around and reused as facing stones in the refacing. Two were removed and fully recorded before being replaced in the wall (Appendix 2). The voussoirs, in better condition than the extant examples at the north and south ends of the wall, have a complex series of mouldings (Fig 11). From the soffit, they are fillet and three-quarter hollow; fillet and roll; hollow; keeled roll; hollow and fillet. This is almost an exact match for the extant voussoirs in the north wall of the refectory; however, the order of the moulding there is slightly different (soffit; fillet and three-quarter hollow; roll and fillet; hollow; keeled roll; hollow and fillet).

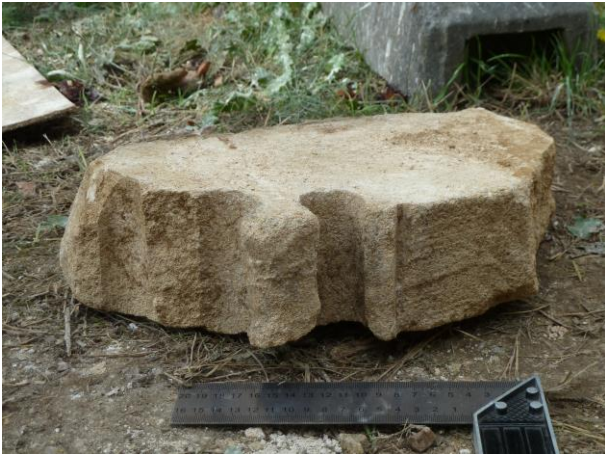
Fig 11: Photo of reused voussoir

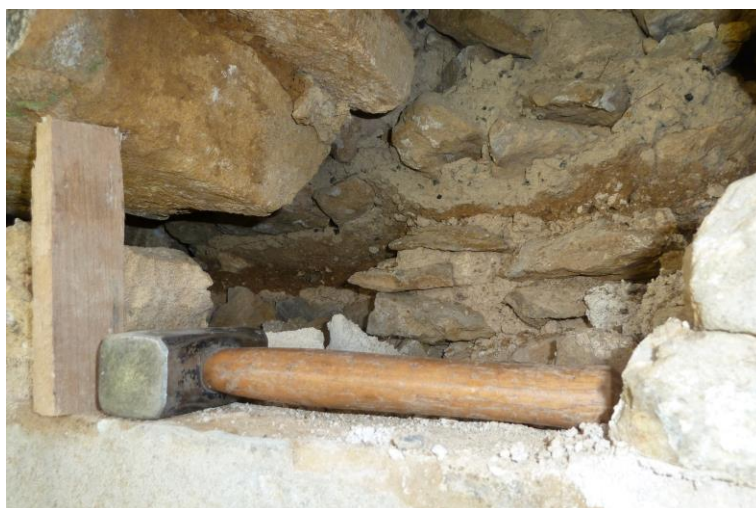
Fig 21: Above bay 10, showing tilted horizontal building break; mortar samples taken both sides of break

A number of mortar samples were taken from deep behind the later refacing, including two above and below a building break (Fig 21; Appendix 1). These probably belong to the original 14th-century building phase here, and the mortar used was very fine, but appears to be more lime-based than clay-based.

21	T	Covered way; bay 10, above arch, core below clearly visible building break (Fig 21)	Cream-buff clay and lime-based mortar, fine with few grit and chalk inclusions, very occasional charcoal, hard	?2
22	M	Covered way; bay 11–12, wall stub, core	Buff clay and lime-based mortar, few grit, very occasional chalk, hard	?2
23	Y	Covered way; bay 11–12, wall above wall stub, deep bedding mortar	buff clay and lime-based mortar, few grits, very occasional chalk and charcoal, hard	?2
24	W	Covered way; bay 12, refacing above vault of east-west covered way, deep bedding mortar	Mid-brown fine clay-based mortar	4e

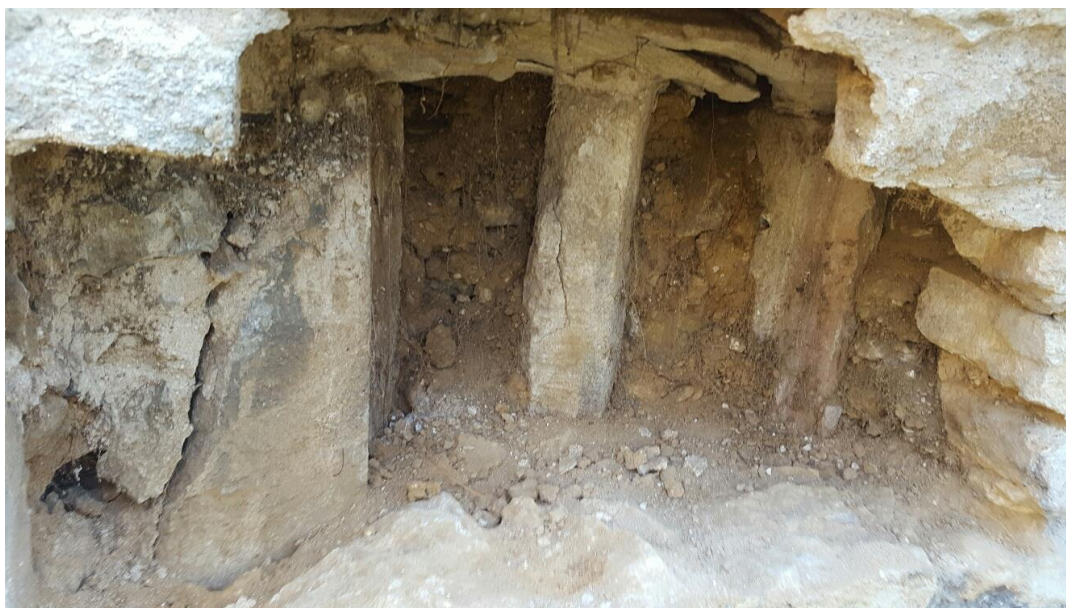
Fig 22: Partially unblocked window in centre of refectory east wall (Julian Vosper)

An early reuse of the refectory is indicated by the door at the north end of the refectory and window in the centre, both blocked. The window was partially unblocked during the current repairs (Fig 22) (though unfortunately no archaeologist was present), showing it to be a square-headed mullioned window, with rather plain mouldings. Since neither the window nor the door were taken apart, no mortar samples belong to this phase. Breaking through the east wall of one of the principal liturgical buildings of the monastery strongly suggests a post-Dissolution date, while the modest size of the window and door suggest some sort of domestic use. This use was clearly over before the early 18th-century, when the refectory no longer had a south wall or roof (see above), and could have been over some time before this.

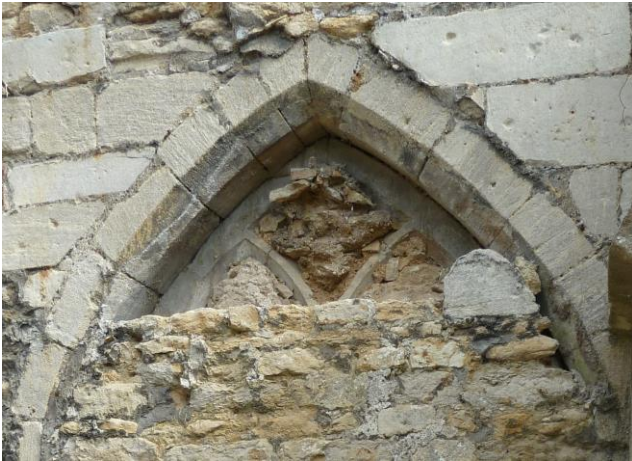
Fig 23: Bay 8, with upper blocking removed, showing the blocking of three quatrefoils from which mortar samples were taken

Possibly belonging to the same works, but using a completely different mortar, are the deep blockings of the various openings. This was only seen in bay 8, where a small section of blocking at the top of the tracery was removed (Fig 23) (**phase 4f**), and was also collected by the contractor from the blocked window in the refectory (**phase 4c**), along with the familiar brown clay-based mortar of the refacing. The mortar was lime-based (Table 1 and Appendix 1) and exceptionally hard, suggesting that it might have been used as a structural element in the opening to which the new facing, using soft mortar, could be fixed. However, this is based only on two samples, and the stark difference between these and the clay mortars might instead suggest a different period altogether. This is not likely to be solved except by some serious (and unlikely) unblocking of the historic fabric at a future date.

8	H	Covered way; bay 8, core of blocking, upper quatrefoil (Fig 23)	Off-white lime-based mortar, frequent grits and occasional charcoal and chalk, very hard; smeared with ?cement slurry from later repair	4f
9	I	Covered way; bay 8, core of blocking, north quatrefoil quatrefoil (Fig 23)	Off-white lime-based mortar, frequent grits and occasional charcoal and chalk, very hard	4f
10	J	Covered way; bay 8, behind facing of blocking, south quatrefoil (Fig 23)	Pale brown fine clay-based mortar with few small pebble inclusions	4e

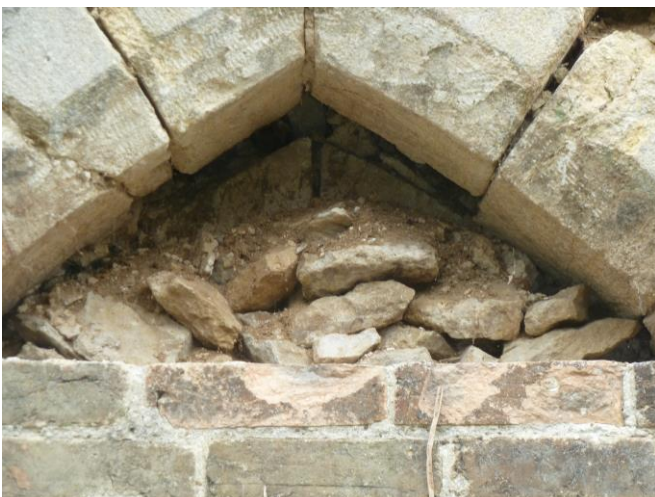
Fig 24: Bay 10, with upper brickwork removed, showing rubble core and back of tracery behind

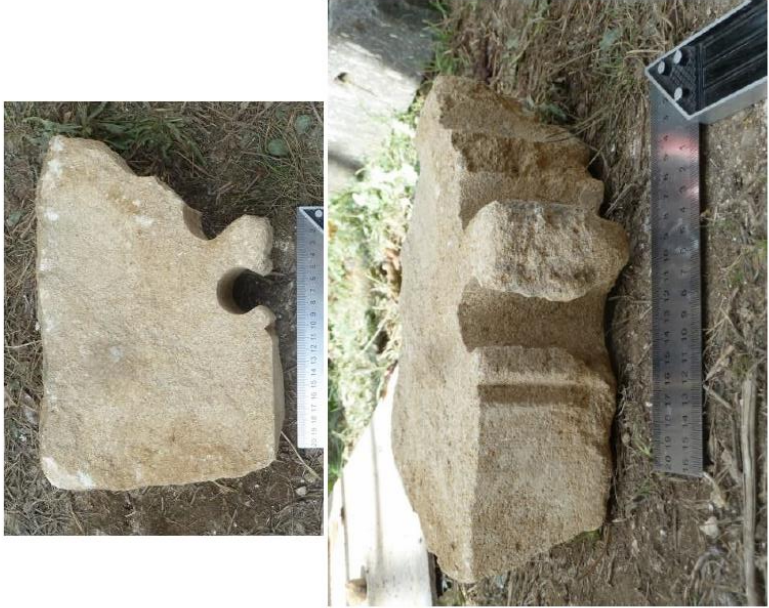
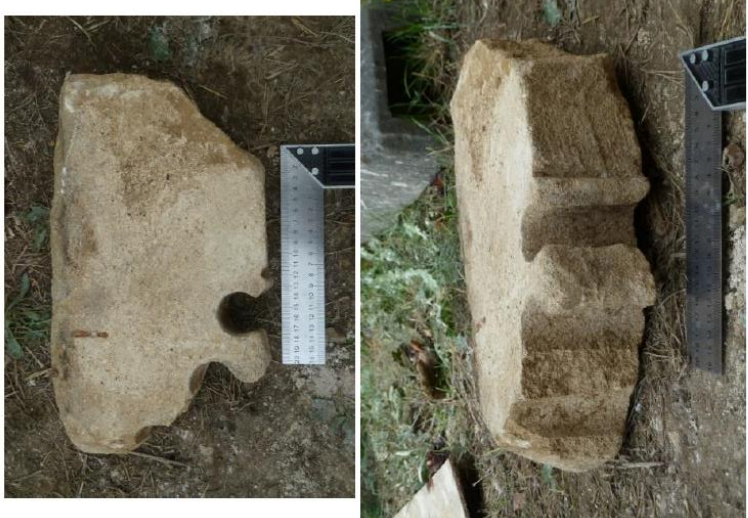
SITE Peterborough Cathedral Precincts	STORE Rebuilt into wall	CONTEXT NO Wall 17 (Bishop's Palace Garden east wall)	SMALL FIND/OLD NO	STONE NO Wall 17 / ST 1
DESCRIPTION Voussoir Complex mouldings, with, from soffit, ¾ roll and two fillets, roll and hollow, broken off ?roll, hollow, broken off ?fillet				
CONDITION Average	COMPLETENESS Incomplete	DIMENSIONS H 97 W 193 D 285 mm	STONE TYPE Barnack	
STONE FINISH Ashlar	MASONS' MARKS	KEYING

TOOL MARKS	MISCELLANEOUS	ATTACHMENTS		
PLASTER	MORTAR	REUSE	Turned round and reused south of lancet 3 from N end	
INTERPRETATION Originally part of wall arcade of east wall of medieval refectory. Reused after disuse of refectory during making good of wall into garden wall				
COMPARISONS Same as Wall 17 / ST 2	OBJECT DATE mid-13th-century	ORIGIN Medieval refectory		
DRAWINGS 1:1 profile (composite with ST 2)	PHOTOS ✓	DATE AND INITIALS JLH 09/09/2016

SITE Peterborough Cathedral Precincts	STORE Rebuilt into wall	CONTEXT NO Wall 17 (Bishop's Palace Garden east wall)	SMALL FIND/OLD NO	STONE NO Wall 17 / ST 2
DESCRIPTION Voussoir Complex mouldings, with, from soffit, ¾ roll and two fillets, roll and hollow, broken off ?roll, hollow, fillet				
CONDITION Average	COMPLETENESS Incomplete	DIMENSIONS H 92 W 200 D 342 mm	STONE TYPE Barnack	
STONE FINISH Ashlar	MASONS' MARKS	KEYING

TOOL MARKS	MISCELLANEOUS	ATTACHMENTS		
PLASTER	MORTAR	REUSE Turned round and reused south of lancet 3 from N end		
INTERPRETATION Originally part of wall arcade of east wall of medieval refectory. Reused after disuse of refectory during making good of wall into garden wall				
COMPARISONS Same as Wall 17 / ST 1	OBJECT DATE mid-13th-century	ORIGIN Medieval refectory		
DRAWINGS 1:1 profile (composite with ST 1)	PHOTOS ✓	DATE AND INITIALS JLH 09/09/2016
