Peterborough Cathedral

Bishop's Gate and No. 25 Minster Precincts

A Report on a Programme of Archaeological Observation and Recording.

Planning Reference Numbers: 13/00520/FUL & 13/00521/LBC
Scheduled Monument Consent Ref: S00058886
Archaeological contractor's Site Code: PCKC

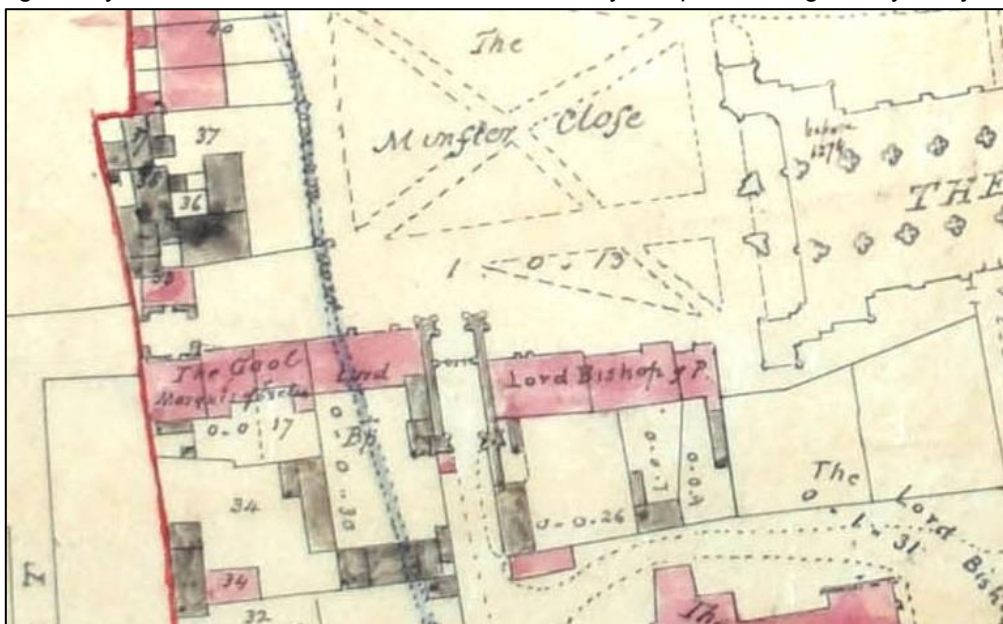
Figure 5
Tracing of an 1822 map (possibly the Enclosure Map) by J. T. Irvine (PCCHER image 1158)
It shows the three-part division of what is now Nos 24–25, east of the Bishop's Gate

In the 19th century, the boundaries between the two properties were subject to change: in 1822 a map shows a division into three, while the 1862 map (Figure 6), shows the range divided into two, but with the drawing room belonging to No. 24 rather than to No. 25 as it does today.

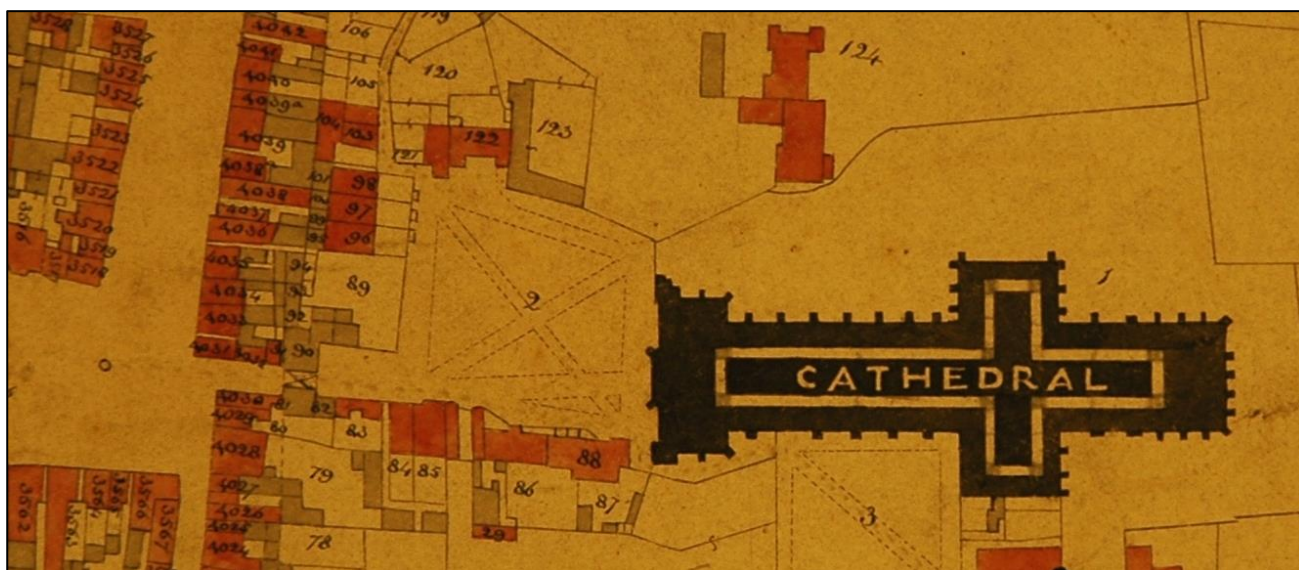
Figure 6
Part of George Smith's map of 1862 (PCCHER image 1160)

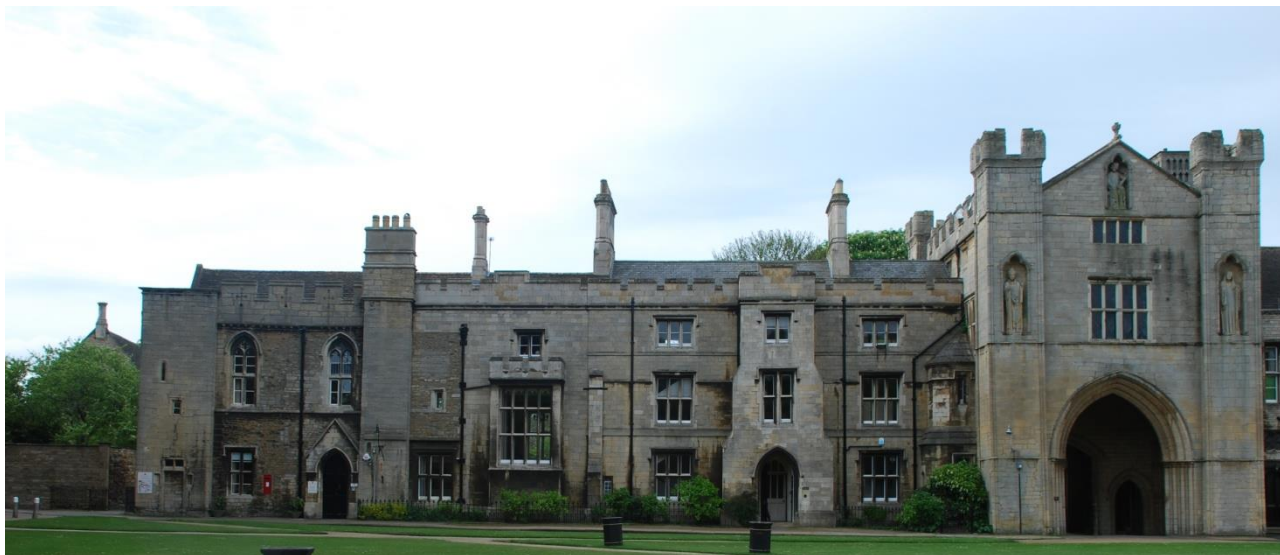
Plate 1
Nos. 24–25 Minster Precincts and Bishop's Gate.
Photograph: Jackie Hall

The gateway was originally three storeys high, with crenellated turrets at each corner, and three statue-filled niches on each of the north (Plate 1) and south walls. The ground floor passage was vaulted in three bays with a cross wall, separating vehicular and pedestrian access, one bay south of the Galilee Court.

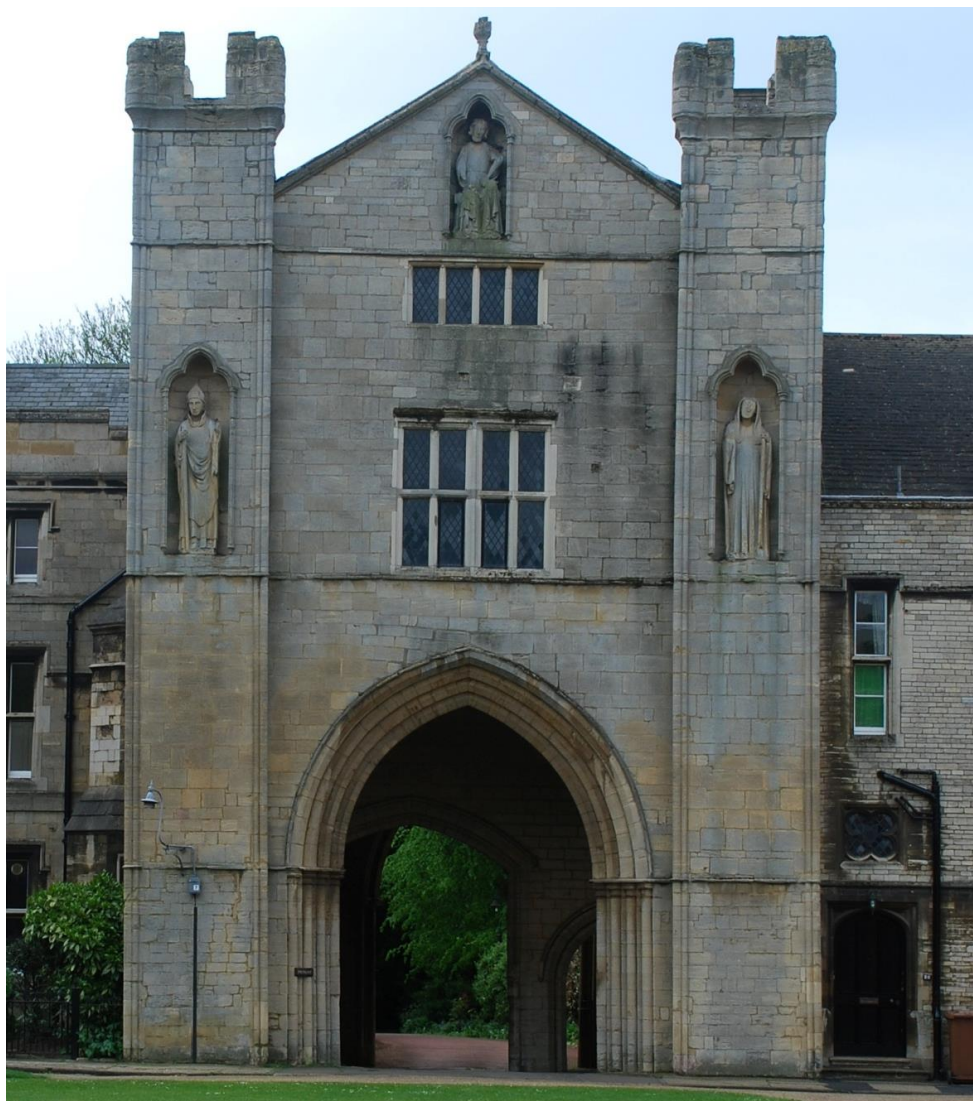
Plate 2
Bishop's Gate, north elevation.
Photograph: Jackie Hall

The aim of the scheduled works was to re-cover the roof, carry out minor but essential masonry repairs, especially at parapet level, and clean and shelter-coat the statues (Plates 2 and 3). On the interior, the poor quality 1970s fittings were removed, a new access made into No. 25, everything made good, and underfloor heating laid below a new floor (on top of the existing floor), in order to make the chamber fit for use as a function room again.

Although close-up inspection highlighted areas of surprisingly poor coursing for such a high status building, most of the points can be made by careful examination of Plates 2 and 3. As noted (Section 1.4.1), the lower part of the gatehouse may belong to 1214–22, as documented by the abbey's chronicler. On the north elevation and part of the south elevation at least, this is characterised by fairly small ashlar blocks and shallow courses. The triple shafts on the turret corners were clearly carved separately and are rarely coursed either with the plain walling of the turrets, or with the main arches of the gateway.

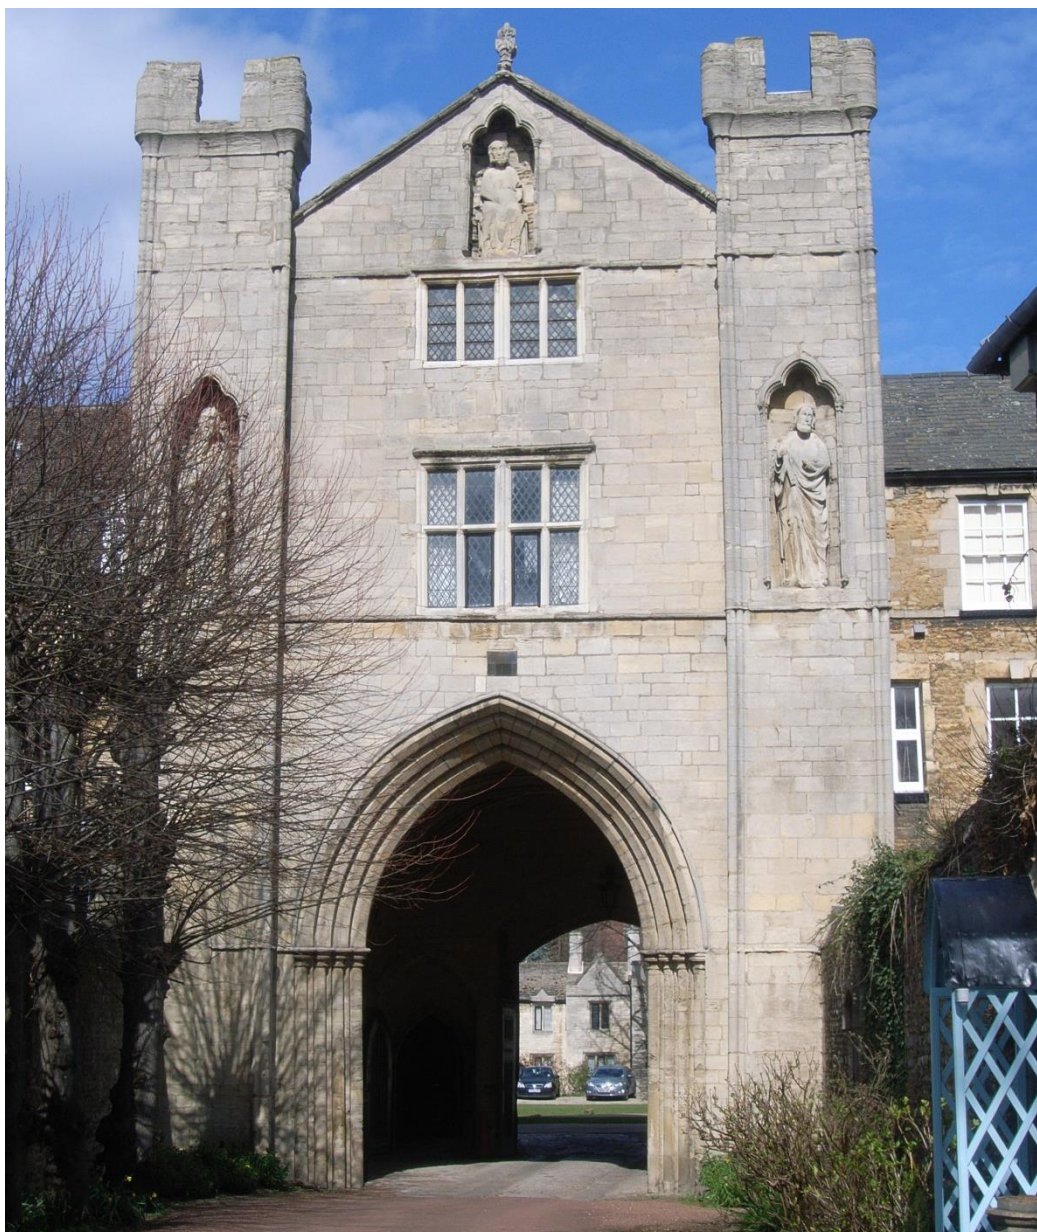
Plate 3
Bishop's Gate, south elevation.
Photograph: Jackie Hall

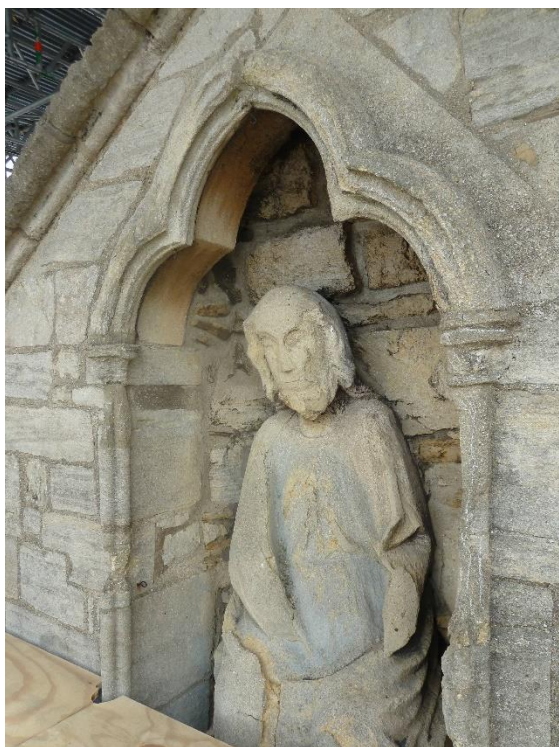
Plate 4
(Archive image PCKC 421)
Knights' Chamber. Upper statue, south elevation (St Peter)
Photograph: Jackie Hall

The niche of St Peter (top, south) is the most disorderly, with a mixture of poorly coursed weathered Barnack ashlar and coursed rubble. The statue is also very badly damaged with the top of the head and parts of the front replaced in mortar (as well as missing hands, something which afflicts all the statues). The triple shafts at the front are also badly damaged compared with the other niches, and the whole area around the niche is messy and badly coursed (also see section 2.2.2). Thus, not only was the back of the niche rebuilt, but it seems likely that the front of the niche with a large area of adjoining masonry was rebuilt at the same time.

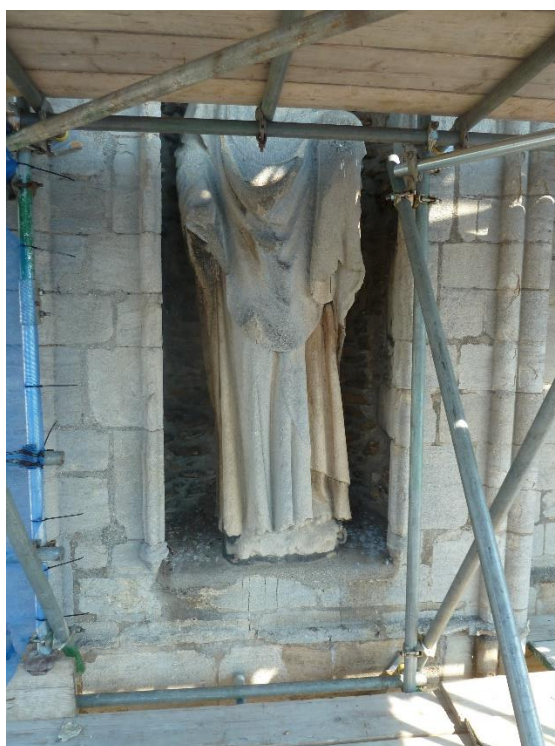
Plate 7
(Archive image PCKC 477)
Knights' Chamber. Left statue, south elevation (St Paul)
Photograph: Jackie Hall

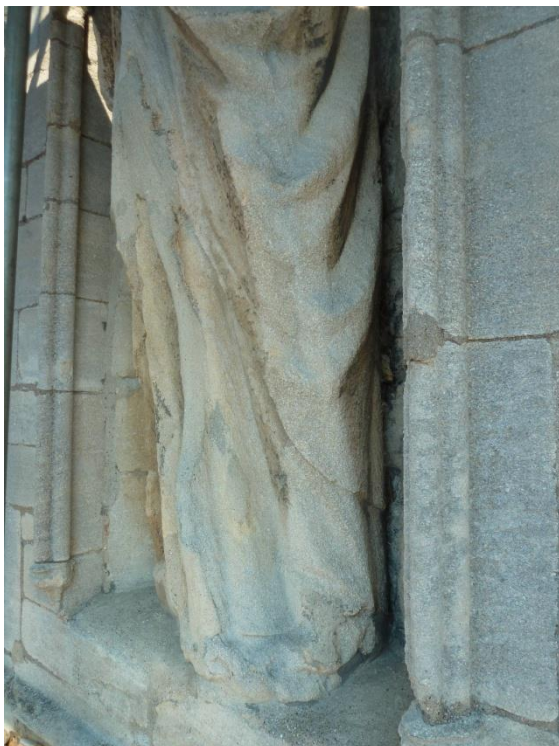
Plate 10
(Archive image PCKC 494)
Knights' Chamber. Right statue, south elevation
(St Andrew)
Photograph: Jackie Hall

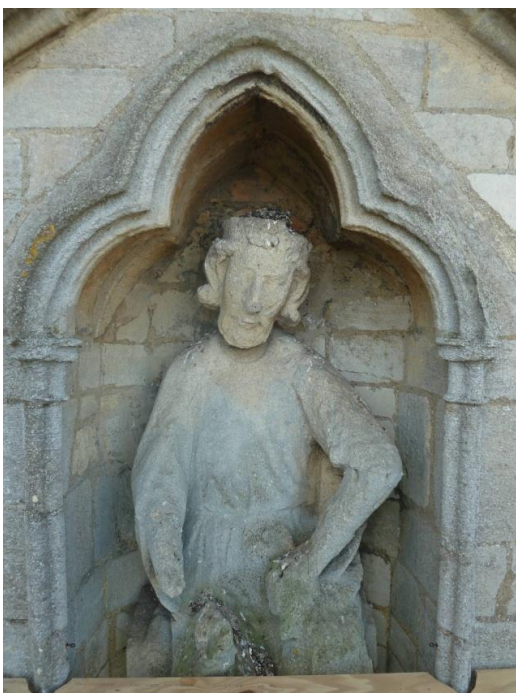
Plate 11
(Archive image PCKC 556)
Knights' Chamber. Upper statue, north elevation (king)
Photograph: Jackie Hall

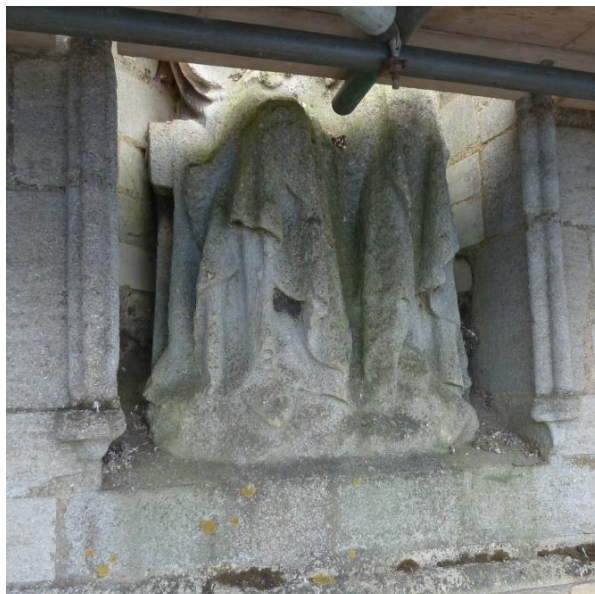
Plate 12
(Archive image PCKC 565)
Knights' Chamber. Upper statue, north elevation (king)
Photograph: Jackie Hall

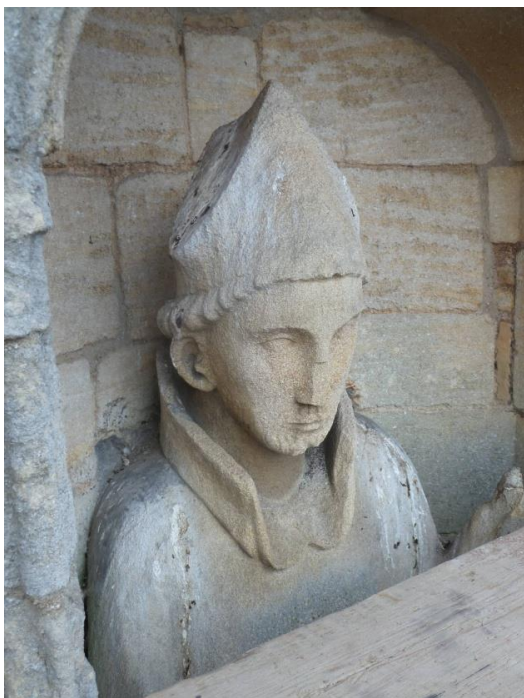
Plate 13
(Archive image PCKC 736)
Knights' Chamber. Right statue, north elevation (Bishop)
Photograph: Jackie Hall

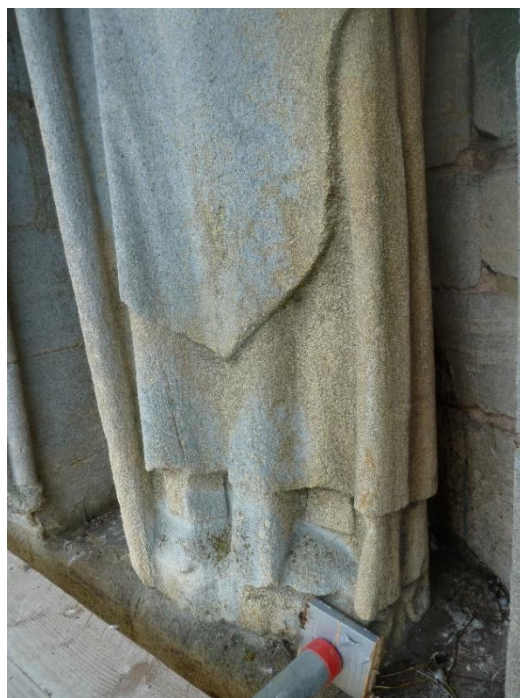
Plate 14
(Archive image PCKC 747)
Knights' Chamber. Right statue, north elevation (Bishop)
Photograph: Jackie Hall

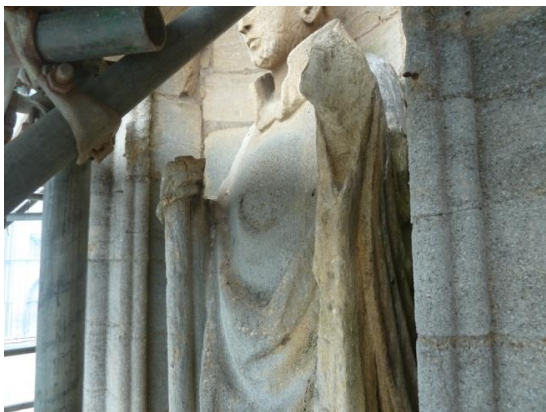
Plate 15
(Archive image PCKC 743)
Knights' Chamber. Right statue, north elevation
(Bishop)
Photograph: Jackie Hall

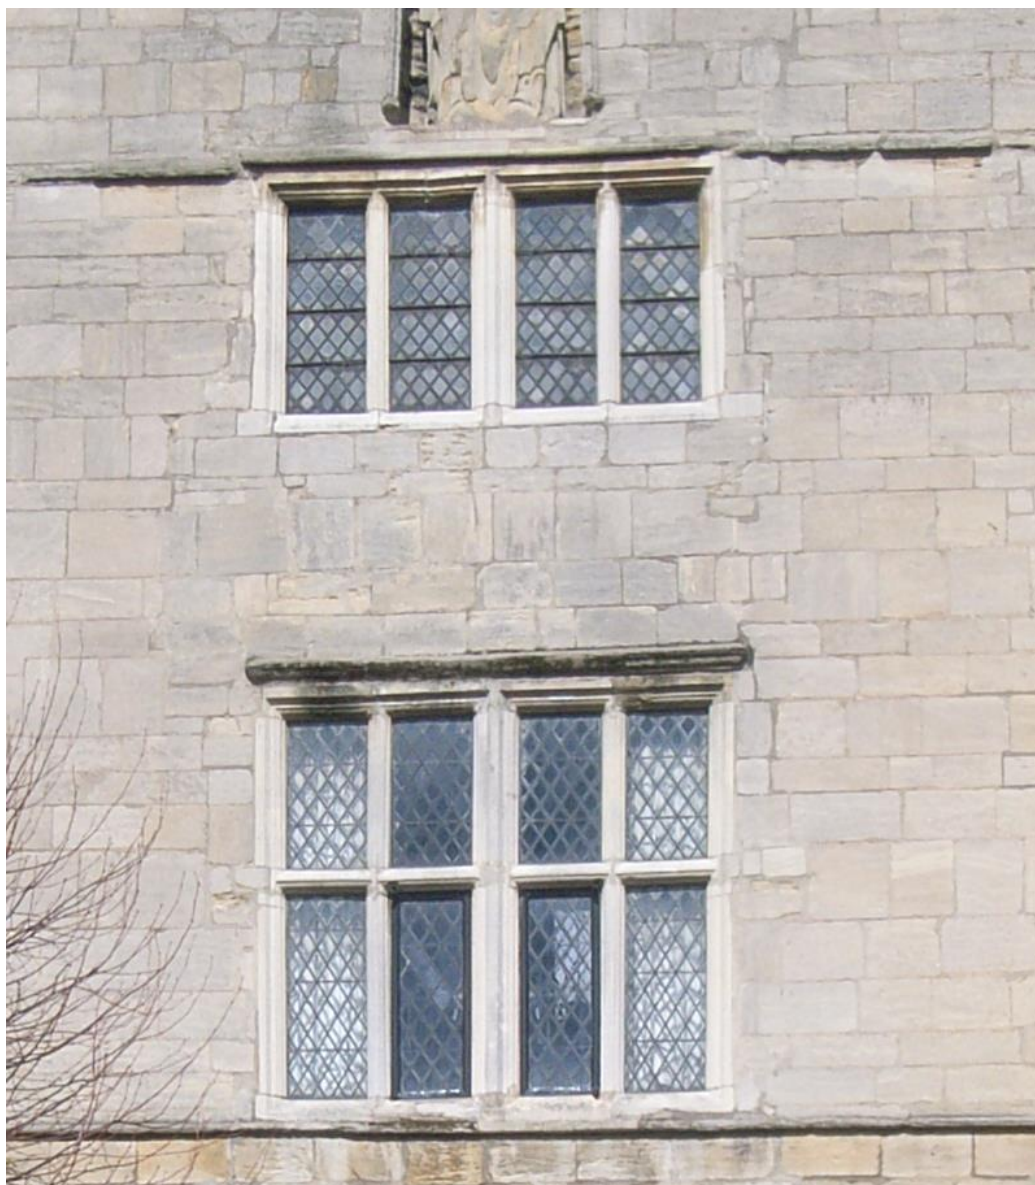
Plate 19
Knights' Chamber. Close up of windows in south elevation, showing the blocking of
the medieval window
Photograph: Jackie Hall

medieval coursing, except where blocking has had to be added between the new windows and the line of the old traceried window in the south wall (Plate 19). The 17th-century upper window on the south side has been blocked on the interior, and further blocked windows of the same date were seen in the east wall (Plate 33).

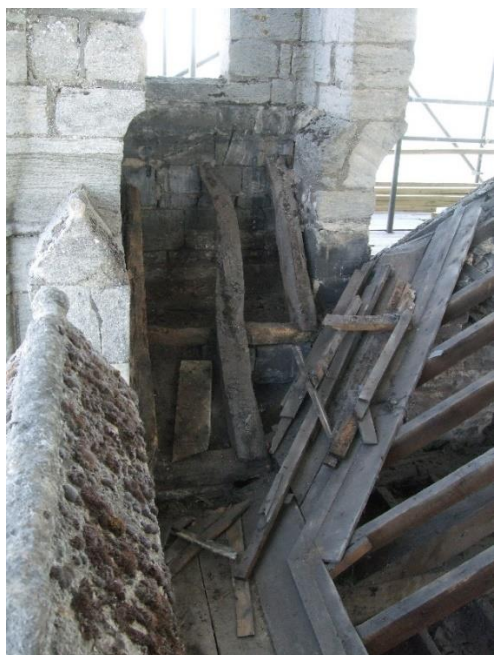
Plate 20
(Archive image PCKC178)
Knights' Chamber. North-west turret, with
old timbers
Photograph: Caroline Atkins

Three of the turrets (north-east, north-west, and south-west) were found to still have ancient oak timbers, propped to create lean-to roofs (Plates 20–23). They may well date from the construction period of the gateway but, in the absence of any carpentry joints or structure, this cannot be confirmed; they are unlikely to contain enough rings for tree-ring dating.

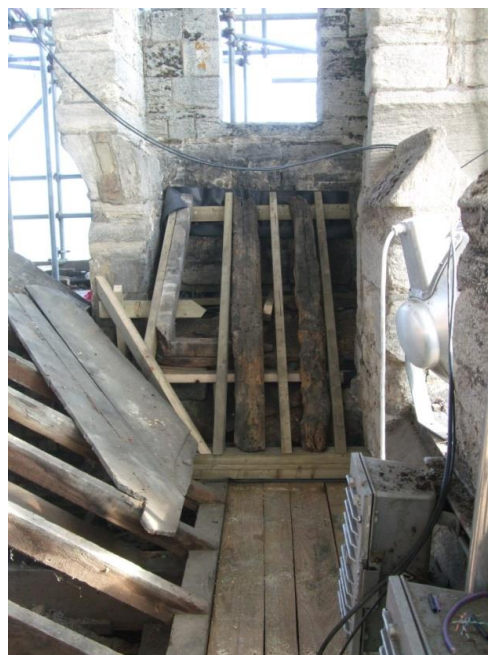
Plate 21
(Archive image PCKC 224)
Knights' Chamber. North-east turret, with old
and new timber
Photograph: Caroline Atkins

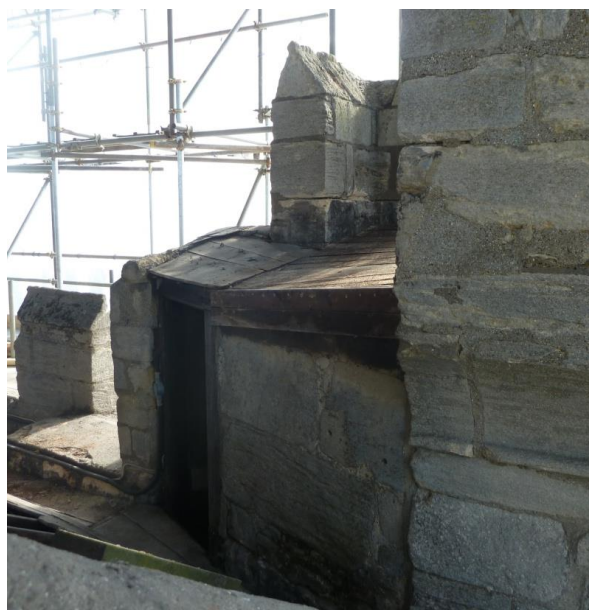
Plate 22
(Archive image PCKC 224)
Knights' Chamber. South-east turret, with exit for
stair
Photograph: Jackie Hall

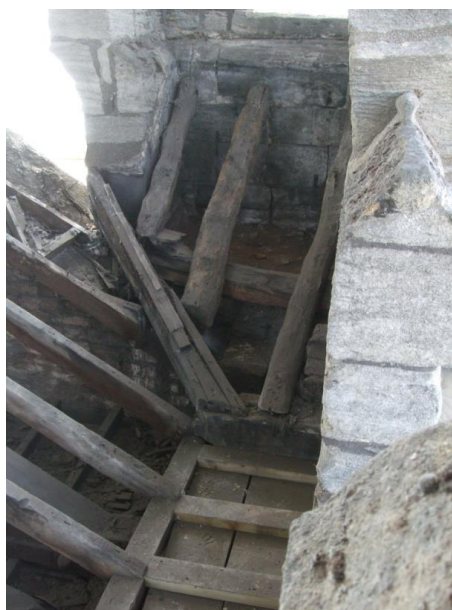
Plate 23
(Archive image PCKC 177)
Knights' Chamber. South-west turret, with old
timbers
Photograph: Caroline Atkins

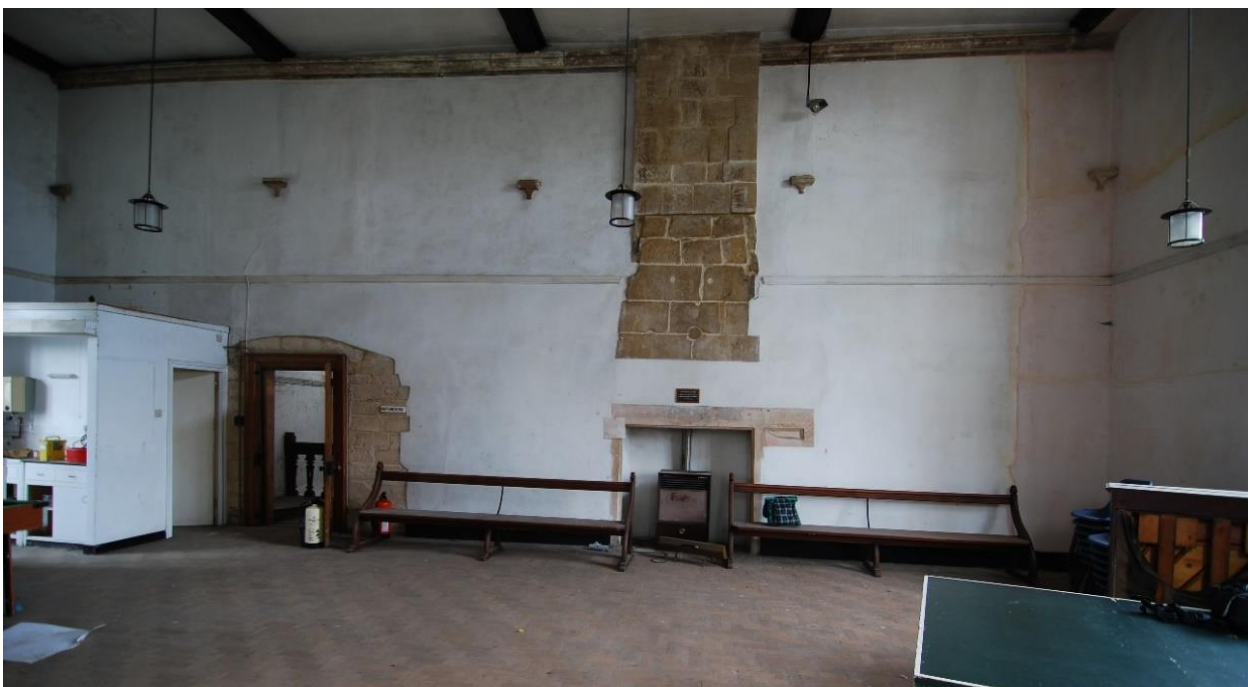
Plate 24
(Archive image PCKC 677)
Knights' Chamber. West wall, showing chimney, corbels and upper cornice
Photograph: Jackie Hall (2012)

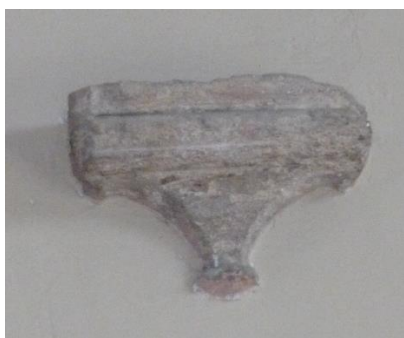
Plate 25
(Archive image PCKC 689)
Knights' Chamber. Corbel from series on east side
Photograph: Jackie Hall

Although there is no trace of the original main roof, there are clues in the interior in the first floor chamber (Plate 24). Both the east and the west walls have five evenly spaced small corbels (Plate 25), top c.4.45m from the floor (note – this is the old floor; the new floor is higher). Although it was not possible to view them close up, or take a moulding profile, they do appear to be both medieval in origin, and of a suitable date for the documented date of Abbot Godfrey's gatehouse. They are not big enough to take joists for an intervening floor level, and are also rather too high for this function. They could, though, have taken the wall posts of an early hammer beam roof (the earliest known is 1290, in Winchester).

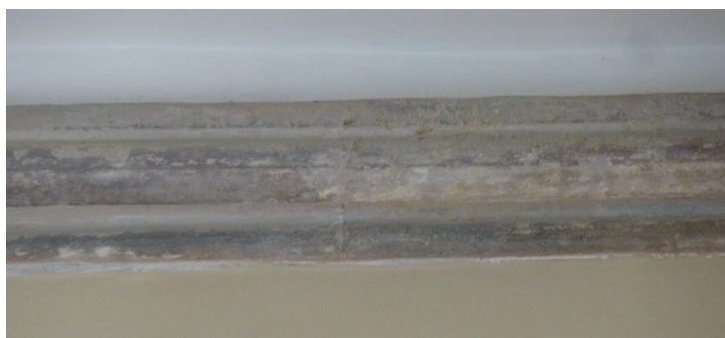
Plate 26
(Archive image PCKC 690)
Knights' Chamber. String/cornice on east side
Photograph: Jackie Hall

This solution has not been proposed before, almost certainly because of the deep, and deeply projecting, stone string-course/cornice at the top of the east and west walls (Plate 26), which would interrupt the junction of wall post and hammer beam. Again, close examination was not possible in the course of the project but, viewed from the floor and from zoomed in photographs, the moulding, with its large central keeled roll, is more reminiscent of a mid-13th-century moulding than a string-course or cornice of any date. This reuse (for more, see below) can explain the general unevenness of the cornice; although they might be jambs, they might also

We have already suggested that the string-course/ cornice (Plate 26) may, in fact, be reused mid-13th-century jamb/voussoir/vault rib and that this string interrupts the medieval wall posts of a hammer beam roof. It thus indicates the replacement of that roof (section 2.2.4). This is likely to have happened at the same time as other major changes, such as the floor insertion; the removal of the hammer beams and arch braces would have increased the available walking space in the upper floor. It is not likely that this quantity of material would be available in the 19th century (the next period of major change), but it could have been available in the century

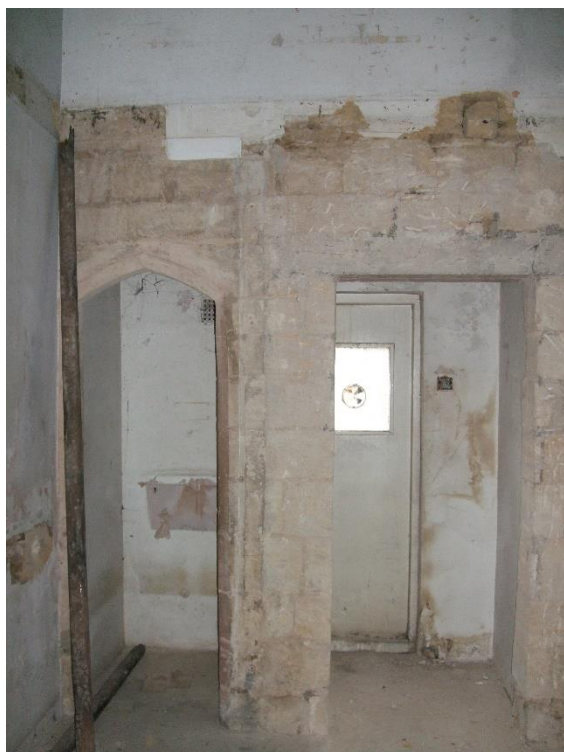
Plate 27
(Archive image PCKC 191)
Knights' Chamber. Doorways at south end of west wall; medieval to left and modern to right
Photograph: Caroline Atkins

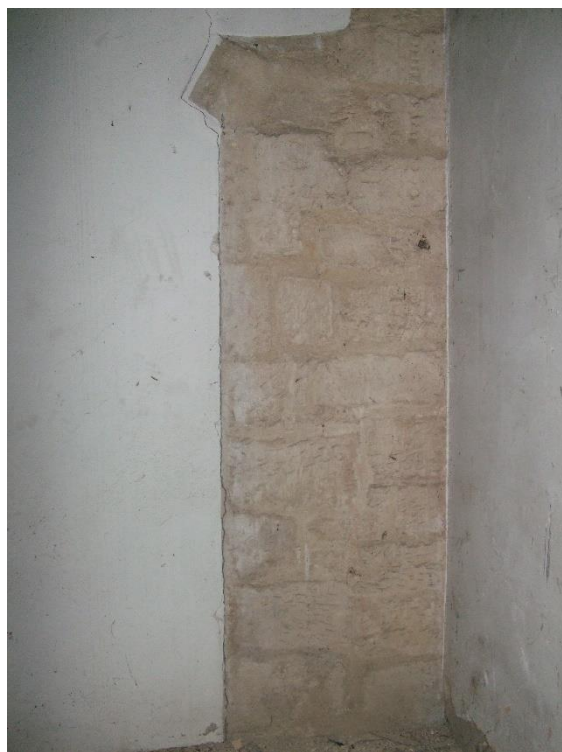
Plate 28
(Archive image PCKC 194)
Knights' Chamber. Remnant of blocked doorway at south end of east wall, once leading to a vice
Photograph: Caroline Atkins

One jamb and part of the arch of a very similar, or even identical, doorway can be found in the east wall, although not tight to the corner (Plate 28). This would have been angled through the wall, leading to a small spiral stair or vice, which is now only accessible from a higher level (see section 2.3.1).

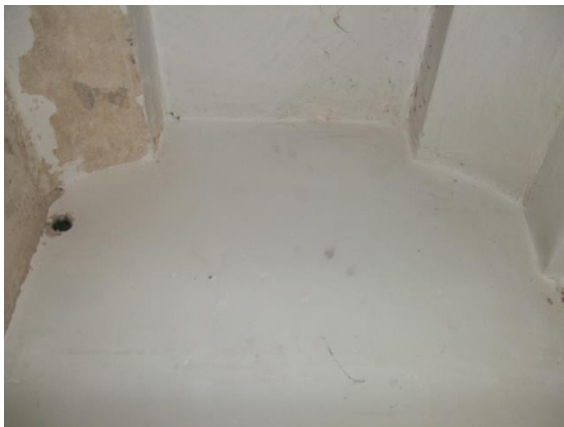
Plate 29
(Archive image PCKC 205)
Knights' Chamber. Shouldered arch of chamber in south-west turret
Photograph: Caroline Atkins

The two northern turrets are not accessible from the interior; the walls are plastered over and we cannot currently know what the medieval arrangements were. In the south-west corner, a fine narrow medieval doorway survives with a pointed segmental arch, the arch and jambs having plain chamfers (Plate 27). The little chamber behind is ceiled with a shouldered arch (Plate 29). There is no evidence of steps, and it seems probable that this turret might have been a garderobe or cupboard.

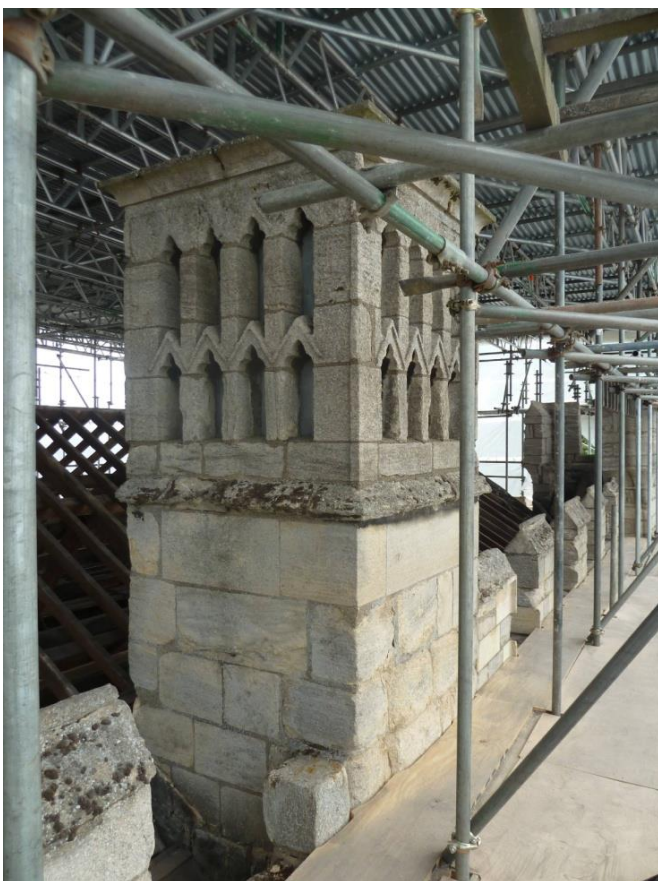
Plate 30
(Archive image PCKC 627)
Knights' Chamber. The chimney at
parapet level, looking south-east
Photograph: Jackie Hall

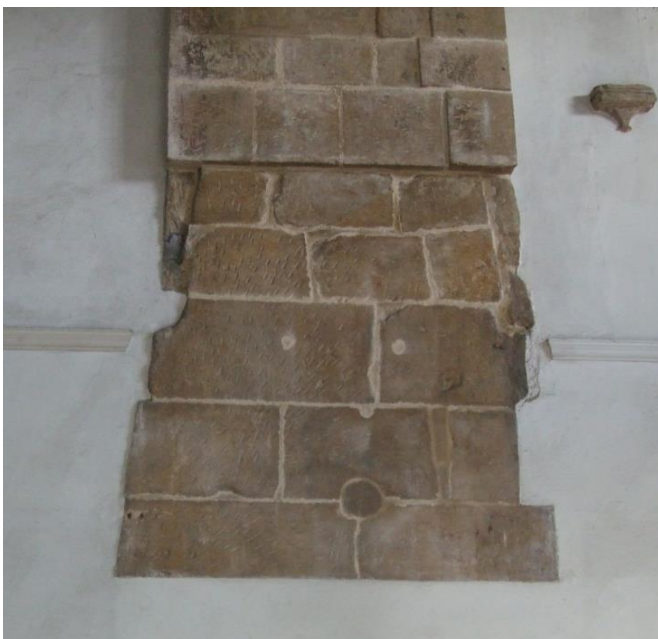
Plate 31
(Archive image PCKC 048, detail)
Knights' Chamber. Detail of chimney
flue, showing cut-back top of fireplace
canopy with reused stones blocking
flue below
Photograph: Caroline Atkins

The external chimney is mirrored on the interior by the continuation of the flue for seven courses below the ceiling, and then by two courses that end in slightly sloping sides to the north and south. This must represent the very top of a sloping fireplace canopy, cut back for the insertion of a post-medieval fireplace, and with reused stone used for enclosing the flue below (Plate 31). A fireplace of similar date and arrangement once

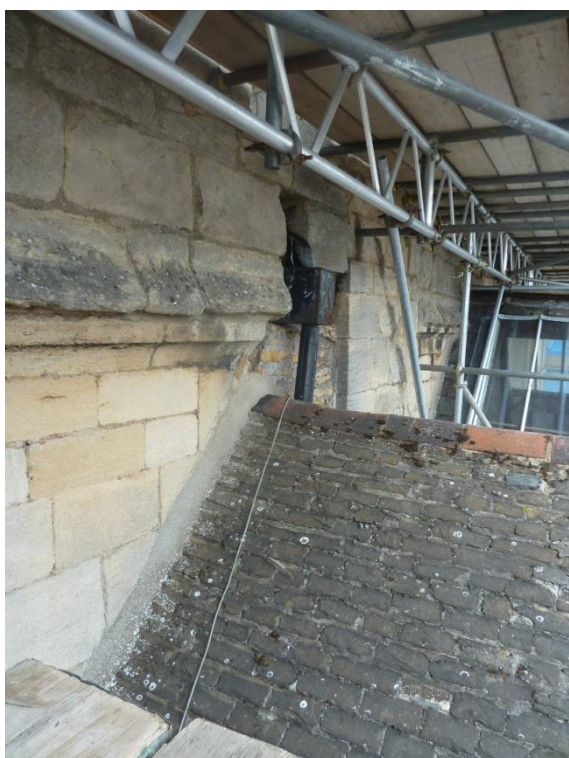
Plate 32
(Archive image PCKC 533)
Knights' Chamber. West side below parapet,
showing sloping projecting weathering course
integral with wall
Photograph: Jackie Hall

On the west elevation of the gateway, between two roofs of No. 26, a sloping integral weathering course, for an adjacent roof, could be glimpsed from the scaffolding, showing that a range already existed here in the early 14th century (Plate 32). Given that the west end of the range (No. 28, next to the Norman Gateway, the principal entrance into the precincts) probably dates from the early 13th century, this is not a surprise (see PCCHER 80098 for No. 28). No roofline is visible externally on the east side of the gate, because the roofline of No. 25 has clearly been raised. It is not clear which roofline is medieval on the east side, but on both sides, there is ashlar at this high level, as opposed to the coursed rubble of the interior in the adjoining range to the east at ground floor level (section 3.4). It is possible that this is indicative of different choices in the 13th century, when the lower part was built, and in the 14th century, when it was completed.

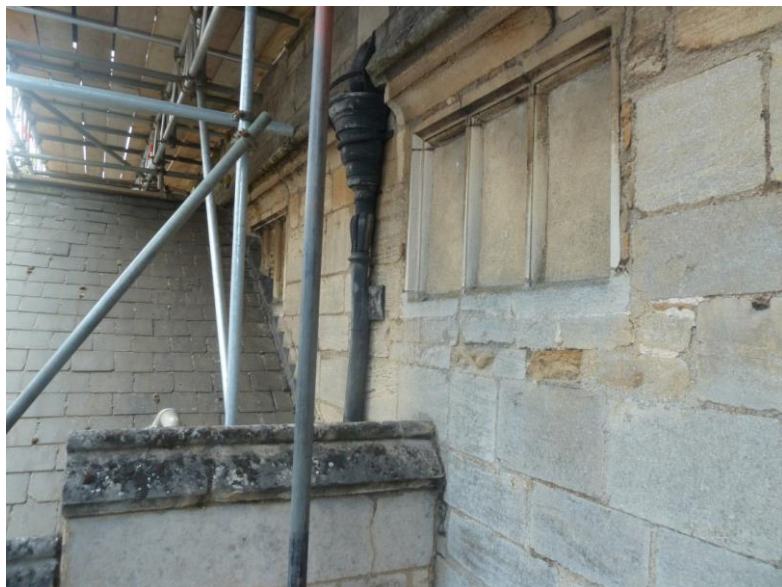
Plate 33
(Archive image PCKC 585)
Knights' Chamber. East side
below parapet on north side of No.
25, showing two blocked windows
Photograph: Jackie Hall

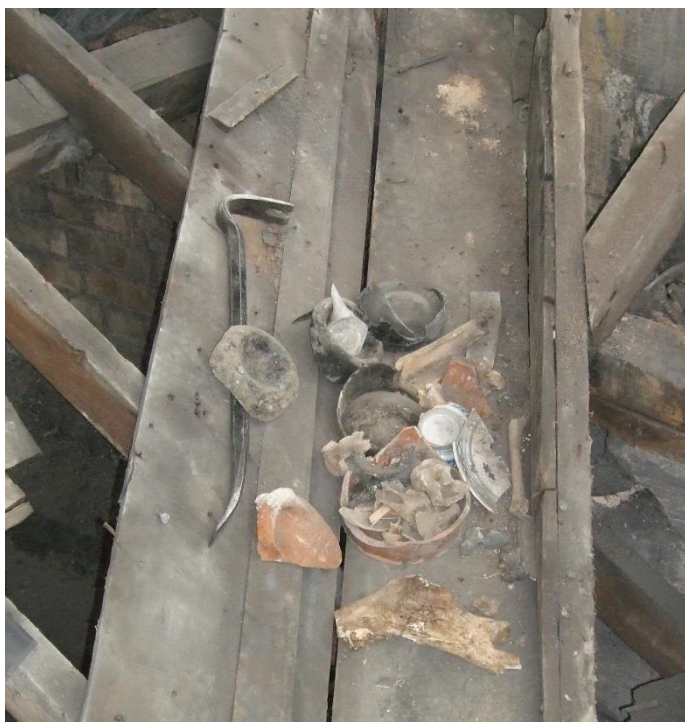
Plate 36
(Archive image PCKC 135)
Knights' Chamber. Assemblage of finds
discovered in north-east turret
Photograph: Caroline Atkins

The contractors retrieved a substantial assemblage of finds from within the north-east turret, during the repairs (context 926; Appendix C; Plate 36). Thirteen fragments of glass were found, all from bottles or other vessels, including three from imported 18th-century mineral water bottle/s, and 8 from green bottles also all probably 18th-century; one of them may have been an alembic, used for small scale distillation, perhaps pharmacological. The pottery covers a similar range, with nine fragments of a single redware jar, only very broadly dated (mid-16th-century–1800); tin-glazed earthenware from a plate (six sherds) and a bowl (late-16th–mid-19th-century); and three sherds of Staffordshire white salt-glazed stoneware from a teapot and saucer, closely dated to 1720–80. Additionally, there were 19 bone fragments, mostly cattle, but also pig and sheep/goat, many with butchery marks (see Appendices).

This does not seem to be an assemblage relating to building work – an alembic and a teapot and saucer in particular being odd things to bring to a building site; mineral water would also be a surprising choice for a builder of this period. This suggests instead that in the 18th century, there was some access from the upper floor into the roof of the turret (via the parapet, perhaps) or, alternatively, the builders of the next roof came across this odd collection of rubbish and deposited it there, rather than taking it to ground level. Either way, the assemblage is indicative of the occupation of the upper floor of the building, rather than any stage in its construction.

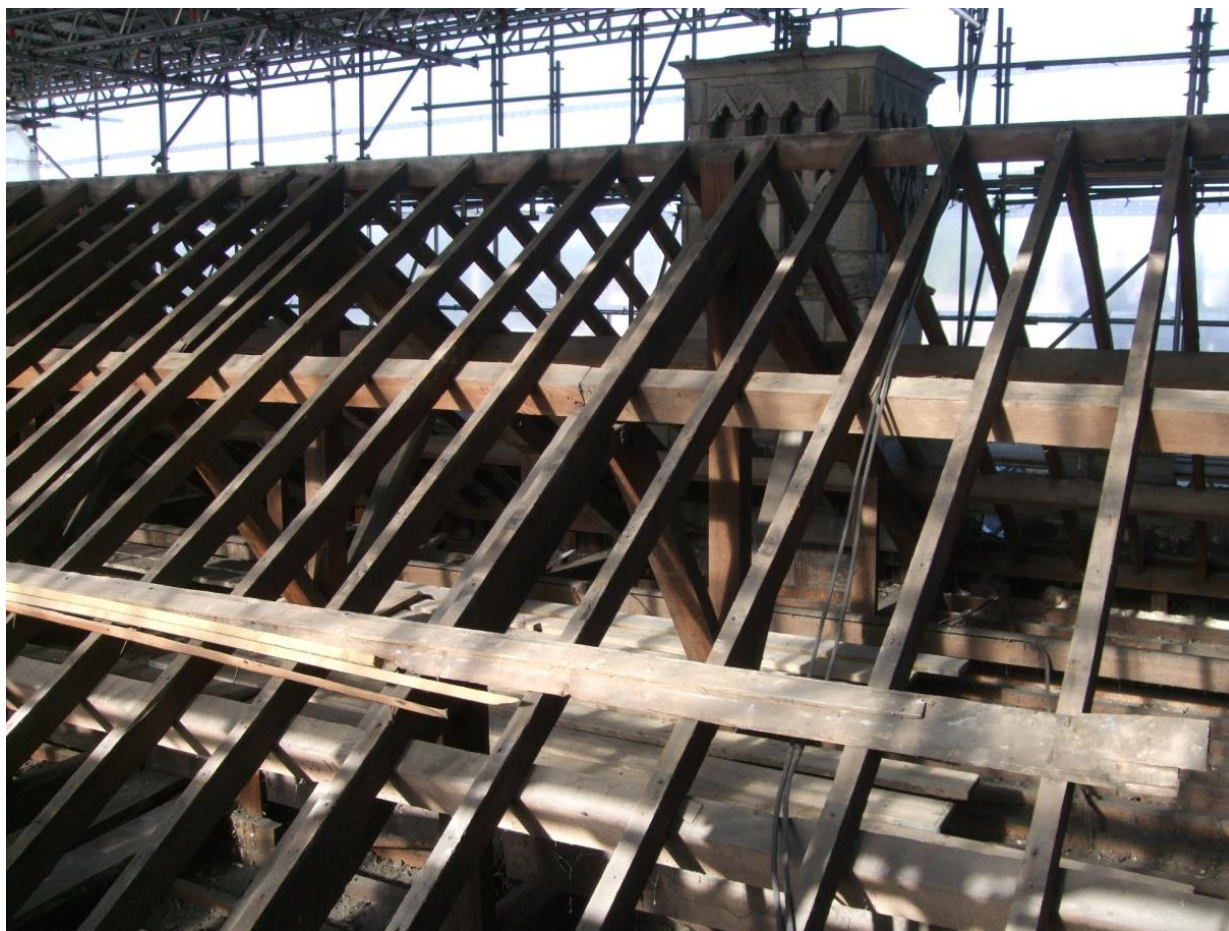
Plate 37

The extant roof is a complete replacement (Plates 37–39). It is a standard kingpost roof with a shouldered kingpost; the sawn quality, the very modern appearance of the carpenter's marks and the use of oak and pine (Hugh Harrison, pers com, but based on photographs, not personal inspection), all suggest a date in the 19th century. At the same time as the roof was constructed, the inner face of the south gable wall was largely rebuilt in handmade pink-red bricks (c.215 x 105 x 61). These are very similar to the bricks found in every dividing wall that was revealed by the 2015 works in No. 25 (section 3.7). Tentatively, this may suggest that the roof was replaced at a similar time to major changes to No. 25, when it was being converted from a basically medieval building to a basically 19th-century one, perhaps between 1822 and 1862, when map evidence shows considerable change to the plan form and property boundaries (section 1.4).

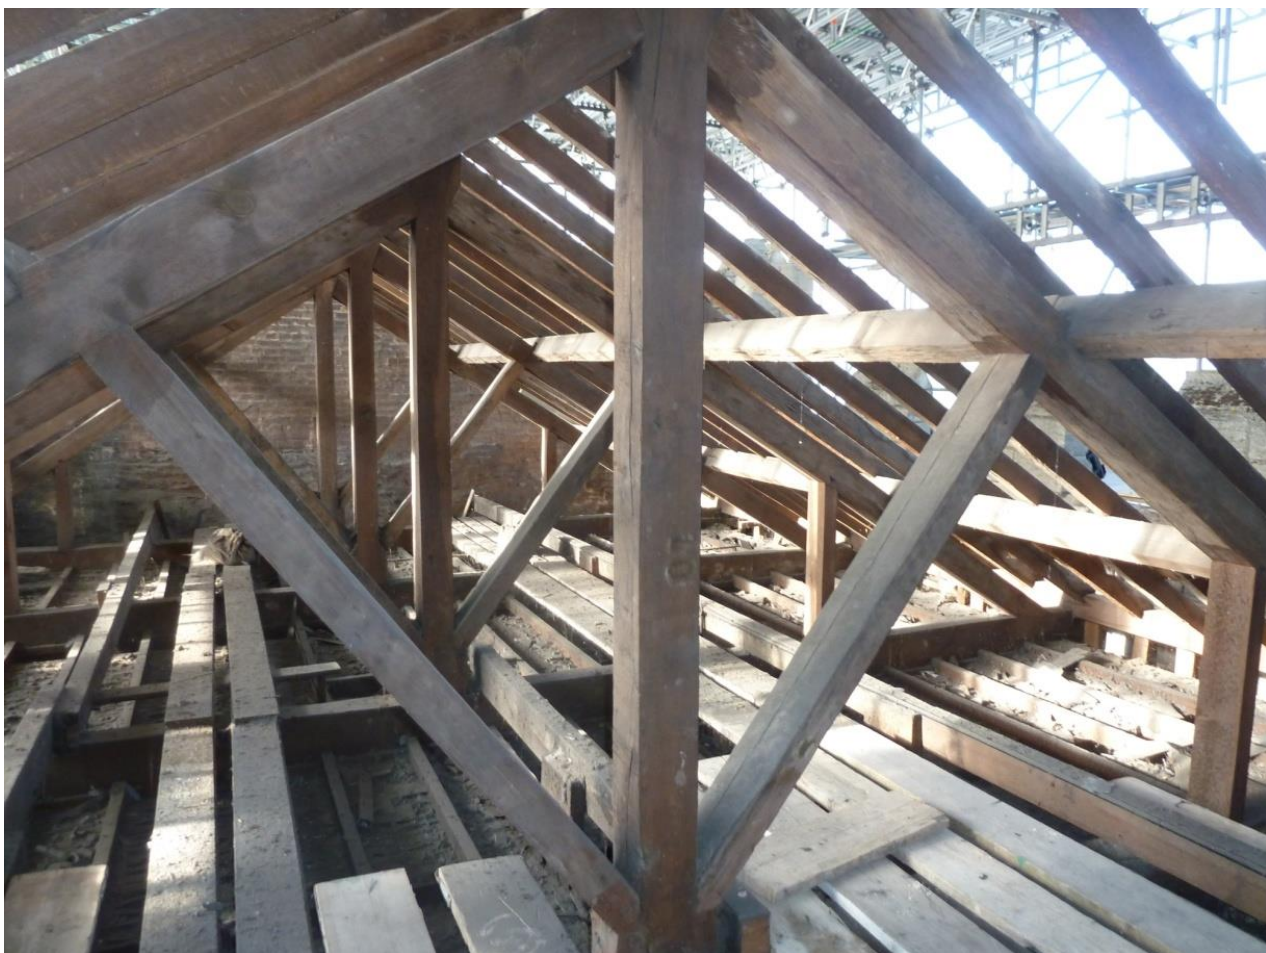
Plate 38
(Archive image PCKC 638)
Knights' Chamber. View of the roof, looking south-south-west.
Photograph: Jackie Hall

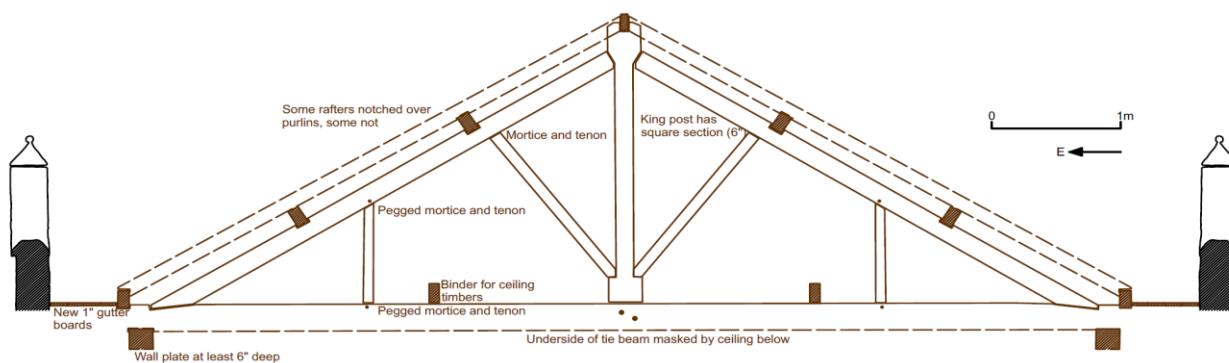
Figure 7
Knights' Chamber, diagrammatic drawing taken from east side of truss 3 (counting from north); RHS mirrored

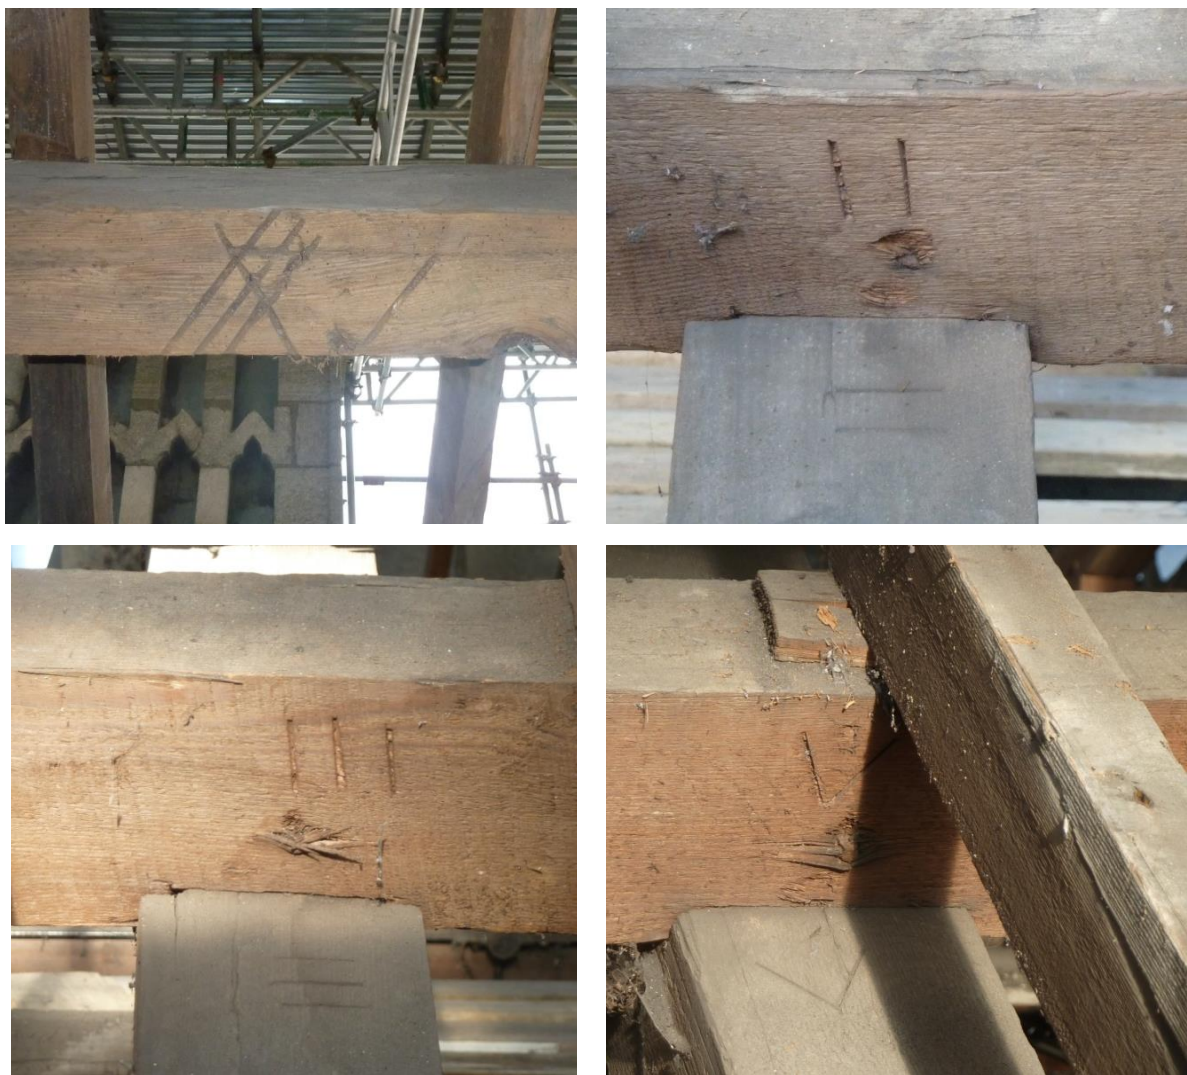
Plate 39
(Archive image PCKC 637, 645, 646, 648)
Knights' Chamber roof: selection of carpenter's marks on trusses
Photographs: Jackie Hall
