Peterborough Cathedral

Bishop's Gate and No. 25 Minster Precincts

A Report on a Programme of Archaeological Observation and Recording.

Planning Reference Numbers: 13/00520/FUL & 13/00521/LBC
Scheduled Monument Consent Ref: S00058886
Archaeological contractor's Site Code: PCKC

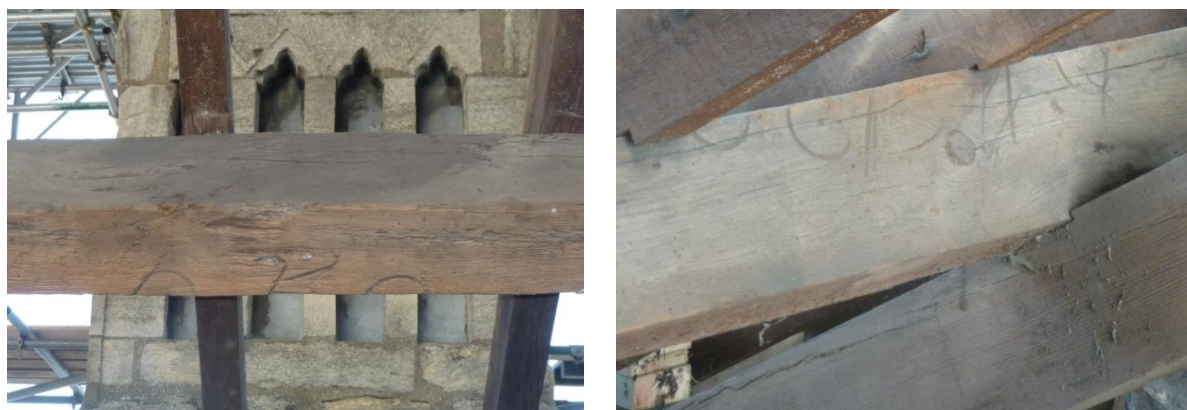
More random marks were also observed, and these may be cargo marks, or marks from a timber yard (Plate 40).

Plate 40
(Archive image PCKC 641, 643, detail)
Knights' Chamber roof: probable cargo marks
Photograph: Jackie Hall

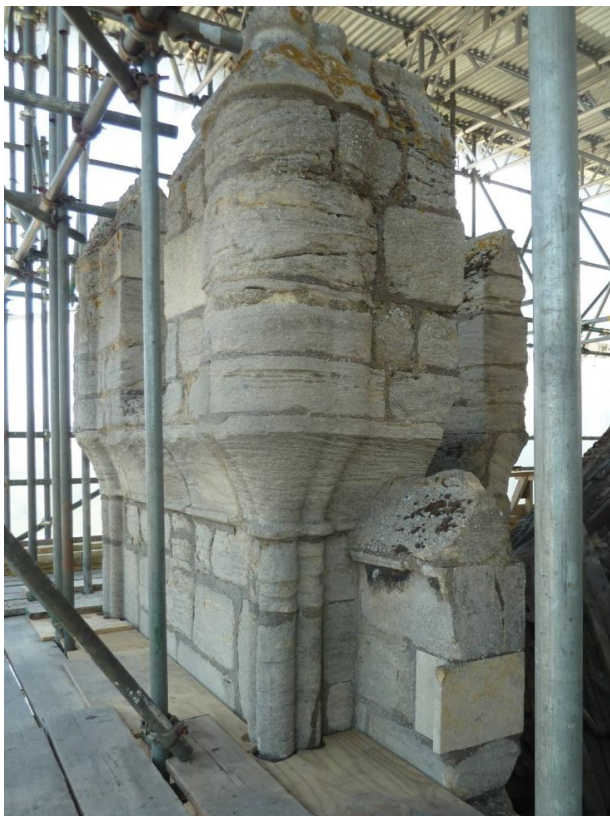
Regular replacement of weathered stone has clearly taken place, notably at parapet level (Plate 41). There appear to have been at least two phases, one using King's Cliffe (finely oolitic, slightly stripy), perhaps contemporary with the roof replacement (it was used in the west front in the 1820s) and one using Clipsham, very similar to the original Barnack. Due to the limited time, it was not possible to record the repairs in any detail.

Plate 41
(Archive image PCKC 495)
Knights' Chamber. Parapet level (north-west turret) with replaced stones clearly visible
Photograph: Jackie Hall

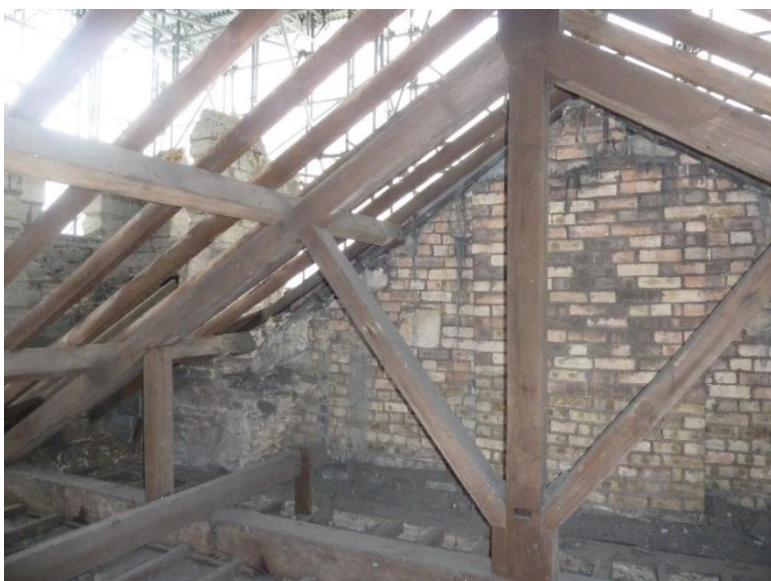
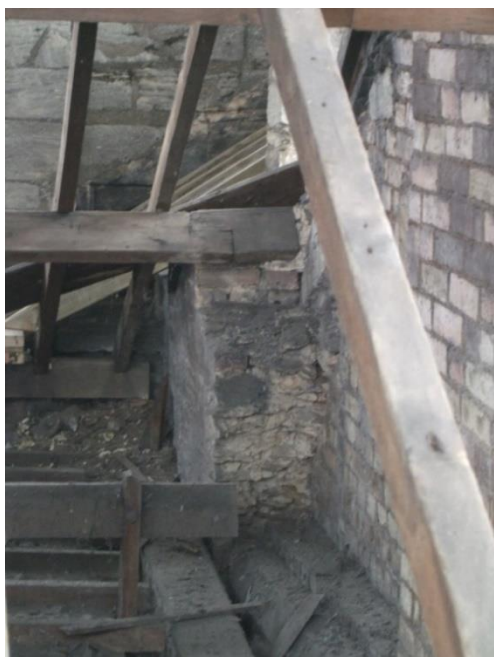
Plate 42
(Archive image PCKC 631)
Knights' Chamber roof space, view of north gable with new brickwork
Photograph: Jackie Hall

Plate 43
(Archive image PCKC 217)
Knights' Chamber roof space, detail
showing thinning of north gable and
extension of purlin
Photograph: Caroline Atkins

At some point in the 20th century, major repairs were made to the north gable wall. The inner (south) elevation was considerably thinned, then refaced with bricks; the purlins of the roof were extended to make up the space (Plates 42–43). The northernmost rafters were twisted at the bottom to make good the gap there. This narrowing of the gable wall implies that its coping has also been replaced, or recut.

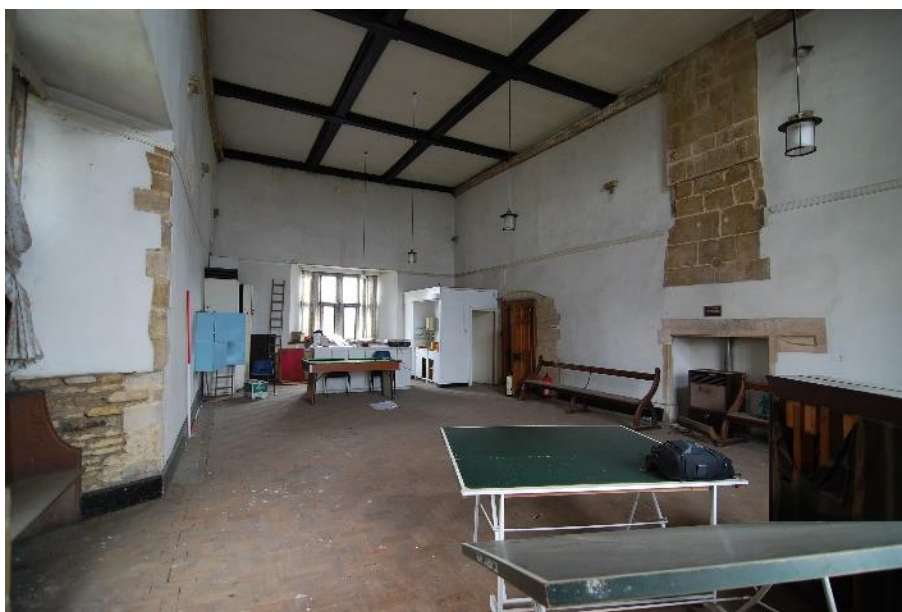
Plate 44
(Archive image PCKC 674)
View of Knights' Chamber in 2012, looking SSW, with kitchen unit/ toilet in SW corner and other
remains of its life as a youth club
Photograph: Jackie Hall

A plaque above the fireplace on the west side of the room commemorates the opening of the Knights' Chamber in April 1970 by the Bishop of Peterborough, following its restoration by the Guild of Centurions. At this time, or afterwards, the chamber was used as a youth club, with a kitchen area and toilet at the south end (Plate 44).

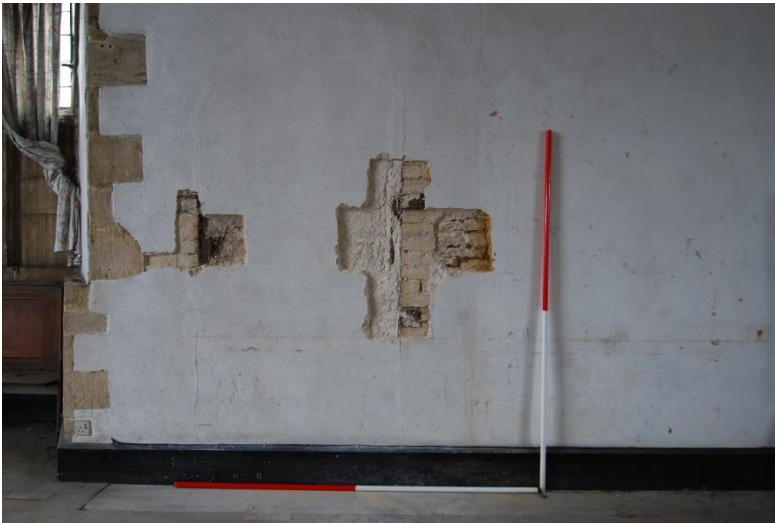
Plate 45
(Archive image PCKC 680)
Knights' Chamber. East wall,
investigation into earlier
doorway leading to No. 25
Photograph: Jackie Hall

On 28th February 2012, investigations were made on the east side of the Knights' Chamber, just south of the window (Fig 2), where marks in the plaster suggested the earlier presence of a door (Plate 45). This confirmed the existence of the door, showing it to have brick jambs against the coursed rubble of the medieval wall.

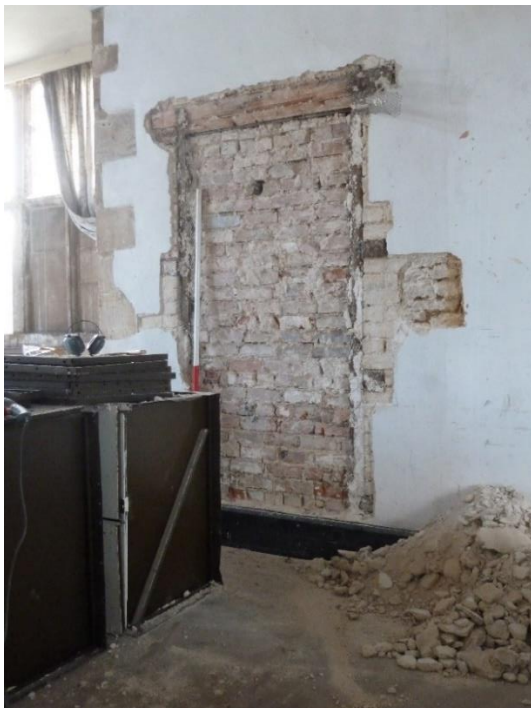
Plate 46
(Archive image PCKC 665)
Knights' Chamber. East wall, blocked door
Photograph: Jackie Hall

On this basis, permission (SMC) was given to break through, which happened in June and July 2015 (Plates 46–47). The former opening was shown to be 1.00m wide and 2.31m high, with modern brick jambs, pale buff to pink. Oddly, the blocking was made of rather older, handmade, bricks (c. 215 x 103 x 64 mm), mostly buff but some pink, covered in a thick layer of lime mortar. Given the similarity of these bricks with those used in the partitions of No. 25, it is probable that the blocking took place during a rearrangement of the upper rooms (perhaps to update the bathrooms). The brick blocking was clearly laid from the east, in No. 25, where its appearance is much neater.

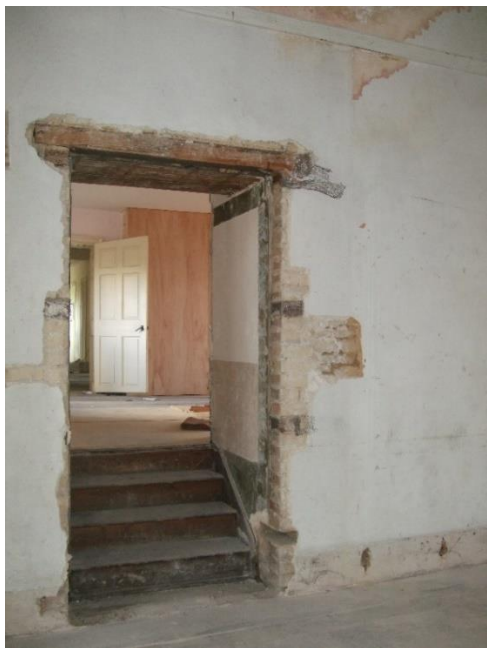
Plate 48
(Archive image PCKC 040)
Knights' Chamber. East wall, door after blocking removed, showing steps
Photograph: Jackie Hall

When the blocking was removed, the four steps (total height 0.70m) leading upwards into the top floor of No. 25 were clearly visible, as was the timber lintel and metal bracing (Plate 48). The new (2015) door occupied the same space.

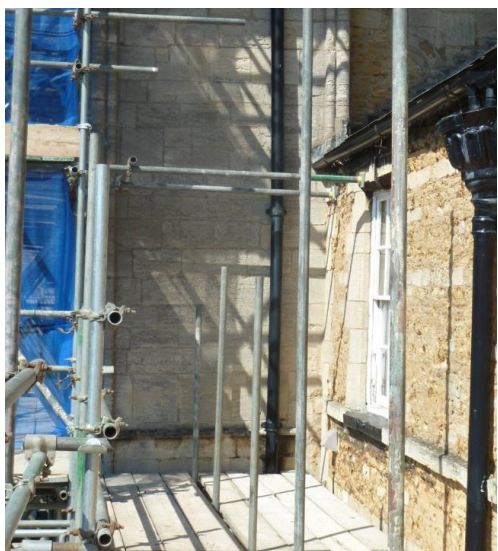
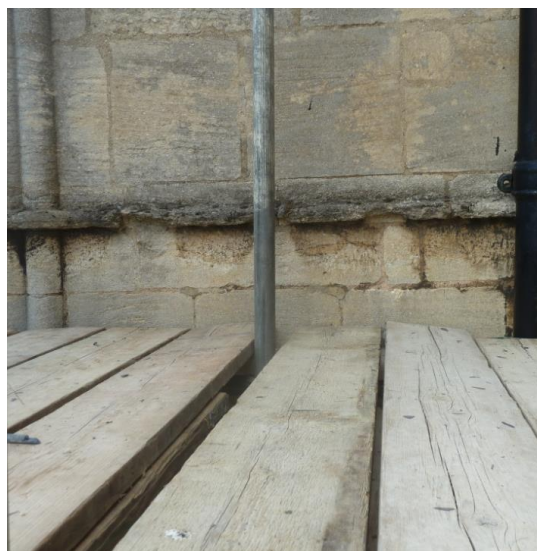
On the east side of the Knights' Chamber, below the middle string-course on the south-east turret, four shallow, rough timber sockets were observed. Almost certainly, they were for some sort of extension to No. 25. There is no evidence of date, but a relatively recent date seems likely.

Plate 49
(Archive image PCKC 460, 463)
Knights' Chamber. East wall of south-east turret, showing rough sockets below string-course
Photographs: Jackie Hall

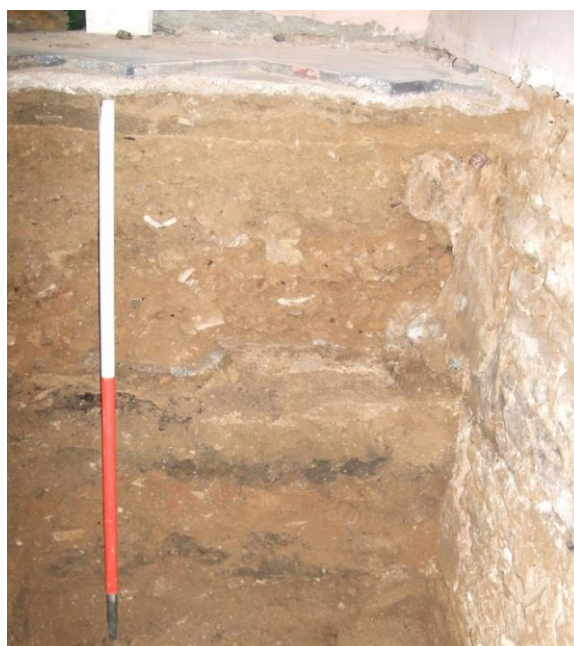
Plate 51 (right)
(Archive image PCKC 010)
Trial Pit 1: N-facing section
Photographs: Caroline Atkins

A small collapse of the upper part of the south side of TP1 exposed (and was no doubt caused by the presence of) a right-angled projection from the gate's east wall. The projection itself (Figure 8, context **915**) had been truncated and was evidenced by only two stones (Plate 51), although more are likely to exist behind the trench section. Stones in the east elevation of the gate wall (**914**), each more than 16cm high (commonly 19cm), and equivalent to at least two courses in the adjacent wall face (Plates 52 and 53), increase the total evidenced

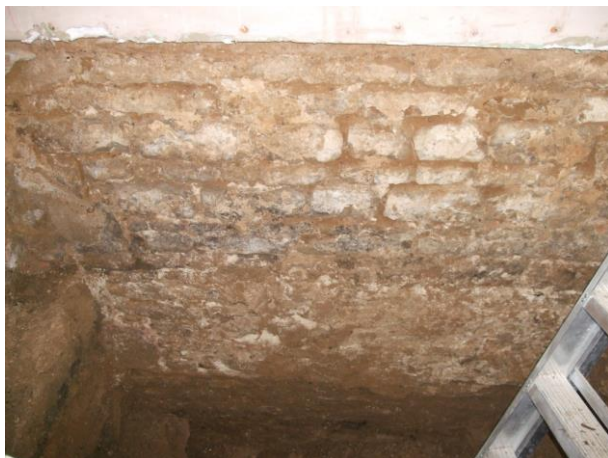
The earliest feature exposed in TP1 was the east elevation of the east wall of the Bishop's Gate (Figure 8, **912** and **914**; Plate 52) which, contrary to expectation, given the ashlar face visible above the roof of No. 25, was found to consist of very roughly cut stones, albeit neatly coursed.

Plate 52
(Archive image PCKC 015)
Trial Pit 1: Bishop's Gate E wall, E elevation.
Photograph: Caroline Atkins

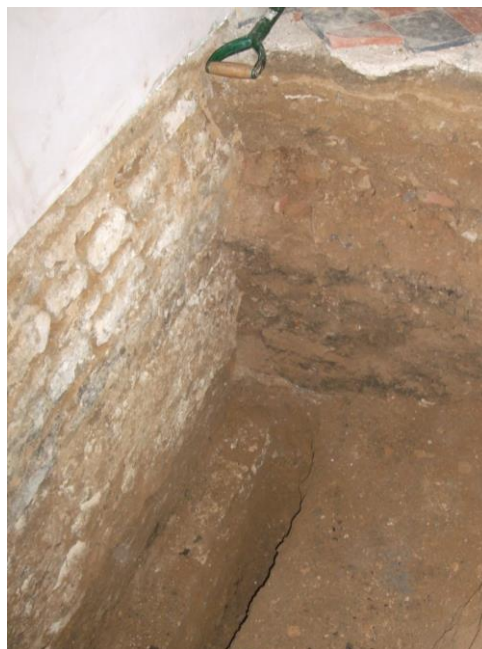
Plate 54

The buried part of the Bishop's Gate east wall is a very substantial piece of masonry, whether measured from our modern ground surface or from the ground surface intended when it was built. The wall's footing (Plate 54) is offset by an average of 13cm and its depth is in excess of 50cm (the limit of excavation in TP1 was 6.43m OD, and the footing's lower limit was not exposed). Ordinarily, it might be reasonable to assume that the top of the footing was intended to lie immediately beneath the medieval ground surface but it appears more probable that bulk deposit **911** represents a final stage in the construction programme, and that the footing offset was intended to be an average of 23cm below the finished ground or floor level at this point.

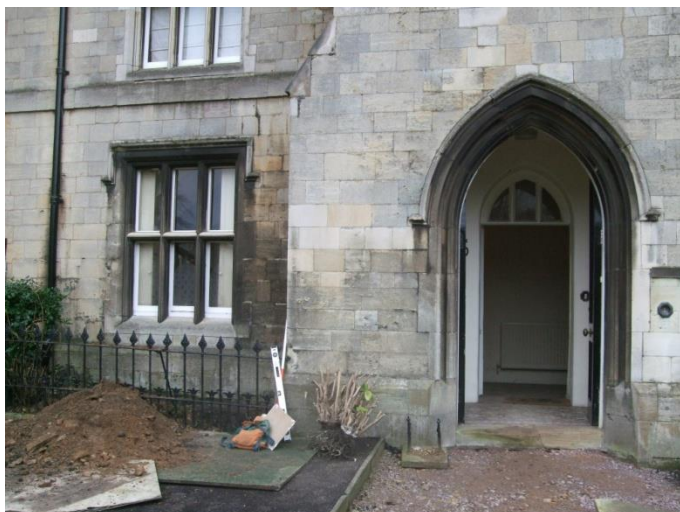
Trial Pit 2, 0.40m N/S by 1.05m E/W by a maximum of 0.95m deep, was located against the north face of the north wall of No. 25 (Figure 2 and Plates 55 and 56), with its west end 1.95m to the east of the external plinth of the east wall of the porch. The whole of this trench was excavated on the 7th January, by hand, by men working for John Lucas Ltd., and periodically inspected, cleaned and recorded by the archaeologist on the same day.

Plate 55
 (Archive image PCKC 029)
 Trial Pit 2: location to the east of the porch.
 Photograph: Caroline Atkins

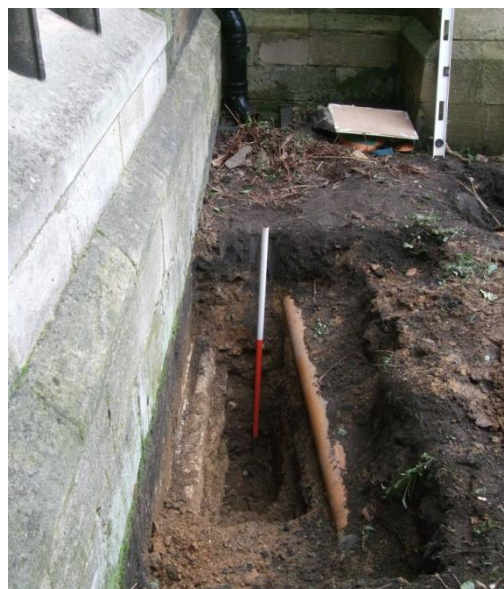
Plate 56
 (Archive image PCKC 016)
 Trial Pit 2: the offset footing.
 Photograph: Caroline Atkins

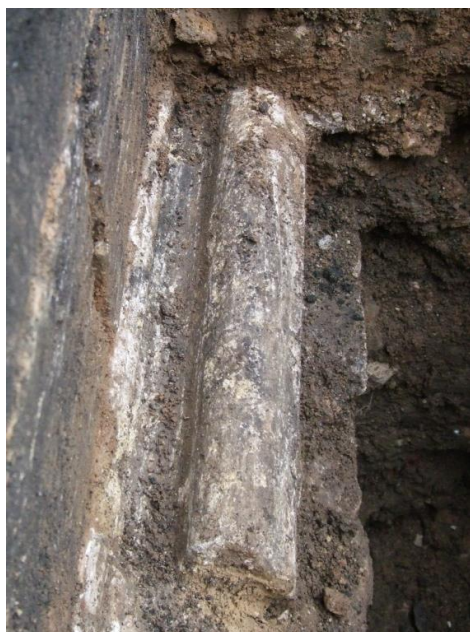
Plate 57
 (Archive image: PCKC 025)
 Trial Pit 2: top of offset footing.
 Photograph: Caroline Atkins

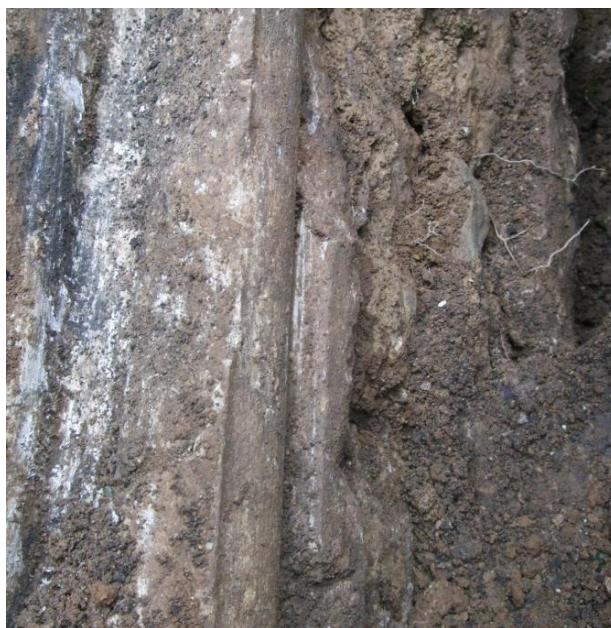
This trench was severely limited in width by the presence of a plastic drain pipe (Plate 56) which ran roughly parallel to the north wall of No. 25, but it was nevertheless possible to expose the bottom of the rubble-stone wall footing, 0.65m below its top, which was offset from the face of the plinth by a maximum of 14cm. This footing, which was the earliest feature exposed in TP2, has a capping course of reclaimed mouldings (Plates 57 and 58). Only one length of moulded stone in this top course is in anything like a good condition, the remainder having been damaged during or following their reuse in the footing. The reused stones have a large central keeled roll (the keel mostly missing), which is strongly reminiscent of the mouldings reused as a cornice inside the Knights' Chamber (sections 2.2.4 and 2.3.2).

Plate 58
 (Archive image: PCKC 026)
 Trial Pit 2: keeled moulding capping offset footing.
 Photograph: Caroline Atkins

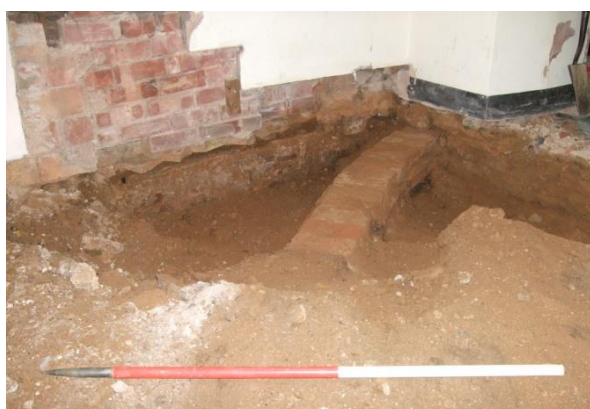
Plate 59

Within the initial 400mm-deep area, which was completely excavated before the lift foundation design was changed, only two features of interest were exposed. The first of these was a breather for the kitchen range (Plate 59), running from the existing range position roughly mid-way along the kitchen's east wall to the NW corner of kitchen and through the north wall (Plate 60). Standard rectangular bricks (230 x 115 x 63mm) had been used for the cap and the channel walls and purpose-made bricks (235 x 165 x 100mm) with a semi-circular channel moulded in their tops (below right) had been used for the channel base. The breather channel was full of soot.

Lift Foundation Trench: NW corner of the kitchen showing the intact range breather.

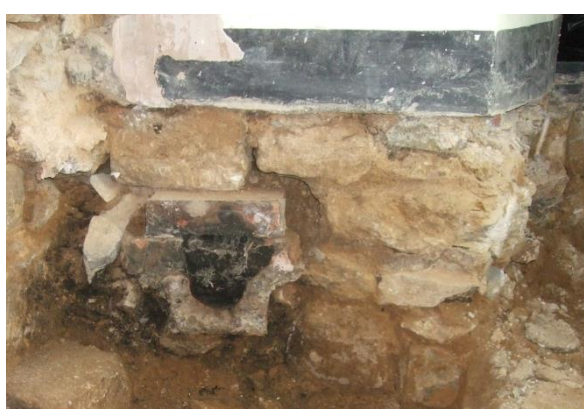
Plate 60

Lift Foundation Trench: NW corner of the kitchen showing the range breather in section.

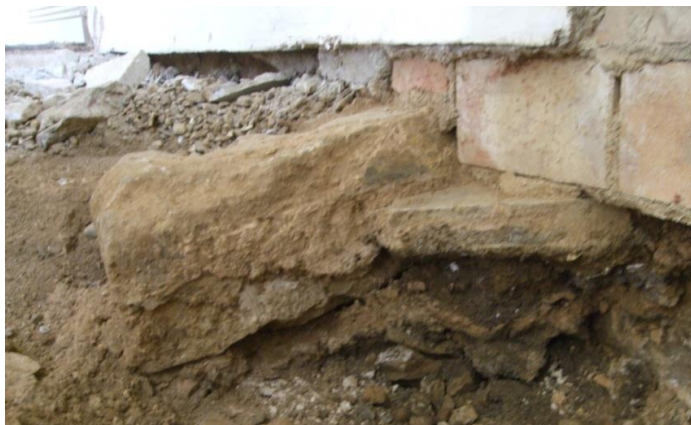
Plate 61
(Archive image: PCKC 068)

The second feature was a large stone set at right-angles to the west wall of the kitchen (Plates 61 and 62), from which it appeared to project. Investigation showed that the stone was not attached to the east wall of the Bishop's Gate but was laid on loose bulk fills close to the wall face. Butting up to the north face of the stone was a floor brick (147 x 120 x 37mm), one of several laid as a floor which projected from a blocked opening in the kitchen's west wall. The edge-bedded bricks of the blocking wall, which sat on top of the floor bricks and the large stone, were associated with the most recent staircase. The large stone clearly served a purpose, potentially before and certainly after the laying of the brick floor, probably as a pad for a timber partition, perhaps at the back of a cupboard under the most recent staircase. No other large stones were found nearby but it is possible that any such were removed when the staircase was dismantled and the red and black tile floor was lifted prior to the commencement of work on the lift foundation trench. In the kitchen demolition, a medieval springer with a broken cusp was identified, which may have belonged to the medieval range preceding No. 25 (Appendix D).

Lift Foundation Trench: The stone set at right angles to the west wall of the kitchen.

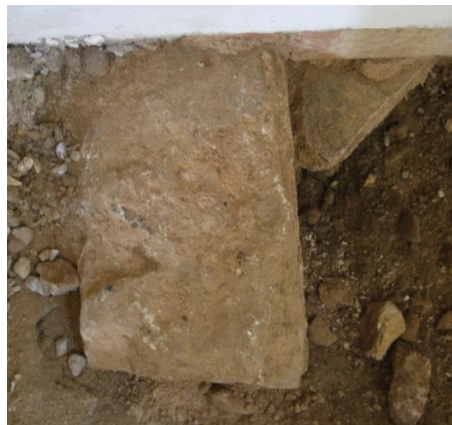
Plate 62
(Archive image: PCKC 069)

Lift Foundation Trench: The stone from above.

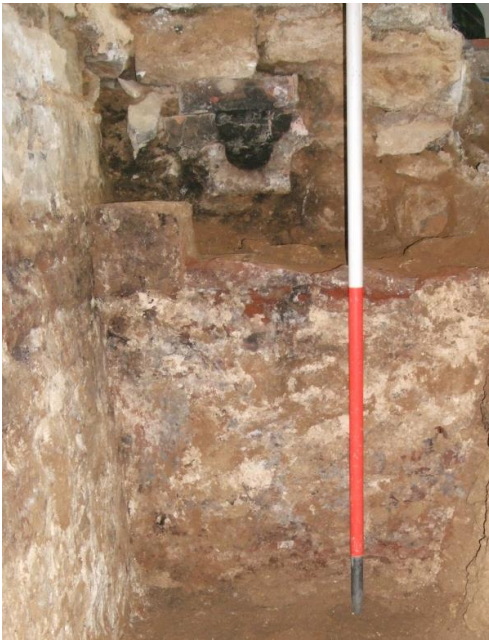
Plate 63
(Archive image: PCKC 120)

The bulk deposits **910**, **904** and **903** described in Section 3.2 were present in the strip foundation trench (**925**, **923** and **922** respectively) but each layer of material was shallower in the northern half of the trench, where they overlay a very substantial bank of lime mortar debris mixed with small fragments of limestone and ceramic building materials (**930**). This material was banked up against the south face of truncated wall **931**, which now serves as the offset footing for the north wall of No. 25 (Plates 63 and 64).

Lift Foundation Trench: north end showing truncated wall **931** with fire-reddening.
Photograph: Caroline Atkins

Abutting the internal elevations of the west and north walls (**914** and **931**) of the south range was a lime mortar floor (**927**) which was present in all parts of the strip trench. The mortar floor appeared to consist of a single layer of lime mortar, with a crust of fine, sandy silt, but much trampled and potentially a product of a sequence of floor surfaces, each laid when its predecessor had worn down to almost nothing. In the small area tested, the mortar was bedded on what appeared to be construction trample, including mortar lumps and grains, pressed into the top of the bulk backfill (**928**) of the Bishop's Gate construction trench. The floor was patchy at best, presumably due to a period of use followed by a period of exposure to a demolition crew, and marked by fire (Plates 63 and 64).

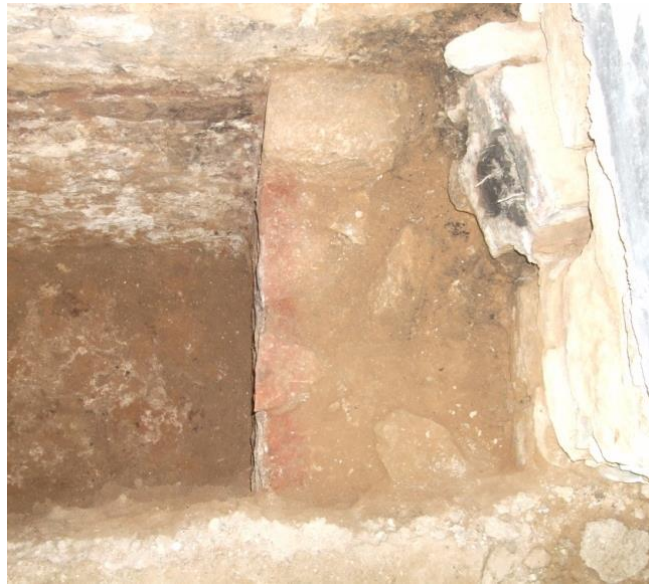
Plate 64
(Archive image: PCKC 142)

Lift Foundation Trench: wall **931** viewed from above, with patchy lime mortar floor **927** to the left of it.
Photograph: Caroline Atkins

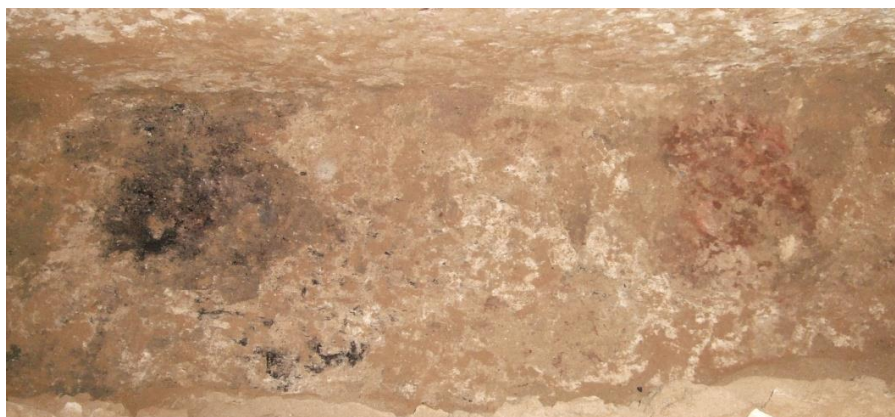
Plate 65
(Archive image: PCKC 144)
Lift Foundation Trench:
the two patches of
burning near the
Bishop's Gate east wall
(**914**, top of frame).
Photograph: Caroline Atkins

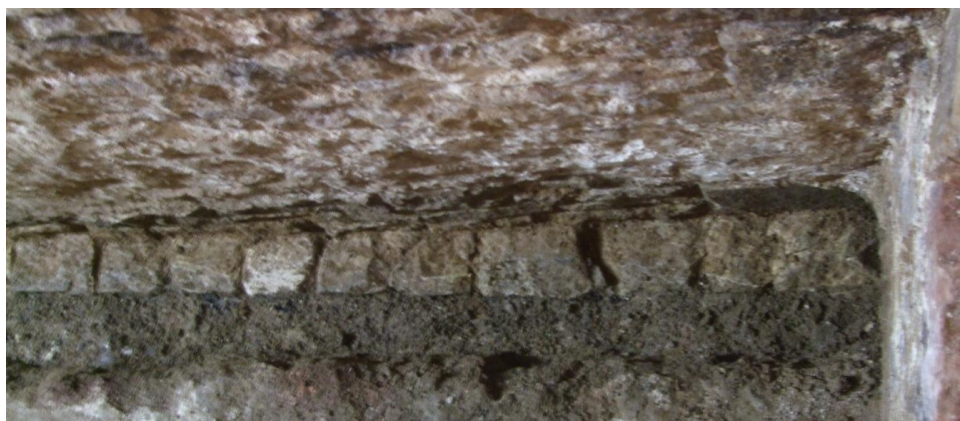
Plate 66
(Archive image: PCKC 183)
Lift Foundation Trench:
the northern half of
footing **929** exposed at
the limit of excavation.
Photograph: Caroline Atkins

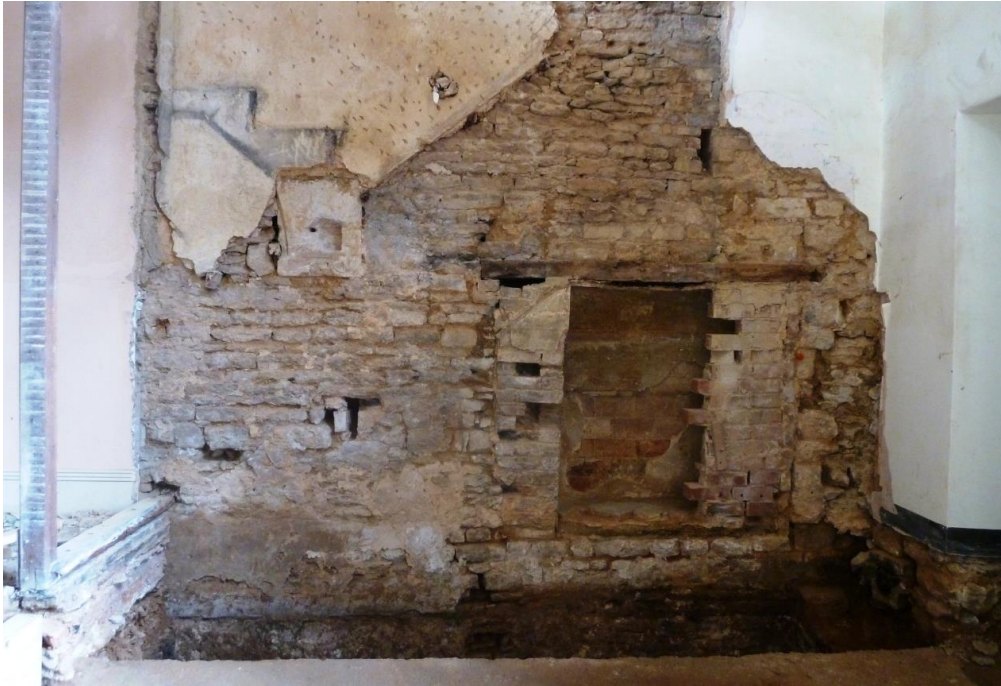
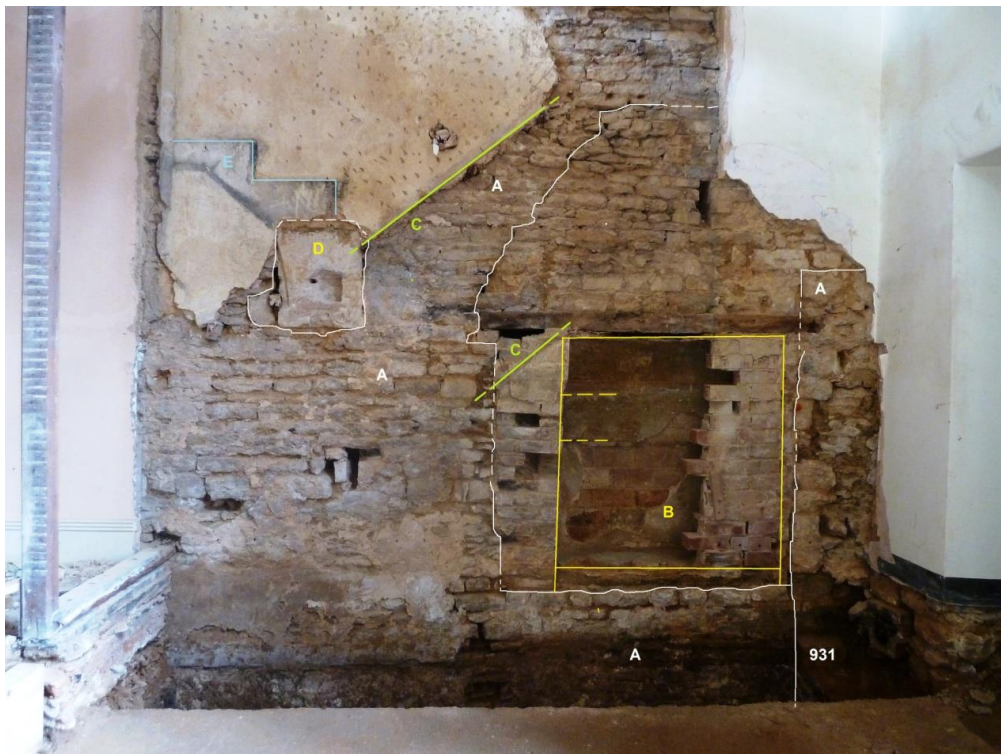
The major part of the elevation shown in Plate 67 consists of the medieval masonry of the east elevation of the east wall of the Bishop's Gate and the truncated north wall of the south range (areas labeled **A**). The cut back stones of the internal quoin are clearly visible above the intact lower courses of the north wall (**931**) where they rise 2.85m above their offset footing. It is probable that the full height of the north wall of the medieval south range is evidenced behind the wall plaster of the upper floors of No. 25 and certain that the sequence of roofs on the south range and No. 25 are evidenced in the stonework exposed in the roof-space of the present building (Plate 68). Unlike the coursed rubble of the lower wall, the high level is ashlar.

Setting aside the small sockets cut into the east face of the Bishop's Gate east wall (Plate 67), most of which relate to staircase and stud wall installation, there are only two significant areas of alteration. The largest of these is the area outlined in white in the right-hand half of the photograph, within which is the yellow-outlined opening labeled **B**. In its most recent form, feature **B** was a plaster-lined recess, fitted with at least two timber shelves (Plate 69). The floor of cupboard **B** was a flush continuation of the floor brick surface on the kitchen floor (see Section 3.3.1).

The narrowing of the opening to create recess **B** appears to have been prompted by the decision to construct a staircase (Plate 67, lime green parallel lines labeled **C**) rising towards the north. The second significant feature of the elevation, the large inserted stone labeled **D**, must either be associated with this period of work (as a fixing point for a structural support) or earlier than it, since the staircase ran across the stone and the wall plaster which lapped over and behind the stair timbers also covered the insertion cut for the large stone.

The large stone itself (Plate 67, **D**; worked stone record PCKC ST3) is described by Jackie Hall as a heavily cut-back engaged double springer, either from a blind arcade or a vault, with a large radius of curvature. Given the appearance of the medieval range, it is tempting to suppose that it originated in a vaulted undercroft below the upper ground hall. However, no evidence of vaulting could be seen in the uncovered areas of the wall, although it could, perhaps, have come from the north or south walls, if the range was vaulted in a single broad N-S bay.

When staircase **C** was replaced by stair **E** (Plate 67, pale blue outline), the staircase which was removed in 2015, recess **B** was first closed by the insertion of brickwork then plastered over.

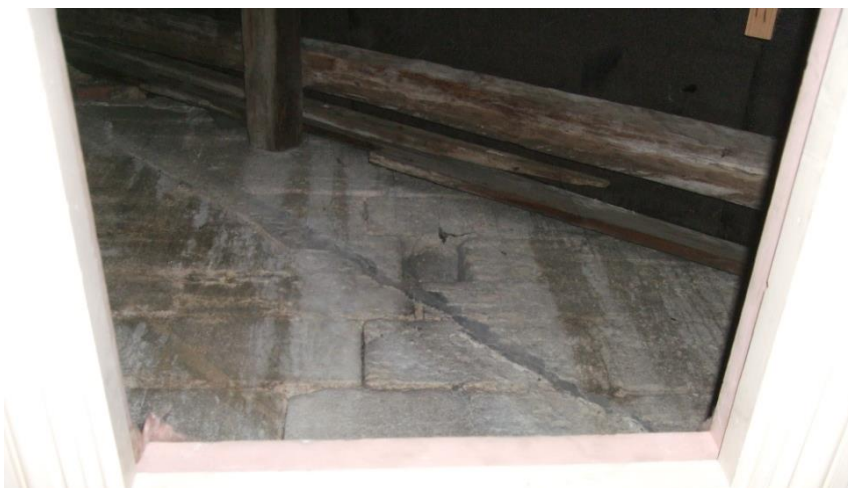
Plate 68
(Archive image: PCKC 190)
Bishop's Gate east wall exterior:
viewed through the trapdoor near
the re-opened doorway
between No. 25 and the Knights'
Chamber.
Photograph: Caroline Atkins

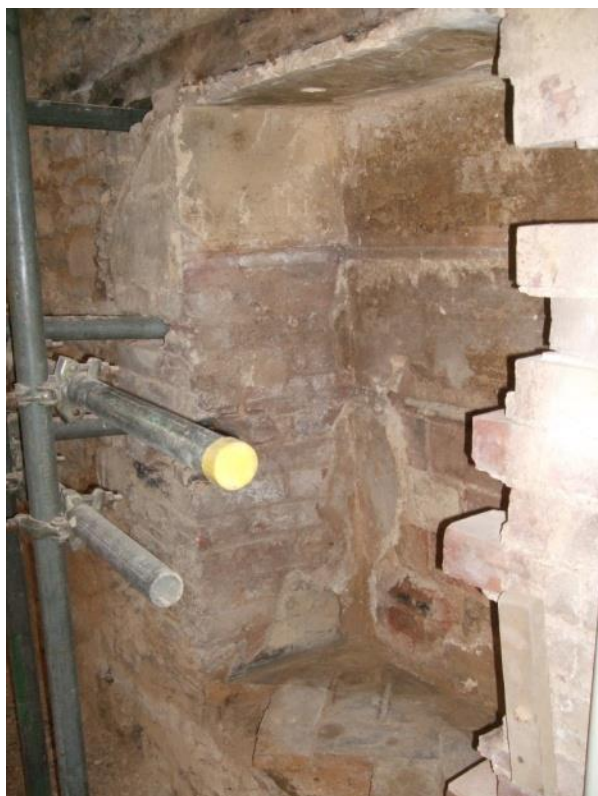
Plate 69
(Archive image: PCKC 082)
Bishop's Gate east wall: Brick &
plaster-lined recess with
impressions in the wall plaster left
by two timber shelves.
Photograph: Caroline Atkins

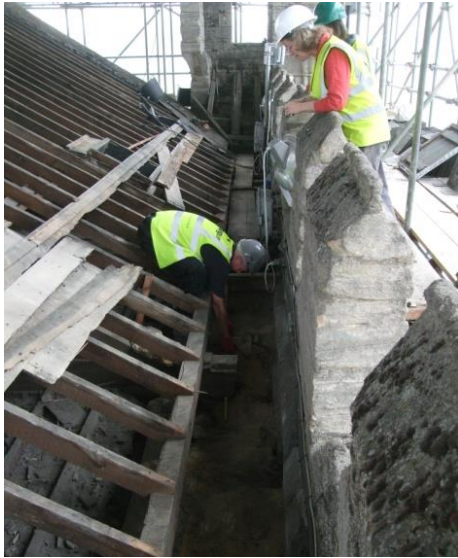
However, there was a larger opening, 1.60m wide, prior to the creation of the 1.18m-wide recess **B**. Both jambs of the earlier opening are of largely medieval stonework and above them is a scar left by the removal of a projecting canopy, indicating that the opening was originally built to serve as a fireplace, presumably that served by the flue recorded during work on the roof of the Knights' Chamber (Plates 70 and 71; Section 2.2.6). At roof level it was not possible to discern whether the flue was a primary or secondary feature of the wall, but primary is the most likely given the difficulty of creating a vertical hole within an existing wall.

Plate 70
(Archive image: PCKC 131)
Bishop's Gate roof east side:
showing the location of the flue.
Photograph: Caroline Atkins

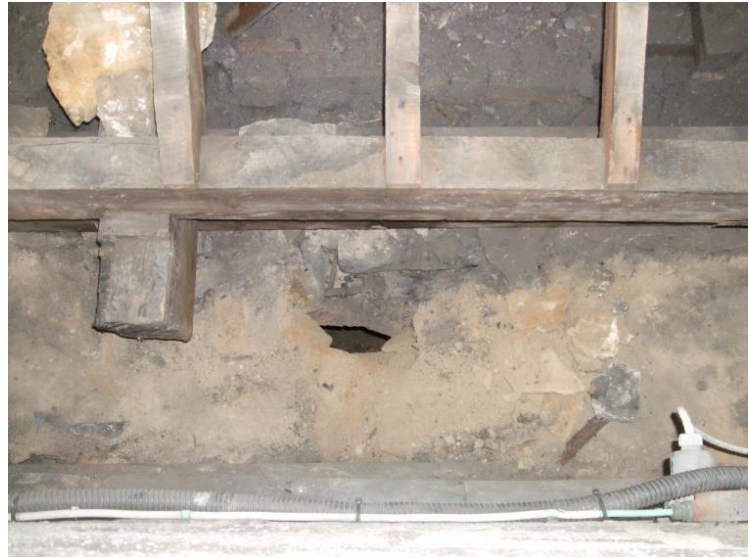
Plate 71
(Archive image: PCKC 133)
Bishop's Gate roof east side: showing the location of the
flue.
Photograph: Caroline Atkins

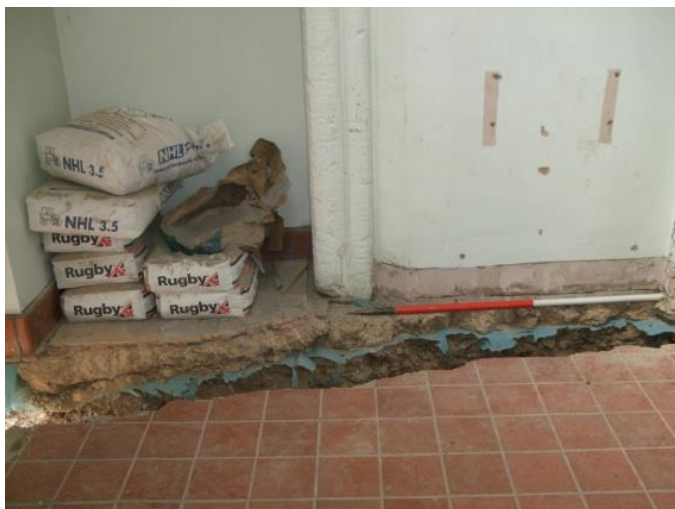
Plate 72
(Archive image: PCKC 158)
Drain trench: inside the scullery,
adjacent to the SE turret of
Bishop's Gate.
Photograph: Caroline Atkins

The excavation of a new drain trench (Plates 72–74), across the scullery of No. 25 and to an existing inspection chamber in its back yard, was carried out by Messenger Construction and periodically inspected by the project archaeologist between 6th and 12th August 2015. Inside the scullery the trench had an average width of 0.37m wide and a maximum depth of 0.53m.

Inside the scullery, the new drain trench ran alongside the east face of the SE turret of the Bishop's Gate but did not expose any of its medieval stonework. The trench was cut through the existing red quarry tile floor surface in the scullery, exposing the concrete slab and its plastic membrane overlying two substantial layers of building debris spread over the backfill of an existing drain trench associated with a rainwater downpipe which remains *in situ* in the NW corner of the scullery. The north side of a construction trench for the scullery's

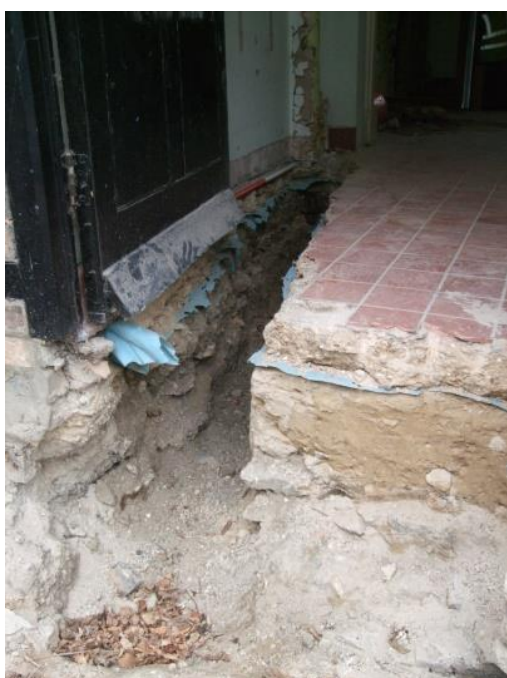
Plate 73
(Archive image: PCKC 162)
Drain trench: beneath the scullery's
outer door
Photograph: Caroline Atkins

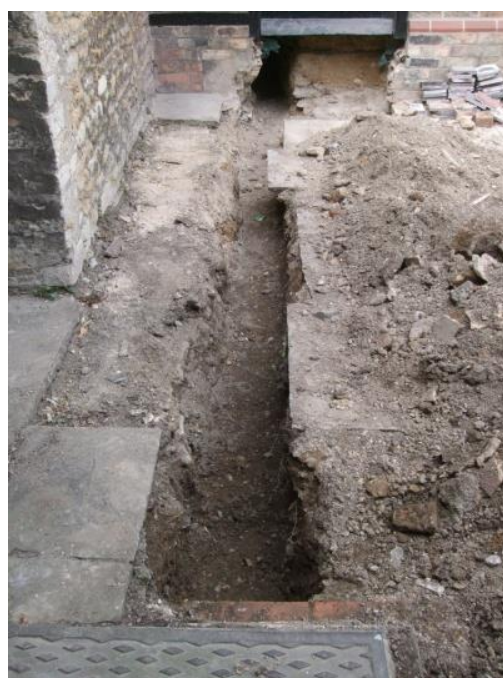
Plate 74
(Archive image: PCKC 158)
Drain trench: across the back yard
of No. 25
Photograph: Caroline Atkins

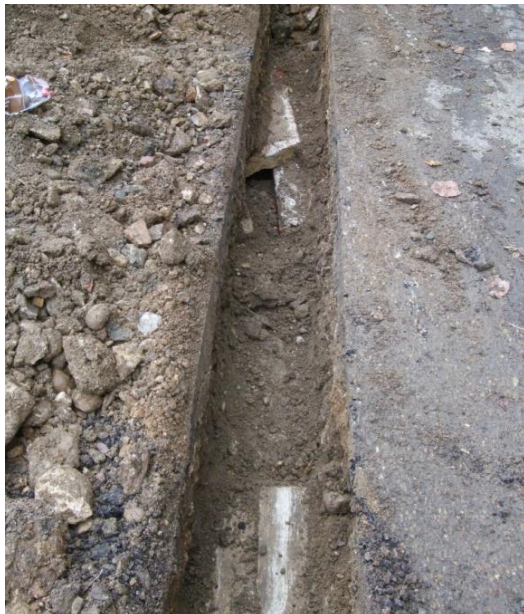
Plate 75

The other feature of interest was a brick-sided channel capped by memorial stones laid face down (Plate 75). Two memorial stones were partly exposed by the trench excavation but neither could be lifted because they were wider than the trench. The corner of one stone was damaged by the machine, allowing limited recording (Plate 76).

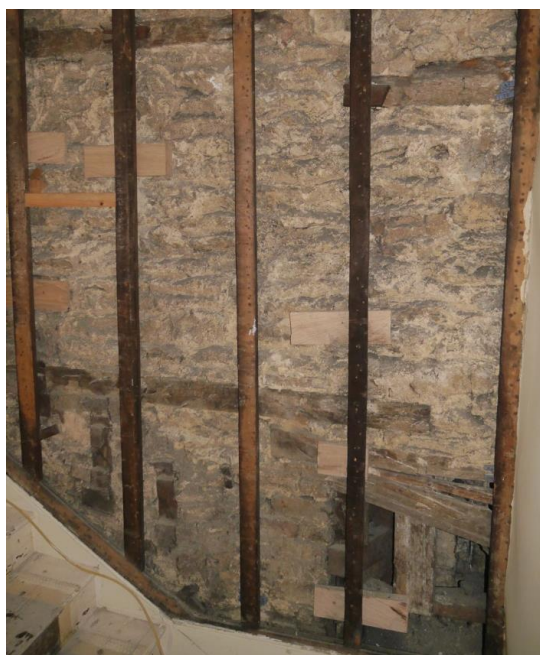
Plate 77

No. 25 north wall internal elevation: showing the location of Plate 79 bottom left.

It proved to be the head of a narrow cusped window, with splays surviving each side, one original in stone and one later, in brick. Investigation showed it to be the top of the lower ground floor window just visible in Plate 1, west of the buttress next to the drawing room. Probably when the stairs were put in, and the front refaced, the window was horizontally divided with timber and the top half blocked. In Carter's engraving (Fig 4), this window is hidden either between the entrance porch and the small tower to the west, or it played some part in lighting that tower from the interior.

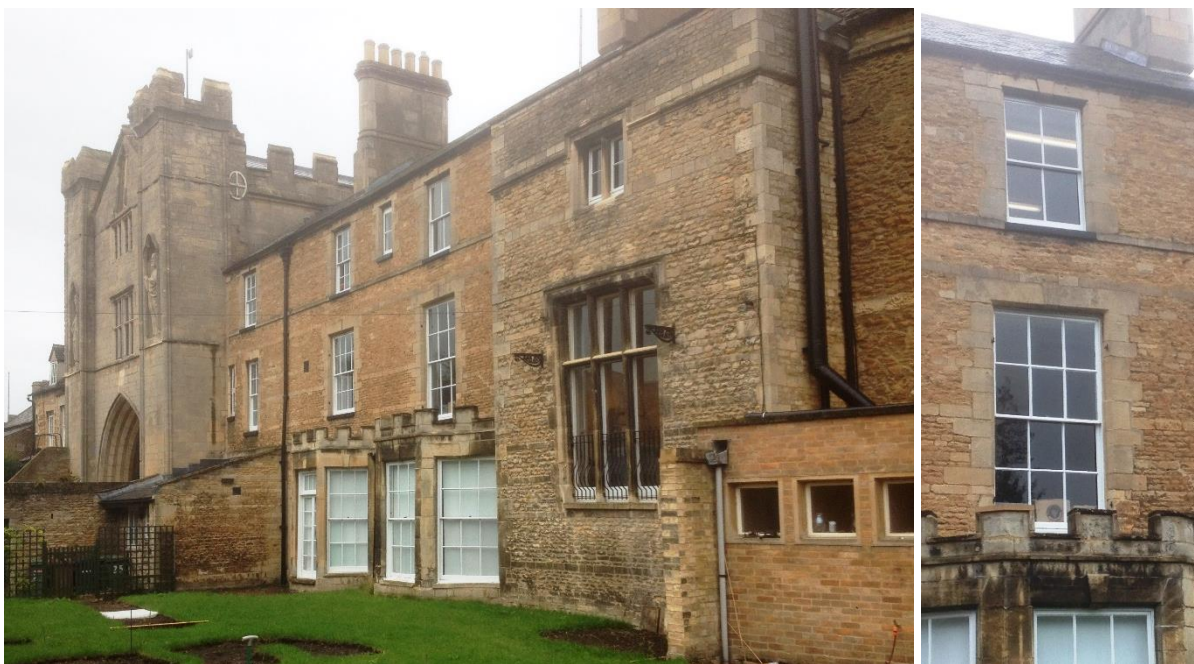
At the same time as the ashlar refacing of the front, the entirety of the south side (rear), between the Bishop's Gate and the drawing room, was rebuilt with coursed rubble, and rectangular windows with ashlar jambs and lintels, each with a keystone (Plate 79).

Plate 79
No. 25 from rear, with close up of window with keystone
Photograph: Stuart Orme

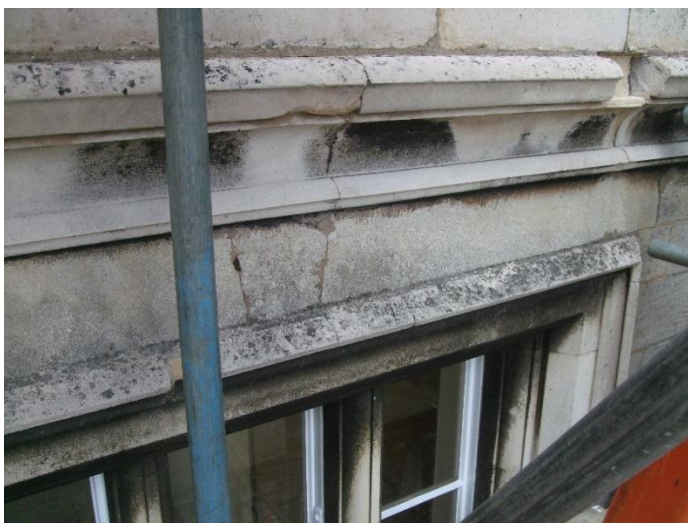
Remnants of these keystone windows can also be seen in the front (north side), usually with the lintels surviving immediately above the extant windows, thus proving this phase to belong with the ashlar refacing (Plates 80–81).

Plate 80
(Archive image: PCKC 262)
Window west of porch, with lintel
with keystone above
Photograph: Caroline Atkins

The last major refenestration replaced the front windows with the still extant mullioned and transomed windows, with square hoodmoulds above (Plates 1, 80, 81); the keystone windows were never replaced on the rear elevation.

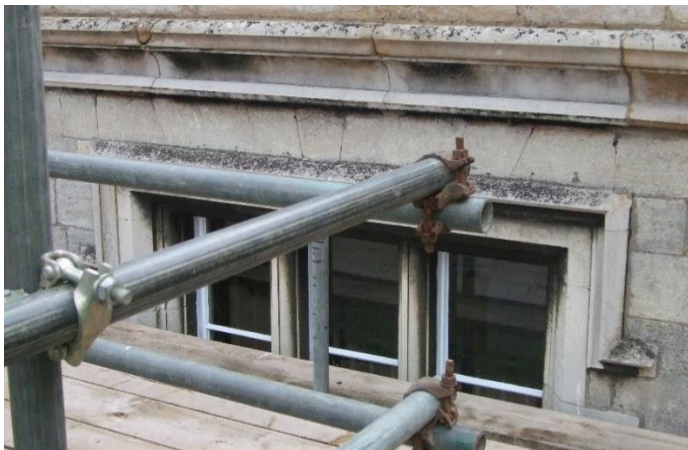
Plate 81
(Archive image: PCKC 262)
Window east of porch, with lintel
with keystone above
Photograph: Caroline Atkins

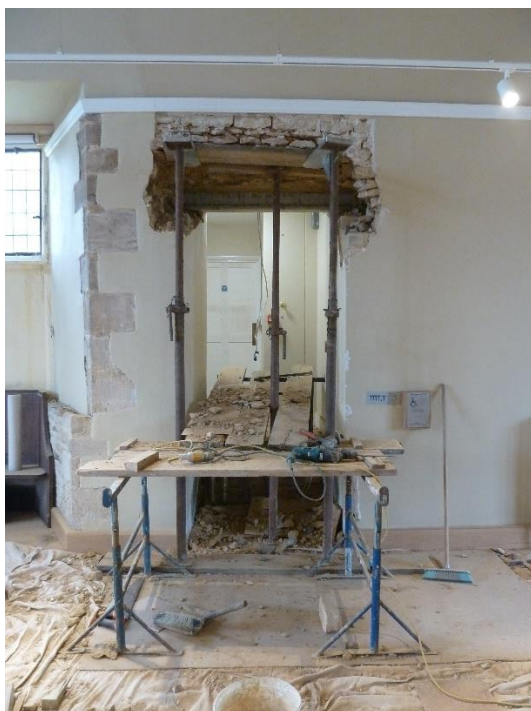
Plate 82
(Archive image PCKC 707)
Knights' Chamber. East wall, extending door for
FlexStep
Photograph: Jackie Hall

In order to accommodate a wheelchair accessible FlexStep, the doorway between the Knights' Chamber and No. 25 was extended upwards (Plate 82, 83). As with the other side of the wall visible lower down inside No. 25 (section 3.4), this showed that the interior wall faces were constructed of coursed ragstone rubble c. 35–75mm high x 150–250mm wide, x 170–320mm deep, probably with occasional courses of ashlar (Plate 84). The mortar used was brown, very fine-grained and clay-based, apparently with no lime. This is similar to both late medieval mortars and post-Dissolution mortars seen elsewhere in the precincts, but different from the later 14th-century lime mortar seen in Hostry Passage (Hall 2010; Hall and Atkins 2017). Clay-based mortar may have been seen as acceptable in a context always intended to have been plastered.

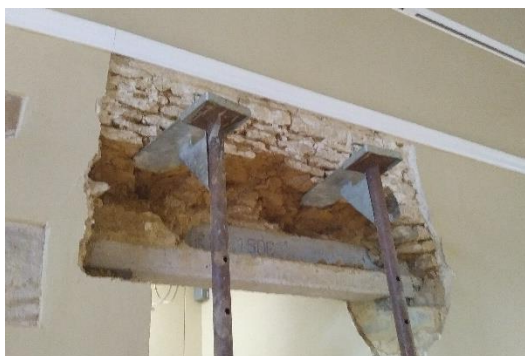
Plate 83
(Archive image PCKC 701)
Knights' Chamber. East wall, above door in
2017
Photograph: Stephen Crane

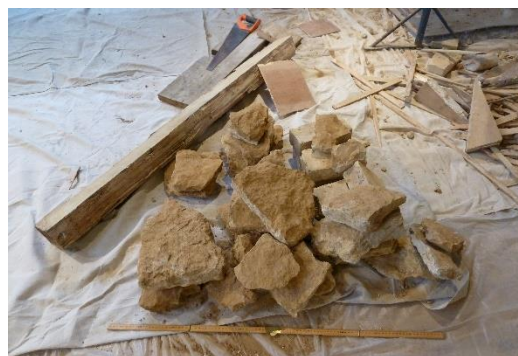
Plate 84
(Archive image PCKC 704)
Knights' Chamber. Wall stone removed from
above door in east wall
Photograph: Jackie Hall

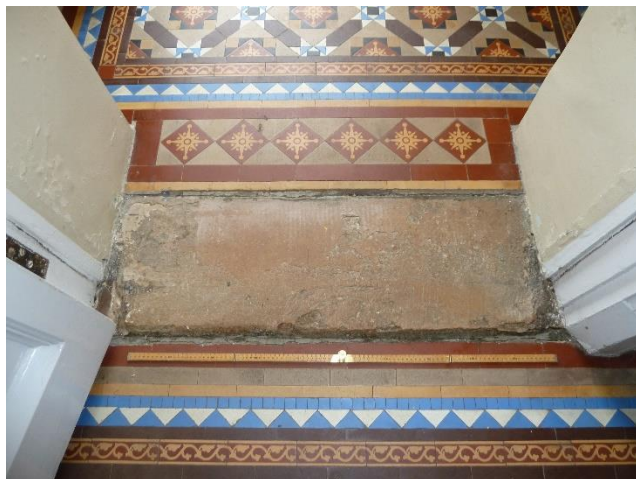
The threshold of the main doorway to No. 25, within the central porch (Figure 2), was lifted and the west end excavated to a depth of 230/255mm (south/north depth; 7.95m OD). The stone threshold was of Ketton stone, and rather thin at 38mm; it lay between two fine sets of probable Minton tiles, within the porch and within the hall of the house (Plate 85).

Plate 85
(Archive image PCKC 715)
No. 25. Threshold, looking north into porch
Photograph: Jackie Hall

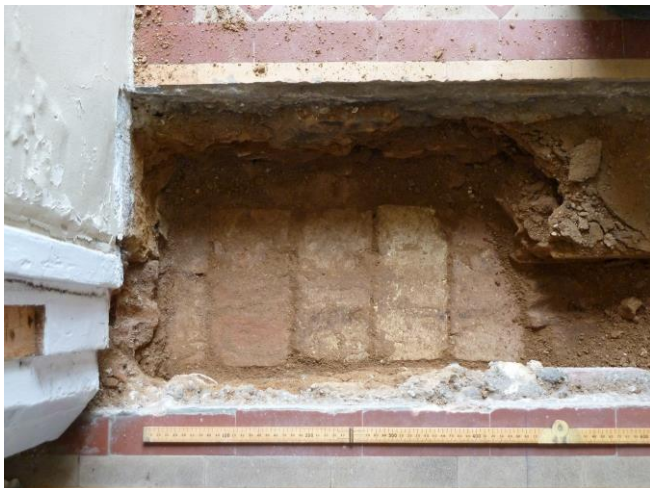
Plate 86
(Archive image PCKC 715)
No. 25. Threshold, brick floor, before removal.
This was set on a brown clay-based bedding
layer
Photograph: Jackie Hall
