Peterborough Cathedral

Bishop's Gate and No. 25 Minster Precincts

A Report on a Programme of Archaeological Observation and Recording.

Planning Reference Numbers: 13/00520/FUL & 13/00521/LBC
Scheduled Monument Consent Ref: S00058886
Archaeological contractor's Site Code: PCKC

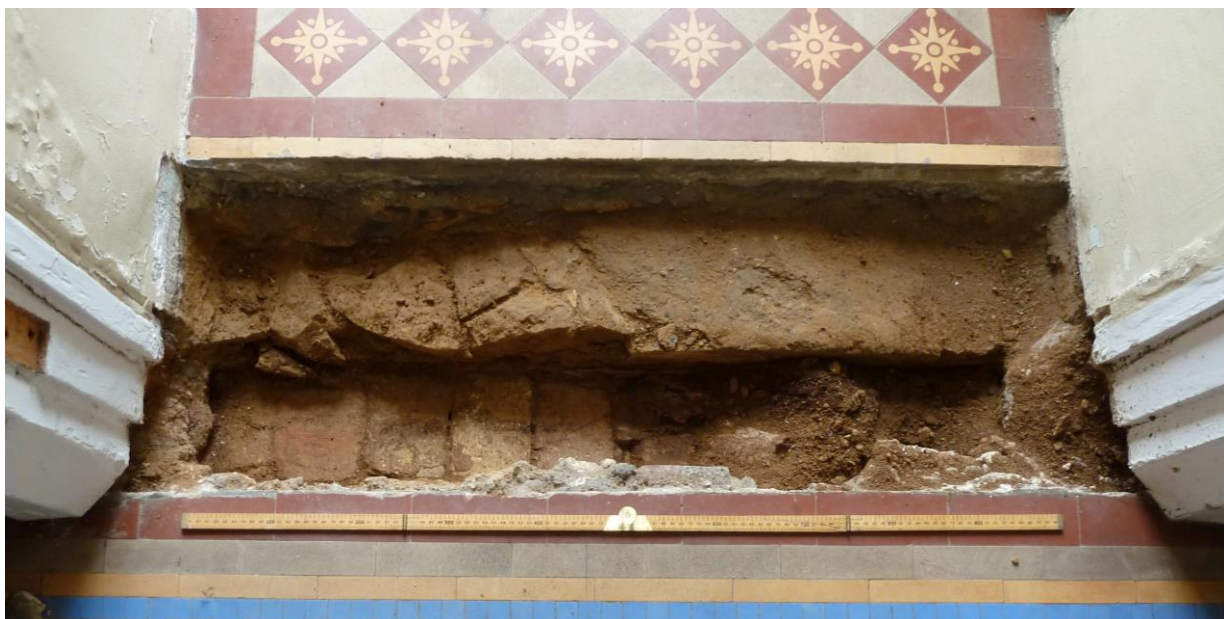
Plate 87

Within the mini-excavation, the earliest deposit seen was a bedding layer of clay-based mortar. Immediately on top of this, a brick floor (or step) was set, with handmade buff or pink bricks c. 105 x 230 x 110mm, similar to those seen elsewhere in No. 25, and perhaps contemporary with the brick floor **919**, seen in the kitchen (Appendix B). The bricks ran underneath a step on the porch side constructed of coursed rubble and brown, clay-based mortar (Plates 86, 87). This showed no wear, and was almost certainly the base for a stone surface (there being no impressions of tiles).

No. 25. Threshold, showing brick floor and clay-and-stone step. On the left (west), the step has been partially excavated to show the coursed rubble construction. On the right (east), the brick floor has not been revealed, as that side did not require excavation to fit the new door mechanism.

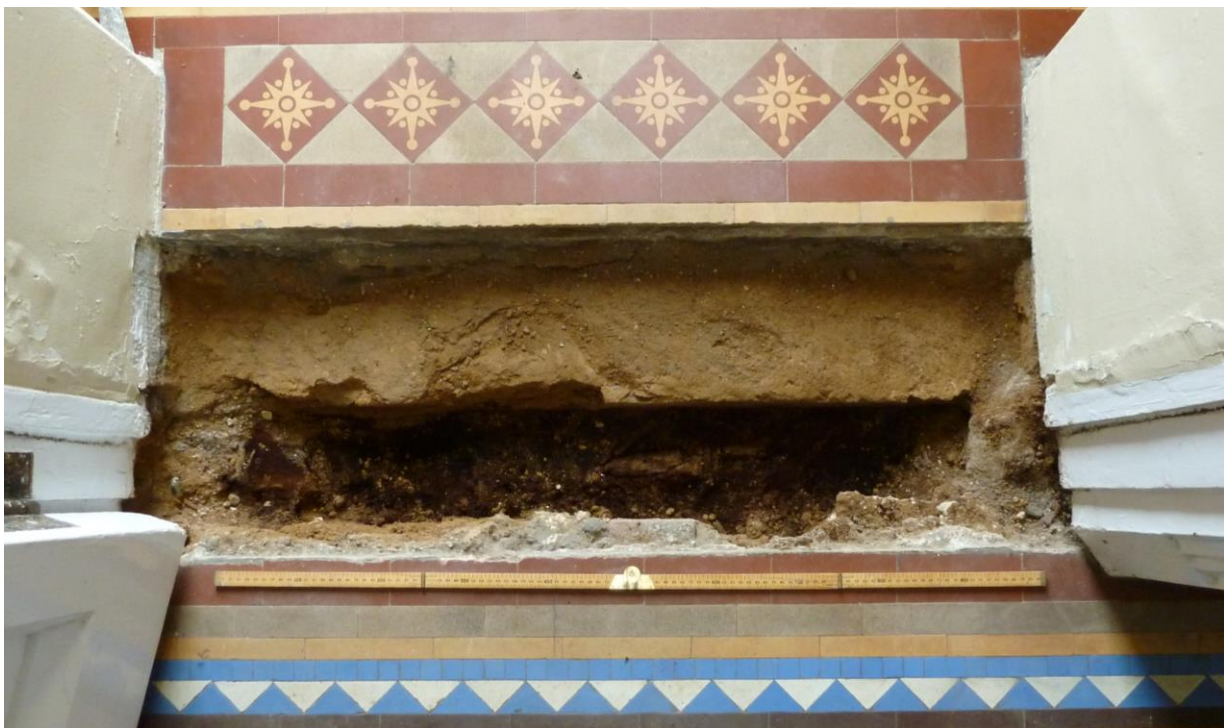
Plate 88

Above both the bricks and the steps, there were a series of levelling layers, preparatory to laying both the Minton tiles and the threshold stone. To help level up the interior floor, a timber, with no structural function, was laid against the step; unsurprisingly, it had mostly decayed, although the very bottom was in better condition (Fig 88). Above this and above the step, there was concrete with occasional brick rubble (50-60mm; thicker in section on the house side), then a thin layer of bedding cement for the tiles (35mm for both tiles and cement).

No. 25. Threshold, showing brick floor and clay-and-stone step, with decayed wood in foreground (south). The decayed wood only filled the space visible, and did not go under the jambs, nor under the Minton tiles.
