Peterborough Cathedral

Apse and Treasury Ramps

Report on Archaeological Observation and Recording.

Archaeological contractor's Site Code: PCTAR

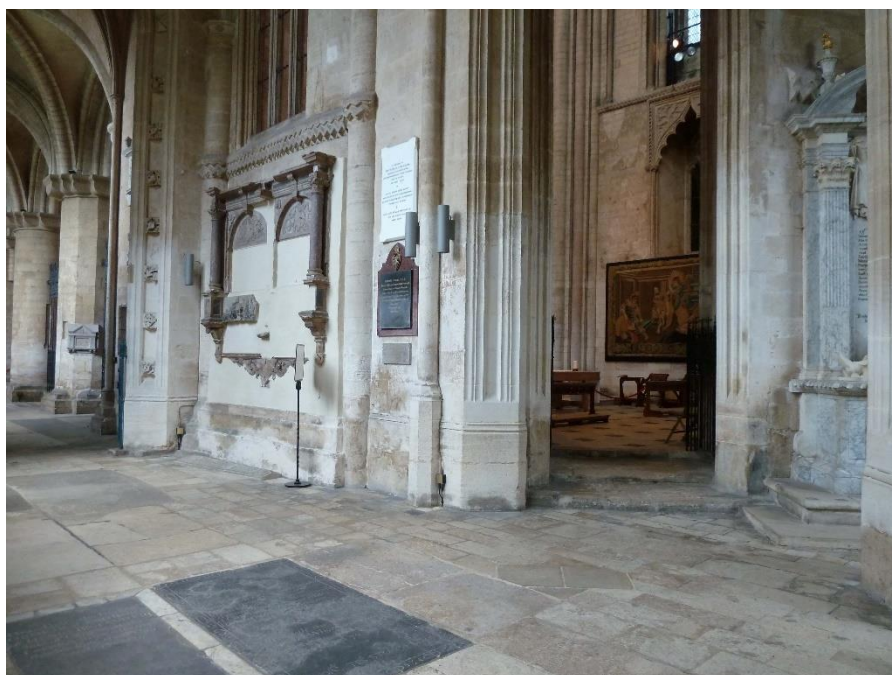
Plate 1
View of ramp location from
ambulatory (New Building).
Photograph: Jackie Hall (2011)

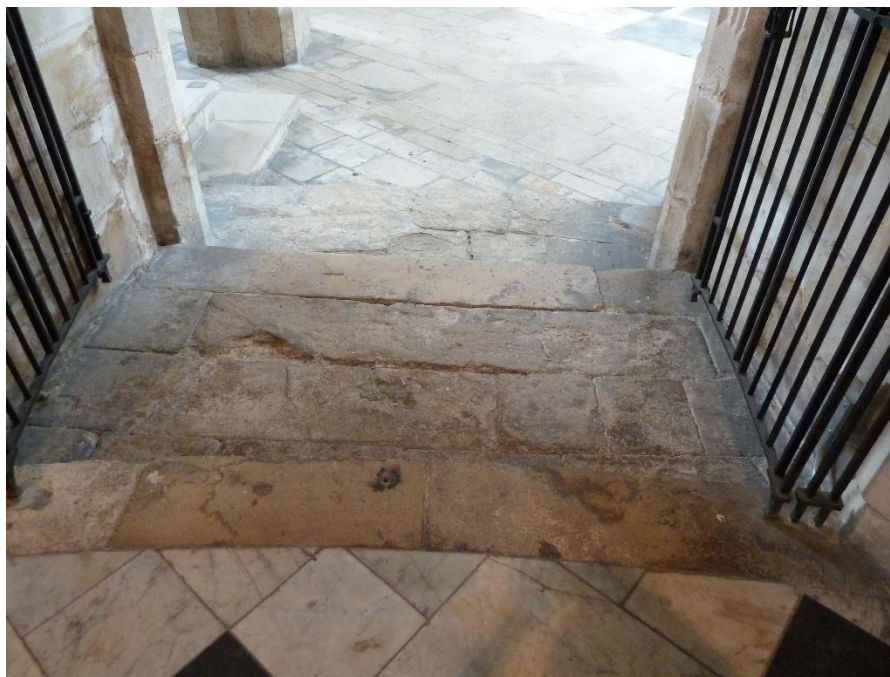
Plate 2
View of ramp location from top showing worn middle and lower steps.
Photograph: Jackie Hall (2011)

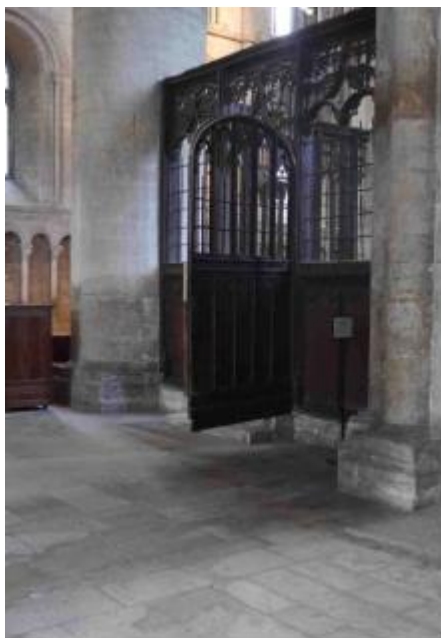
Plate 3
Treasury, showing screen.
Photograph: Stephen Oliver

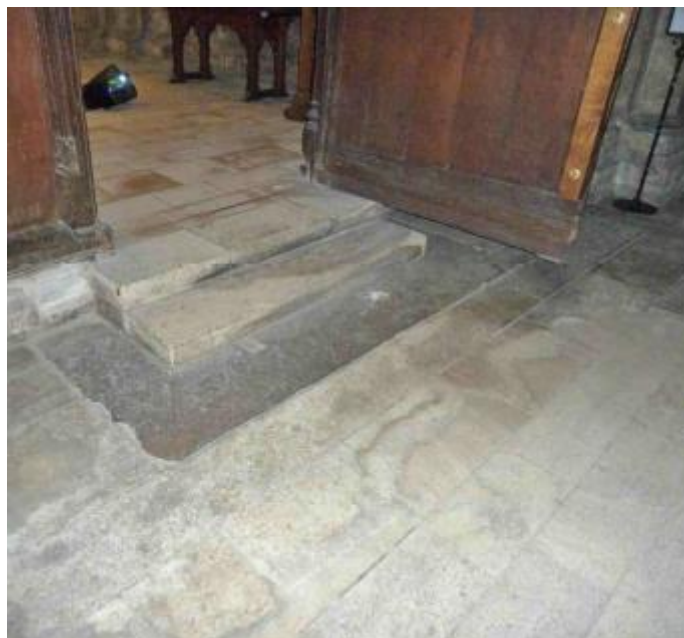
Plate 4
Treasury, showing modern paving, with ledger below step
Photograph: Stephen Oliver

The ledger slab was partially visible prior to the works (Plate 4) but it only became fully visible after the removal of the old steps (Plate 13). It was carefully moved (frontispiece), so that it would not be destroyed and was available for close inspection. It is of Purbeck Marble, and a plain rectangle 2.33 x 0.965 x c.0.09 m. It has only a single indent, for a short plain brass, 340 x 70–75mm with three fixing locations. Examination showed that it had not been turned over and reused.

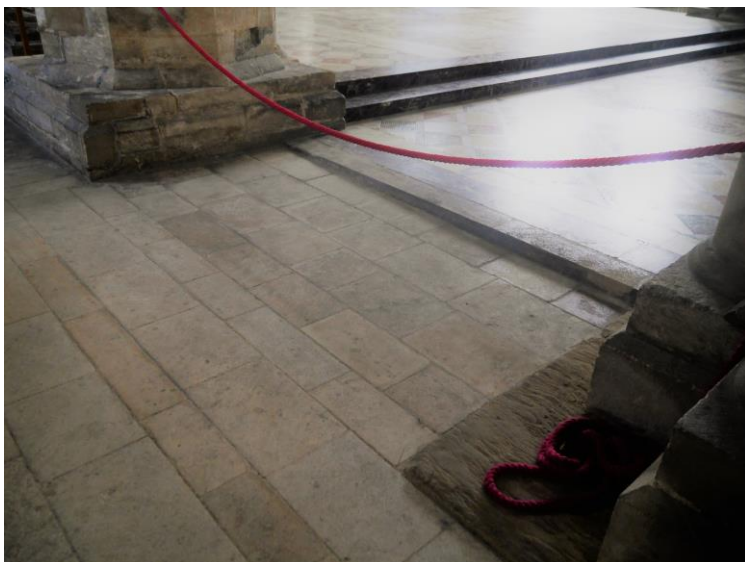
Plate 5
Presbytery north aisle, bay 1,
showing new location for ledger
stone, prior to works.
Photograph: Stephen Oliver

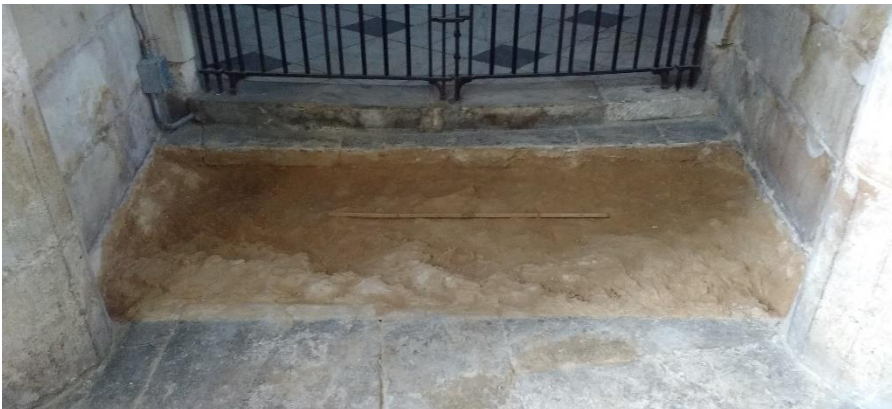
When the central step was removed, it was found to be bedded on hard buff lime mortar, apparently continuous with the mortar bed running under the jambs of the opening, c.20–40mm deep (Plates 6 and 7). Since these jambs belong with the 16th-century New Building, this shows that both the mortar bed, and the step, were also 16th-century.

Plate 6
(Archive image PCTAR 43)
Steps into apse, after
removal of central step
Photograph: Jackie Hall

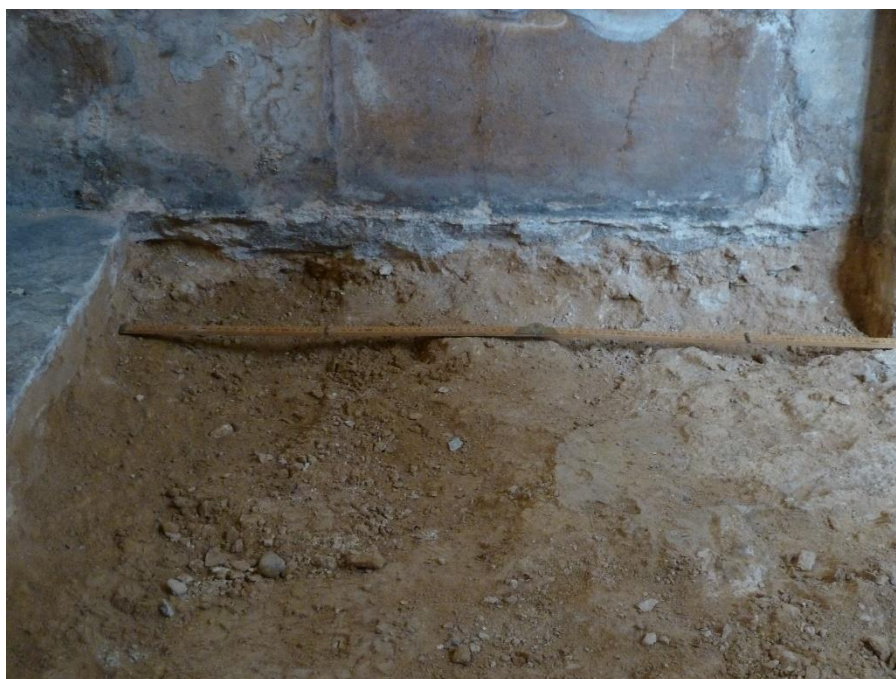
Plate 7
(Archive image PCTAR 45)
Section at north-east
side of apse step; buff
mortar upper and right;
sand and rubble lower
and left
Photograph: Jackie Hall

Immediately below the mortar lay a deposit of dark orange sand and rubble, with very little lime; only the top was seen (at c. 9.31m OD) and it was not excavated. Since this layer also appeared to run beneath the jambs of the opening but was very different from the bedding mortar for the step, there is the real possibility that it is the original wall core of the 1118 apse foundation. There were no finds or other dating evidence.

The slabs of the outer step projected 50–100mm below the central, removed, step (Fig 2 and Plate 7). Because of later pointing in the jambs, it was not possible to discover the relationship between these inner stones of the step and the jambs i.e. they could be either 12th-century, contemporary with the plinth, or 16th-century, contemporary with the opening.

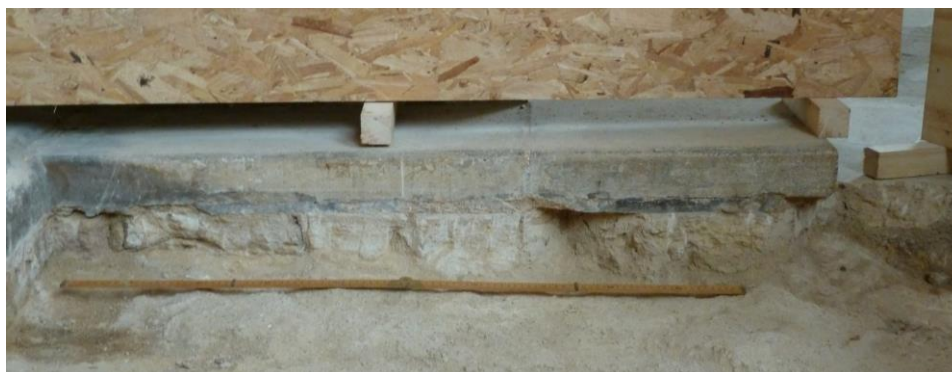
The area shown in Fig 2 outside the apse was excavated by the masons to a depth of 65–170mm; 65mm next to the apse plinth and up to 170mm on the outer edge. For the most part, the 1930s 2in (50mm) thick Clipsham Stone paving slabs were bedded on 20–30mm of 1:1 cement mortar (Plate 8). In three areas, the masons found patches of significantly softer bedding mortar, and it is suggested that this related to piecemeal repair or replacement, using a lime mortar, probably by Julian Limentani, Cathedral Architect, 1989–2014. Below the cement was a thick layer of cement-based concrete.

Plate 8
(Archive image PCTAR 55)
Section at north-east
side of removed apse
paving
Photograph: Jackie Hall

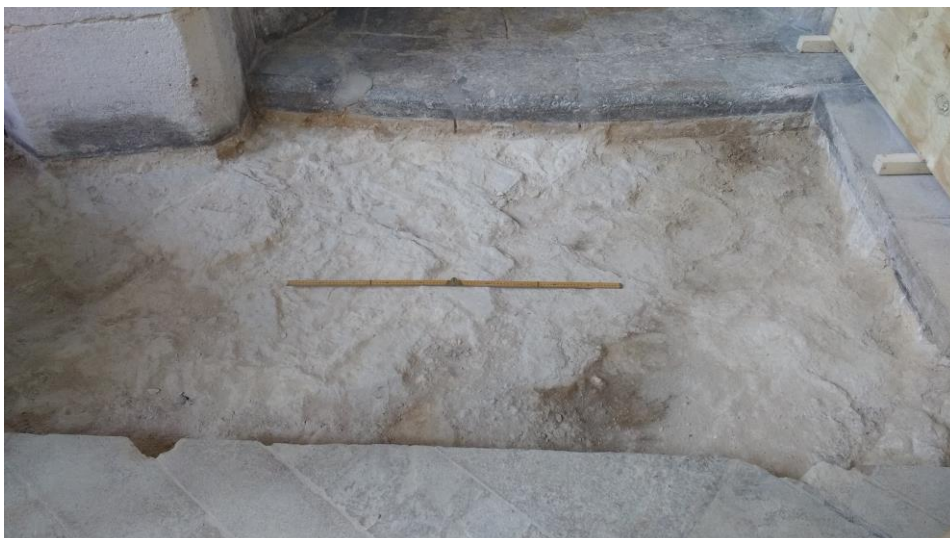
For the most part, the bottom of the concrete was not reached, and was therefore more than 80-90mm thick (Fig 2 and Plate 9). At the west end, however, the concrete was removed directly onto the top of burial earth (Fig 2 and Plate 10).

Plate 9
(Archive image PCTAR 48)
East end of trench,
showing concrete
Photograph: Jackie Hall

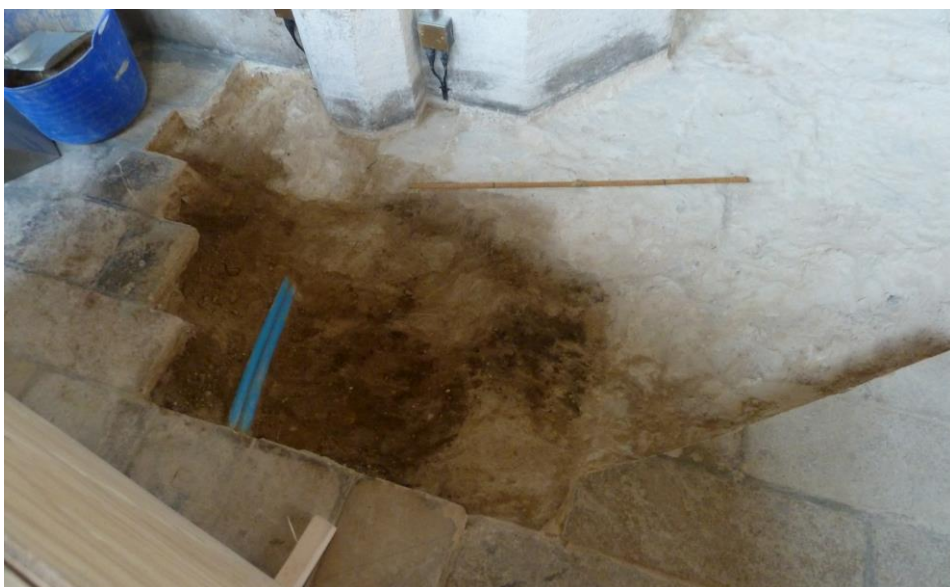
Plate 10
(Archive image PCTAR 52)
West end of trench,
showing concrete, burial
earth and pipes
Photograph: Jackie Hall

Only the top of the burial earth was reached, 110–140mm below floor level (9.095–9.065m OD). Five fragments of disarticulated bone were disturbed and reburied as close as possible to the site of disturbance; they probably result from more major disturbance in the 1930s. Two parallel modern blue plastic pipes emerged 135mm below the top of the south-west baulk, seemingly heading for the electrical fittings in the pier i.e. despite their colour, they appeared to be conduits for electrical wires.

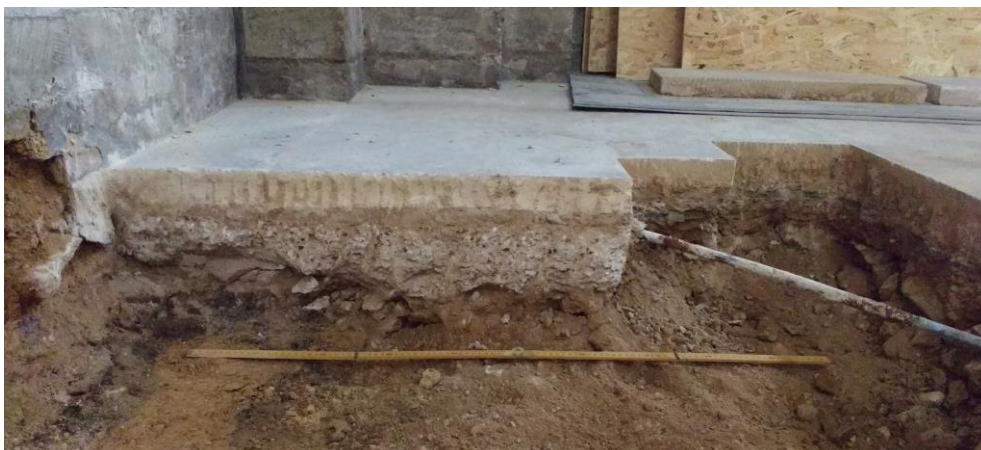
The removal of paving and bedding layers to a depth of c.0.5m in the treasury and 0.3m in the adjacent presbytery aisle i.e. to the same bottom level proved to be remarkably uninteresting (Plates 11–12). Across

the whole area, the 2in (50mm) thick Clipsham Stone paving slabs (in one instance a 65mm Ketton Stone slab) were bedded onto 30–45mm of 1:1 cement mortar, and then onto concrete. In the treasury, with its higher floor level, the concrete was 110–160mm thick, compared to 95–120mm in the aisle. Below this, was a thick unbottomed layer of levelling material – sand and rubble with dumps of mortar and other material within it – more than 250mm thick in the treasury and more than 125mm thick in the presbytery aisle. There was no dating evidence, and we cannot be certain whether this is 1930s levelling in preparation for a new floor, or whether it is late Victorian, associated with the major programmes of underpinning that took place throughout the church. The lower part of this deposit (only seen by the archaeologist in section) could have been the original 12th-century strip foundation running between the piers. Given the similarity in colour and material between this and foundation that is definitely 12th-century, in the apse and in the presbytery arcade (above and below), this is perhaps likely.

Plate 11
(Archive image PCTAR 40)
East end of trench in
presbytery
Photograph: Jackie Hall

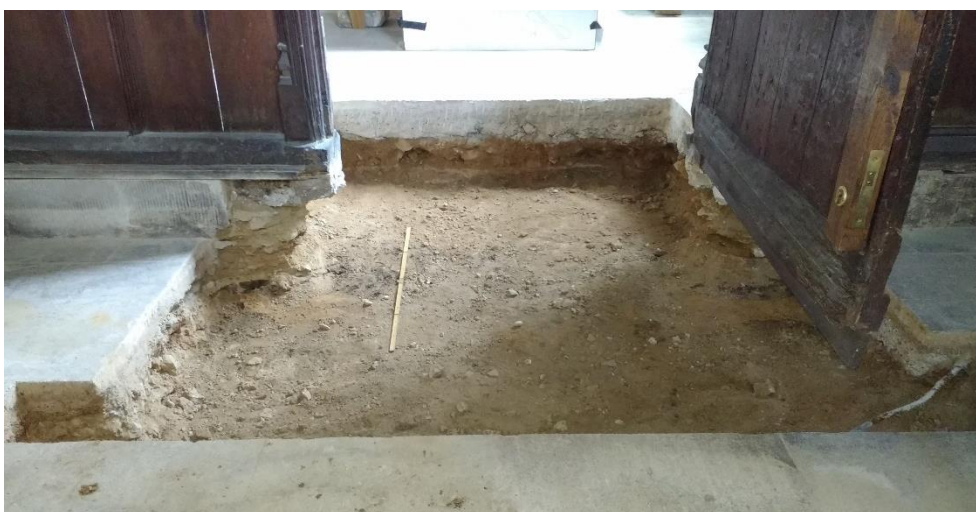
Plate 12
(Archive image PCTAR 40)
Whole of trench,
viewed from treasury
Photograph: Jackie Hall

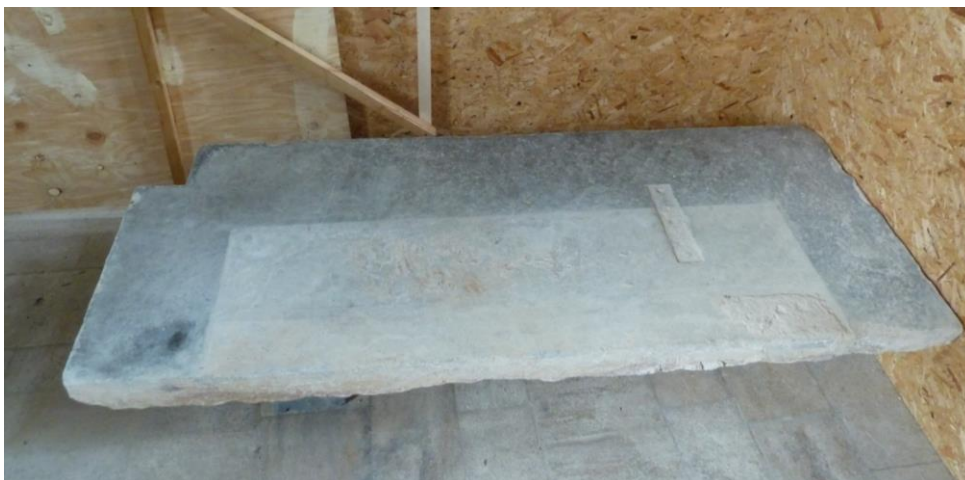
A cut out in the bottom left corner indicated that its former, perhaps original, position was up against an architectural feature or a monument. In likelihood, this was between two of the piers of the main arcade in either the nave or the presbytery, which have squared plinths.

It is probably late medieval or early modern.

Plate 13
(Archive image PCTAR 25)
Ledger stone
Photograph: Jackie Hall

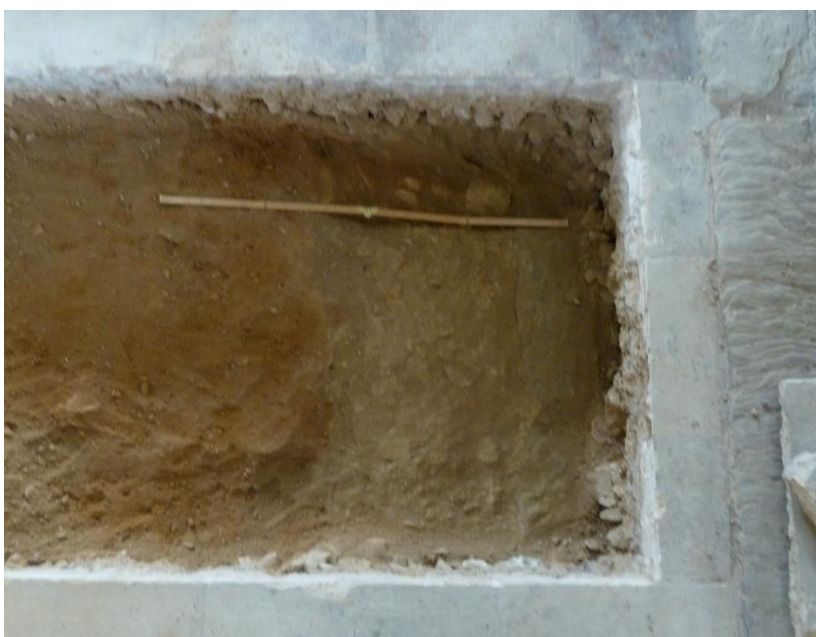
The earliest deposit was the strip foundation between the two piers (Plate 14), seemingly made of orange sand and ragstone rubble, with no lime mortar at all. This was not excavated, but appeared to be rammed to make a well-compacted foundation, the top of which was c.245mm below floor level (c. 8.88m OD). The west end of the trench was naturally excavated to a lower level (300mm below floor at deepest point), because the fill here was softer, and made up of yellow-brown sand and small aggregate. This difference clearly marked the cut for the Victorian excavation of the crossing pier foundation and the pit for the new foundation of 1883. The fill itself is also probably Victorian, given its difference from the 1930s materials above. Its removal revealed the lower sandstone course (on top of concrete) of the Victorian foundation in the west side of the trench.

Plate 14
(Archive image PCTAR 72)
Presbytery aisle; west end of trench for ledger stone. On the left side, the orange sandy 12th-century foundation can clearly be seen, and on the right, the brown-grey concrete of the Victorian foundation for the crossing pier, with one of the sandstone courses described by Irvine just visible far right with the trench.
Photograph: Jackie Hall

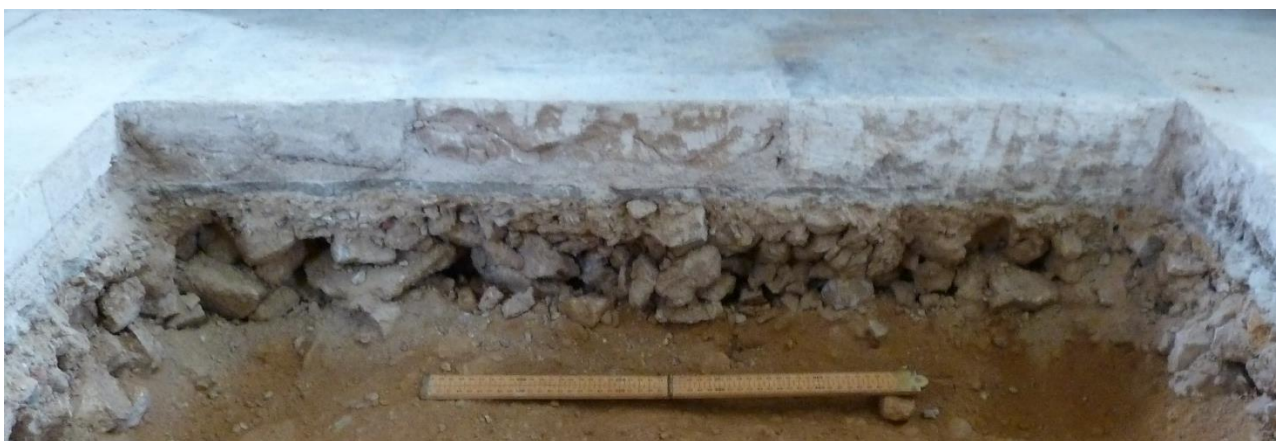
Plate 15

This softer west end was partially filled in with large stones (eg c.300 x 220 x 110mm), which probably marked the beginning of the many layers making up the base for the 1930s repaving. Apart from these stones, five different layers were clearly visible (Plate 15).

The lowest levelling deposit was principally medium-large stones in some cement mortar, in a thick layer (80mm); above this was a fairly soft cement-based concrete with 50–70% aggregate, only 50mm thick – it appeared to have been poured in, as it had a very flat upper surface (plate 16) and the larger stones had sunk to the bottom. Above was a thin (12–17mm) layer of possibly neat cement, followed by bedding cement-based mortar (40mm; probably a 1:1 mixture) on which the 2 in (50mm) paving slabs were laid.

Presbytery aisle; east section of trench for ledger stone. At the bottom (not in section) the 12th-century foundation is visible, with two layers of aggregate/concrete above, two layers of concrete/cement above that, with the paving slabs on top.

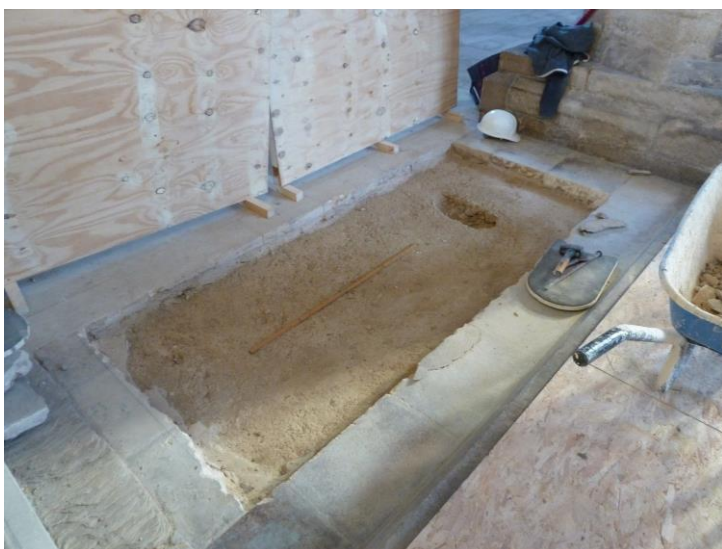
Plate 16

Presbytery aisle; trench for ledger stone, showing top of concrete with high level of aggregate
