Collaton Cable Trench

Programme of Archaeological works

March 2014

Reference: PA13/11698

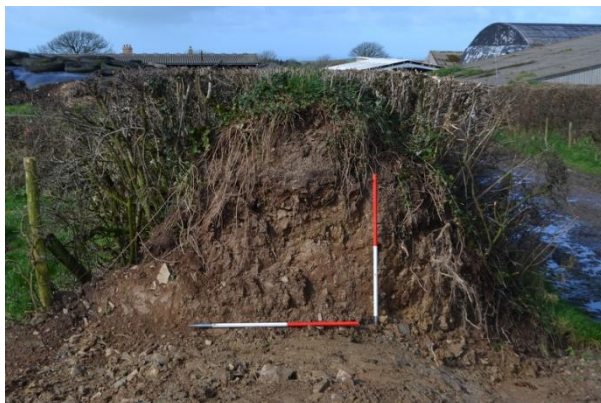
Figure 1.0: Hedge Section 1 removed at field boundary along existing farm access, (view west)

Both of the hedge banks [009] recorded are made of earthen banks of topsoil measuring 1.5m to 1.7m in height. The base width is 2.8m to 3.0m tapering equally on both sides to 0.6m to 0.7m at full height. Neither hedge section had been faced with stone, as is often the practice with Cornish hedgerows and while there are inclusions of shale stone up to 25cm in size within the hedge bank matrix there is nothing that could be interpreted as structural.

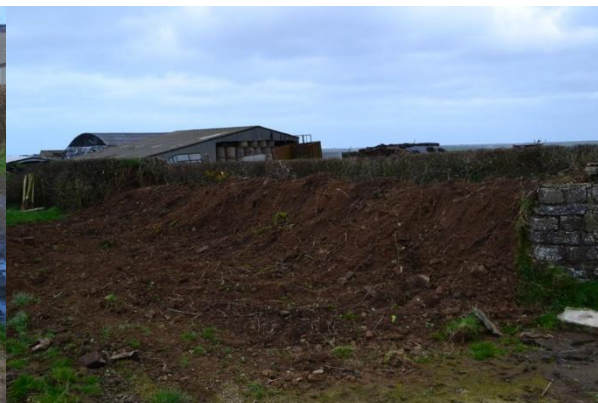
Figure 1.1: Hedge Section 1 stripped of vegetation and being removed

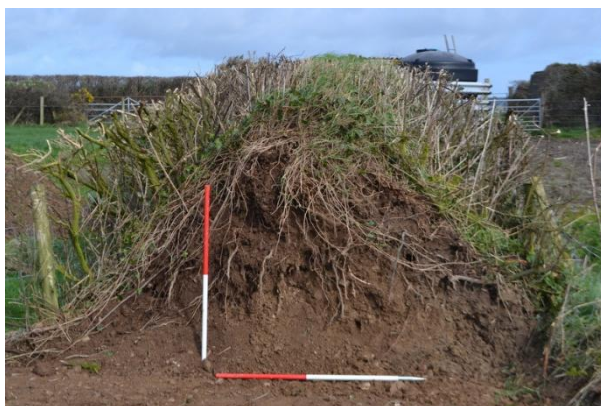
Figure 1.2: Field boundary 2 removed (view north)

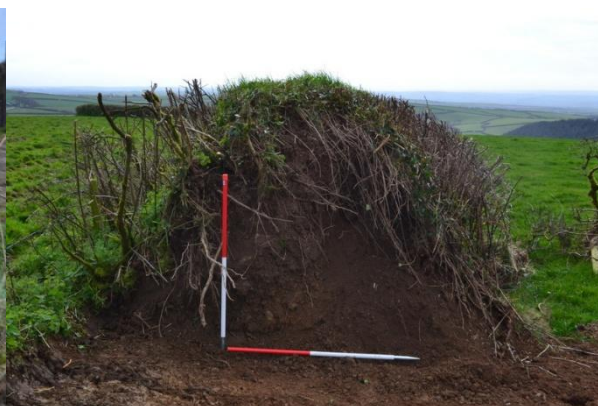
Figure 1.3: Hedge Section 2 removed (view south)

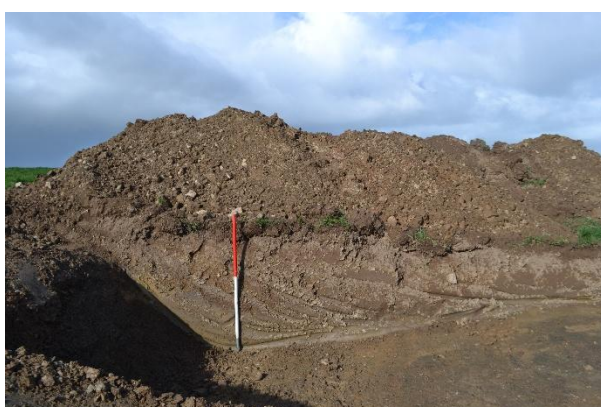
A section of the boundary ditch was excavated with the machine bucket and cleaned up by hand. The ditch cut [003] ran east to west and was 0.7m in depth by 1.9m wide and had a concave base with a steep break of slope to the south and a moderate break of slope the north. The fill [004] of the cut was a clean/sterile greyish brown compact clay.

No finds were recovered either from the ditch fill [004] or from any of the topsoil [001] and no other archaeological features were identified within the trench.

Figure 1.4: Section through boundary ditch in Trench 1 (view east)

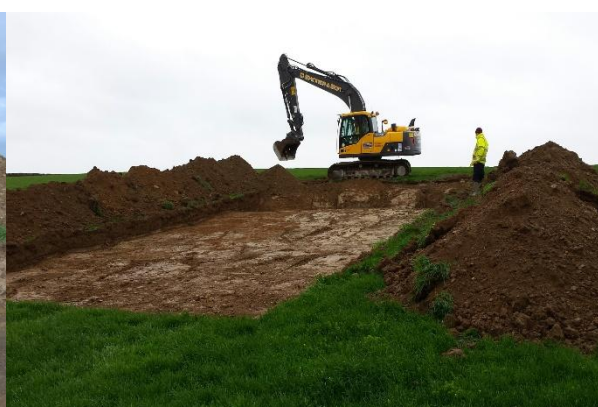
Trench 2 measured 13m by 73m. The topsoil [001] was on average 35cm in depth and was very similar, if not identical, in character to that of Trench 1; as was the underlying natural [002] morphology. Several amorphous areas of clay [005 – 008] were noted and although they appeared natural these were excavated in order to be thorough. Excavation confirmed these pockets and bands of clay were part of the natural [002] geology.

No archaeological features of any description were located within Trench 2 and no finds were recovered from the topsoil [001].

Figure 1.5: Trench 2 being stripped (view southeast)

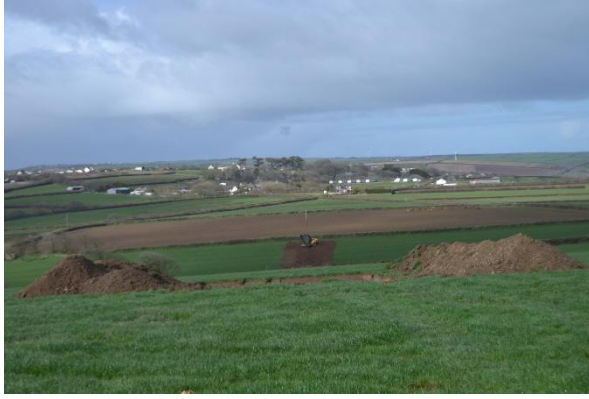
Figure 1.6: Trench 3 in distance and Trench 1 in foreground during backfilling (view north)

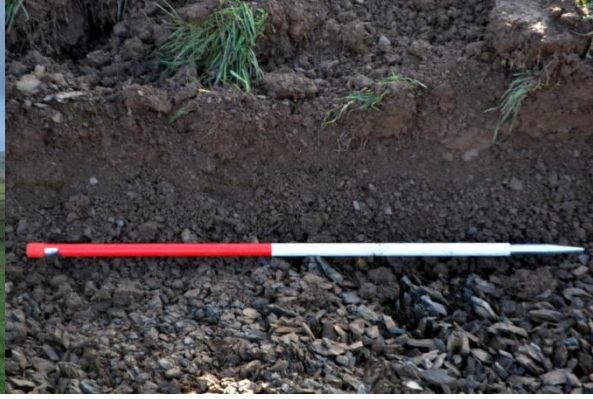
Trench 3, measured 9.5m by 68m. The topsoil [001] was on average 30cm in depth but far deeper (up to 70cm) at the southern end. Again the topsoil [001] was similar in character to the first two trenches but was a little heavier and contained more clay at the deeper southern end.

Removal of the topsoil [001] revealed the underlying natural [002] shale with no archaeological features identified. One small sherd of post-medieval/modern pottery and a short length of clay tobacco pipe stem were recovered from the topsoil [001] during stripping.

Figure 1.7: Trench 3 section, (view east)
