Archaeological Report on Work Undertaken at

Stockwell House,

Badby,

Planning Application: Ref DA/2013/0810

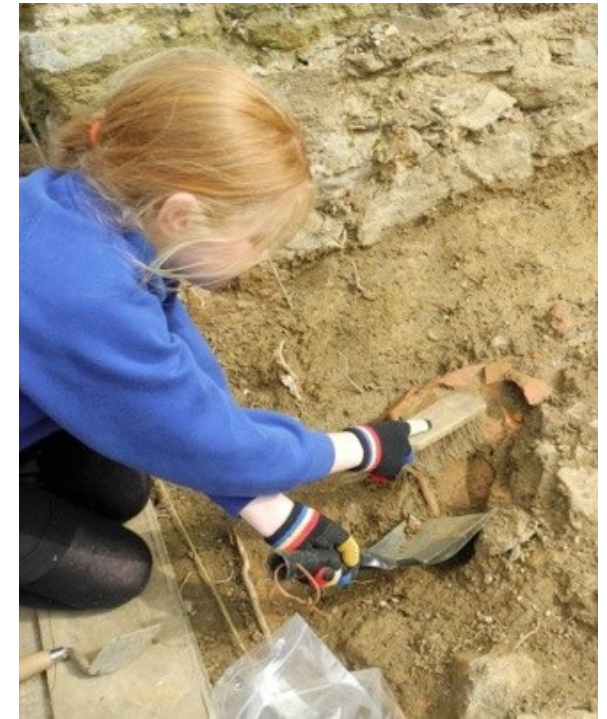
Fig. 1 Area C, excavation of C010, pottery filled soakaway.

5.3.3. A large concrete pad incorporating a square socket with the remains of a vertical timber post (C008) was excavated to the north of the forge whilst a pit (C009) packed with a loose fill comprising almost entirely of large pieces of smashed plant pot (C010) was investigated close to the northern end of the west wall (C011) of the building. This was interpreted as a soakaway for a former down pipe from the building (Fig. 1).

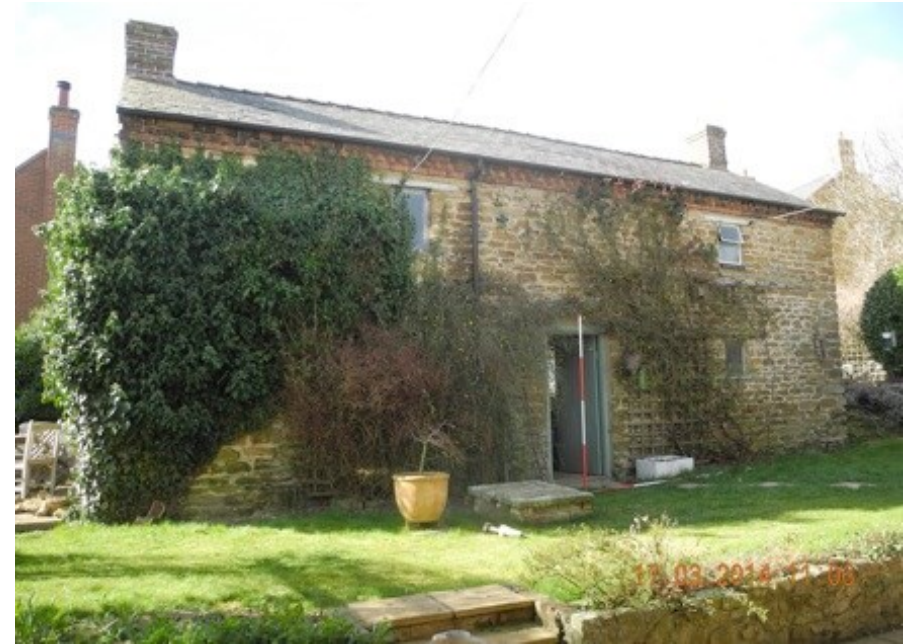
Fig. 2 The building from the north east.

5.4.3 The building was rectangular in plan measuring approximately 11.50m by 4.50m with a wall thickness between 0.45m and 0.50m (Fig. 17). The wall was of roughly coursed ironstone rubble but unusually was lined throughout with a single thickness of brick (Fig. 16). Enquiries amongst local builders and a conservation architect have failed to find another example of this practice. Detailed examination indicates that the brick lining is part of one build rather than a later insertion. Externally the north and south walls were capped with three courses of brick, the middle course being set diagonally to create a saw tooth decorative effect (Fig. 2).

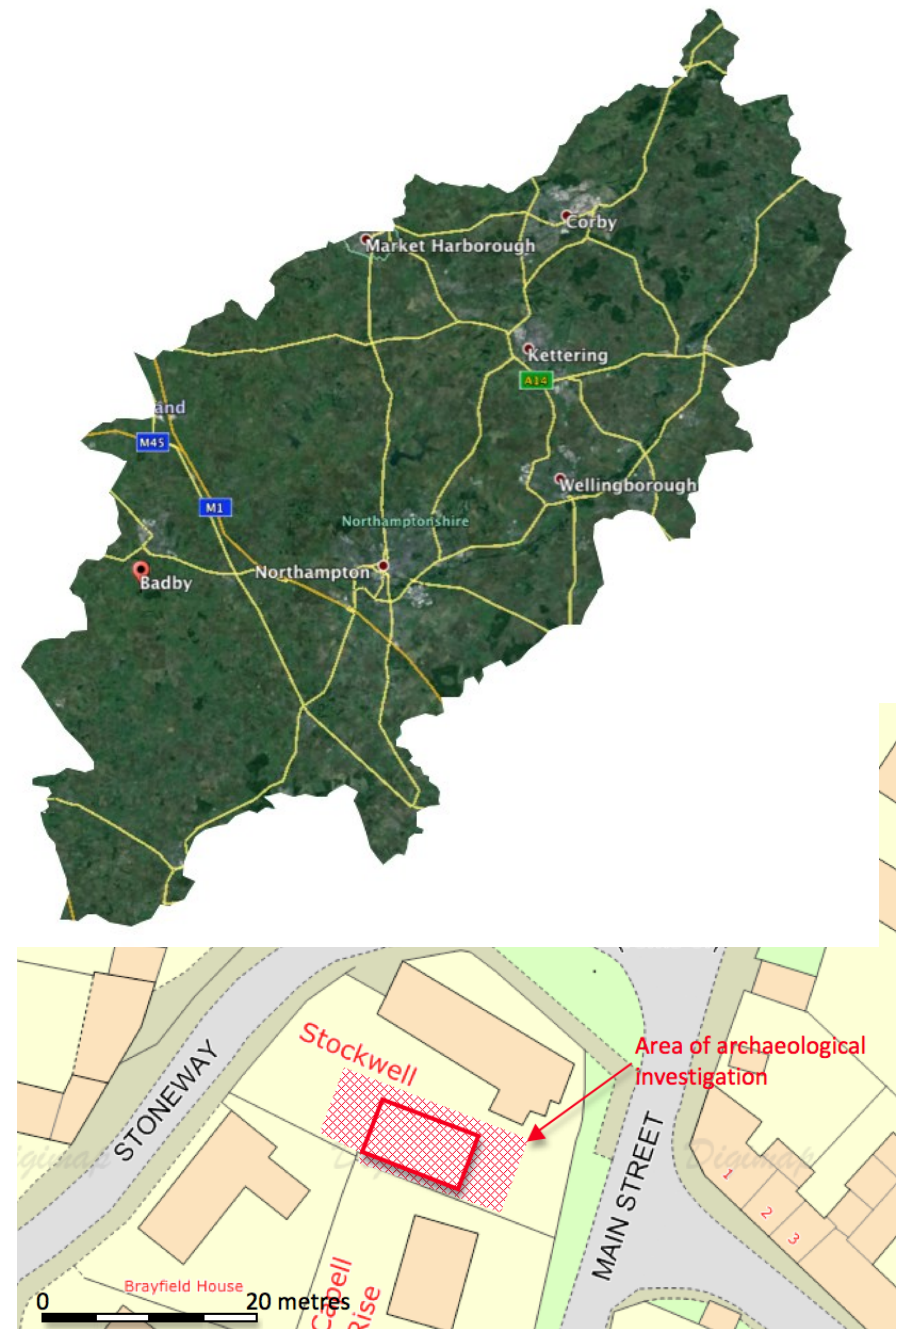
Fig.3 Stockwell House, area for investigation

3.2 The study area comprises an unoccupied two storey stone and brick outbuilding (Fig. 2) to the rear of Stockwell House and the land immediately surrounding it together with attached areas of approximately 12 square metres each to the east and west (Fig. 3).

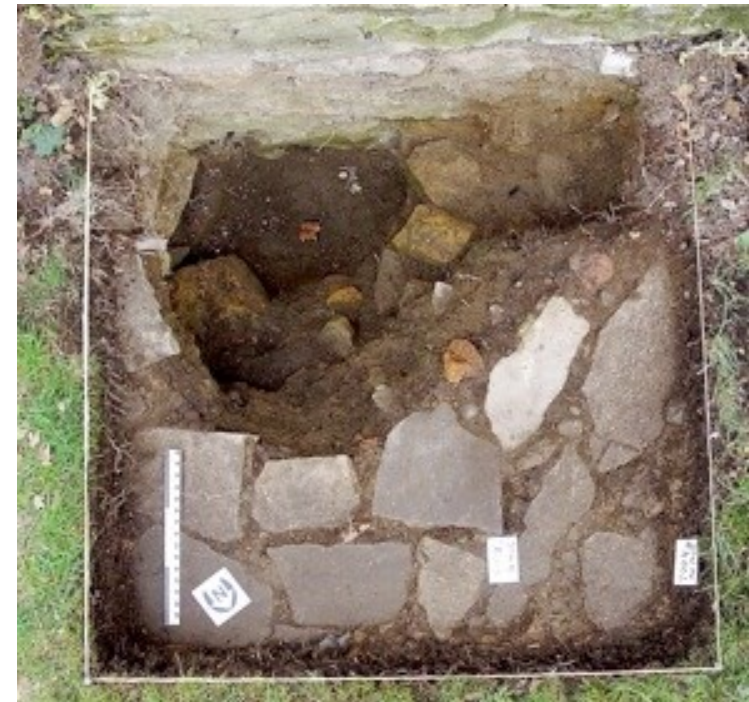
Fig. 4 Area A, Test pit on north side of building

5.1 AREA A. An irregular test pit approximately 0.90m by 0.60m and up to 0.80m deep had been dug (A007) by a contractor to examine the building's foundations on its northern side (Fig. 4). This was redefined as a 1m square test pit and the remaining turf and topsoil (A001) within stripped away to reveal a series of irregular concrete slabs laid as 'crazy paving' (A002). The sides of the pit were cleaned and three more contexts identified: a thick (0.40m) make up layer of clayey loam (A003); an irregular spread of ironstone (A004) which may be the remains of an earlier yard, and a dark loamy level (A005) lying below it (Fig. 6). Foundations for the north wall (A006) occupied a narrow (0.30m) cut (A008) for the full depth of the pit.

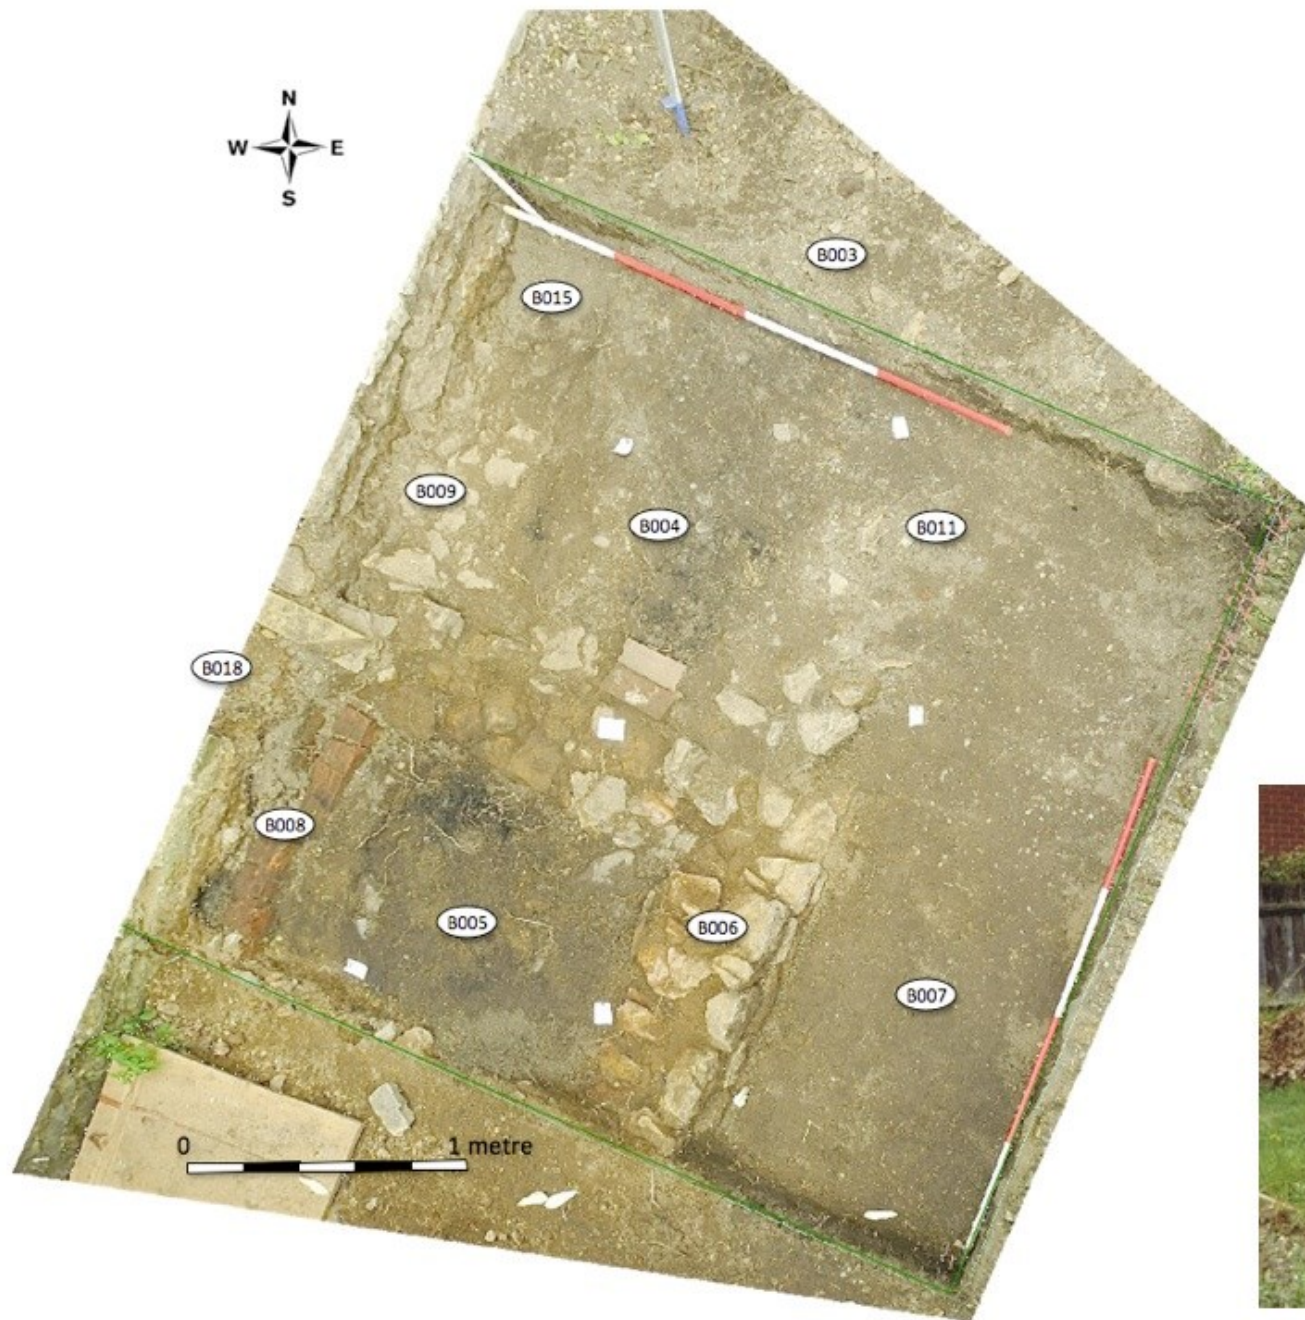
Fig. 7 Area B after removal of B003

5.2.1 AREA B. This area lay on the east end of the building and had been occupied by a patio of square concrete slabs (B001) overlying an earlier hard standing of irregular iron stone slabs (B002) both of which the contractor had removed. This left a mixed layer of debris including loose gravel with some ironstone fragments (B003). 1 square metre of this was cleared close to the centre of the area and it became immediately obvious that there were a number of archaeological features surviving and so a trench 3m square was laid out and B003 removed completely (Fig. 7).

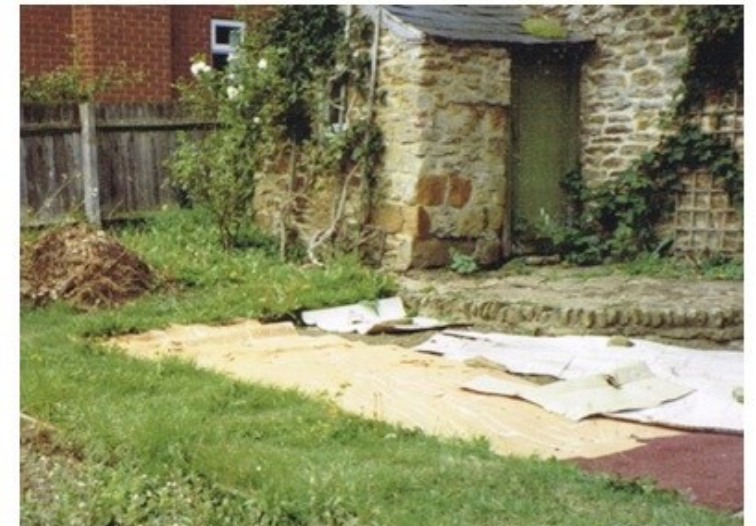
Fig. 8 Privy viewed from north east, August 1996

5.2.3 The north and east walls of the privy were exposed (B006), the southern wall was outside the excavated area. Beyond the privy wall to the east was a layer of dark loam (B007) probably an earlier garden soil. The surviving wall stood a couple of courses (0.25m) above this (Fig. 9). A similar dark loam with significant proportions of ash and coal in it (B004) lay to the north but was sealed by the worn remains of ironstone paving (B009) marking the original entrance. Further to the north was a shallow cut (B019) against the face of the building (B018) filled with a loose very dark loam (B015) which was interpreted as a planting pit.

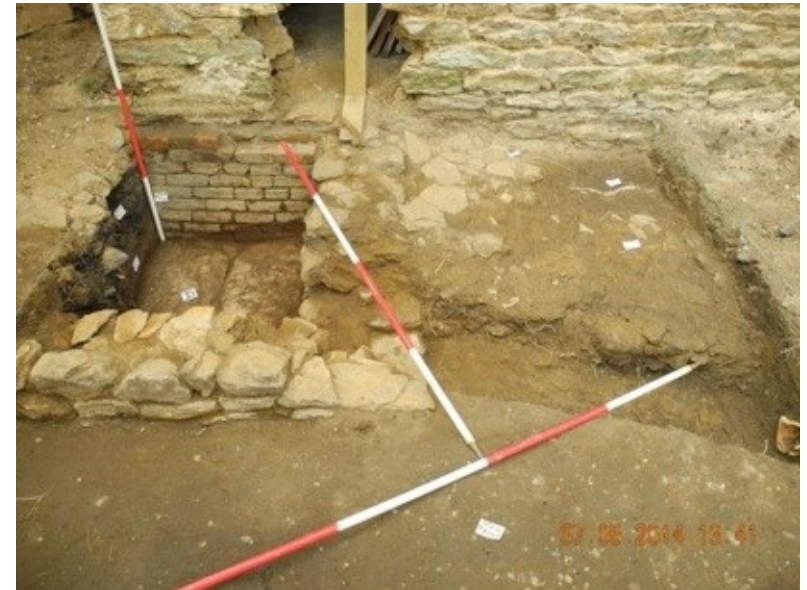
Fig. 9 Area B viewed from east.

5.2.2 The most obvious feature was an 'L' shaped foundation of ironstone rubble set against the south east corner of the building (B006). The owner informed us this belonged to a small privy (Fig. 8) which had stood on the site until demolished in 1996. However, the latest feature in the trench was the cut (B012) and fill (B011) of a 20th. century drain pipe (B013) which ran across the site, cut through the north wall of the privy, and disappeared into the section to the north and south (Fig. 9).

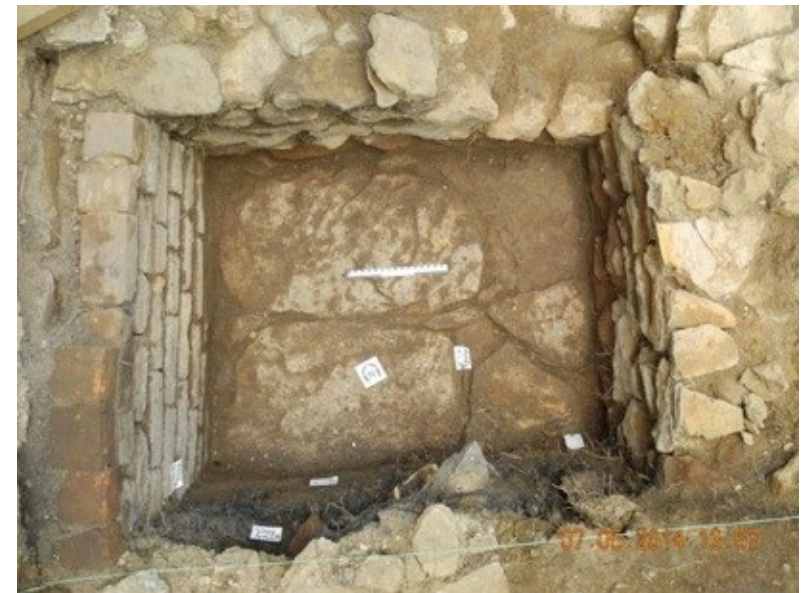
Fig. 10 The cesspit, vertical view, north to the top.

5.2.4 The inside of the privy was marked by a thick deposit (0.30m) largely composed of coal dust with some larger lumps of coal (B005). This gave way to a loose silty multi-coloured layer (B010) which was evidently the fill of a cesspit below the original privy which presumably originally had a timber floor. This gave out onto a well laid stone slabbed base (B014) in the harder grey form of the local ironstone giving the pit a maximum depth of 0.50m (Fig. 10). The pit was lined along its west side against the ironstone wall (B018) with a single thickness brick wall (B008) presumably to limit the spread of noxious material into the accommodation. Finds suggested the pit was cleared out until its final closure and sealing with debris from a coal shed around the middle of the 20th. century.

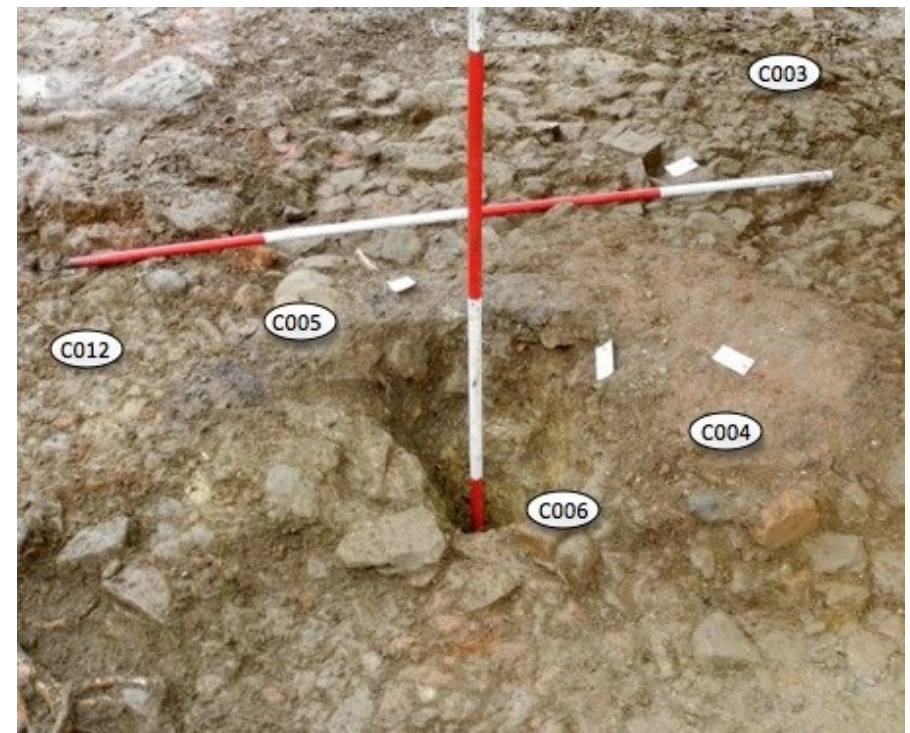
Fig. 12 Area C, forge area from south.

5.3.2 Just to the south west of the centre of the trench was a complex feature which was viewed as the location of a small forge (Fig. 12). This consisted of a compact platform of reddish gravel, ash and burnt stone (C004) interpreted as the base of a hearth. A large negative feature, roughly 0.50m in diameter and around 0.60m deep (C006), with a loose rubble fill (C007) was seen as the setting for a timber anvil base. This lay immediately west of the hearth base and was partially surrounded on the north and west by a semicircular deposit of hammer scale (C005). The hard standing to the west had an admixture of sand and ash (C012) presumably reflecting the normal working surface as used by the smith.

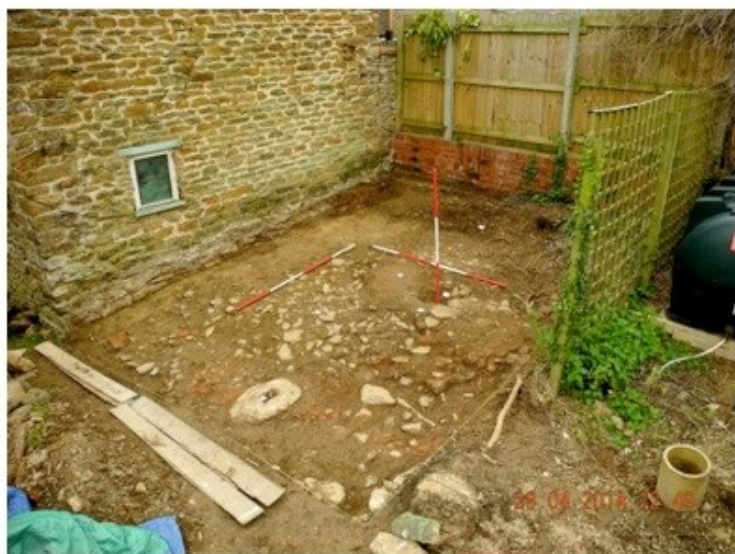
Fig. 13 Area C after removal of C001, view from North west.

5.3.1 AREA C. The contractor had already removed large quantities of topsoil and other garden elements such as a rockery leaving a mixed layer of loose rubble and loam (C001) across the whole area. This was cleared away over an area of roughly 25 square metres. The underlying layer (C003) was a spread of rough ironstone cobbling with numerous brick fragments included in the surface. The density of stone and brick diminished towards the northern edge of the area. Towards the south east corner of the area the underlying layer of yellowish clay (C002) was showing through presumably where the contractors had scraped it away.

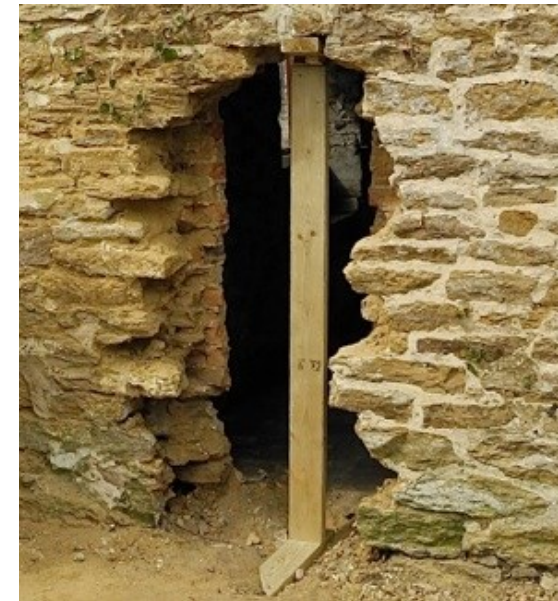
Fig. 16 Cut through east wall showing construction.

5.4.2 In the areas examined the building had no differentiated foundations, rather the ironstone walling was simply taken down to what was considered to be an appropriate depth which varied considerably. The south, west and western portion of the north wall are based on a terrace of natural yellowish clay (B017, C002) which slopes gently down towards the north east before dropping away under the north east corner of the building. In the test pit (Area A) the walling goes down over 0.80m whilst on the opposite corner there are barely three courses (0.25m) below the interior floor level. The fact that a considerable portion of the building is founded directly on this natural suggests that the area was artificially terraced to the south west thus removing any earlier deposits. To the north east a considerable depth of stratification was revealed in a 2.50m deep soakaway pit dug by the contractors.

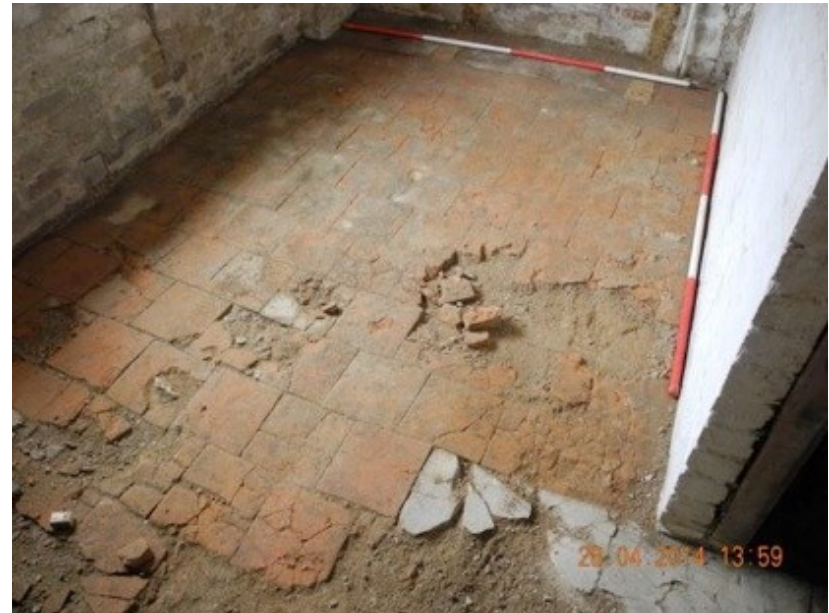
Fig. 18 Quarry tile flooring in southern portion of west bay looking west

5.4.5 The ground floor was divided into two bays by a cross wall west of the front door. The western bay (Fig. 18) was floored in badly degraded square quarry tiles (D001) on a mortar (D002) bedding laid directly on the underlying clay (D003). A single brick thickness wall had been constructed on the tile floor to further subdivide the bay into a smaller northern part and a larger southern section. In both rooms were low brick walls designed to support work benches and towards the east end of the northern room was a concrete foundation for a piece of machinery which would have secured by four bolts, possibly a pillar drill. At the west end was a shallow chimney breast with a small blocked fireplace.

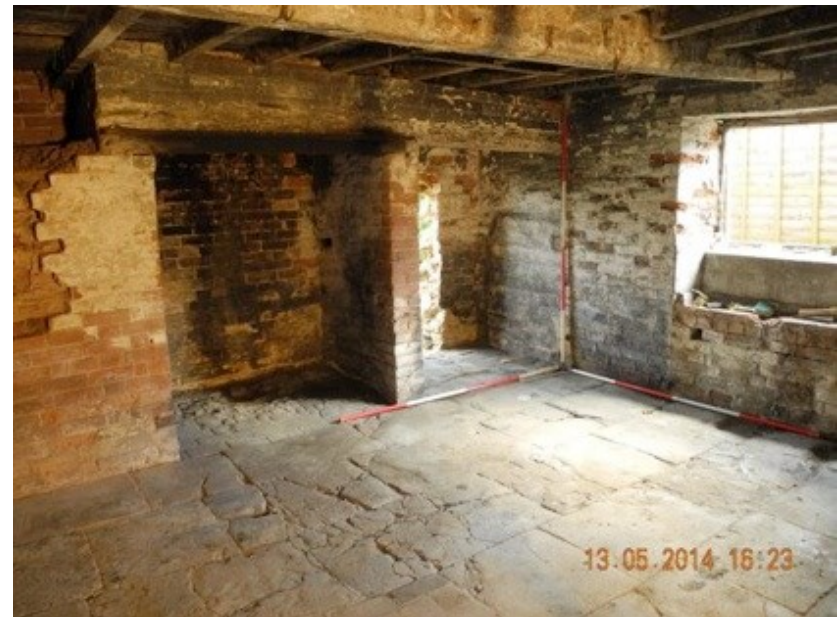
Fig 19 East bay with stone flags and fireplace looking south east

5.4.6 the eastern bay was the larger and contained the stairs to the rising along the line of the dividing wall. The room was floored with stone flags (E001) above a make up layer of sandy rubble (E002) which lay on yellow clay (E003). On the east wall a large open fire place, brick floored under a timber bressummer, was flanked by a raised circular bread oven to the north (Fig. 20) and to the south by a small brick floored bay which, given indications in the adjacent wall, was the site of a copper (Fig. 21). Formerly there was, against the south wall under the large window, a stone sink, below the site of this survived a drain with a square cast iron grid.

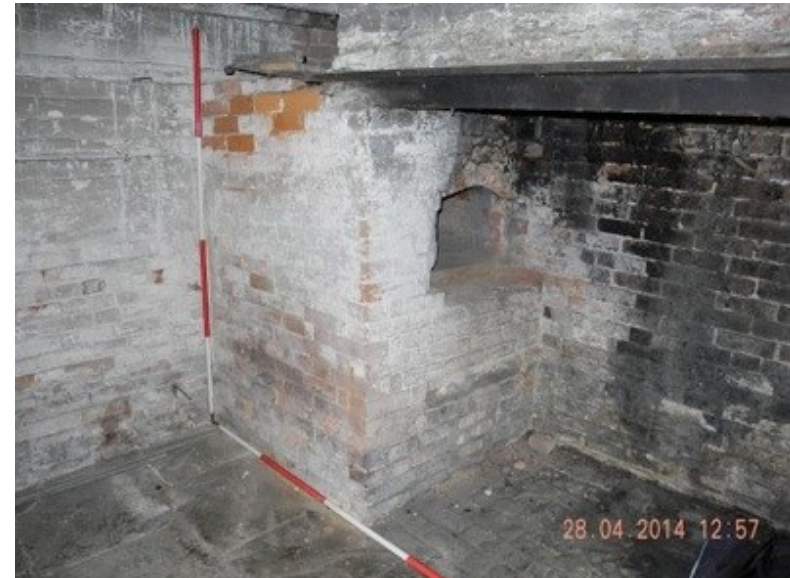
Fig. 20 Bread oven north of fireplace looking east

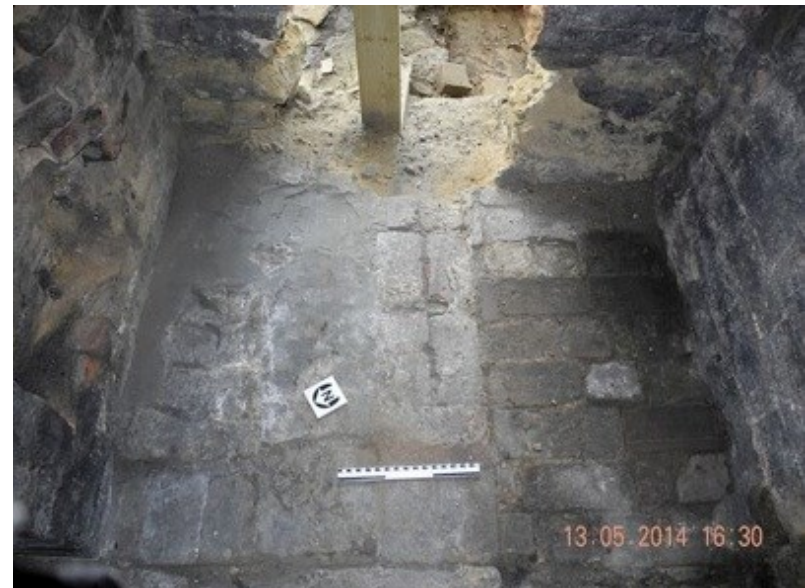
Fig. 21 Bay to south of fireplace looking south east

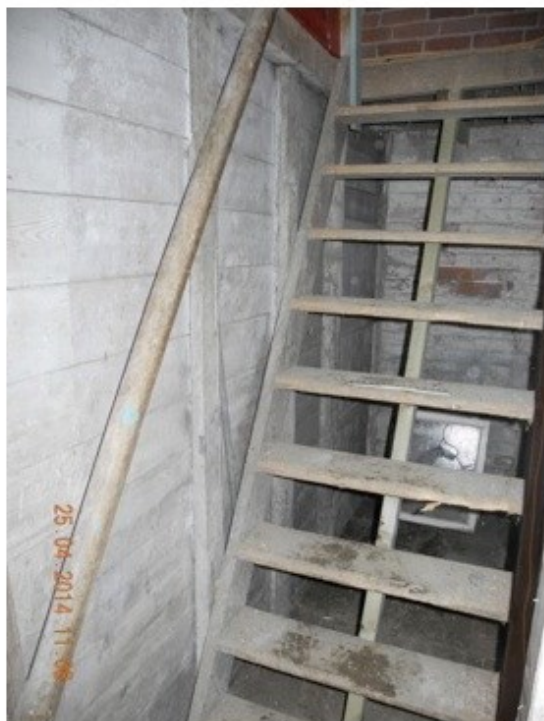
Fig. 22 Stair with flanking partition and handrail looking north

5.4.7 A wooden ladder stair (only treaders, no risers) was positioned against the dividing wall climbing towards the south wall (Figs. 22 and 24). This was partitioned off from the room using four vertical posts and horizontal planking creating an under stair space which was entered at the south end by a plank and batten door with hand forged hinges and thumb latch (Fig. 23). A rounded handrail was fixed against the partition and where the stair opened onto the first floor it was partially enclosed by a further low post and plank partition. The entrance to the stair was originally closed off by a door, now lost, but a shaped wooden keeper for a thumb latch survives on the first post of the lower partition. Also surviving is the plank and batten door to the rooms in the west bay which

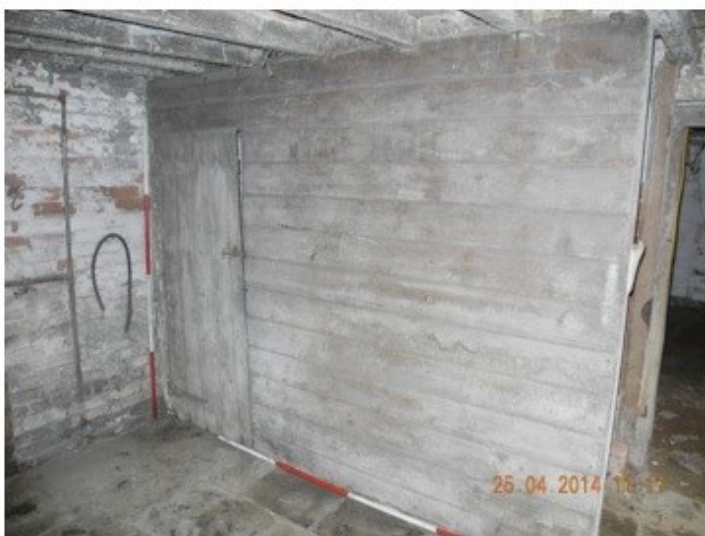
Fig. 23 Partition with door (left) and keeper for latch (right) looking west

also had hand forged hinges and thumb latch. A mixture of timbers was use including oak for some of the posts and chestnut and elm for some of the planking.

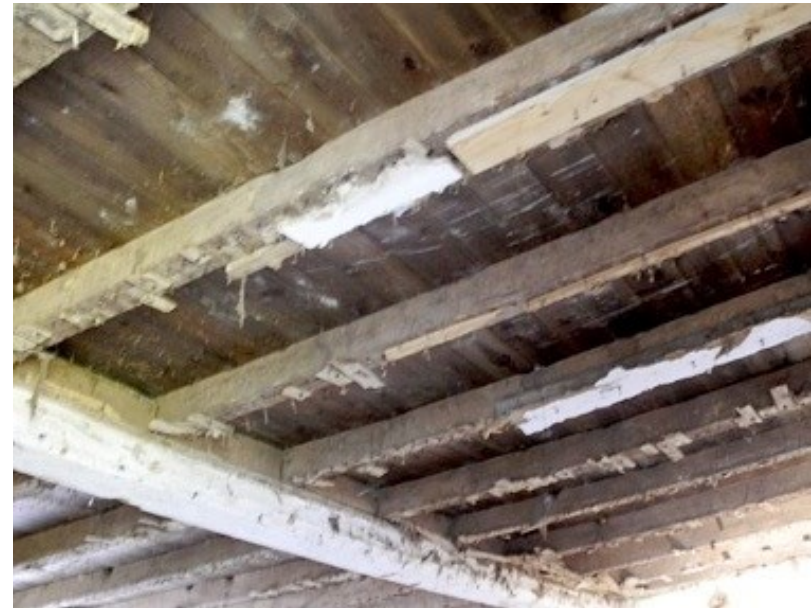
Fig. 25 Spine beam and joists, west bay looking south west

5.4.8 The first floor was supported on joists jointed into two spine beams. That in the west bay was set into the partition and end wall roughly 0.20m square with a chamfer of 0.03m. The joists appeared machine cut and were 0.10m square and carried a suspended lath and plaster ceiling below and softwood floorboards above (Fig. 25). The construction of the floor above the east bay was significantly more robust with a large (0.30m square) deeply chamfered (0.10m) spine beam running north south and carried on the outside walls. The joists were 0.20m square and carried the floorboards above but there was no evidence for a plaster ceiling below (Fig. 26).

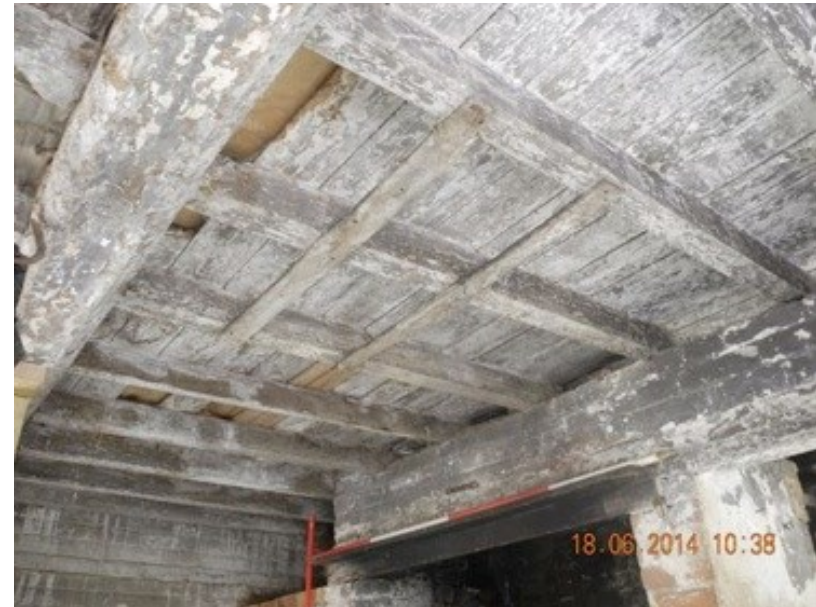
Fig.26 Spine beam and joists, east bay looking north east

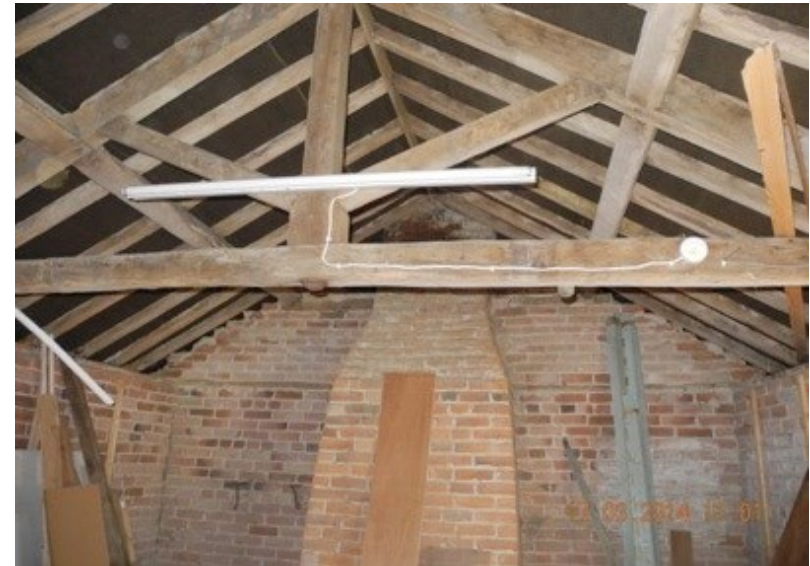
Fig. 27 Chimney breast and roof construction, east end

5.4.9 Fittings to the first floor had been removed by contractors, floor boards were badly wormed and insecure. There were chimney breasts evident at either end of the building, that at the west end being significantly the larger. These gave way to brick chimney stacks which had decorative string courses but no surviving chimney pots. The roof was of modern construction, felted and slated over softwood rafters but was based on three earlier king post roof trusses with iron fittings (fig. 27).

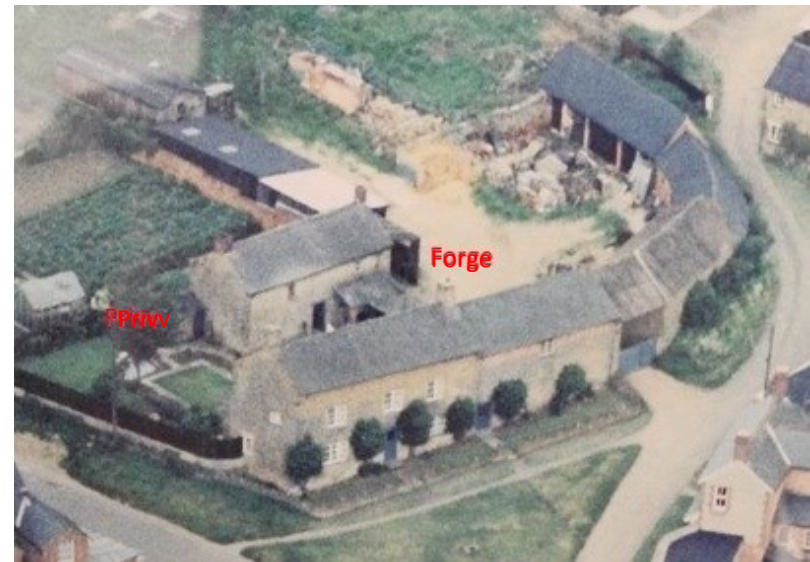
Fig. 28 Stockwell House and yard, aerial photograph from the north east believed to have been taken in the 1960s

house and approached by an ironstone paved path. This arrangement is shown in an aerial photograph from the 1960s (Fig. 28). The associated cesspit was cleared out regularly until the middle of the 20th. century when mains drainage arrived and a water closet inserted. At this point the cesspit was closed and carefully capped with a thick layer of coal and coal dust from a nearby coal shed. One imagines this would have then been paved although no trace of this remains. Before demolition it was used for casual storage and the area in front of it converted to a patio.

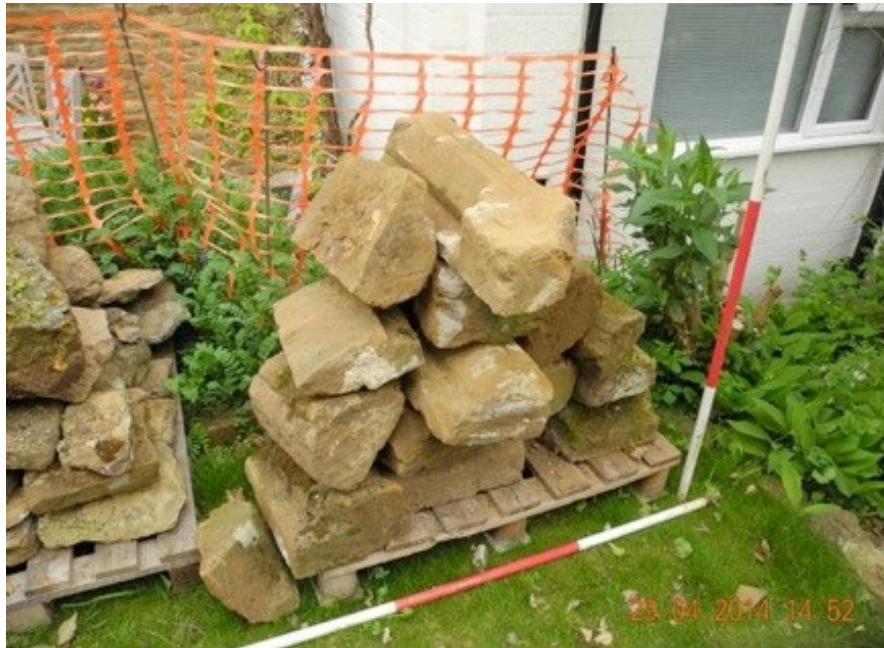
Fig. 29 Architectural fragments from around the garden collected together by the contractors

intermittent and infrequent. The presence of a builder's yard also explains the quantities of architectural fragments (Fig. 29) from a large building of the 16th. or 17th. centuries (See Appendix 3)

Scattered around the garden were 19 architectural fragments, They had been used for landscaping and steps and had been collected together by the contractor for convenience's sake and piled on a timber pallet (Fig. 29). Each stone was examined, measured and photographed. All the pieces were of ironstone and all sections of mouldings from around window openings with flat splays. There were no mullions or transoms within the assemblage. Wood-Jones suggests that this form is commonly found in the region and can date from anything from the late 16th. century to the early 18th. century (Wood-Jones 1963:257). Their presence may be explained
