# Archaeological Investigation: Monitoring and Recording

Carriage Splash,  
Croome Park  
Croome d'Abitot  
Nr High Green  
Worcestershire  
WR8 9DW

Report by Stephen Wass  
MA, MCifA (7651)  
Polyolbion Archaeology  
For Alan Cox, Birch Brothers and  
Janine Young, Archaeologist, The National Trust

November 2017

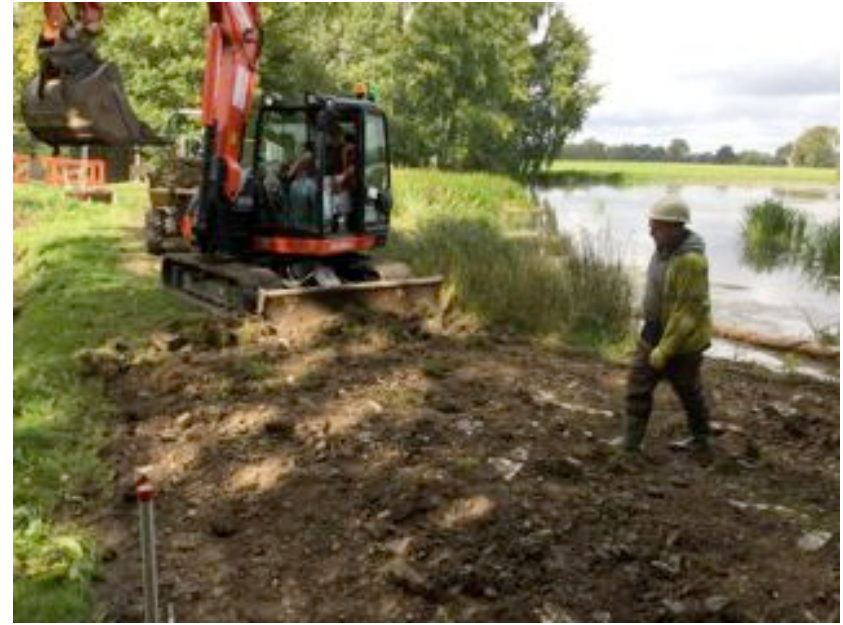
Fig. 4 Work to strip the topsoil begins, view looking west.

3.1 Observations were carried out as the upper surface of the causeway was removed by machine (Fig. 4). Initially the topsoil was taken out to a depth of around 20cm then a second pass was made removing the remains of an earlier metalled surface. Samples of stone slabs were recovered and an area roughly 2m x 1.5m excavated by hand to examine the character of the metalling. Towards the western end of the causeway the upper portion of a brick built conduit was uncovered, cleaned and recorded. Here, as elsewhere on site where possible the context numbering as used by Whitefoot and Williams has been retained. All recording was done digitally on a tablet computer.

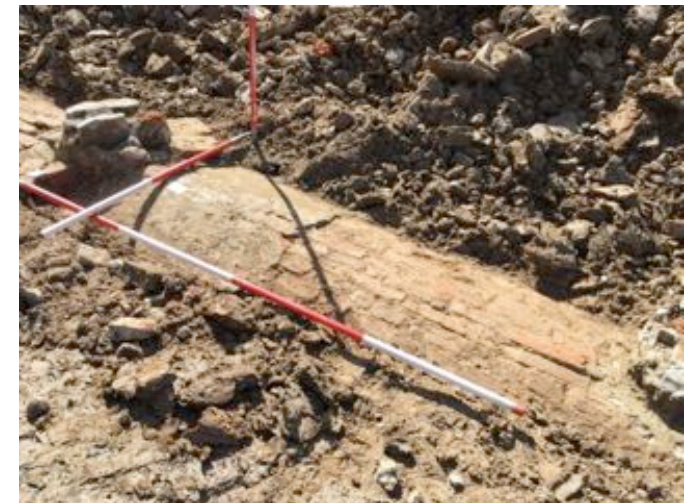
Fig. 8 Central part of conduit looking south west.

4.2 The Conduit. Further stripping of the make-up levels of the causeway (003) uncovered the line of vaulted brick conduit (043). The hand made bricks were laid longitudinally on edge in a light buff lime mortar (Fig. 8). The bricks varied in length from 240 to 245mm with a thickness between 65 and 70mm and were a light red in colour (Munsell colour value 10R 7/8). Having run on a slight diagonal across the causeway towards the southern end the conduit was constructed with a rather clumsy bend (Fig. 10) to bring it into line with a rectangular brick built pier (042) which contained the outlet (Fig. 9). These bricks were slightly shorter and better made with a darker red (Munsell colour value 7.5R 4/8) fabric and are probably a later rebuild. The pier was partially capped with a stone edging presumably for cosmetic effect. At the north end was a modern concrete slab with sluice gate. At two places along its length repairs had been made from ground level using modern concrete.

5.6 The Conduit. This brick built feature is undoubtedly part of the original construction of the causeway as there was no evidence for a cut into which it could have been inserted. The causeway of course also functions as a dam. In the normal course of events water would drain from the surrounding fields and there would be a steady flow of water towards the southern end of the River. The aim would be to keep the top of the causeway submerged but not too deeply. The conduit and

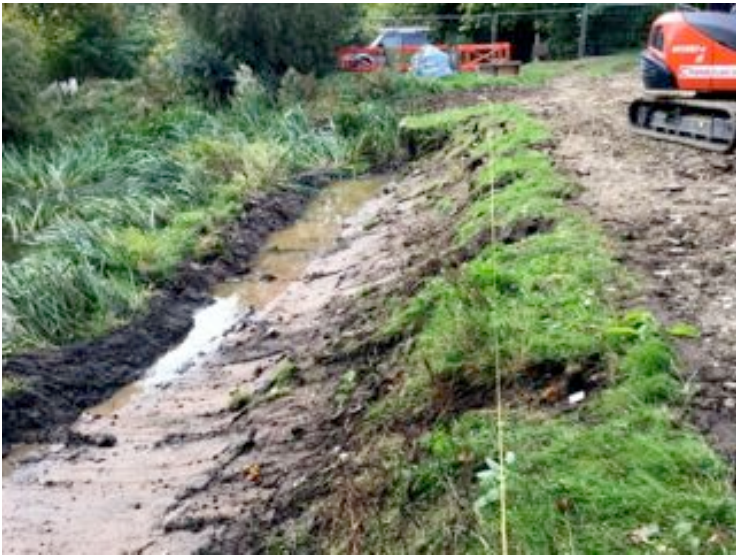
Fig. 11 Line of posts looking west.

4.3 The Wooden Posts. These had already been studied in some detail by Whitefoot. Although there was some variation in the overall pattern essentially there were probably 15 pairs of posts typically around 50 cm apart irregularly spaced at intervals between 1.5m and 2.5m. along the southern edge of the causeway (Fig. 11). The posts 031/032 and 033/035 were spaced to straddle the brick pier suggesting their late arrival on the scene. In places there were additional timbers lying against the face of the south slope of the causeway which may have been additional bracing either between the pairs of upright posts or between the down stream post and the causeway bank (Fig. 12). In places posts were doubled up or additional posts inserted indicating periods of repair and replacement. In one instance (020) a large iron spike remained in situ. This construction is clearly marked as a footbridge on the first edition Ordnance Survey map.

5.7 The footbridge is probably a late addition and again its function must be questioned as it was certainly an easy walk to pass around the southern end of Croome River. It may be that the bridge dates from a time when the causeway had become more of a functional crossing place, the bridge put up so that farm workers could perhaps lead wagons or livestock across the ford from one part of the park to another.

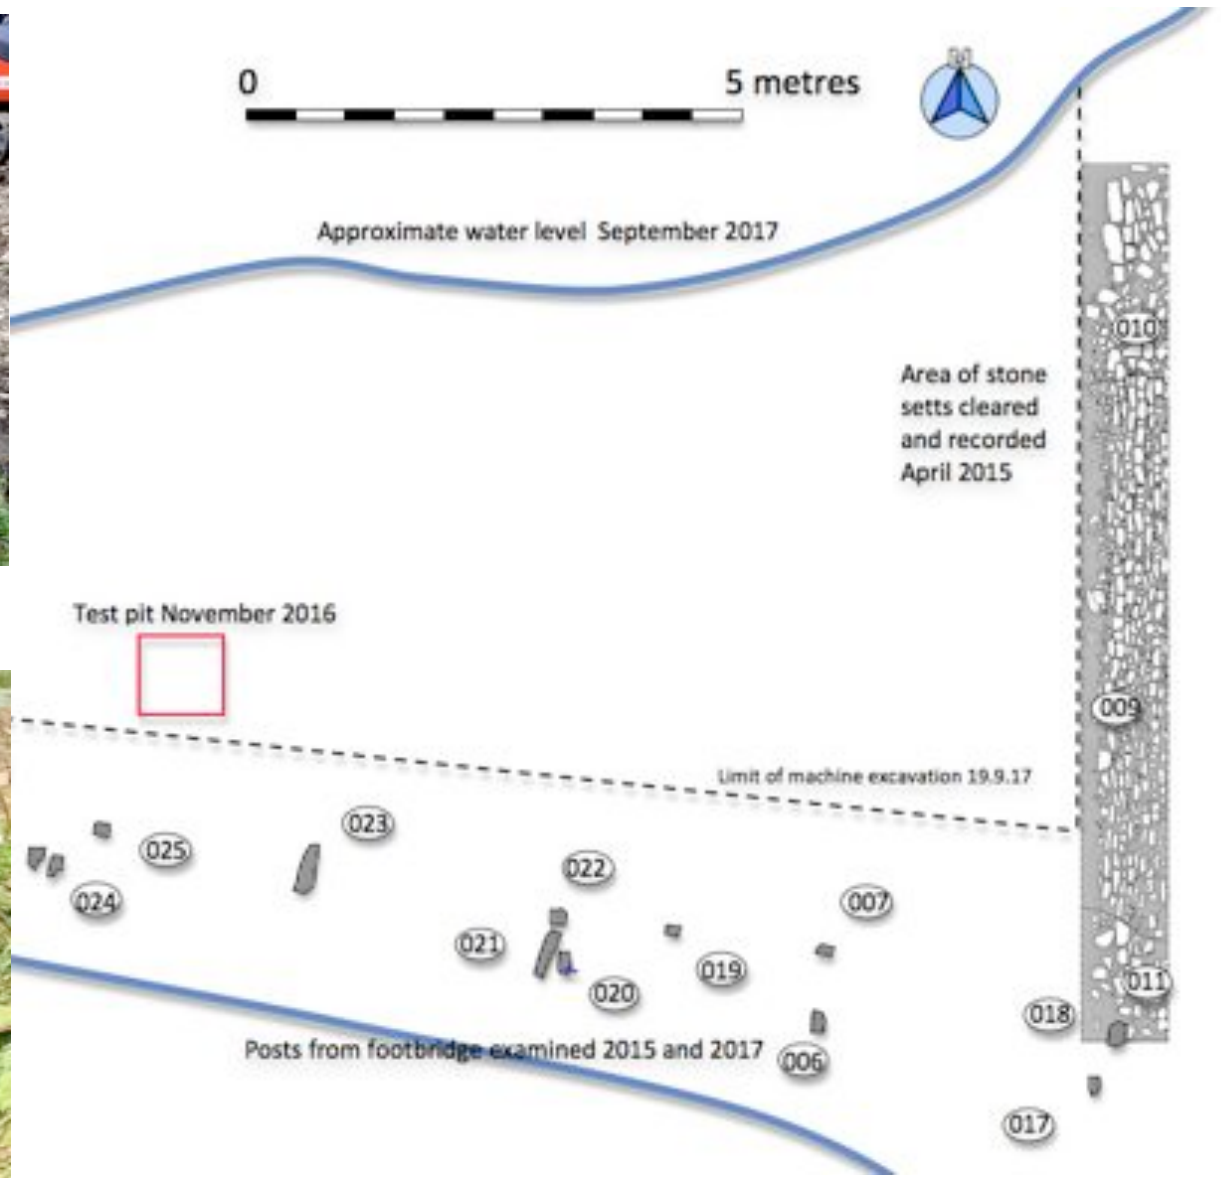
Fig. 13 East end of causeway, Plan.

4.4.1 The Pitched Stone Surface (East). Previously partially exposed and recorded by Whitefoot in 2015 (Fig. 13) there were two distinct areas at the eastern and western ends of the causeway. The eastern section (009) is roughly 6m wide on its western edge and extends around 2.5m to the east where it is lost under encroaching vegetation and a modern footpath (Fig. 14). This appears to be its limit as inspection of the woodland immediately to the east which included probing the ground with an iron road pin revealed no further traces. The stones are laid transversely and on edge to a depth of between 25 and 30cm. but vary widely in size from 10cm to 30cm in length. Whitefoot identified two flanking areas of rubble to the north (010) and the south (011).

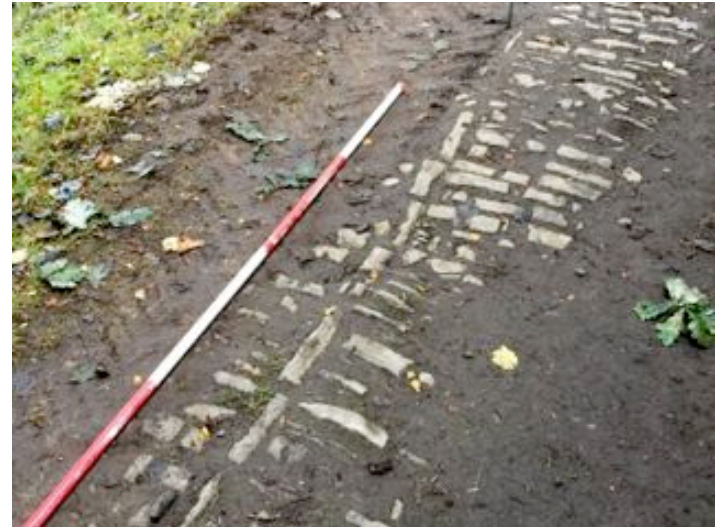
Fig. 16 Pitched stone surface to west, centre section looking east.

In the initial section adjacent to the causeway the stones are again laid transversely (Fig. 15) but further down the trackway some stones are laid longitudinally presumably to strengthen the surface (Fig 16). The metallised surface finishes at the boundary of the meadow to the west with distinct line of smaller rounded blocks (Fig. 17). Whitefoot also identified rubble spreads (013 North and 015 south) flanking and supporting the metallised surface.

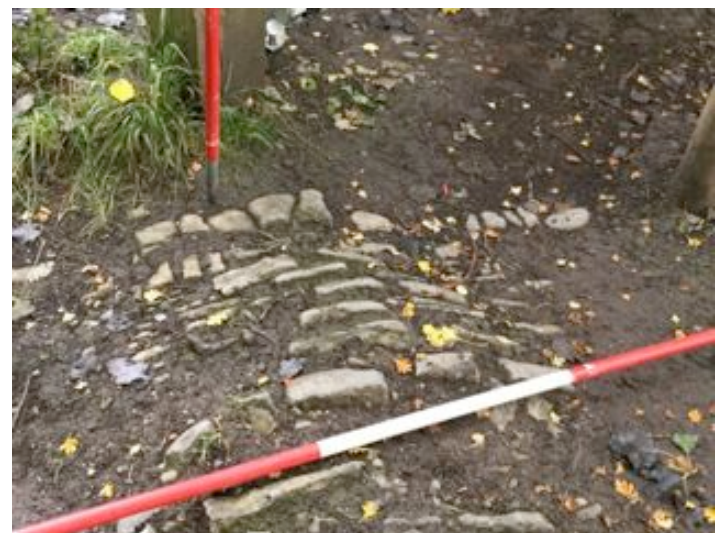
Fig. 17 Pitched stone surface to west, end section looking west.

4.4.2 The Pitched Stone Surface (West). Again brought to a well defined edge at the west end of the causeway this surface (014) extends as a trackway running along the south side of Croome River for around 55m.

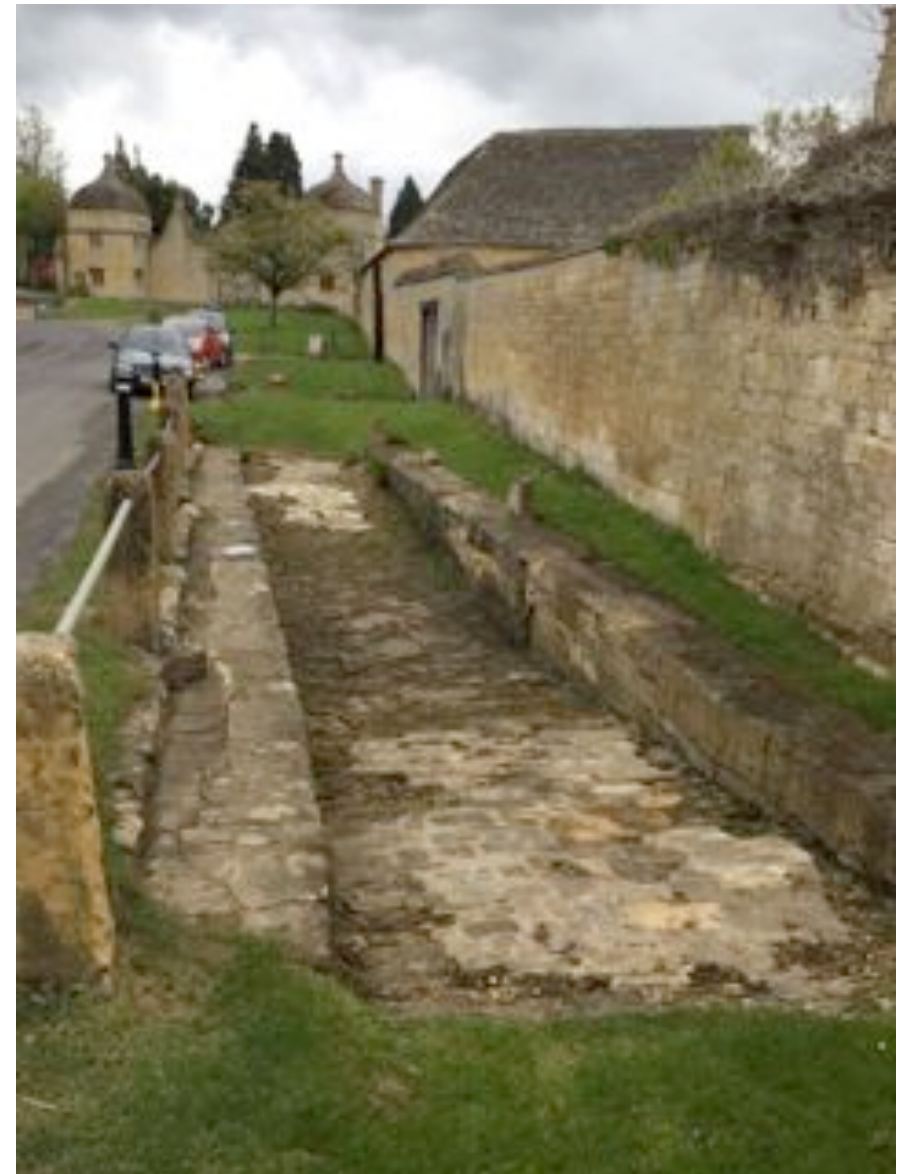
Fig. 18 Carriage splash at Chipping Campden looking east.

5.1 The key questions are what is this feature and how did it function? It is not clear who first identified it as a 'carriage splash' indeed a more neutral term might be 'ford', a feature common throughout the transport network of early modern Britain and still familiar on lesser used roads today. The key distinction is whether its role is primarily a functional one, enabling wheeled and other traffic to pass from one side of the park to the other, or whether the pleasurable excitement of driving into and through a large body of water was the main motivation. Contemporary documents appear silent on the issue and existing parallels are very thin on the ground. There is a named 'carriage splash' on the approach to the site of the former 17<sup>th</sup>.- century mansion of Sir Baptist Hicks at Chipping Campden but this appears more functional, perhaps in terms of a place to wash away the mud that would accumulate during wet weather, than a leisure feature (Fig. 18). Water splashes occasionally feature as adjuncts to village ponds and streams where again presumably they could be used for washing down vehicles as well as perhaps watering stock. Examples are known from old postcards at Brockenhurst in Hampshire, Upwey in Wiltshire and Langley in Berkshire.

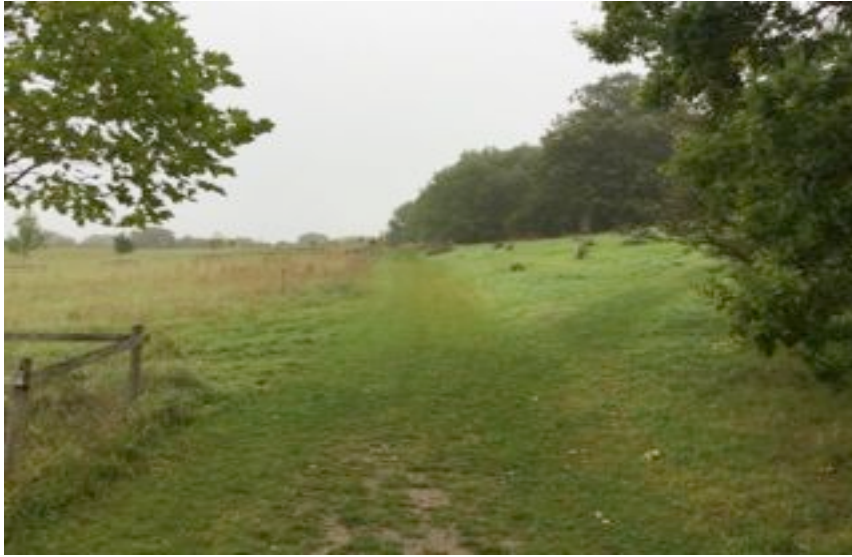
Fig. 19 View of terraced approach way to carriage splash looking east.

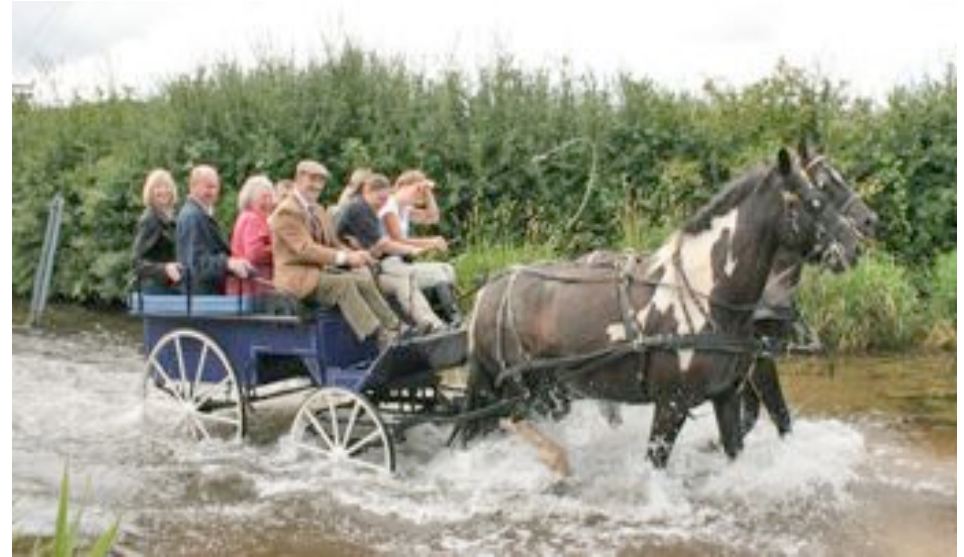
Fig. 20 A modern day carriage splash, photo courtesy of Celebration Carriages (<http://www.celebration-carriages.co.uk/picnicrides>).

5.2 Evidence from the layout around the site suggests that ‘carriage splash’ is an appropriate name and indeed places it within a circuit that was carefully planned to achieve a desired effect. The key factor in this assessment is the length of the pitched stone surfaces. To the east it extended no more than a couple of metres beyond the causeway whilst to the west it continues a considerable distance further west. This only makes sense if we imagine a short stretch at the entry point, just enough to help protect the bank, and a much greater distance covered on the far side to enable the wet coach and horses to drain and dry with a decent footing to move away on. This in effect indicates something like a one way system with the coaches picking up speed coming down the hill from the east, there is a marked terrace way here (Fig. 19), then splashing spectacularly through the water. You can see a similar effect in modern day carriage driving trials and leisure use (Fig. 20).
