10.7 The Ancillary Building (Area 2)

10.8 Conclusion

12.0 CONCLUSION

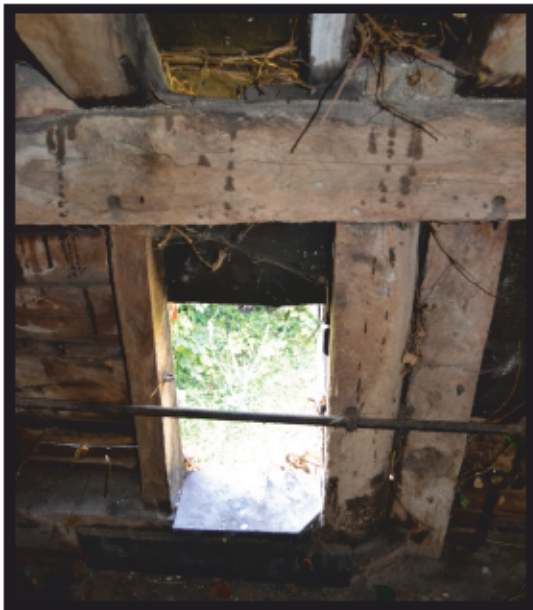
Plate 17. The Barn (Area 1), West Elevation, 1st Floor, Internal, Small Window (facing west)

A small single casement window is located on the first floor of the west elevation just below the wall plate and between the studs; it may be a later addition, as it has no

definitive surround. A second modern window has been installed on the ground floor, with the construction of the workshop.

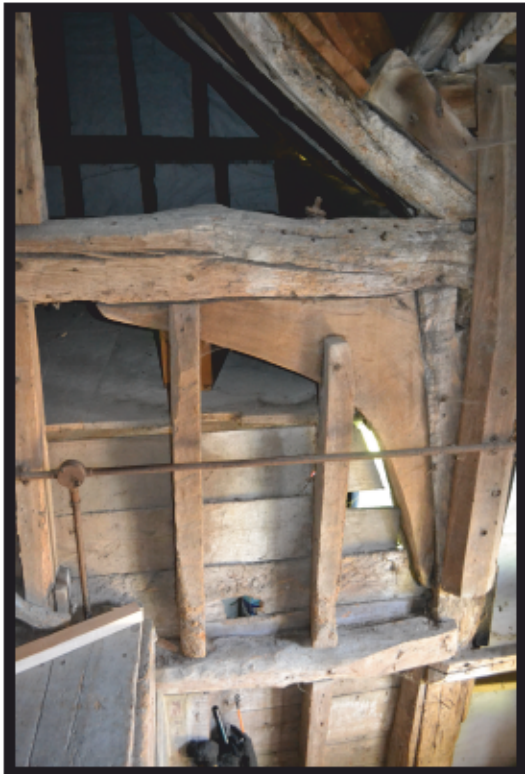
Plate 18. The Barn (Area 1), 1st floor, east section of the central bay division, facing north

The bay division to the north is in good condition. Although it has been repaired over time, the repairs have been sympathetic and the overall appearance is a fair indication of what it would once have been.

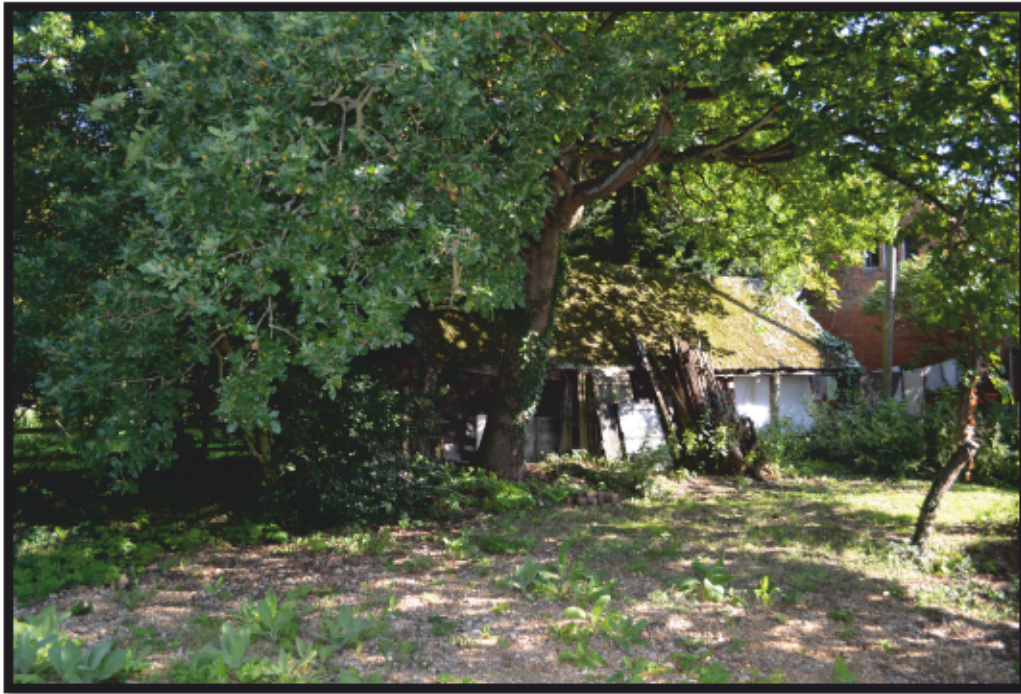
Plate 20. The Ancillary Building (Area 2), South Elevation, External (facing north)

The Ancillary Building to the north elevation is known by the current owner as 'The Cattle Shed'. The name may have some connection to its historical use. It measures 15 ft. x 40 ft. and would have been large enough for ten cattle. It is a timber-framed structure built in the same fashion as the Barn, with a brick floor and thatched roof that was replaced in the 1950's with an asbestos sheet roof. It is open to the east and south, where the yard would have been. The yard boundary is still maintained with hedges and trees. The Ordnance Survey maps show that this building has been significantly reduced from its former size and the current owner has memory of it being dismantled and rebuilt. Therefore, the construction has little historical merit.

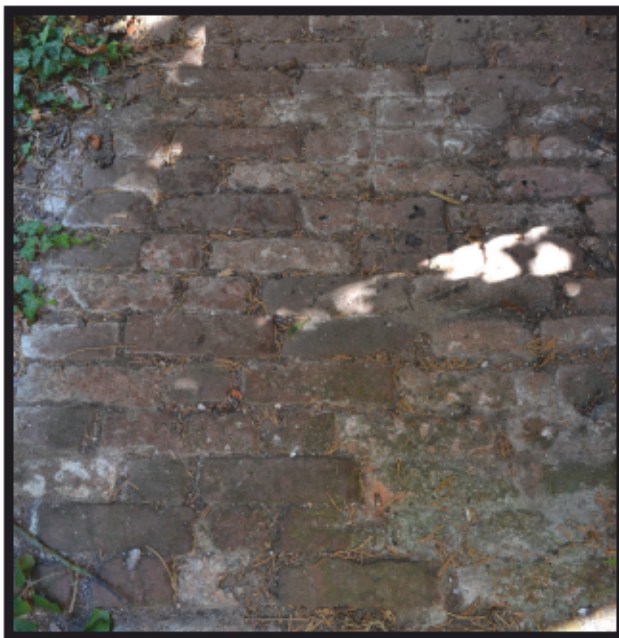
Plate 21. Ancillary Building (Area 2) - Brick floor, facing west

Plate 12. The Ancillary Building (Area 2), The Brick Floor (facing west).
