**An Archaeological Photographic Survey**  
**Of**  
**Gainford Wesleyan Methodist Chapel**  
**Gainford**  
**County Durham**

**June 2015**

This photographic survey was carried out in advance of the residential conversion of the former Methodist chapel in Gainford, County Durham (Grid Reference NZ1697716755).

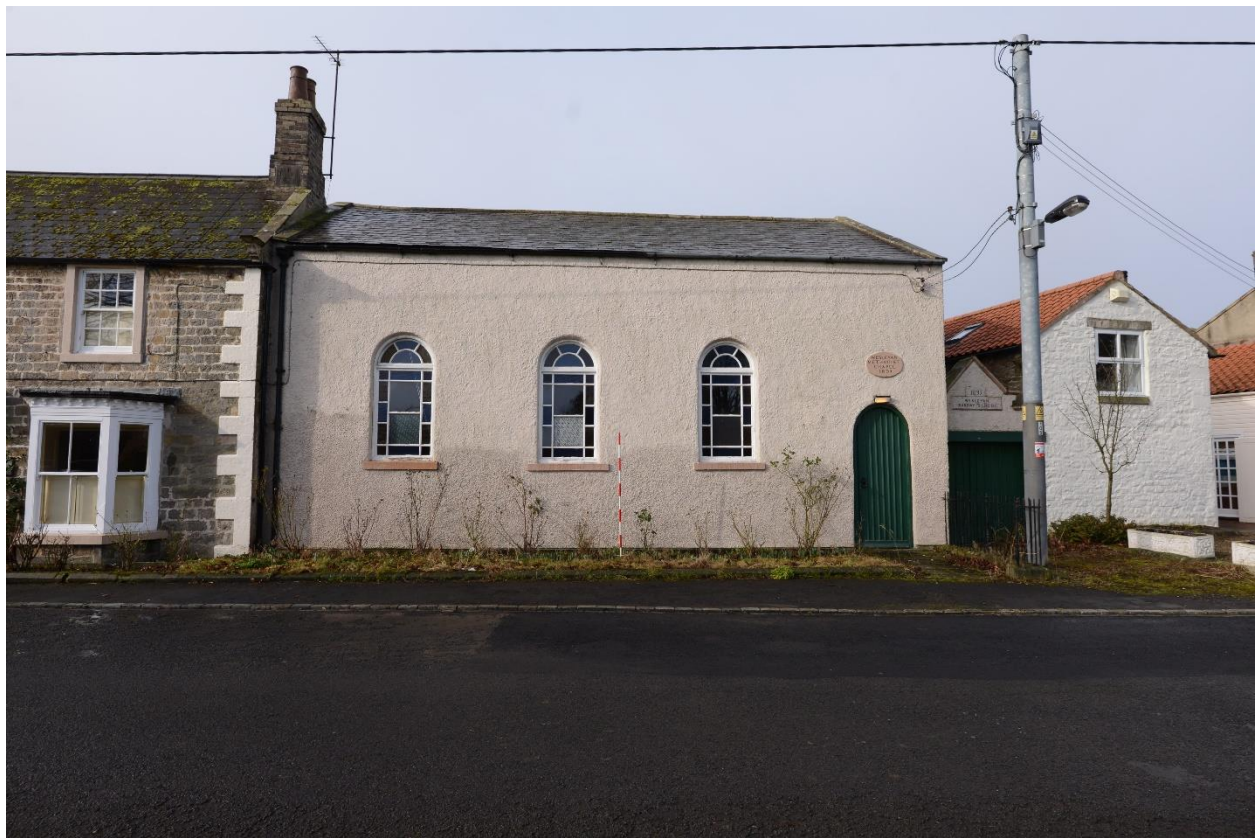
Plate 2 East elevation, facing village green

The main chapel building faces east over the village green (Plate 1). It consists of stone masonry, overlaid by render applied at various different periods, under a slate roof (Plate 2). There are three arched windows with panels of coloured glass and a nameplate over the door (Plate 3).

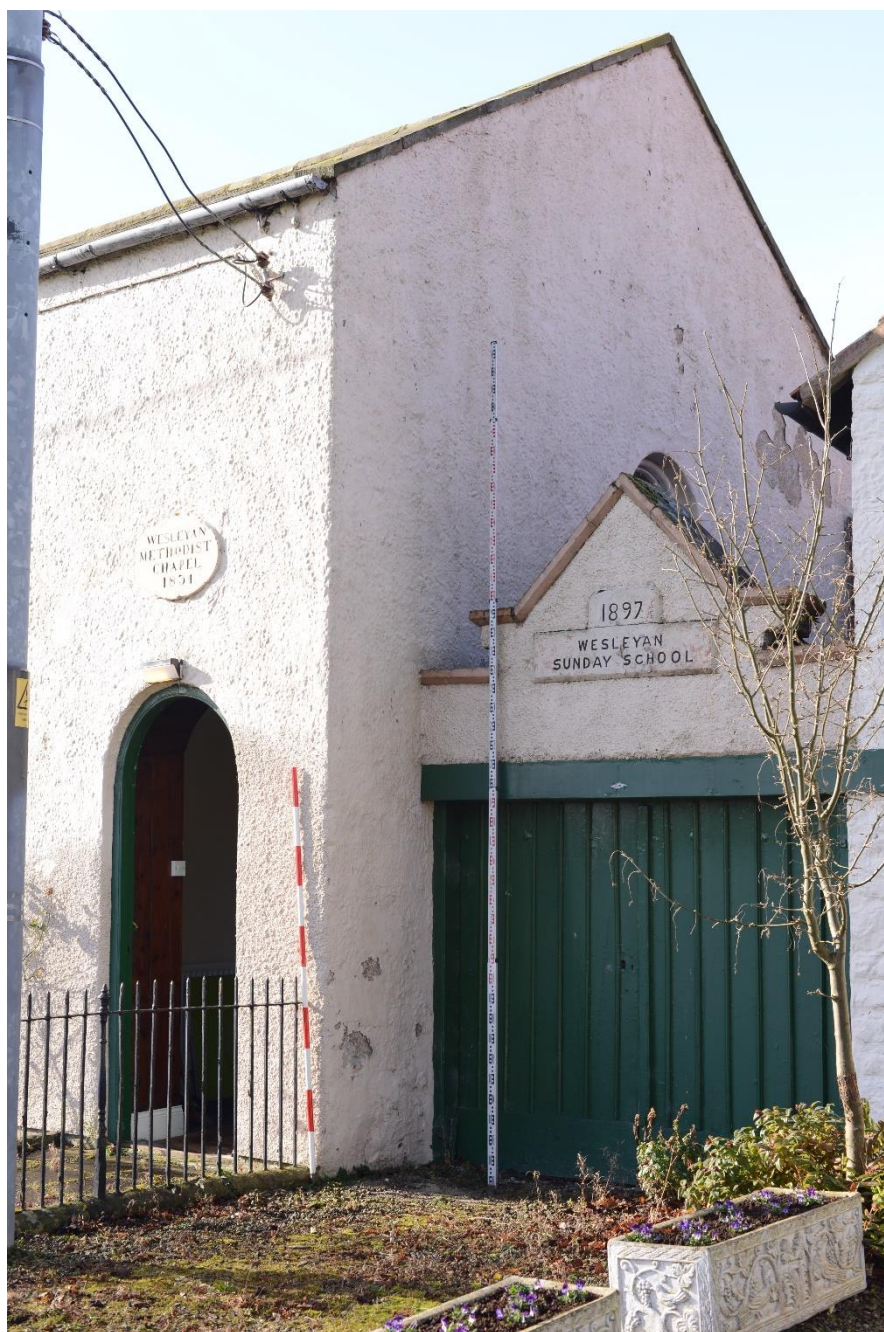
Plate 4 East elevation, north-east oblique perspective

Double wooden doors to the north of the chapel lead into a covered passageway that was once the entrance to the Sunday school (Plate 4). The entrance has an ornate parapet detail above with the Sunday school nameplate (Plate 5). The passageway is part covered by a tin-roof at two different levels (Plate 6 looking west and Plate 7 looking east). Plate 6 also shows the arched partially stained glass window in the north elevation of the main chapel building, which is mostly obscured from other views.

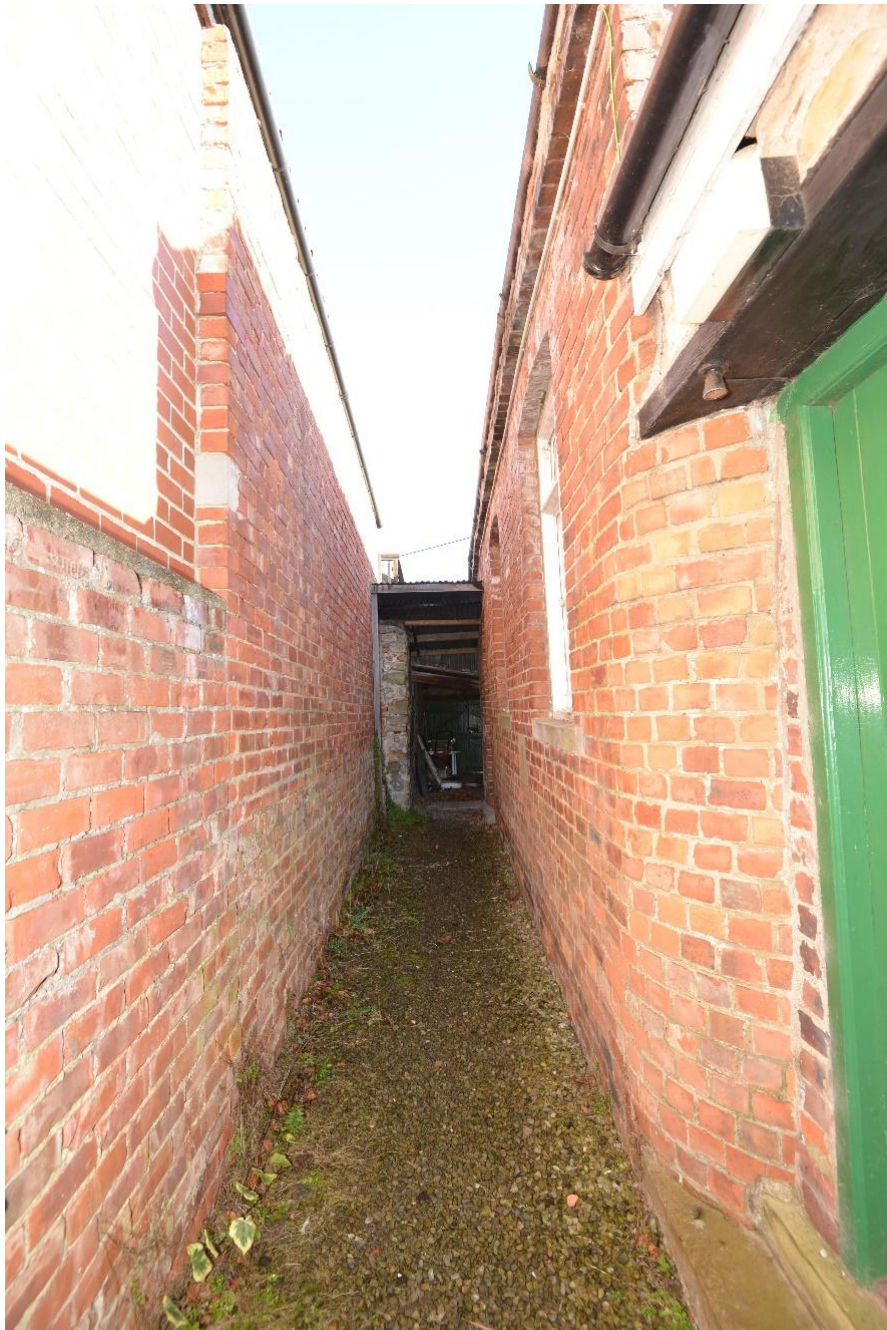
Plate 8 Passageway along north elevation of Sunday school (looking west)

The Sunday school is constructed of red brick along its north elevation and stone masonry along the west and south elevations, with a slate roof. Plate 8 shows the passageway along the north elevation of the Sunday school with detail of curved brickwork at its north-western corner (partly obscured by the adjoining kitchen extension). The west elevation of the Sunday school (taken from the field to the rear of the site) is shown in Plate 9. Plate 10 shows the part-rendered west elevation of the main chapel (taken from the garden of the adjoining property No 36 Low Green and including their lean-to summer house). The south elevation of the Sunday school and the flat-roofed kitchen extension is shown in Plate 11. The slate roof of the Sunday school contains two clear glass tiles which serve to illuminate the roof void below.

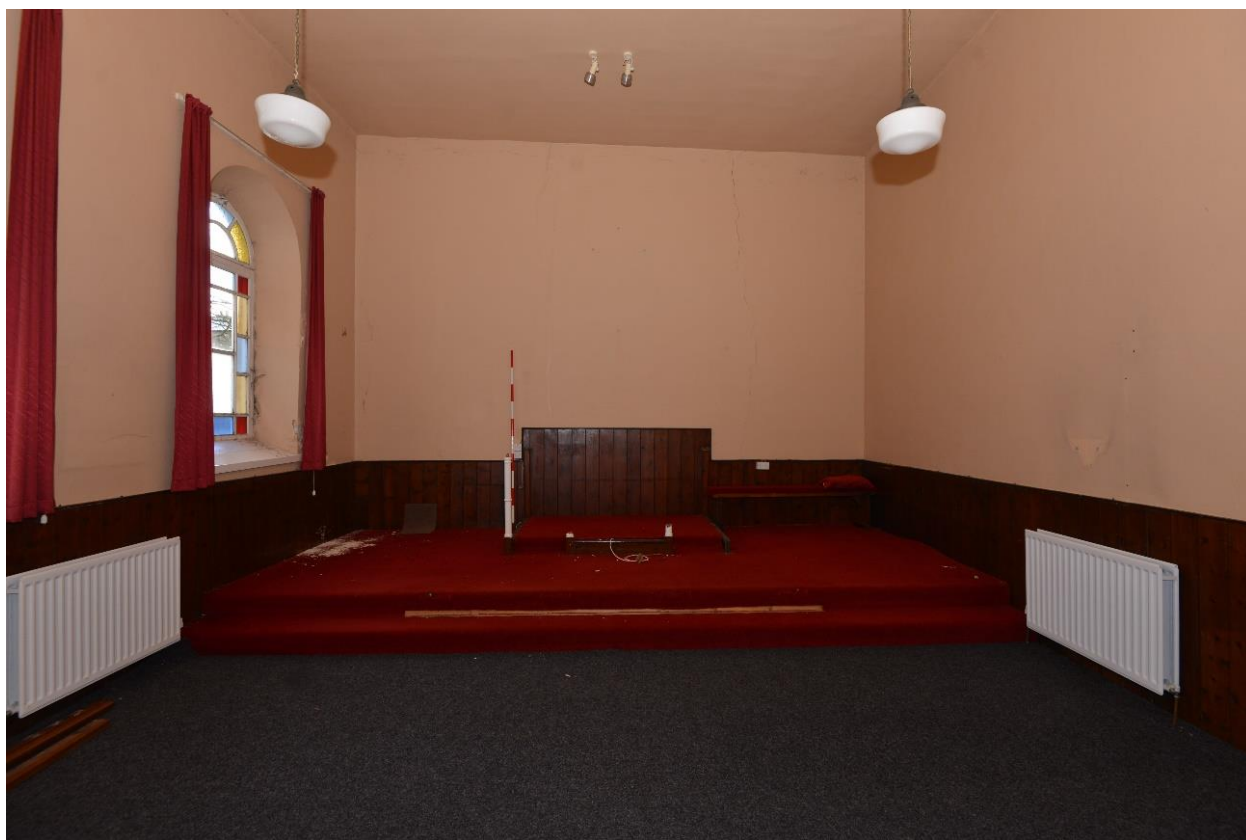
Plate 15 Chapel interior south elevation

The main chapel building has been divided into an entrance hall (Plates 12, 13 & 14) which leads into the Sunday school to the west and the main hall to the south. The main hall has a raised altar area (the altar was removed by the Methodist Church prior to transfer of ownership) at the south end (Plate 15), with wood paneling along the walls. There is an arched window in the west elevation (Plate 16). Plate 17 shows the north elevation, with an arched window high in the gable (covered by a curtain in this photograph), and the partition wall and door to the entrance hall. Three arched windows are located in the east elevation (Plate 18). The windows are very similar in design, a detailed photograph is shown in Plate 19.

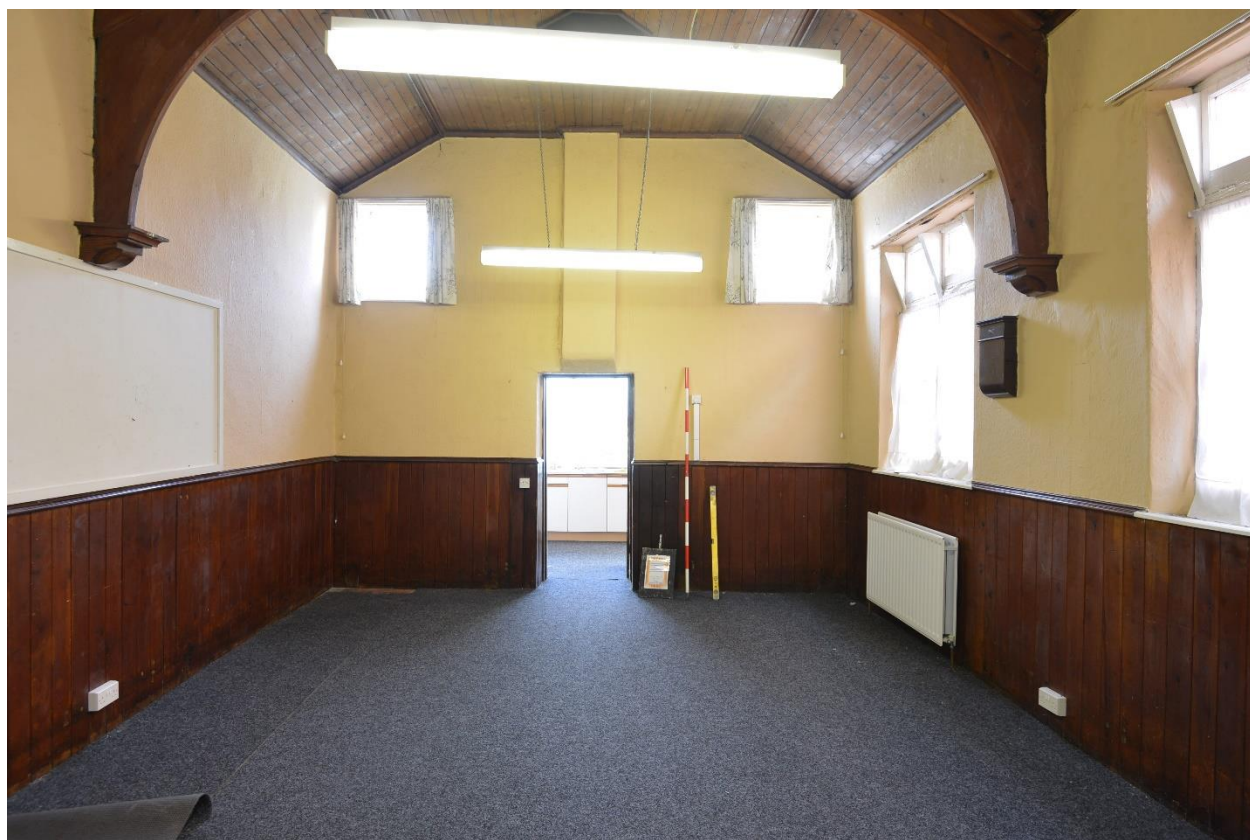
Plate 20 Sunday school interior west elevation

The main axis of the Sunday school is oriented perpendicular to that of the main chapel building. Plate 20 shows the Sunday school looking west, with the original chimney breast above the door to the kitchen extension and two windows high in the gable (further detail in Plate 21). The northern elevation is shown in Plate 22, with two large windows (Plate 23) and a door leading to the covered

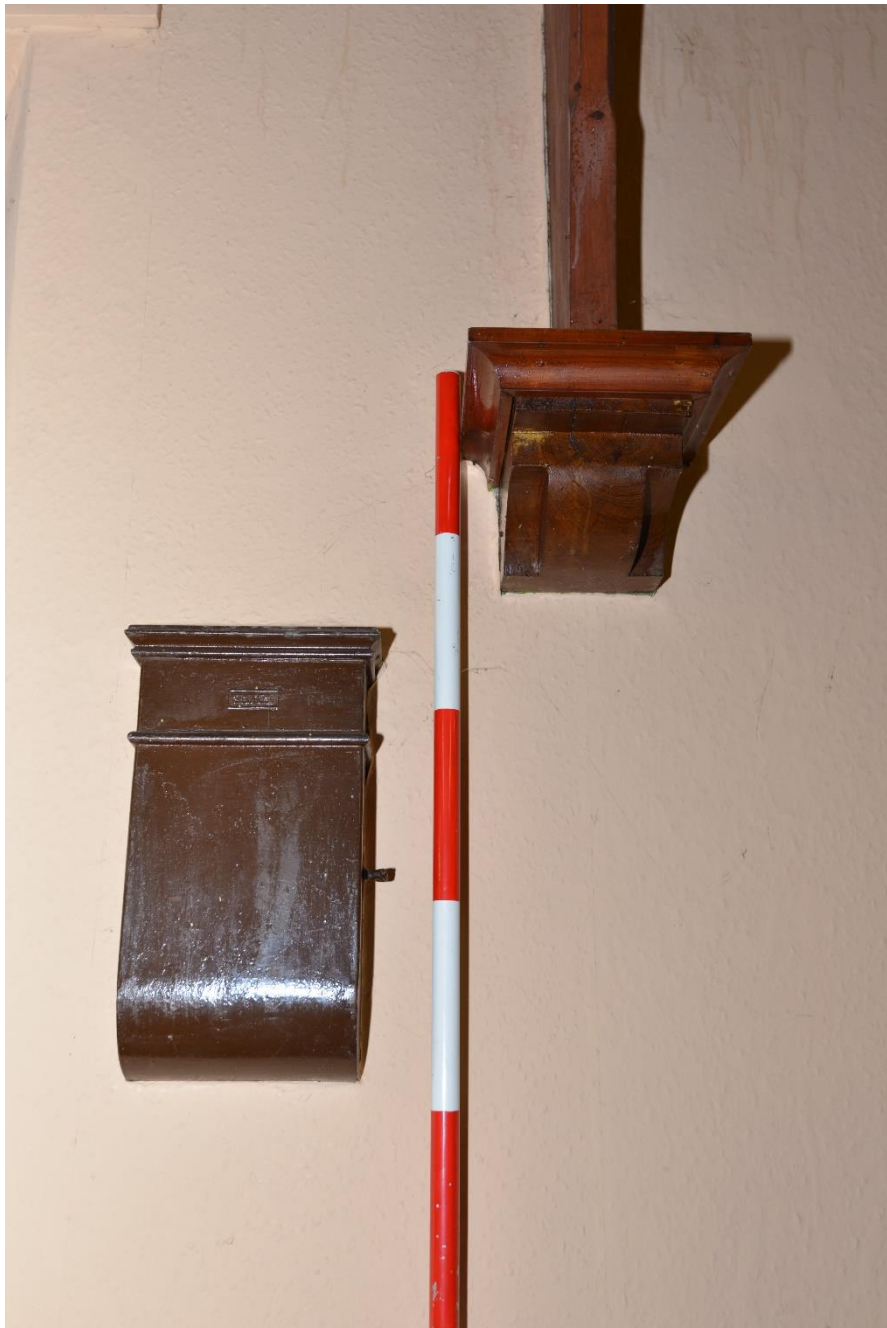
Plate 25 Sunday school interior ventilator detail north elevation

passageway (Plate 24). Also visible are two inlet boxes with decorative handles to control ventilation into the room (Plate 25). A door to the entrance hall of the main chapel and arched stained glass window are located in the eastern elevation (Plate 26). This window (detailed in Plate 27) would presumably have been external prior to the Sunday school being built in 1897. Plate 28 shows the southern elevation of the Sunday school, including the wooden floorboards and floor hatch to the cellar where the carpet has been lifted, with wood paneling along the walls. The Sunday school has a wood paneled ceiling with three octagonal hatches (Plate 29) giving access to the roof void above supported two carved ribs (detail shown in Plate 30).

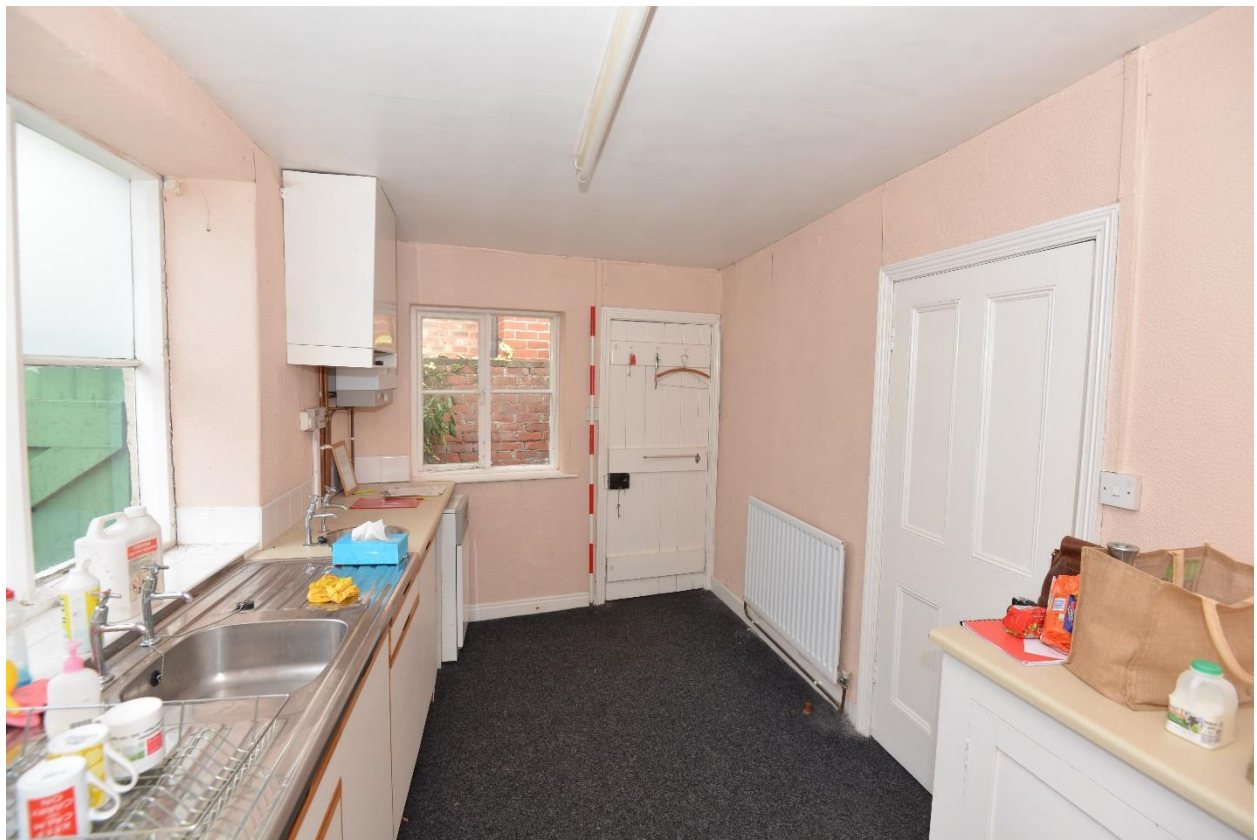
Plate 31 Kitchen lean-to interior north view

To the rear of the Sunday school is the later addition of the kitchen, which is built of rubble masonry with a flat roof. Plate 31 shows the kitchen looking north, including the north-facing door into the passageway and the east-facing door into the Sunday school.

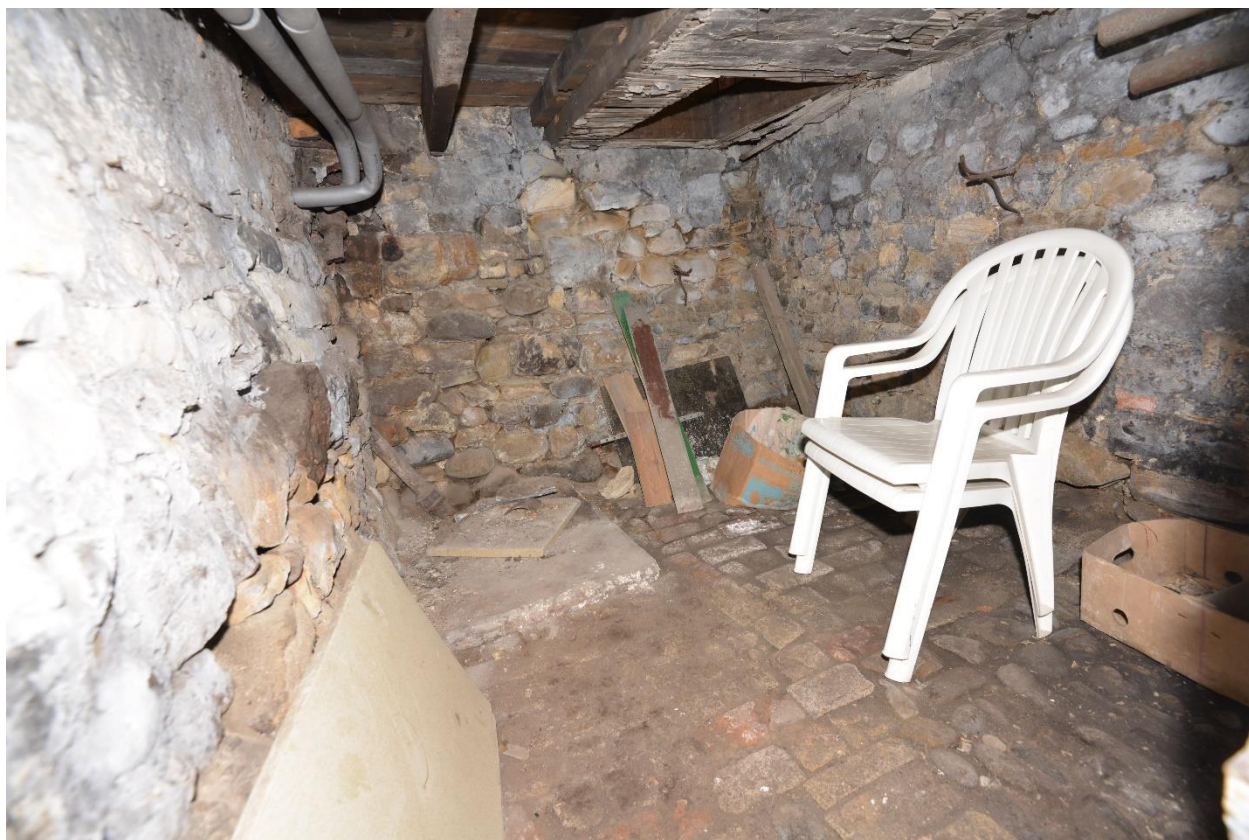
Plate 32 Cellar interior south view

The cellar occupies a small area beneath the eastern end of the Sunday school accessed by a flight of stone stairs from the passageway and a hatch from the Sunday school. Plate 32 shows the interior of the cellar looking south and Plate 33 looking north.
