Archaeological Test Trench Report

Apartment 39, Hampton Court Palace.

10th February 2016

Site Code: HCP 142

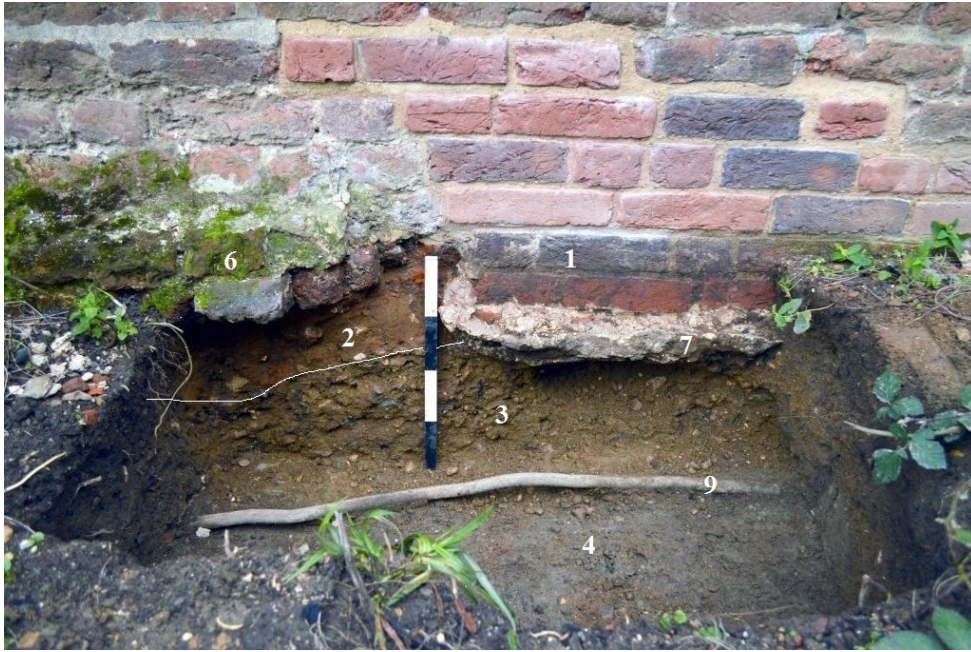
Figure 2: South-facing section showing the wall construction

Context (1) was the main construction of the brick wall. No foundation was identified beneath and the current ground level obscures a mere two courses of bricks (Fig. 1). As the focus of the report is the below ground archaeology the main structure of the wall has not been split into separate contexts. For a fuller analysis of the wall see appendix II.

mortar is composed of coarse gravelly concrete, indicating that this particular feature of the wall may be a later addition, repair or an attempt at redirecting rainwater away from the building? It had been thought that it may have been related to a culvert structure, but viewed from this small trench it is difficult to tell though seems unlikely. Below this level are two courses of brick at the bottom of which is a thin layer of sandy gravelly concrete mortar measuring between 0.02 m and 0.06 m **Context (7)**

- 3.3 **Context (2)** was a soft beige sandy deposit with frequent fragments of CBM and signs of bioturbation directly below the third course of this elevation on the western side of the trench. The first two courses of brick seem to have broken away or have been deliberately removed. Interpretation of this feature is difficult, it may relate to the placement of a small drainage structure or simply damage caused to the building by unknown previous activity.

- 3.4 **Context (3)** was a substantial layer of compact, silty sandy coarse gravels containing small angular stones and occasional fragments of CBM. It seems to lie within a foundation cut (5) and may represent the founding level upon which the wall was built. The compact gravels make a fairly solid base for the structure, but are not necessarily stable. The lack of a foundation is nonetheless curious and is likely a contributing factor to the current poor level of stability in the wall structure.

- 5.1 In order to have a better understanding of the construction history and foundation of the wall it would be helpful to widen the current trench along the length of the elevation. This should help determine what function the “flashing” is serving and will clarify whether the lack of foundation courses is a consistent feature along the whole length of this elevation.

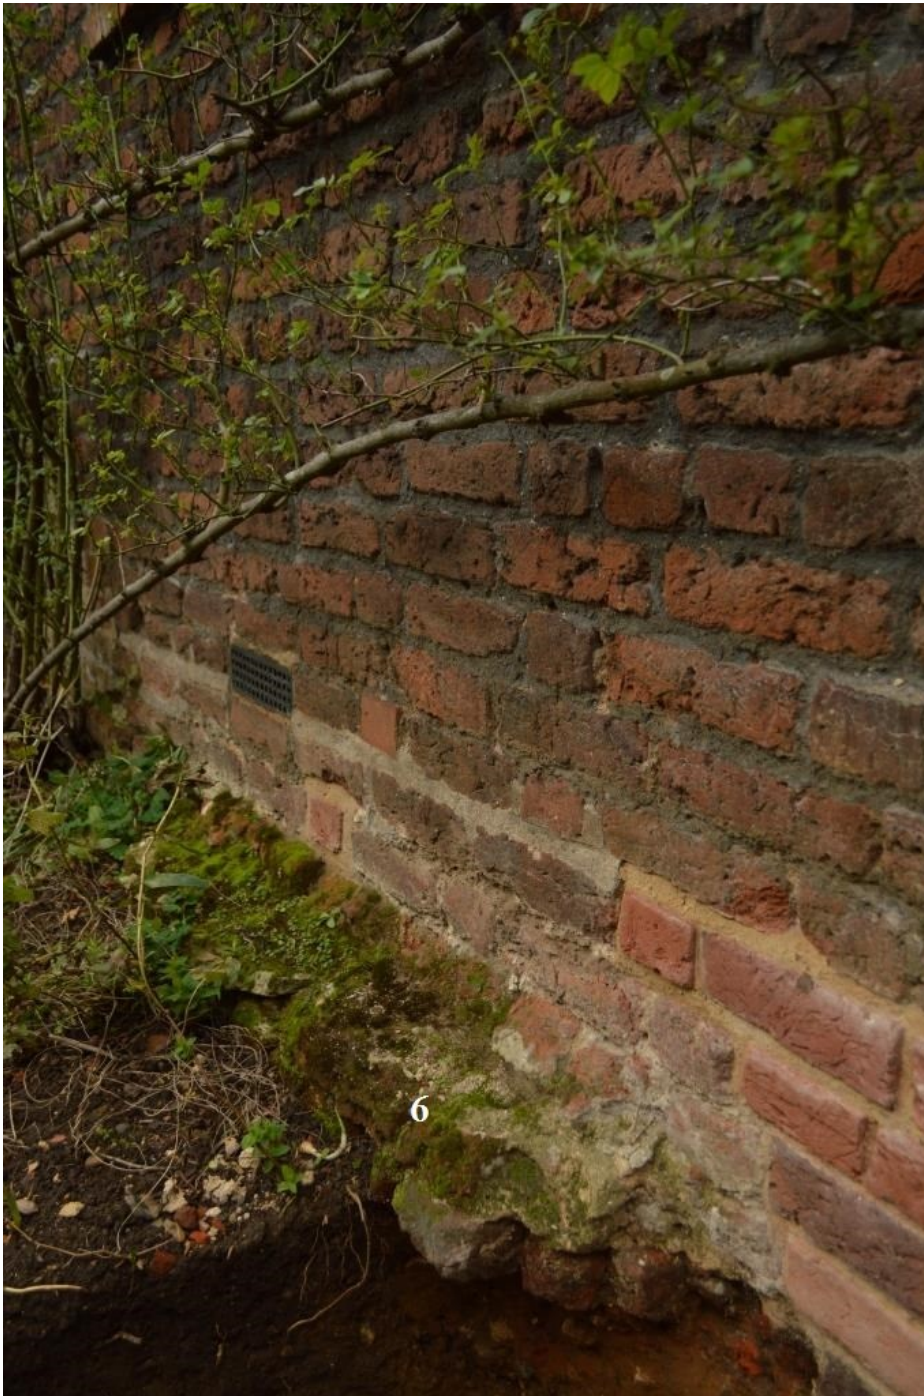
- 3.2 At ground level there was a crude 0.24 m thick 'flashing' like element **Context (6)** (Fig. 2) composed of rough-looking header bricks and thick mortar. This feature curiously did not extend across the whole length of the wall but ran over a length of 1.35 m. The

Figure 2: View of the concrete flashing (6) observed along the bottom of part of the south-facing elevation (1).
