# Old Hospital Block Lamp Post Repair, HM Tower of London

*An Archaeological Watching Brief*

**Code: ToL 155**

March 2016

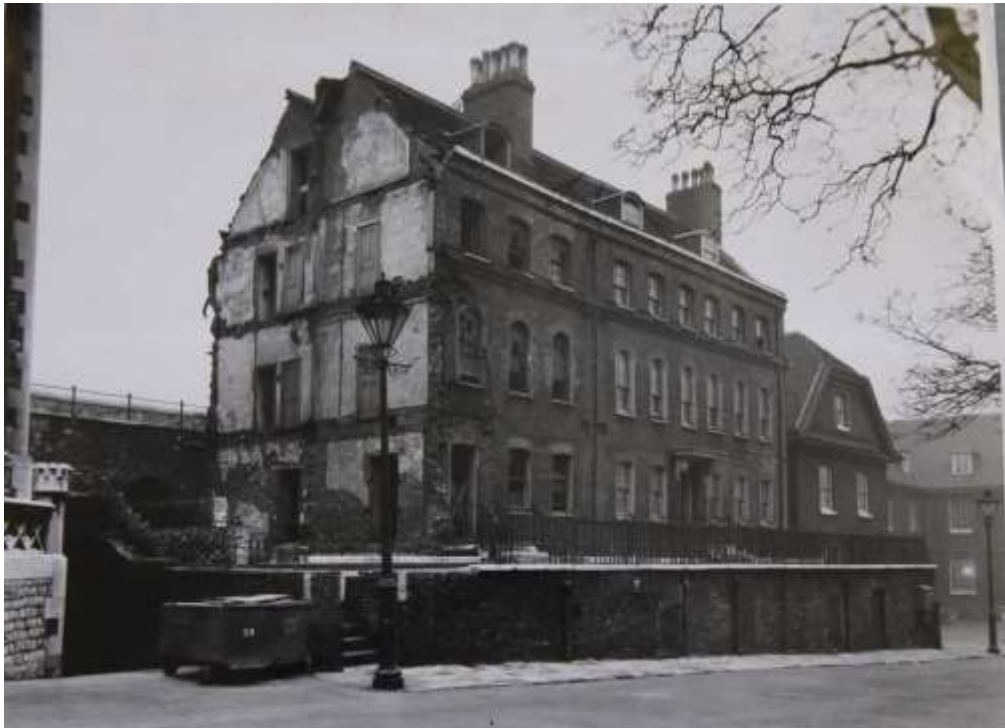
Figure 3: "Old Hospital Block - Elevation of damaged north end before demolition commenced" - A.742/2, 1950

The location of the lamp-posts at the north-western and south-western corners of the Old Hospital Block frame the building and seem to date at least to the Victoria era based on their form and style. They certainly already existed in the early 20<sup>th</sup> century as they are clearly visible in photographs taken in 1909 (See figure 2). Despite the northern half of the terrace being bombed in 1940 the post-bomb photos show that both lamp-posts were still standing unscathed (See Fig. 3).

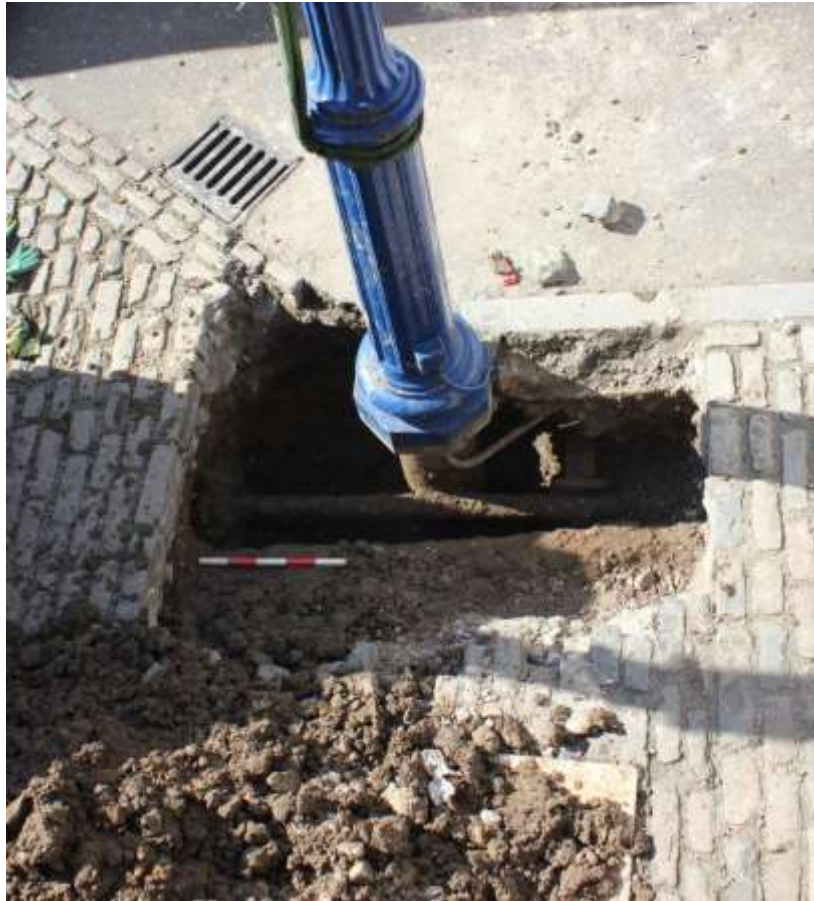
Figure 5: View of excavated area looking towards the west

and held in place by the soil and structures around it. In order to see if there were any fractures in the metal work a larger excavation space was needed. Work resumed on Monday 14 March 2016 and a trench measuring 1.65 m x 1.40 m was opened up around the lamp-post to a depth of 0.9 m (See figure 5).

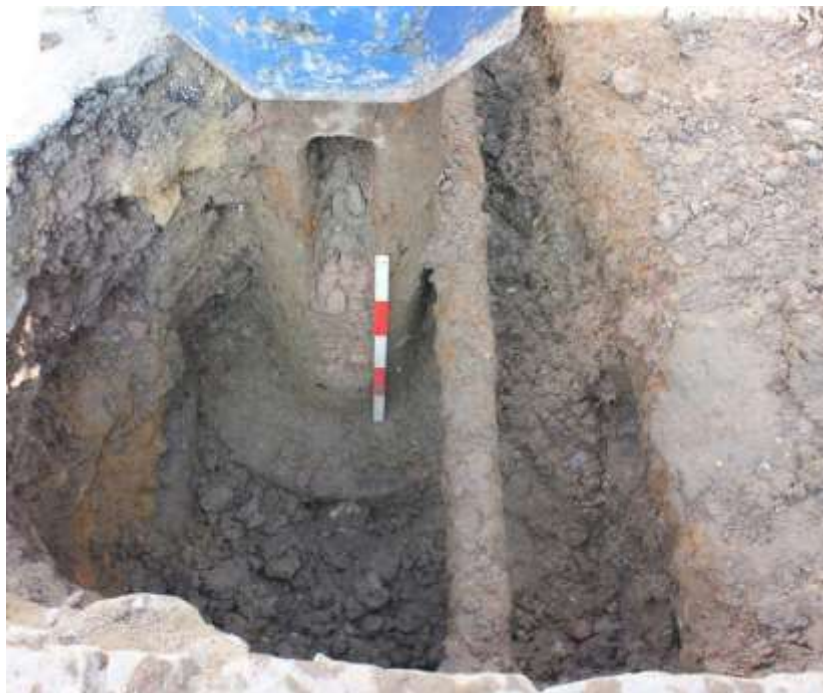
Figure 6: View showing the base of the lamp post and the services.

No archaeological features were observed in this trench due to the presence of a number of services, including a water mains pipe measuring 0.18 m in diameter at 9.01 m OD, a gas pipe measuring 0.09 m in diameter at 8.81 m OD and a probably foul drain pipe was apparent in the western section (see figure 6). The installation of these modern structures together with the installation of a drain to the east would probably have truncated any evidence of archaeological or architectural elements.

The base of the lamp beneath the ground level measures 0.86 m with a diameter of 0.25 m. It sits on a flange base with a diameter of 0.55 m which is unsupported. The whole structure is apparently held in place by the earth and the paving slabs surrounding it. The trench itself has been backfilled by a sticky gravelly and slightly waterlogged silty sand material observed to a depth of around 0.75 m. It contained a number of residual finds including a fairly large quantity of bricks and mortar, which appear to be around 17<sup>th</sup> century in date, measuring 0.1 m x 0.07 m x 0.23 m, as well fragments of slate and one sherd of green-glaze pottery.

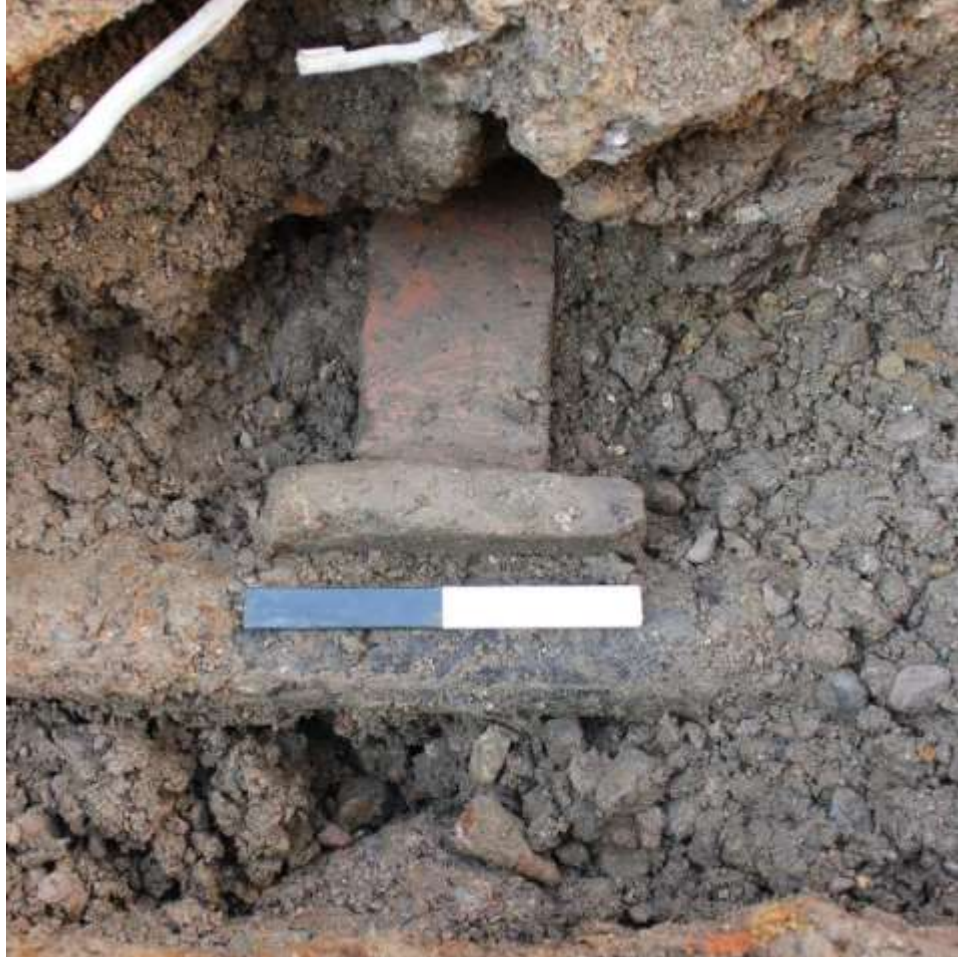
Figure 7: The wedge-like feature against the gas pipe

The only feature present was the existence of one brick measuring 0.1 m x 0.07 m x 0.23 m and a small limestone slab 0.19 m long and 0.03 m thick that seem to have been used as a wedge against the gas pipe on the northern end of the trench at 8.87 m OD (See figure 7).
