# HCP 144

## Apartment 39 Railings Conservation Project

*An Archaeological Evaluation Report*

*July 2016*

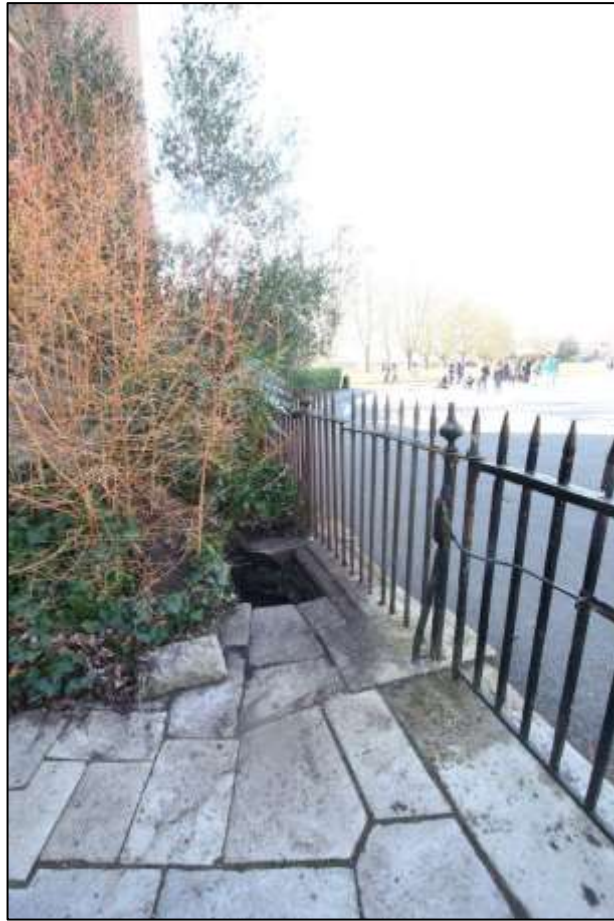
**Figure 2: Trench I on the West Front**

4.1 Trench I was located along the West Front railings to the north of Apartment 39 and adjacent to the gate entrance leading into the garden. It measured 0.55m x 0.86m with a depth of 0.7m (Fig2). The purpose of this excavation was to reveal and record the foundation levels of the Portland stone baluster plinth (contexts 2 and 3) supporting the iron railings (context 21).

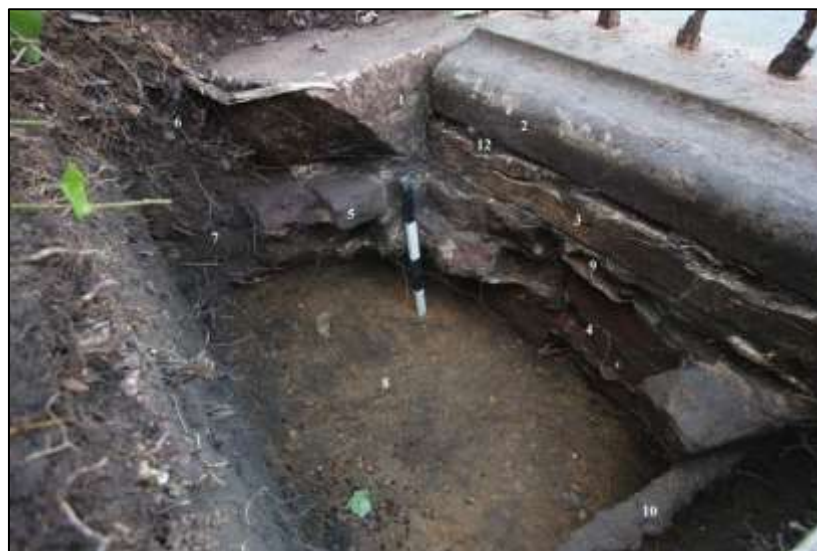
**Figure 3: View of south facing and east facing sections in Trench I**

4.2 The earliest context exposed was a layer of coarse orangey brown sandy gravels (**context 8**) observed at a height of approximately 8.53m OD, this was directly overlain by two brick foundation structures, (contexts 4 and 5) (Fig.3).

4.3 (**Context 4**) corresponds to the main foundation level of the plinth stone (contexts 1 and 2). It was a north-south linear construction composed of three courses of red bricks, each measuring 55mm x 100mm x 220mm (Fig. 3). The surface of the bricks was generally smooth but with some evidence of weathering. The structure measured a total height of 0.23m. The joints measured on average 20 mm and the bonding material was composed of a soft creamy yellow sandy lime mortar. There was no pointing. Much of context 4 was obscured by the abutting structure (context 5), and it has also been truncated to the east by the later installation of a pipe, (context 10). The combination of

(**Context 5**) was a north-south aligned structure forming a right-angle with context 4, and corresponded to the foundation of context 1 (plinth stone supporting the vertical stay). It was composed of two courses of red bricks measuring a total of 0.2m in height, and 0.35m in length. The width is unknown as it extended beyond the limits of the trench. The bricks were slightly different in appearance to those observed in the main east-west foundation wall (context 4). They had a more yellowish tinge with sharper arrises. Individual bricks measured on average 60mm x 100mm with the joints in-between measuring around 15mm. The bonding material also differed in that the sandy lime mortar was slightly coarser in consistency entirely covering the bricks in places. Whilst the structure has been badly damaged due to the encroaching vegetation and plant roots, it also seems to have been truncated as the bricks had a jagged broken appearance. As a result this structure appears very rough and untidy but would probably have originally been squared off, fitting neatly against context 4, (the main east-west foundation of the railings). Above this structure, and also overlying (context 4), were disorganised layers of limestone chips and fragments (**context 9**), which correspond to a bedding/levelling layer for the plinth stones (Fig.3). This context had a maximum depth of 0.12m.

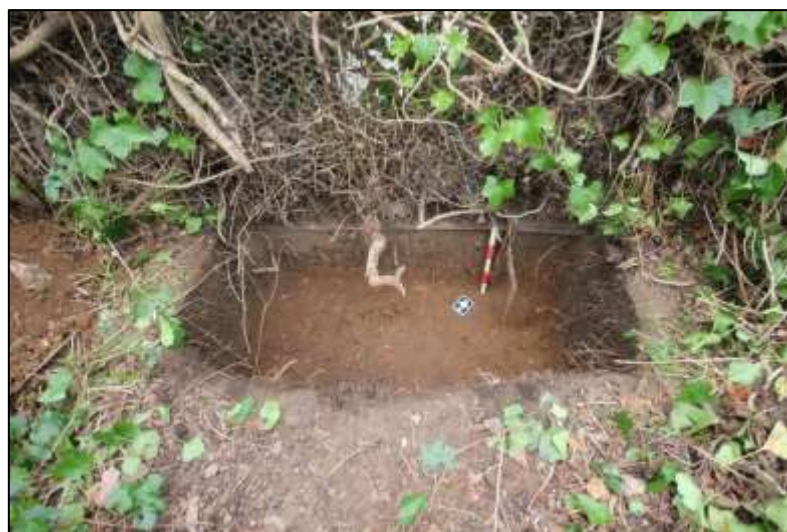
Figure 4: North-facing view of Trench II

Trench II was located within the confines of the garden in front of Apartment 39 along the pathway between the West Front and Barge Walk (Fig.1). It measured 1.45m x 0.7m with a depth of 0.7m. The lowest deposit observed, into which a supporting up-right (context 17) has been driven, was **context 15**, composed of coarse sandy gravels containing fragments of animal bone. This may be some sort of levelling layer associated with the garden. This was overlain by subsoil or garden soil (**context 14**) composed of loose mid-brown silty sand with a depth of 0.3m, containing occasional fragments of CBM and a large quantity of clay pipe stems. These two deposits were truncated by a small linear installation cut (**context 20**) associated with the railings, which was observed in the east, west, and south facing sections and recorded photographically. The cut measured 0.13m in width with a maximum depth of 0.4m. It was filled by very loose and soft grey homogenous fine silty sand (**context 18**) and contained no finds.

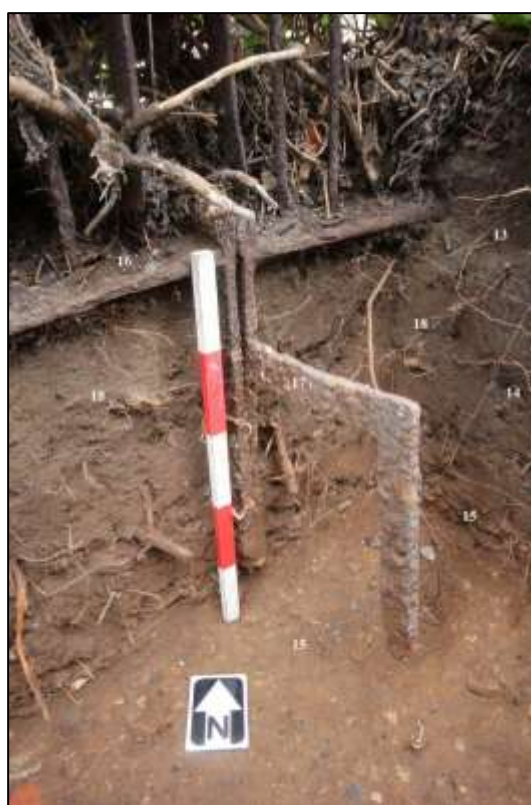
This part of the railing structure did not include the historic baluster plinth. There were merely a line of pickets (**context 19**) supported by an iron crossrail at the base (context 16) measuring 0.02m wide by 0.01m deep, which in turn was supported at regular intervals by a two-pronged upright simply wedged into the ground (**context 17**) (Fig.5). The main upright was comprised of two sections

measuring 0.46m in height, which have bonded together through the process of corrosion at the bottom. Each upright section measured 0.02m x 0.05m. Connected to the eastern-most section was a bracket-like feature, the horizontal part measuring 0.21m in length whilst the vertical section measured 0.31m in height, creating the “double-pronged” upright. This particular section of the railings was entirely obscured by a dense blanket of ivy, which has led to extensive damage to the railings. Many of the pickets have corroded to such an extent that they have completely come away from the railing base (**context 16**).

Figure 5: View of 'double-pronged' supporting up-right, context 17.

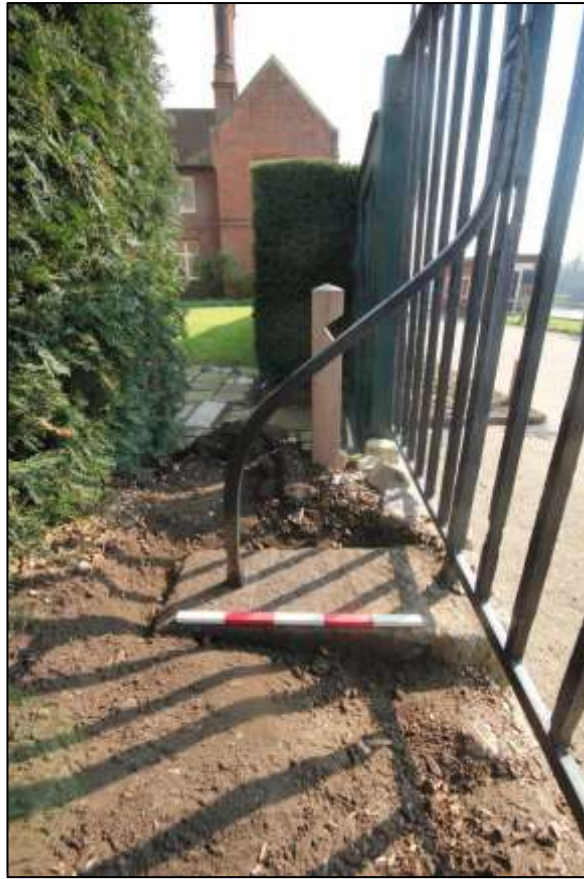
- 4.9 Excavation in Trench III was limited to the cleaning of a small area along the Barge Walk railings adjacent to the gate leading into the Apartment 39 garden. This revealed one of the 19<sup>th</sup> century stone plinths supporting the railings. This section had already been excavated during the works carried out for the installation of electric cables in spring 2015 (HCP 129), so a photographic record of the foundation levels had already been made. The plinth measured 0.7m x 0.3m and was composed of limestone. This part of the railing was likely installed in 1878<sup>2</sup>. The photographic record from the HCP129 project shows the foundation level, which appeared to be made up square concrete plinths, is located c.0.4m below the current ground level (Fig.8).

Figure 6: Barge Walk railings and stone plinth

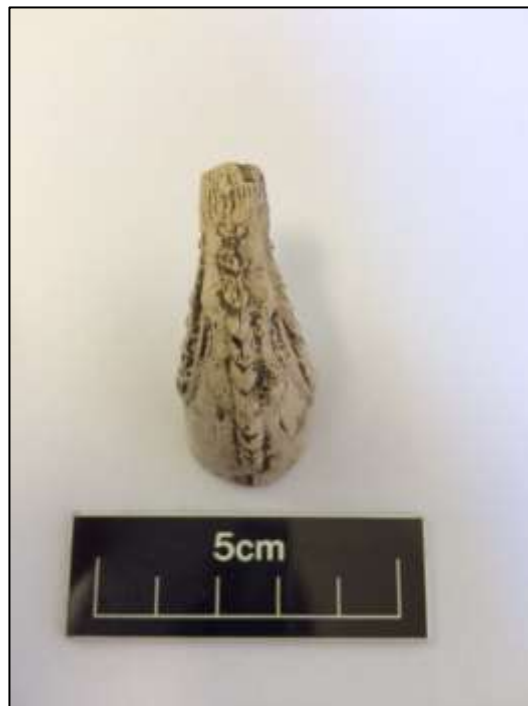
Figure 7: Clay pipe from context 7

The railing structure as a whole was covered by the subsoil/garden soil (**context 7**), which produced a number of finds comprising of several fragments of CBM and clay pipe including a decorated fragment with a leaf pattern covering the seam of the bowl, and no spur indicating an early to mid-18<sup>th</sup> century date (Fig.7). This layer was overlain by the topsoil (**context 6**) which in part covered the upper surface of the plinth stones and the Yorkstone paving.

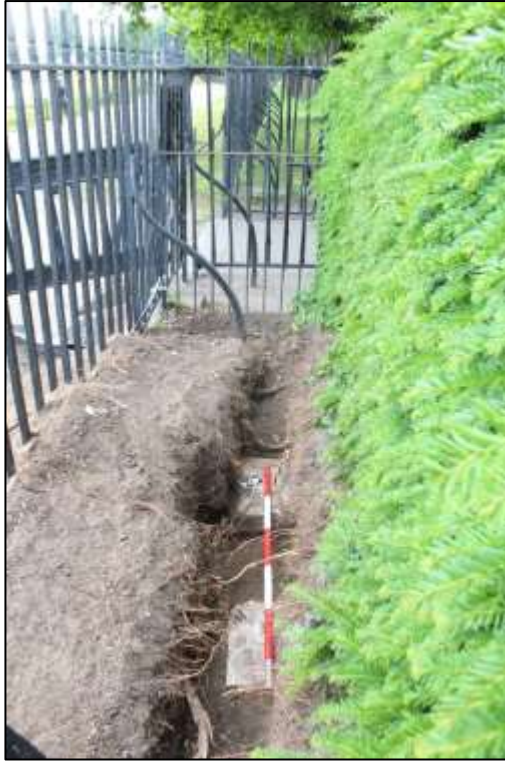
**Figure 8: Foundation plinths of the Barge Walk railings (HCP129 - FKL)**

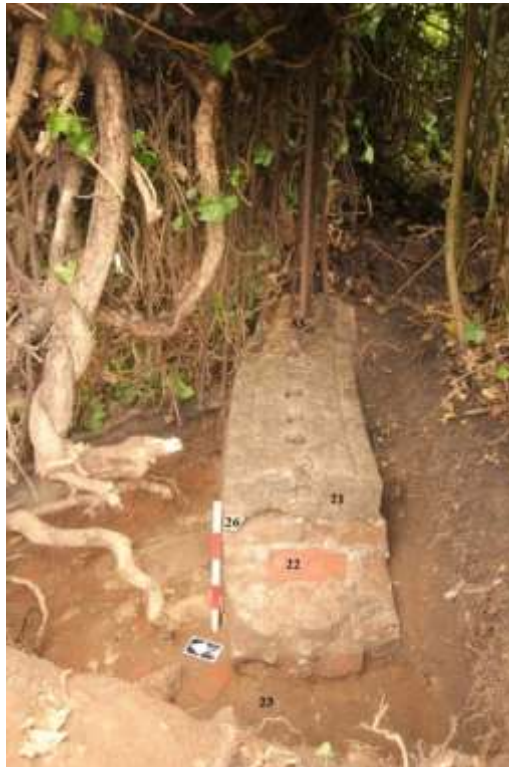
- 4.16 Before laying the baluster plinth, a bedding layer was placed on the final course of bricks consisting of fragments of mortar and small concrete wedges for a neater finish on the two faces (**context 26**). Above this thin layer was the plinth stone itself, (**context 21**) (Fig. 9, 10, 13). The plinthstone observed was dressed Portland stone and measured 0.94m x 0.43m x 0.16m and was curved. The baluster plinths in trenches I and IV were different in form and quality of stone, the stone in trench IV being slightly more porous. The plinth in Trench I was greater in length and depth but was less wide than its counterpart in Trench I and also presented a slight curve which the other section did not. Another difference was that while there was only one single plinth stone on top of the foundation in this trench, there was an extra Portland stone block beneath the plinth in Trench I. Perhaps this compensated for the reduced height of the overall structure in this far eastern section. Context 21 also had more angular lines and had a number of holes visible on the surface

**Figure 9: View of the railings, plinth and foundation in profile**

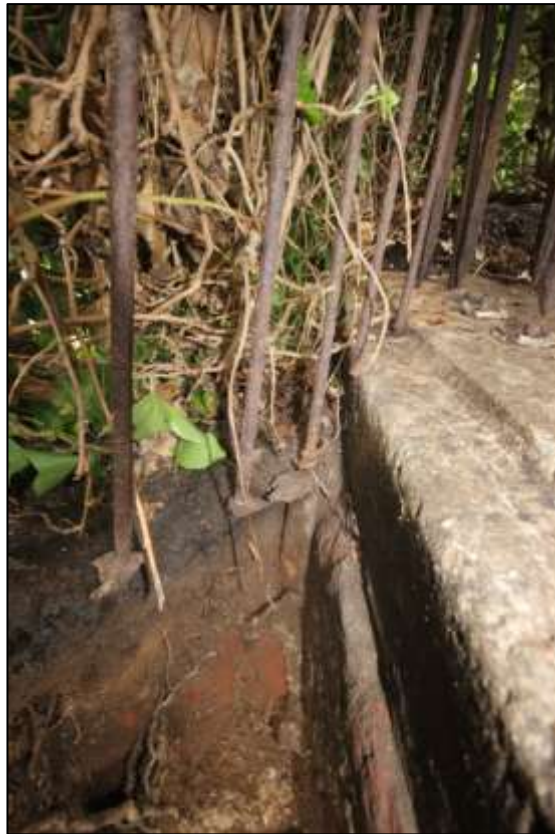
- 4.17 The iron pickets were no longer connected to the sockets, of which there were seven in total on the terminating plinth stone, four of which retained the lead caulking. The two eastern-most sockets were re-used to link the new railings with the old ones, and it seems that three crudely crafted holes were scored into the stone on the northern edge (Fig. 9, 10) in order to insert the new pickets, creating an arc at this interconnecting section of the railings. Inserted against the northern face of the plinth stone and foundation was the supporting upright and crossrails (**context 33**) which have not survived well due to corrosion. This is the same structure as was observed in Trench II.

Figure 10: Detail showing the link between the historic fence line and the later railings

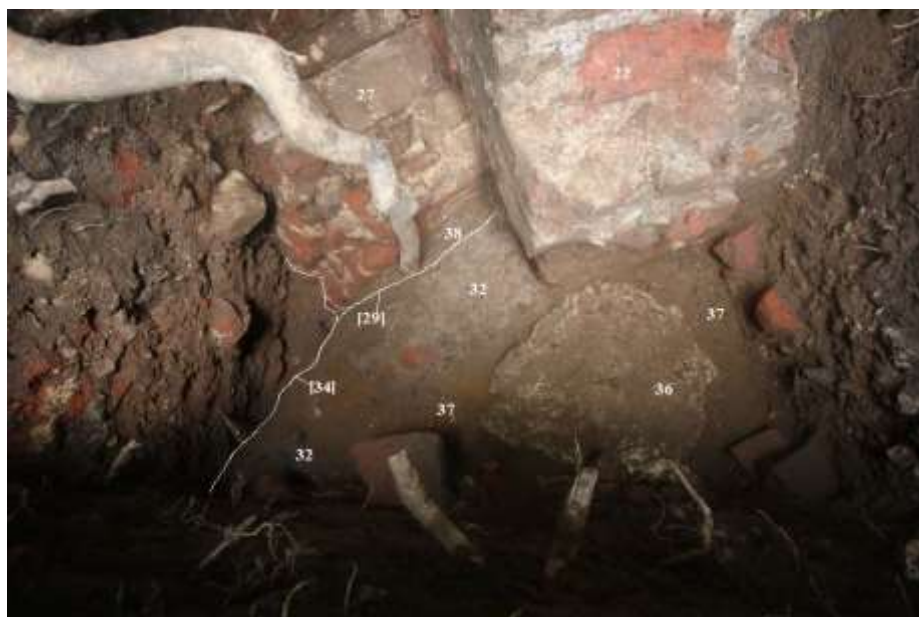
- 4.11 The earliest layer exposed was (**context 37**) seen at 8.33m OD (Figs. 12, 13). It was composed of yellow/orange coarse-grained sand with signs of bioturbation and contained no anthropic material. Without excavating further it was impossible to ascertain whether this was a natural deposit or whether it was re-deposited material corresponding to a phase of levelling. This context was overlain by two elements (**context 32**) and (**context 36**) which, although they had no direct relationship with one another, were almost certainly related to the same phase of activity given their corresponding levels (Fig. 12). These contexts both sat at 8.36m OD at their highest points. (**Context 36**) was a single sandstone slab measuring 0.47m x 0.42m x 0.02m located in the southern corner of Trench IV and looked as though it could be the remnants of some sort of flagstone surface possibly related to wall 27. The stone was quite heavily eroded and a sample was collected. **Context 32**, which also overlay context 37, was a compacted mix of charcoal and ash-like material containing moderate quantities of mortar and fragments of CBM compressed into the layer, perhaps as means of consolidation. It was patchy in nature measuring a maximum depth of 0.03m but may, like the stone slab, correspond to a ground surface or preparation layer pre-dating the first phase of the railings. There was no evidence of *in situ* burning.

Figure 12: East-facing view of the features underlying the historic plinth and foundation

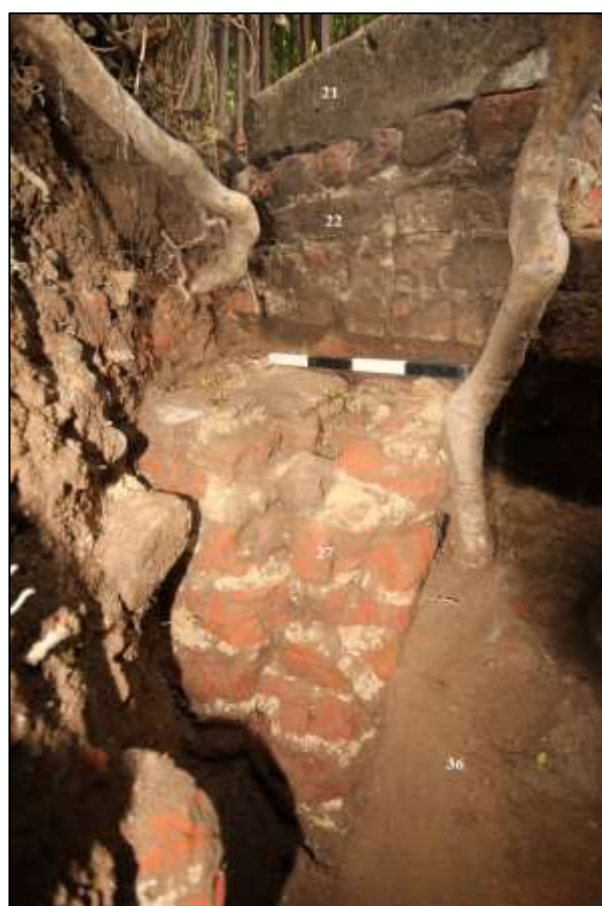
- 4.12 (Context 32) was cut by what appeared to be a very tight construction trench (**context 29**) measuring 0.06m from the south-western face of wall (context 27), and was backfilled with a sandy material (context 38) similar to (context 37) (Fig. 12). This was the construction trench for a narrow north-west/south-east running brick wall structure (**context 27**) exposed below the foundations of the phase I railings. It was observed over a length of 0.4m, continuing towards the south-east beneath and probably beyond the railings (context 22) and sitting at approximately 8.10m OD at its base. The wall was only 0.37m in width, with a maximum surviving height of 0.46m. To the north-west it had clearly been dismantled, and most of the bricks had been broken at this end. The construction was composed of up to seven courses of squat orangey red three-quarter or half-bat bricks,

Figure 13: North-west facing section of the fence line foundation and the earlier structure 27

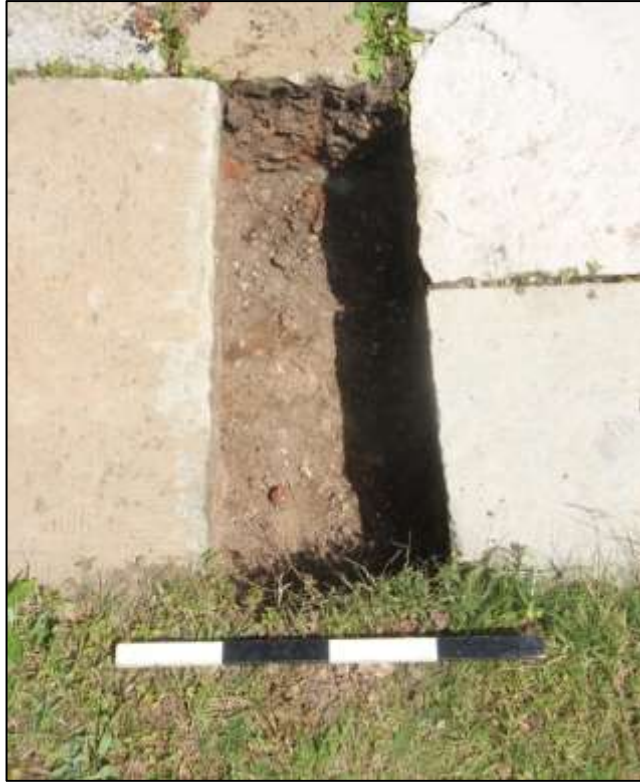
**Figure 14: Trench V**

- 4.19 Trench V was located 19.6m south of the north-western corner of Apartment 39 along the western face of the building. It measured 0.6m (E/W) x 0.25m (N/S) x 0.2m (d). No archaeological features were uncovered in this trench, simply a silty sandy loose dark grey bedding layer (**context 39**), which was also present in trenches VI and VII, overlying a silty sandy dark grey soil containing fragments of CBM and small sub-angular stones.

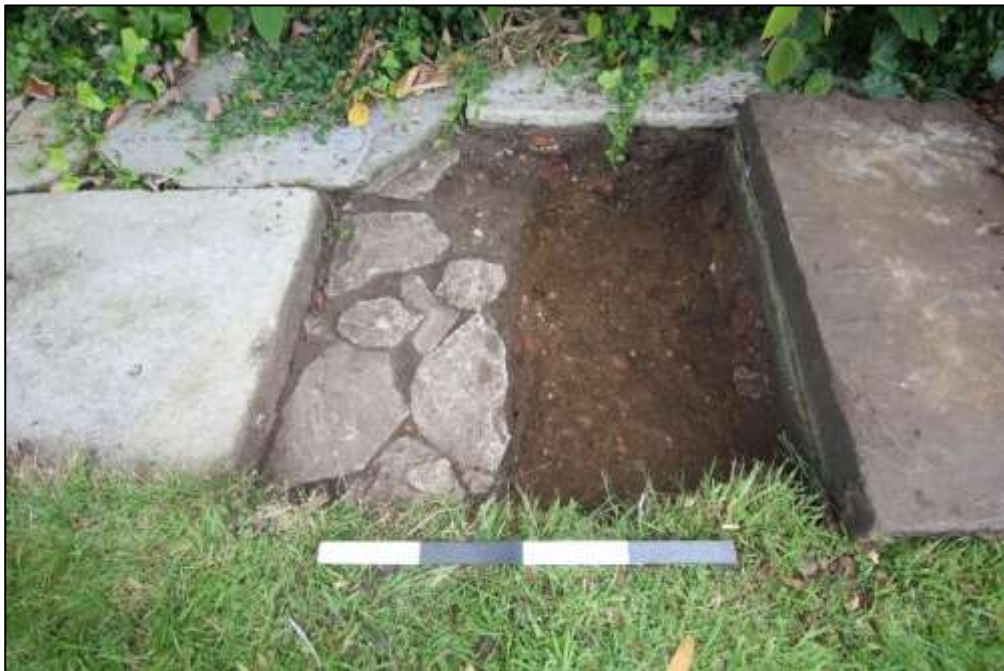
- 4.20 Trench VI was located 11.40m south of the north-western corner of apartment 39, and measured 0.64m (W/E) x 0.65m (N/S) x 0.18m (d). The earliest layer observed in this trench was **context 42**, composed of orangey/brown sandy silty friable gravels with inclusions of occasional CBM fragments; this context was also observed in Trench VII. The context was observed over 0.12m and was overlain by **context 41**, which was composed limestone fragments of varying sizes arranged to so as to lie flat and to roughly fit together forming a pathway. There was no mortar between the stones. This feature represents the remnants of an earlier crazy-paving style pathway running in front of Apartment 39, the date of which is uncertain. The paving was overlain by the bedding layer **context 39**.

**Figure 15: Trench VI with the limestone paving, context 41.**

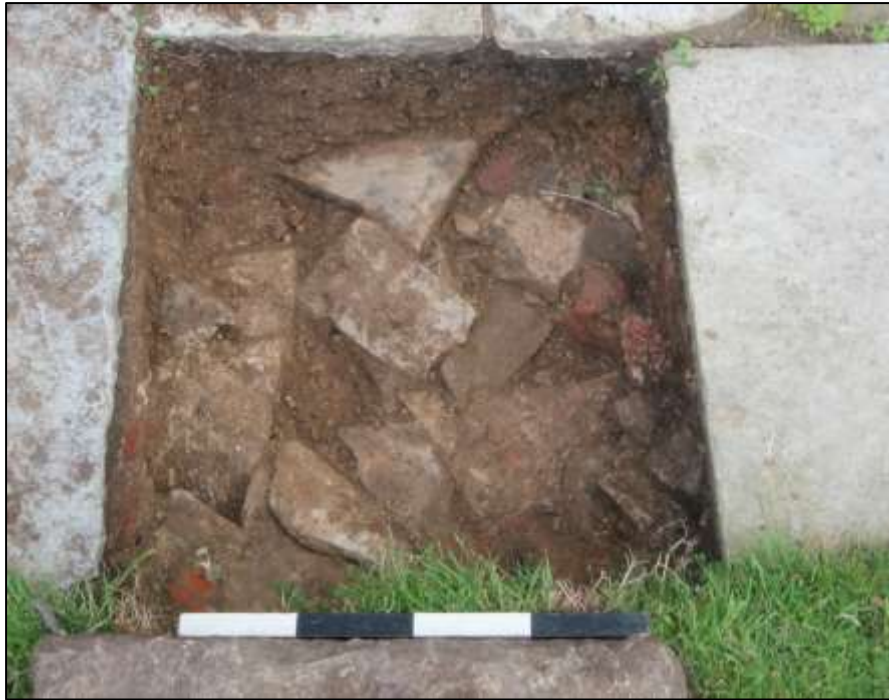
- 4.21 Trench VII was located 4.40m south of the north-western corner of Apartment 39, and measured 0.55m (N/S) x 0.58m (E/W) x 0.2-0.3m (d). Located at 0.2m below the current ground level was a layer of demolition material (context 43) composed of a sandy silty loose deposit containing large blocks and slabs of limestone as well brick and mortar fragments. This was only excavated in plan, therefore the depth is unknown. This layer was overlain by context 42, which in turn was overlain by context 39.

Figure 16: Trench VII, context 43

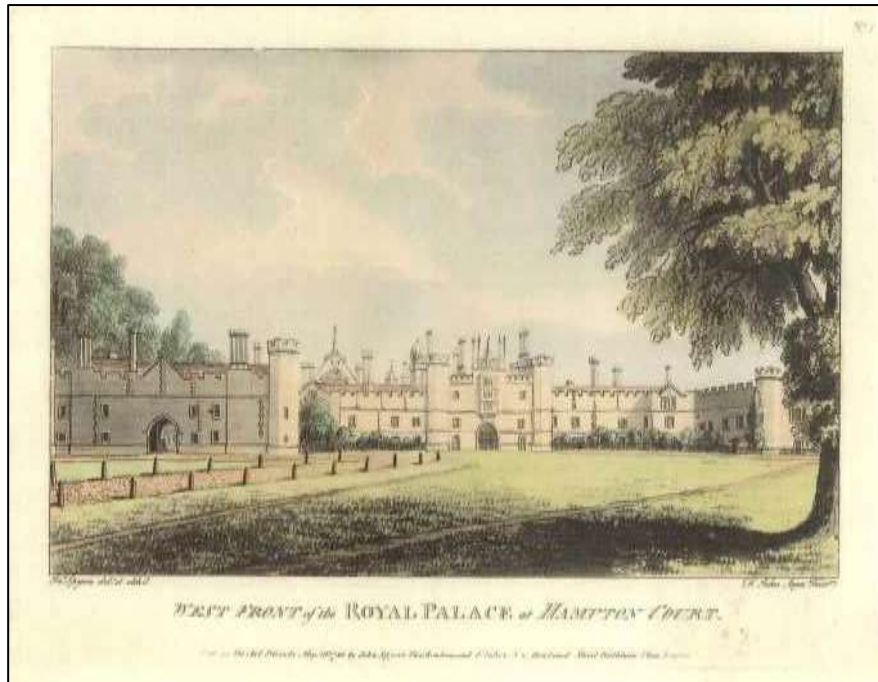
Figure 18 : View of the West Front - John Spyers 1786

- 2.8 A later John Spyer's sketch depicting the West Front (Fig.18) clearly shows a set of simple railings in place by 1786, but these are much closer to the building than the ones that exist today. Nevertheless, the railings do seem to delimit a small garden in front of Apartment 39 with the apparent presence of trees and shrubbery behind the fence line.

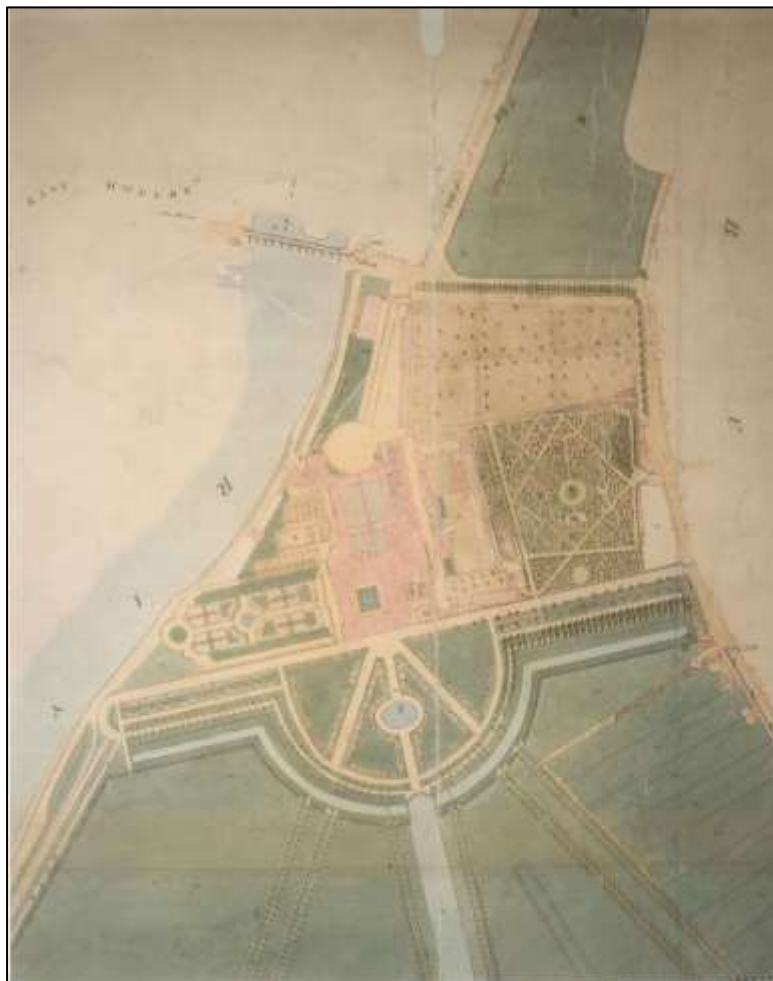
Figure 19: Henry Sayers' plan of Hampton Court Palace, 1841 - Work 34-1349

- 2.9 Henry Sayer's 1841 plan (Fig. 19) illustrates some of the changes that took place from the late 18<sup>th</sup> century to the mid-19<sup>th</sup> century, including the creation of a parade ground between the causeway and the Barrack Block, which was gravelled over soon after the outbreak of the French Revolutionary wars in 1792. It also illustrates, with more clarity than the earlier Spyer's drawings, the set of railings along the southern side of the forecourt forming the first phase of the enclosed garden that we see today in front of apartment 39.
