# HCP 152 Kitchen Garden Pop-up Socket Installation, Hampton Court Palace

*An Archaeological Watching Brief*

*August 2016*

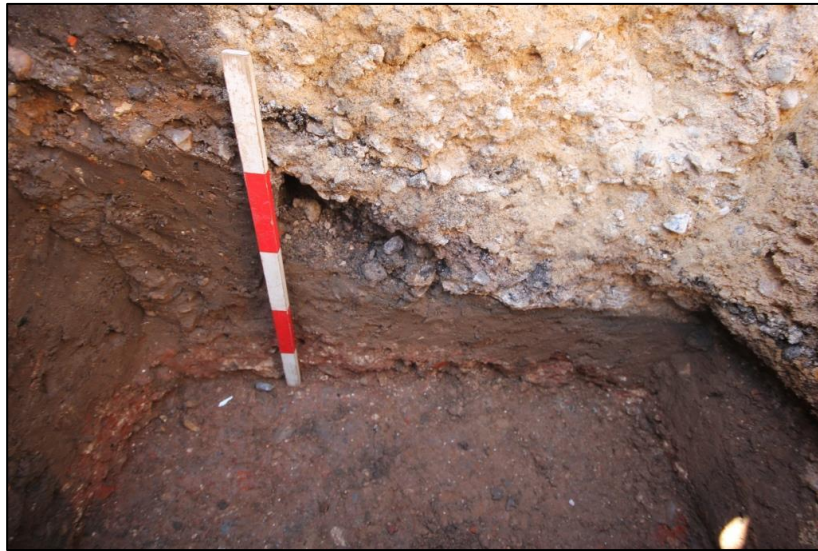
- 4.4 This was overlain by a layer of crushed brick and mortar **(7)** measuring 0.07m in depth and appearing at c. 9.70m OD (Figs. 2, 3, 6). No finds were associated with this context. This layer was overlain by a wet clayey sandy silty horizon containing a few gravels, stones and fragments of CBM **(5)**.

**Figure 2:** East-facing section of Trench I showing the crushed CBM path at the base, layer (7).

- 7.2 The only archaeologically significant feature recorded was deposit (7), which appeared near the base of the east-facing section and part of the north-facing section of Trench I. This layer of crushed CBM and mortar was likely the remains of a 19<sup>th</sup> century pathway running along the eastern perimeter of this central western compartment of the Kitchen Garden. The level of this feature (9.70m OD) was consistent with the suspected earlier path way (2112) observed during the watching brief phase of the HCP 104 project<sup>2</sup>.

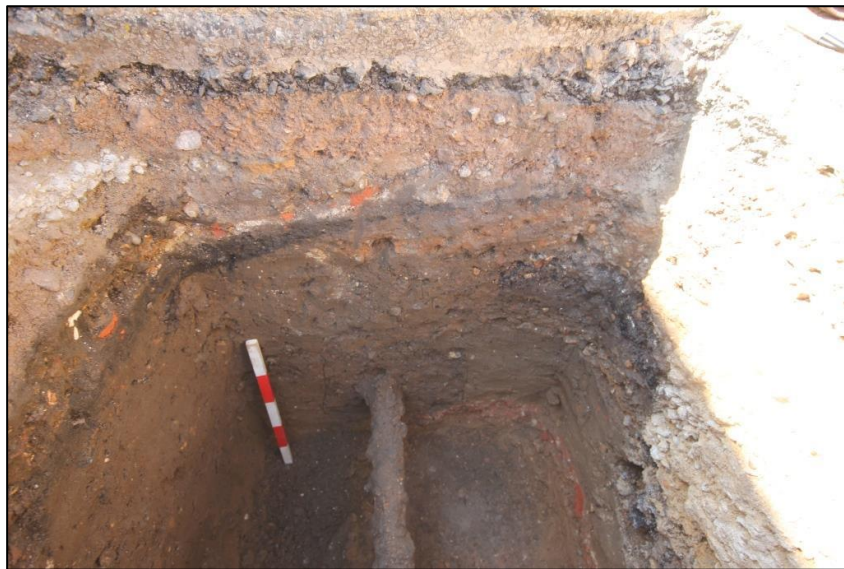
- 4.5 Layers **(7)** and **(5)** were truncated by the installation of an early 20<sup>th</sup> century water pipe running north-south. The backfill of the installation trench was then overlain by a heterogeneous gravelly levelling deposit **(4)** containing rubble material, fragments of cement and mortar as well as a squared block of limestone measuring 0.22m x 0.22m x 0.12m (Fig.5). The block had lead caulking and the remains of an iron picket inserted in the centre. The layers above, **(2-3)** were associated with the make-up layers for the tarmac ground surface **(1)**, which were all truncated by the concrete encasement of the below-ground power socket **(17)**.

**Figure 3:** North-facing section of Trench I showing context (7) and the truncation caused by the water pipe and below-ground electric boxes.

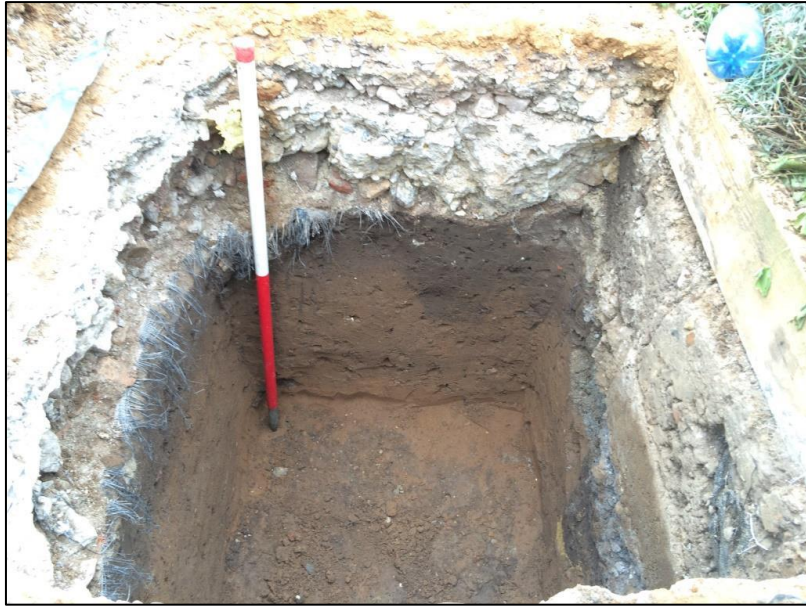
- 4.6 At the base of Trench II was the same sandy brickearth material that was observed in Trench I **(18)** and **(12)** but here it appeared at a depth of 9.12m which is consistent with the incline in the natural observed during the evaluation stage of the HCP 104 project. It was overlain a silty sand material **(11)**, similar to deposit **(5)**, which was in turn overlain by a dark brown cultivated soil horizon **(9)**. Both deposits **(11)** and **(9)** were truncated by cut **[14]**, which was visible in the west-facing section, recorded over a depth of 0.35m and a width of 0.28m at the top narrowing to 0.15m at the base. It had a flat base with near-vertical sides and was filled by deposit **(10)**, dark greyish brown silty sand with few inclusions.

**Figure 4:** West-facing section of Trench II showing context (14)

- 7.3 In Trench 2 a feature presenting a cylindrical form in profile was seen in the west-facing section cutting through garden soils [14], and would seem to be a later 20<sup>th</sup> century garden feature, though no finds were associated with the fill.

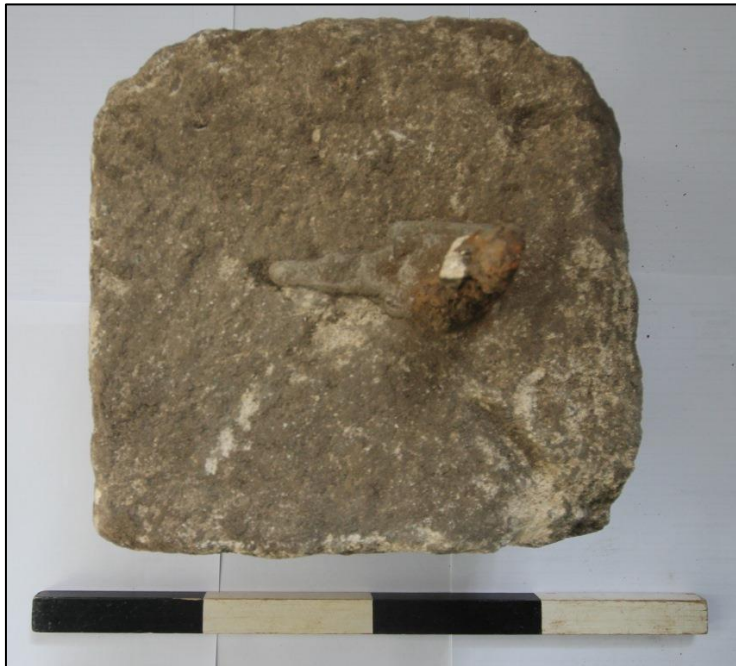
**Figure 5:** Limestone railing plinth found in context 4 of Trench I

- 7.4 A number of residual finds including several 19<sup>th</sup>/20<sup>th</sup> century pottery and china fragments were gathered from deposit (11) in Trench II. A Portland stone plinth with the remains of lead caulking and an iron picket was also uncovered in the backfill material of Trench I. It had clearly once functioned as a section of railing. Over the centuries, the palace railings have undergone many alterations, some having been destroyed, repaired and replaced many times and it is not unusual to find building debris in the Tiltyard since in the mid to late 17<sup>th</sup> century much of the area seems to have been kept clear as a piece of waste ground, and was used as a store for old masonry until the 1690's when the area was transformed into a kitchen garden for William III and Mary II (Longstaffe-Gowan, p.136). The stone could thus be the remnants of such debris, churned up, and brought back to the surface as a result of horticultural activity.

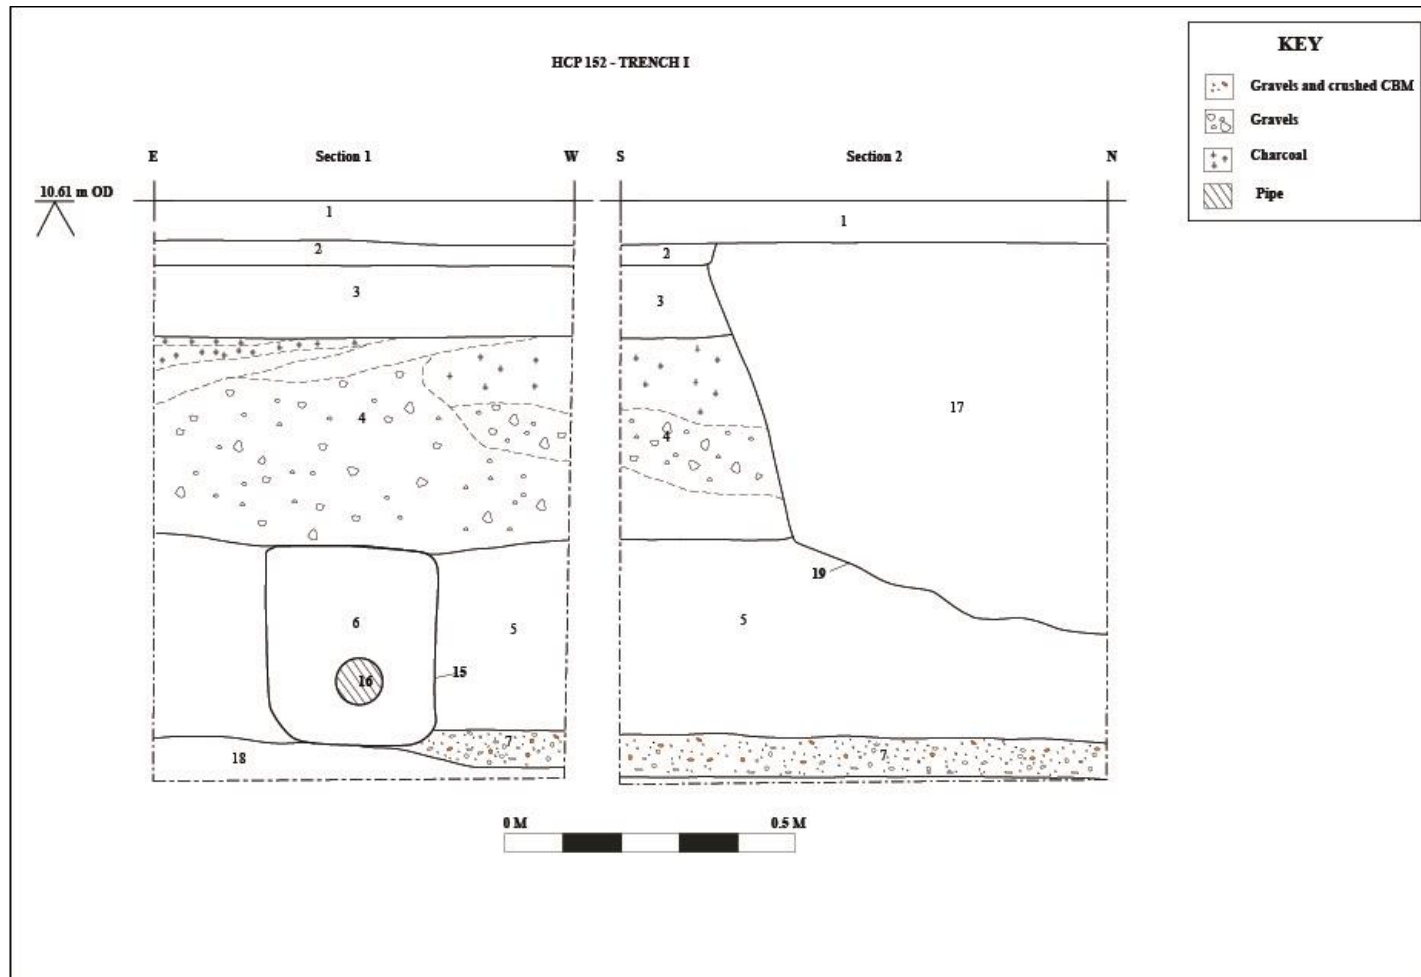
**Figure 6:** North facing and east-facing sections of Trench I

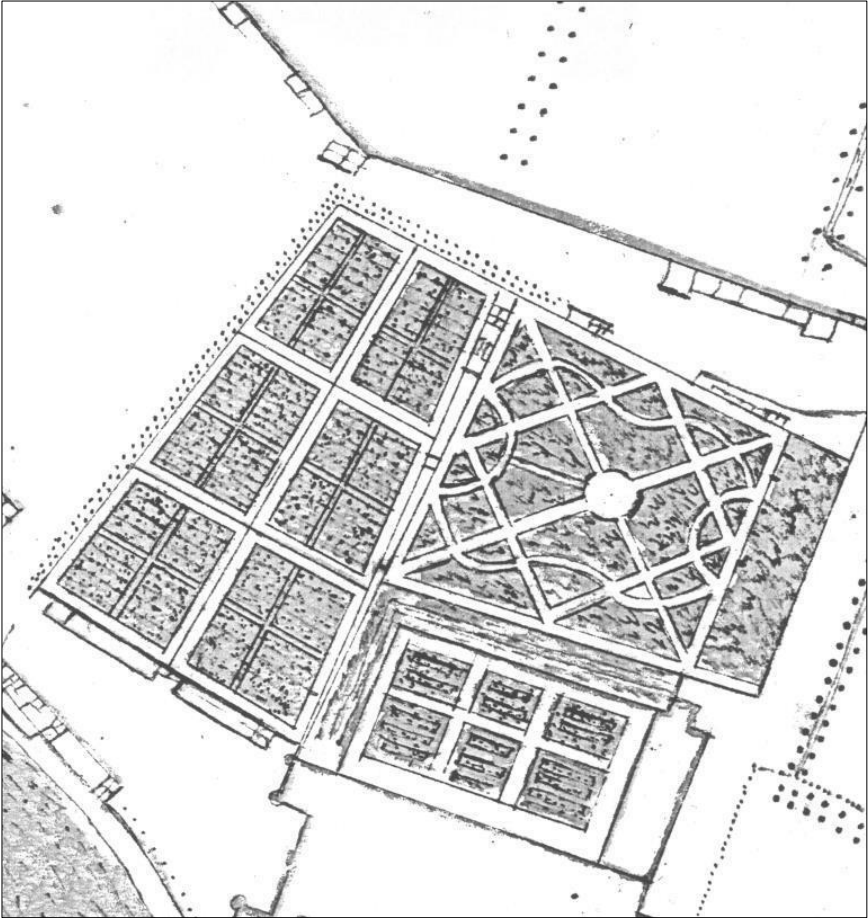
**Figure 3:** The Kitchen Gardens, Melon Ground and Wilderness c. 1698, extract from William Talman's plan of Hampton Court. ©RIBA

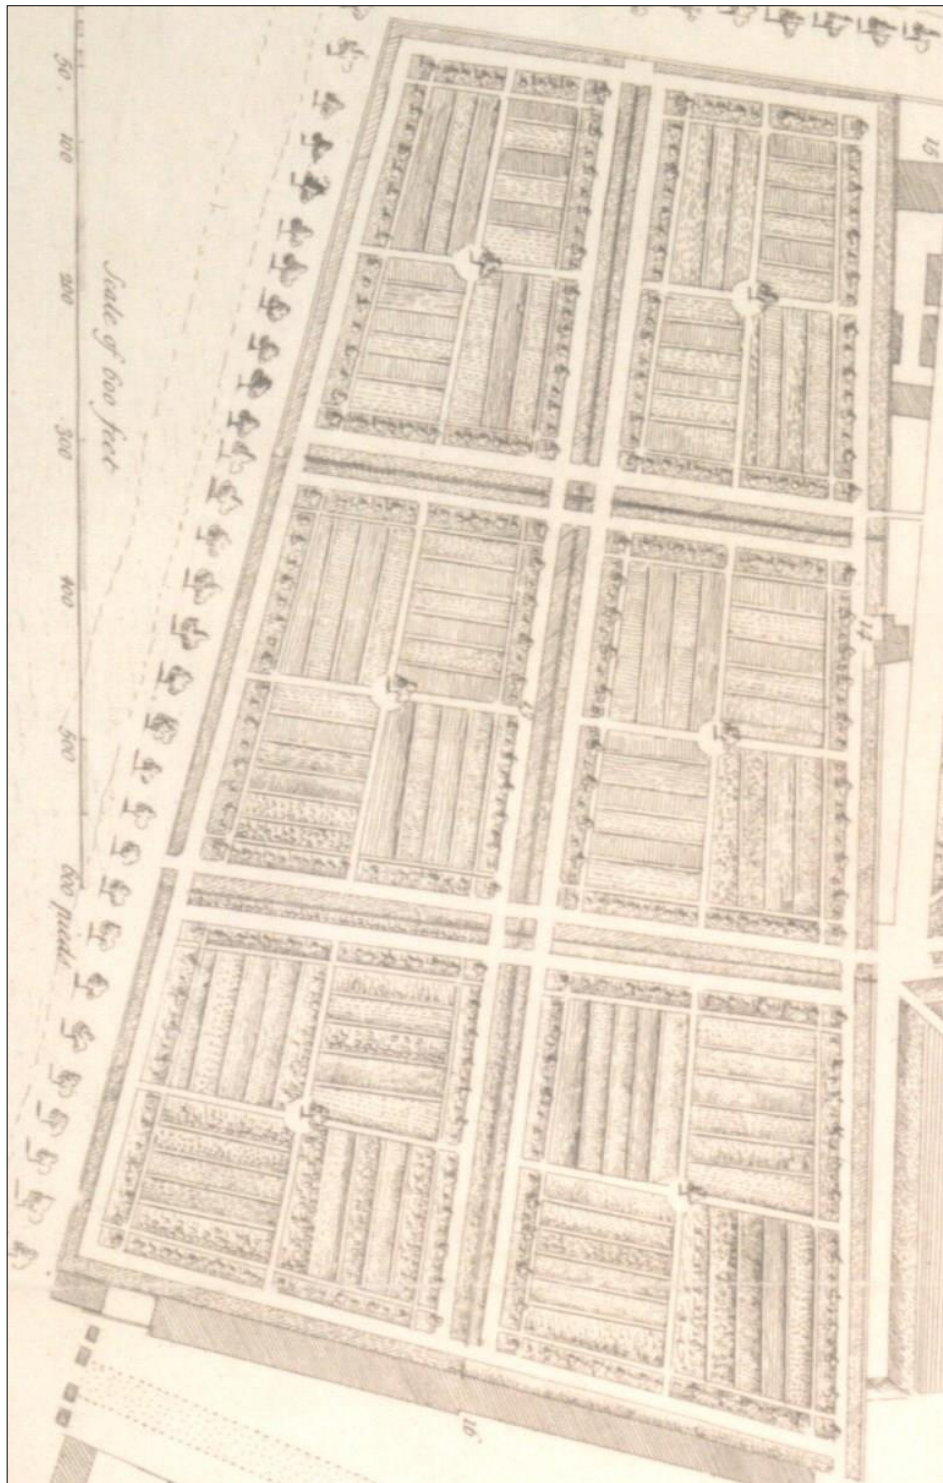
**Figure 4:** Layout of the Kitchen Gardens c. 1736, extract of John Rocque plan. © EH

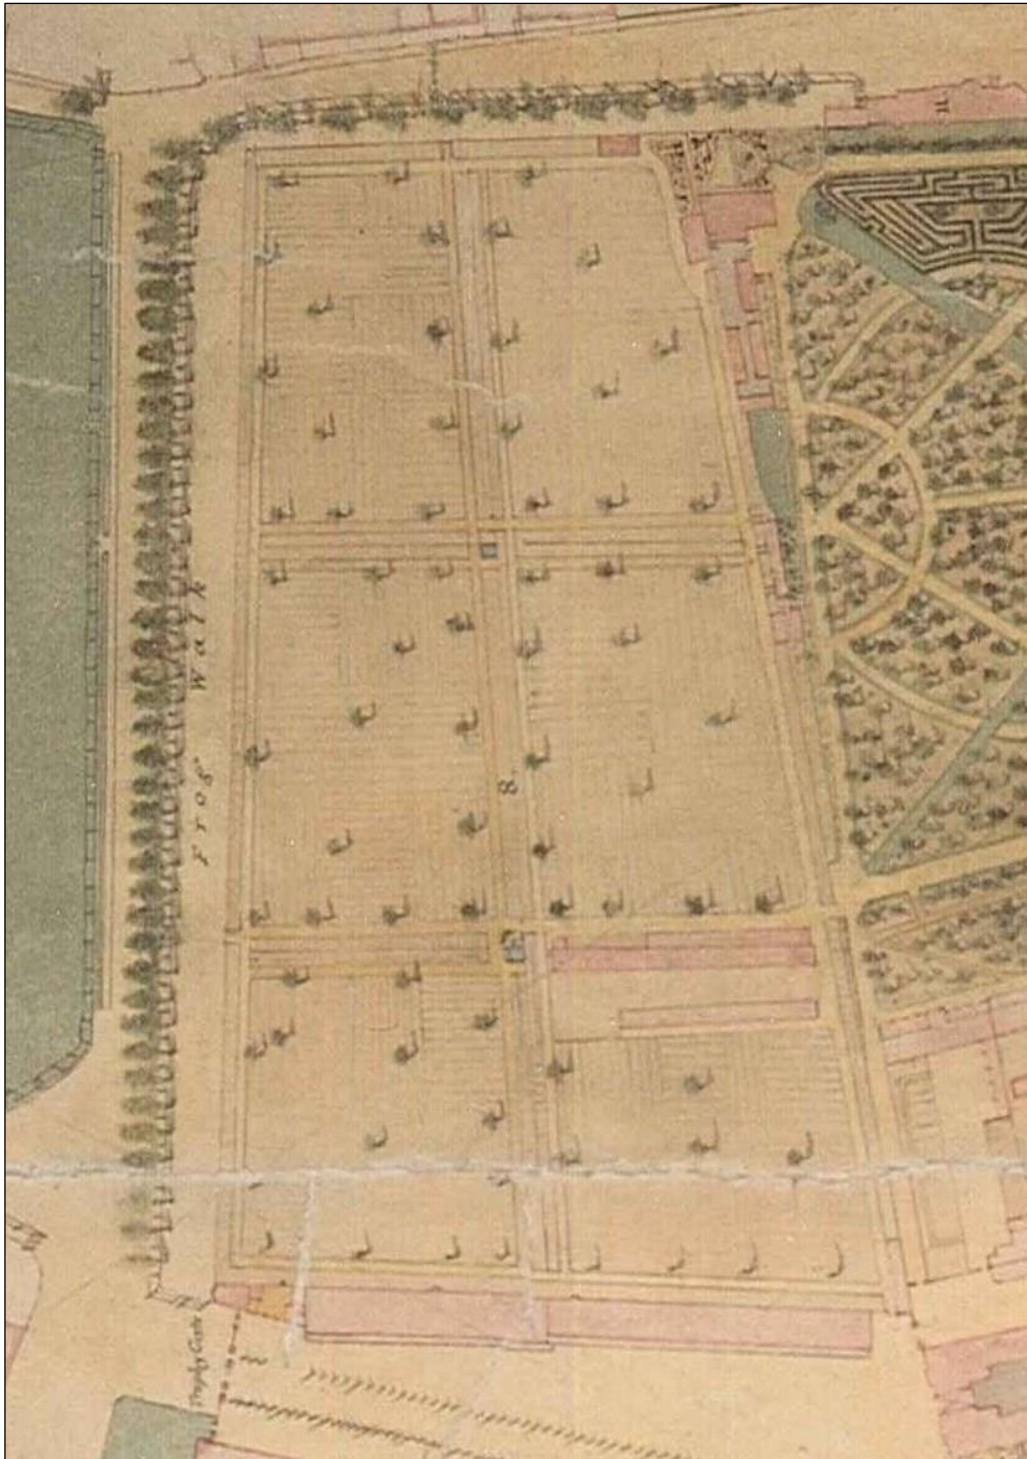
**Figure 5:** Extract from Henry Sayers' 1841 plan of Hampton court Palace Parks and Gardens. The Tiltyard was still in use as a kitchen garden, with the addition of wells and potting sheds/glasshouses in the south-eastern compartment

- 3.7 The Kitchen Garden required a lot of water, and there would have been several wells within the confines of the Tiltyard. According to an 1805 repair account, they were built of stone (TNA WORK 5/94). Henry Sayer's plan of Hampton Court Parks and Gardens shows two square water features along the central axis wall at the intersect of the cross walls (Fig. 12). The northern feature still exists today and may sit on the site of an earlier well.
