HCP 146

## Installation of Bicycle Posts on Tennis Court Lane, Hampton Court Palace

*An Archaeological Watching Brief*

*May 2016*

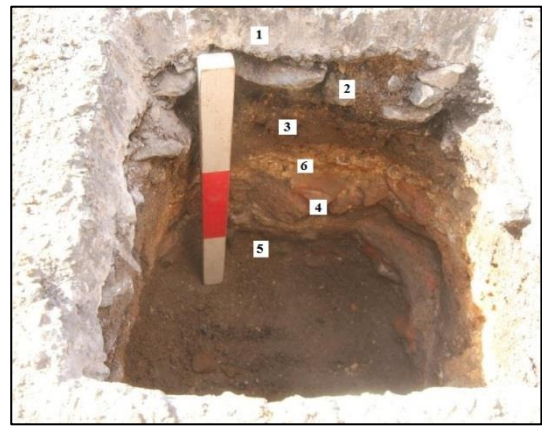
Figure 3: Trench A, south-facing section

- 4.2 The earliest deposit exposed in Trench A was composed of loose sandy silt containing charcoal flecks and small fragments of ceramic building material (CBM) (5). This was overlain by layer (4), which was a loose rubble material found consistently along this western line of five trenches and measured 0.17 m in depth. It was overlain by a thin band of coarse sandy lime mortar measuring 0.04 m in depth (6), which was followed by layer (3), a loose silty sandy deposit containing occasional fragments of CBM. It measured 0.05 m in thickness.

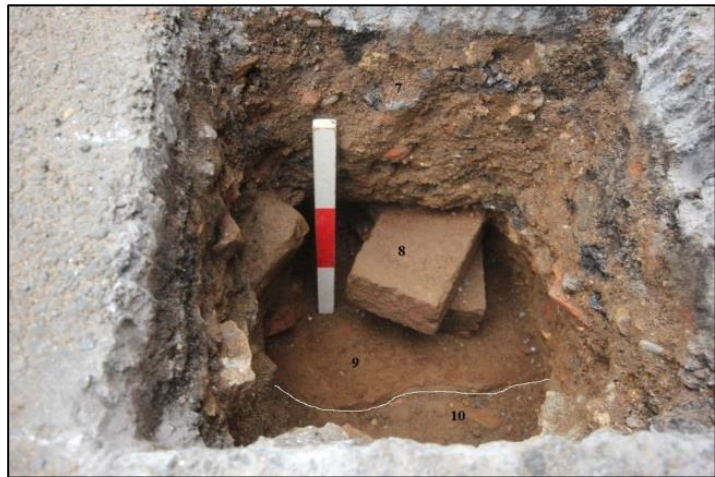
Figure 4: Trench B, east-facing section

- 4.3 The earliest deposit exposed was a heterogeneous layer composed of greenish silty clay and coarse sands and gravels at 8.86 m OD (10). This was partially overlain by a hard compact metallised surface (9) with an orangey brown rusty colour. It measured a mere 5 mm in thickness. This was directly overlain by a dump deposit containing two squared pinkish red bricks measuring 0.06 m x 0.10 m x 0.23 m (8). The bricks and surface (9) were overlain by rubble backfill (7) similar to contexts (4), (12), (16) and (19).

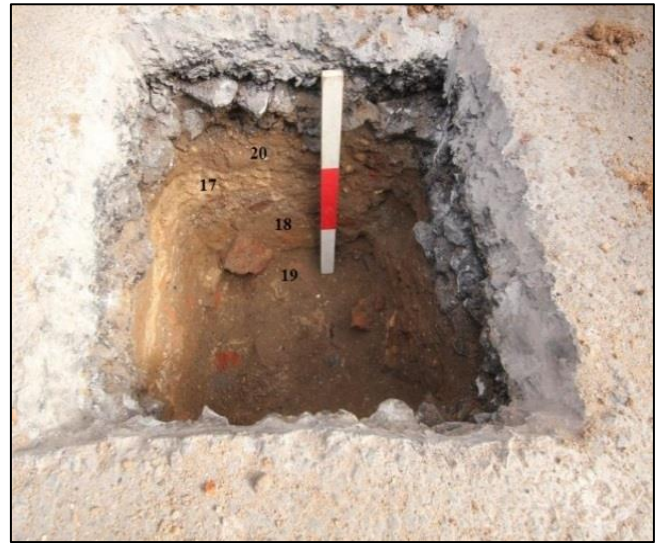
**Figure 5: Trench C, south-facing section**

- 4.4 Trench C had the same stratigraphic sequence as Trench D. The earliest layer observed was a loose silty sand deposit containing rubble material and a few fragments of 19<sup>th</sup> century porcelain (19). This was overlain by layer (18), a compact sand deposit with pockets of coarse sandy mortar and occasional small fragments of CBM, measuring 0.03 m in thickness. This was then followed by deposit (17), a thin band of coarse sandy mortar equivalent to deposits (14) and (6) in trenches D and A. This mortar layer came to an abrupt end at the eastern end of the trench. Finally, layer (20), which overlay (17), was the equivalent of (13) seen in Trench D and consisted of loose silty sand with occasional small fragments of CBM and small stones.

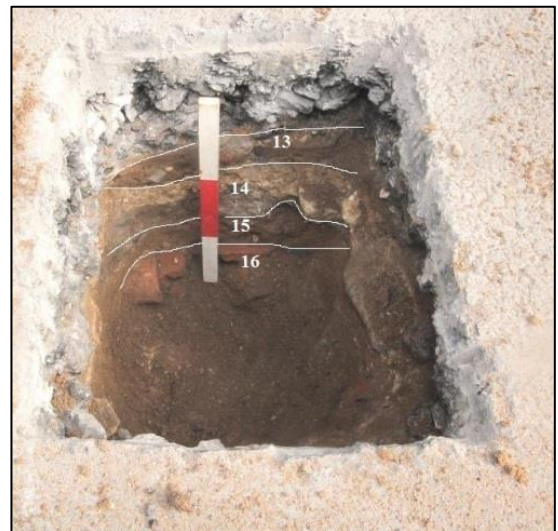
**Figure 6: Trench D, south-facing section**

- 4.5 Trench D revealed the same sequence as was observed in Trench C. Details of the equivalent contexts can be found in Appendix I and Figure 6. Deposit (16) contained a couple of pottery fragments and a large quantity of CBM, mainly consisting of roof tile, of which a sample was taken.

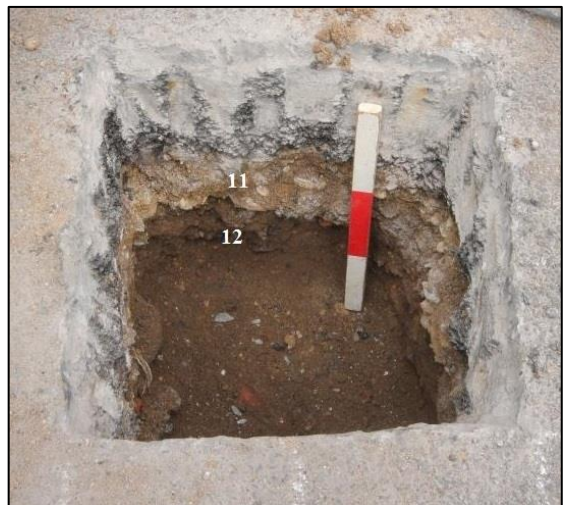
**Figure 7: Trench E, south-facing section**

- 4.6 Deposit (12) was the earliest layer exposed corresponding to the rubble layers observed in Trenches A, B, C, and D (deposits (4), (7), (19), and (16)). It contained several fragments of glass and a large quantity of CBM. This was overlain by deposit (11), a band of sandy gravels measuring 0.06 m in depth.

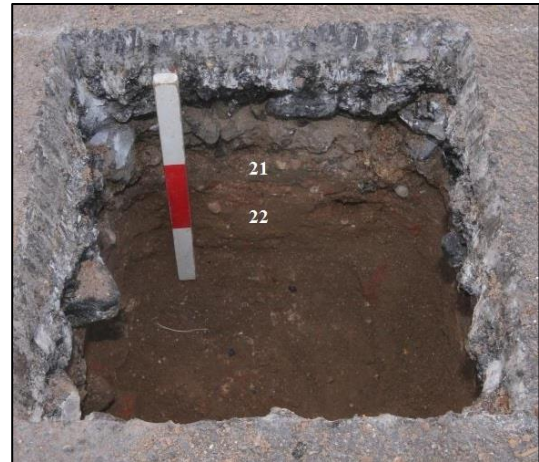
**Figure 8:** Trench F, south-facing section

- 4.7 Trench F was the first trench excavated on the eastern side of the Works Yard entrance. The earliest deposit exposed was layer (22) composed of friable reddish brown silty sand with a high content of brick dust, mortar fragments and small stones. It was exposed to a depth of 0.14 m, and may correspond to the levelling layer uncovered in Trench 1 (see section 5.8). This was overlain by deposit (21), a thin lens of loose greyish brown silty sand.

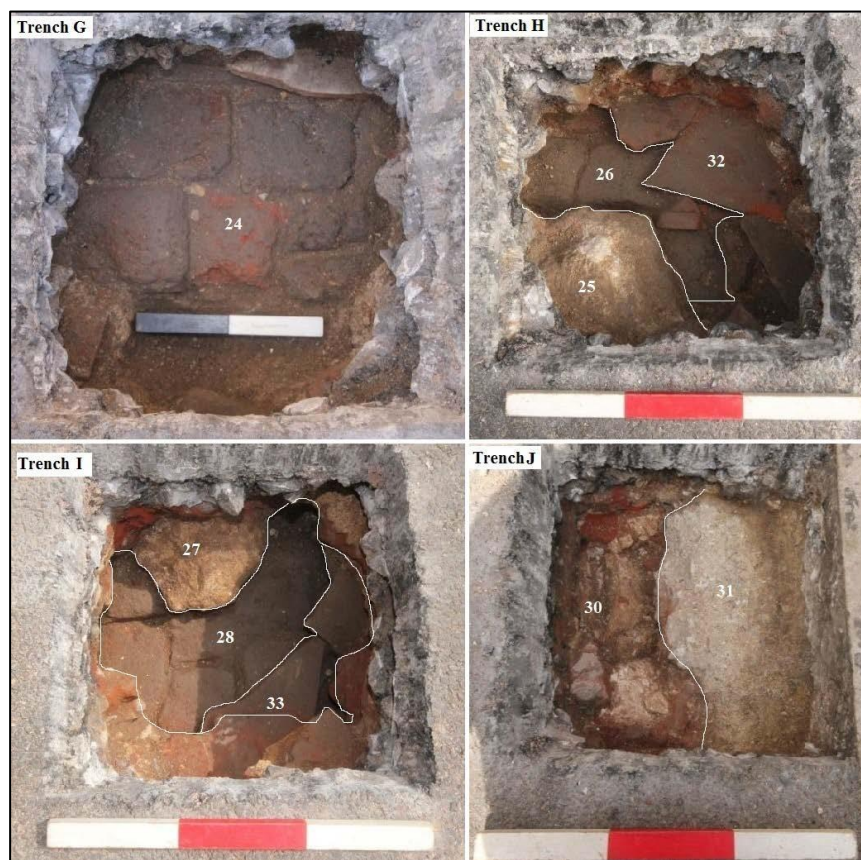
**Figure 9:** Trenches G to J

- 4.8 Six of the ten trenches excavated on the eastern side of the Works Yard entrance consistently revealed the presence of the same archaeological feature resulting in a revaluation of the installation of the bicycle posts. In order to determine the extent of this feature and to find an alternative location for the posts a larger trench was excavated, Trench 1.

- 4.13 Overlying the brick surface in some places was a dump of broken tiles, visible in Trench H (32), Trench I (33) (Fig.9), and Trench N (42) (fig. 12), which in turn was followed by a dump of rubble overlying the archaeology (44) and very similar to that which was observed in trenches A-E.

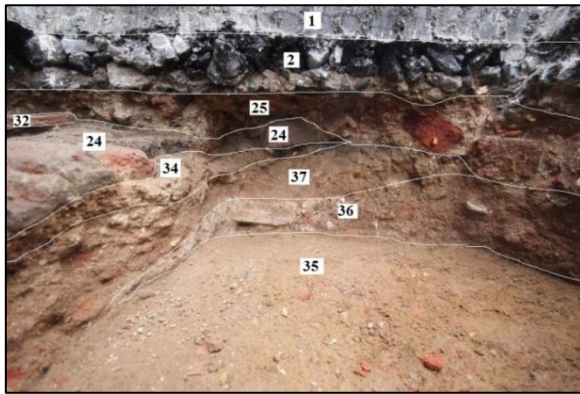
**Figure 10:** West-facing section in Trench 1

4.10 The earliest deposit exposed was buried soil horizon (35) observed in Trench 1 at a height of approximately 8.87 m OD; 0.31 m below the current ground level. It was composed of greenish brown friable sandy silt with occasional small stones and pockets of light greenish clay as well as occasional fragments of mortar and brick, which probably filtered through from the overlying rubble rich deposits. This layer was directly overlain by a substantial rubble deposit with a large quantity of coarse sandy lime mortar and fragmented bricks observed in the west-facing section of trench 1 (36). This layer seemed to slope downwards from the west to the east. It was overlain by levelling layer (35) associated with the brick surface (46), and was observed in trenches F and M (layers (22), (40) as well as Trench 1 (layer (37)). It was a compacted layer of reddish silty sand containing micro-fragments of brick and coarse sandy mortar nodules. Above was a thin band of sandy lime mortar 0.02 m thick corresponding to the setting bed for brick surface (46). This brick surface was observed in Trenches G, H, M, N, O, and I

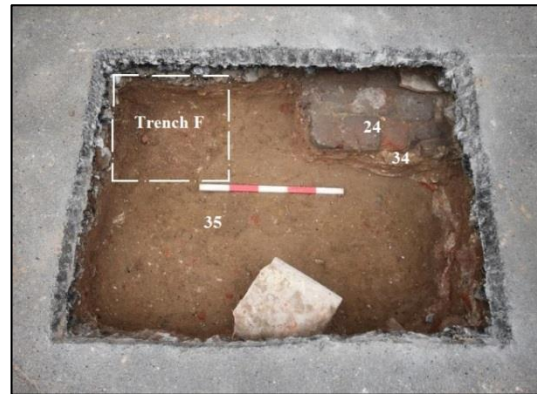
**Figure 11:** Trench 1, final phase of excavation

4.9 Trench I was located between Trenches F and G (see Fig 2), and measured 1.10 m x 0.8 m x 0.4 m

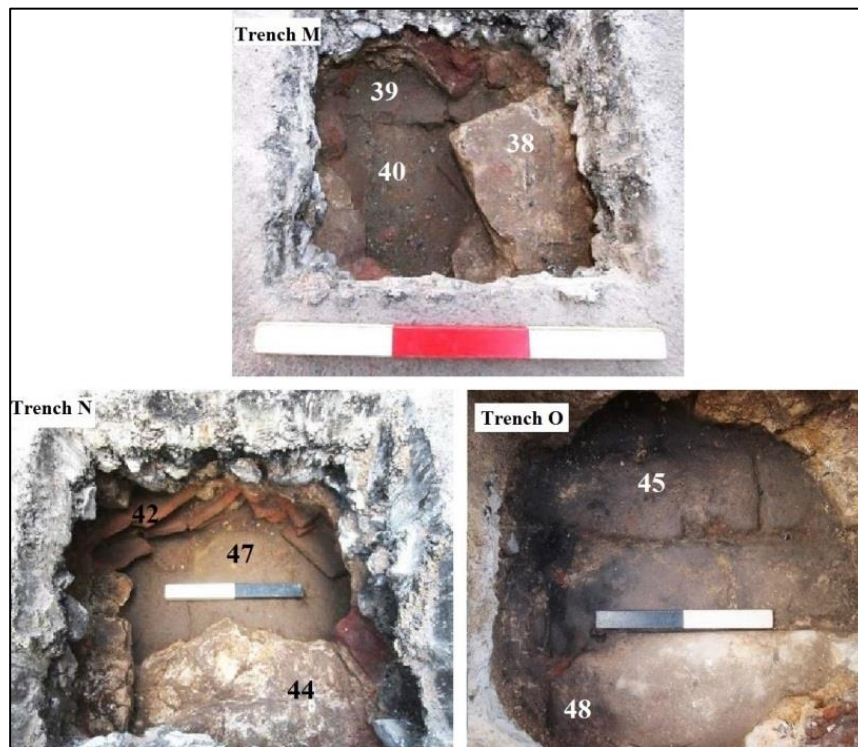
**Figure 12:** Trenches M-O with brick surface 46

- 4.11 This brick floor, where conserved, was in a good state of preservation. It was composed of unfrogged red bricks measuring on average 100 mm x 220 mm x 30 mm – 40 mm +. The bricks appeared weathered and worn, suggesting their use in an area of heavy circulation. They were crumbling away in some places though this may be due to the effects of some sort of truncation of an undetermined nature located near trenches F, K, L and M where brick surface (46) was not conserved.
- 4.12 The surface was best seen in Trench O where it survived beneath the concrete foundations of the contemporary stone paved surface outside the reception area. In this particular trench, a section of a Yorkstone slab was also visible (48), the full extent of which was not observed due to the confined nature of the trench (Fig. 12).

- 5.4 The presence of a Yorkstone slab observed in Trench O may indicate the existence of some sort of threshold, though of course the restricted view posed by the limited size of the trenching does not provide an informed interpretation.
