HCP147 Garden Graphics Installation, Hampton Court Palace

An Archaeological Watching Brief

Alexandra Stevenson August 2017

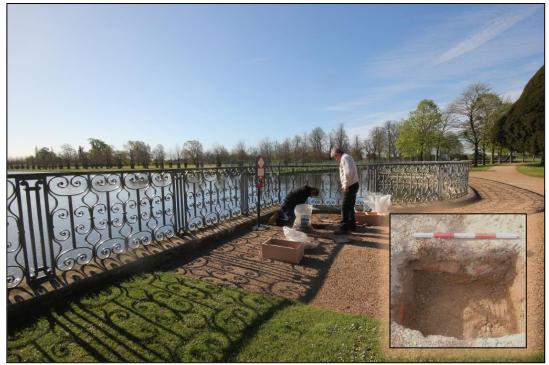
3.10 The trenches excavated in front of the Long Water exposed three layers of gravel associated with the garden paths. The southern-most trench also revealed the presence of a number of bricks lying in an apparently organised fashion (context 10), though given the size of the trench it is difficult to define its nature or function (Fig 4).

Figure 4: Graphic G7 in the process of being installed, Long Water, East Front. Inset: section showing context 10.

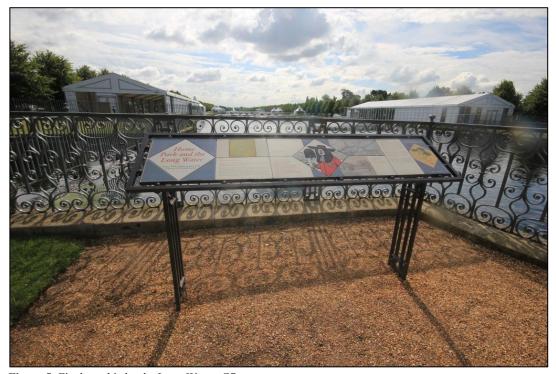
Figure 5: Final graphic by the Long Water, G7

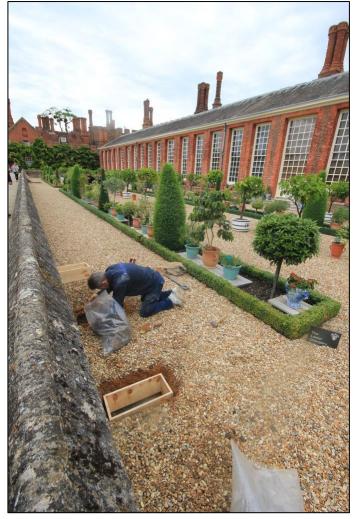
Figure 7: Excavation of graphic G14 trenches in the Lower Orangery Garden

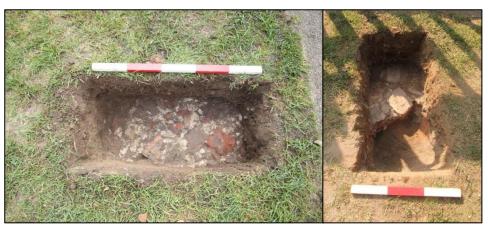
- 3.6 Graphic 1a is located in the central eastern compartment of the former Tudor Tiltyard on the eastern corner of the grass area.
- 3.7 At the base of both trenches was a soft silty sand horizon with micro-fragments of charcoal, small stones and flecks of mortar, appearing at a height of 10.27m OD (contexts 3 and 5). This was overlain by a layer of compacted rubble composed of sandy, gravelly yellow/white lime mortar with large fragments of brick of varying types. The deposit measured between 0.12m and 0.14m in depth. This layer was encountered in both trenches (contexts 2 and 4) (Figure 8). It seems most likely to correspond to a sub-base layer for a 19th century pathway.
- 3.8 These contexts lay 20cm below the ground level, directly beneath the topsoil (context 1).

Figure 8: Graphic G1a, context 4.
