HCP 165 Tennis Court Lane and Works Yard IS Cable Installation, Hampton Court Palace

An Archaeological Watching Brief

Alexandra Stevenson

September 2018

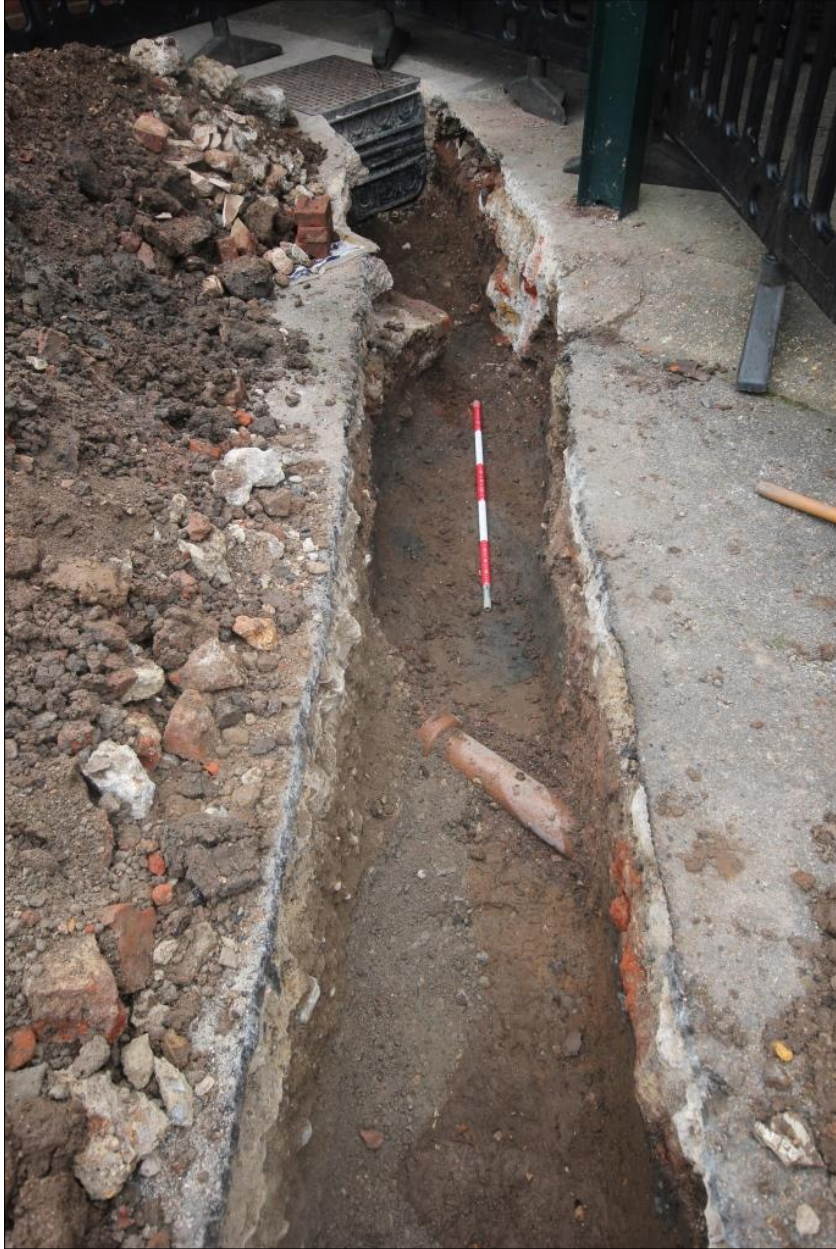
Fig. 2: General shot of the eastern end of Area I, adjacent to the cycle shed

5.3 Area I encompassed the east-west section of trench beginning at the cycle shed, continuing just beyond the archway that provides access from the east to the west parts of the Works Yard (Fig. 1). The trench was excavated to a maximum depth of 0.6m in this location.

5.4 No natural soils were encountered. The earliest archaeological layers included a sequence of sterile, damp sandy clay soil horizons containing few visible inclusions other than a few pebbles and stones (107), (104), (103), (112), (111). The earliest deposit in the sequence was (107), a homogenous greenish brown sandy clay, which may correspond to the remnants of a buried garden soil. Whilst the proceeding layers may also be remains of garden soils, they may equally correspond to levelling deposits. These soils were cut by the installation of a number of services and overlain by mixed rubble backfill materials (see matrix in Appendix II).

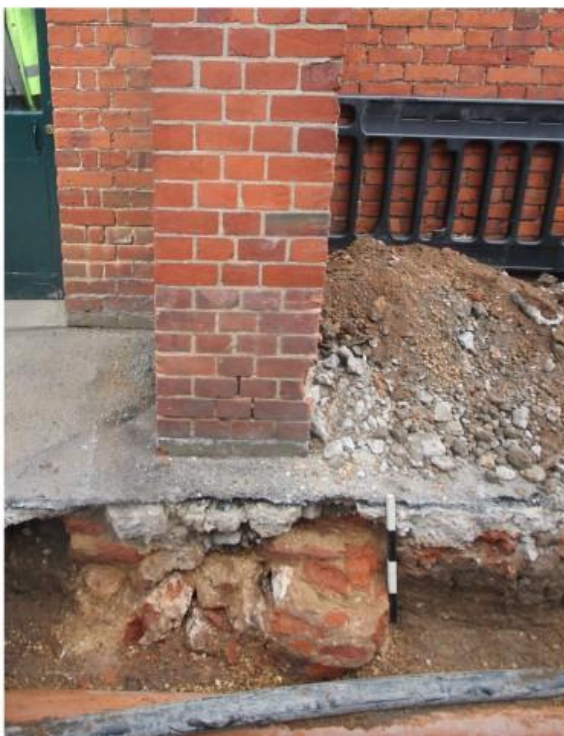
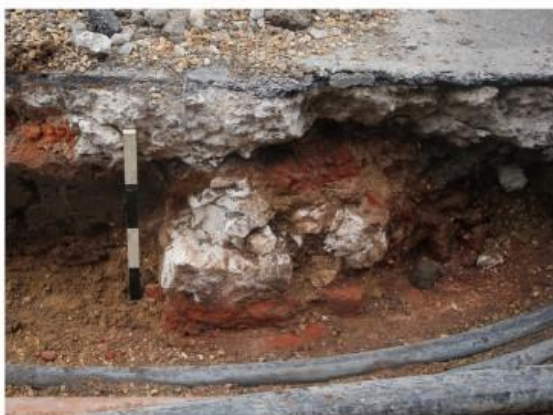
Fig. 3: Walls (123) and (126) located along the line of the boundary wall and beneath the arch providing access between the eastern and western sides of the Works Yard, Area I

5.5 A north-south aligned wall was encountered below the arch pillar between the east and west sides of the Works Yard (123), (126) (Fig. 3). The structure was between 0.7m and 0.8m wide. It was difficult to determine its exact width as it was heavily truncated by modern services and was in a poor state of preservation. It was composed of bricks and chalk rubble. The brickwork was bright orange in colour, friable, and contained a few micro-fragments of flint. Neither the bonding pattern nor the pointing were intact, though the bonding material was composed of coarse beige sand containing lime nodules. The bricks individually measured 220mm x 60mm x 100mm. This section of wall was overlain by modern-make-up layers associated with the tarmac as well as the 20th century redbrick arch pillar (125).

Wall 123

Wall 126

- 6.3 A north south-wall was encountered beneath the existing arch that links the western and eastern parts of the Works Yard (Fig.3). This wall was also observed during watching brief works undertaken by Oxford Archaeology in 2013 (HCP112). Whilst much of the structure was composed of 19th century brickwork, there was also a crude damaged brick dating to c. 1529-1566. Furthermore, the foundation of the wall was composed of chalk rubble, often characteristic of early post-medieval structures encountered elsewhere around the palace. As such, it was thought possible that the existing Works Yard building was partially constructed over an earlier footing, which may represent the remains of an early wall located around the eastern edge of the post-medieval moat delimiting the western end of the Privy Orchard.

- 6.4 It would seem, therefore, that a wall has existed in this location for over 500 years, but clearly has been rebuilt, repaired and repurposed over the centuries, at one stage extending all the way to the north face of the palace. Daphne Ford's phased plans of the palace also indicate that the extant wall dates to the second half of the 17th century, but probably overlies the boundary wall that enclosed the Tudor Privy Orchard. The southern extent of this north-south wall was demolished between 1736-70 when this section disappears from plans and surveys of the palace. The majority of the 17th century wall that divided Carpenters Yard from the Melon Ground is now mostly hidden behind the early 20th century Works Yard buildings.

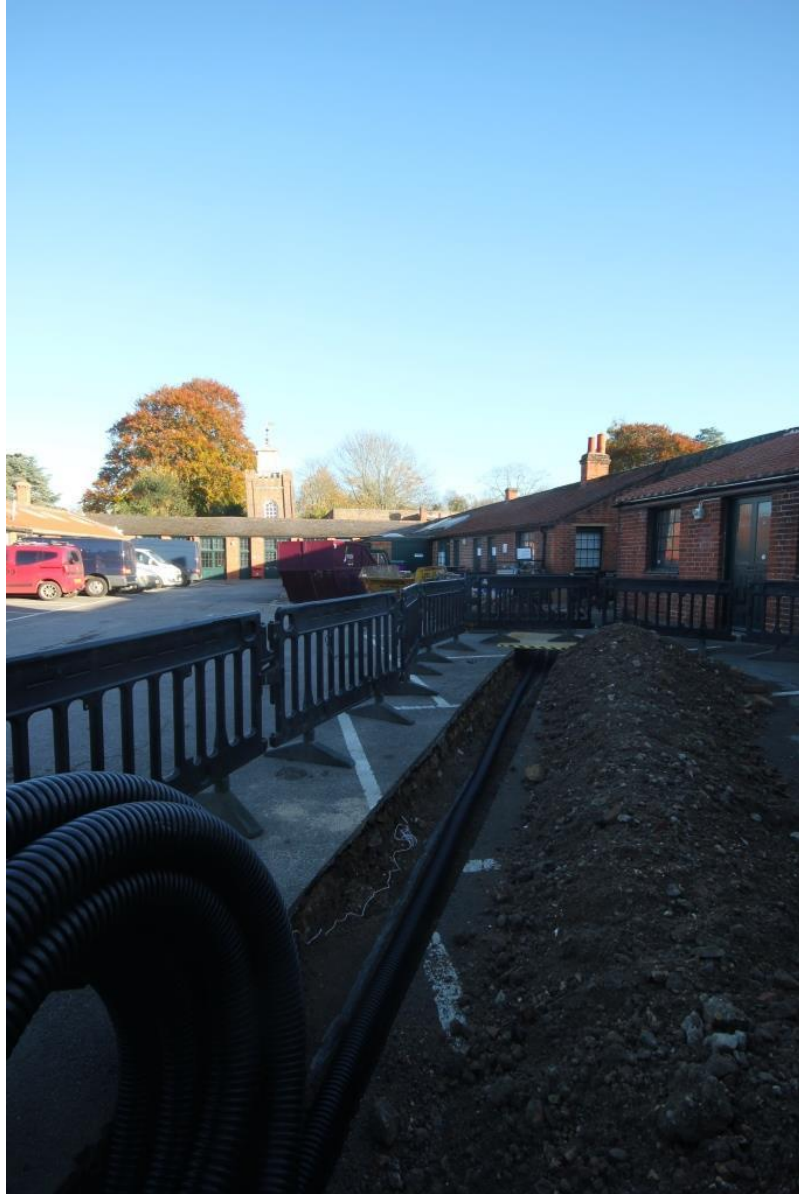
Fig. 4: IS cable trench looking north in the Works Yard, Area II

5.6 Area II comprised a north-south section of trench located on the southern side of the Works Yard extending up to the entrance (Figs. 1 and 4). At the base of the trench were the remains of a crushed brick deposit (129) 0.5m below the current cobbled surface. It was observed over a length of 1m and was located approximately 1.5m north of the entranceway into the Works Yard. It was heavily truncated by modern services and was overlain by mixed rubble backfill material (127).

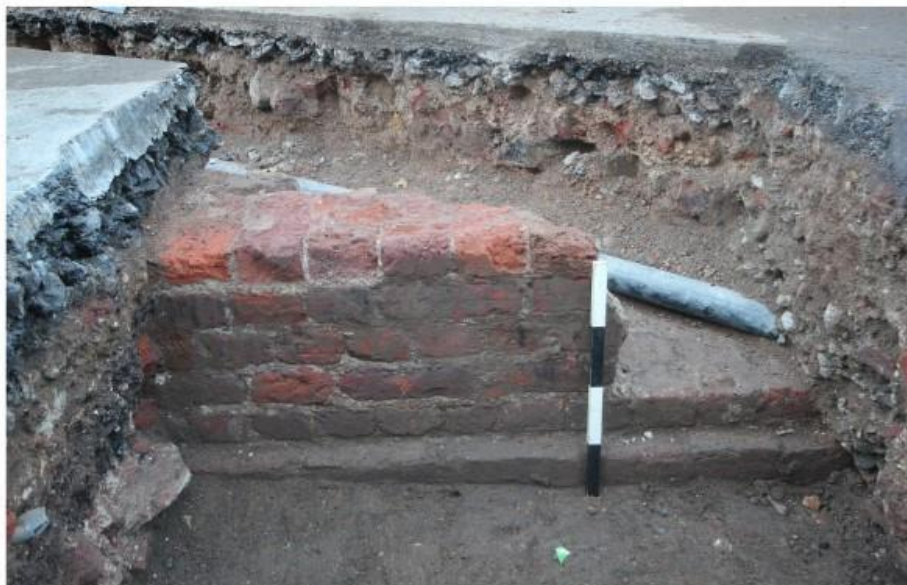
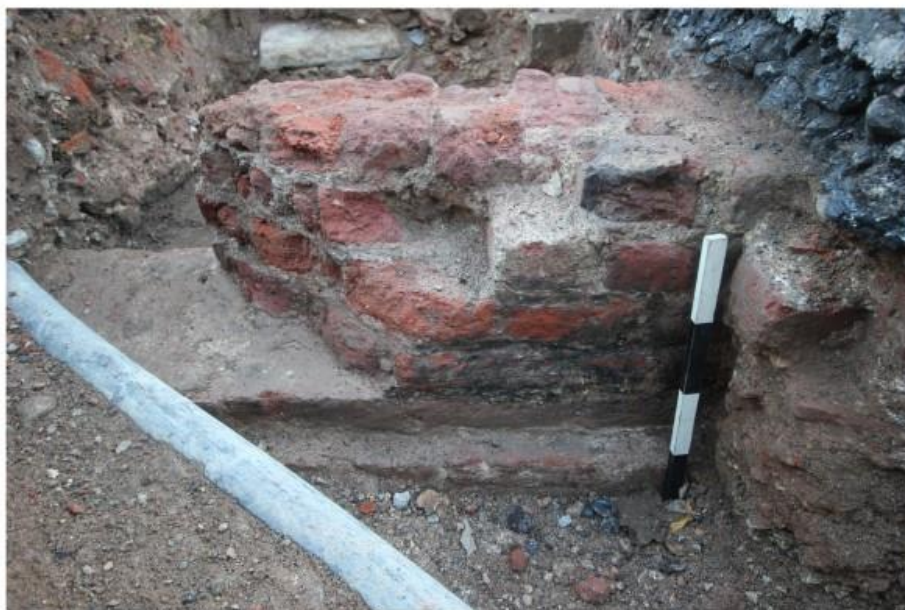
Fig. 5: Wall (136/155) in Area III to the south of the Works Yard entrance

- 5.9 The earliest feature recorded in Area III was an east-west aligned brick wall (155/136) located 3.5m south of the upstanding Works Yard boundary wall and exposed at 0.16m below the tarmac surface. This wall was truncated by mechanical means during the installation of new services in 2013 and was recorded during a watching brief by Oxford Archaeology (HCP 112), where its full height was exposed (height not recorded). During the current project, however, the wall was exposed over a height of 0.45m and over a length of 1.12m. Its offset foundation level (155) was recorded and observed over one course of bricks, though during the watching brief in 2013, its full extent was observed over five courses of brick laid in English bond pattern. The elevation (136) was preserved up to five courses of brick and was also laid in English bond pattern, though rather irregular towards the top. The fabric of the brick was sandy and friable with either a brown to deep rose or orangey red colour. The bricks contained gravel or flint inclusions and occasional clay pipe fragments. The bricks measured individually 210-220mm x 60mm x 100-110mm. The bonding material was a soft grey gritty lime mortar containing black inclusions. Once the wall had been recorded, the elevation was partly dismantled by hand in order to make way for the cables. The area dismantled was already crumbling as a result of having been truncated by the insertion of services in 2013.

- 5.10 Elevation (136) was abutted by a number of levelling deposits containing demolition rubble (see matrix, Appendix II and context description in Appendix I). The wall had also been heavily truncated to foundation level by the installation of services in 2013.

South-facing elevation of wall 136

North-facing elevation of wall 136

- 6.7 The wall had been heavily truncated by the installation of services in 2013, but it was nevertheless recorded at both foundation (155) and elevation (136) levels. The whole structure was comprised of a mix of orangey red, brown and rose coloured bricks, the fabric appearing most akin to Brick Type V in Daphne Ford's brick typology, which suggests that this structures dates to the mid-19th century.

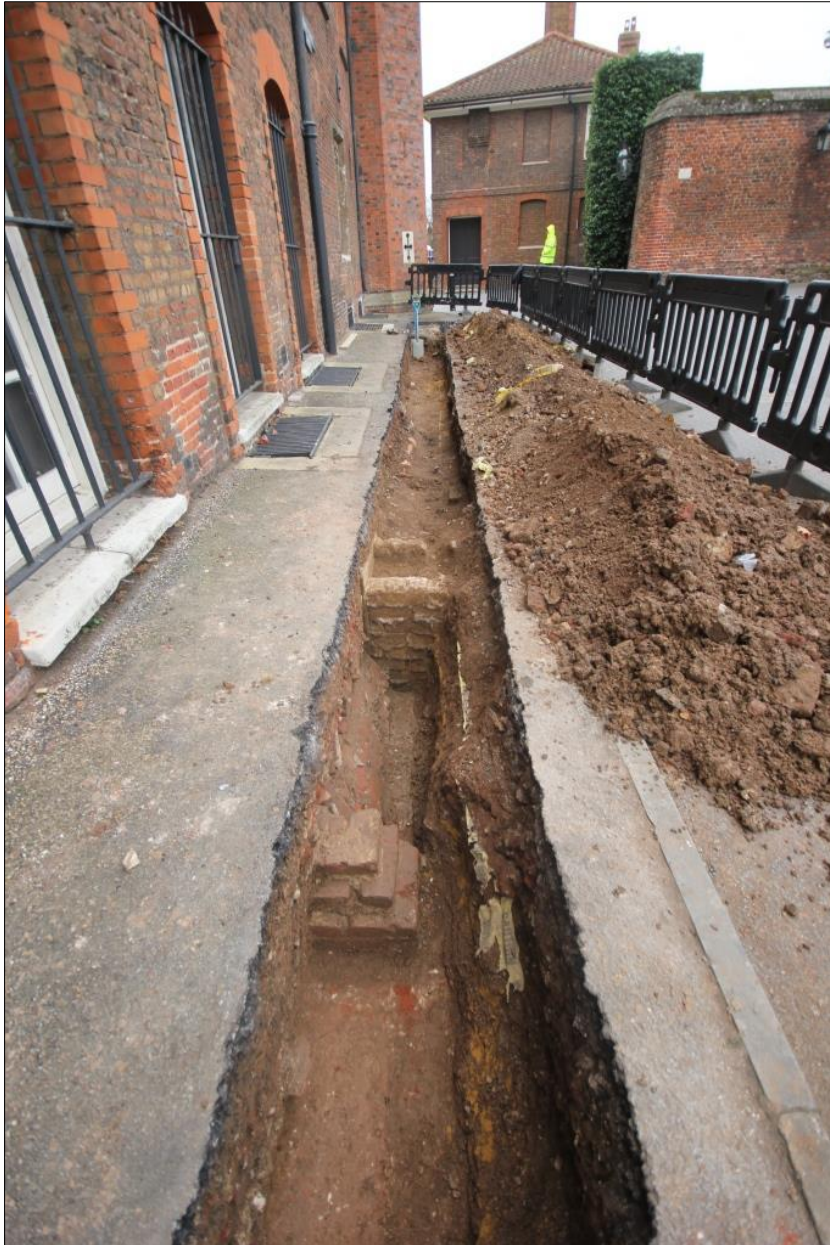
Fig. 7: Area IV, IS Cable trench on Tennis Court Lane, looking west

- 5.11 Area IV was an east-west section of trench located at the foot of the north elevation of the palace at the west end of Tennis Court Lane.
- 5.12 A number of built structures and archaeological features were recorded at the base of this trench. The earliest features were a tubular redbrick structure (168), and two segments of a compacted crushed redbrick surface (147) and (162). None of these features presented physical relationships with one another.

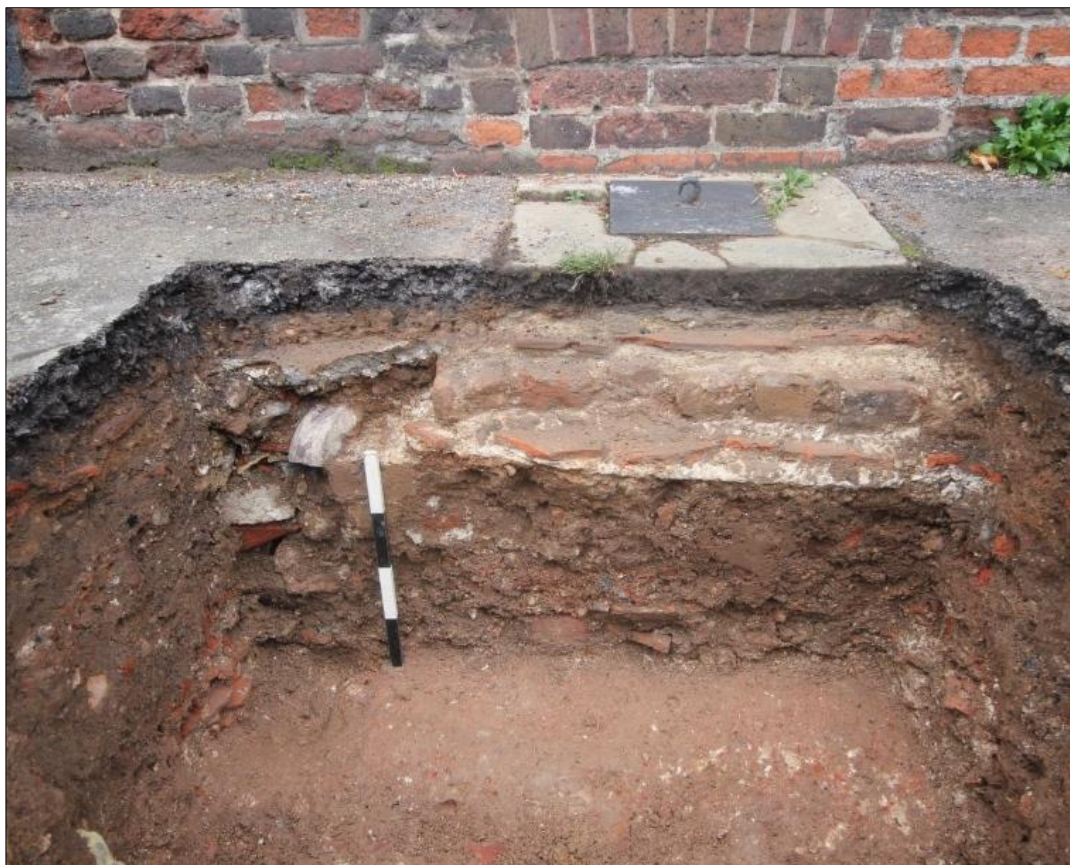
Fig. 8: Eastern end of Area IV, Coal chute 144/145, and layer 147

- 5.14 Layers (147) and (162) appeared to be contemporary; however, they were located approximately 3m apart. Layer (147) was located at the far eastern end of the trench, level with the coal chute (Fig. 8), whilst layer (162) was located immediately east of (168). Both layers were recorded at 0.7m below the current ground level and were characterised by a compacted coarse sandy red material containing gravels, small fragments of mortar, micro-fragments of brick and flecks of manganese and iron-panning. There were no visible artefacts. Both (162) and (147) were truncated by modern services running east-west along the north side of the trench.

- 5.16 These features were overlain by a sequence of levelling deposits followed by backfill material associated with the installation of services in the 70's and the laying of the current tarmac surface and pavement (see Appendices I and II).
- 5.17 One of two coal chutes was recorded in section at the far eastern end of the trench (Fig. 8). A cast iron square coal cellar plate sits flush within a Portland capping stone (144). In section, a brick structure was observed beneath the capping stone. It was recorded over two courses of brick and tile that were bonded together with a cementitious gritty lime mortar.

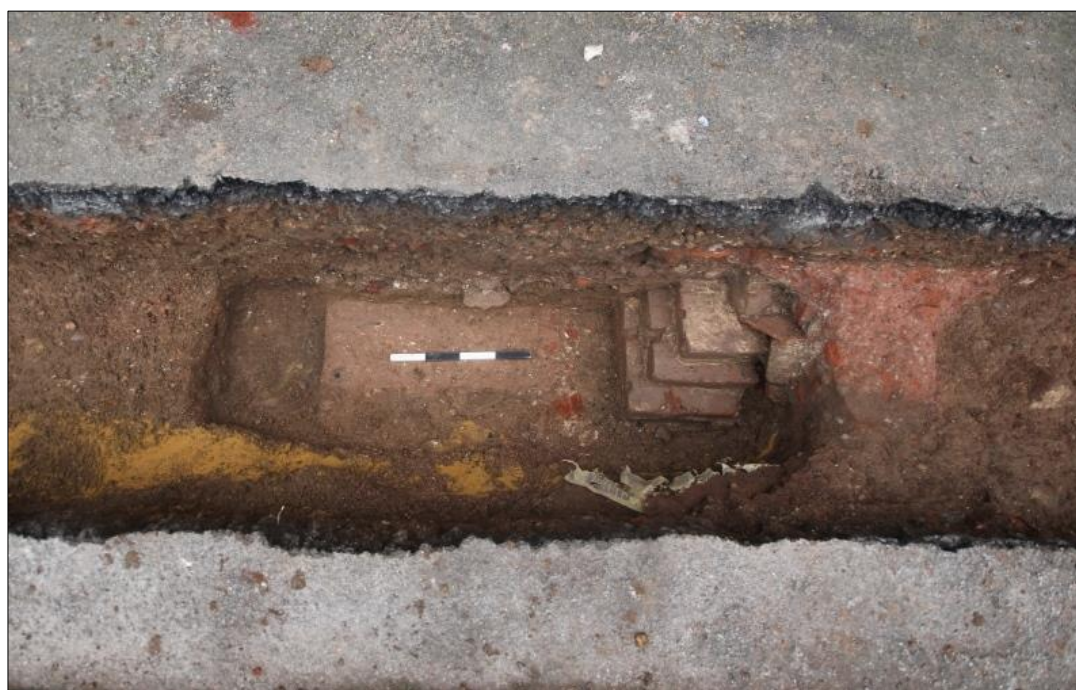
Fig. 9: Stepped brick structure (163), layer (162), and overlying rubble layers

- 5.15 Layer (162) was truncated by stepped brick structure (163). It was observed over five courses of brick amounting to a height of 0.6m. The top three courses were stepped on the eastern face, but the western elevation was flush. Its full extent was not excavated. It was composed of a mix of plum-red and orange coloured bricks measuring 215mm x 60mm x 100mm. The bonding material was mostly a soft sandy beige coloured lime mortar. A harder mortar exuded over the bricks on

the east and west faces. There was no obvious pointing. Mortar was present on the bed of the upper course of bricks suggesting the feature has been demolished to this level.

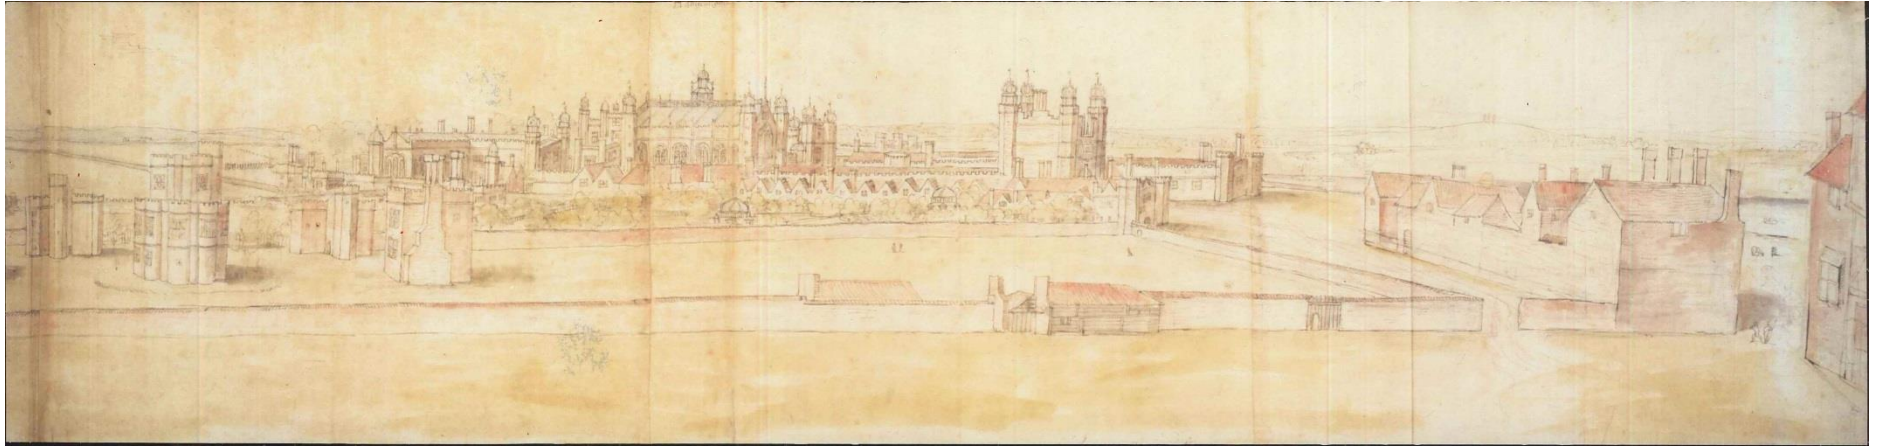
Fig. 12: Wyngaerde's 1558 view of the palace with the Tiltyard and Privy Orchard in the foreground (Ashmolean Museum, LIV 9a)

- 4.5 Accounts from 1531 indicate that the Privy Orchard was adorned with seven King's beasts in timber as well as two arbours, indeed, this arrangement can be seen in Wyngaerde's c.1555 sketch of the north side of the palace (Fig. 12). The north-eastern part of the Privy Orchard was occupied by an open tennis court, which may have existed as early as the late 15th century during the Daubeney phase of occupation. In 1537, a covered bowling alley was built perpendicular to the palace, stretching from Prince Edward's lodgings across to the northern boundary wall of the Orchard, creating a smaller rectangular space at the eastern end of the moated area.

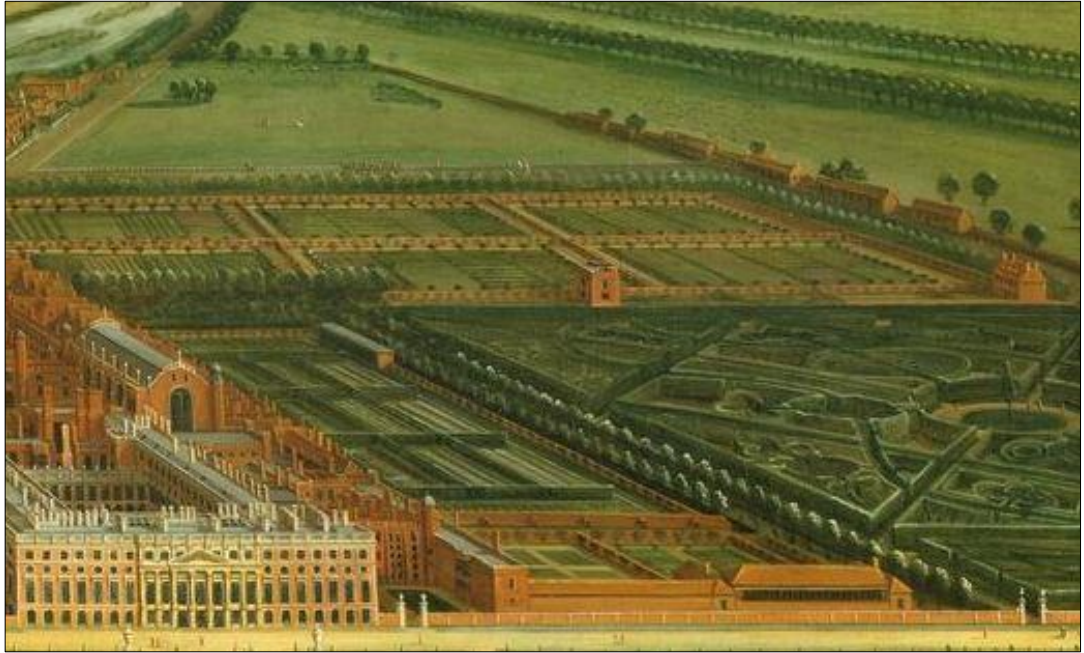
Fig. 13: Extract from Leonard Knyff's c.1703 view of Hampton Court Palace and Gardens, showing the Melon Ground, Wilderness and distant Kitchen Gardens located in the former Tiltyard (HCP)

- 4.7 By the late 17th century, the Great Orchard was converted into the Wilderness, whilst the former Privy Orchard became known as the Melon Ground, which can be seen in Leonard Knyff's early 18th century views of the palace and the gardens (Fig. 13) showing six separate divisions of land and a glasshouse in the north-west corner. A plan of the palace and gardens from 1714 illustrates the western boundary wall of the Melon Ground extending up to the north face of the palace with an entrance or gateway. By the second quarter of the 18th century, the southern side of the Melon Ground was bound by a wall, which appears on John Rocque's 1736 view of the palace (Fig. 14). Also illustrated on this plan is the Georgian House, which was built as a kitchen in 1716 on the southern side of the Melon Ground. A public lavatory or "necessary house for persons of Fashion" was built 1718 immediately to the west of Georgian House and an addition to the Tudor Kitchens was built against the north elevation of the palace. These buildings, along with the 18th century boundary wall signal the establishment of the future Tennis Court Lane, known at this time as North Inferior Court.

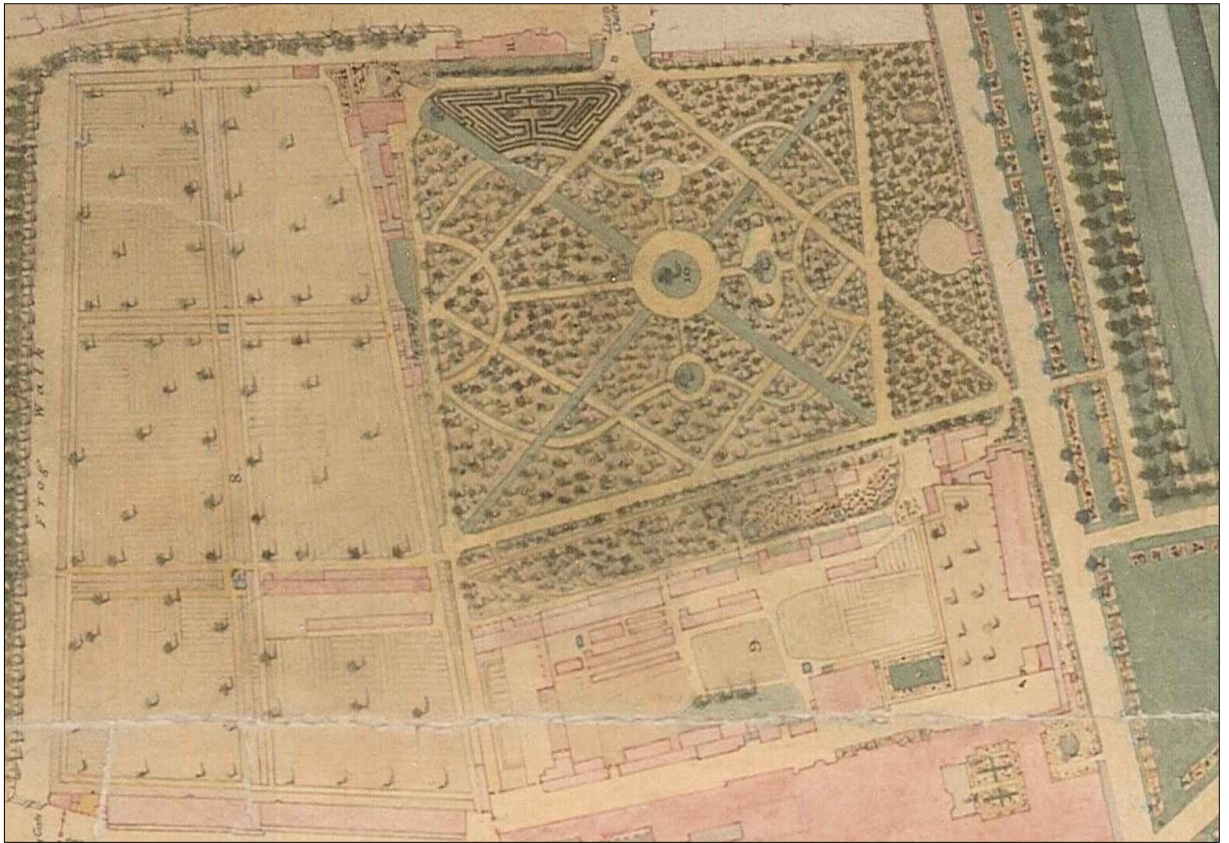
Fig. 16: Extract of Henry Sayer's 1841 Survey of Hampton Court Palace and Gardens showing the development of the Nursery Ground and Works Yard to the west (HCP WORK 34-1349)

its name. This narrow slip of ground immediately in front of the northern façade of the palace was fast becoming a bustling street with workshops, sheds and store yards. Henry Sayers's 1841 plan of the palace and grounds clearly illustrates this development (Fig. 16).

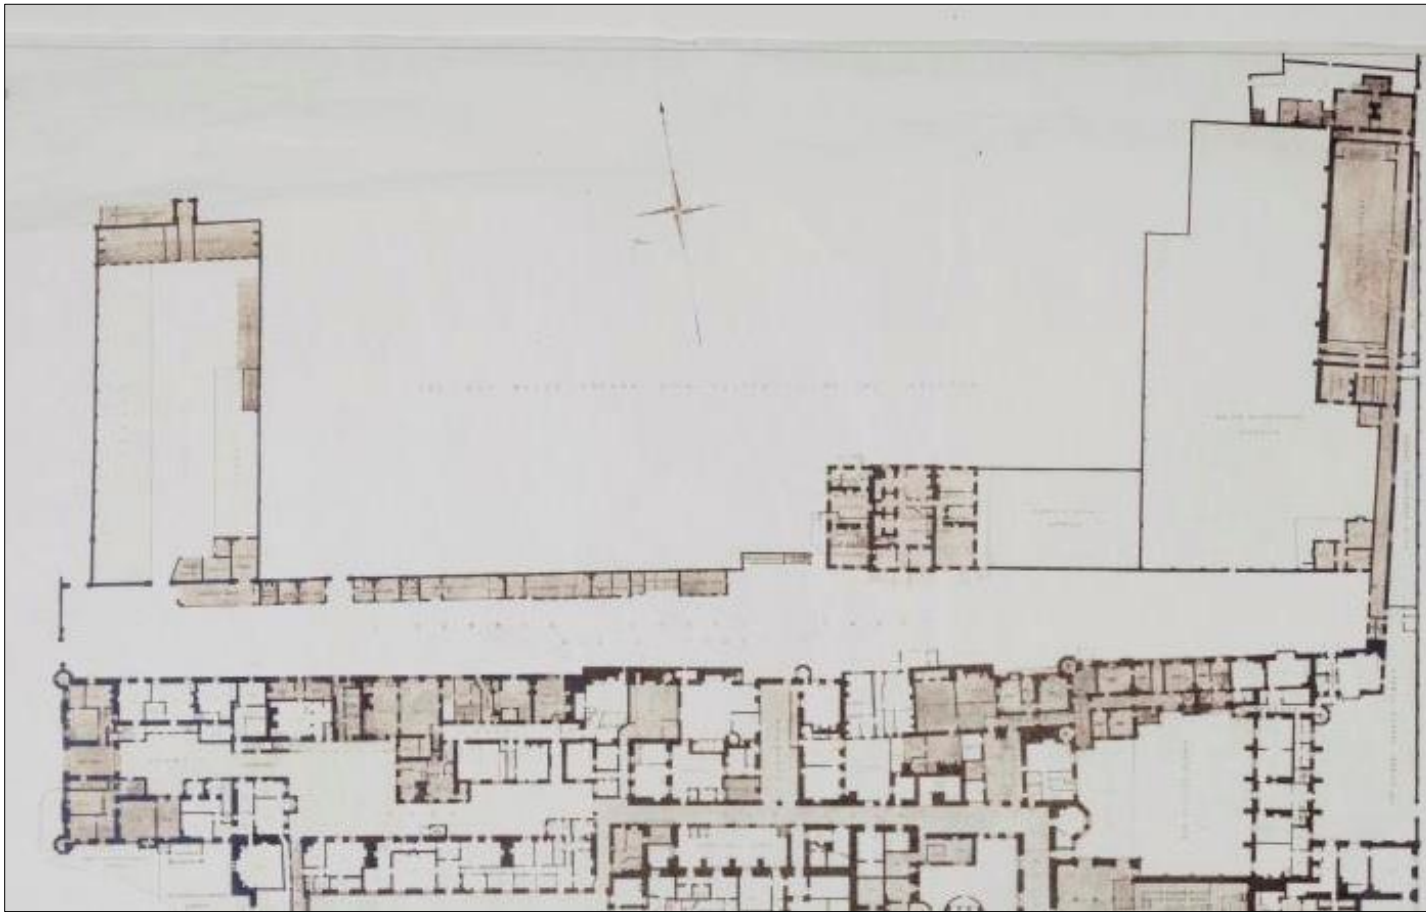
Fig. 17: Extract from the 1852 Survey of Hampton Court Palace, showing the building development along the north side of Tennis Court lane
