# HCP 154

## Apartment 39 Railings Conservation, Hampton Court Palace

*An Archaeological Watching Brief and Investigation*

**ALEXANDRA STEVENSON**  
JUNE 2019

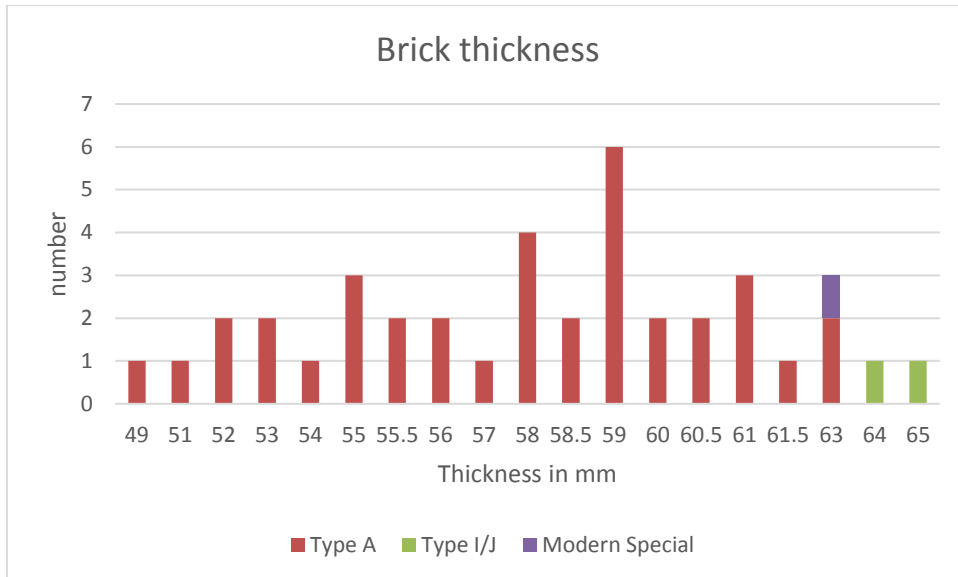
**Graph 1:** Number and range of thickness in mm of all bricks

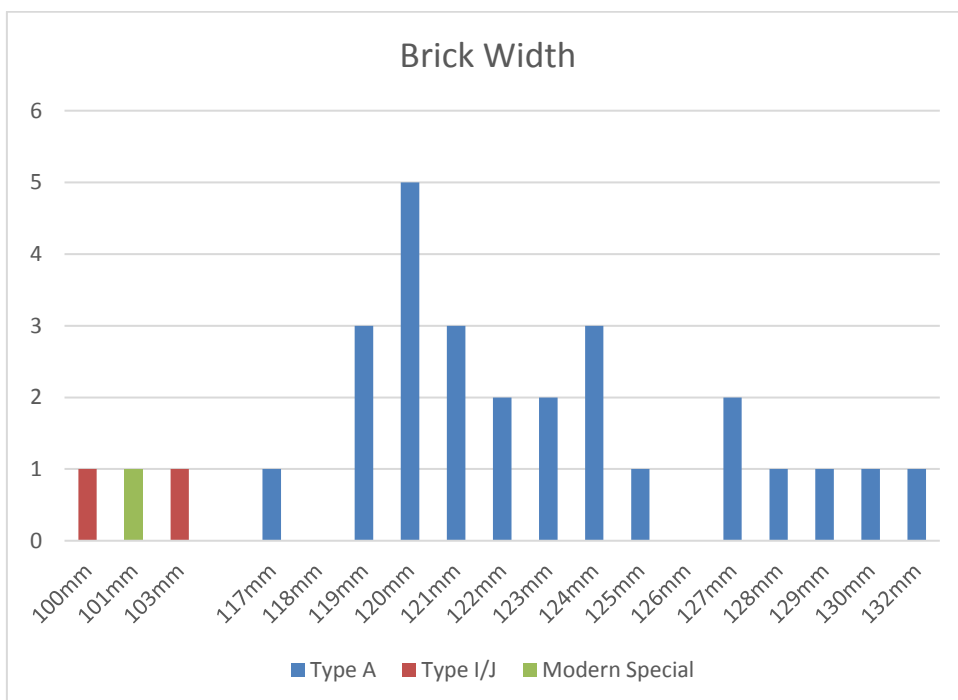
**Graph 2:** Number and range of width in mm of Type A bricks

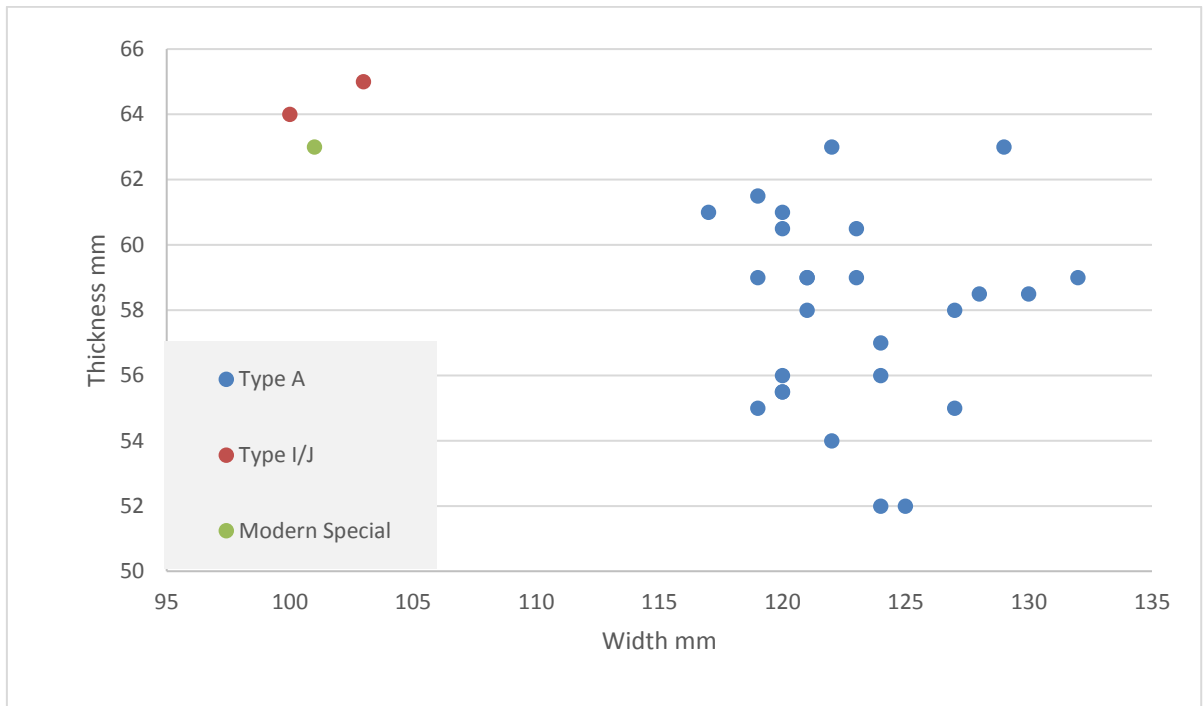
**Graph 3:** Plot of thickness:width of Type A bricks with two possible sub-groups ringed defined by width

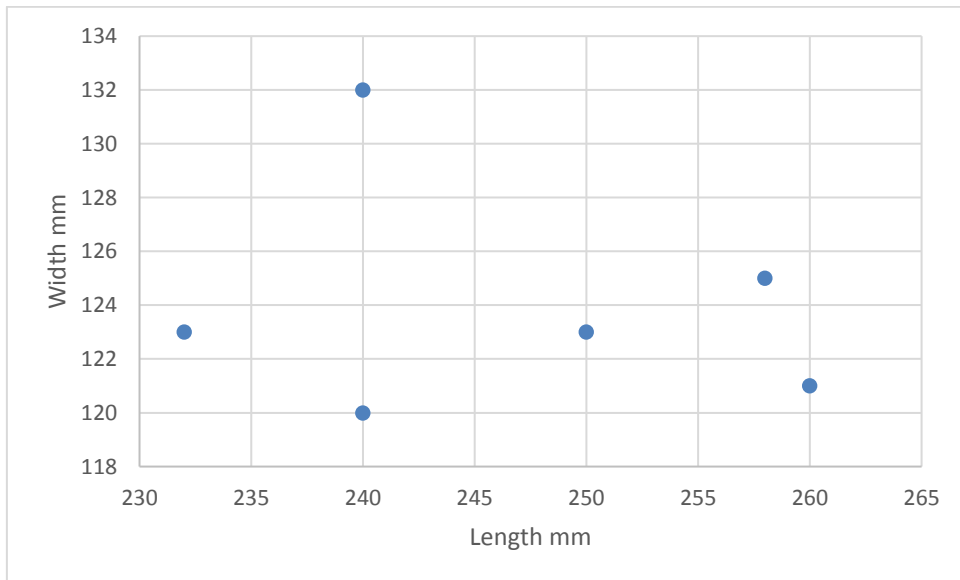
**Graph 4:** Plot of width:length of Type A bricks and ringed as for the groups in figure 3

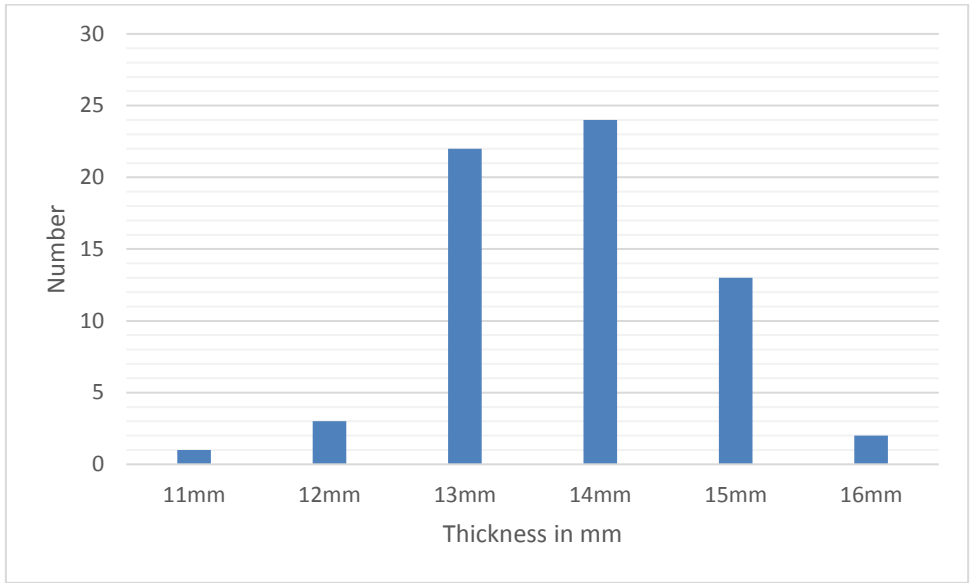
**Graph 5:** Number of peg tiles in relation to tile thickness

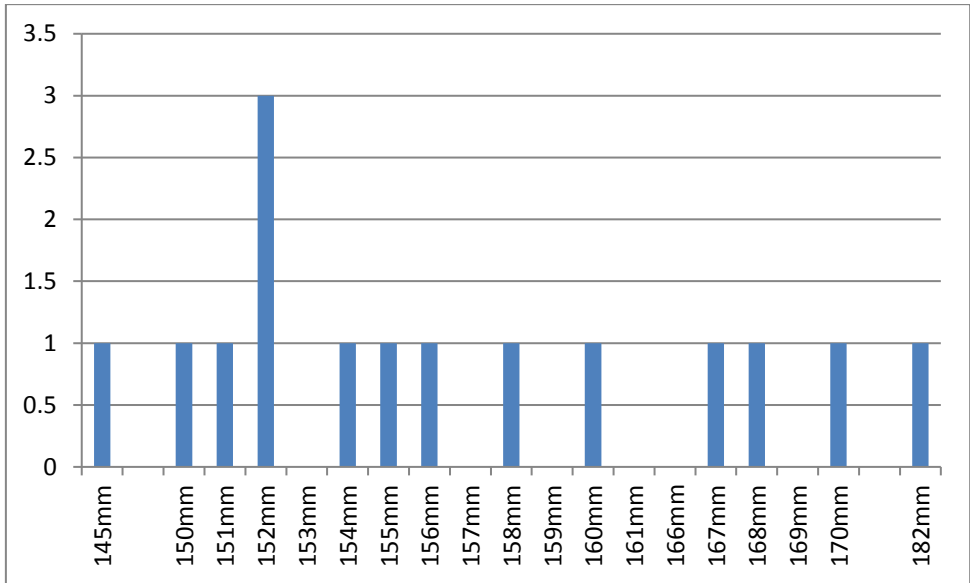
**Graph 6:** Number of peg tiles in relation to tile width

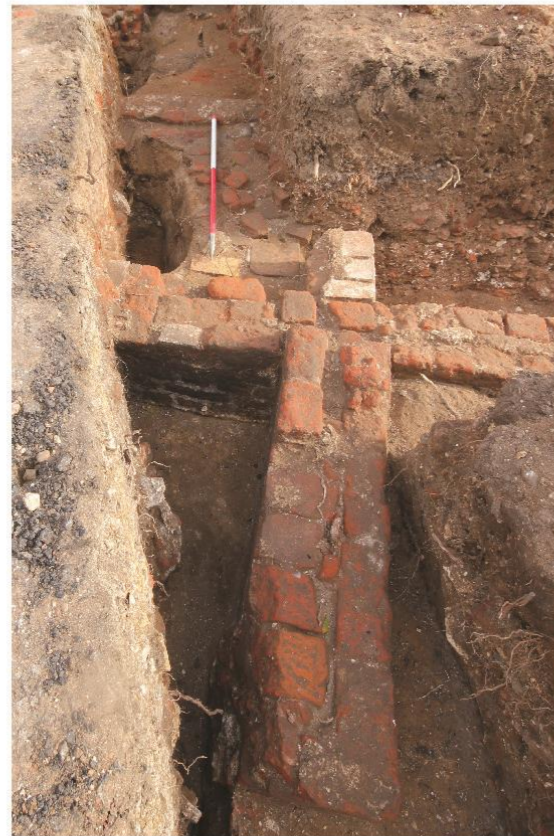
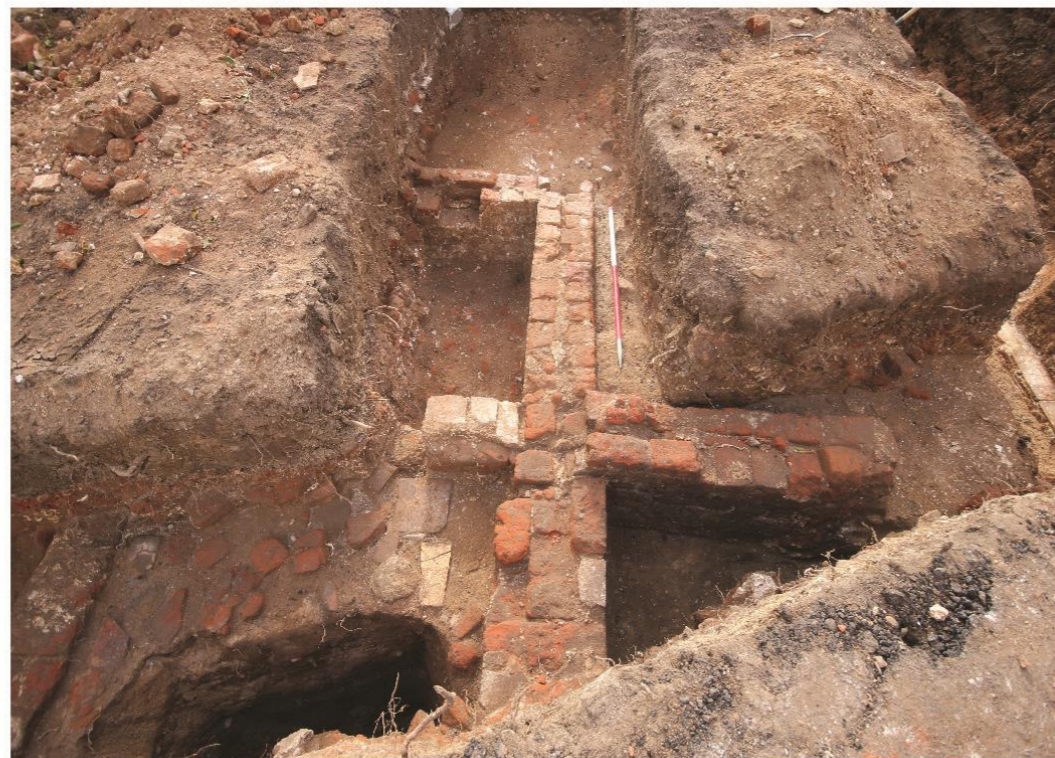
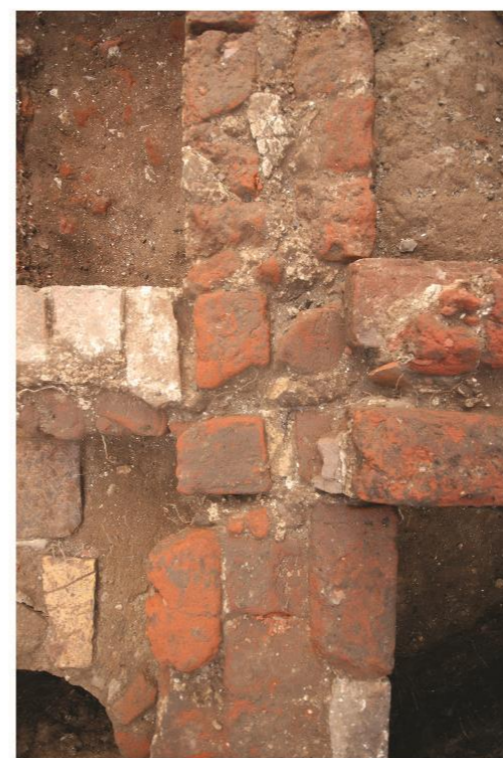
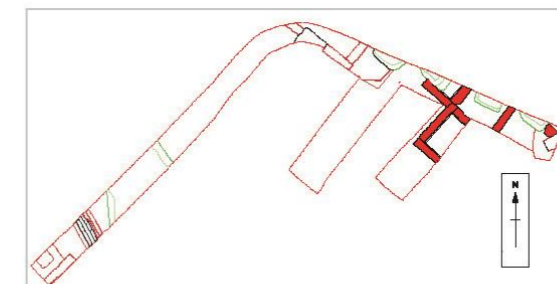
**Figure 3:** Building A. Top: Space 1 excavated to base of wall. Bottom left: Looking south, Space 3 and 1 and basement Space 2. Bottom right: intersection between Walls 2, 3, 5, and 7. (Illustration by A.Stevenson)

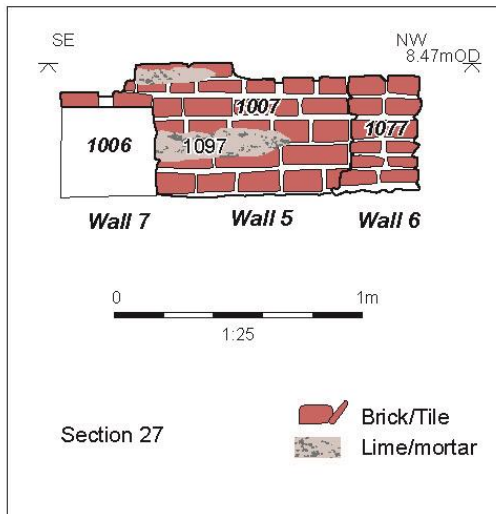
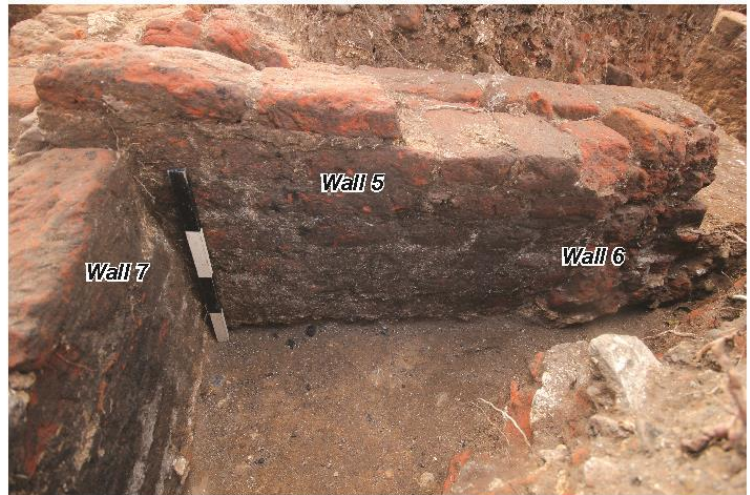
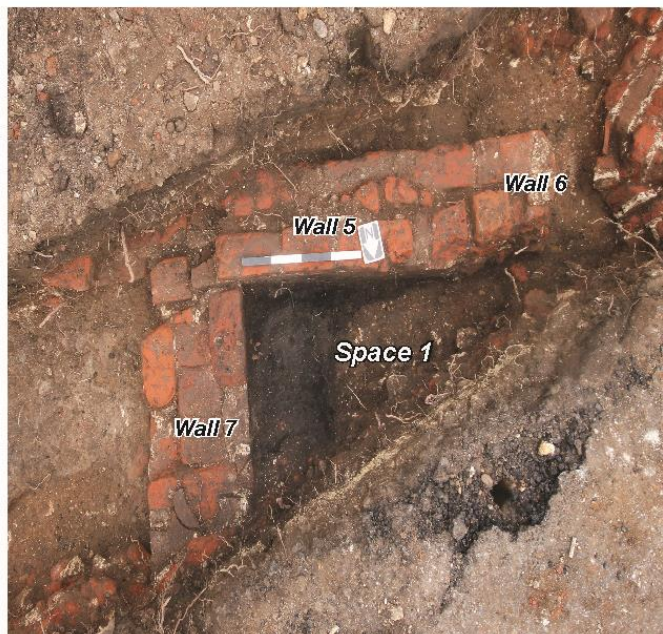
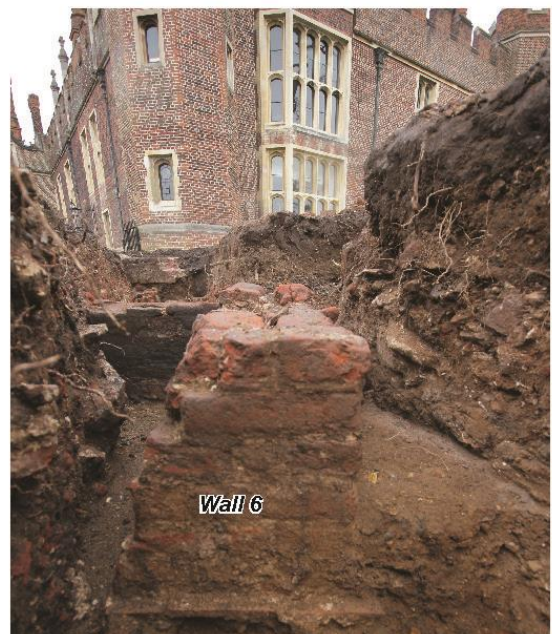
Figure 4: Bottom left - tiles (1093) at the base of Wall elevations (1007) and (1077). (Illustration by C.Rousseaux, edited by A.Stevenson).

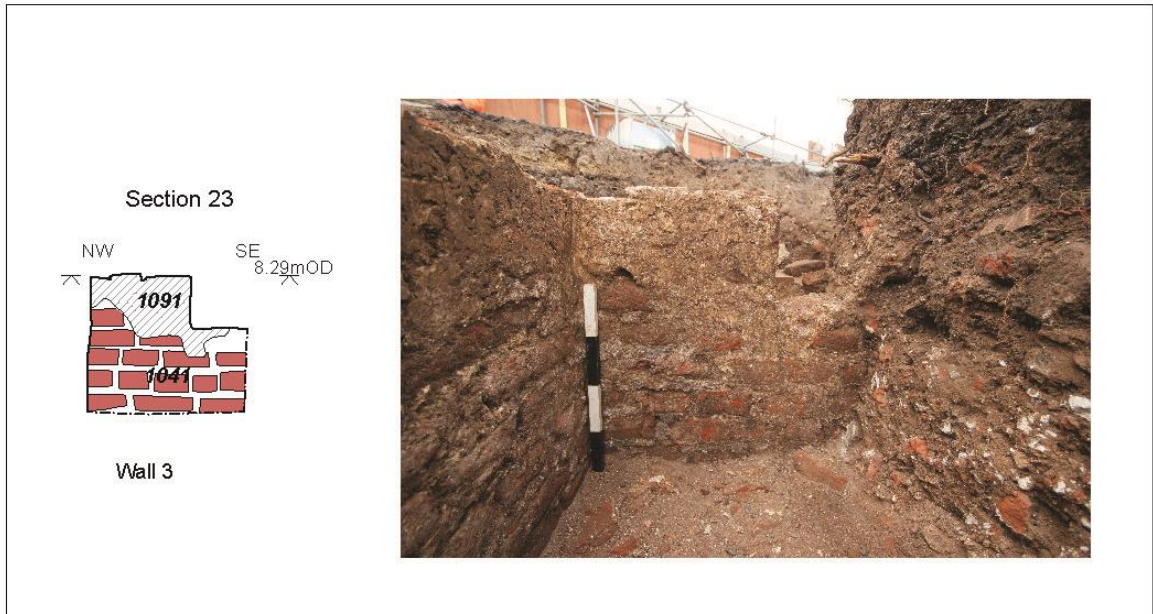
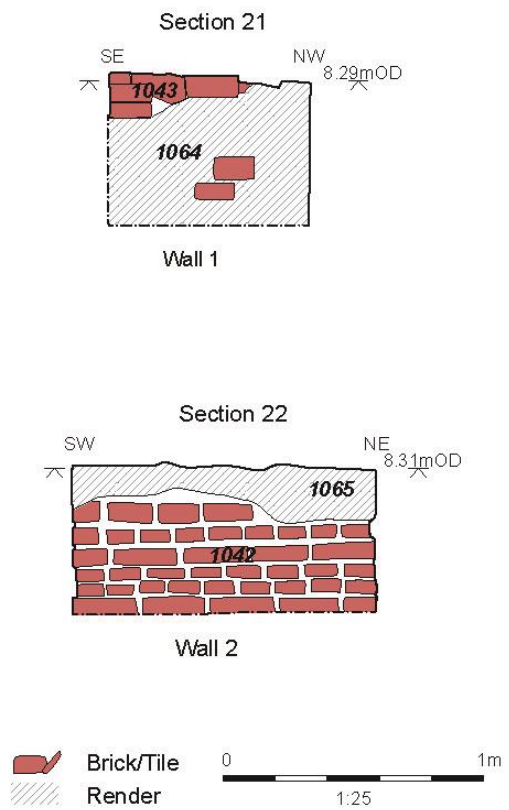
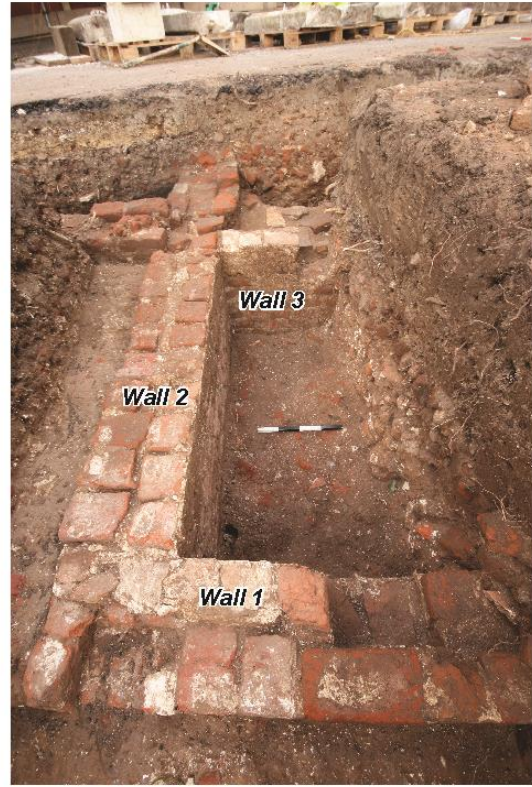
Figure 5: Top: view of opening in Wall 3. Bottom: looking north towards Space 2 (Illustrations by C. Rousseaux).

- 4.11 Space 2 was located at the far southern end of Building A in Extension I, and was enclosed by Wall 1 to the south, Wall 2 to the west, and Wall 3 to the north (Fig.5). The eastern limit was not observed. The internal space measured 1.4m north-south.. Each wall elevation was of a similar build, observed over a maximum of seven courses of brick, measuring up to 0.31m in width. The walls were two bricks wide, composed of a mixture of full-size and half-bat bricks and occasional tiles. The bricks were friable and sandy in texture and had an uneven surface with rounded arises. They were bright orange/red in colour. The bonding material was composed of beige/white course gritty lime mortar, with inclusions of lime fragments. It was difficult to observe the brickwork pattern as most of the internal faces were covered with render, however where small patches were exposed it appeared to be predominantly header bond, with occasional stretchers dispersed randomly. All the walls were protected with a 15-20mm thick lime mortar render, which was preserved in patches. The render (1064) on Wall 1 was well preserved, covering the entire north face of the elevation. The segment of wall delimiting the north end of the room, Wall 3, appeared to have an opening. It seemed to be a deliberate feature of the wall rather than an area of damage. This was corroborated by the presence of a small patch of wall render on the east face of the wall. The floor level of Space 2 was never reached, despite being the deepest area of the whole excavation reaching a depth of 7.86m OD (1.2m below to the present ground level).

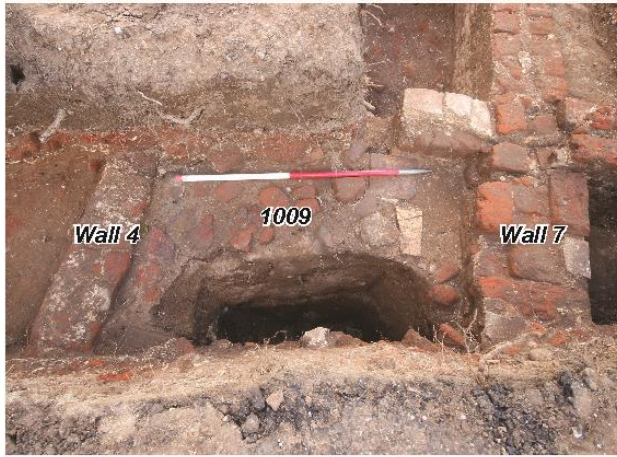
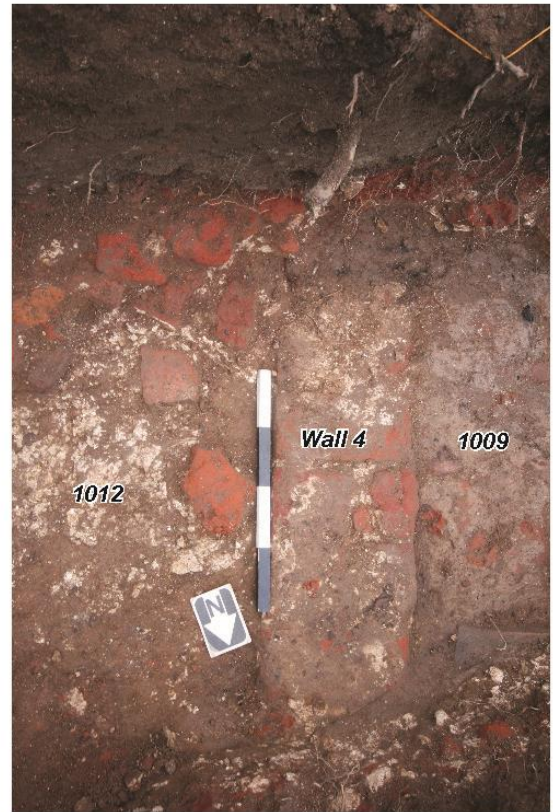
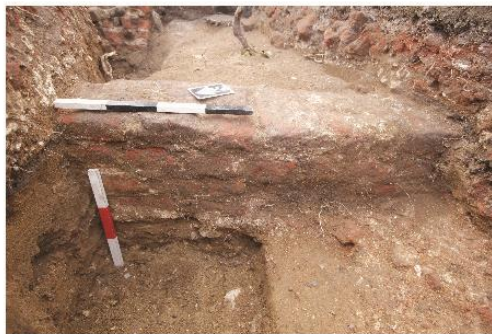
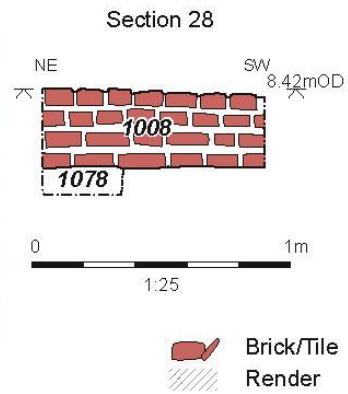
**Figure 6:** Top right: Space 3 and deposit 1009 with Flemish-style glazed tiles. Top right: Wall 4 partially overlain by deposit 1009. (Illustration by C. Rousseaux).

- 4.13 There were several make-up layers in Space 3, signalling at least two episodes of floor laying, with stratigraphy indicating the dismantlement of Wall 4 during the lifetime of Building A. The earliest deposit associated within this room was (1071), which appeared at around 8.20m OD. It was a loose mixed mid-orangey brown, sandy bedding layer with grey brown mottling, logged over a depth of 0.12m. It was overlain by (1069), which was the patchy remains of a compacted gritty mortar surface containing crushed fragments of CBM and three fragments of roof tile. The deposit was recorded over a depth 0.1m and overlain by (1066); a small patch of ashy silt containing frequent charcoal fragments, measuring no more than 0.05m in depth. This ashy material was characteristic of the occupation layers seen across Buildings A and B appearing repeatedly in three of the five internal spaces (Group 14). These fine layers or lenses were probably associated with the same episodes of deposition.

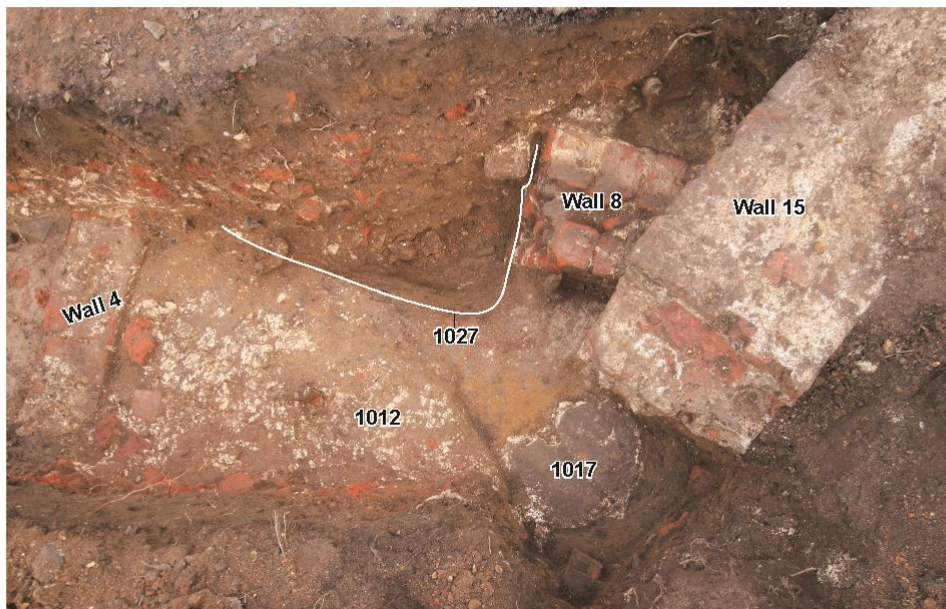
**Figure 7:** Top: Wall 8 overlain by Wall 15, and truncated by pit 1027. Bottom: overhead shot of Space 4, collapsed plaster layer 1012

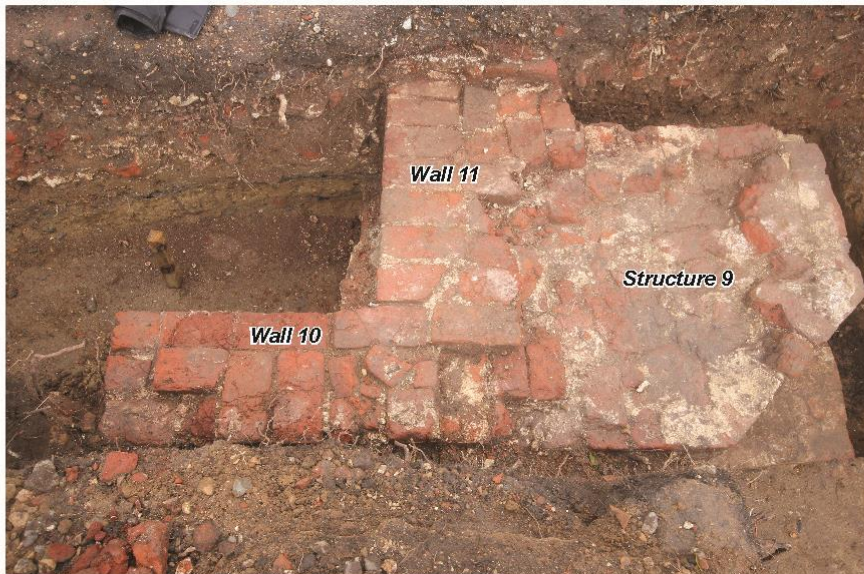
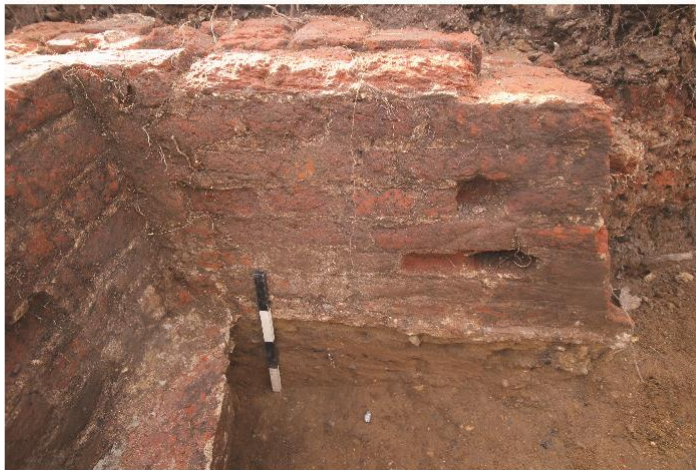
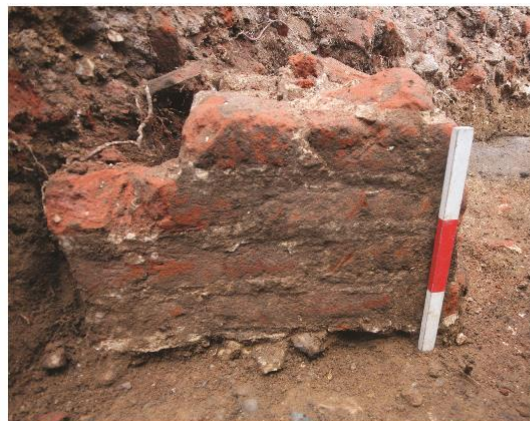
Walls 10 and 11, and Structure 9 as seen in plan from the south

North-facing elevation of Wall 10, segment 1015

North-facing elevation of Wall 10, segment 1016

**Figure 9:** Wall 10, Building B.

- 4.18 The east-west extent of Space 5 was roughly 2.5m long; its north south extent was not defined. To the south, the space was delimited by Wall 10, which was broken into two segments, (1015), and (1016). There was no discernible foundation level. The wall was 2.6m in length and had a width of 0.4m. It survived up to a height of 0.5m, and up to eight courses of brick. The bricks were an orangey red colour, of a soft crumbly sandy fabric, and measured 250mm x 50-60mm x 120mm. The brickwork pattern was consistent with all the other walls recorded, presenting a header bond with occasional stretchers. The pointing had mostly weathered away, but where it remained visible, it appeared to be quite rough. The bonding material was a coarse sandy lime mortar. At the base of the wall was a line of tiles (1094) that probably corresponded to the floor level of Space 5.

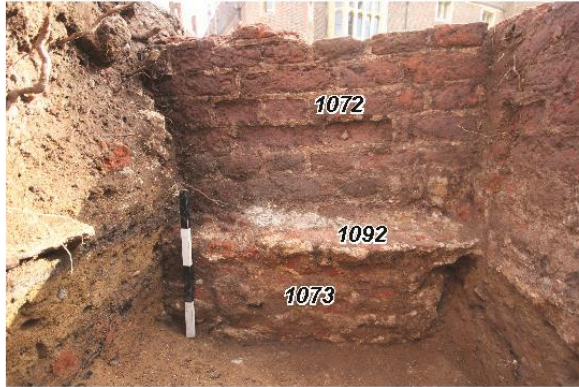
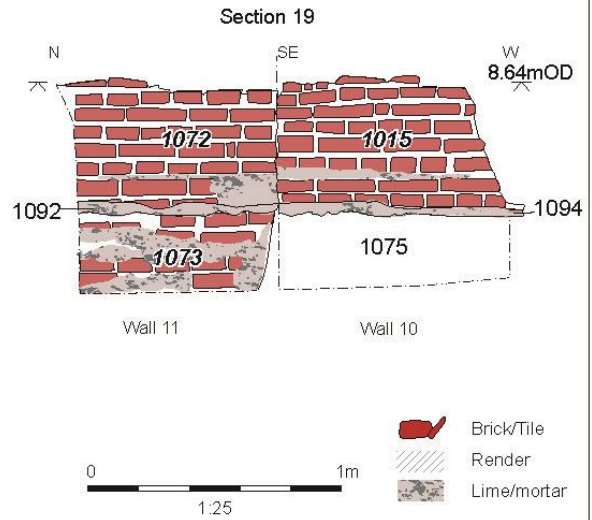
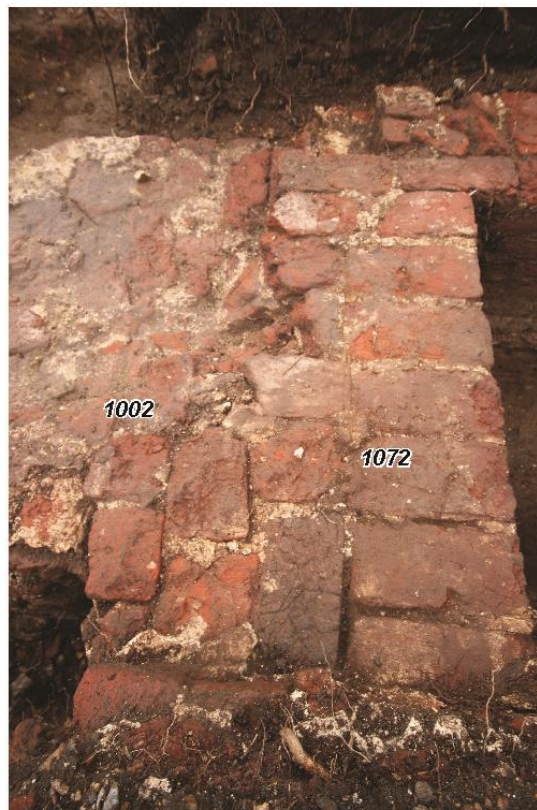
West-facing elevation of Wall 11

Wall 11 as seen in plan from the north

Figure 10: Wall 11, Building A. (Illustration by C. Rousseaux, edited by A.Stevenson).

- 4.19 Wall 11 abutted Wall 10 and was on a north-east/south-west alignment, recorded over a length of 0.96m before disappearing beyond the north limit of the trench. It was composed of a foundation (1073) and an elevation (1072). The base of the foundation was not reached, though it was recorded over 0.32m and four courses of brick. It was offset 100mm from the elevation. Most of the brickwork was concealed behind thick beige/white sandy lime mortar. A sequence of make-up and levelling layers was recorded abutting the foundation of Wall 11, consisting of compacted, coarse sandy gravels (1075), and (1068) (see Appendix II). The elevation of Wall 11 (1072) was conserved over eight courses of brick amounting to a height of 0.46m and with a width of 0.4m. The brick fabric contained fine aggregates as well as occasional large pebbles and stones. The brickwork pattern was similar to that observed in Wall 10. However, the mortar joints were better preserved in this wall with evidence of double-struck pointing on the upper two or three courses of brick. The bricks were remarkably soft and crumbly. A 20mm thick layer of mortar and crushed brick (1092), covered the offset foundation

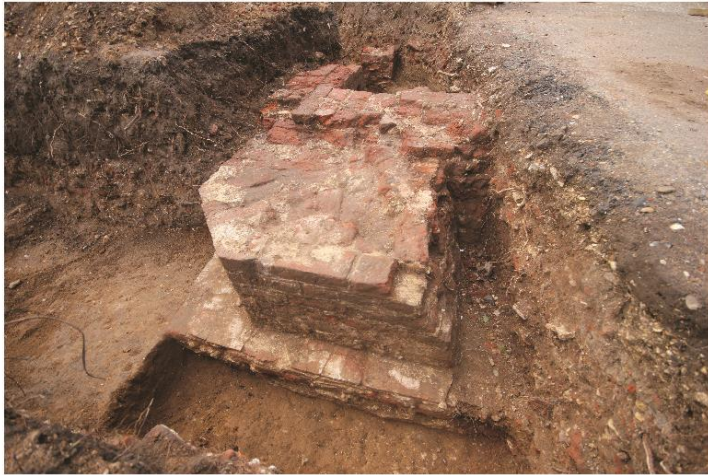
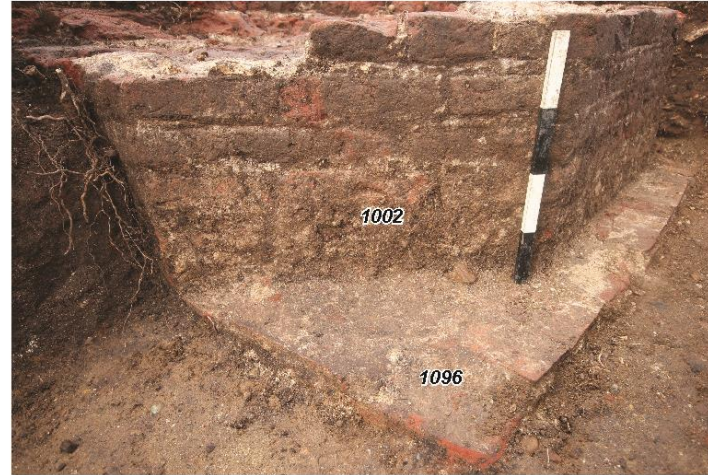
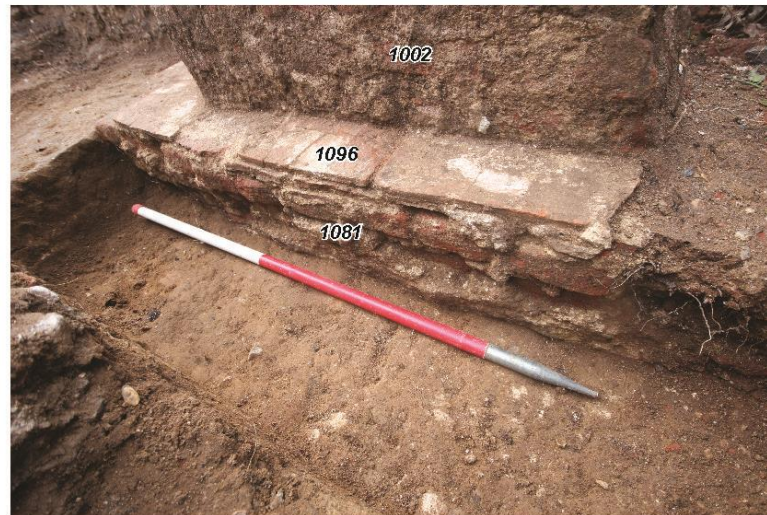
Figure 11: Top left: looking west towards Structure 9. Top right: south-east face of Structure 9. Bottom: foundations beneath Structure 9

- 4.20 Constructed against the east faces of Walls 10 and 11 was a remarkably well preserved polygonal brick-built structure (Group 9). It appeared at just 0.12m below the current tarmac surface, at approximately 8.7m OD. The structure comprised a foundation (1081) and elevation (1002). It was truncated by a later pit [1004] (Group 13), partially damaging the east face, and destroying both the northeast and north faces. The base of the structure was not reached, however a linear trench was excavated running along the base of its east face (Fig. 11), which enabled the characterisation of the upper three courses of the foundation. The brick was a typical early Tudor fabric; deep orangey red in colour, uneven surface texture, rounded arises, friable and rather crumbly. The bonding material was a beige sandy lime mortar with frequent lime nodules. There was no pointing work at foundation level; indeed, much of the brickwork was obscured by mortar. The foundation was offset 100mm from the east-facing elevation, and extended 0.4m southwards to align with the south face of the elevation. Overlying the offset foundation were two layers of floor tile (1096) each 20mm thick, and bonded together with lime mortar. The tiles extended from the east and southeast faces of Structure 9, aligning neatly with the south elevation in an east-west direction. Some of the tiles along the north-south alignment had the remains of mortar on their edges, suggesting their continuation at least in an eastwards direction.

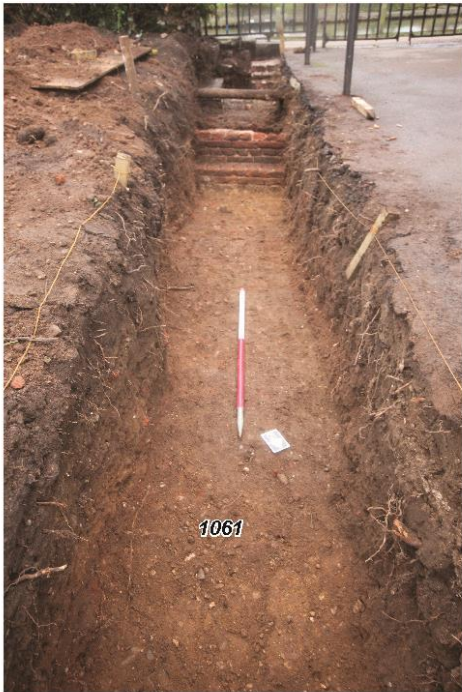
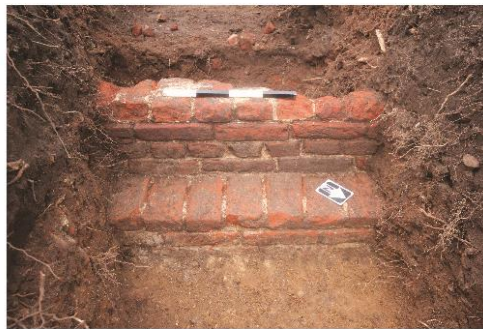
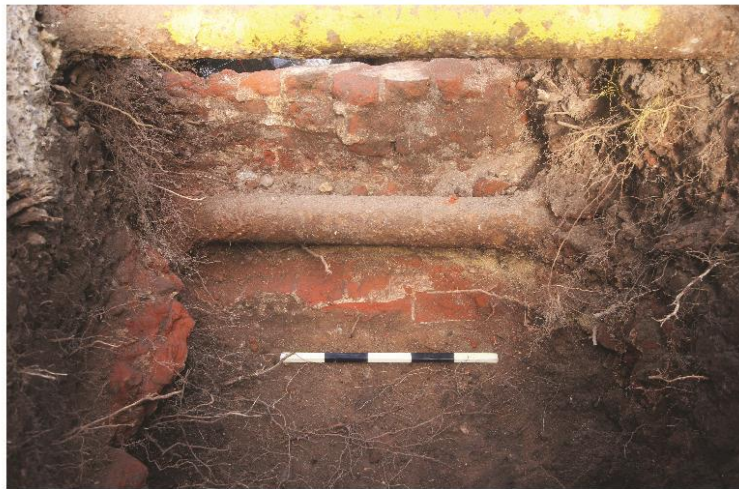
**Figure 12:** Henrician Great Wall, Wall 12. Top: north-facing elevation. Bottom: south facing elevation truncated by 20th century service. (Illustration by C. Rousseaux).

- 4.26 At the far southern end of the north-south branch of the trench, a damaged segment of the Henrician boundary wall or “the Great Wall” was uncovered (Wall 12) (Fig.12). The wall was recorded at foundation (1076) and elevation (1034) level. The base of the foundation was not reached and only the top three courses of brick on the north face were recorded. The foundation was 0.74m wide and was offset 0.2m from the elevation. The brick fabric was orangey red in colour with a sandy texture and an uneven surface. Individually the bricks measured an average of 230mm x 50mm x 115mm. The brickwork pattern was English Bond and the bonding material was composed of a white sandy lime mortar. The pointing technique was not clear, as much of the mortar was eroded. Above this footing was elevation (1034), which was constructed with the same brick type and arranged in the same bond pattern. Only the north face survived over four courses of brick, the south face was destroyed in the 1980’s by the installation of services.

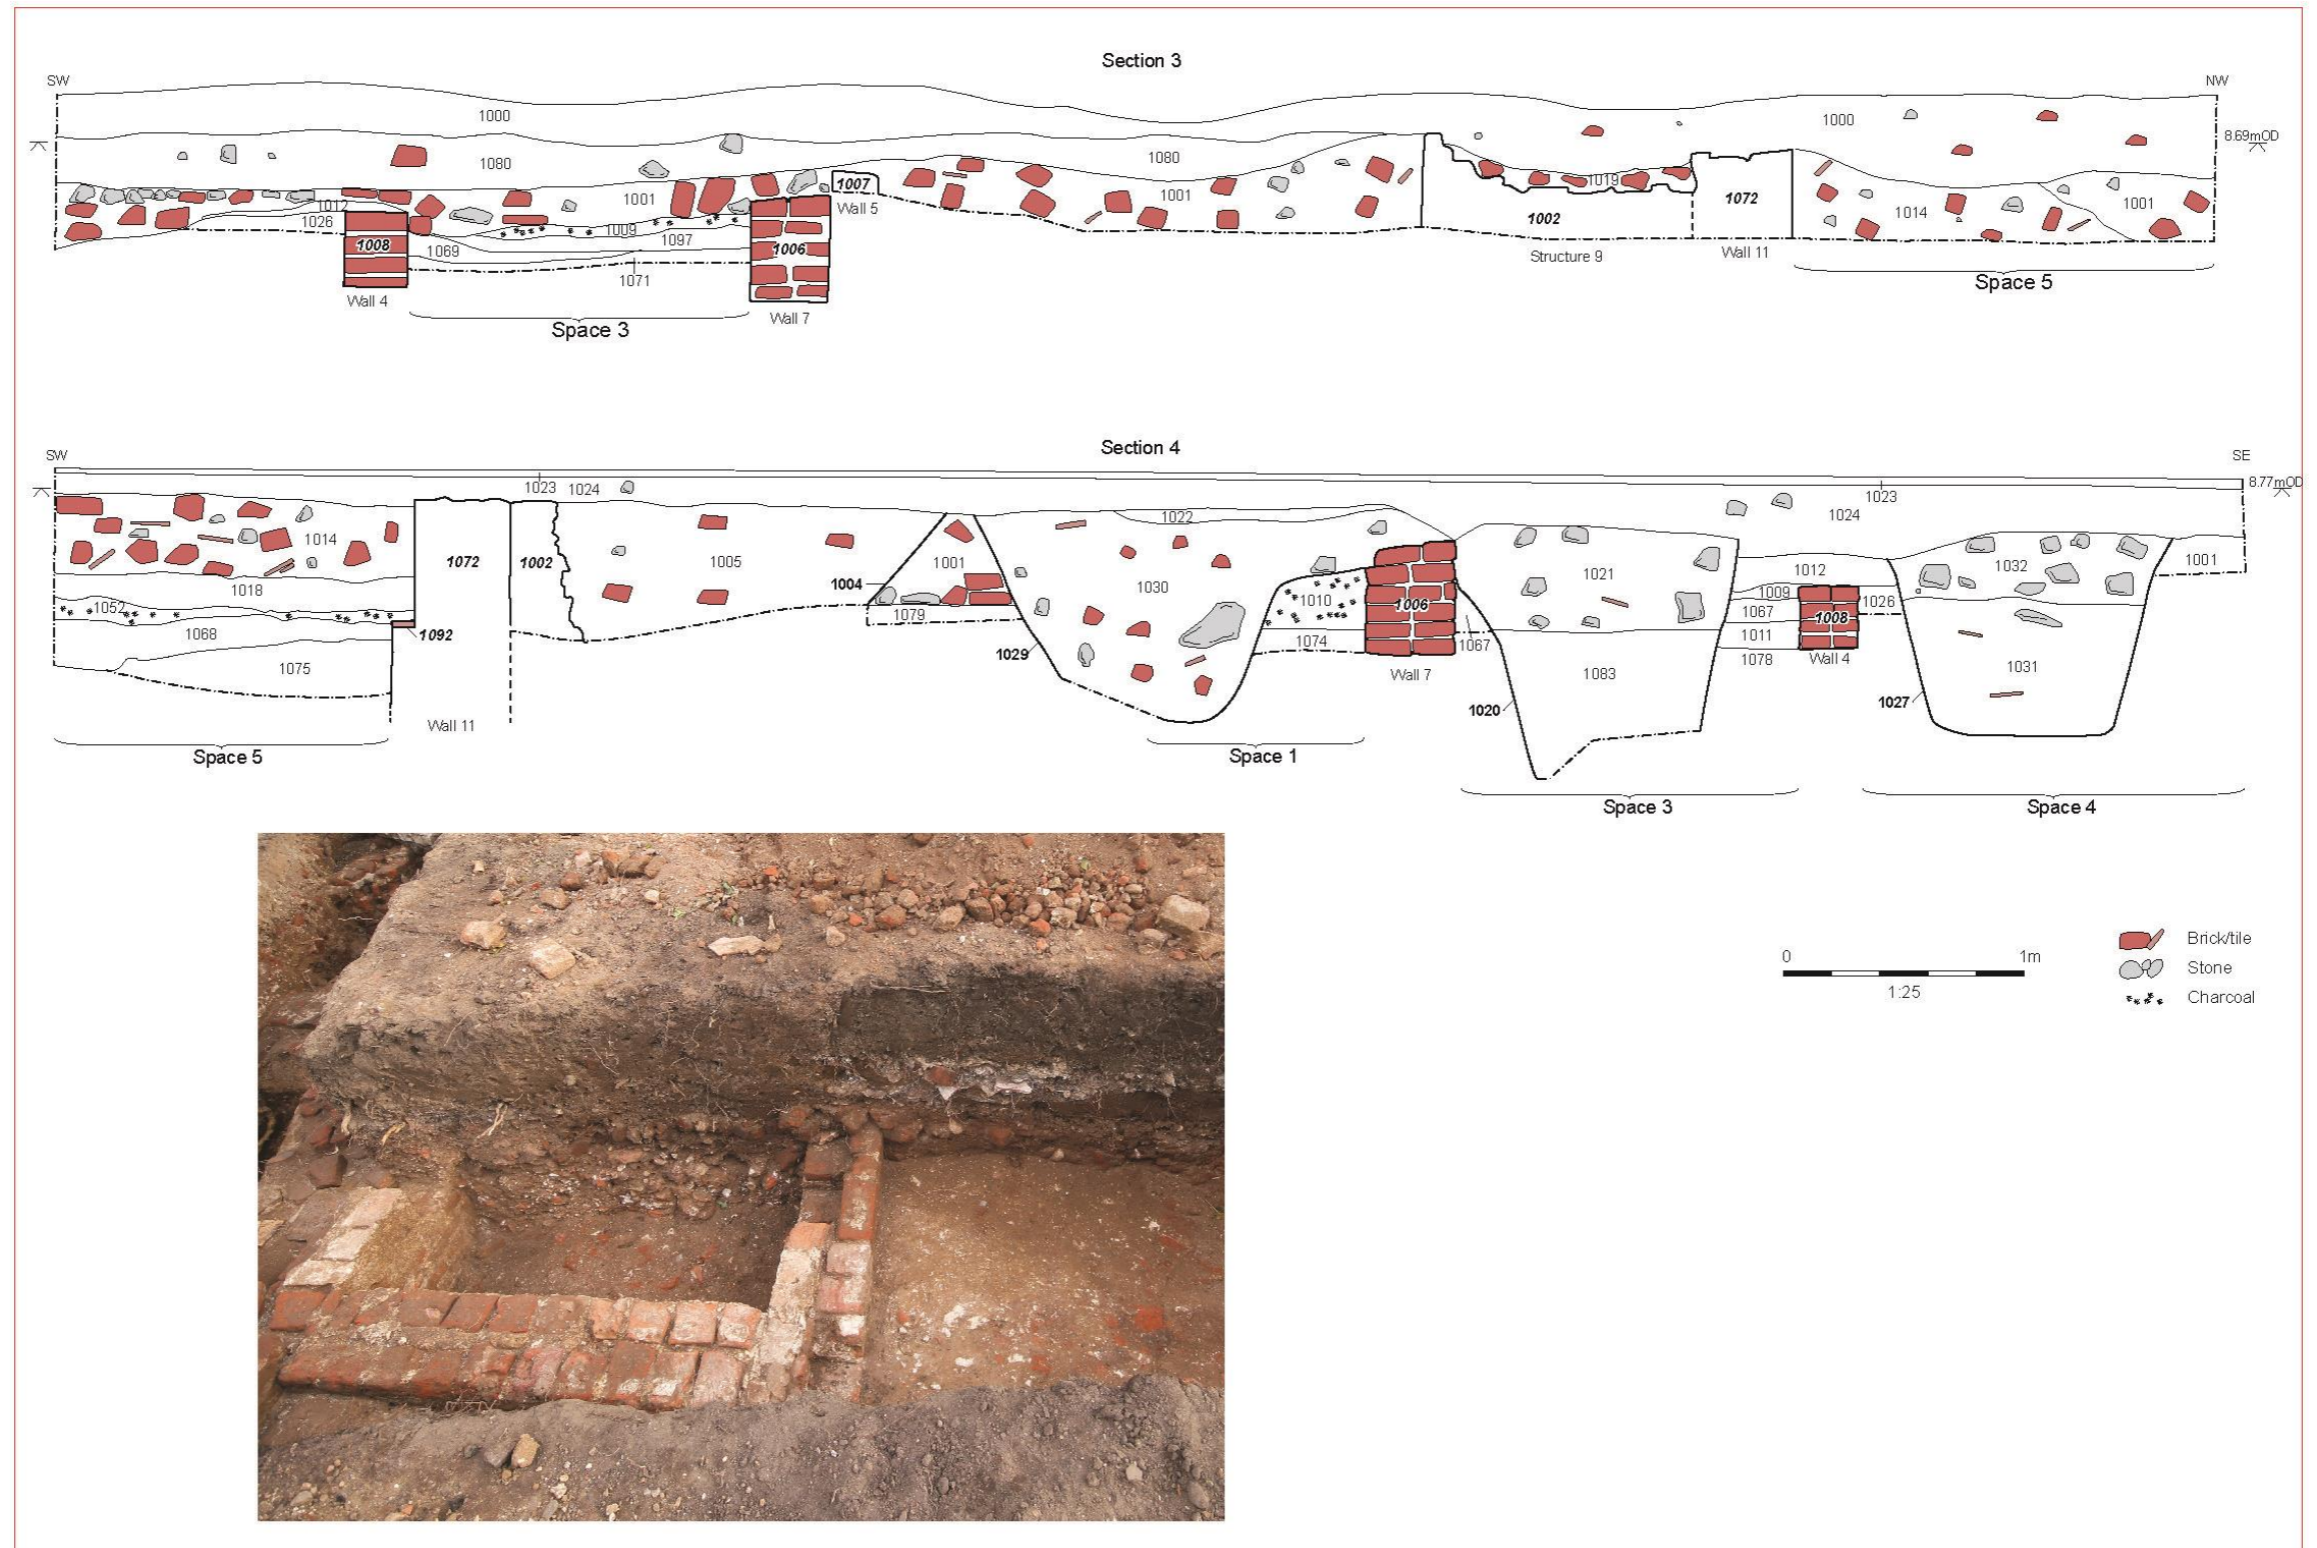
**Figure 13:** North and south facing sections of the east-west branch of trench and shot of Space 2 from the west, looking at the demolition dump in section. (Illustration by C. Rousseaux, edited by A.Stevenson).

- 4.25 Overlying these deposits, and burying Buildings A and B, was a horizontal dump of demolition material seen across the entire east-west branch of the trench as well as in Extensions 1 and 2. These included: (1001), (1047), (1019), (1050) (Fig.13). This layer was a loose mid-brown silty sand rubble deposit containing large quantities of brick and tile as well as a two fragments of triangular-shaped architectural oolitic limestone (in 1001).

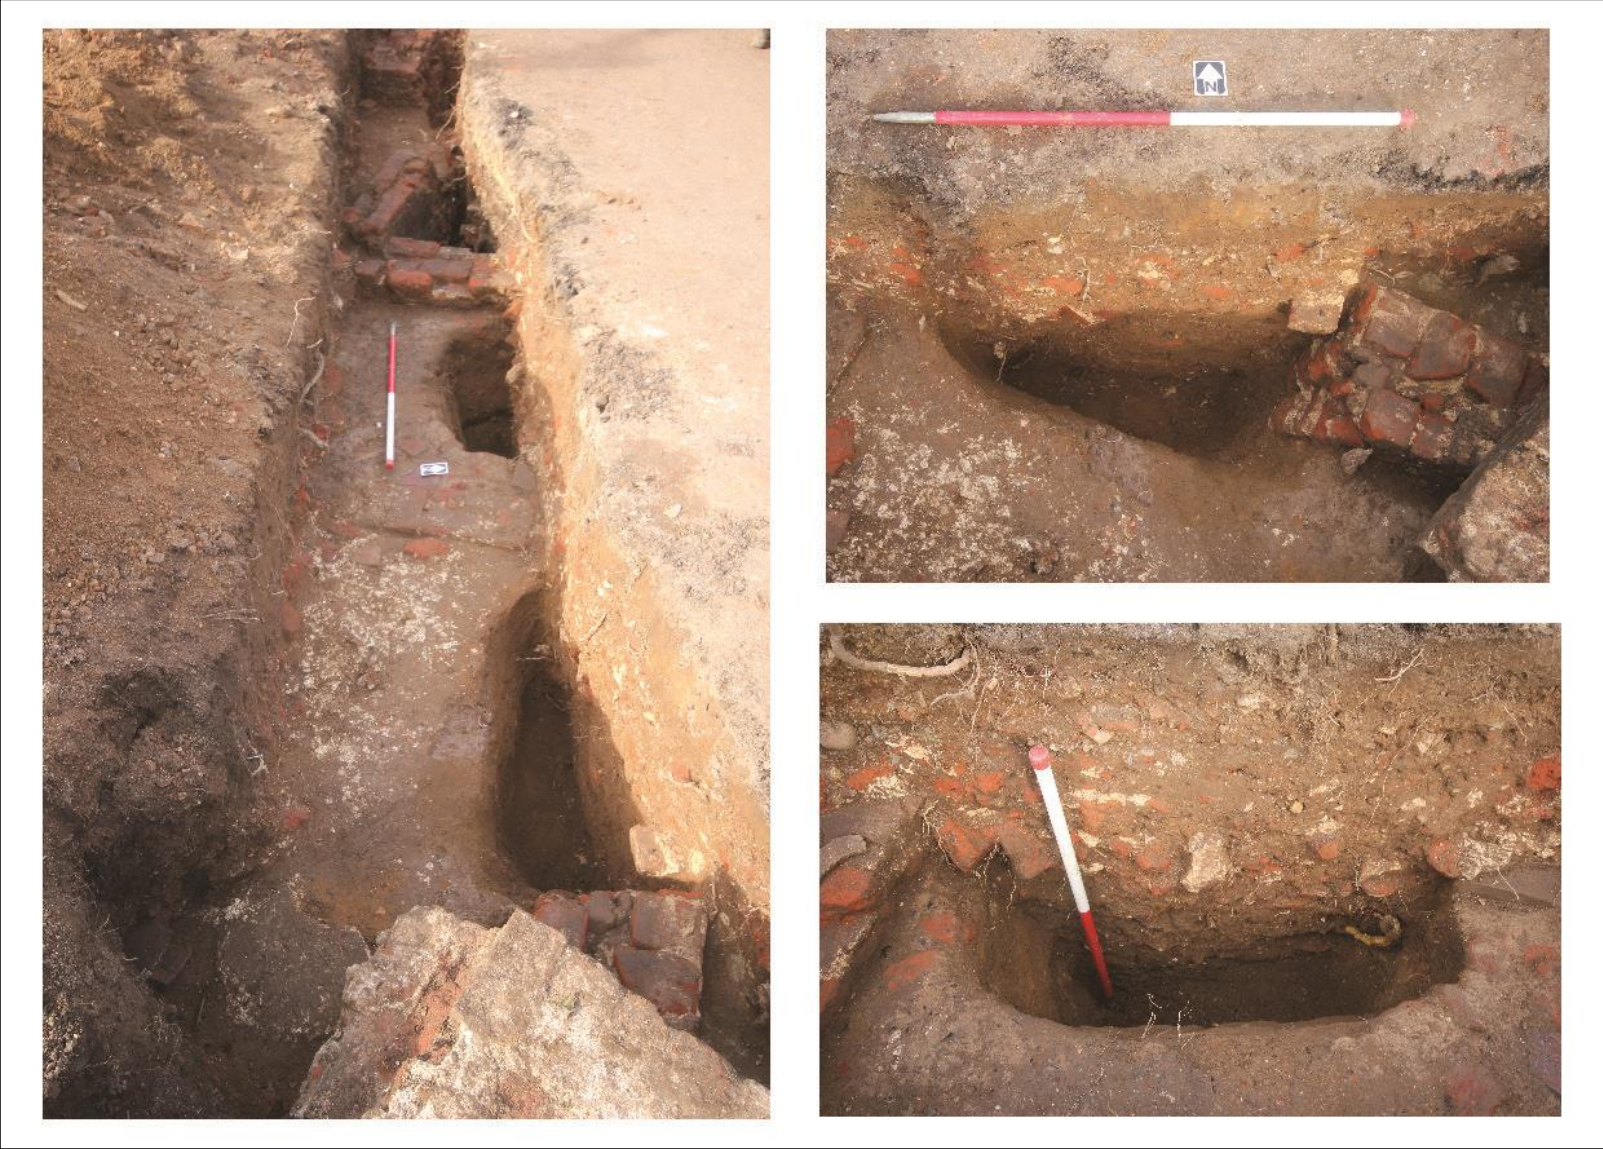
**Figure 14:** Tree pits (Group 13), cutting through the demolition rubble and Tudor archaeology.
