# HCP 154

## Apartment 39 Railings Conservation, Hampton Court Palace

*An Archaeological Watching Brief and Investigation*

**ALEXANDRA STEVENSON**  
JUNE 2019

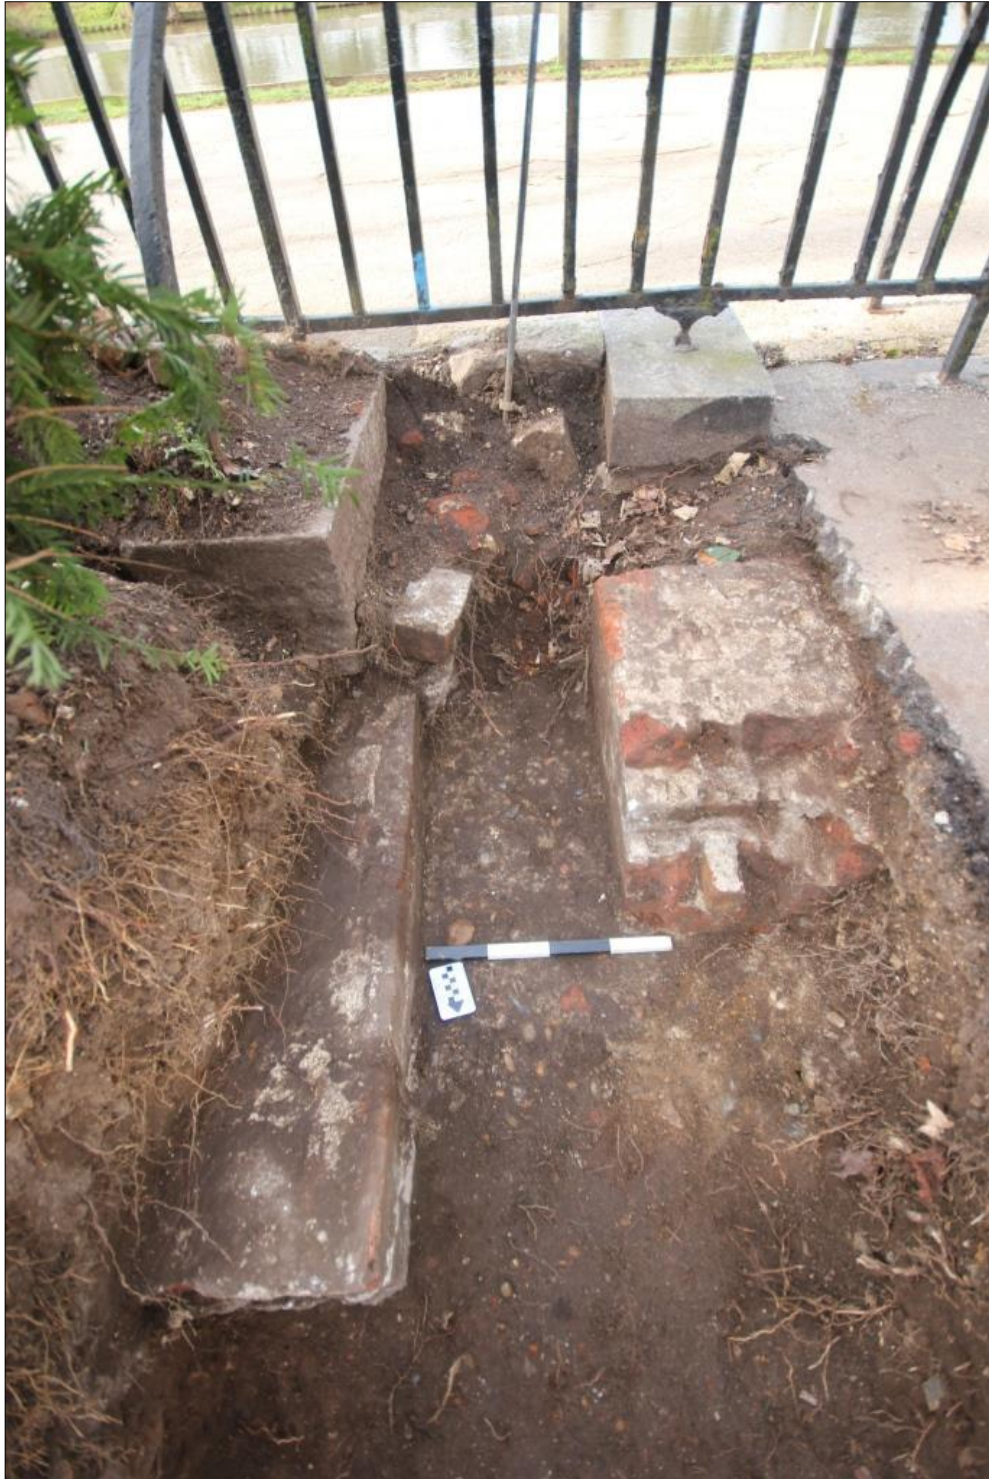
**Figure 15:** Looking south towards the Barge Walk railings and Structures 1058, 1059, and 1060.

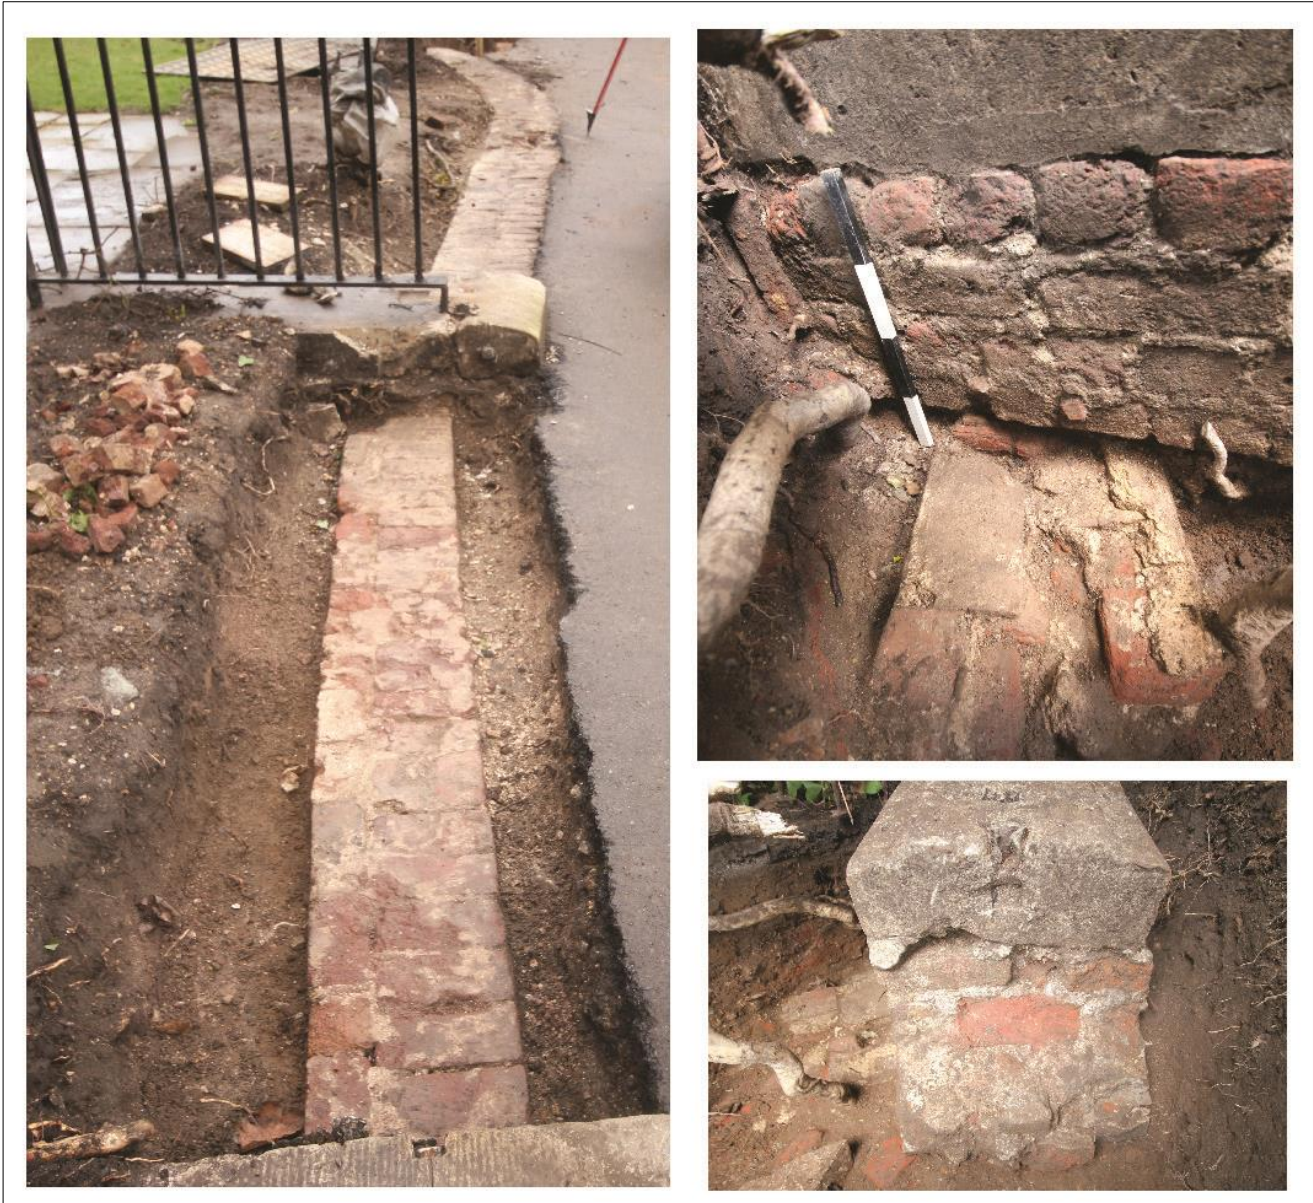
**Figure 16:** Left: Wall 16 and Wall 15 in the background. Right: Wall 15 overlying Tudor Wall 8 (images from HCP 144).

- 5.1 The *in situ* railing plinth and foundation is a 21m curvilinear line beginning at the gate adjacent to the crenelated moat wall and extending 6m beyond the north-west turret of Apartment 39. Beyond this point, the structural remains have been truncated and replaced with a simple paling composed of wrought-iron pickets with a base rail.
- 5.2 In order to undertake conservation and repair work on the stone plinths, some had to be removed from position (Figs. 17-20). This action provided the opportunity to record the morphology of the plinth stones, and to check for any interesting features such as stonemason's stamps or tool marks. The removal of the plinth stones also exposed two sections of the brick footings (Fig.16).

- 5.3 The brick foundation supporting the plinth stones appeared to be composed of two separate units, Wall 15 and Wall 16. The earliest section, Wall 16, was recorded over a length of 3.5m, beginning immediately east of the gate perpendicular with the north-west turret of Apartment 39 and presumably running eastwards up to the gated entrance into the Apartment 39 garden adjacent to the moat. The section of footing exposed (1082)

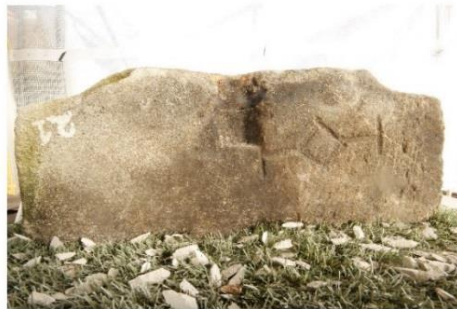
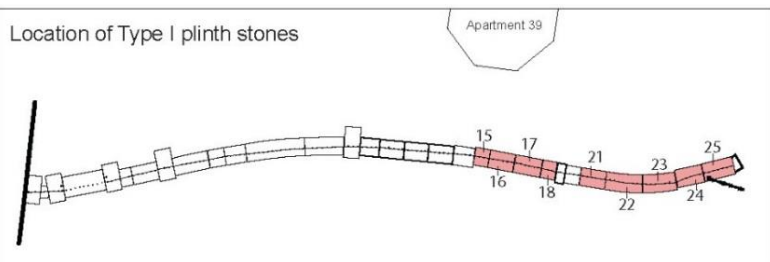
**Figure 18:** Type I plinth stone location and profile

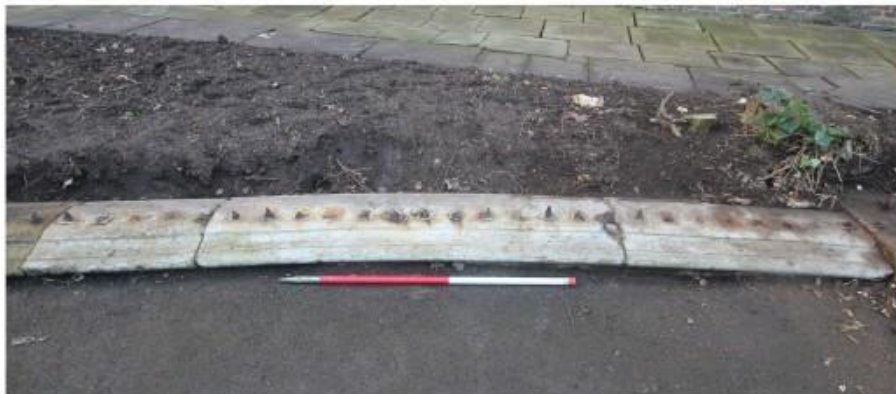
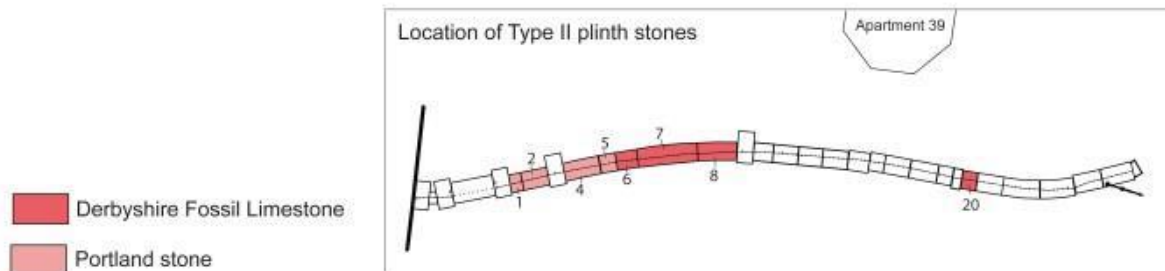
Plinths 6, 7, and 8 in situ

**Figure 19:** Type II plinth type location and profile, and stone type

- 5.8 Type II was made up of a group of seven plinth stones located immediately west of the main gate into Apartment 39 (plinths 1-2, 4-8), and one isolated plinth stone of this type towards the western end of the railings (Plinth 20). Plinths 1, 2, 4 and 5 were Portland stone, whilst Plinths 6-8 and Plinth 20 were Derbyshire Fossil Limestone (see Fig.19). The Derbyshire Fossil Limestone plinths appeared to be less prone to mossy growths than the Portland stone, but both materials presented signs of damage including cracks and fracturing. There were signs of reuse on Plinth 5 with the presence of four infilled sockets. The plinths had an asymmetrical profile. Only plinth 20 was removed for conservation, the others were repaired *in situ*.

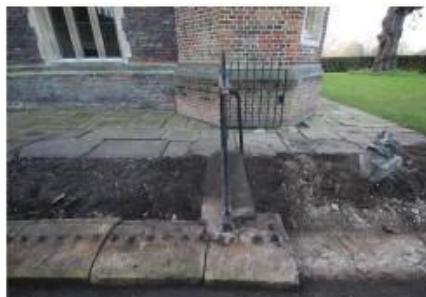
Plinth 12

Type III plinth stones in situ, before conservation

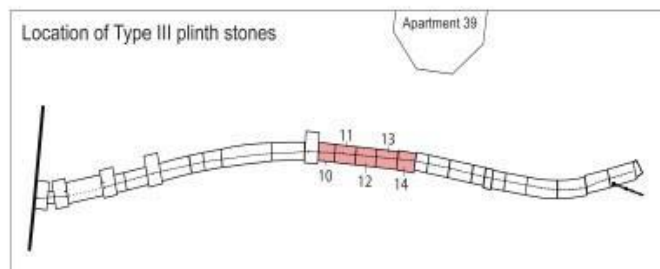
Figure 20: Type III plinth stone profile and location

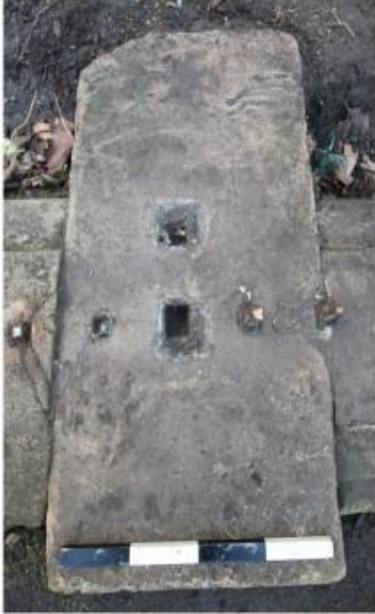
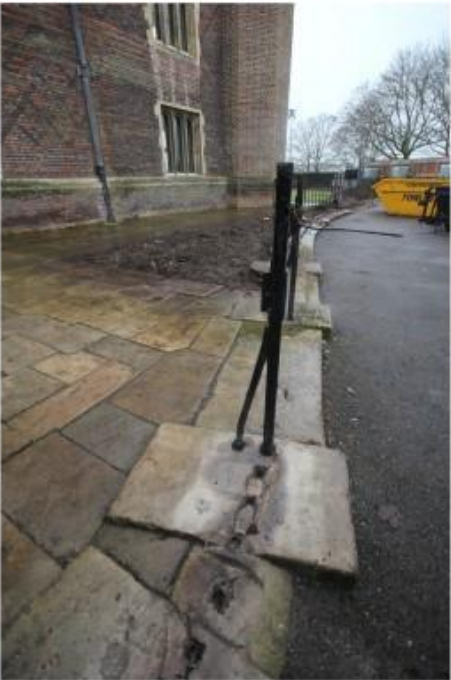
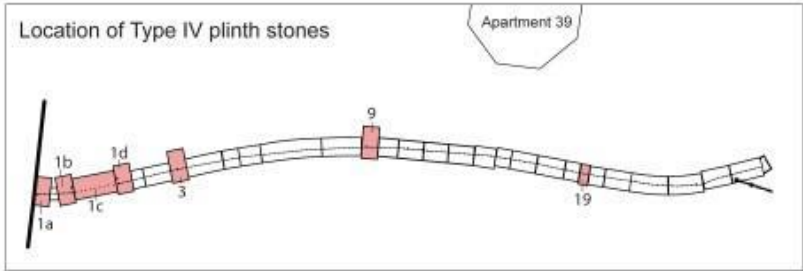
Figure 21: Type IV plinth stone location and form

- 5.10 Type IV was a group of six rectangular Portland stone blocks that served as backstay supports (1a, 1b, 1d, 3, 9, and 19). Only Plinth 19 was removed for repair, the others were repaired *in situ*.

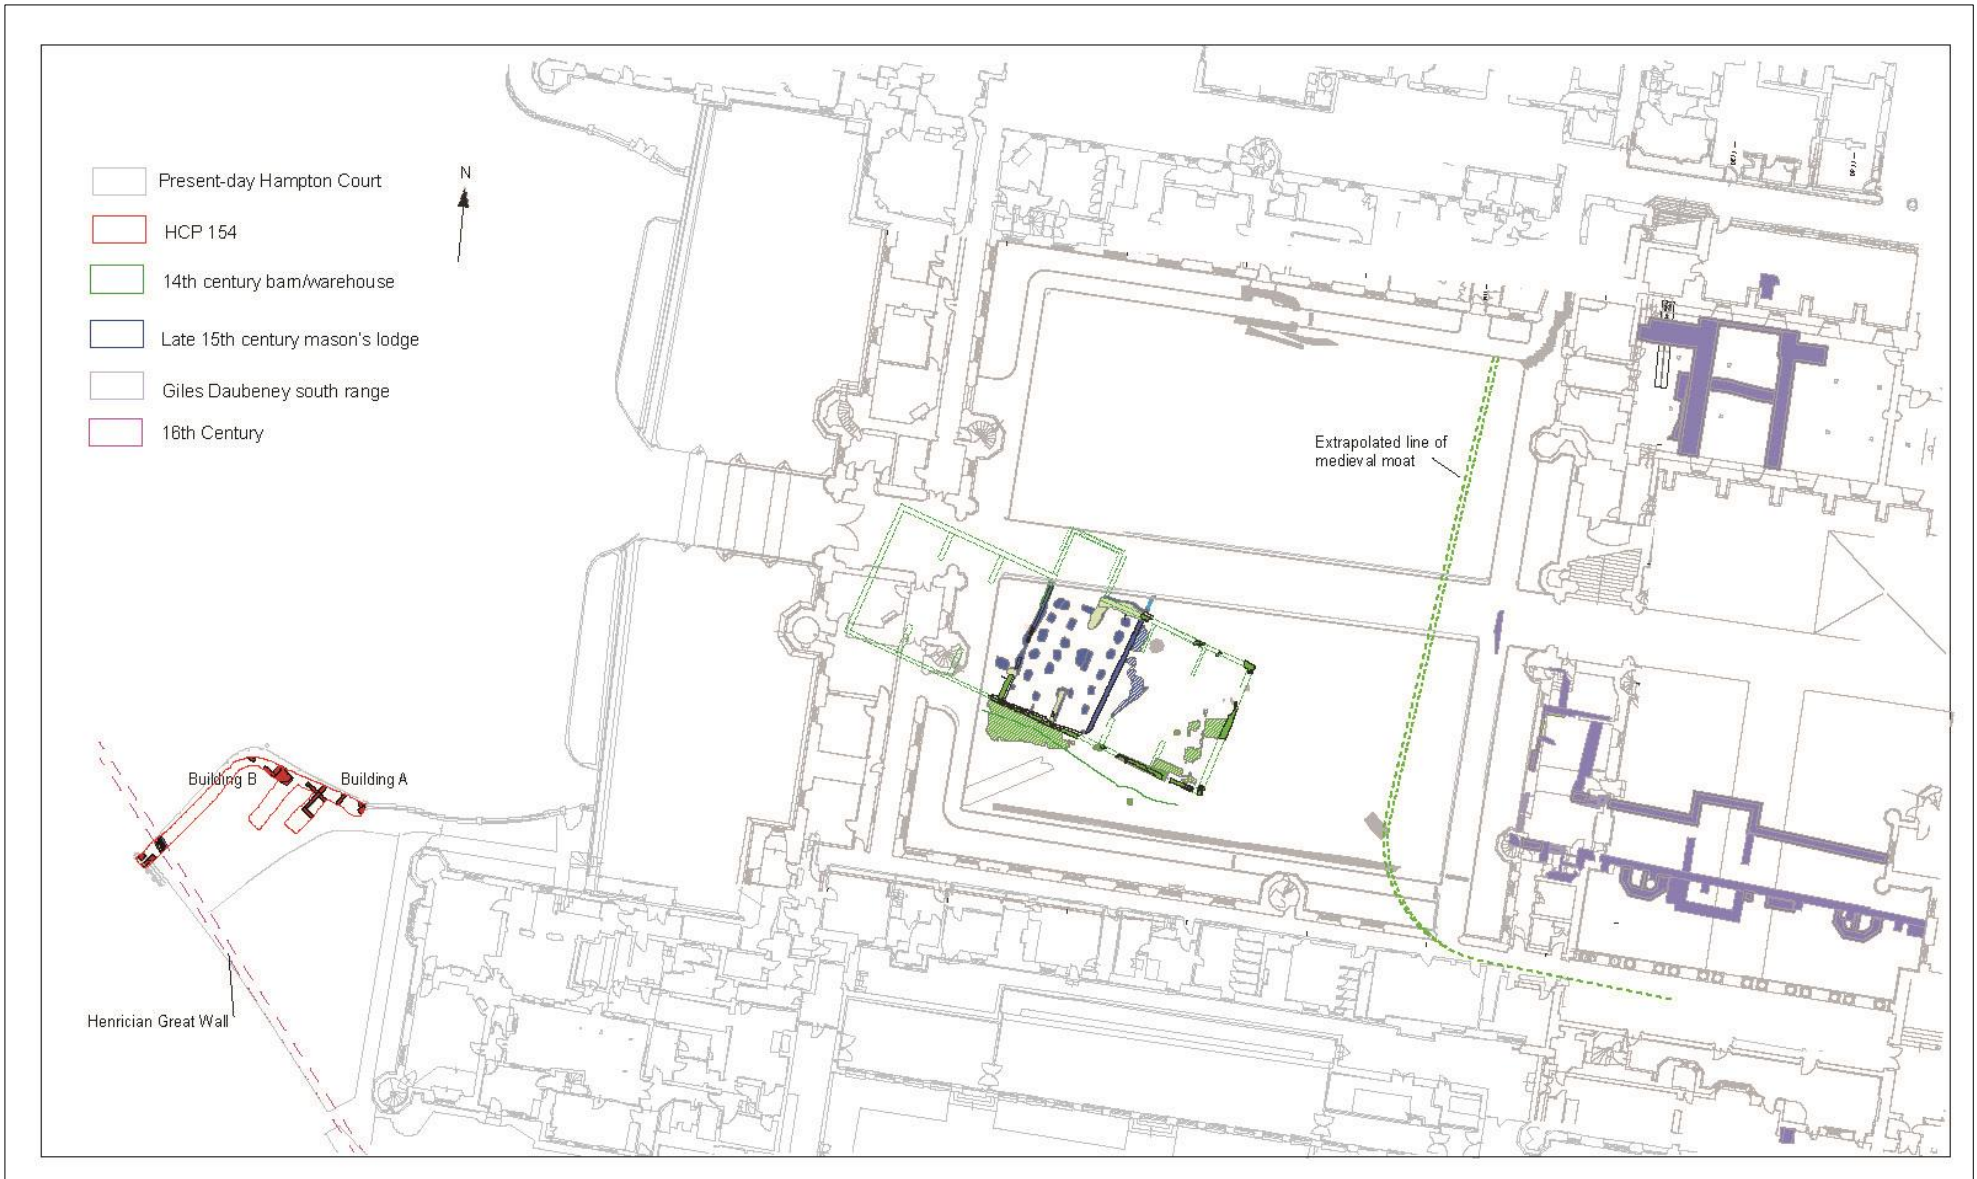
**Figure 22:** Plan illustrating the alignment of some of the different phases of building at Hampton Court

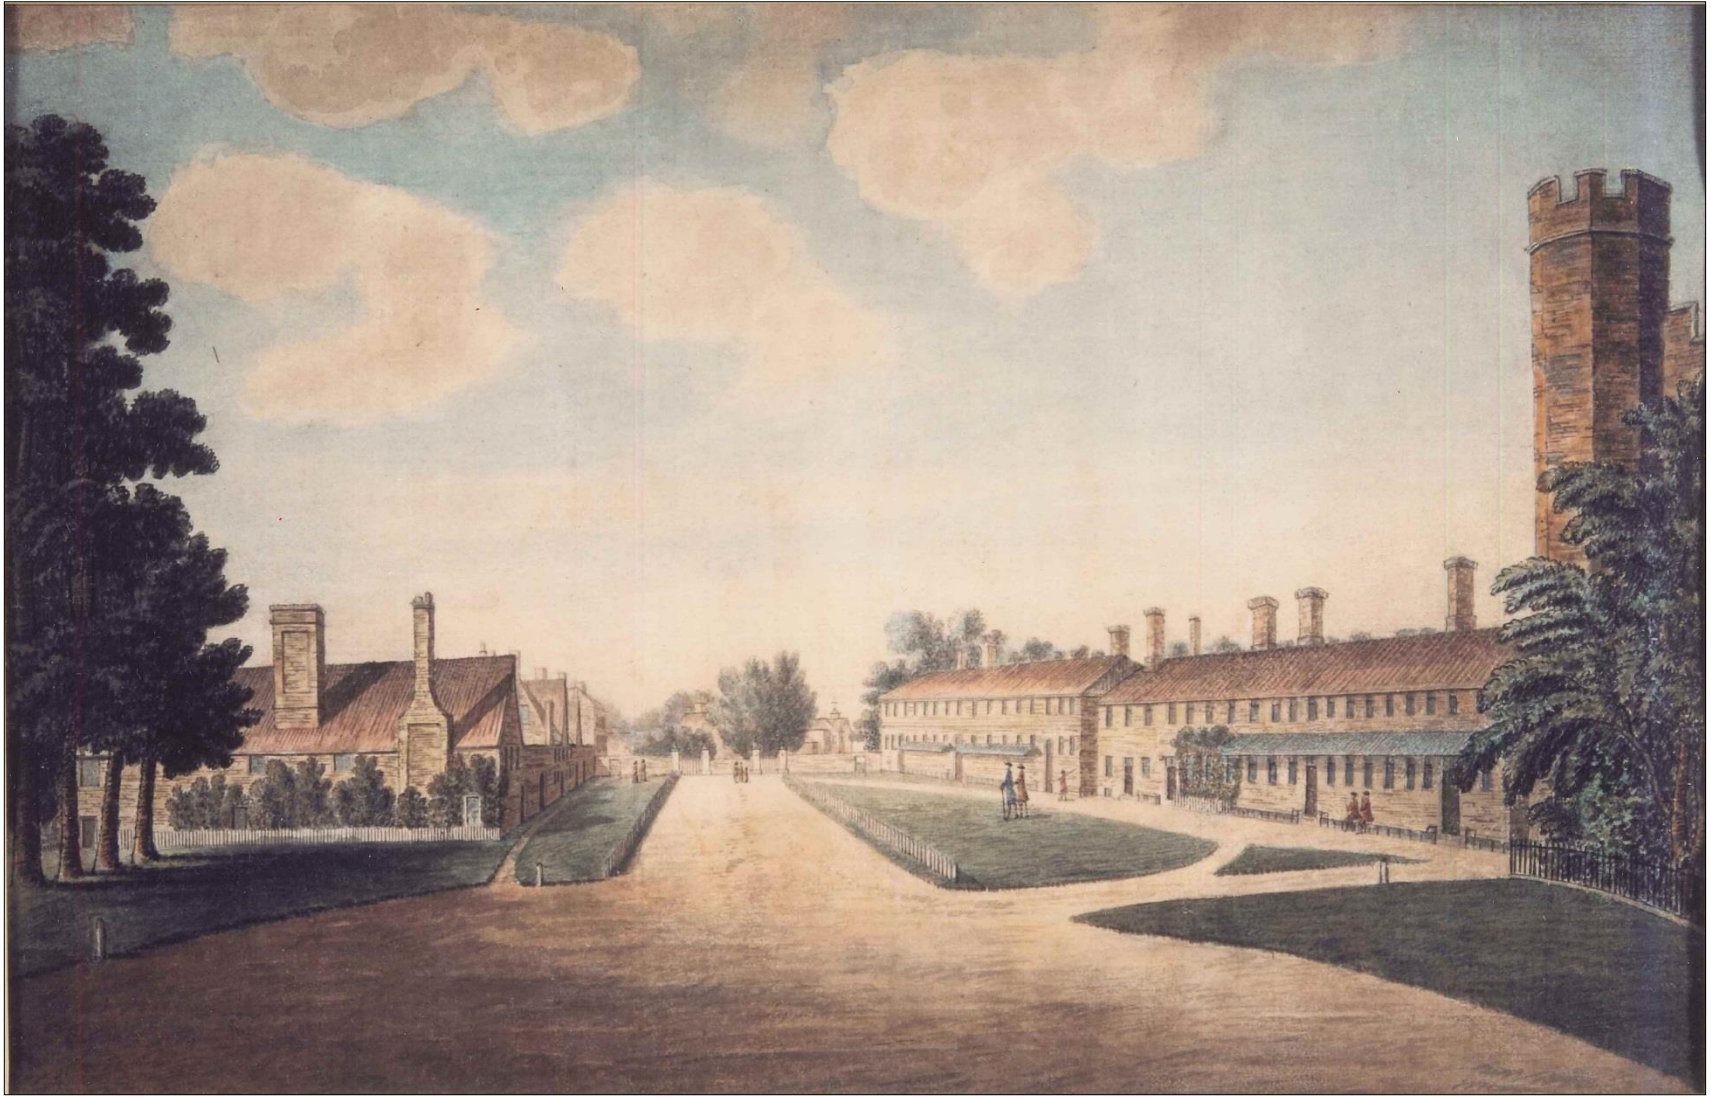
**Figure 24:** 1662, Dirk Stoop sketch showing the arrival of Charles II and Catherine of Braganza. A crenelated wall can be seen in front of the palace

- 3.5 The next major changes on the West Front occurred between 1558 and 1662. A view of the West Front painted by Dirk Stoop in around 1662 (Fig.24) shows the arrival of Charles II and Catherine Braganza and features a low wall, apparently with parapets, pinnacles and beasts surrounding the Apartment 39 wing. However, thus far, no surviving evidence of this wall has been found. In 1662, a timber cavalry barracks was constructed for Charles II against the southern wall of the Tiltyard. This was replaced in 1689 by the present day Barrack Block.

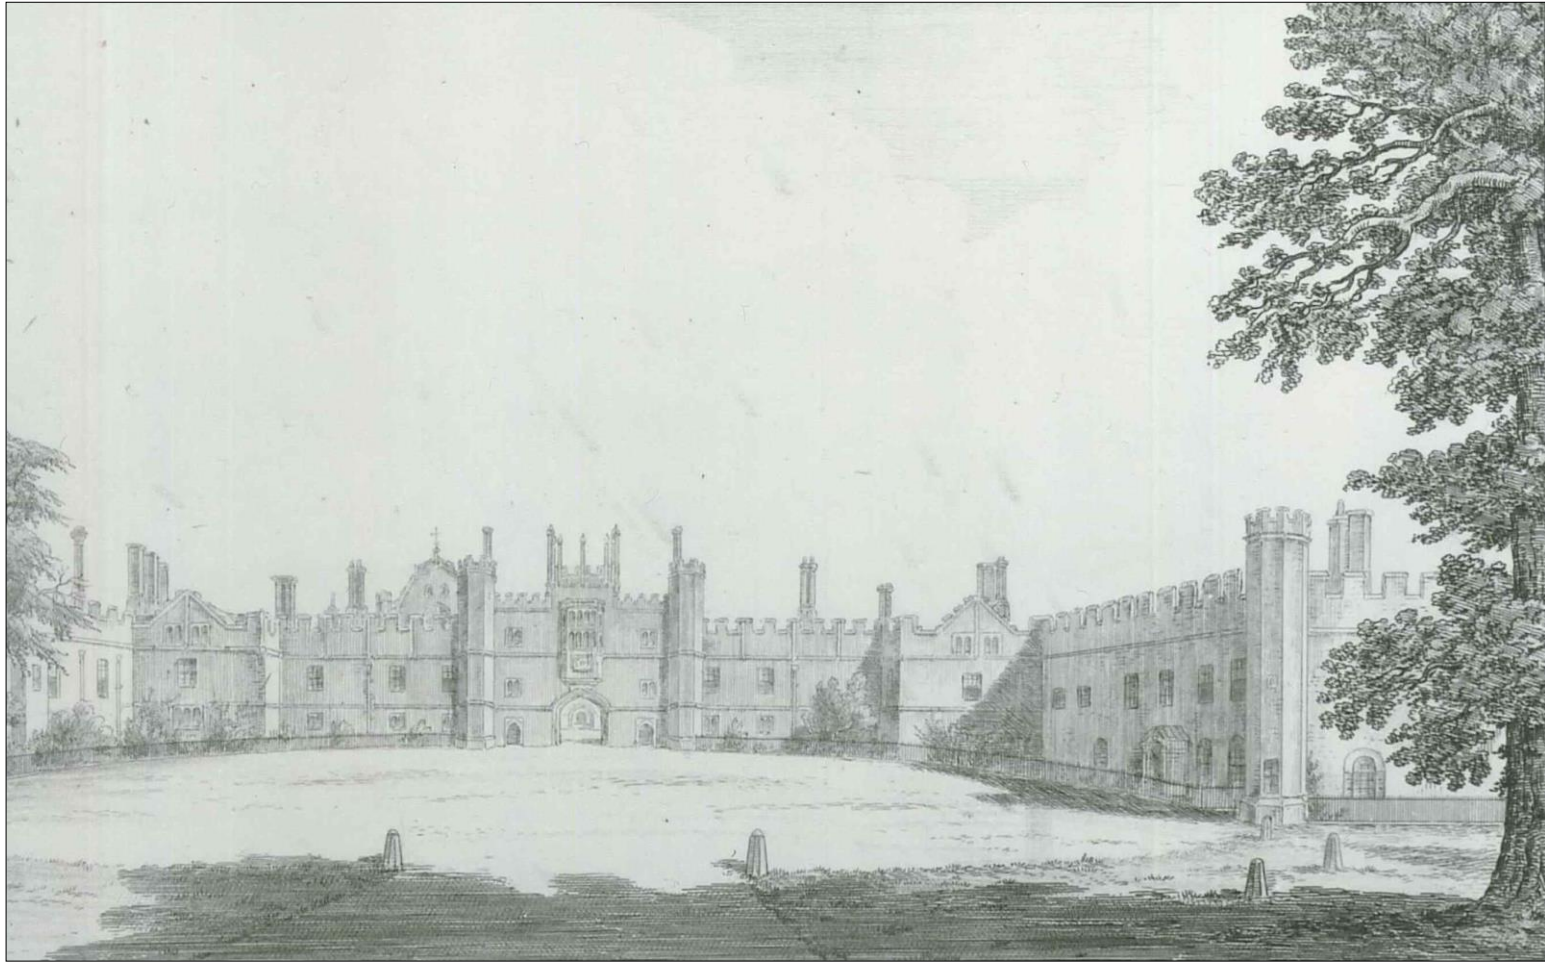
**Figure 26:** John Spyers sketch of the West Front c.1786. © Historic Royal Palaces

- 3.6 In around 1700, the moat was filled in and a circular sweep created in front of the palace’s western façade between the northern and southern wings with three radial paths projecting westwards including a Ragstone causeway leading up to the Outer Gate. The paths, causeway and sweep were all flanked with Portland stone bollards. This whole layout was presumably an attempt at imitating the *patte-d’oie* in the Fountain Garden (Longstaffe-Gowan, 2003). Several images from this period show a railing running between the two turrets on the west elevation of Apartment 39 (Fig.25, 26).

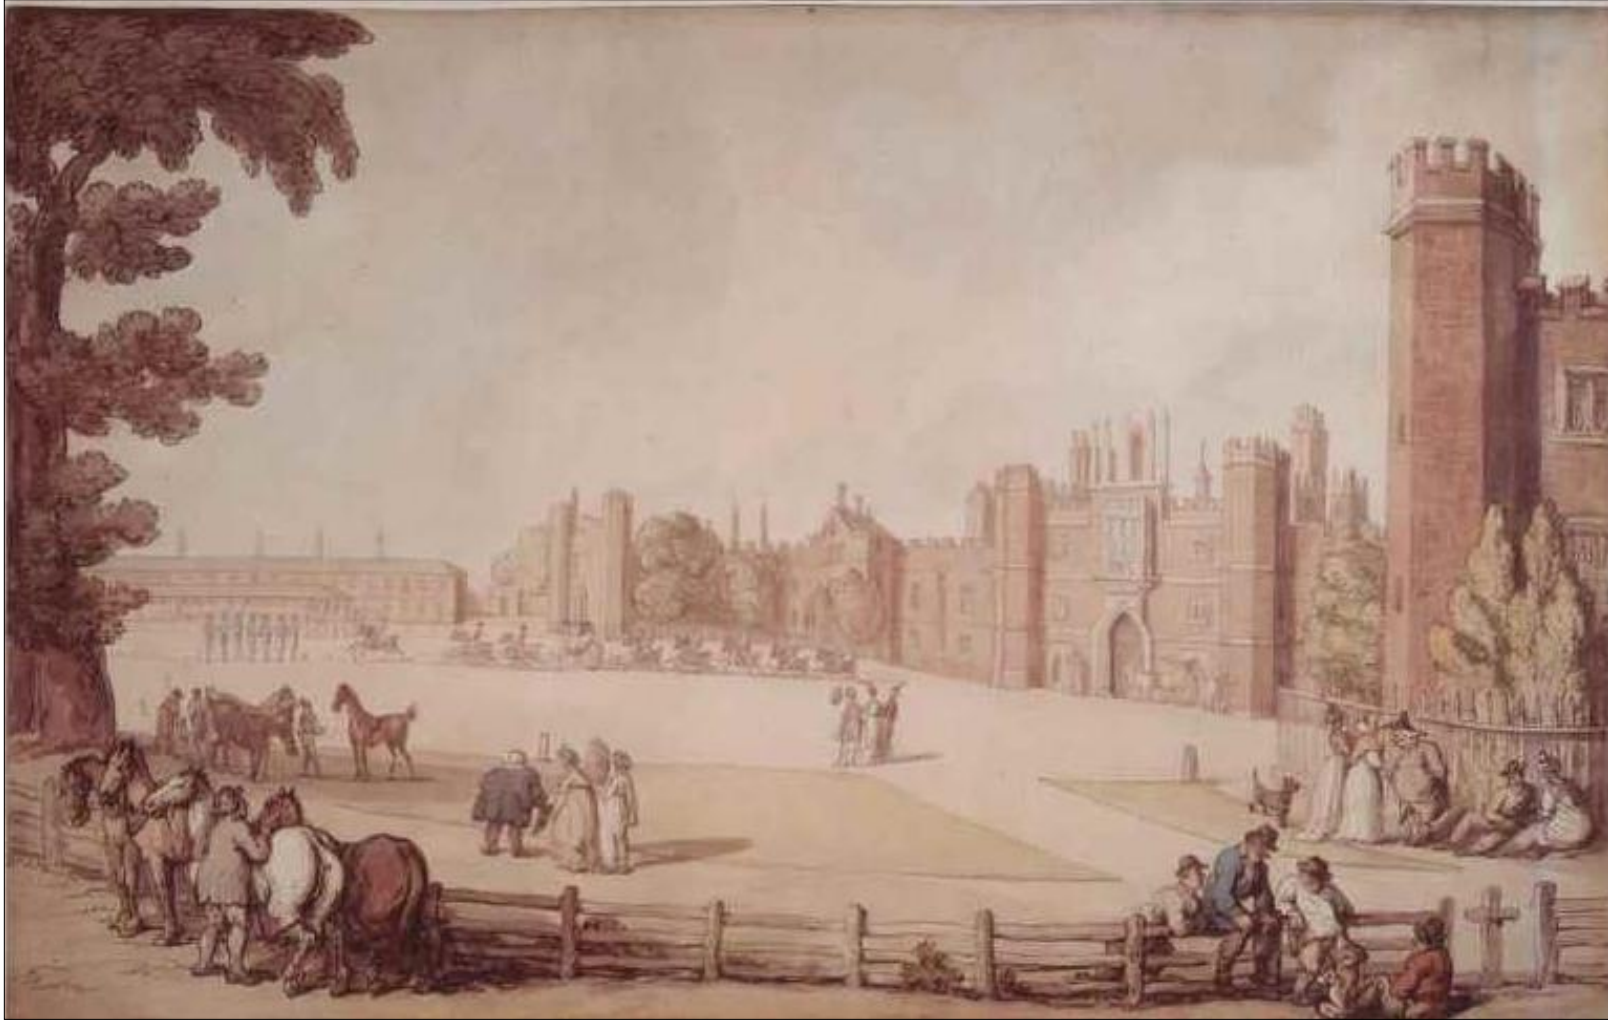
**Figure 27:** Sketch of Hampton Court Palace from the west, showing a dwarf wall with railings around Apartment 39, c.1800. © Historic Royal Palaces

39. A further set of railings can be seen extending from the other side of the turret along the west face of the apartment. These railings can be seen in detail in a sketch from 1800 (Fig.27), showing a dwarf wall supporting two sets of iron railings. By the 1820's the configuration of the railings changed to extend all the way around the north-west turret of Apartment 39 creating a private enclosed garden for the Grace and Favour residents (Figs.28 and 29). Further changes were made in 1881-1882 when the garden in front of Apartment 39 was extended westwards as part of Princess Frederica of Hanover and Baron Von Pawel Rammingen's redevelopment of the nearby stable block. In 1910, the eastern section of the West Front railings were curtailed by the re-excavation of the moat.

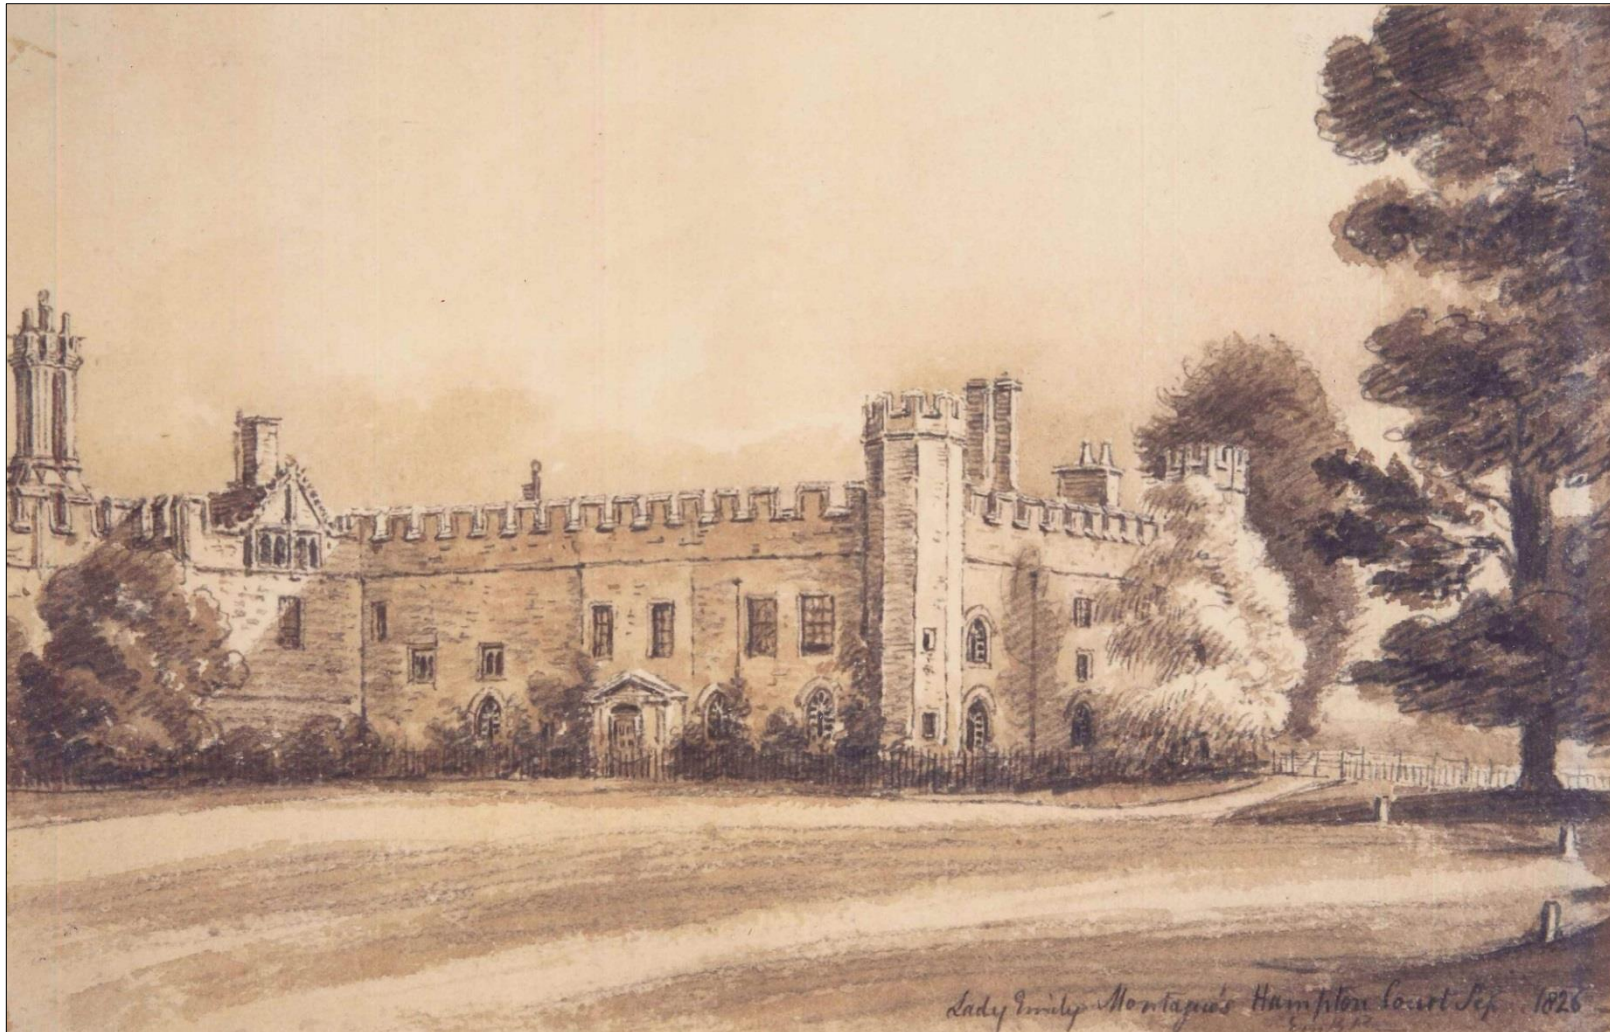
**Figure 28:** The West Front viewed from the south, showing the railings extending around the north-west turret of Apartment 39, Rowlandson, 1820. ©V&A.

- 7.27 In the first half of the 19<sup>th</sup> century, a small enclosed garden was created all the way around Apartment 39; a sketch by Rawlinson in 1820 shows that by this time the railings appear to have extended around the turret on the north-west corner of Apartment 39 (Fig.28). A later sketch from September 1826 illustrates a similar configuration when Housekeeper, Lady Emily Montagu, was resident (Fig.29). This 19<sup>th</sup> century reconfiguration was again confirmed by the archaeology exposed during this project. A later segment of railing foundation (Wall 15) abutted the earlier 18<sup>th</sup> century footings (Wall 16), extending 7.5m westwards from the north-west turret of Apartment 39. This section of brickwork was wider than the earlier Wall 16, and was composed of a visibly different and later brick type. Furthermore, the phase II foundation abutted the phase I brickwork at the point where the original railings appeared to make a right angle to adjoin the north-west turret of Apartment 39. The railings were then extended 7.5m westwards before making a southwards turn towards Barge Walk. However, the north-south extent of the early 19<sup>th</sup> century railing foundation was later truncated, probably as a result of being dismantled when the garden was further extended around 60 years later.
