East Front Irrigation, Hampton Court Palace HCP 169 and HCP 106

An Archaeological Watching Brief Report

**Alexandra Stevenson
Historic Royal Palaces**

January 2020

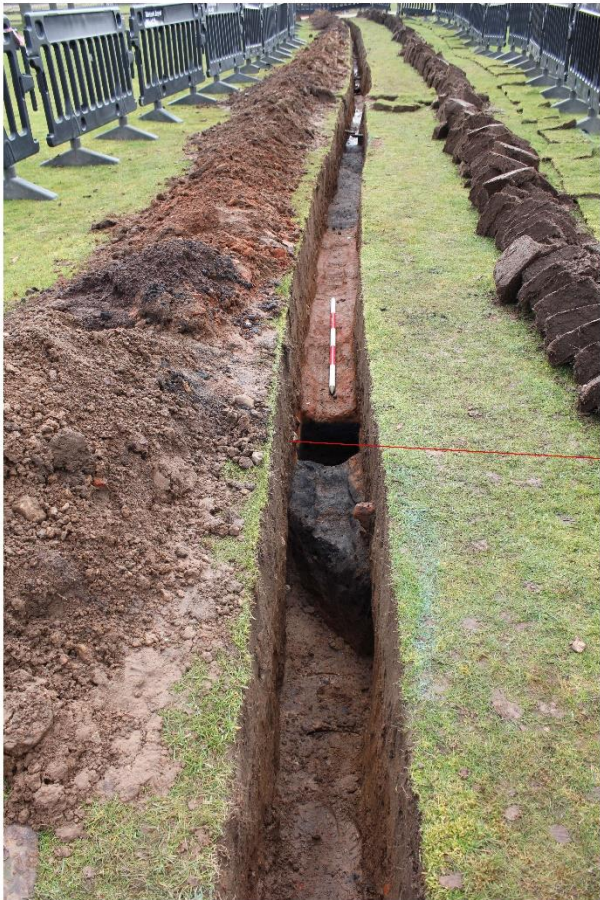
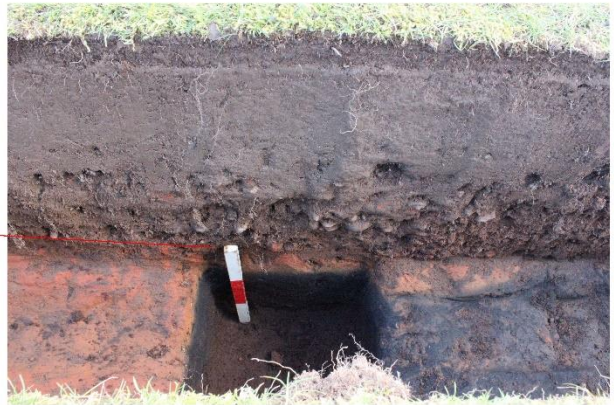
Figure 3: Potential brick clamp at the western end of the trench, Deposits (3) and (5)

- 4.1 Natural stratum was not encountered during this excavation. The earliest deposit recorded was located between 0.5m and 0.6m BGL. It was a soft, grey homogenous, and damp, sandy silt buried soil horizon (6). No finds were uncovered from this deposit. It was overlain at the western end of the trench by a sequence of heat-affected soils extending 8.5m east-west. A small test pit was excavated through this sequence (Fig.3). At the base, it was difficult to clearly distinguish the interface with the underlying buried soil horizon (6), which appeared to be discoloured with a very dark brown to black colour, fading to dark reddish-brown with depth. The overlying deposit was a 0.12-0.18m-thick layer of compact, gritty, homogenous, black burnt sand (3), which was in turn overlain by a compact, bright reddish orange brick dust and sand deposit (5), up to 0.08m thick. This upper deposit was conserved over a length of 3.5m, and appears to have been truncated, presumably by the reworking of soils in this area.

- 6.5 The striking colours represented by two clear areas of burning within the narrow confines of the excavated trench during the watching brief in 2018, are characteristic of the appearance of brick clamp remains. Given the confined nature of this investigation it would be difficult to confirm, however, evidence drawn from previous archaeological investigations at Hampton Court and further afield, as well as information drawn from the Hampton Court Palace Works Accounts certainly go some way to supporting this interpretation.

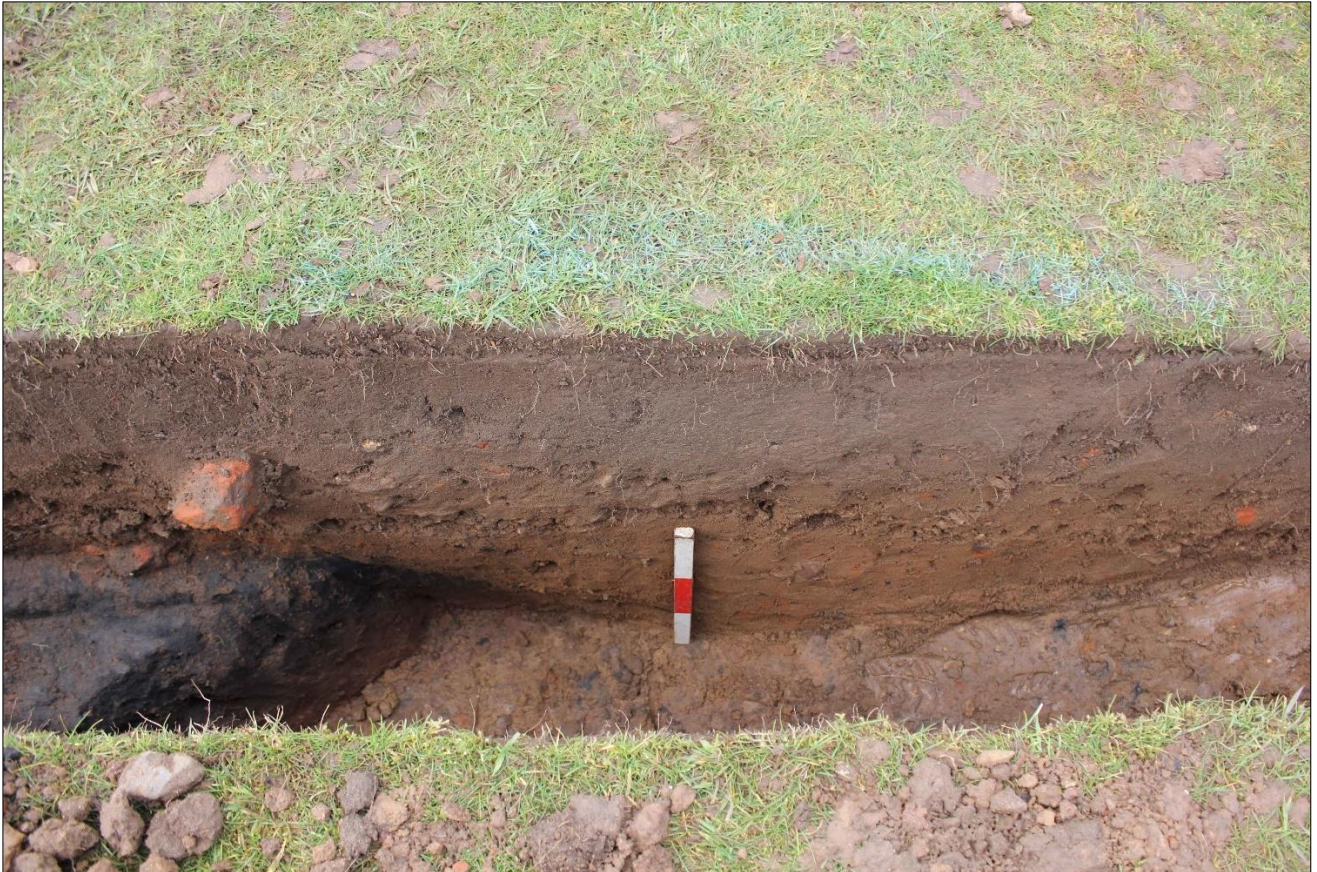
Figure 5: Possible pit feature [7] at the far west end of the trench

- 4.3 At the far western end of the trench, a possible pit [7] with steep edges was recorded, however, there was not a clearly defined edge, so this feature is somewhat dubious. It was 'filled' with a soft, homogenous silty sand (8) and truncated the black (3) and red (5) sand deposits as well as the garden soil deposit (6) described above. No artefactual material was recovered from this feature.

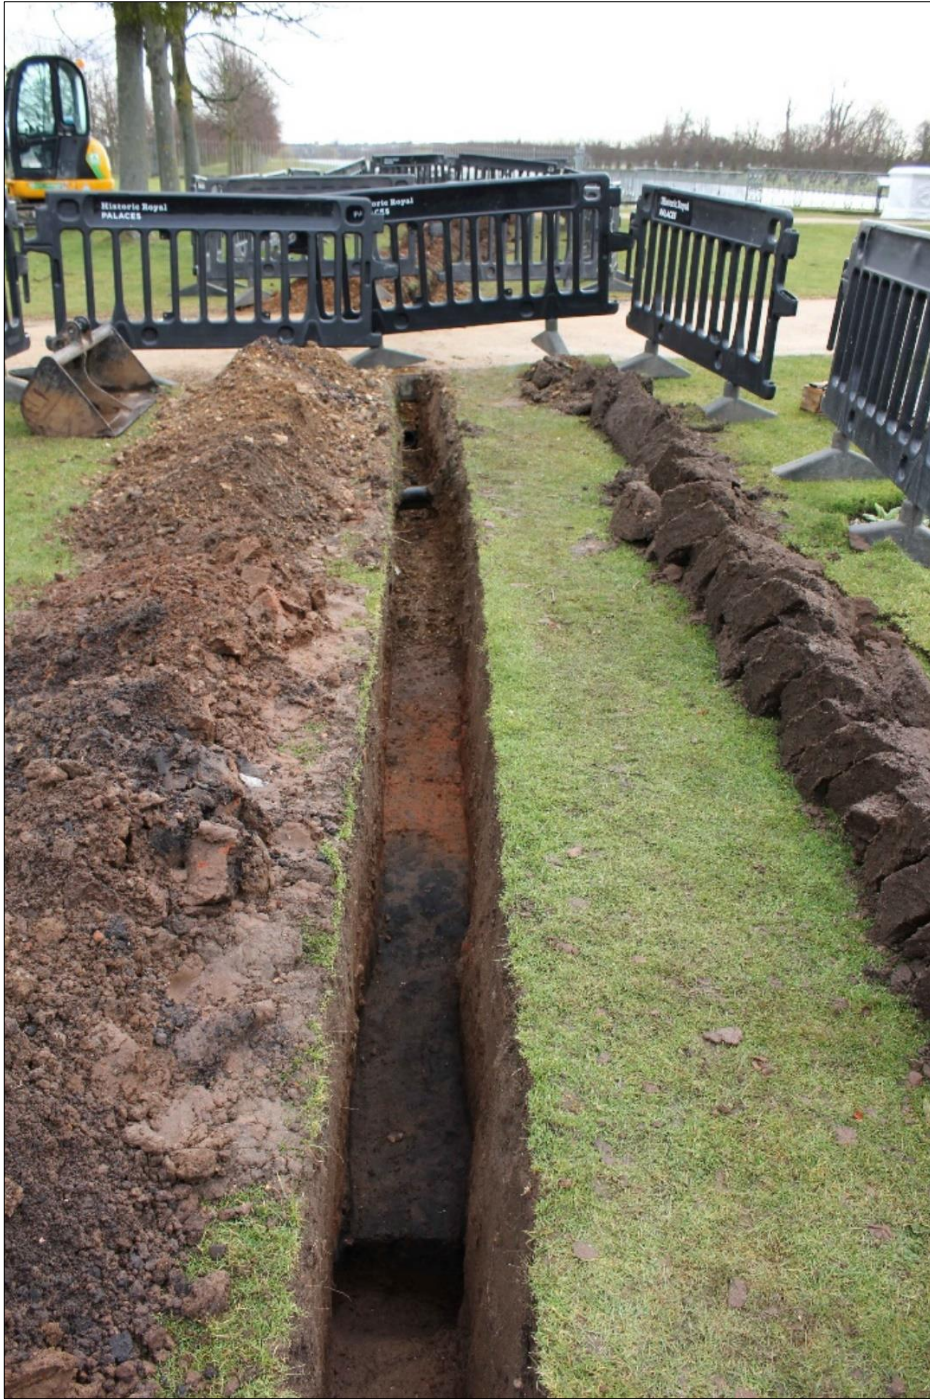
Figure 6: Potential brick clamp deposits (15) and (16), and gravel layer (9)

- 4.2 The same sequence was recorded 18.5m further east towards the central portion of the trench approximately 1.5m west of the pathway north-west of the Long Water. This series of deposits, represented by the burnt black sand (15) and the brick dust (16), was recorded over a much smaller area: 2.5m east-west. However, gravels (9) overlay the brick dust deposit at the eastern end, so the sequence was either obscured by unexcavated layers or truncated. Given the distance that separates these two analogous sequences of deposits, it would seem that they represent two separate features.

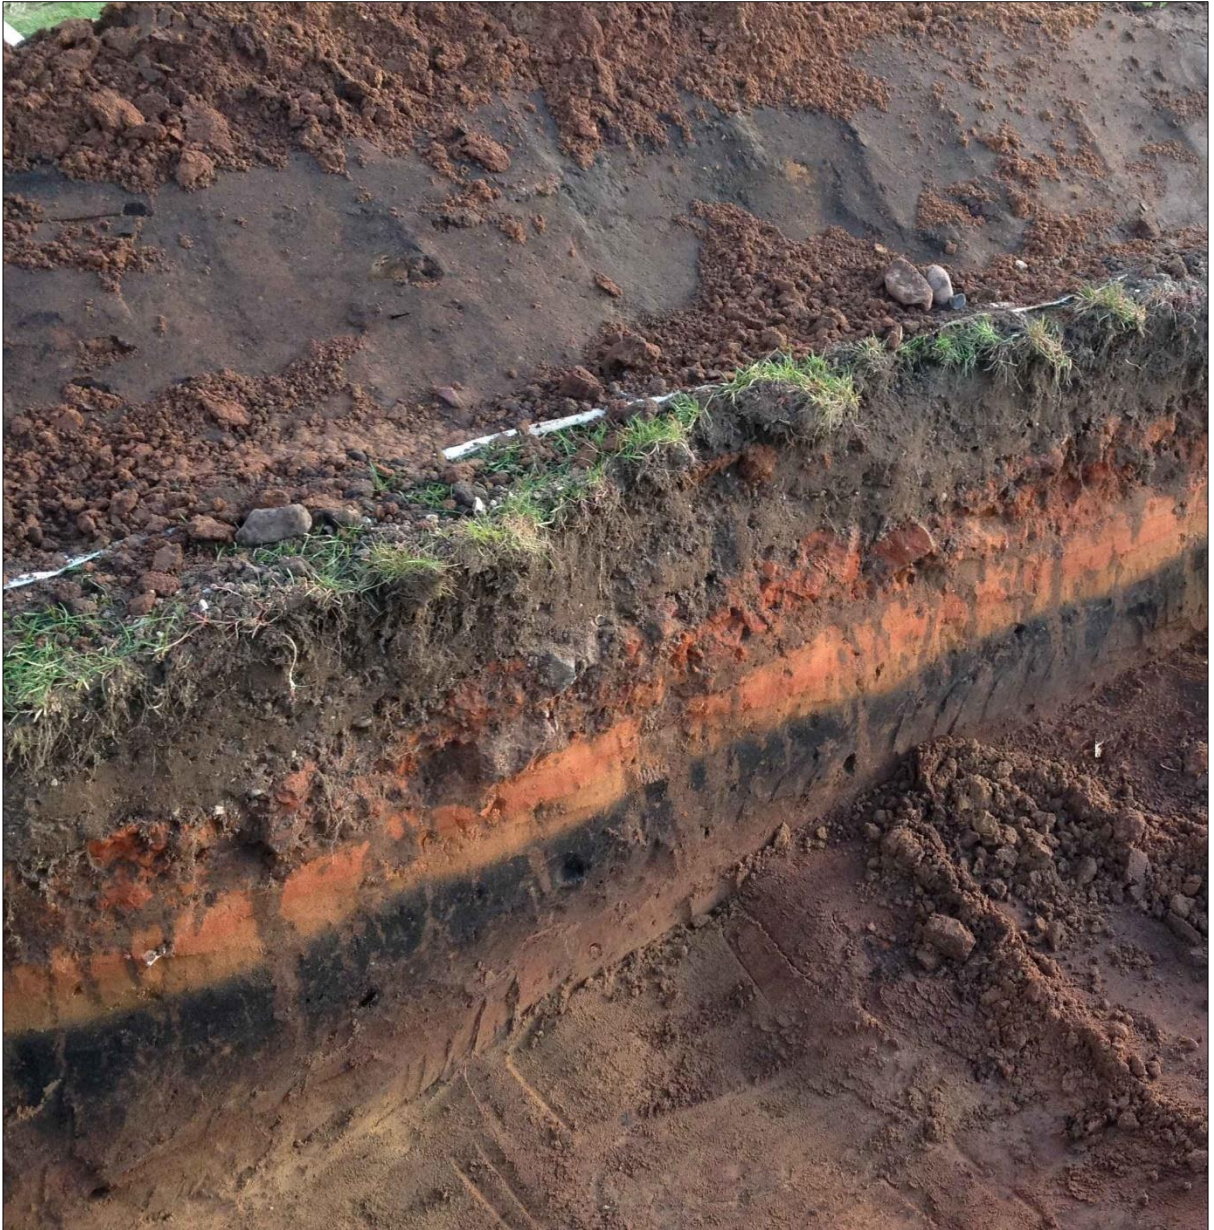
Figure 7: Brick Clamp in Home Park near the Kingston Gate shown in section

- 6.6 In January 2014, an archaeological watching brief was undertaken during groundworks to replace the existing roadway of Home Park Road within the grounds of Hampton Court Park (HCP 114). Archaeological remains were plentiful, and among the most significant was the discovery of two brick clamps relating to either the Wolsey or Henrician construction phases of the Palace (1515-1547). They measured 12m x 4.5m and 7.68m x 7.32m respectively, though their east-west extent extended beyond the confines of the excavation. The brick clamps identified during HCP 114, consisted of a sequence of burnt deposits. At the base was a zone of heat-affected subsoil, followed by a layer of black burnt sand, thought to be burnt turf or topsoil incorporating remnants of fuel waste, which was in turn overlain by a layer of red burnt sand and brick dust, likely the remaining debris from the firing of the bricks and the subsequent demolition of the brick clamp. One of the brick clamps was overlain by a brick rubble deposit associated with the broken and discarded elements produced after the brick clamp was dismantled and the fired bricks were

gathered. Although there was very little brick rubble recorded during HCP 169, the photographic record of the brick clamp features in Home Park shows a remarkable similarity to the appearance of the deposits exposed during the watching brief in the Great Fountain Garden (Figs. 3 and 7). The major difference, however, was that the features recorded during the Home Park Road Project were exposed over a much wider area, providing the opportunity to examine some in situ structures. One of the clamps retained four bricks in section (two stacked on two), and a line of broken bricks was recorded in section, possibly representing remnants of the primary course of bricks forming the base of the brick clamp. Both clamps recorded in Home Park appeared to have been set within a gentle hollow, possibly to improve the stability of the temporary brick structure enabling the stack of bricks to be sloped towards the centre⁸.

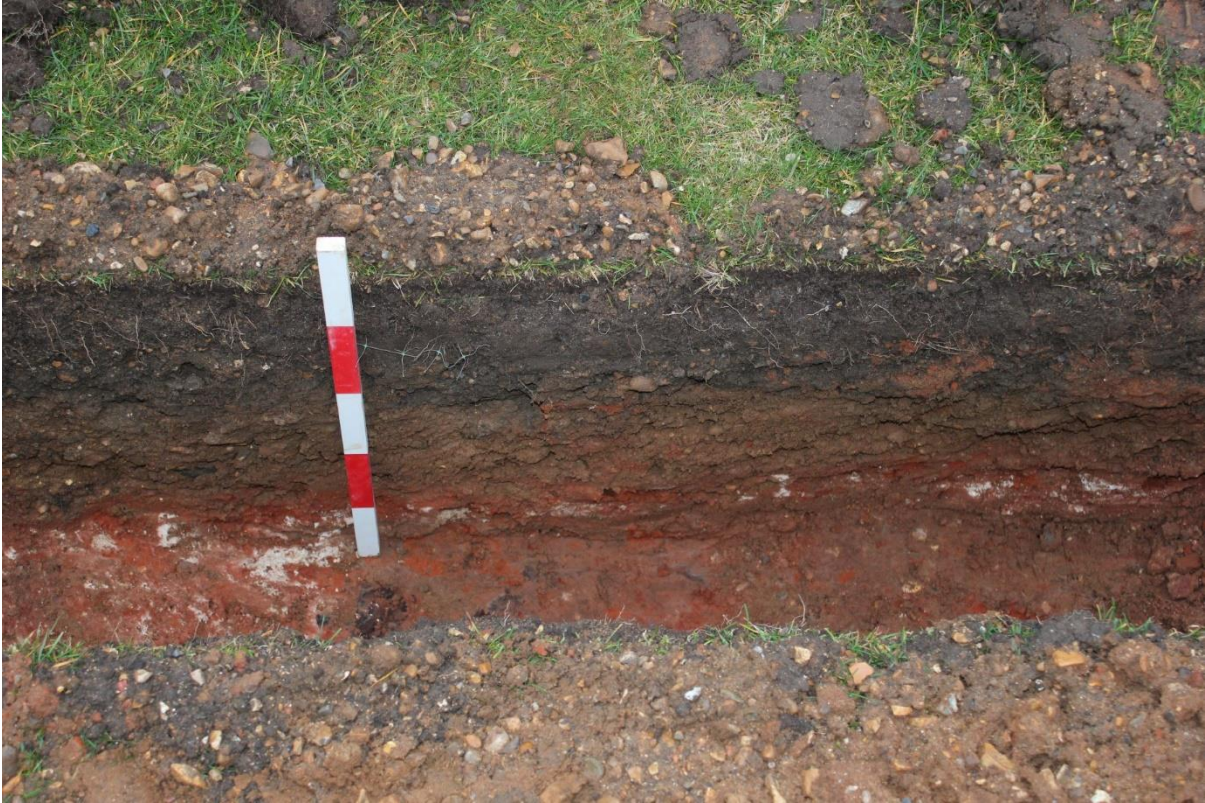
Figure 8: Deposits recorded in the Great Fountain Garden during HCP 106

- 4.6 The complete site archive associated with the watching brief undertaken in 2013 was not identified. Only a set of digital photographs and a small number of finds were recovered. Nevertheless, the limited data was sufficient enough to make a few inferences about the nature of the archaeological remains in this area.
- 4.7 The photographic record indicates that the trench was excavated to a maximum depth of 0.5m, with a sequence of light brown gravelly/silty deposits overlying a homogenous silty sand layer. This sequence was overlain by 0.12-0.15m of topsoil. Towards either the central or eastern portion of the trench (it was difficult to ascertain the exact location from the photographs alone), a layer of crushed brick and mortar with patches of what appears to be charcoal was observed. This deposit was located at an upper height of around 0.3m BGL.

- 6.13 The watching brief in 2013 (HCP106) did not appear to expose any evidence of brick kilns, however the project did reveal what appears to be a section of a crushed brick and mortar surface at approximately 0.3m BGL. Its appearance was much more mottled and heterogenous than the brick dust deposit recorded during the 2018 watching brief. Deposits of this nature have been found across the Hampton Court Palace grounds at similar levels, including in the works Yard, Tiltyard, and the Wilderness, and are usually associated with earlier garden paths. A small assemblage of brick, roof and floor tile, and fragments of mortar were collected from this site. It produced a relatively close date range of between 16th and 17th century, most brick associated with the Henrician type bricks (Types B, C, and D). The mix of materials collected, alongside the presence of mortar would tend to suggest that it corresponds to scattered demolition rubble associated with the destruction of the Tudor palace in 1689, rather than being indicative of waste material associated with brick firing.

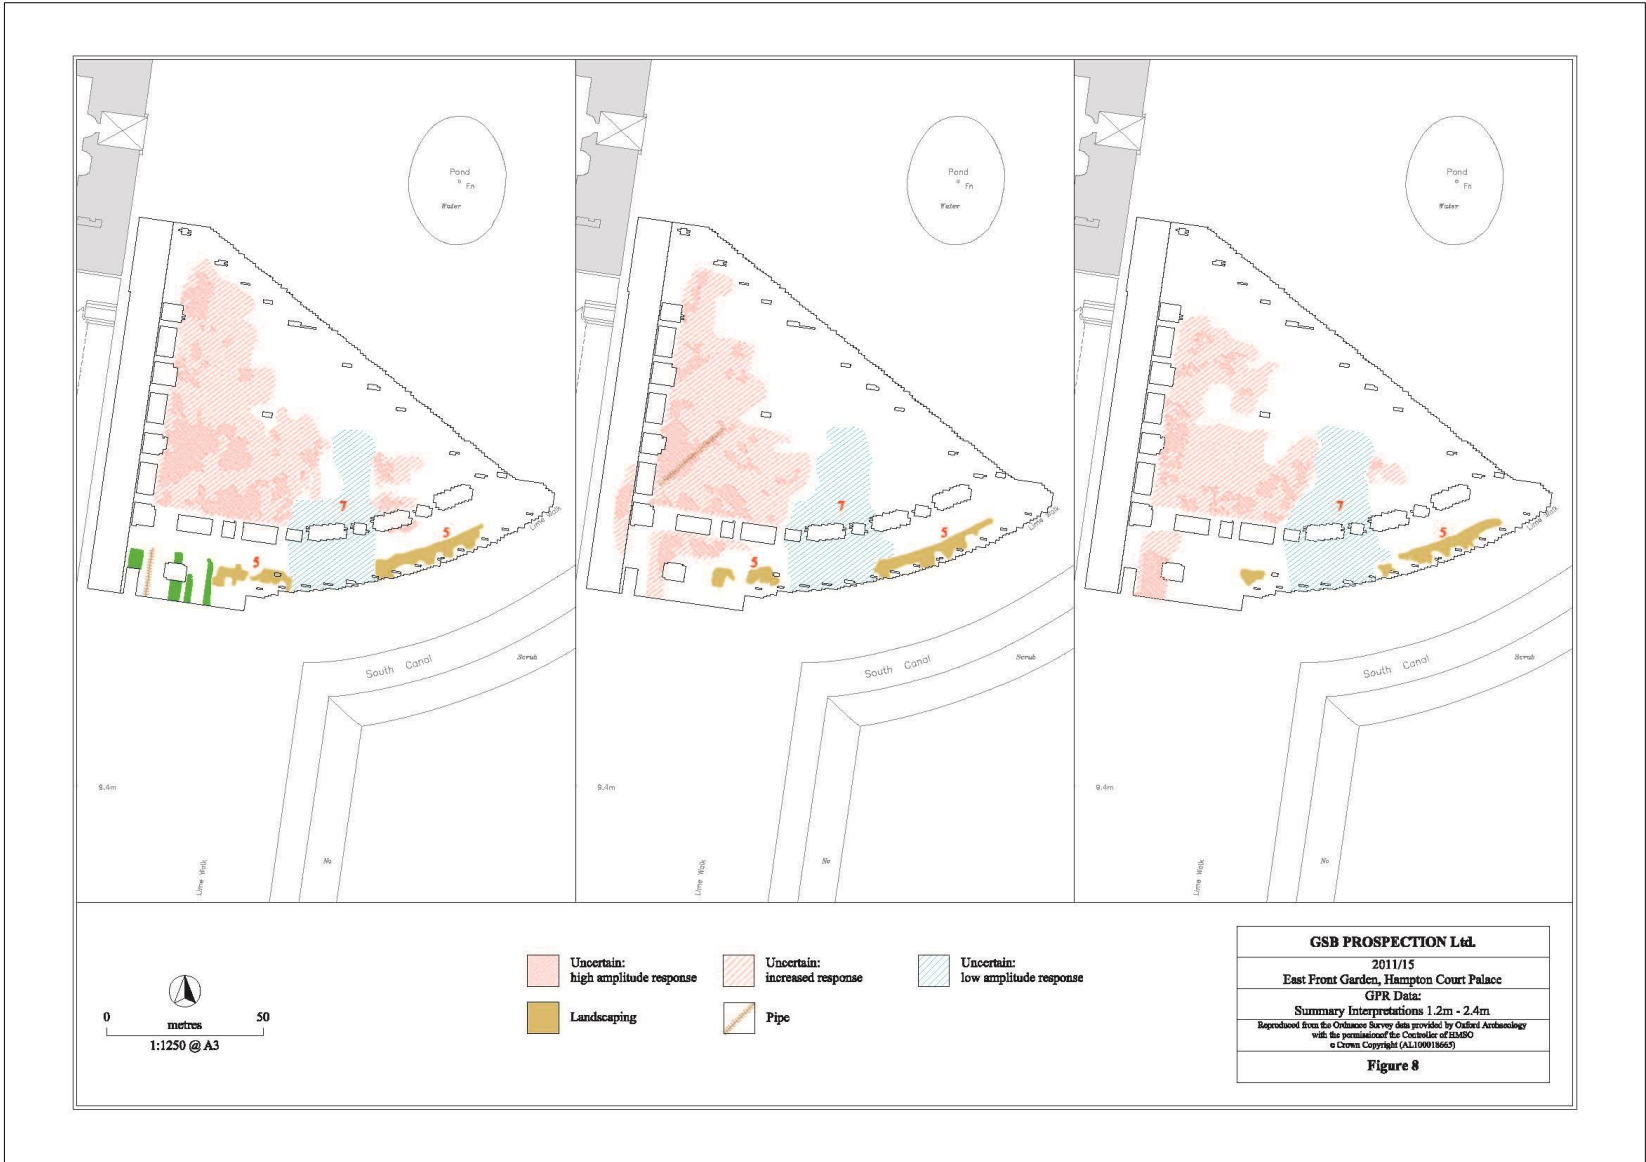
Figure 12: Plans showing the results from the GPR survey, the area of low amplitude signal is represented by the blue area 7

- 3.16 In 2011, the southern half of the grassed demi-lune area of the Great Fountain Garden was the subject of geo-physical survey undertaken by Oxford Archaeology, including resistance survey and Ground Penetrating Radar survey (GPR). No complete pattern of response recognisable as any of the earlier formal garden layouts was seen, however, the survey does seem to have revealed the location of one of the quatrefoil fountains illustrated in drawings of the late 17th-century garden layout. Areas of high resistance and increase response from the GPR may represent former garden paths, planting beds and other landscaping features. A "broad amplitude zone" was recorded (Fig. 12), possibly representing a cut feature with relatively well-defined extents. This finding was a something of a mystery as no such feature is known to have existed according to records.

- 3.17 A myriad of pipes and drains were recorded by GPR, and this was by far the clearest set of data.
