# **Kirkby Ings MIOS Design Review**

High-level Cultural Heritage Survey Report

26 April 2018

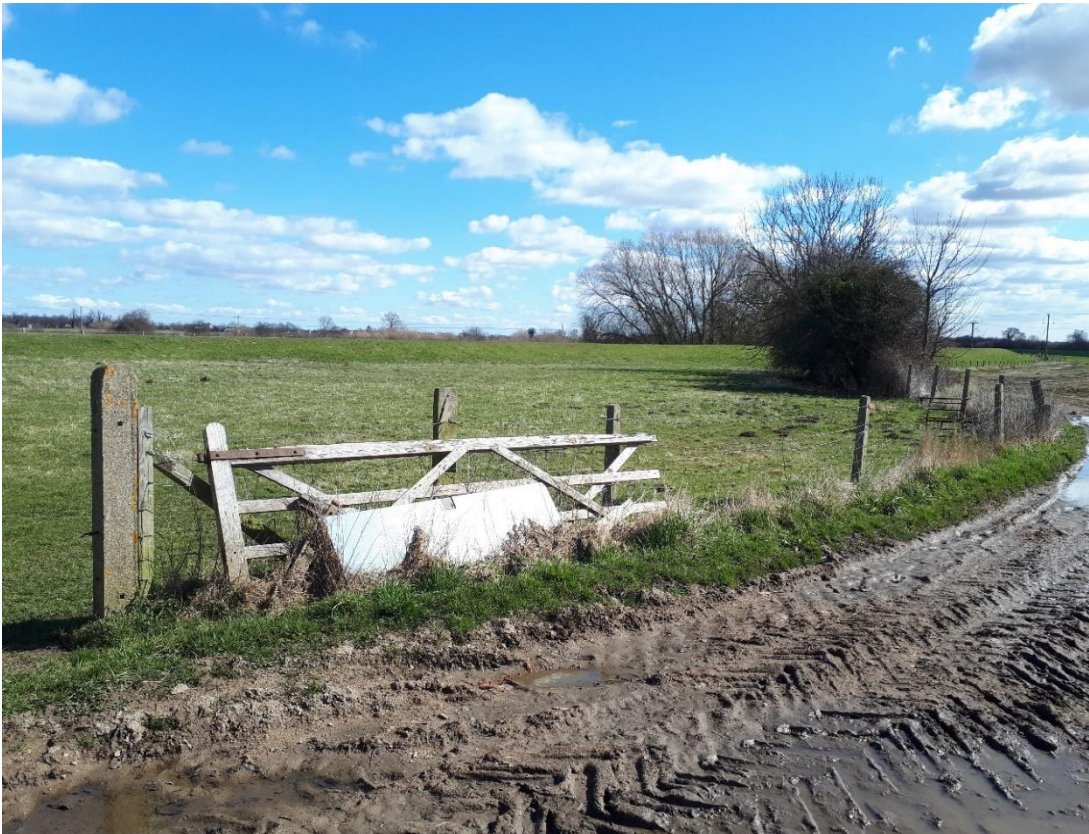
Bowlam Bank is an uneven earth filled impounding structure (Photo 1 and 2) at the south-western limit of the reservoir positioned between a series of agricultural fields. It lies on relatively flat land on the Roxby Formation which the British Geological Survey records as: “Mudstone, Calcareous. Sedimentary bedrock formed 247 to 272 million years ago in the Triassic and Permian Periods. The local environment is dominated by lakes and lagoons. The sedimentary rocks are lacustrine or shallow-marine in origin.” Information from the Kirkby Ings MIOS Review (Mott MacDonald, 2018) concluded the embankment is constructed from imported clayey material.

**Photo 1: Overview of Bowlam Bank**

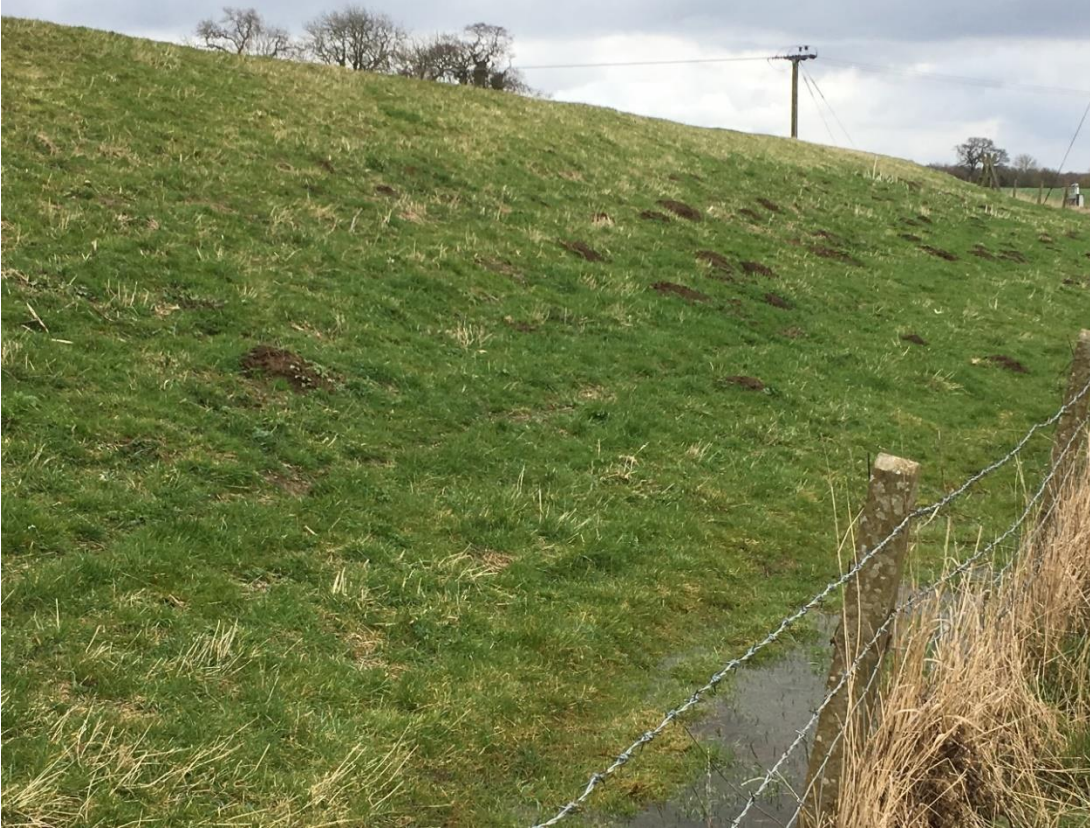
**Photo 2: Close-up View Bowlam Bank illustrating uneven nature**

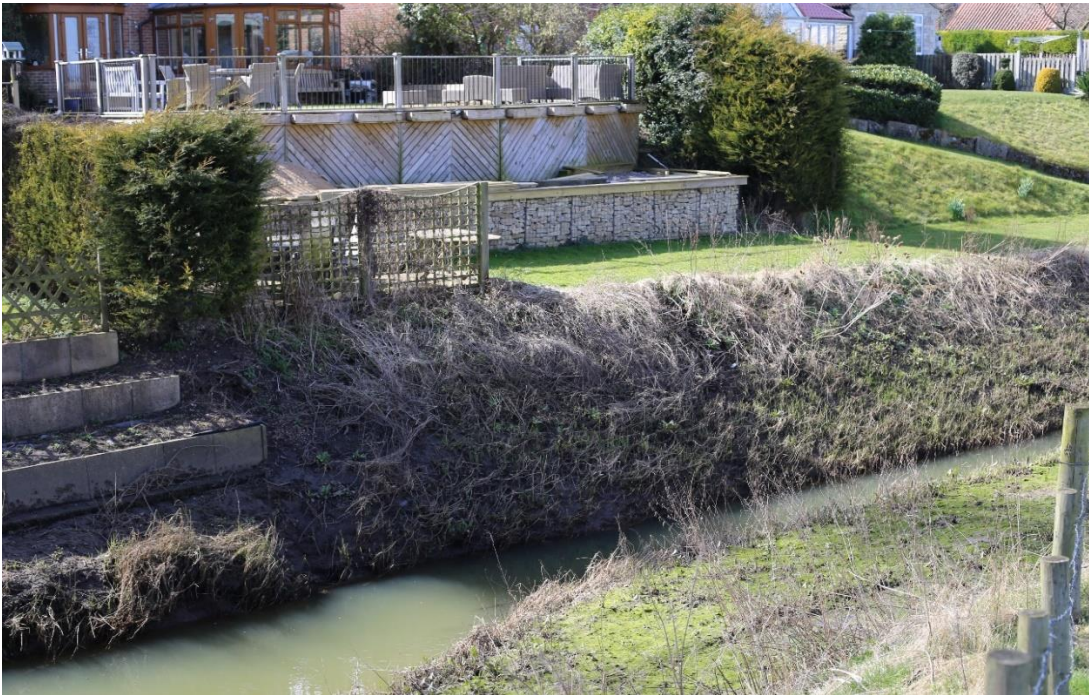
Ulleskelf flood barrier extends along the rear of properties fronting West End and Main Street as a series of walls and smaller embankments at the south-eastern end of the reservoir (Photo 3 and 4). Generally, the topography is flat and level following the course of the river with large areas of natural floodplains and open water meadows to the north. It lies on soils described by the British Soil Survey as “Sherwood Sandstone Group which consist of sedimentary bedrock formed approximately 237-272 million years ago in the Triassic and Permian Periods. The local environment was previously dominated by rivers.”

**Photo 3: Part of Ulleskelf flood barrier**

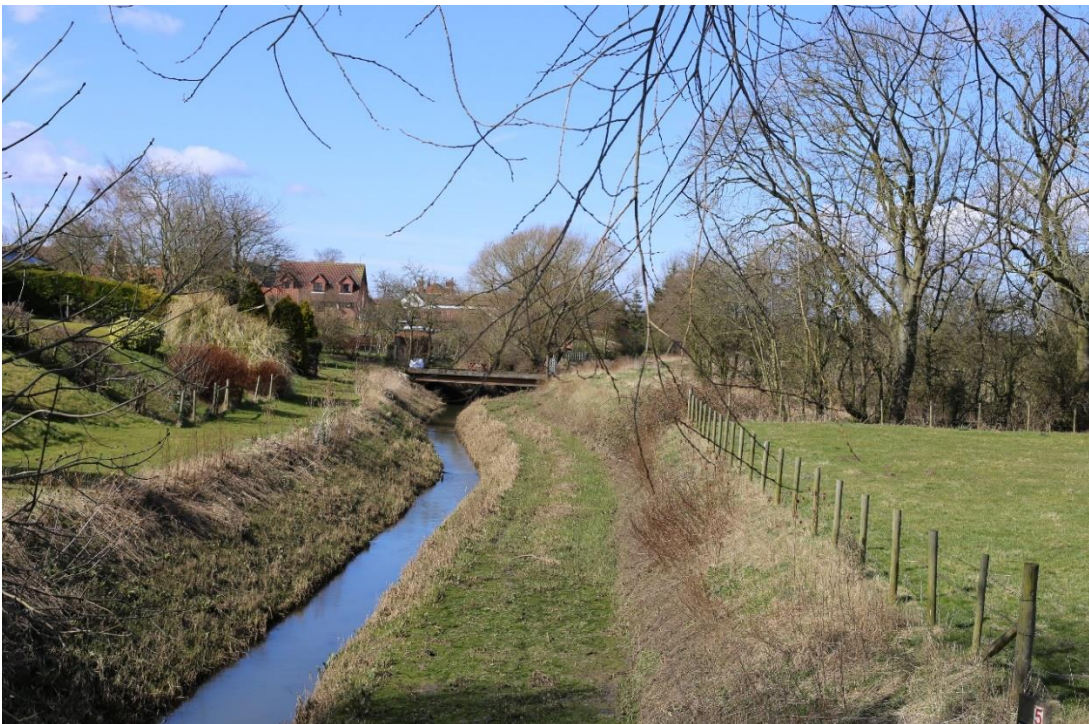
**Photo 4: Overview of riverside embankments**
