<b>Project:</b>	UU41 Blacker Farm, Pilling Lane Sewer Relay		
<b>BIM reference:</b>	UU41-MMB-00-ZZ-DO-C-0010	<b>Revision:</b>	A
<b>Prepared by:</b>	Zara Burn	<b>Date:</b>	11th February 2021
<b>Approved by:</b>	Ross Cameron	<b>Checked by:</b>	Vicky Nash
<b>Subject:</b>	Archaeological Site Walkover Results

## 1 Introduction

Yorkshire Water Services (YWS) have identified the requirement to refurbish a combined sewer section running through Blacker Woods, Pilling Lane, Skelmanthorpe (centred at National Grid Reference SE 423950, 411150) to improve conveyance and resolve surcharge and pollution risk.

This technical note has been produced by Mott MacDonald (MM) on behalf of Mott MacDonald Bentley (MMB) and their client YWS following an archaeological site walkover at the location of the sewer. The presumed line of the boundary to the medieval Elmley Park known on the West Yorkshire Historic Environment Record (HER) runs through the woods roughly parallel to Park Gate Dike (HER Ref. No. PRN 4607) and a weir is shown on the Ordnance Survey First Edition of 1852 at NGR SE 424176 411125. At the request of West Yorkshire Archaeology Advisory Service (WYAAS) it was recommended in the first

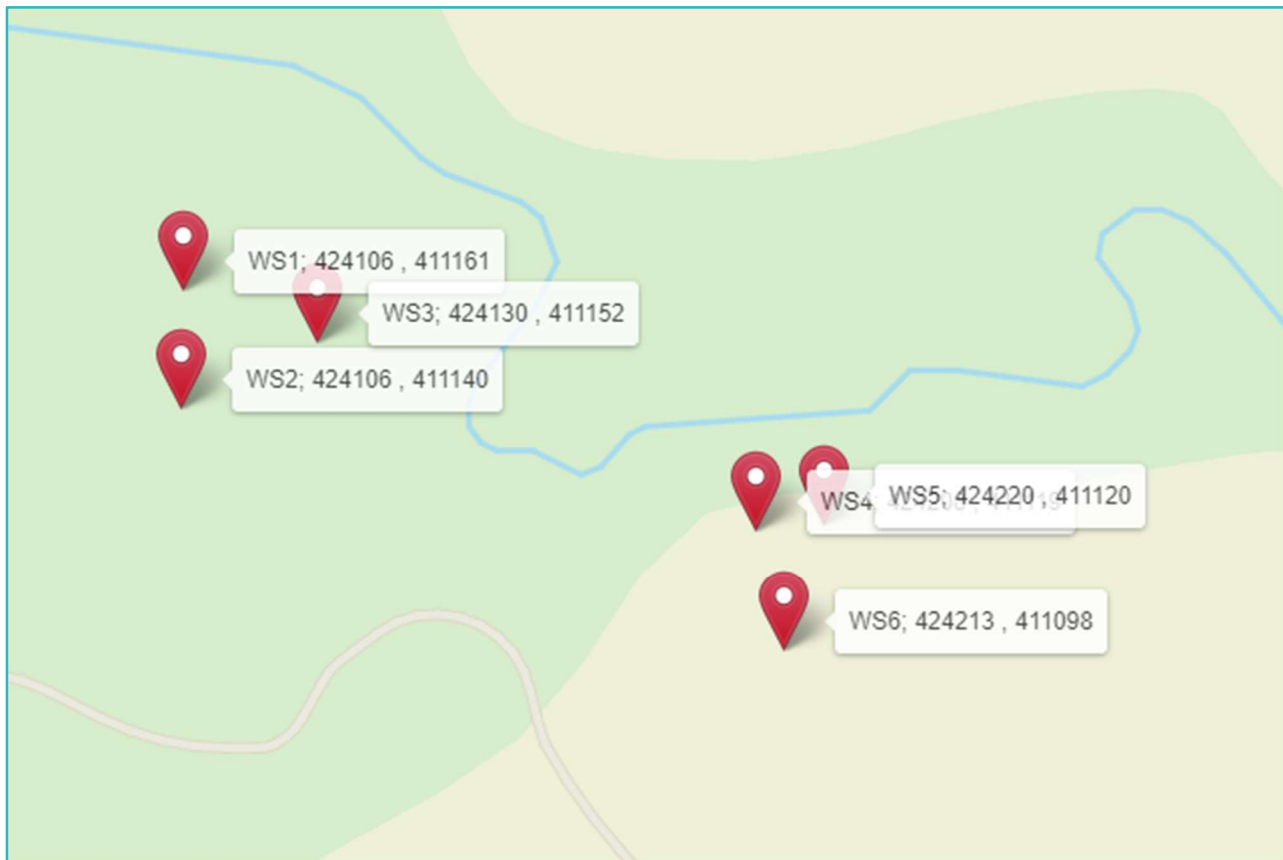
**Figure 4.1: Borehole locations**

Six windowless sample exploratory boreholes (WS1-6) were undertaken to understand the below ground stratigraphy on site. The locations are shown on **Figure 4.1**. WS1-3 covered the area around above ground pipe 2 and WS4-WS6 around above ground pipe 1. Made ground was encountered across WS2 and WS4-WS6 ranging from 0.40m up to a depth of 1.80m which overlaid grey silty clays. In WS1 and WS3 dark brown sandy clay approximately 0.15m deep overlaid brownish dark orange clay with some gravelly sand inclusions. Where made ground survives on site, presumably from when the current sewer was laid, archaeological deposits will have been removed.

- Borehole logs at both areas of proposed excavation indicate a significant depth of made ground and disturbance. Excavations for the sewer relay involve replacing the existing buried combined sewer where archaeological remains would have already been removed. No further archaeological work is recommended during these excavations due to previous disturbance.

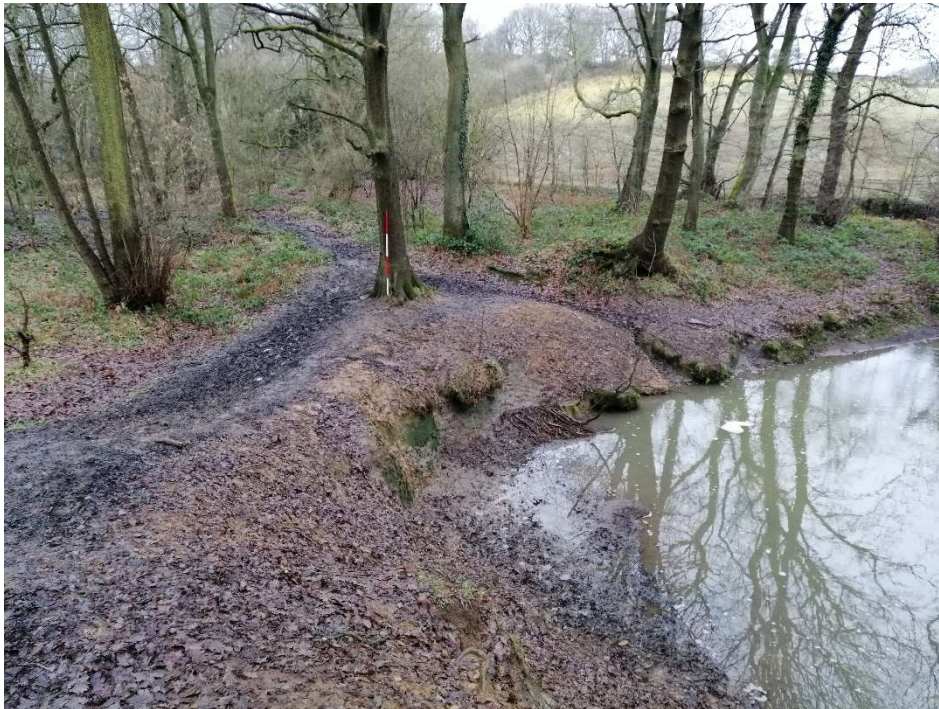
**Photo A2.1: General view of Park Gate Dike and Emley Park Boundary  
HER Ref. 4607. Facing North-west**

During the site walkover, the boundary was traced as a well-defined narrow footpath following the course of Park Gate Dike measuring c. 1.20m wide (see Photo A2.1 and Appendix B.2). The footpath was much less well-defined between manhole SE 241111101 and above ground pipe 1 suggesting a degree of disturbance when the sewer was initially constructed. Equally there was no trace of the boundary beyond manhole 1102 suggesting the known route from historic maps and the previous field survey in 1985 which show the boundary crossing Park Gate Dike and continuing north-eastwards are accurate (see **Photo A2.2**).

- Emley Park medieval boundary survives as a well-defined footpath through Blacker Woods. The existing below ground sewer between above ground pipe 1 and manhole SE241111101 lie to the south of the boundary and therefore works will not impact the feature. It is recommended during construction any construction vehicles be kept off and away from the footpath between manhole SE241111101 and Park Gate Dike. This will allow the boundary to be preserved in its current state.

- The photographs taken during the site walkover should be made available to the West Yorkshire HER to form part of the record for Emley Park medieval boundary (Ref: PRN 4607).

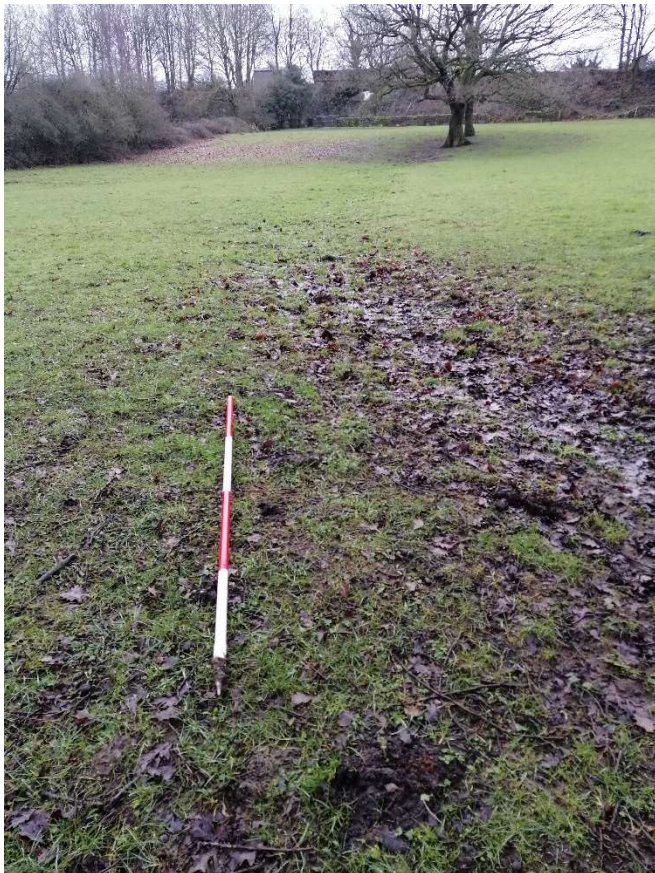
**Photo A2.3: Possible shallow dyke in field south of temporary working area. Facing South.**

The first potential previously unknown heritage asset was a shallow linear running on an approximate north to south alignment in the field immediately south of the proposed working area (see **Photo A2.3**). The feature was identified running between two trees as a very shallow depression. It was approximately 1.00m wide and could not be traced beyond the most northern tree. The first edition Ordnance depicts the features as a former field boundary or shallow dike (highlighted as green on **Figure 4.2**) running between the later known position of the Kirklees Light Railway and Park Gate Dike. The slightly curving nature of the feature, its route heading towards Park Gate Dike and the surviving shallow nature would suggest a shallow dyke.

- The access route will utilise existing tracks as far as possible. Where construction machinery needs to be brought through the field to the south of proposed works area. The route of the shallow dyke should be avoided to preserve the feature in-situ. The dyke does not appear to continue beyond the limit of the tree closest to the working area and therefore any works beyond this point would not impact on the feature.

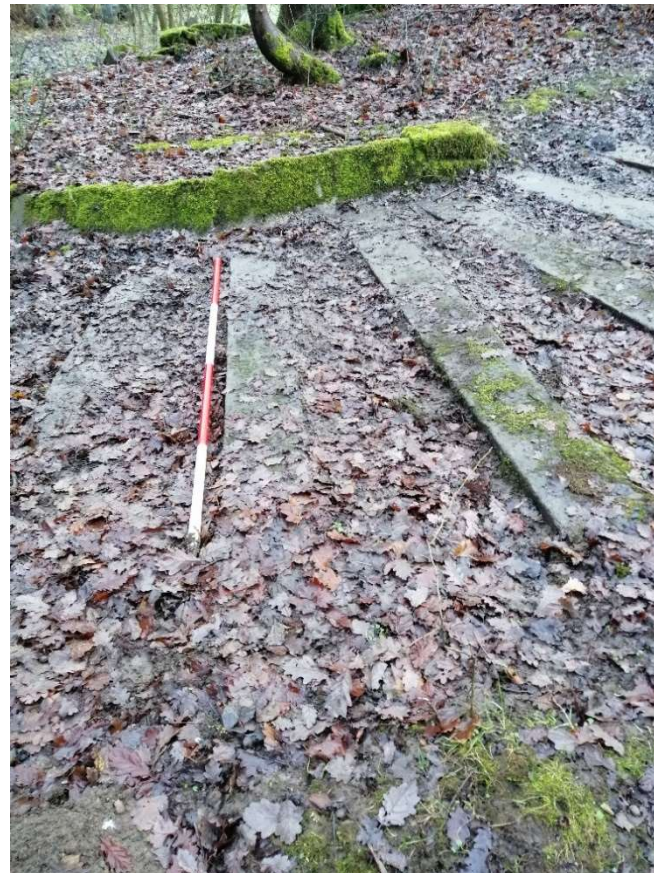
**Photo A2.4: Concrete steps near above ground pipe 2. Facing East.**

The second, much later feature was a set of concrete steps close to above ground pipe 2 at NGR SE 424094 411139 (see **Photo A2.4**). They comprised a concrete curved kerbstone and six lengths of concrete slabs approximately 2.5m long. These steps were positioned on sloping ground close to the position of above ground pipe 2 and were likely inserted when the pipe was constructed to easily get down to the lower boggy ground.

- The concrete steps close to the position of above ground pipe 2, although relatively modern in date should be preserved in-situ. Construction vehicles should be kept away from the feature to prevent any damage.
