AMP7 Bockhampton Rising Main

Historic Environment Desk Based Assessment

October 2022

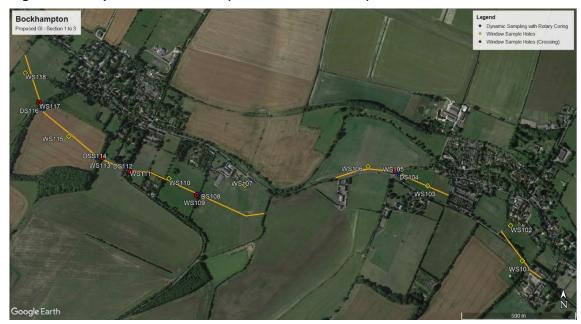
Figure 1.1: Proposed GI locations (Sections one to three)

The locations of the boreholes are represented below in Figure 1.1 and Figure 1.2.

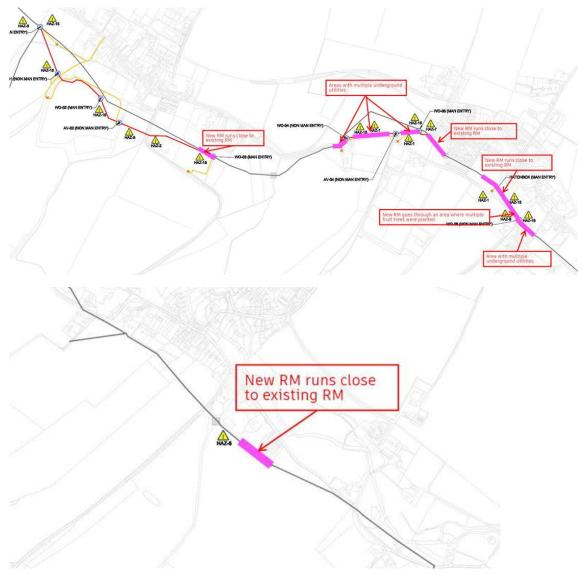
Figure 1.3: Areas along the pipeline with previous disturbance (highlighted in pink)

The pink highlighted lines in Figure 1.3, below, indicate where there have been previous disturbance along the pipeline:

- The new rising main will be located in parts within *c* 3 to 5m to the existing rising main. The trench for the existing rising main was *c* 5m wide, so the new trenching will likely be located within the footprint of the original trenching in these areas (the design team will install the new rising main as close to the existing rising main as possible at these locations); or
- Where there are multiple underground utilities in the area (field or highway) and where the landowner has planted multiple fruit trees in the area (which required trenching). In this location the new trenching will be located within the footprint of the original trenching.

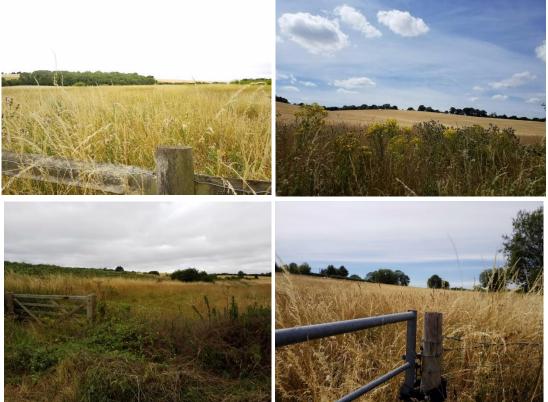
Photo 4.7: Site Visit Crop Conditions

The fields were accessed by public footpaths. For many of the fields, the crop coverage and size of weeds were too high to access and as a result, possible archaeological features relating to the historical landscape could not be determined or identified.

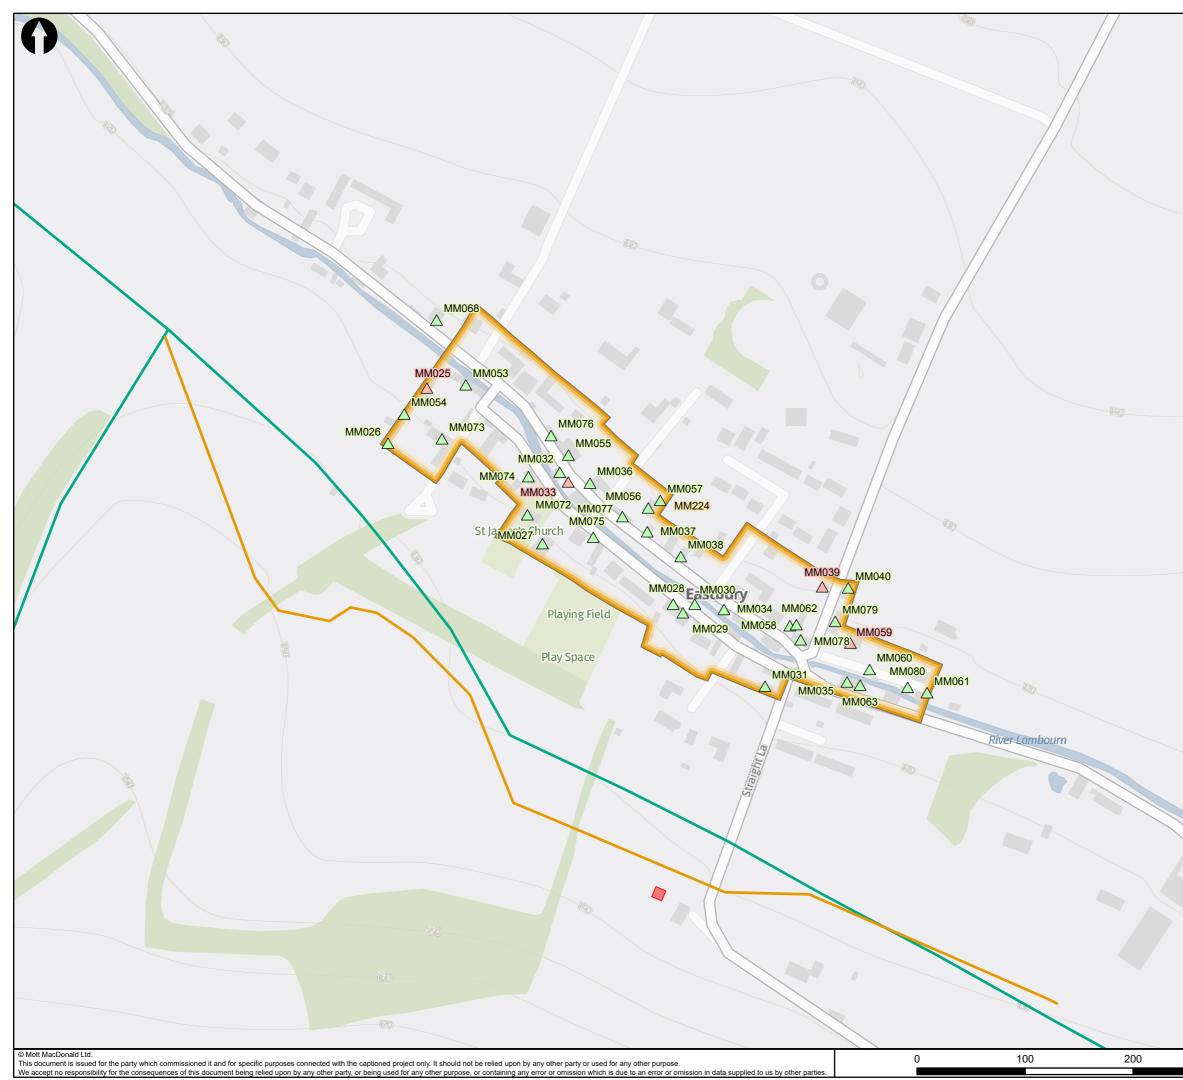
Drawing Title: Designated Heritage Assets -											
	Sheet										
	Sneet	1013									
	Scale:			Sheet Si	ze:		Status:				
		1:3,500			3		S1				
300	Drawing Nu						Revision:				
300 Metres		JE-BOCKP1	ZZ-10)1-DR-	CE-00	060	P03				
	© Thames Wa	ter Utilities Ltd 2017.

Mott Mac							
	M			3-10 Syd Croydon,							
		Μ		Jnited Ki							
	MOTT			T +44 (0	,	4 2000					
	MACDO	DNALD		W mottm	ac.com						
	NOT FOR CONSTRUCTION										
	Current Revision Information										
	Project Works Data: Mott MacDonald, 2022 © Historic England 2022. The Historic England GIS Data contained in this material										
	was obtained on 04/01/2022. The most publicly available up to date Historic England GIS Data can be obtained from HistoricEngland.org.uk.										
	GB Topographic: Contains OS data © Crown Copyright and database right 2022 Contains data from OS Zoomstack GB Background: Contains OS data © Crown Copyright and database right 2022										
	k	., .			•						
	GB_Hillshade: Contains OS data © Crown Copyright and database right 2019										
	Legend										
150	- New rising main replacement										
	— E	Existing rising main									
	Compound										
	C Project works 1km buffer

△ Grade I listed building										
\triangle Grade II listed building											
	_										
	△ Grade II* listed building										
		onservatio	in an	04							
	Location Map										
		East	tbury		Garst	ton					
			1	East	Garsi	LOIT
