# **Brampton Bryan**

Archaeological Desk Based Assessment

July 2022

The project involves the construction of a new sewage treatment works, to replace the existing septic tank that currently serves the village. The site will occupy a footprint of 1254m<sup>2</sup> and new structures will include:

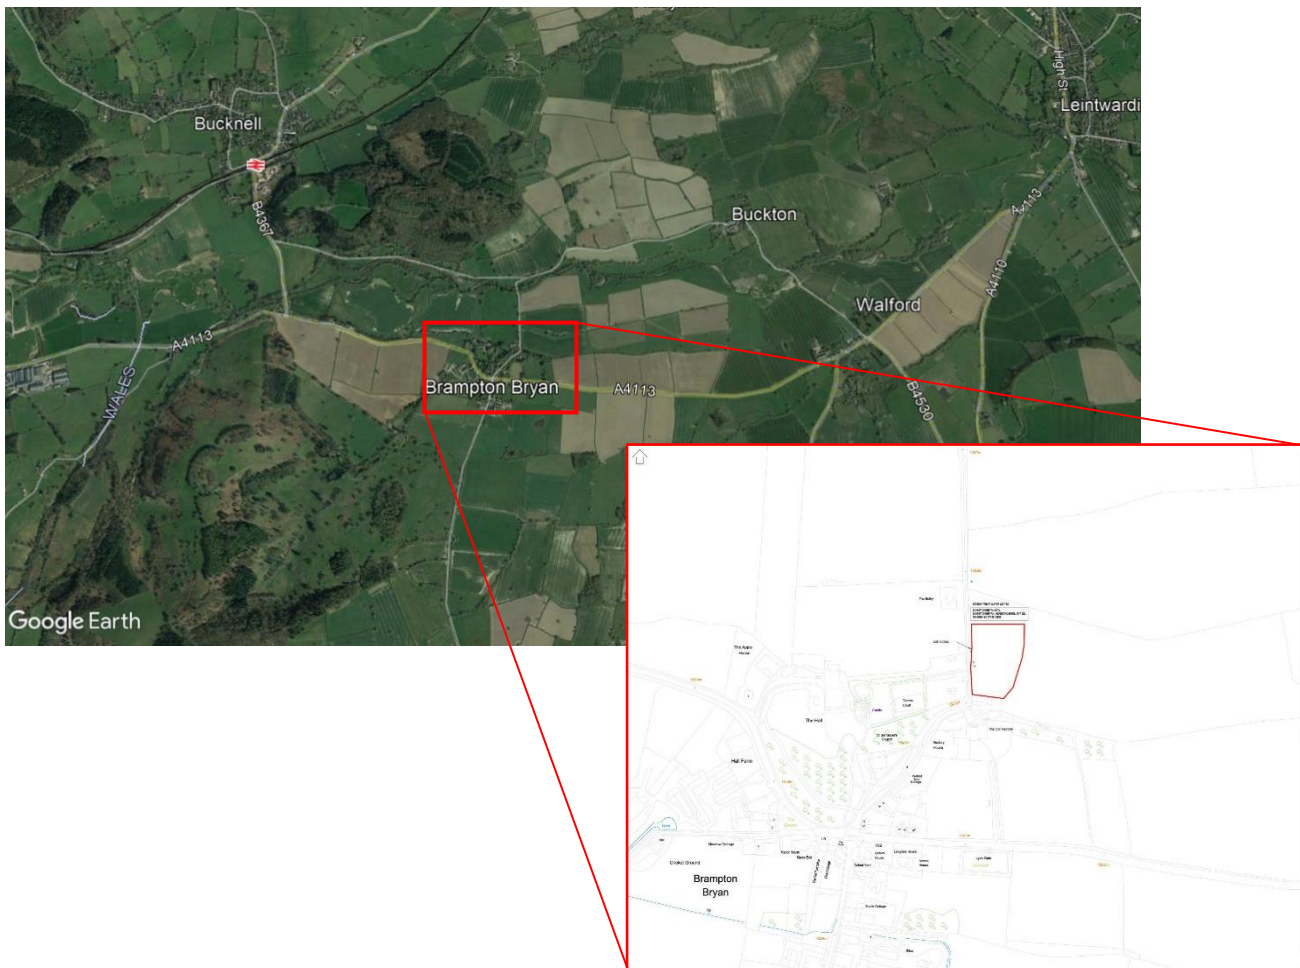
**Figure 1.1: Site location and red line boundary**

Brampton Bryan STW (hereby referred to as 'the site') is located approximately 2km east of the Wales/ England border in Herefordshire, SY7 0DL (NGR reference SO 37172 72660), as shown in Figure 1.1.

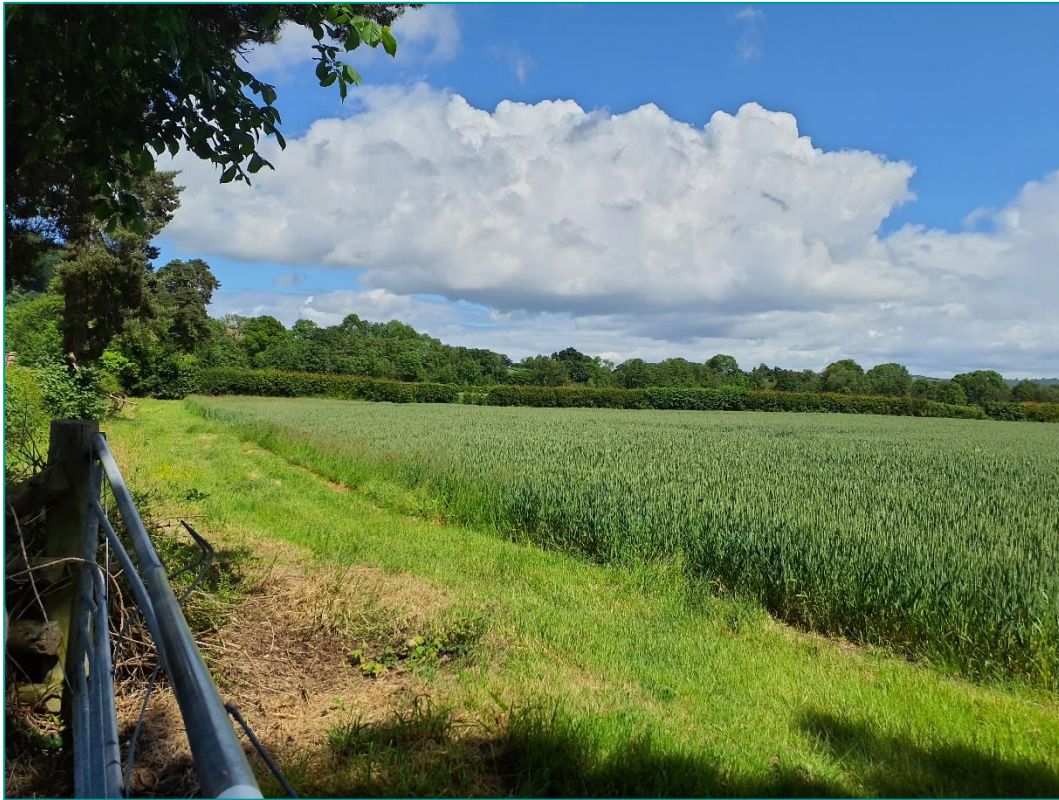
**Figure 4.1: The site from the western boundary, facing north-east**

Although access into the site was not possible and could therefore not be assessed in detail, the area was visible from the access point to the field. The site was noted to be used as arable land and topographically flat. There was no evidence of substantial ground disturbance, only superficial disturbance that may have been caused by ploughing.

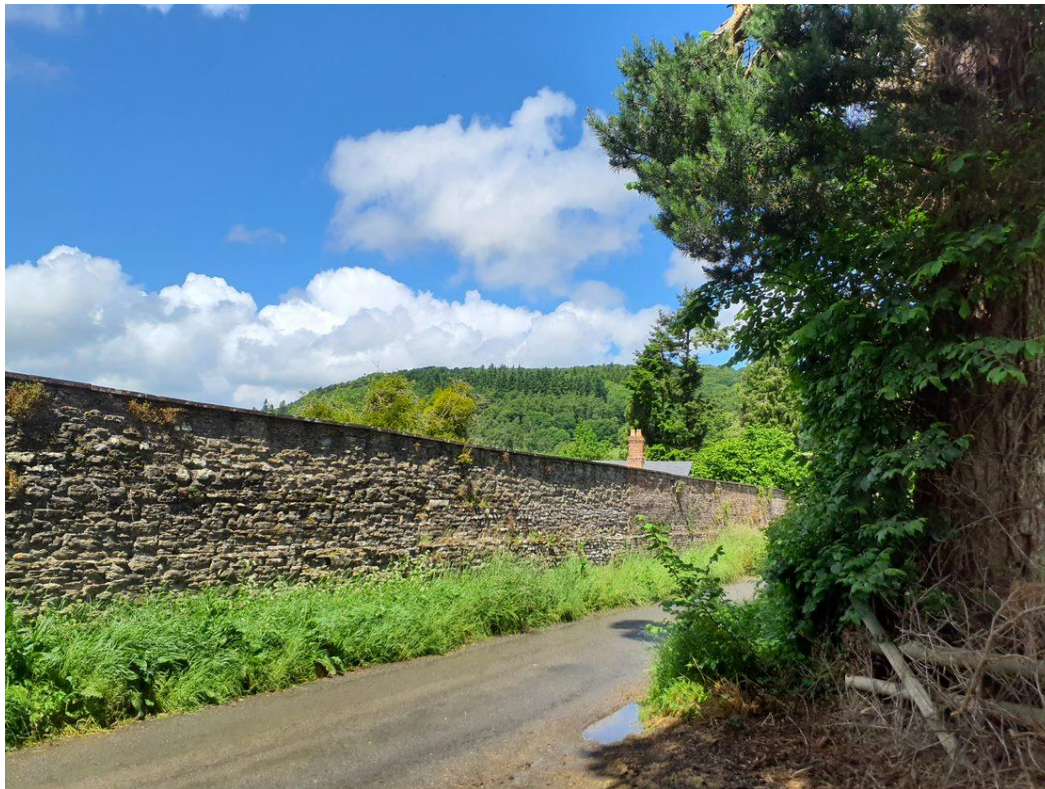
**Figure 4.3: View of Coxall Knoll (MM04) from the entrance to the site**

Most heritage assets were noted to be well screened from the site by other buildings, vegetation and topography. The hill on which Coxall Knoll (MM04) is located is visible from the site, but the hill was noted to be shrouded in trees which would limit views to and from the scheduled monument. It was observed that while there was no intervisibility between the site and the castle (MM01) at ground level due to tall walls and hedgerows, the site may be visible from the castle at higher levels.

Given its raised elevation, the site has the potential to be intervisible with the multiple enclosure hillfort on Coxall Knoll (MM04). However, during the site walkover, it was noted that the hill of Coxall Knoll is shrouded in trees and so the STW would not be visible from the monument itself, thus not altering how the monument is appreciated and experienced.

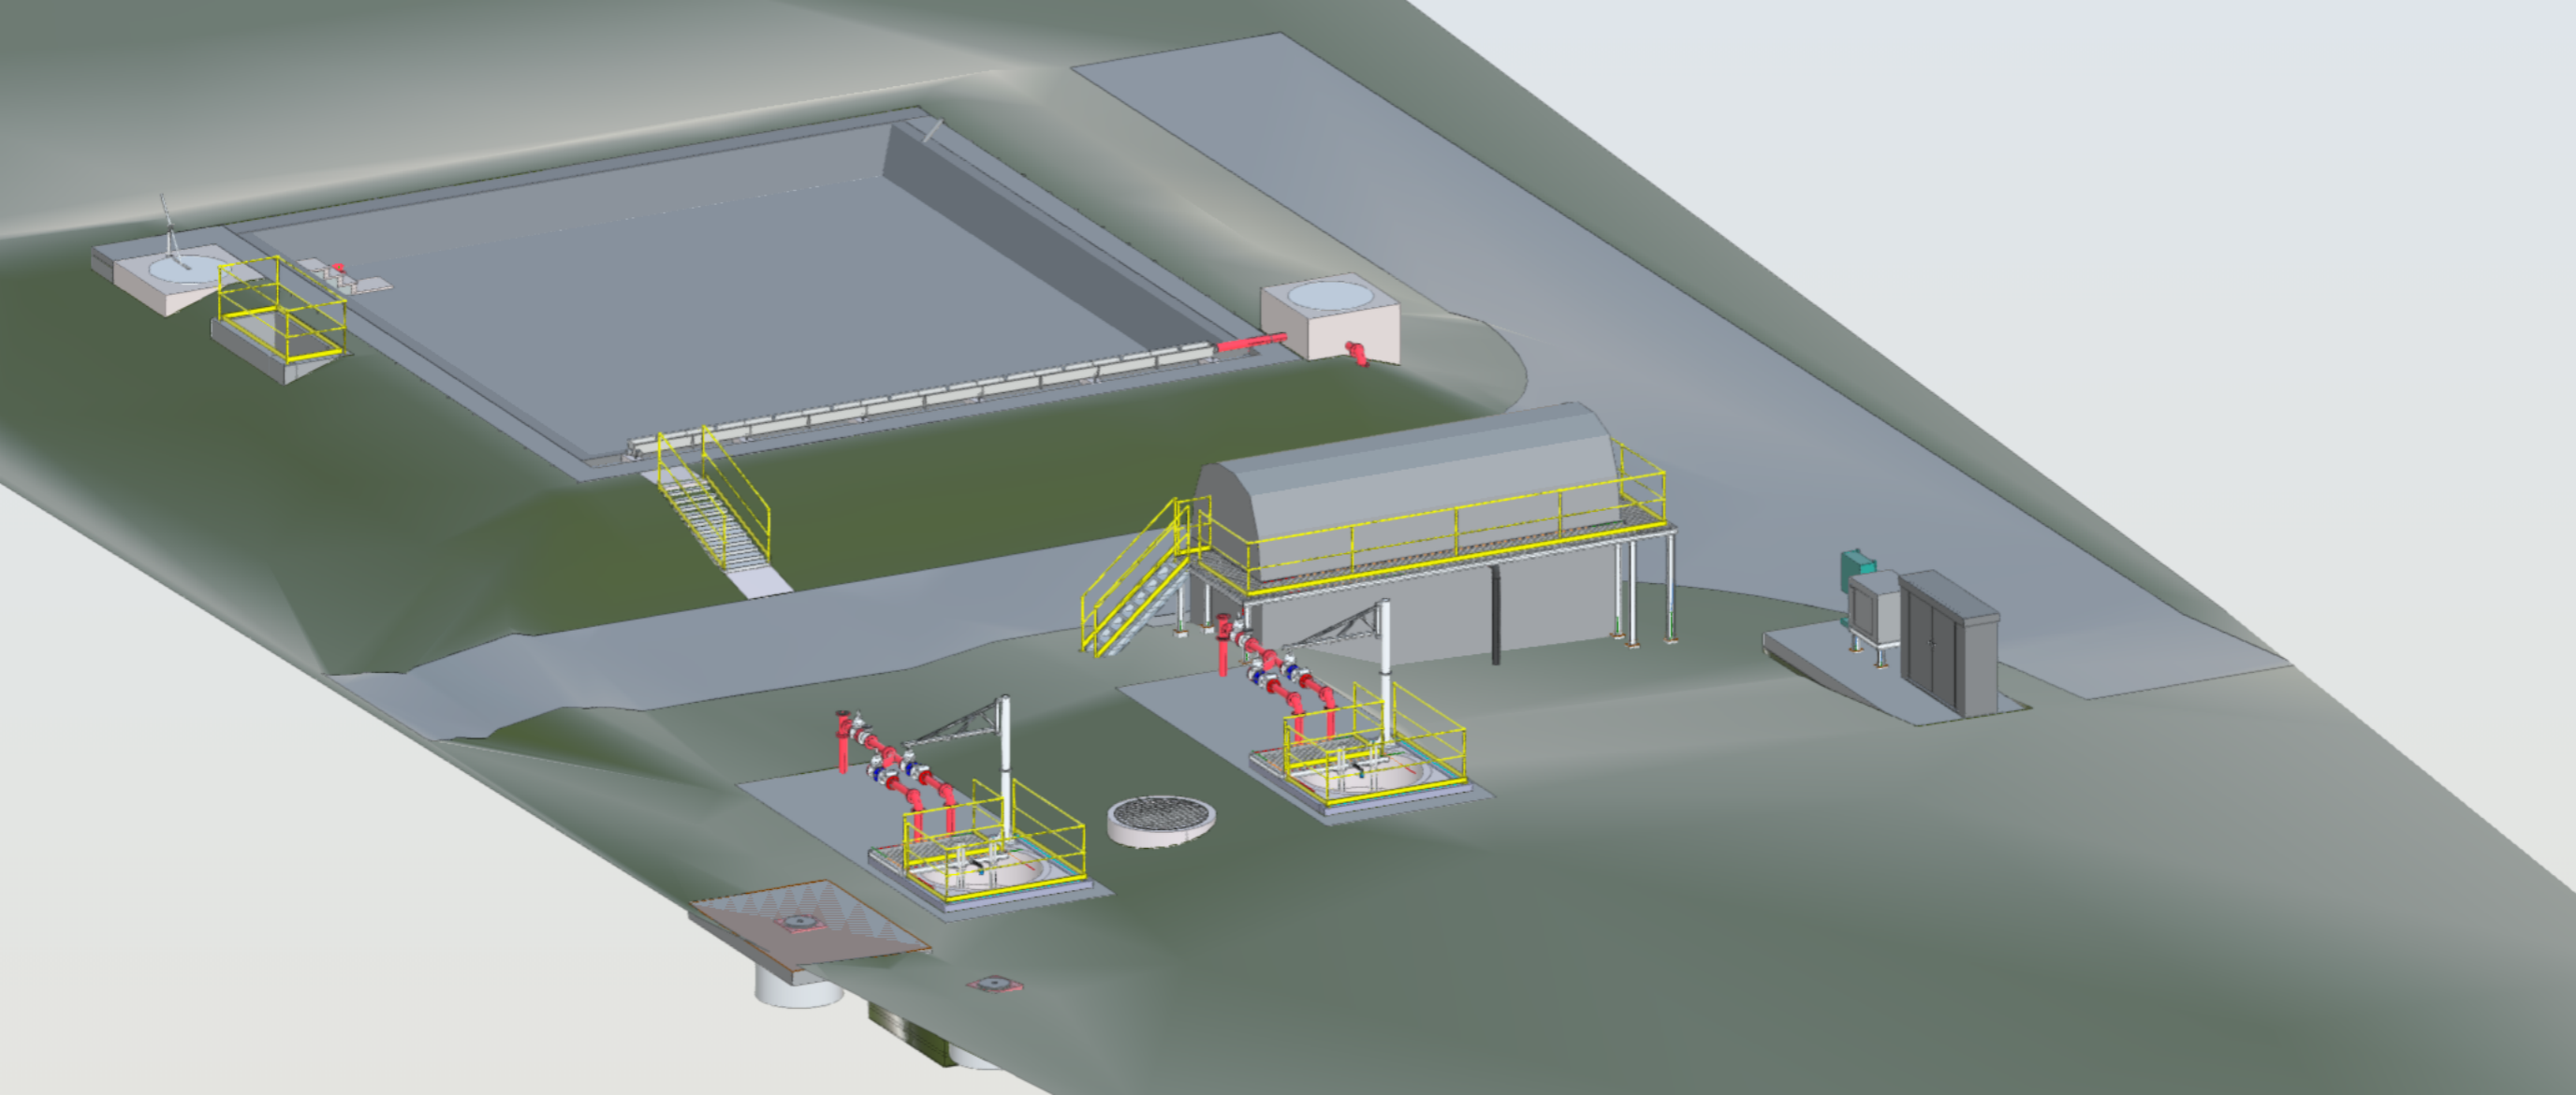
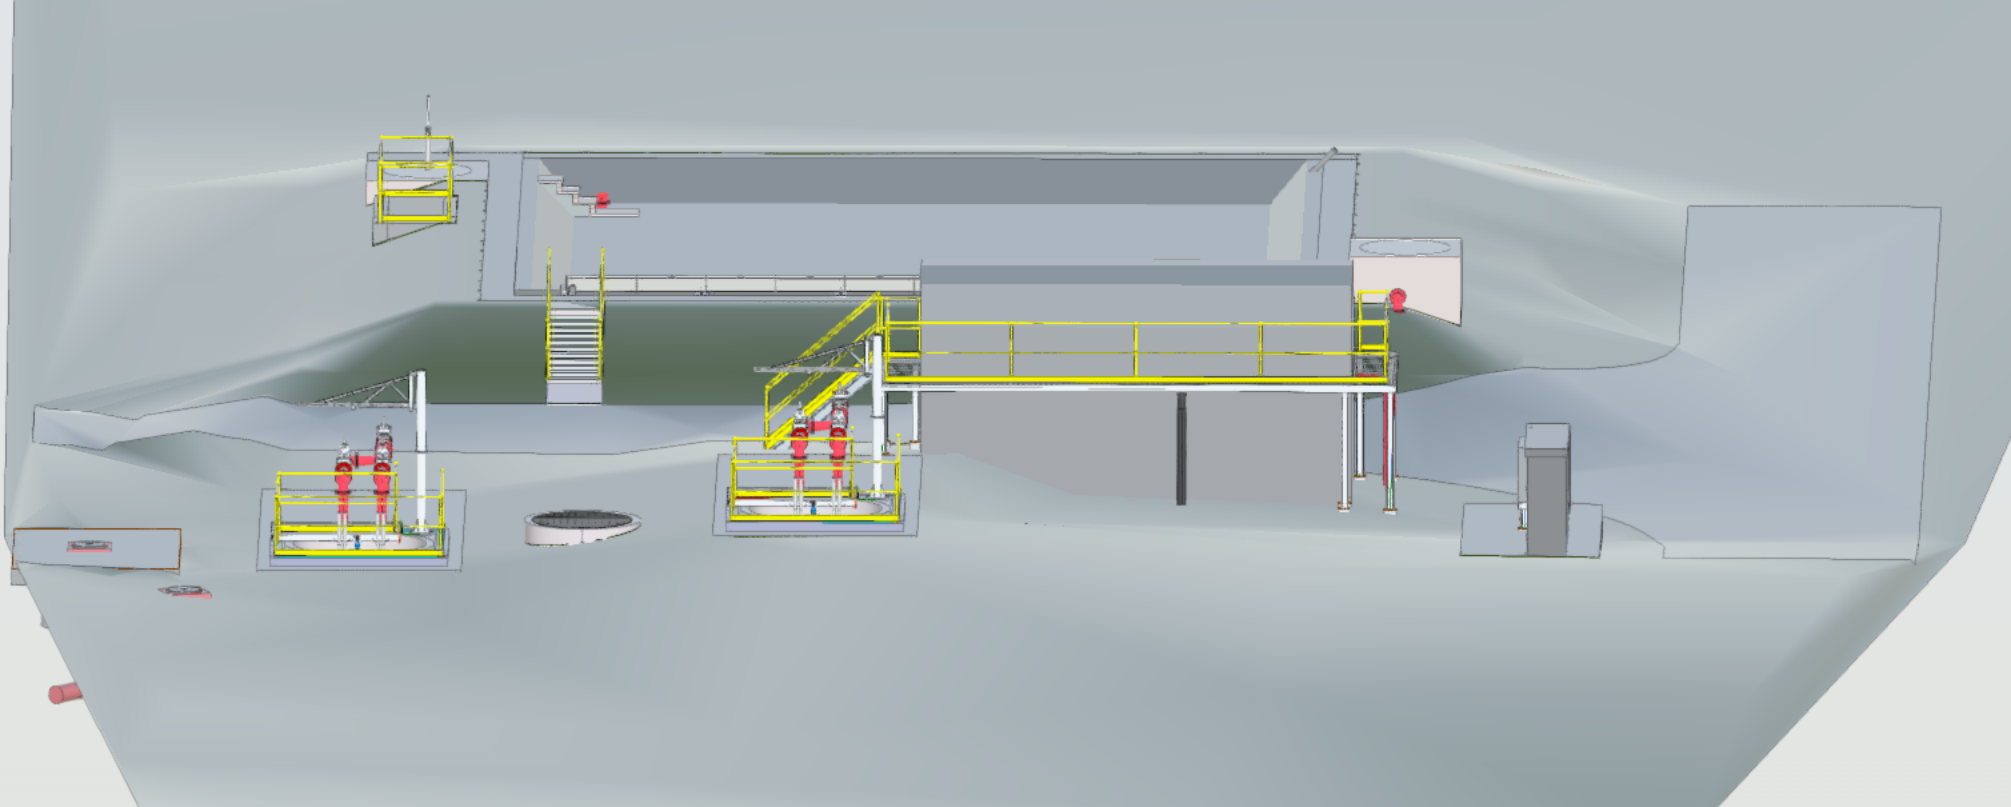
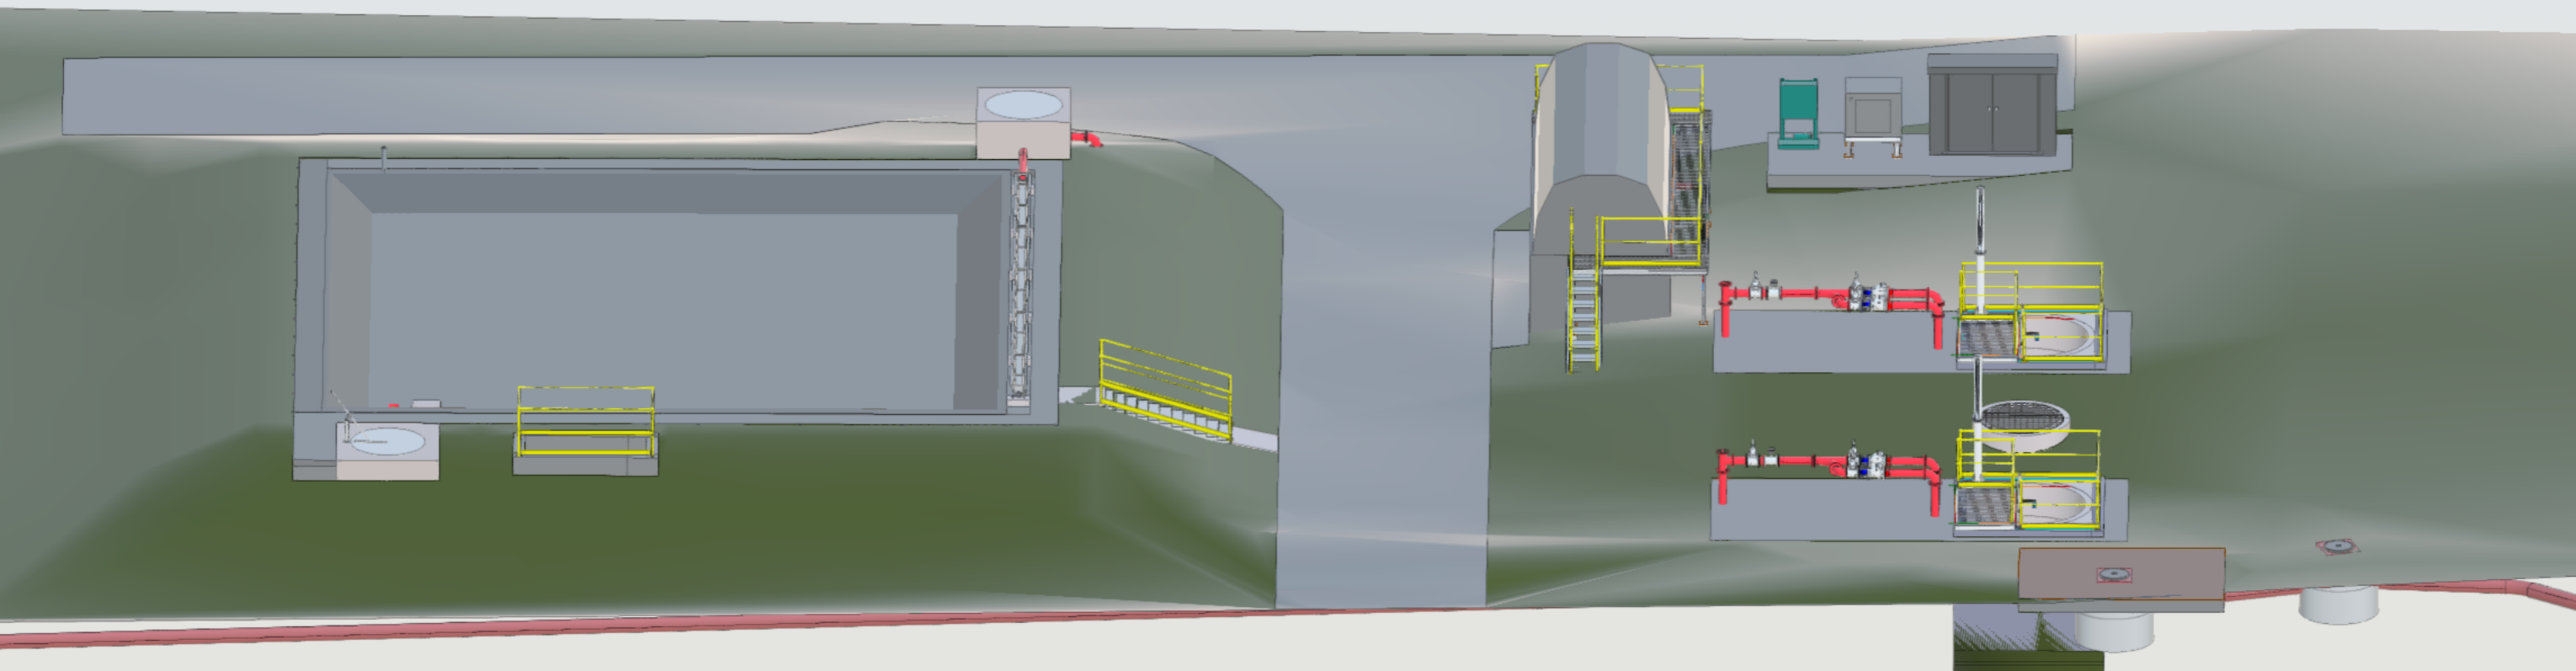
## C. Plan of proposed works

- A new RBC (Rotating Biological Contactor)
- A new inlet chamber with copasacs
- A new bypass to reedbed distribution chamber
- A new horizontal flow reedbed (150m<sup>2</sup> in size)
- A new FFT (Full Flow to Treatment) pumping station with high level overflow to storm pumping station
- A new storm pumping station
- A new FE (Final Effluent) sampling chamber
- A new rising mains to downstream chamber
- A new MCC (Motor Control Centre) & MCC kiosk building
- A new back-up generator for pumping stations
- A new access road
- A new site fencing and gate

3D visualisations of the scheme can be seen in Appendix C.
