Stockton Wood Resurfacing

Archaeological Watching Brief

October 2011
Highways Agency

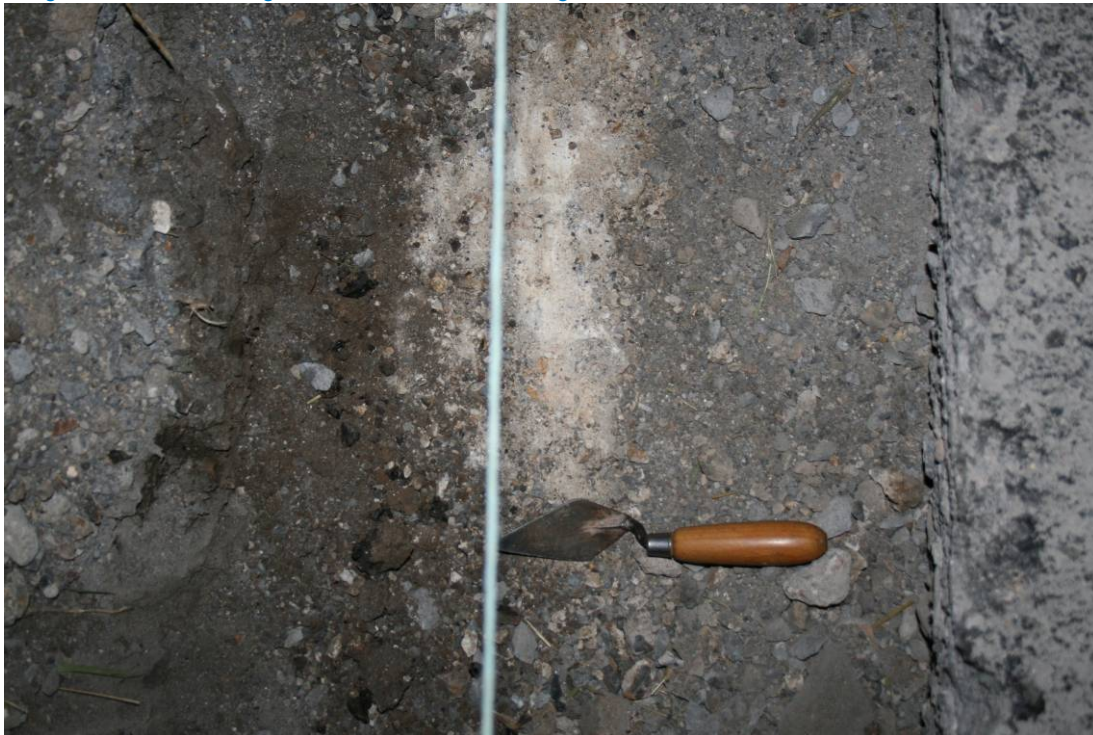
Image04, View of kerbing trench from above showing sub surface concrete and road material.

No archaeological features or deposits were encountered. The trench was excavated through the previous road surface and made ground to a depth of 300mm. A concrete layer associated with the old kerbing was present at the base of the trench (Image 04). The made ground comprised loose gravely, clayey loam with inclusions of modern material (Image 05). The trench did not extend deeper than the made ground deposit. This was consistent throughout the length of the trench for the kerbing works.
