Leuchars Station, Fife

Ground Investigation Monitoring, Data Structure Report

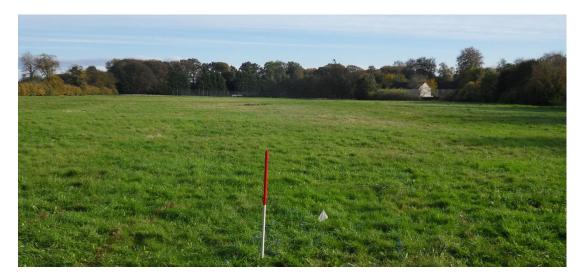
The northern of the two areas (Photo 1.1) is referred to as Area 1, or the Sports Pitch and currently comprises flat, open pasture (centred on NO 46031 21240). Area 1 is not currently exploited for agriculture and is a popular spot with dog walkers. Trial pits 4-9 were excavated in Area 1, with 1-3 excavated on the access route along Adam Close to the north west.

Photo 1.1: View south east across Area A (Photograph 014)

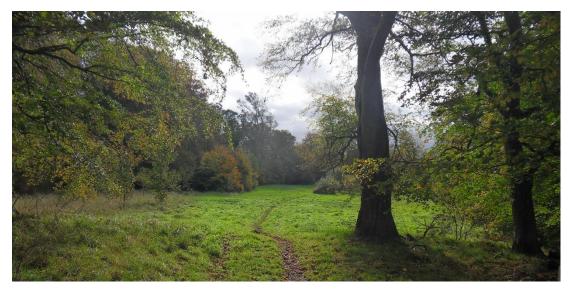
Trial pits 10-14 were excavated in Area 2 (centred on NO 46094 21019), to the south of Area 1 and geographically separated from this by a modern sports pitch, the houses on Playfair Drive and a line of mature policy trees associated with the Earlshall GDL (Photo 1.2). Area 2 is also referred to as Technical Area – East.

Photo 1.2: Looking south into (Photograph 040)

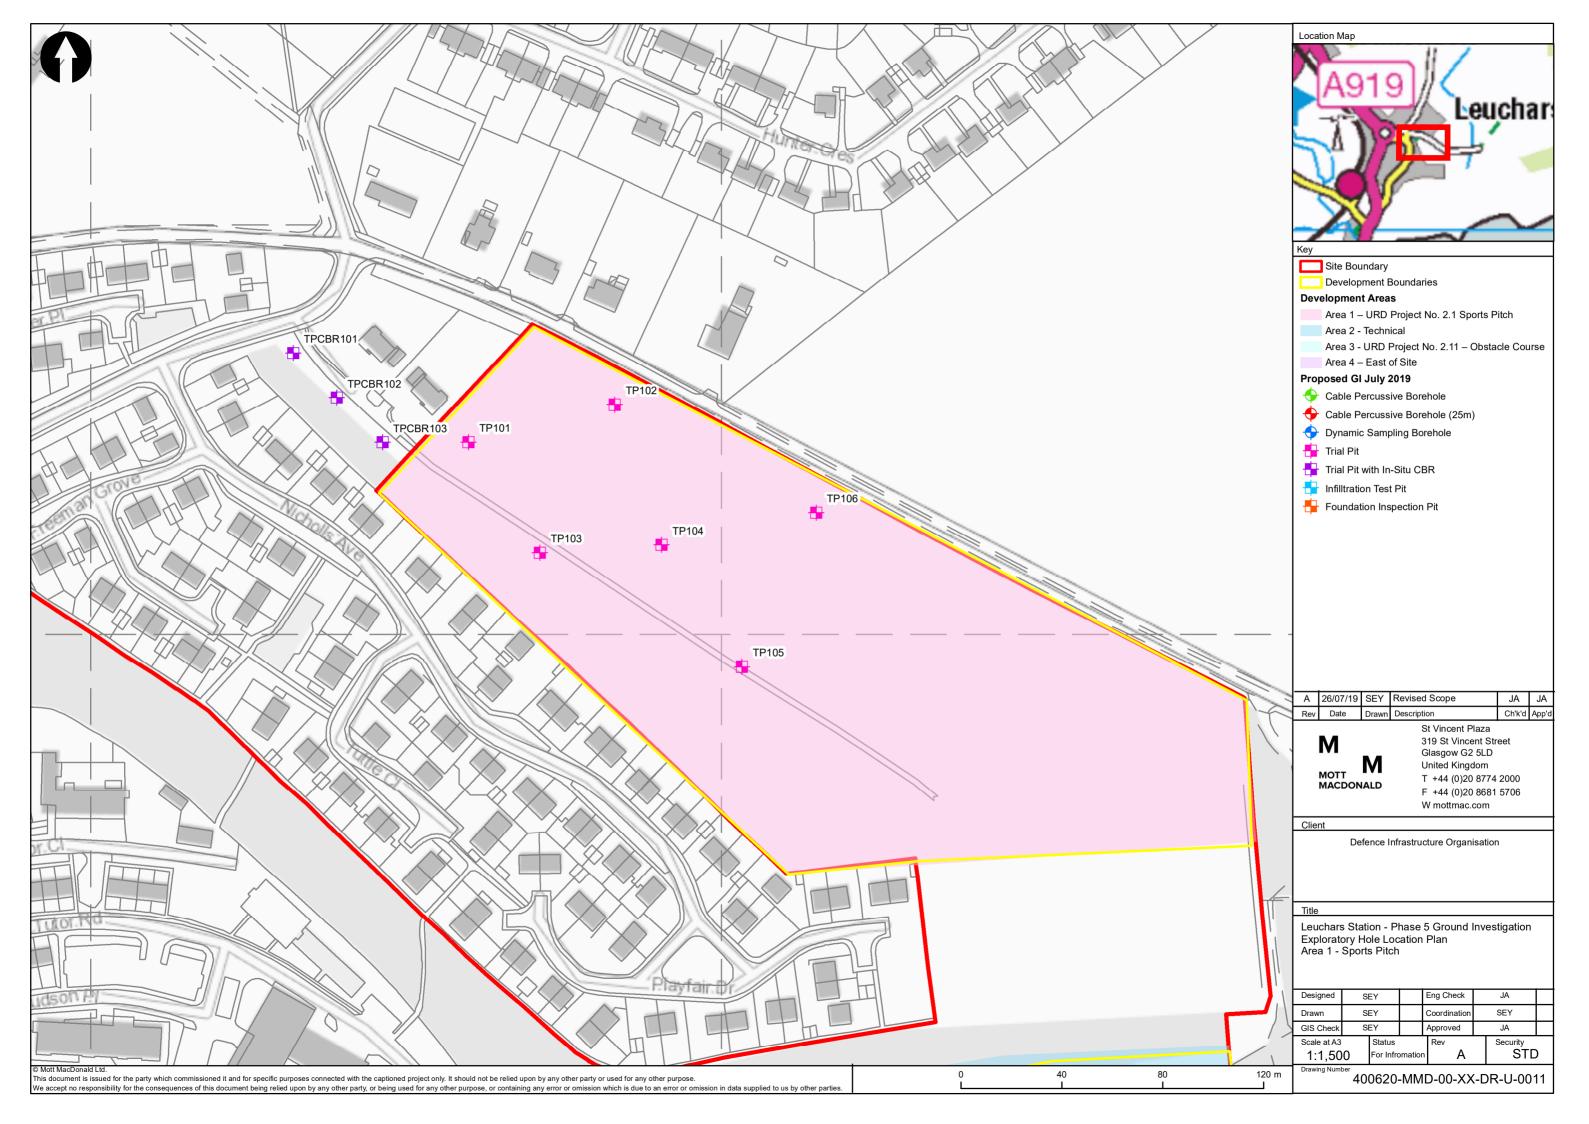
The ground investigation works subject to archaeological monitoring are clustered in two clearly defined areas immediately north of Leuchars Station (Figure D.1 and Figure D.2). Both areas are located within the Earlshall GDL.
