Concrete Barn, Foxton: Statement of Significance

Foxton Travel Hub

May 2021

Document reference: 418368-MMD-ENV-XX-RP-EN-0009

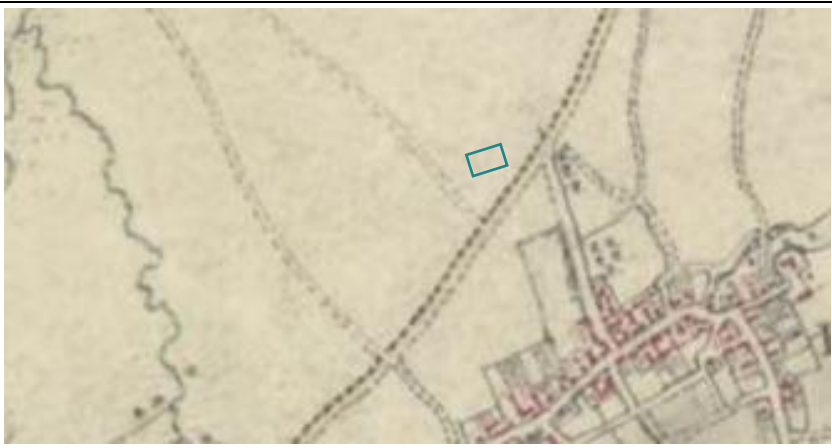
| Name | Dates | Image | Comments |
|--|---|---|---|
| 'Cambridge 23' Ordnance Survey by William Hyett | Depicted date 1808 | | This map depicts Foxton village and the surrounding area prior to the construction of the railway line and the Concrete Barn. The map shows the surrounding countryside as unenclosed and features a number of paths connecting Foxton to the surrounding area. The Royston Road which runs north-east to south-west is depicted as a main road. Foxton village is shown as clustered on the high street with some properties having substantial gardens. |

Study of historic mapping focused on the north-west of Foxton illustrates little change in the area, with the exception of the construction of the railway during the mid-nineteenth century. The below map regression has been used to inform understanding of the development of the area surrounding the barn. A blue rectangle illustrates the approximate location of the Concrete Barn prior to its construction, in order to focus the analysis.

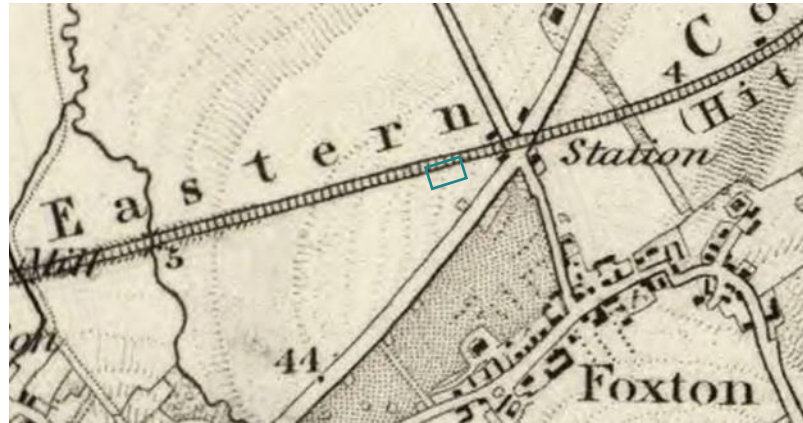
51. Cambridge.
Creator
Great Britain. Board
of Ordnance
Publisher: Thomas
Colby (1784-1852)

bisected by the railway. The field is shown as freehold belonging to William Hurrell Esq.

The map shows some development to the west of Foxton village and the construction of the railway line, then known as the Eastern Counties Railway, Hitchin and Cambridge Branch. A number of station buildings are evident around the level crossing.

Foxton village appears to be a similar size to as depicted in the 1830 map.

A small unshaded building that is not extant today is depicted to the south of the Concrete Barn.

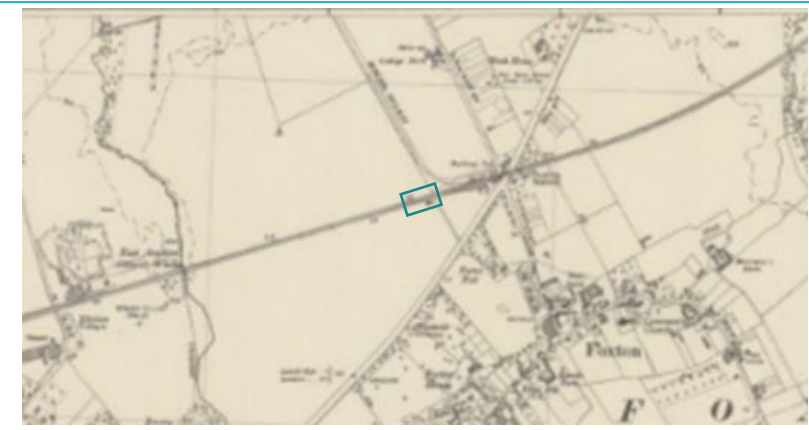
| <p>Sheet 148. Saffron Walden.</p> | <p>Depicted date 1946</p> | | <p>This map shows the expansion of the cement industry in the vicinity of the Concrete Barn. An additional railway branch line has been constructed, giving access from the Barrington Cement Works directly to the mainline just to the east of the Concrete Barn. There is evidence of chalk quarrying to the south-west of the Concrete Barn, associated with the former Ingleside Chalk Works, shown on this map as connected by tramway, labelled 'Mineral Railway' to the East Anglian Cement Works. The land in the immediate vicinity of the Concrete Barn has remained in agricultural use. The small building to the south of the Barn is not shown on this map. The small outshot to the north of the Concrete Barn is not drawn, nor are the railway sidings serving the Barn, likely a simplification (see comments relating to 1980 map, below). The small unshaded building to the south of the Barn is also not present. Within Foxton village, there has been some development between the station and High Street, and in-filling of gaps between buildings in the village centre.</p> |

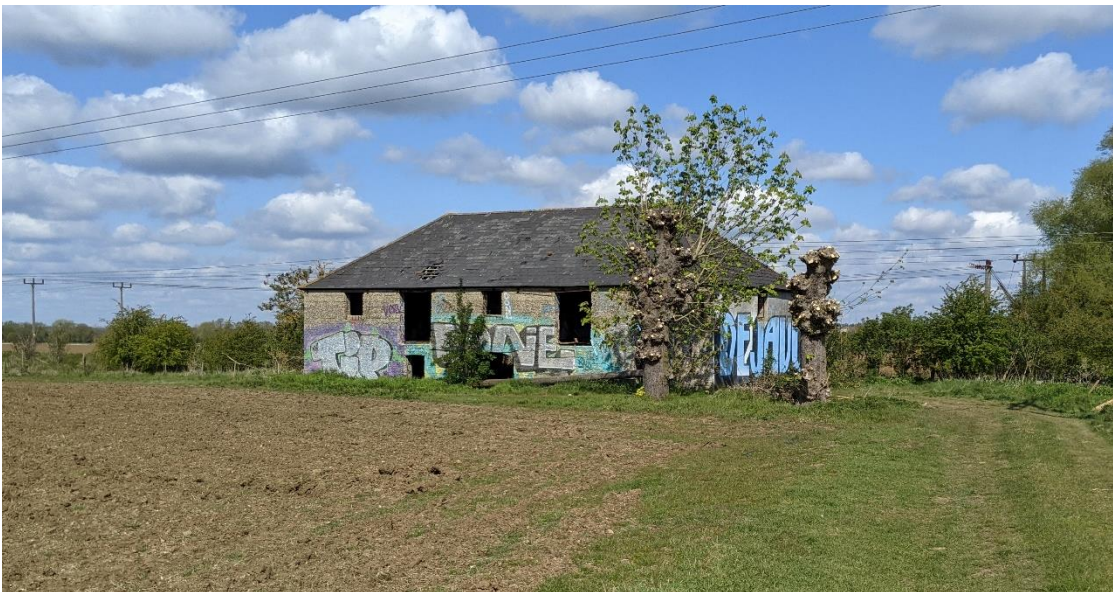
Figure 4.1: Exterior of the Concrete Barn from the south

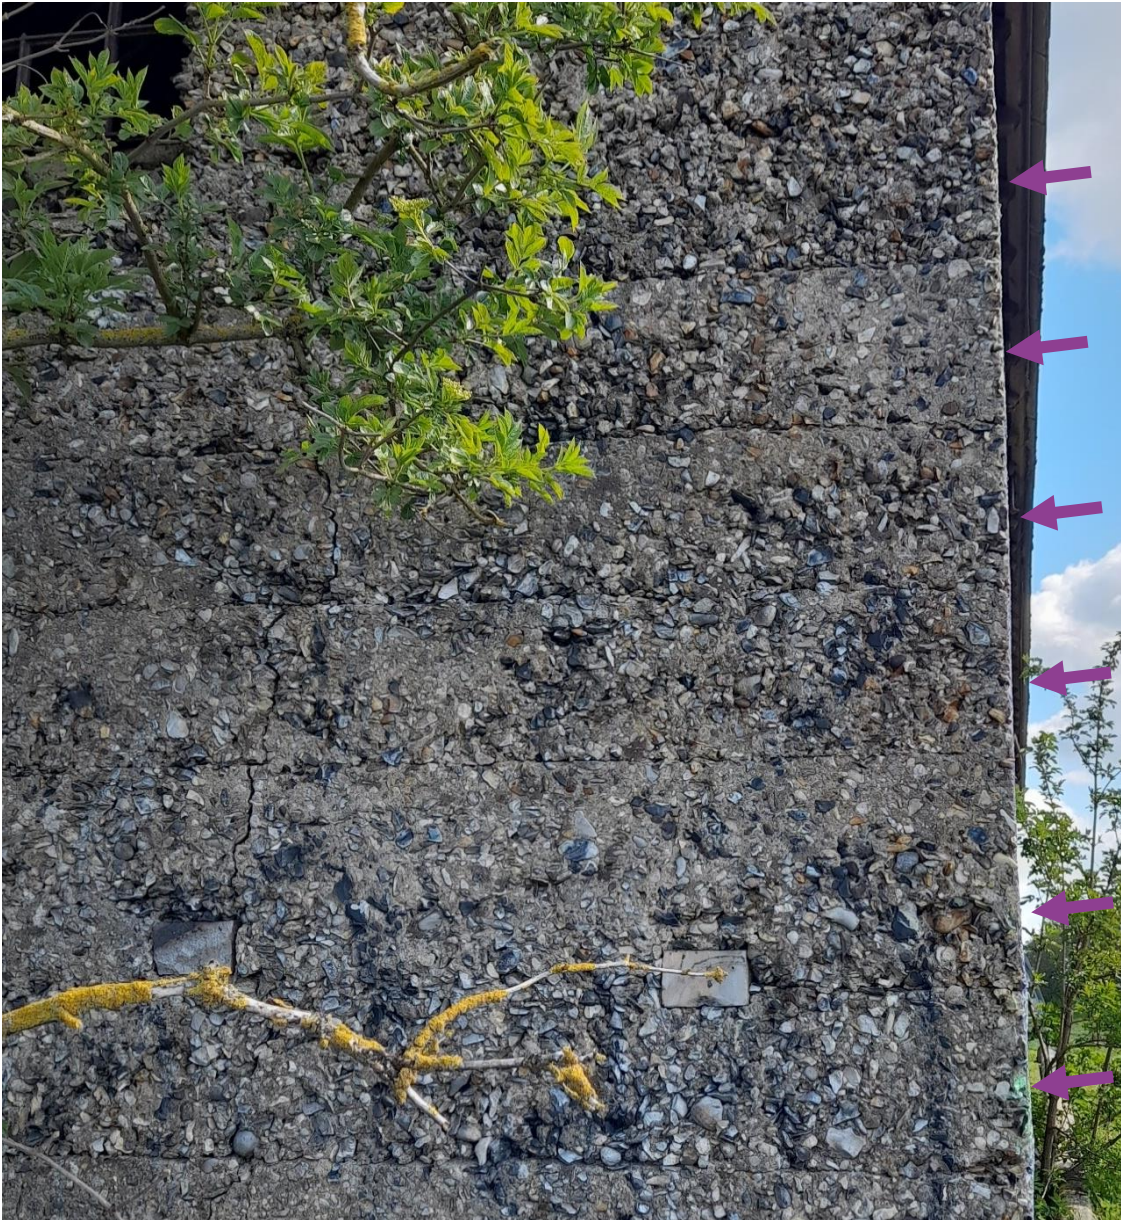
The Concrete Barn was constructed in-situ using timber shuttering, evidence of which is visible on the non-rendered walls of the building. The cement was poured in layers, with each layer requiring time to set prior to pouring the next. Each layer is discernible from the others due to this construction method, creating a striped appearance on the unrendered walls of the building. The spread of aggregate from layer to layer is particularly inconsistent, perhaps reflecting the experimental and pioneering use of this material in the area.

Figure 4.2: Western elevation depicting the uneven composition of the no-fines concrete across the different layers. The purple arrows depict the location of each of the layers.

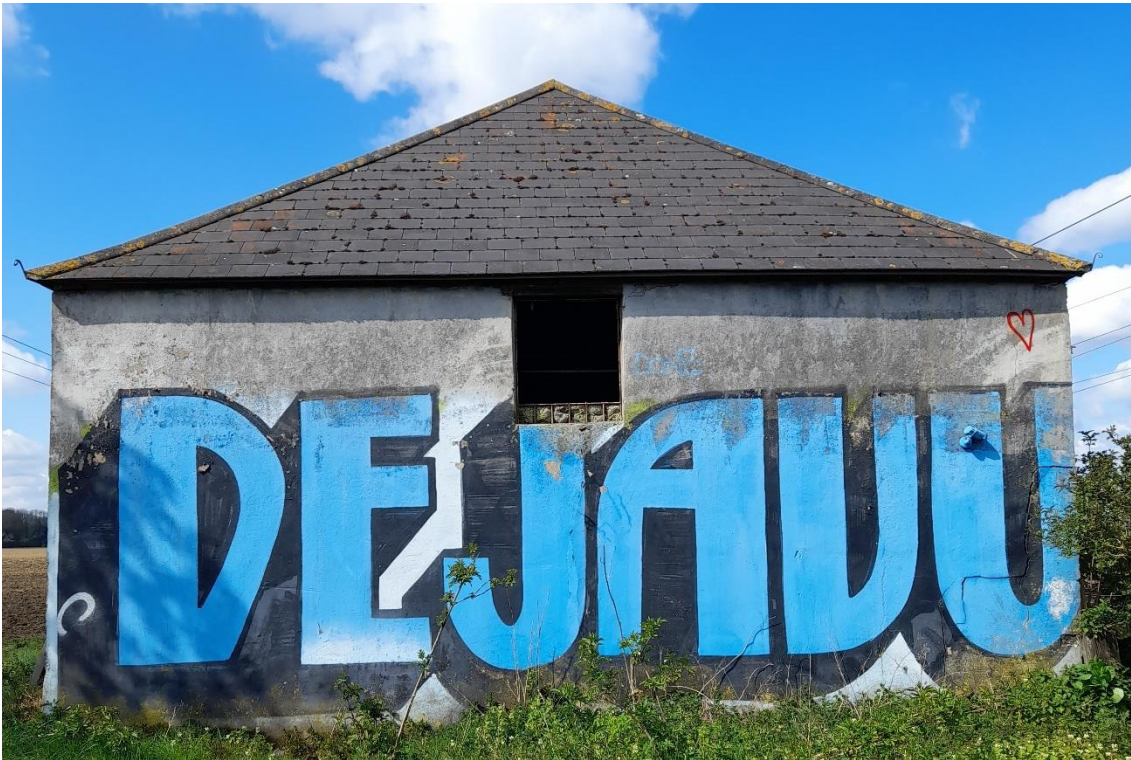
Due to the uneven finish of no-fines concrete, caused by the shuttering process and the composition of the material, buildings constructed in this way were often covered with a cement render. The majority of the internal walls of the concrete barn, including the window reveals, are rendered, possibly to neaten the appearance of the building. Externally, only the eastern elevation of the building is rendered, though it is possible that other areas may have previously been rendered but that it has not been maintained.

Figure 4.3: Eastern elevation of the Concrete Barn

It is unclear why either only one of the elevations was rendered, or only one elevation's render has been preserved. However, the visibility of this elevation from the railway line and the render has made it a popular location for graffiti. The survival and repainting of this 'de javu' graffiti, likely by Graffiti Artists, All Type No Face, is a testament to the visibility of the spot, perhaps explaining its survival.¹⁶

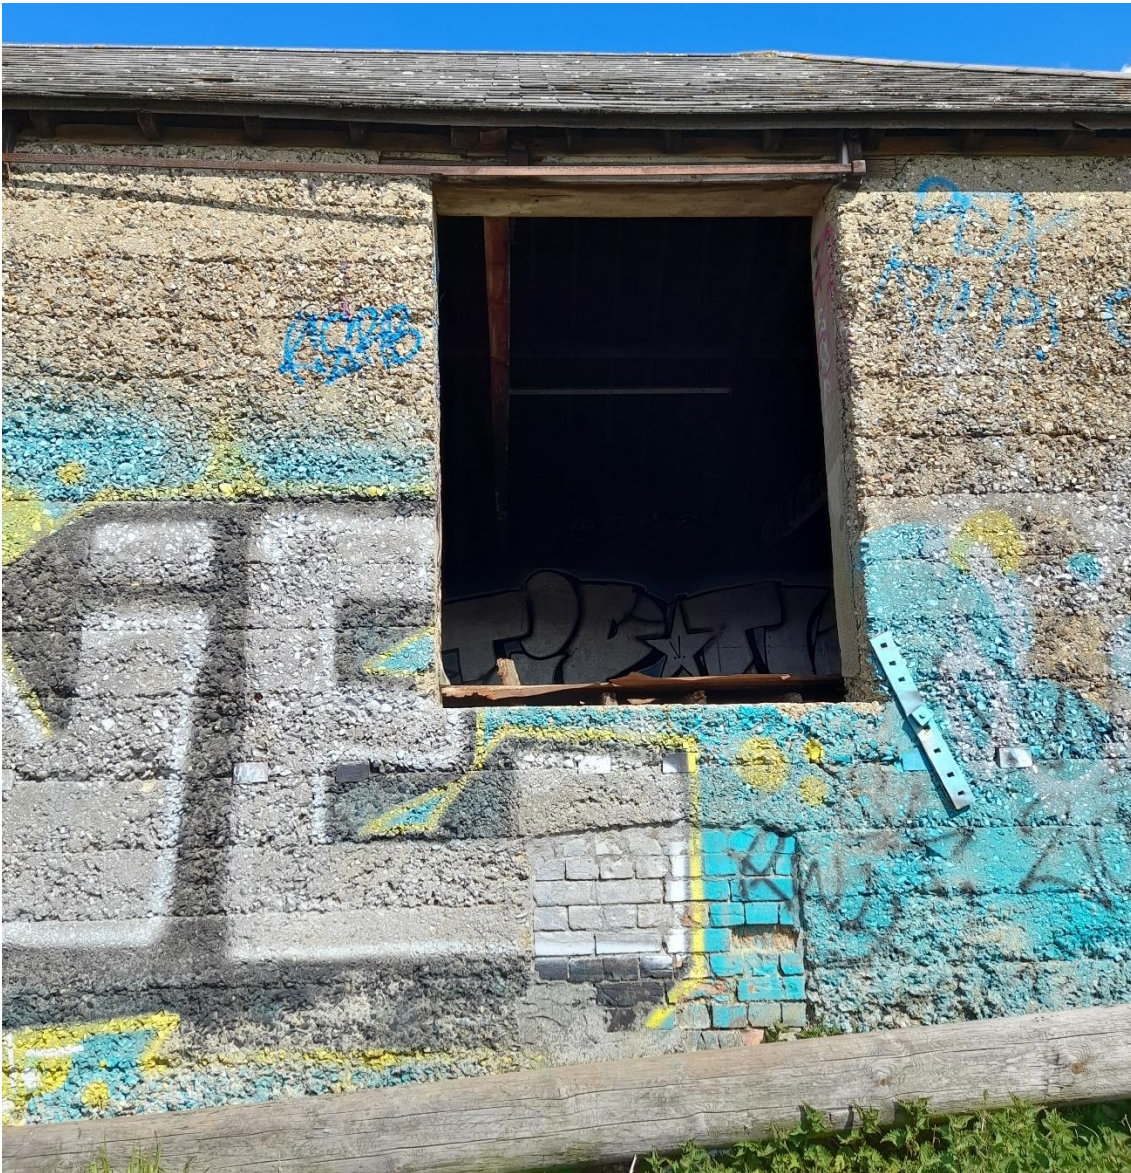
Goods would have been delivered to the front (southern elevation) of the building, and directly deposited into the building at first floor level through one of the first floor doors. The height of these doors appears to be approximately an appropriate height for goods to be taken off the back of a cart and directly placed into the building, without having to lift them. The remains of rails for sliding barn doors are present in situ (Figure 4.5), with one of the barn door rollers and possibly some surviving timber abandoned inside (Figure 4.6). The substantial columns of the undercroft on the ground floor are suggestive of the first floor being used for storing heavy items (Figure 4.7). The first floor is a single space open to the rafters, creating a space to store a substantial amount of goods.

Figure 4.5: Southern elevation, depicting one of the large first floor openings for goods to be transported through.

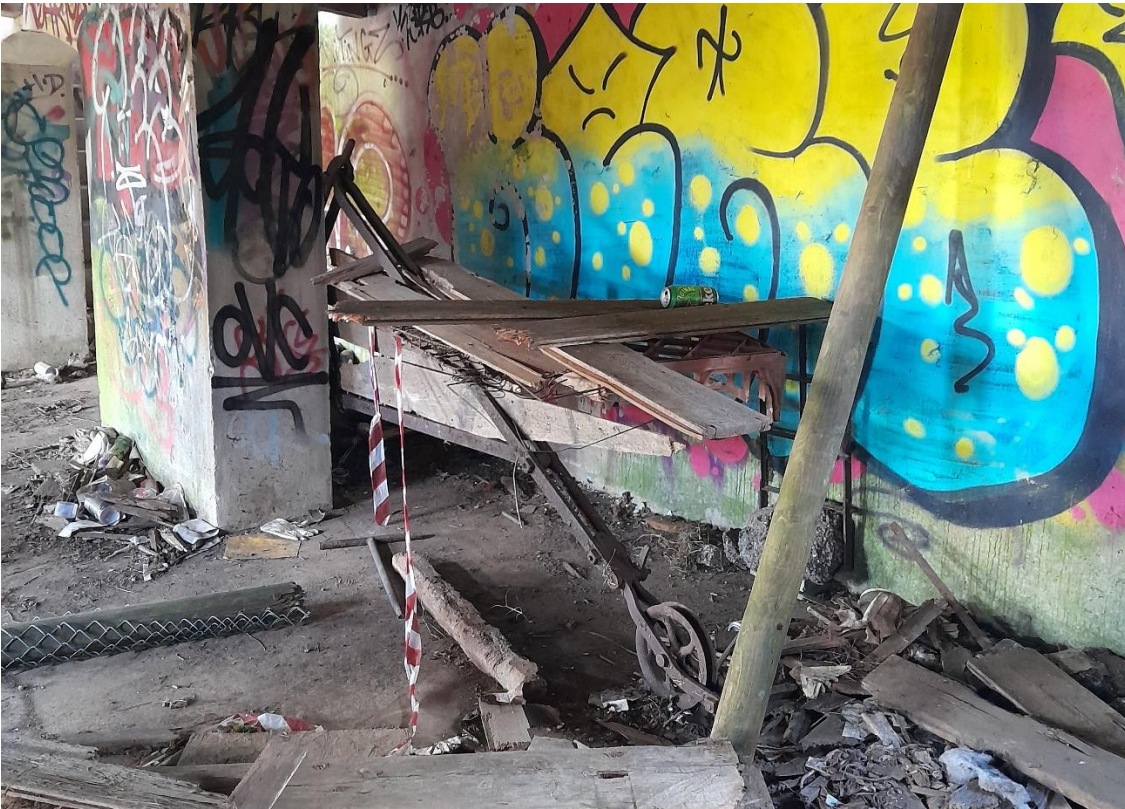
Figure 4.6: Possible remains of one of the barn doors abandoned inside.

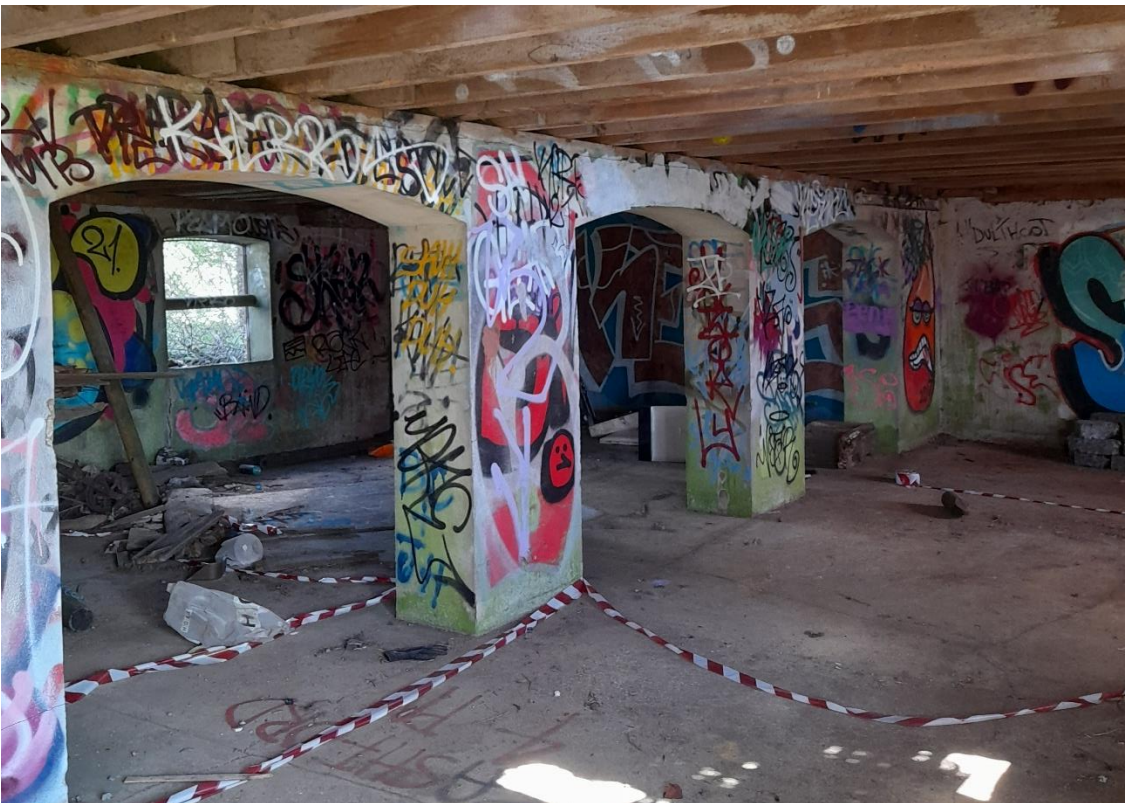
Figure 4.7: Concrete arcade supporting the first floor, facing north-east.

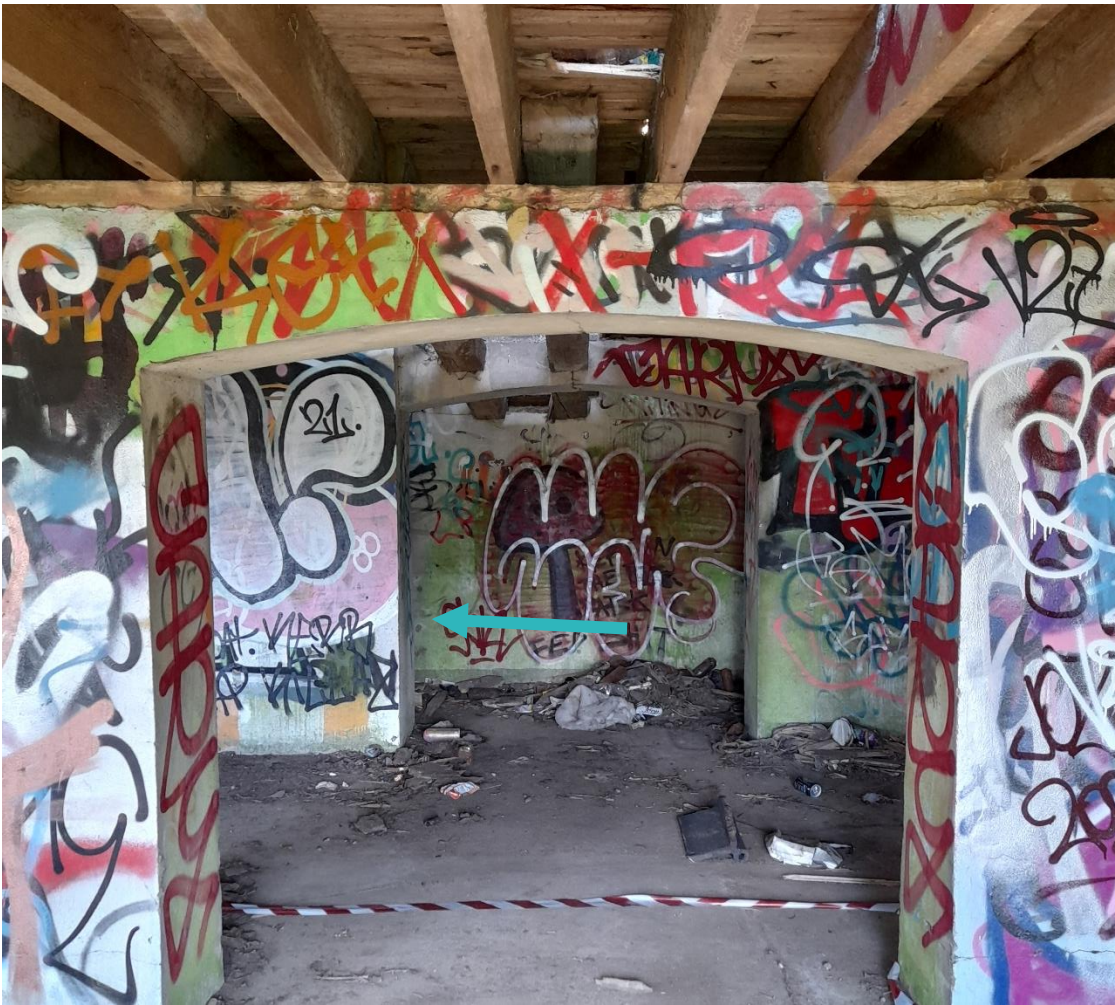
The northern elevation historically featured a central opening at first floor level, approximately the same size as the doors on the southern elevation facing on to the railway tracks. The opening is now infilled and rendered, with the outline evident in Figure 4.10. The material used to infill the opening is unknown, but is likely to be the cheapest available at the time of the works, possibly cement. An internal ramp that runs from the first floor downwards would have allowed for the easy movement of goods on to a train. Equally, the ramp would have facilitated the movement of goods into the Concrete Barn from the train. The ramp is composed of two long timbers that are fitted into two of the concrete arches for stability (Figure 4.8;

A small, steep stair offers internal access from the ground floor to first floor level. The location of the stair is indicated in Figure 4.8; there is no clear photograph due to access restrictions during the site visit.

Figure 4.8: Ground floor depicting the location and arrangement of the first-floor ramp. The blue arrow indicates the location of the stair.

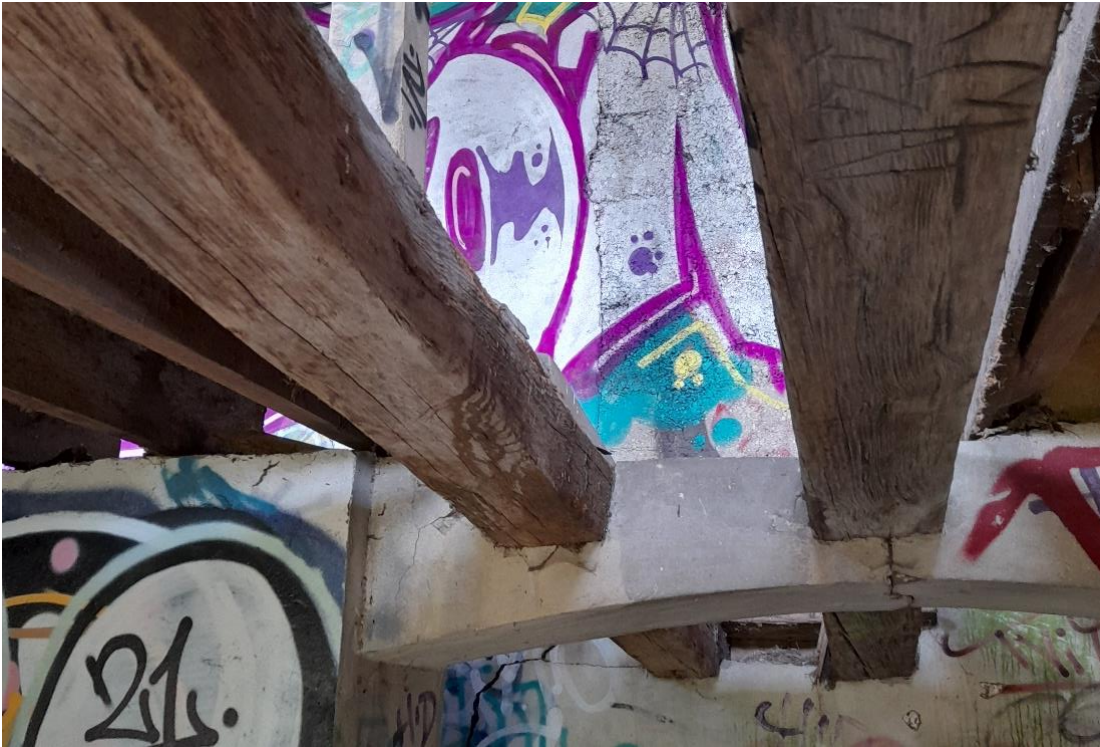
Figure 4.9: Close up of the timbers that form the ramp, between the horizontal floor joists.

The timber joists are also clearly of a later date than the ramp and appear far less worn, as is evident in Figure 4.9 above.

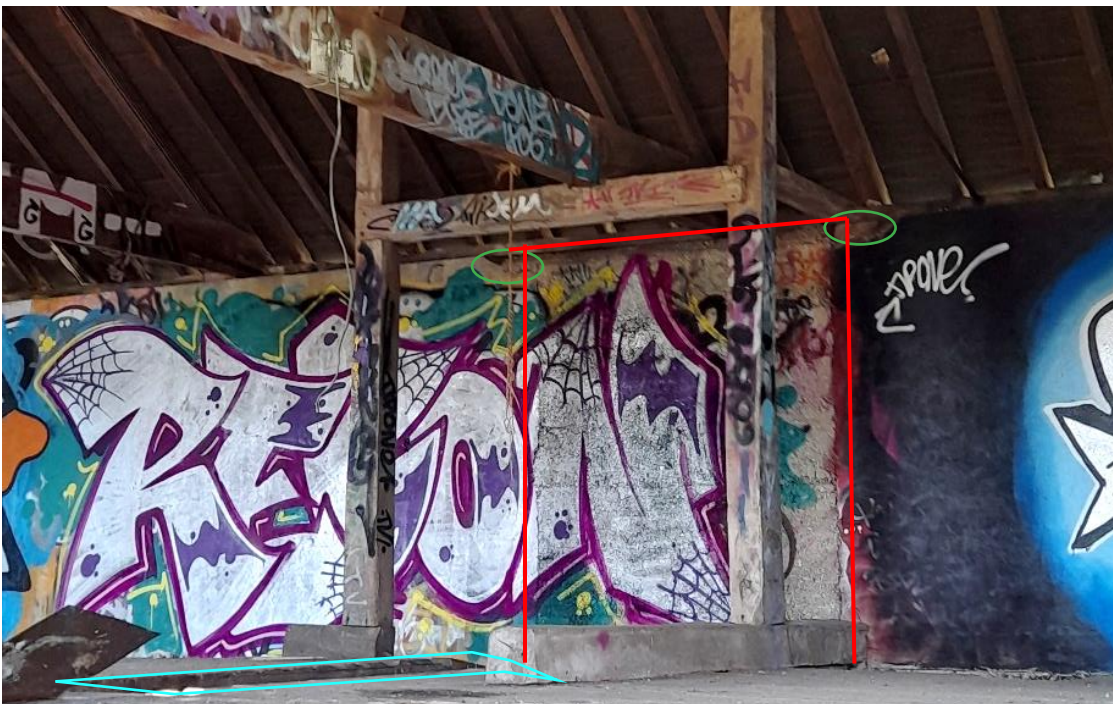
Figure 4.10: View of the ramp and H-framed timber structure from the first floor. The ramp is situated in the gap in the floor, outlined in blue. The original location of the lintel ends are circled in green and the red lines depict the location of the former opening.

The design of the ramp supports the view that the building was used for the storage and transportation of goods. This is of note, given the buildings' proximity to Foxton Goods Shed, situated just to the east at the station, which traditionally operated for the same purpose. This suggests that the Concrete Barn was a private storage and transit facility for a single merchant, supported by the private railway sidings adjacent to the barn.

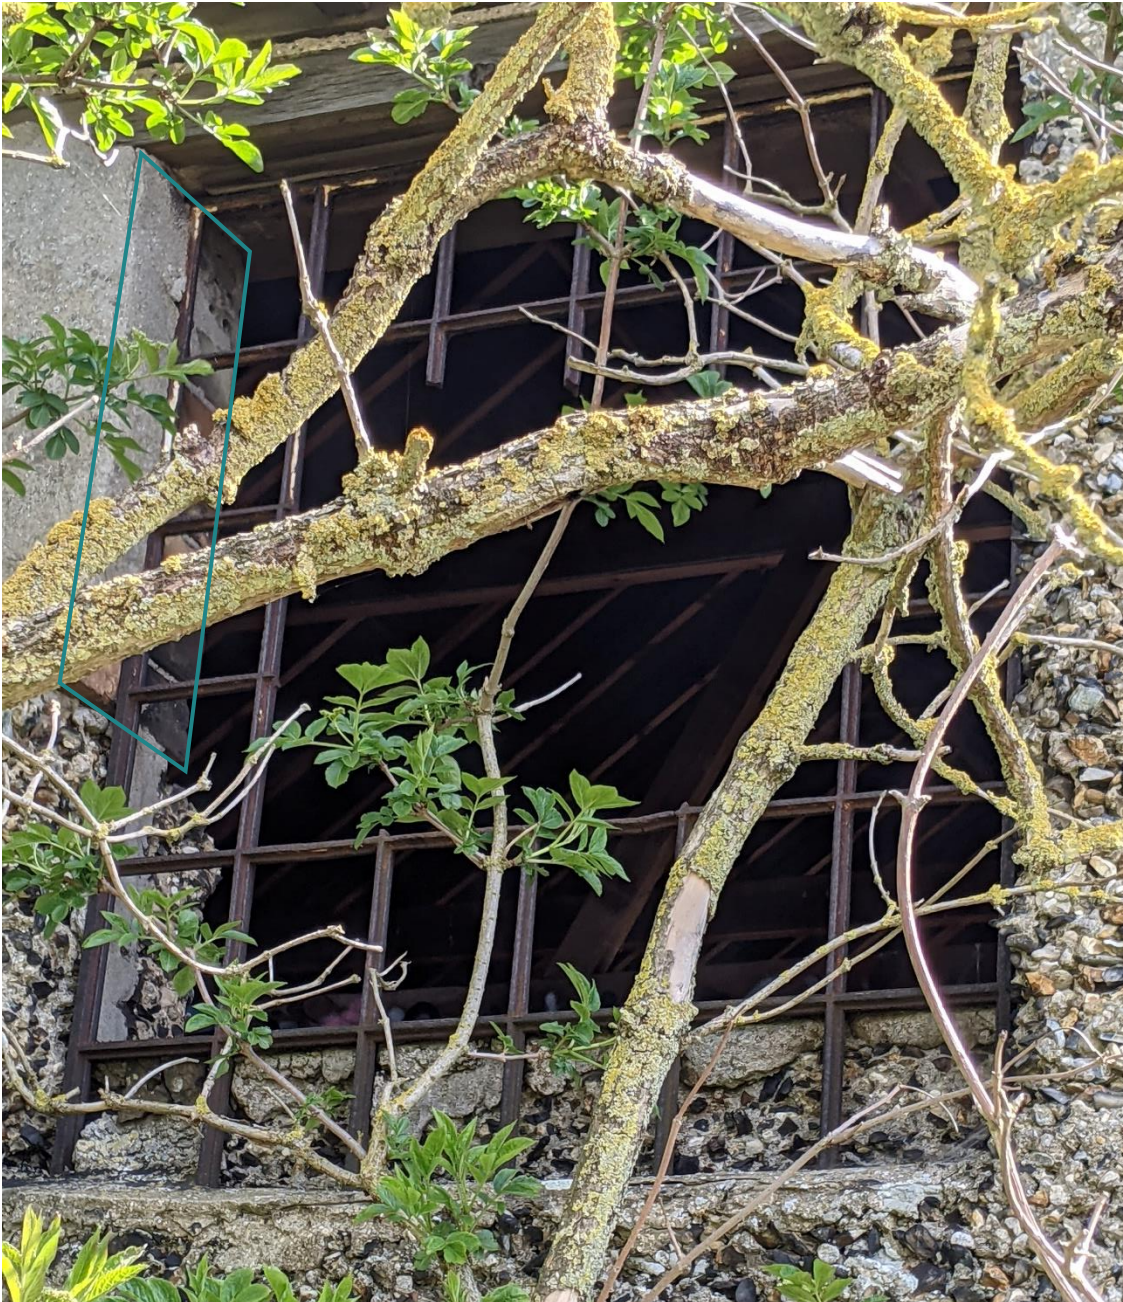
Figure 4.12: The best example of the cast iron windows of the Concrete Barn, on the western elevation. There is evidence of later brick infill to the upper left of the window, outlined in blue.

The height of the windowsills on both the ground and first floors were raised following the construction of the building, evident in Figure 4.12 and Figure 4.13, where a layer of concrete is visible behind the bottom glazing bars. The higher sills were also formed from no fines concrete, suggesting that they were built up at the same time as the infilling of the rear opening to the railway line and two of the infilled windows. A further change was likely also contemporaneous with these changes: raising the height of the first floor.

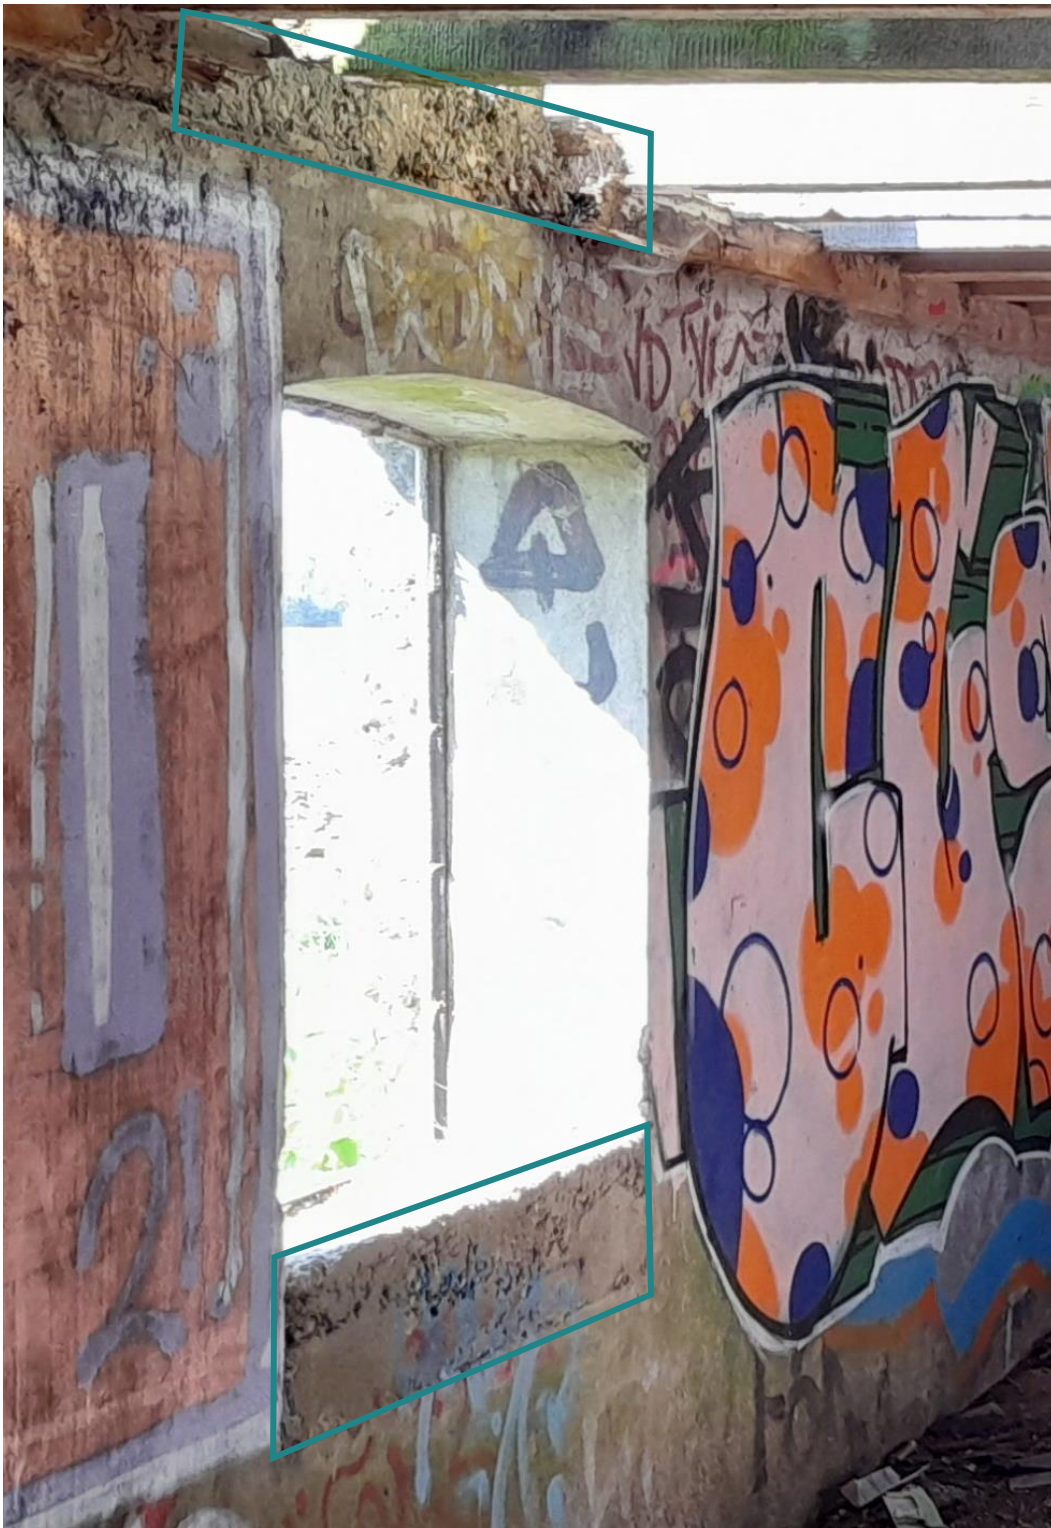
Figure 4.13: Interior of the Concrete Barn depicting the later cement infills to the building, outlined in blue.

The increased height of the ground floor is evident in Figure 4.13, where cement infill is visible above the window. This change is also visible externally, where the headers of the bricks used to plug the holes previously occupied by the floor joists are evident, and where the existing floor joists sit above the first-floor door openings (Figure 4.14, **Error! Reference source not found.**).

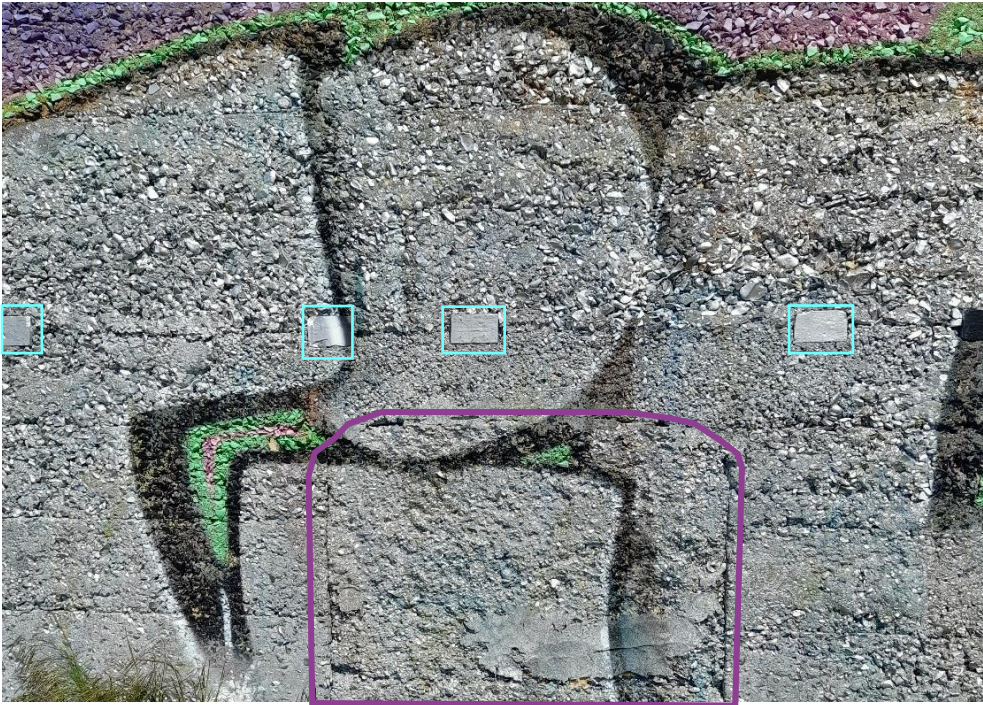
Figure 4.14: Ground floor of the southern elevation depicting the row of header bricks (outlined in blue) inserted at the former first floor level, and the outline of an infilled window beneath (outlined in purple).

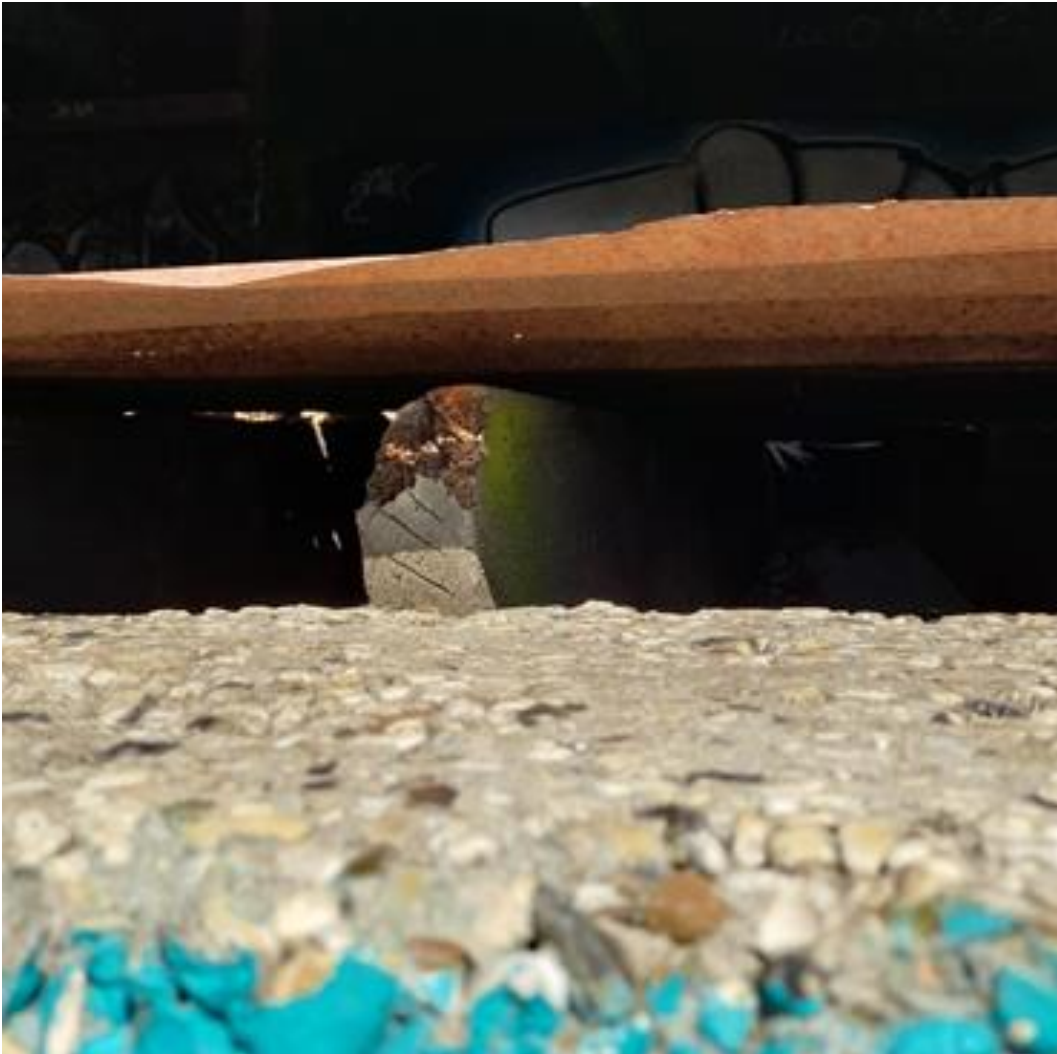
Figure 4.15: First-floor door opening depicting the joists sitting above the sill of the doorway

The reason for the change in floor height was presumably to create a more useable space on the ground floor, where the ceiling was very low. The increased first floor height would have made the base of the first-floor windows quite low to the floor, perhaps deemed unsafe or inappropriate for agricultural storage, which is perhaps why the bottom row of windowpanes was blocked up. However, this does not explain the increased height of the sills on the ground floor. The extent of changes and the use of no-fines concrete to undertake them suggests they were all undertaken at a similar time, most likely associated with the change of use from a transit warehouse to agricultural store.

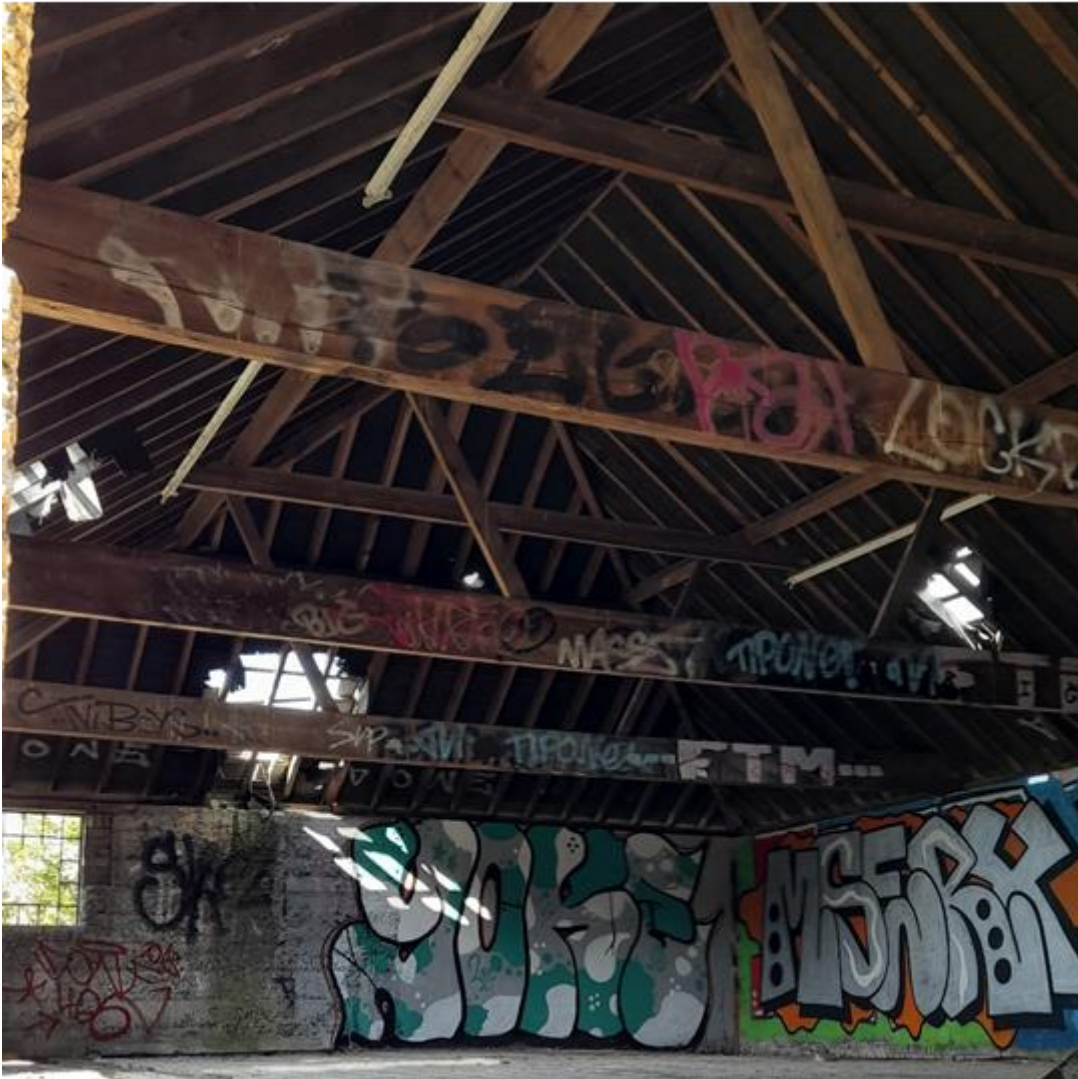
A further change to the interior of the building is the installation of strip lighting in the Concrete Barn, presumably during the latter half of the 20th century (Figure 4.16), suggesting the building remained in full use throughout this period. This date would tie in with the changes to the adjacent railway line and possibly a change of use for the building.

Figure 4.16: First floor of the Concrete Barn showing the timber roof trusses, holes in the roof and the strip lighting (outlined in blue).

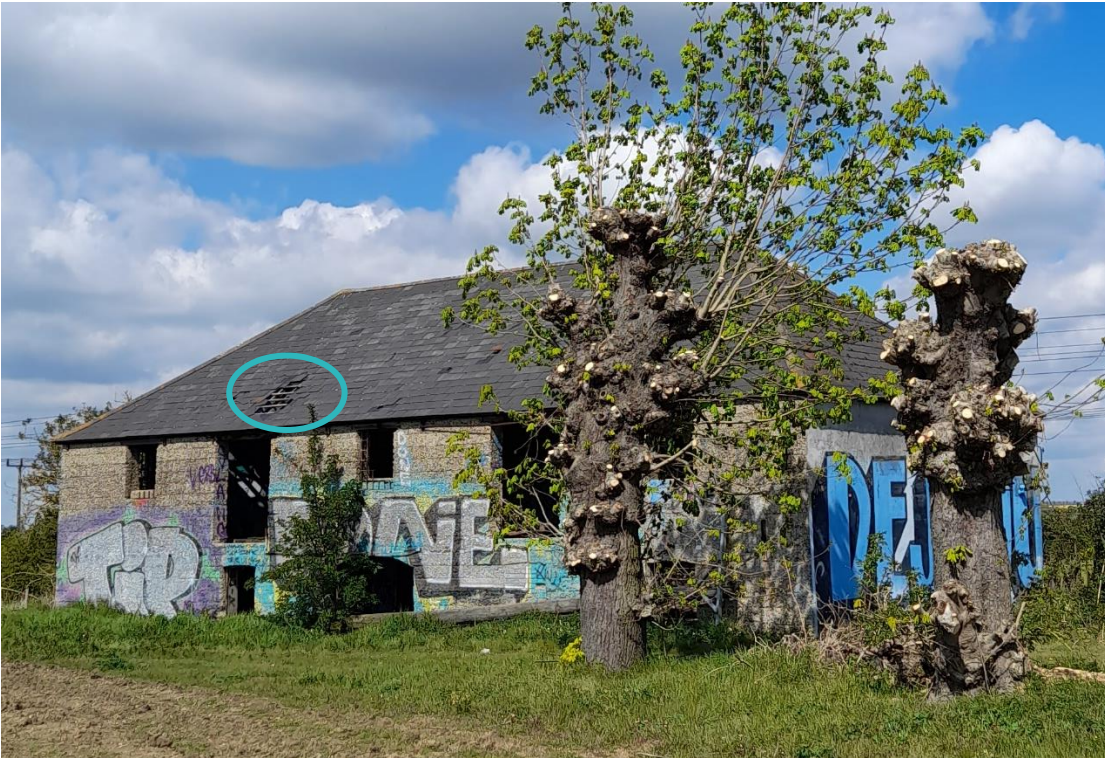
The Concrete Barn listing notes that the existing slate roof is a 21st century replacement, though already there are areas of tiles missing; the original roof covering could have been either slate or tiles.¹⁸

Figure 4.17: Exterior of the Concrete Barn showing the relatively new roof tiles and area of missing tiles circled.

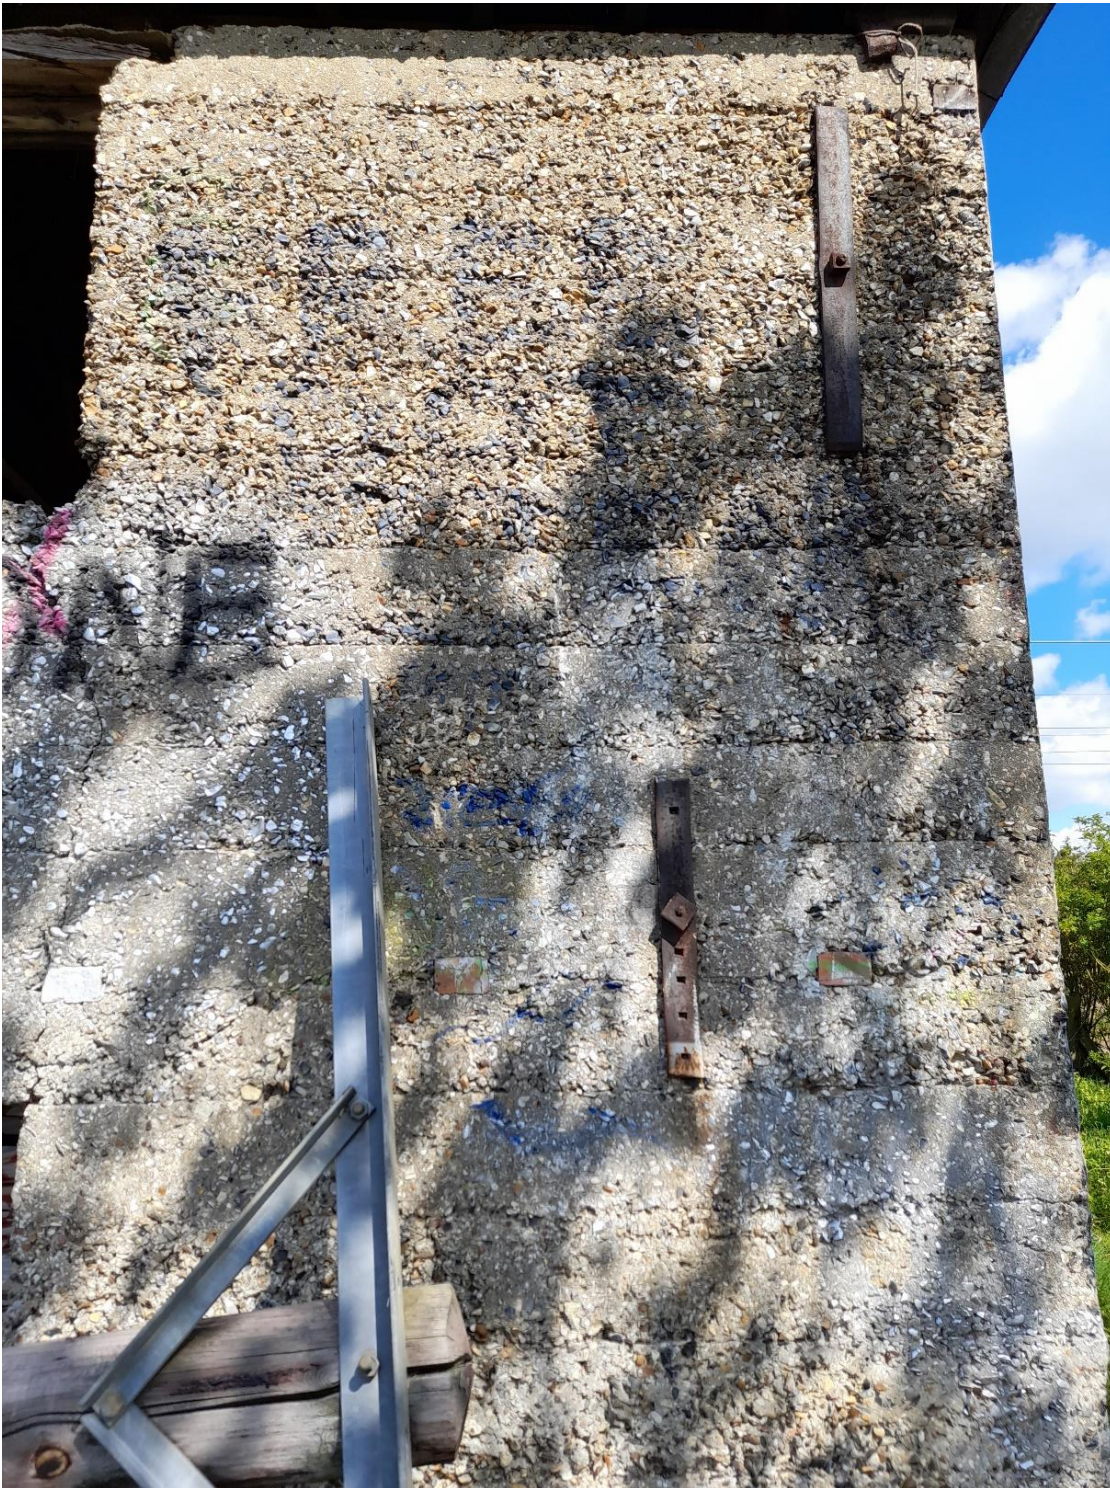
Figure 5.1: Eastern corner of the southern elevation, depicting the stripes left from each pour of the concrete.

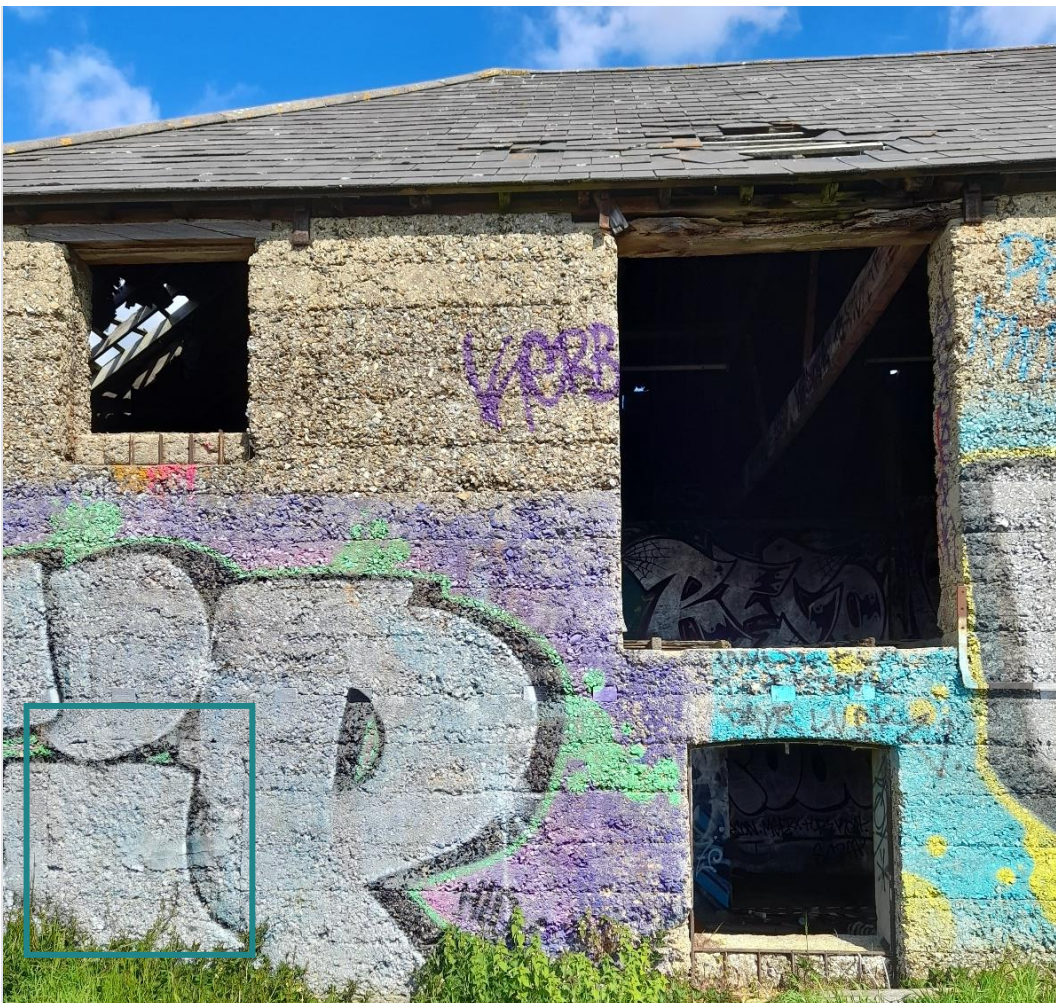
The interior and exterior of the Concrete Barn have some architectural and artistic interest. The southern, principal elevation has the most architectural and artistic interest due to the originally symmetrical composition of this façade. This has been compromised somewhat by the infilling of two of the windows with brick, which imbalances the façade slightly. It is unknown whether the symmetry of the principal elevation was the result of careful design or simply informed by the requirements of the building's intended use. As a possible show building for the early cement industry in South Cambridgeshire, a designed architectural symmetry is likely in order to demonstrate the abilities of the material. Alternatively, as a functional building constructed as cheaply as possible, it is more likely that the symmetry is fortuitous or informed by the requirements of the owner.

Figure 5.2: Southern elevation illustrating a blocked-up window (outlined in blue)

The ground floor openings are all situated beneath a segmental arch in order to better spread the weight of the upper floors on the building. The arches add some visual interest to the building, contributing to the architectural significance of the building.
