Concrete Barn, Foxton: Statement of Significance

Foxton Travel Hub

May 2021

Document reference: 418368-MMD-ENV-XX-RP-EN-0009

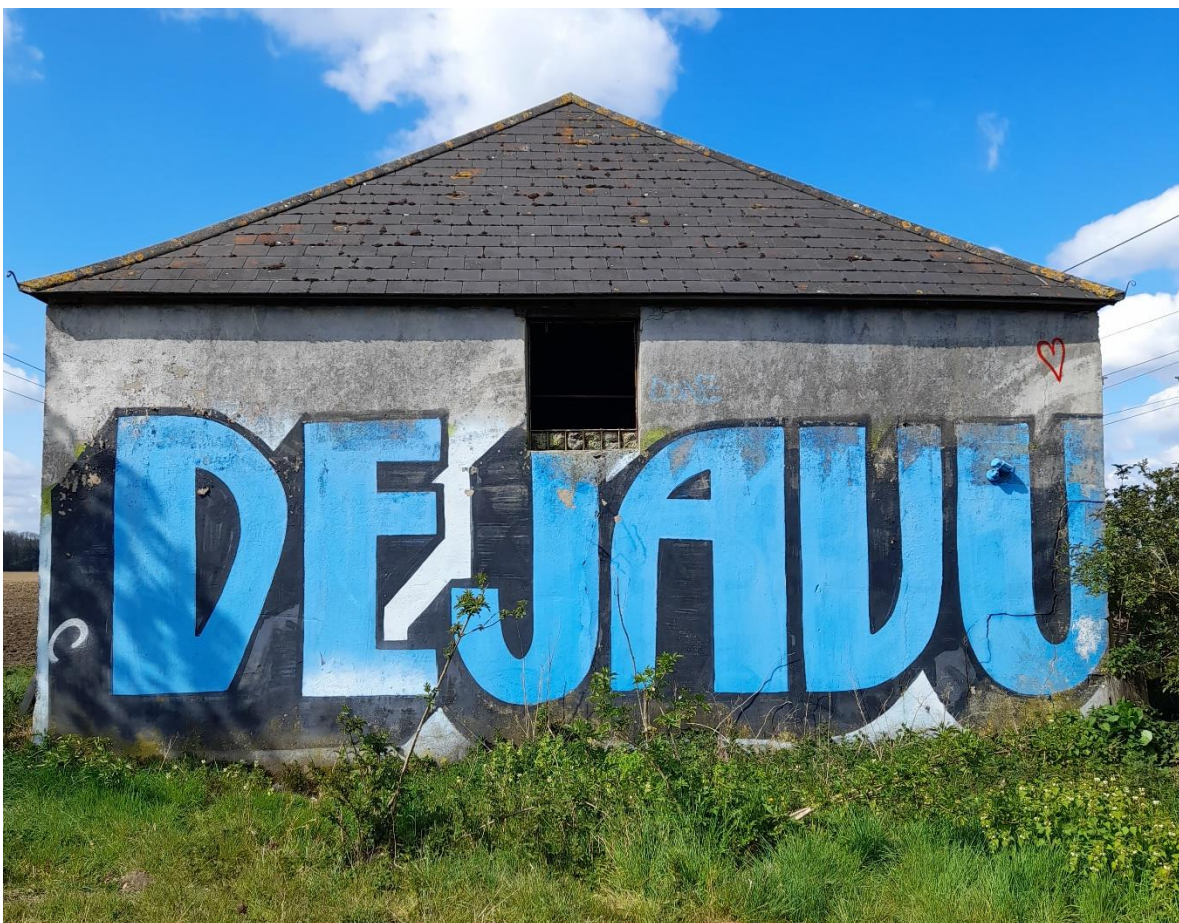
The substantial amount of graffiti that decorates the interior and exterior of the building detracts from the ability to understand the construction method of the building but does give the building some artistic interest. In particular, the 'DE JAVU' graffiti on the eastern elevation is particularly prominent, and a recognisable feature of the area for railway passengers passing by. The graffiti's attribution to local Graffiti Artists, All Type No Face adds to its artistic value, and links it to other graffiti in the area.

Figure 5.3: Eastern elevation of the Concrete Barn, featuring 'DE JAVU' graffiti.

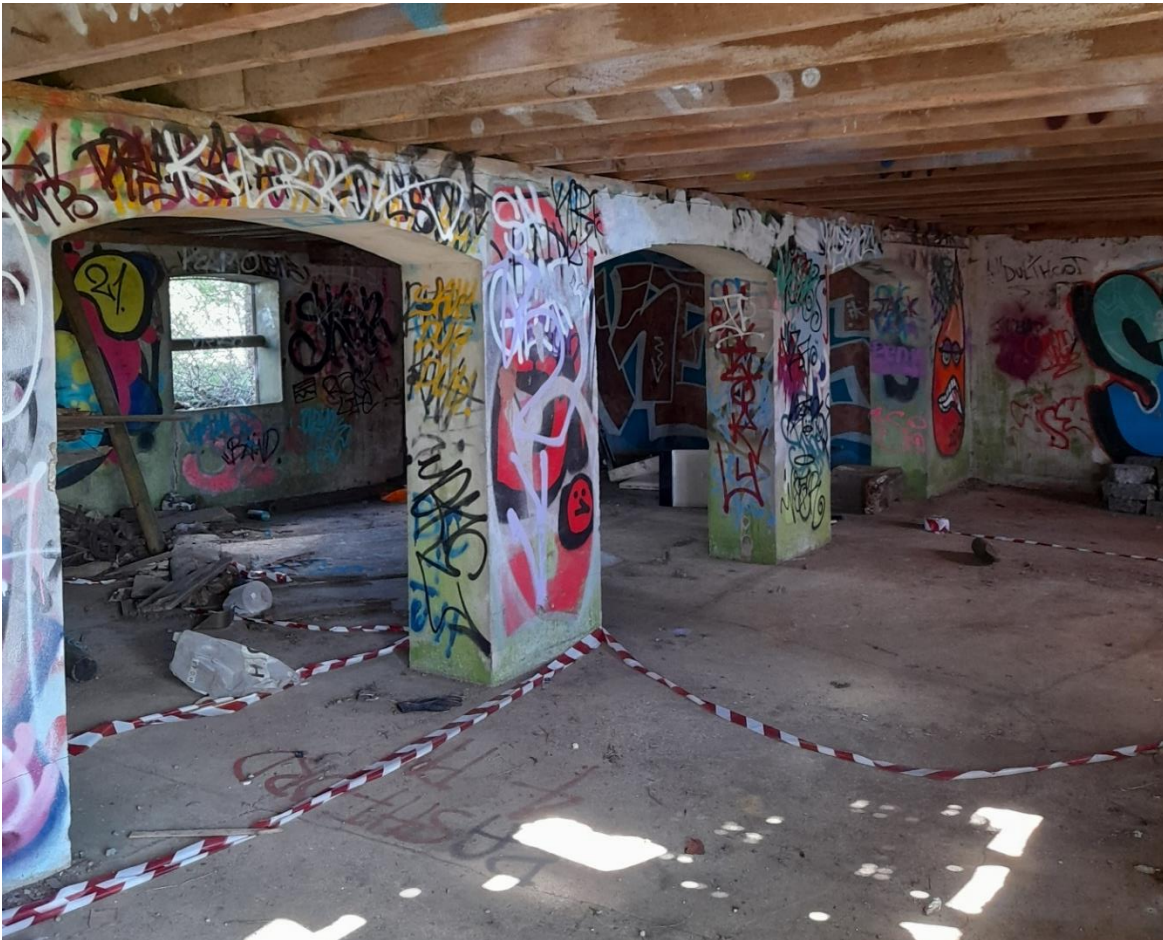
Internally, the ground floor arcade provides some architectural interest, due to its regular geometry, and the use of segmental arches matching those used for the ground floor doors and windows.

Figure 5.4: Ground floor arcade

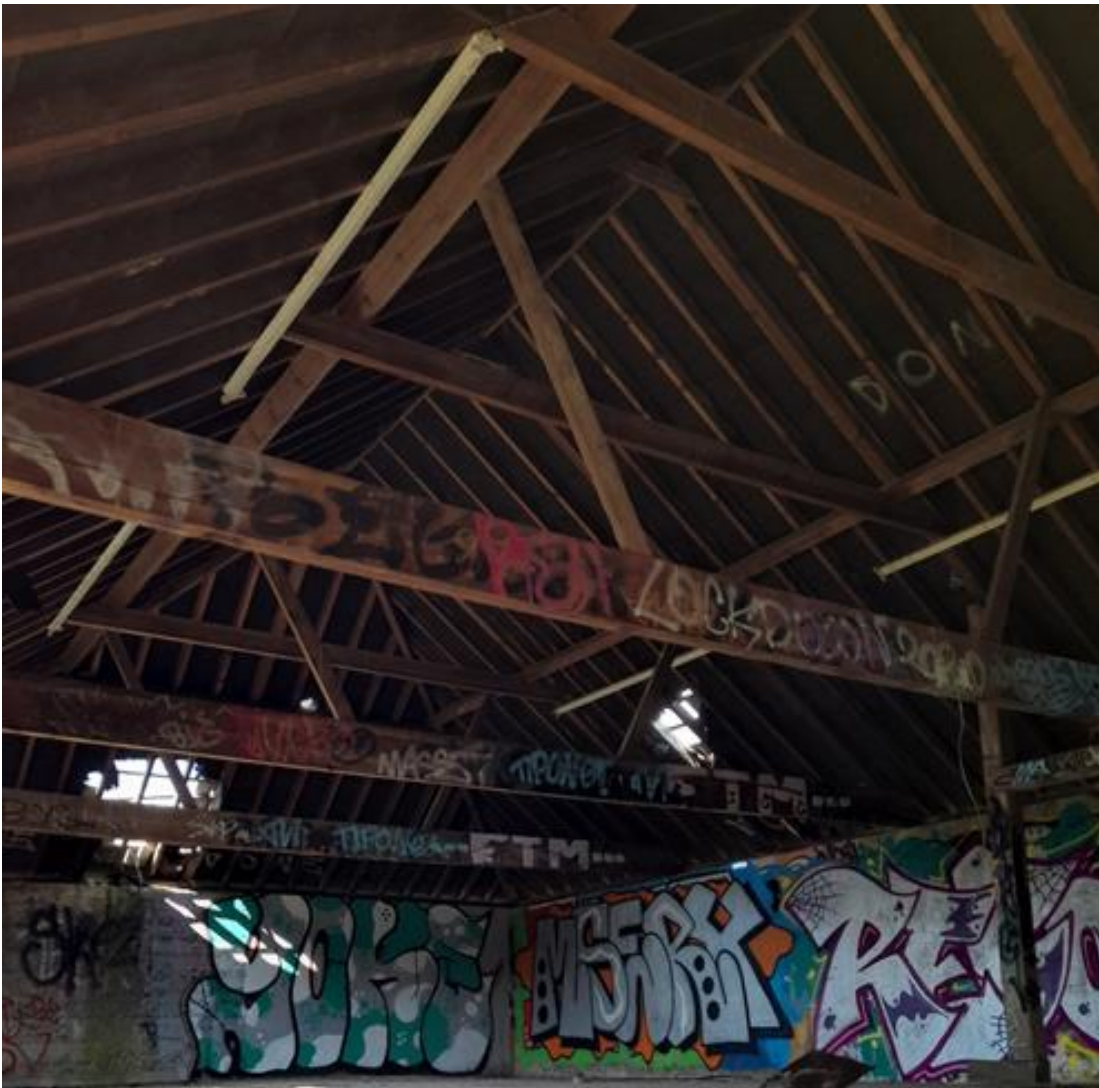
Additionally, the openness of the first floor allows the scale of the building to be appreciated, contributing to its architectural interest. In particular, the visibility of the pine roof trusses allows for an understanding of the building's structure beyond that of its concrete construction, as well as an appreciation of the craftsmanship associated with the building (

Figure 5.5: First floor showing timber roof trusses

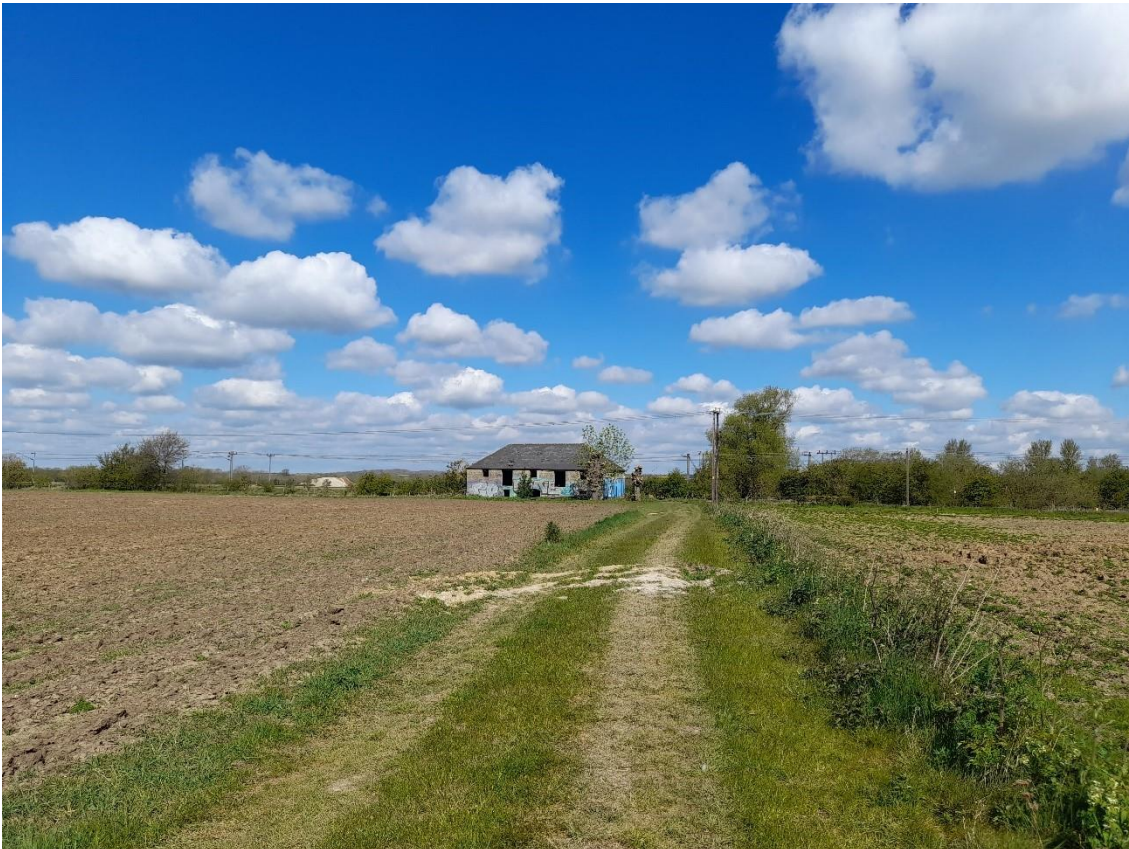
Figure 5.6: Contextual image of the Concrete Barn in its agricultural setting.

The setting of the Concrete Barn contributes to its significance as it facilitates the ability to understand the function and operation of the asset. The Concrete Barn's proximity to the railway line was the primary reason for the building being constructed where it was, and the survival of this visual relationship aids the ability to understand this element of the Concrete Barn's history. Additionally, the Concrete Barn's location in an agricultural context is unchanged since its initial construction, which consequently helps to appreciate the original design intent and appearance of the building. More recently, the Concrete Barn has been used for agricultural storage, which strengthens the link between the building and its setting.

During consultation with the Conservation Officer, it was noted that whilst the agricultural setting does contribute to the ability to understand the asset and its historical use, this is not as significant as the historic fabric of the building itself. This indicated that the surrounding area could be developed in a way that the significance of the building would remain intact and evident.
