Wigmore STW

Archaeological Desk Based Assessment

July 2022

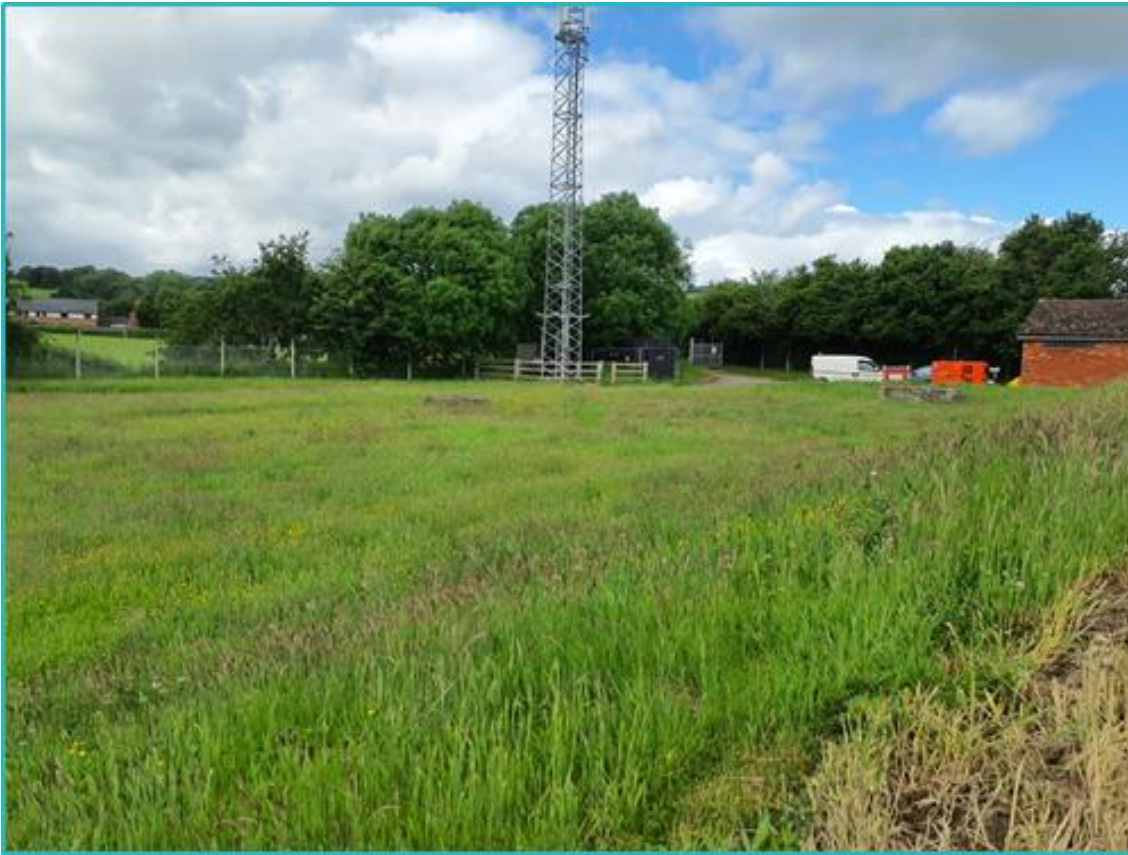
Figure 4.1: NW facing view of entrance to site from the centre of site. Mature vegetation screens the site from Wigmore village to the NW of the site.

It was noted that the site is well enclosed by vegetation; there were few external views between trees, particularly on the northern edge of the driveway which is lined by a mature, managed hedgerow to the north, restricting views into the village.

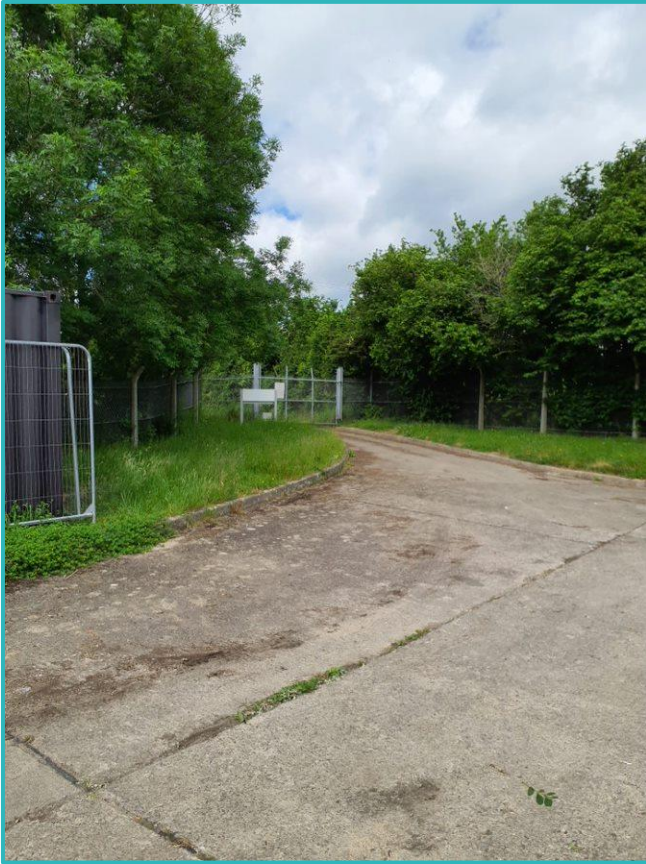
Figure 4.2: Entrance to STW, facing NW

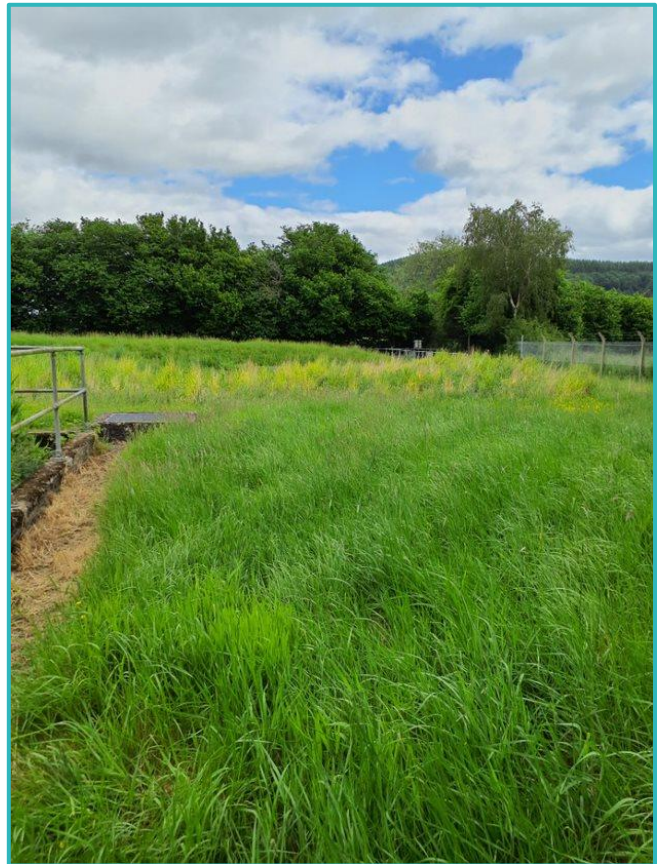
Figure 4.3: SE boundary of the site

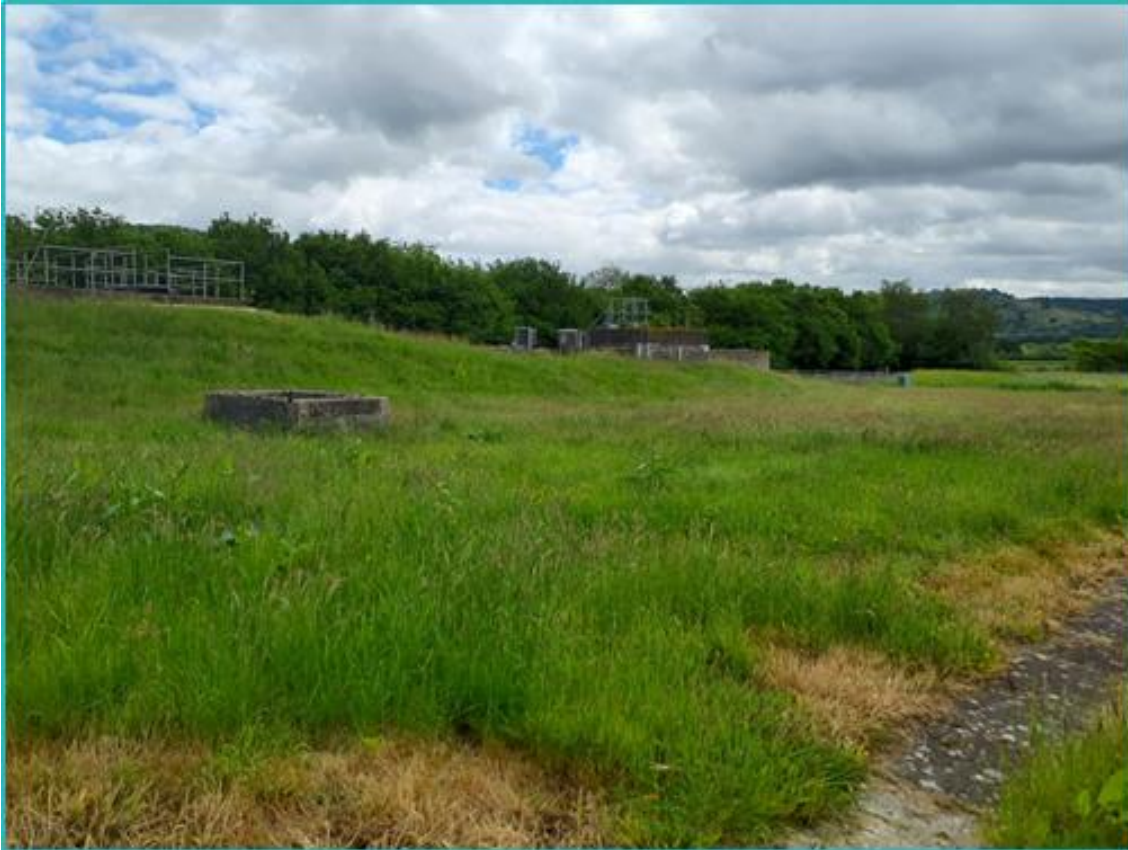
Figure 4.4: Built up ground and STW infrastructure within the site, facing SE

Within the site, much of the ground appeared to be disturbed by the existing structures or built up, likely with excavated material from previous development within the site. The whole site appeared at a higher elevation to the surrounding land, implying considerable deposits of made ground across the site. Evidence such as several manholes and drains that were noted throughout the site indicate the presence of underground infrastructure relating to the STW, inferring further ground disturbance in these areas.

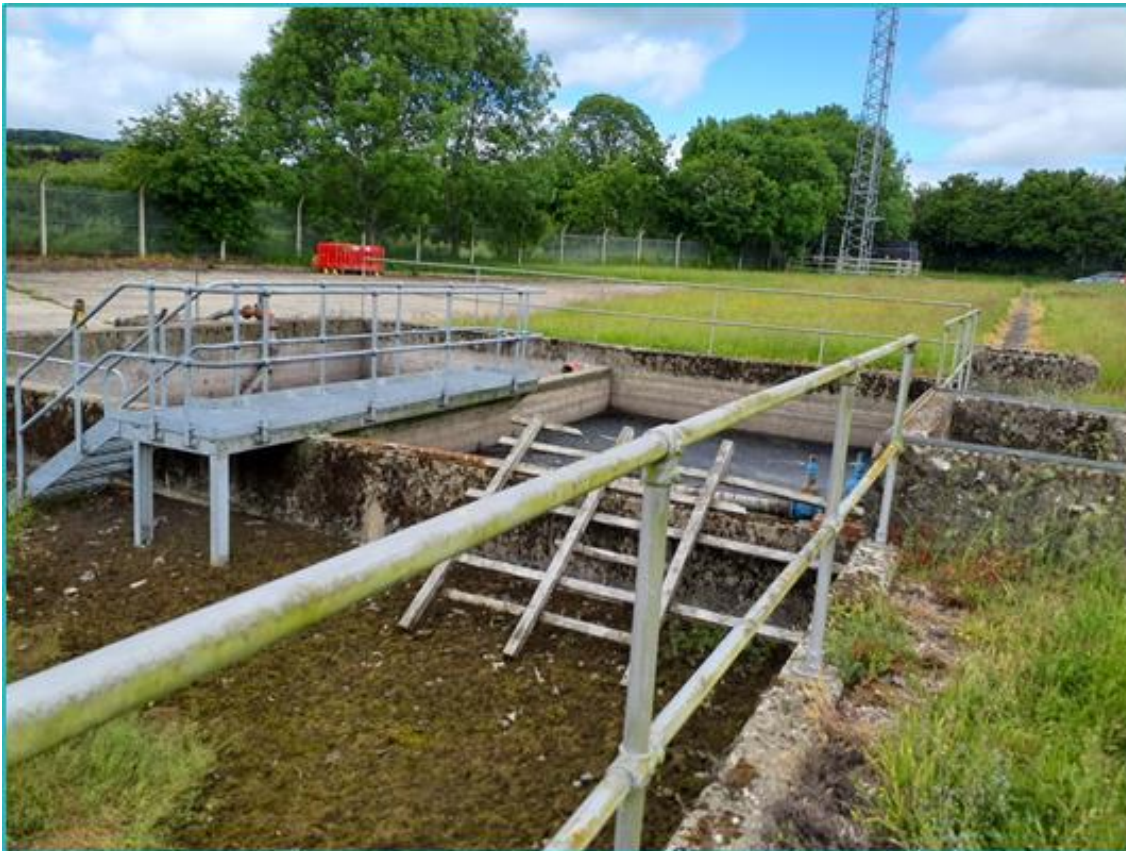
Figure 4.5: Ground disturbance caused by existing STW infrastructure

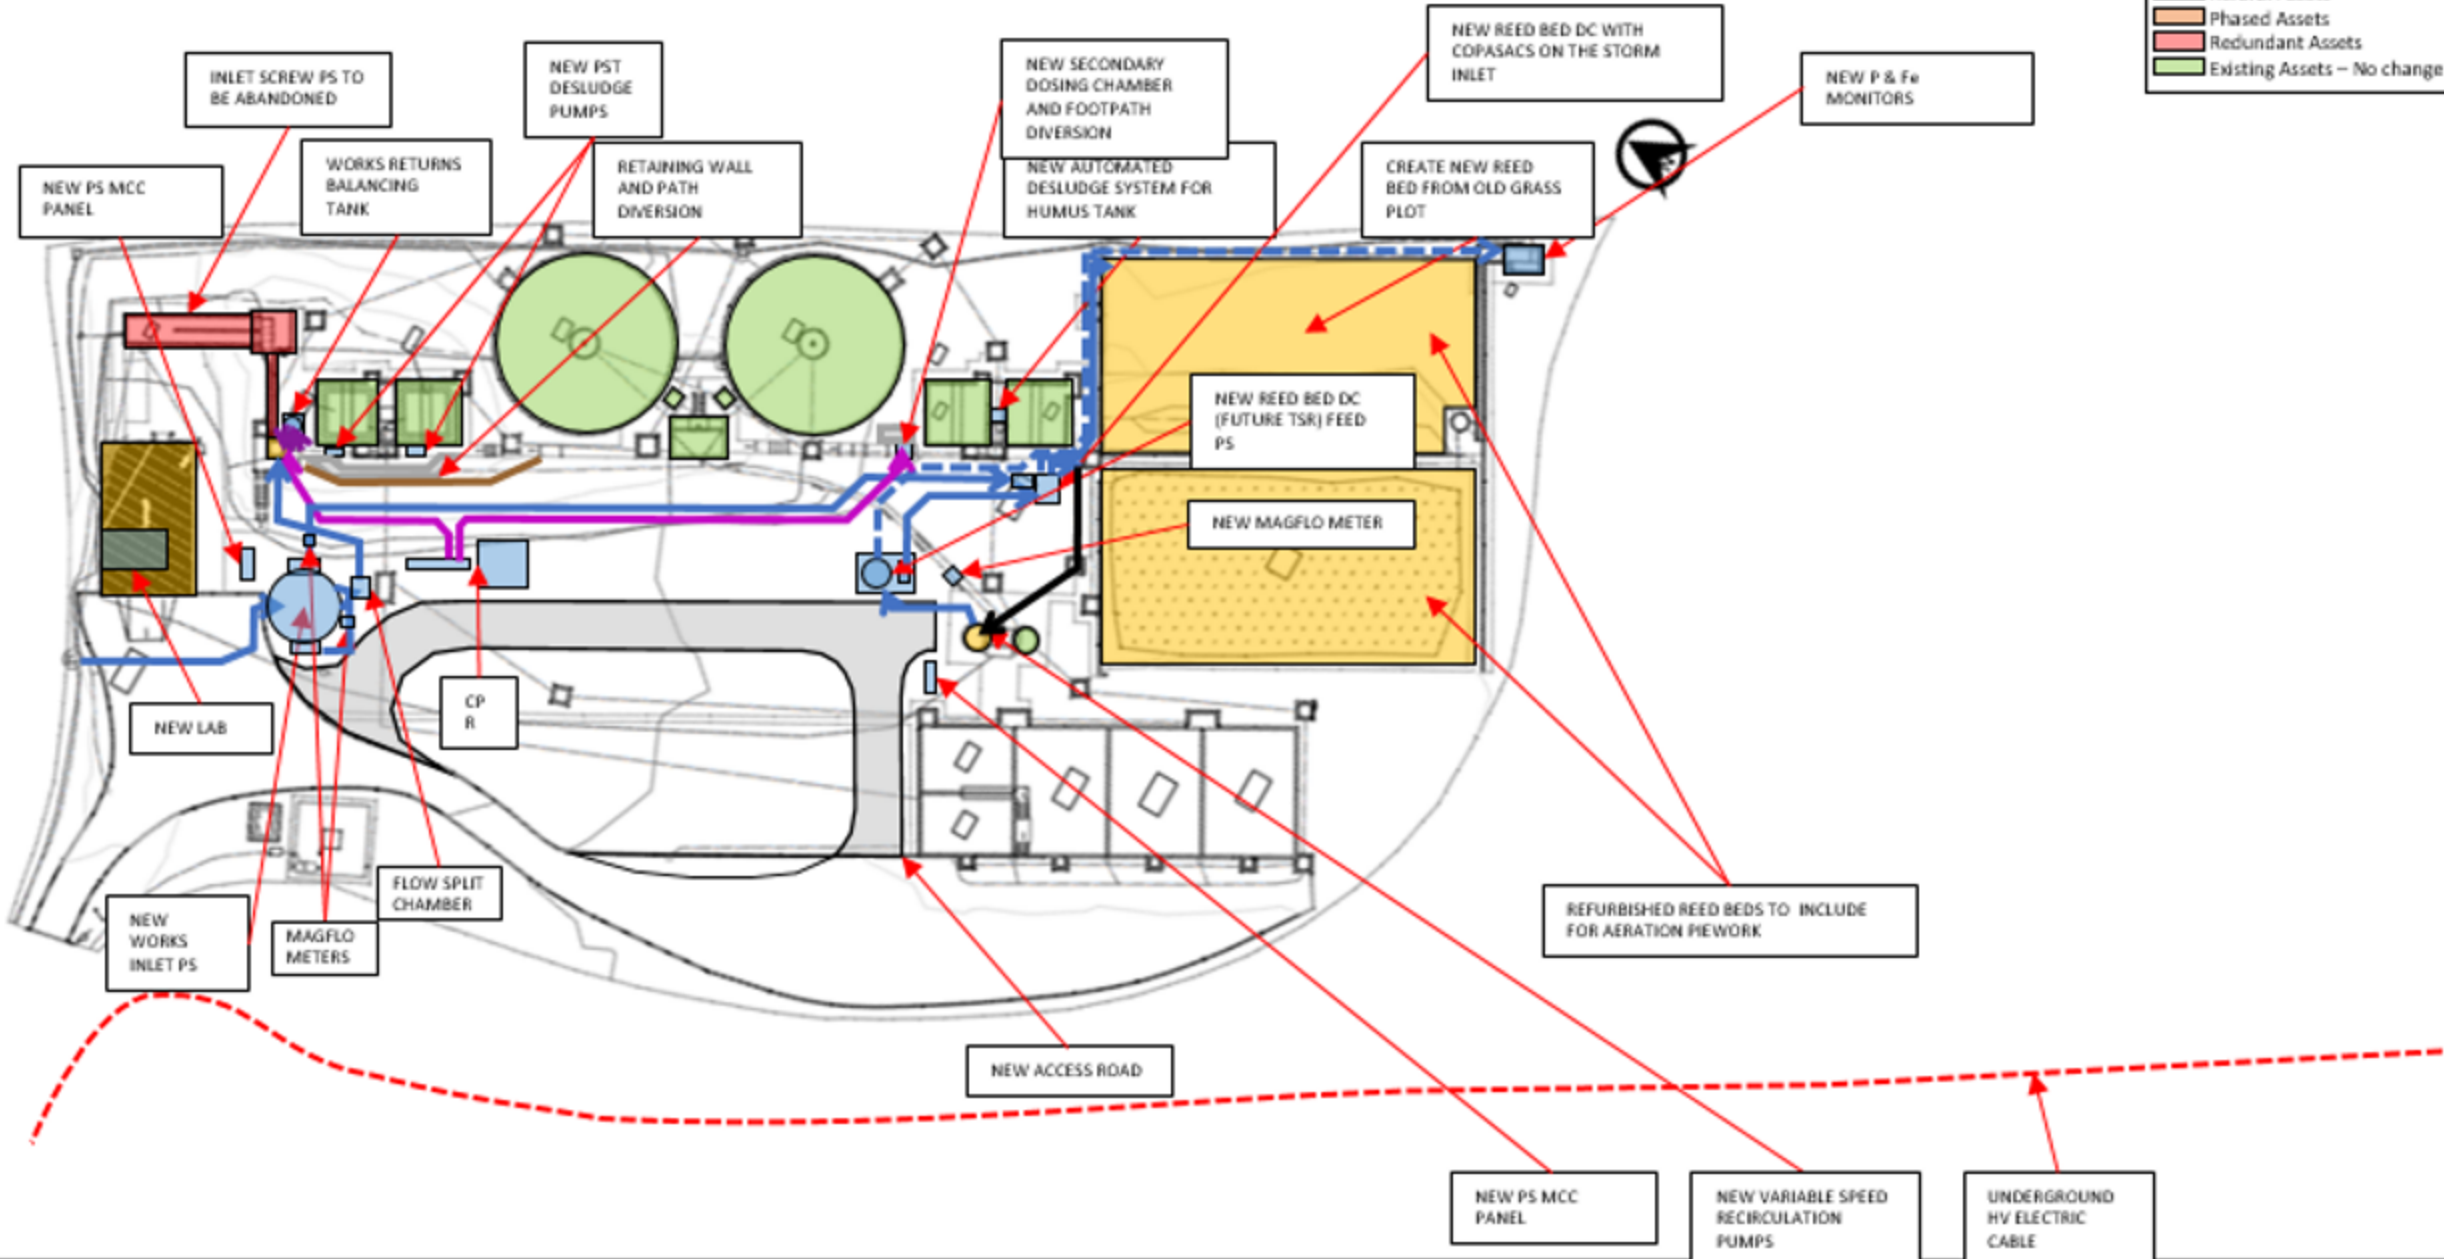
- Treatment Route
- Returns
- Chem Dosing line
- New Assets
- Refurb. Assets
- Phased Assets
- Redundant Assets
- Existing Assets - No change

The project involves the renovation of the existing STW. This includes the construction of new structures, the refurbishment of existing structures and the decommissioning of existing structures. A new access road is also proposed. A plan of the proposed works is included in Appendix C.
