# Archaeological Building Recording

## **PEAR TREE COTTAGE, UPPER GREEN, MORETON PINKNEY, NORTHAMPTONSHIRE**

Commissioned by DJC Associates  
in relation to planning and Listed Building consents:  
S/2010/0971/FUL & S/2010/0972/LBC

**February 2012**

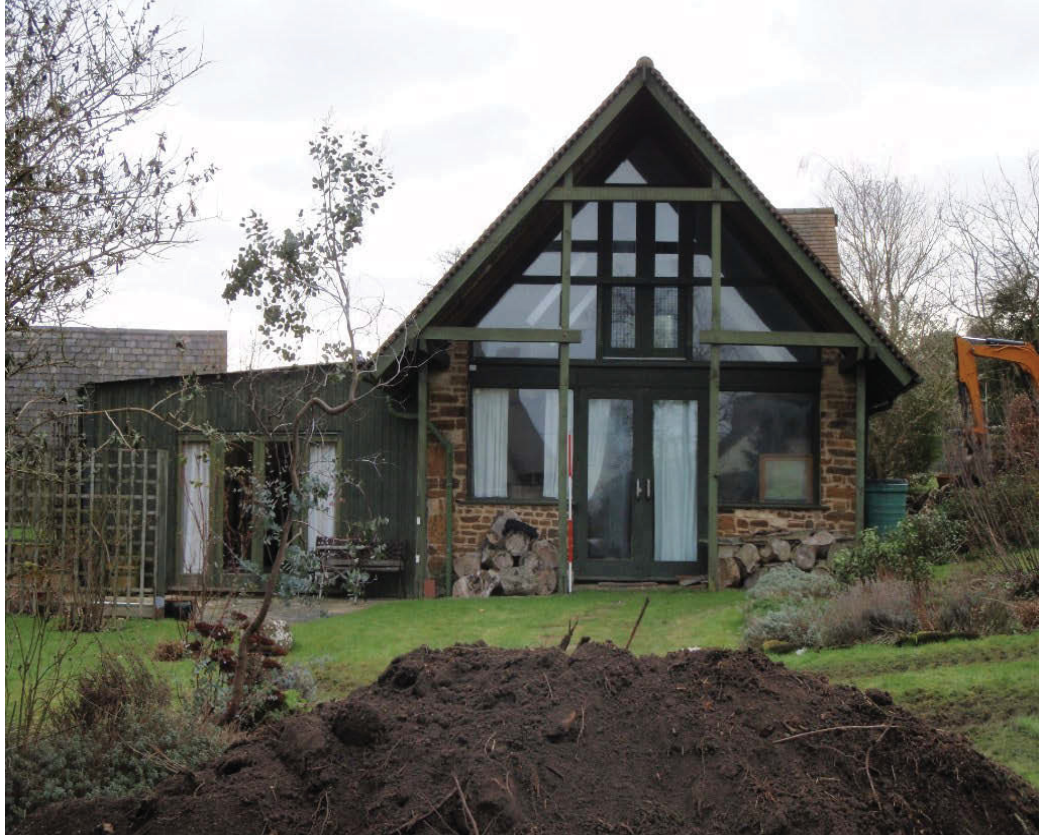
The outbuilding comprises a two-storey stone built barn with a modern block built single-storey extension attached to its north east elevation. The building is c.15m from Pear Tree Cottage and occupies a location towards the rear of the garden plot being partly terraced into the sloping ground on its southern corner. As noted above the main structure was re-roofed in 1988 with the addition of a dormer with stepped access to the south west elevation. The main north west elevation (plate 1) features full height glazing over which the eaves of the plain tile roof project, supported by green-stained timber and oversailing a stone paved threshold.

Plate 1: North West main elevation

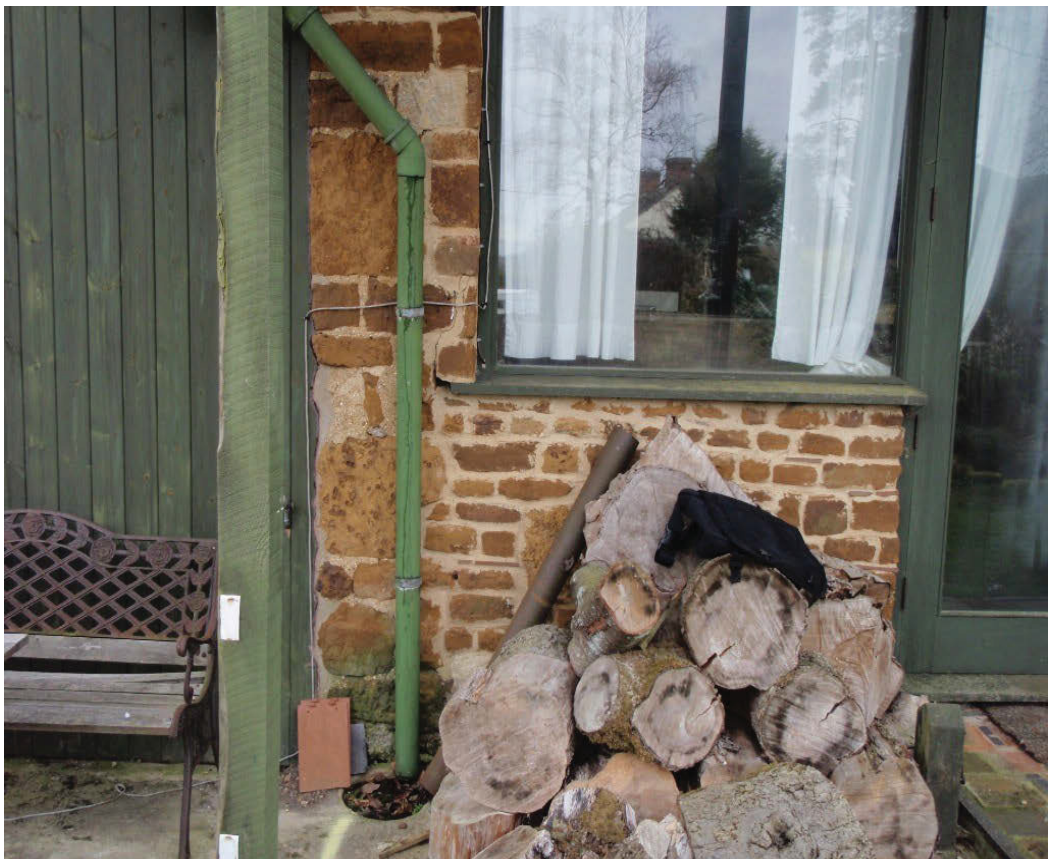
Plate 2: Detail of stonework in NW elevation

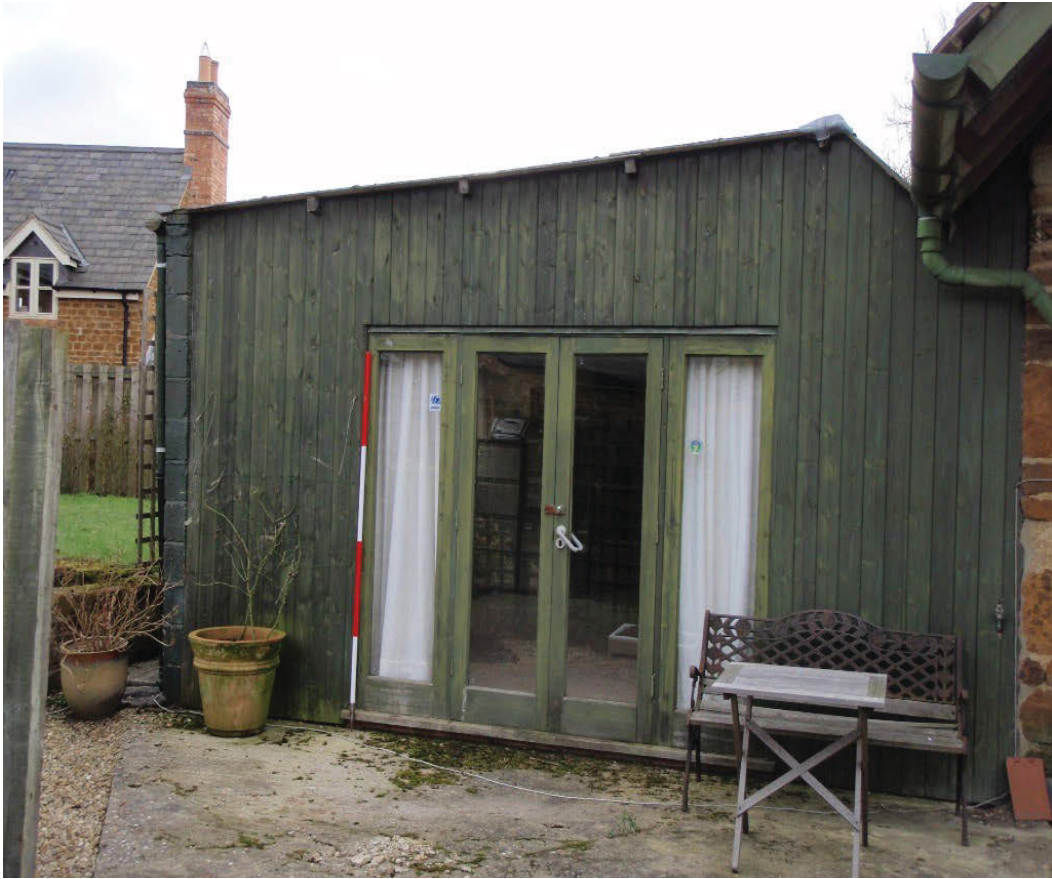
The attached and later single-storey extension is clad with matching green-stained timber boarding on its north west elevation, with french doors opening onto a gravelled patio (plate 3). The extension's north east elevation (plate 4) is of block work construction pierced by two double glazed timber casements. It's rear south east elevation is roughcast rendered and contains a single timber casement window (plate 5). It is roofed in shallow monopitched corrugated sheet with a deep gully where it butts the main structure (plate 6). A narrow paved gully is formed adjacent to the north east elevation by a brick retaining wall against the higher garden lawn.

Plate 3: NW elevation, modern extension

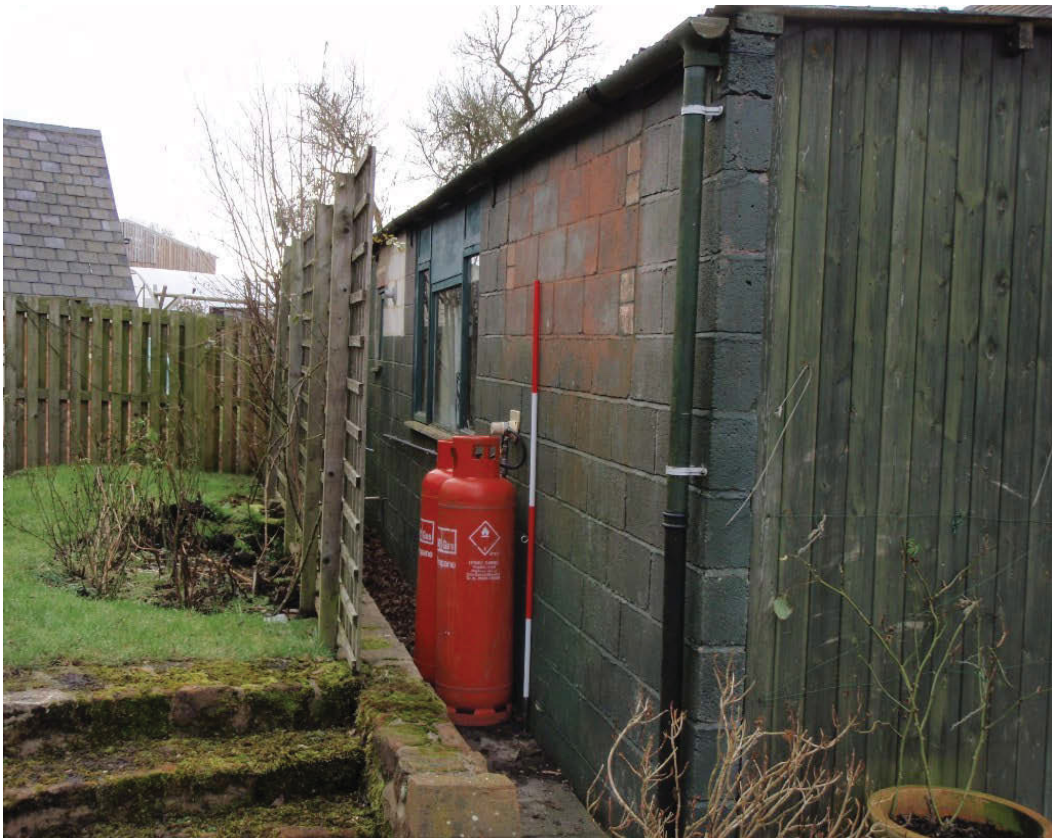
Plate 4: North East elevation, modern extension

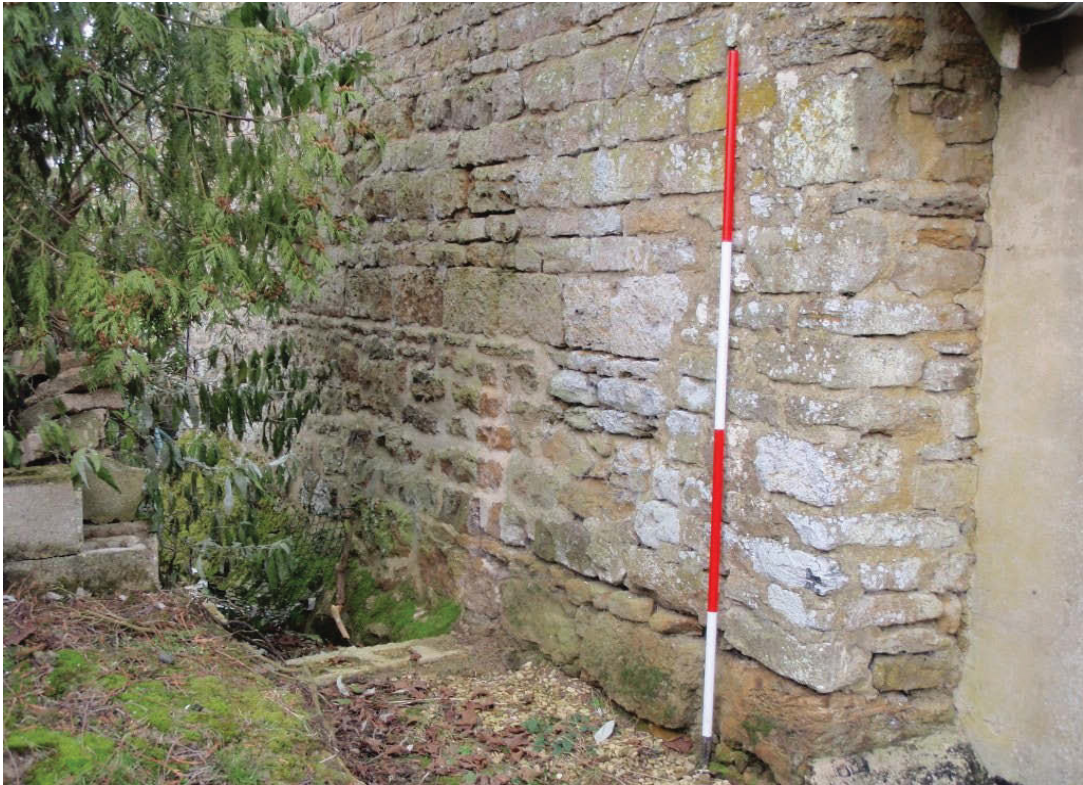
The rear south east elevation of the main structure is pierced by a single modern timber casement at first floor height (plate 9). This elevation shows considerable cement repointing including a very fresh area where a stub block wall projects and joins the block retaining wall which skirts this part of the building (plate 7). Above this the stonework is neatly coursed with well-shaped and substantial blocks of limestone, some oolitic. Minor repairs in brick are evident on the southern corner at the eaves (plate 8). Lower down on the southern corner of this gable the stonework steps out forming a plinth and the suggestion that, given the height of the adjacent modern retaining wall the original foundation courses may be partly exposed in this area perhaps to relieve moisture ingress caused by the structure originally being cut into a bank (plates 6 & 7).

Plate 7: SE elevation showing repointing and part demolished block wall

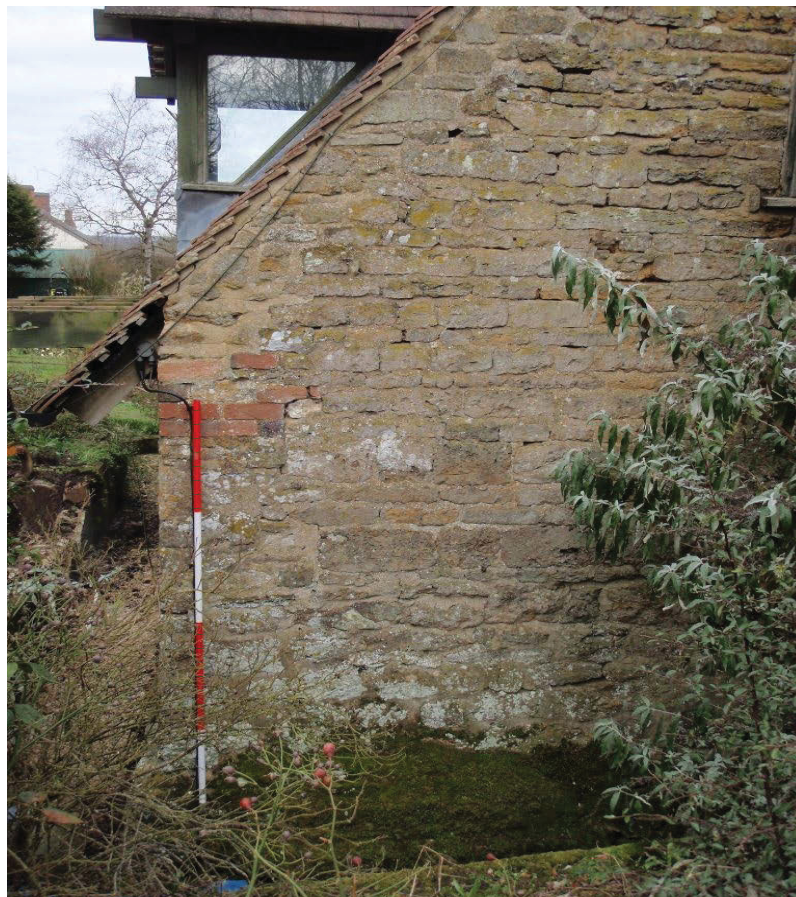
Plate 8: SE elevation showing brick repair

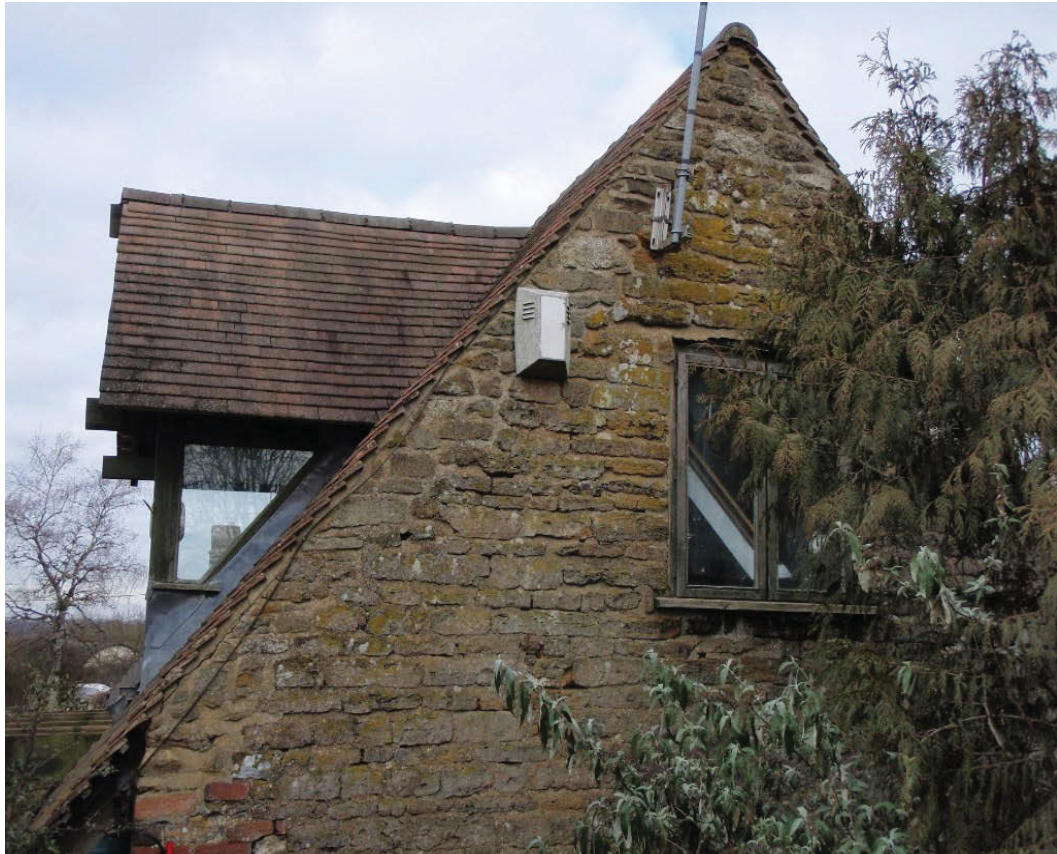
Plate 9: SE elevation gable detail

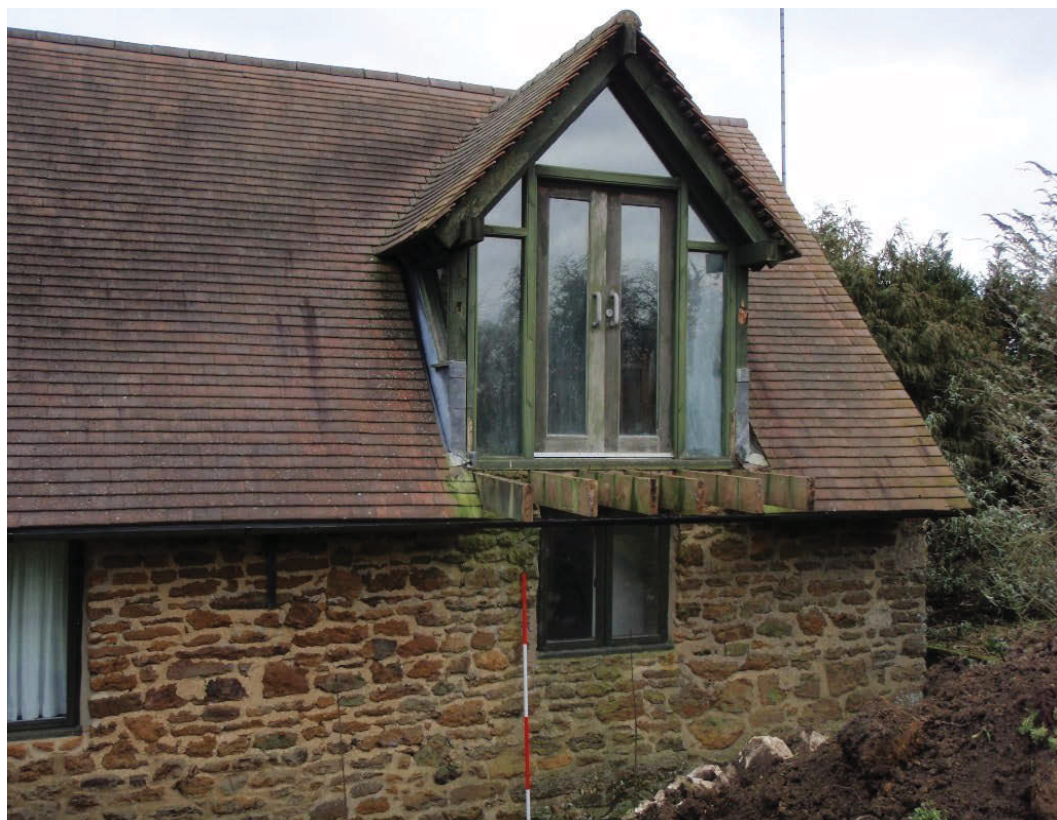
The stonework of the south west facing side elevation (plate 10 & 11) is characterised by smaller coursed ironstone with much cement repointing. Two modern casement windows again in green-stained timber pierce the elevation yet both have obvious steel lintels and their openings may be entirely recent creations. At first floor height the modern dormer projects with a glazed front surrounding double doors opening onto timber steps leading down onto the raised garden area. The opposing roof slope is pierced by two Velux rooflights.

Plate 10: South West elevation showing modern dormer entrance

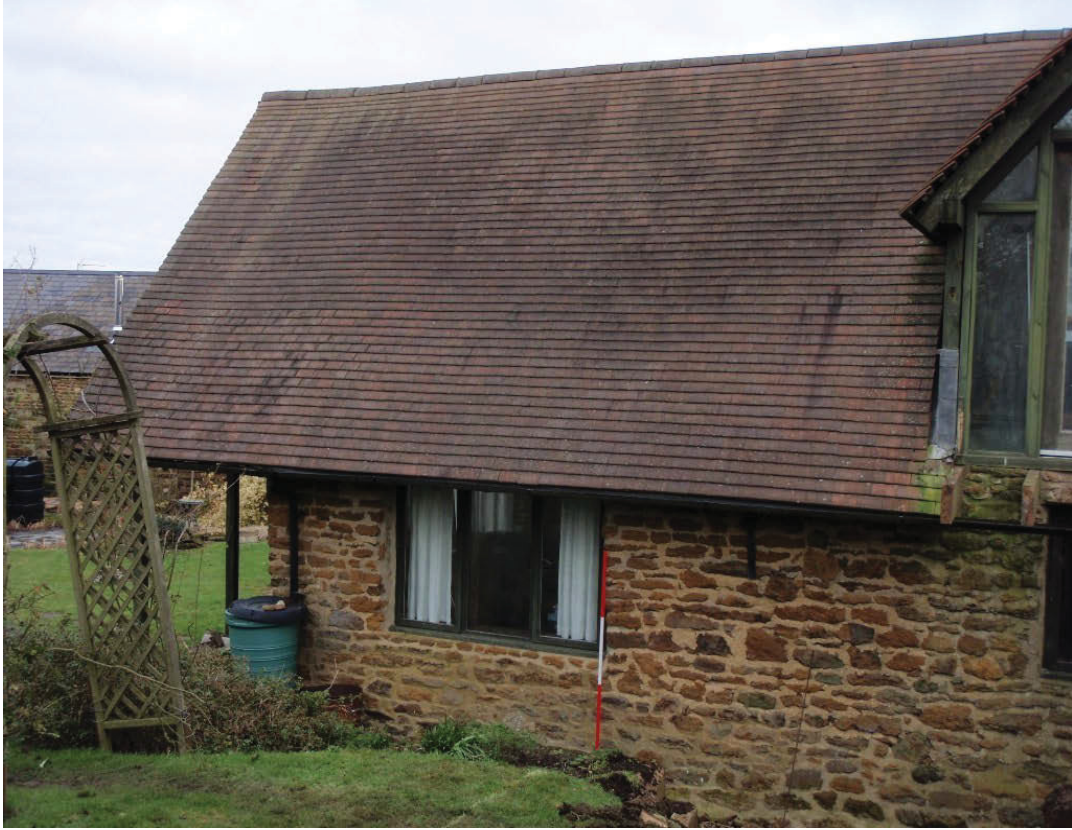
Plate 11: SW elevation

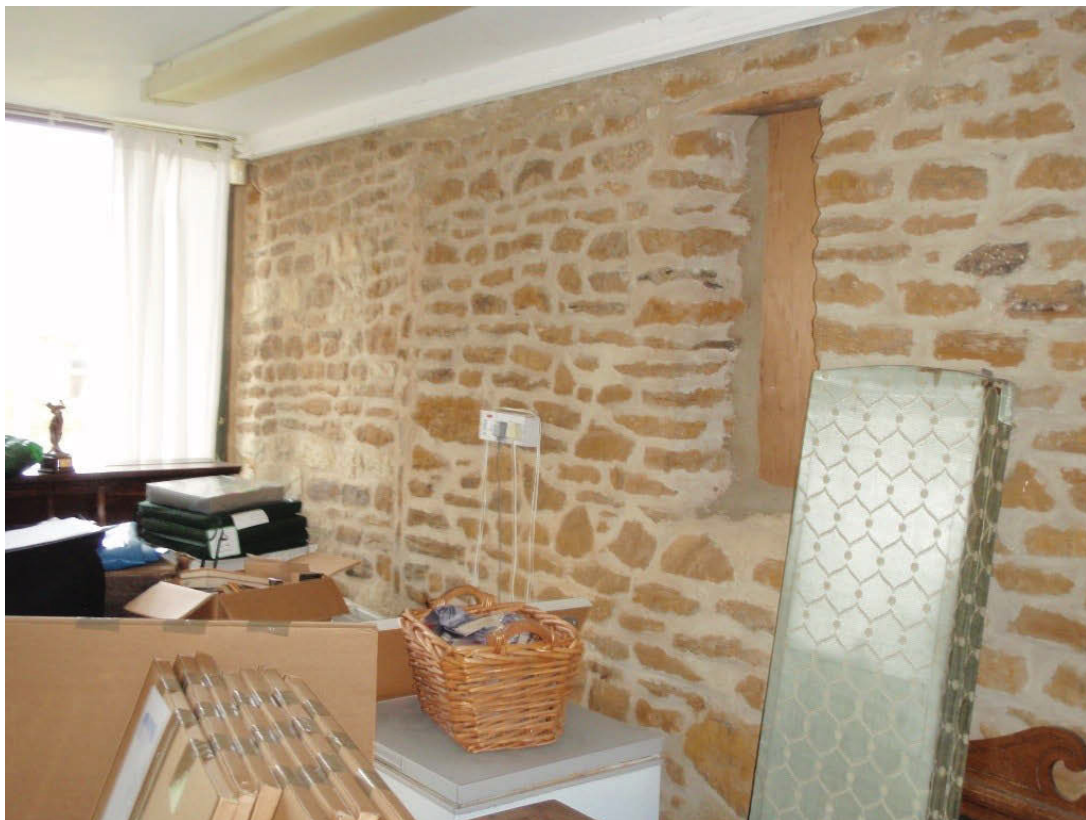
- 5.2 The original purpose of the structure is difficult to determine from the available evidence. However, it can be stated with confidence that it was broadly agricultural in nature and this is supported by surviving features such as the two blocked ventilation slits characteristic of what are usually referred to as 'barns' in the regional vernacular. The positioning of the building within what was clearly orchard in the 19<sup>th</sup> century raises the possibility that it may have functioned as a fruit store and certainly there is nothing to contradict this interpretation. The structure appears to have originally been terraced into the rising ground to the south east and this may have been deliberate, creating a cool environment in the lower part of the barn. This too may have eased access to the possible pitching hole (and loft?) in the south east gable perhaps via the outshot shown on the 1848 tithe map (figure 3). Unfortunately the loss of the original entrance via the north west gable effectively constrains further interpretation limiting the value of this record as a contribution to regional vernacular typology.

Plate 14: Games room showing stonework jointing and blocked ventilation slit in NE wall

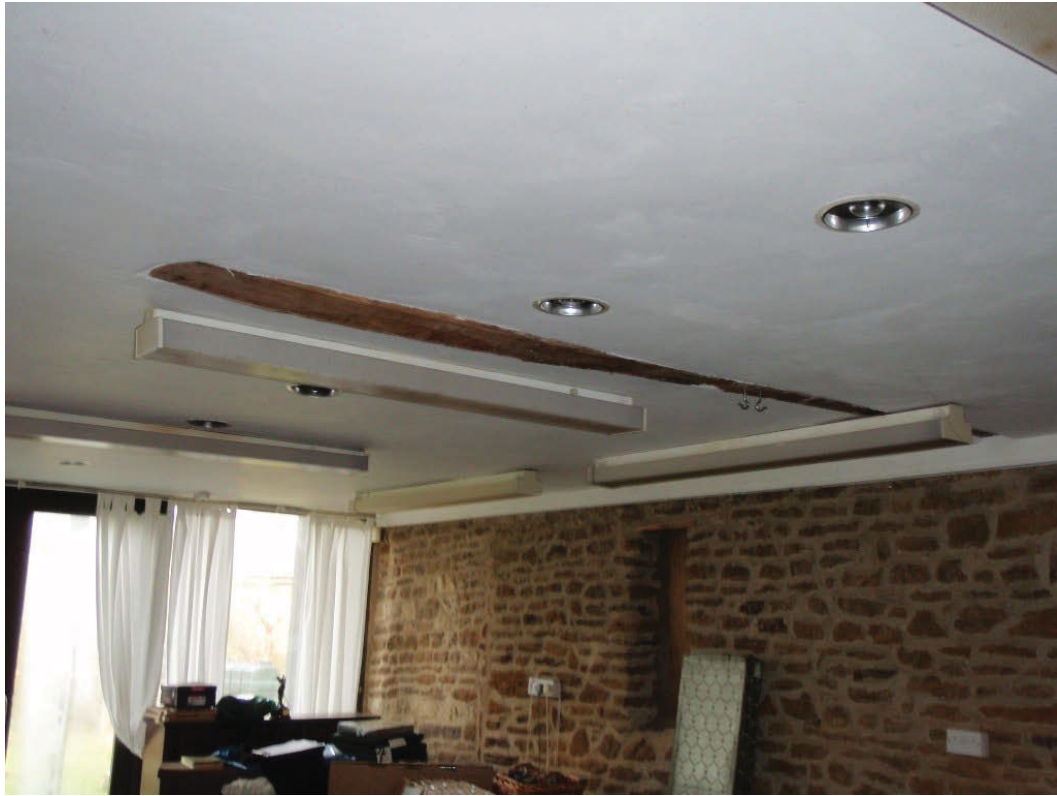
- 5.1 The outbuilding is clearly much altered and has lost much of its original character and structural elements including the larger part of the north west gable stonework and the original roof structure and covering, although a single tie beam survives. The warped appearance (which is probably original and selected for) of the tie beam and the fact that it has bark surviving on one face suggests that it pre-dates the widespread mechanisation of sawmills in the latter half of the 18<sup>th</sup> century (Harris 1979, 17-18). As such this hardwood timber, if original (and the paired mortices suggest it is), could be the best indicator of the date of the original structure. This combined with the neat masonry surviving in the south east gable makes it tempting to suggest that the outbuilding may be contemporary with the westward extension of Pear Tree Cottage with datestone of 1701 which also comprises well coursed and shaped masonry.

Plate 15: Games room, showing exposed timber joist in ceiling

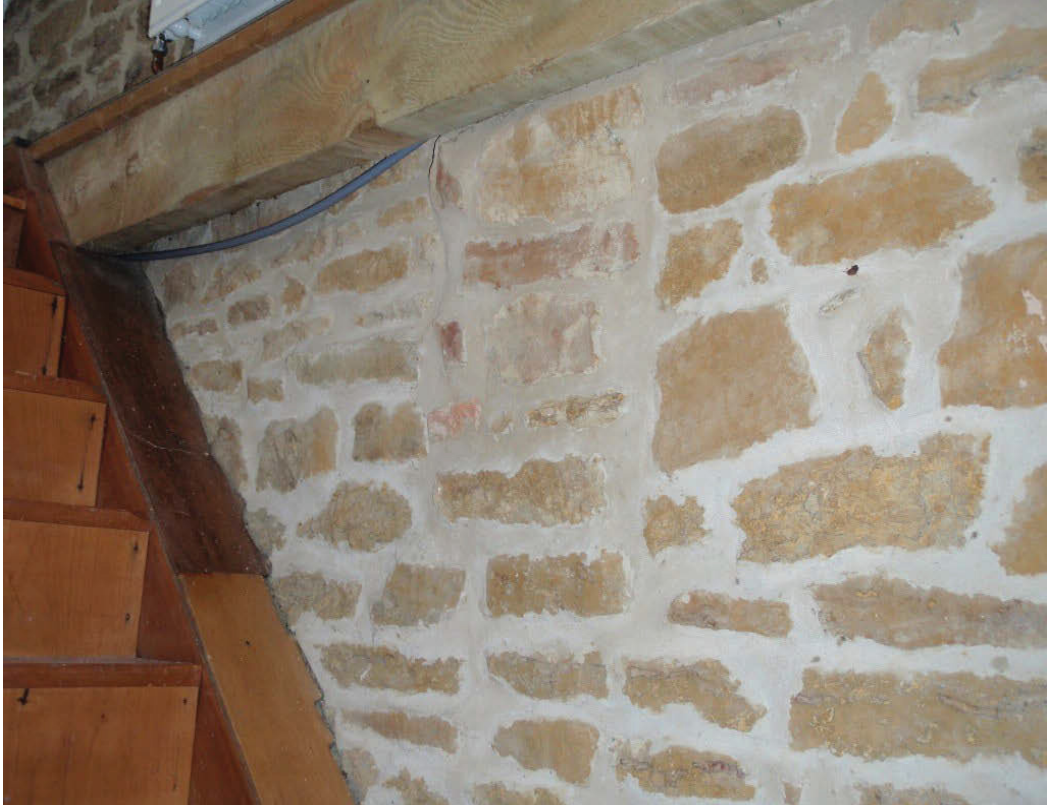
Returning to the main structure, a clearly inserted modern timber staircase is accessed through a plank boarded door and leads to the upper room. The exposed stonework of the gable adjacent to the staircase contains a probable blocked ventilation slit or niche, not visible externally (plate 19).

Plate 19: Possible blocked opening in SE gable wall

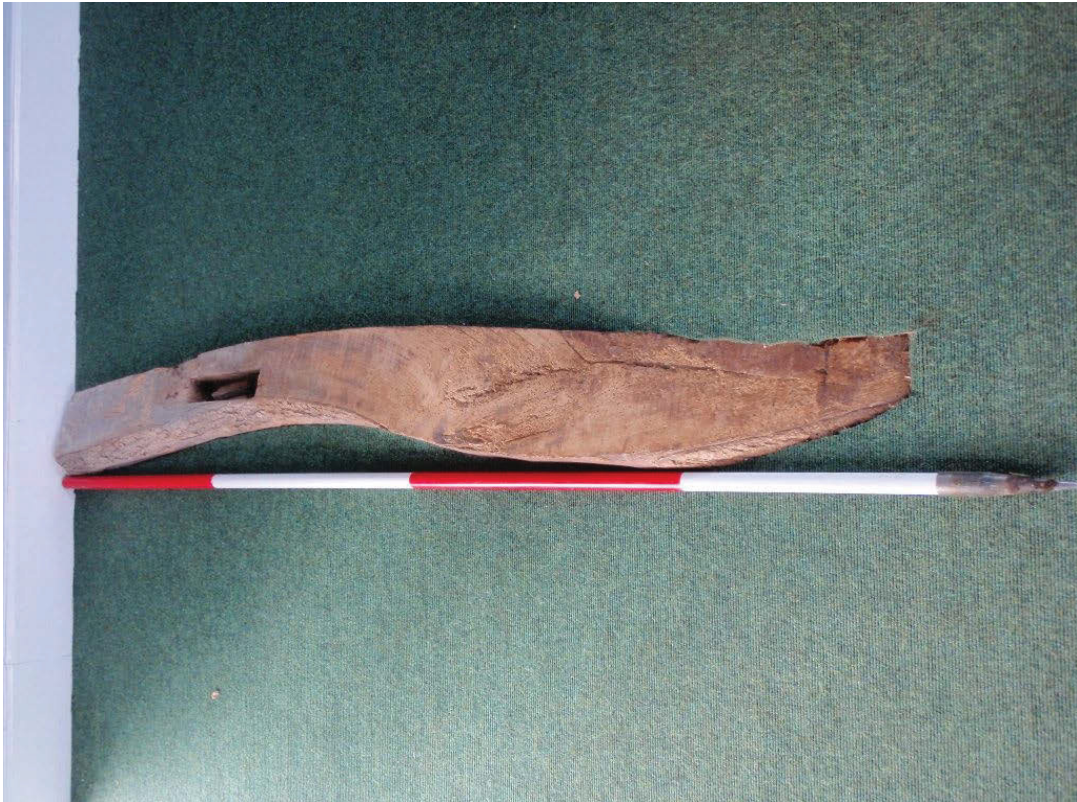
The first floor comprises an attic style room with plastered and white painted ceiling and carpeted floor. Twin Velux rooflights pierce the north east slope of the ceiling, the modern dormer entrance to the south west (plates 20 & 22). The warped tie beam visible in the lower room is exposed in the floor with mortices for struts or braces visible at each end, hinting at the configuration of the now lost original truss (plate 21). A possibly original window opening or former pitching hole with half pole timber lintels over a modern casement pierces the southeast gable its sill lined with modern clay tiles (plate 23).

Plate 21: Exposed timber joist showing strut slot in floor of Upper Room

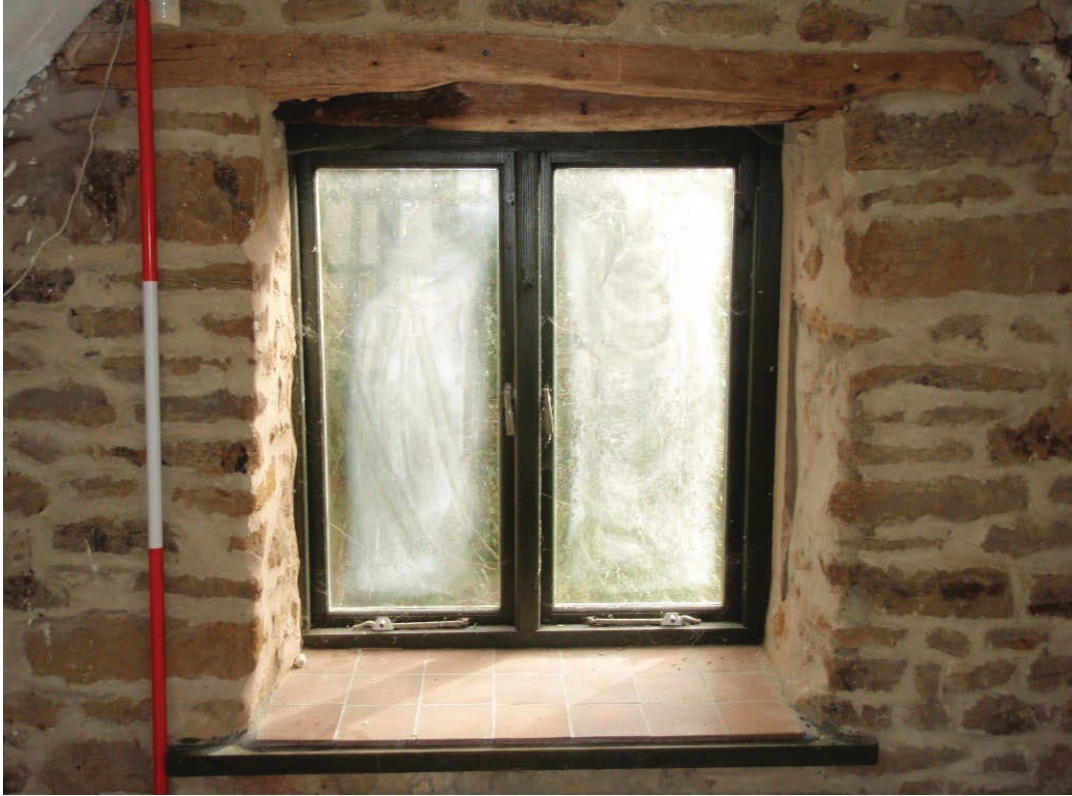
Plate 23: Window detail, Upper Room SE gable
