# Aldington Lodge, Offenham Road, Evesham

Archaeological Evaluation Report

Planning Reference W/13/01289/OU

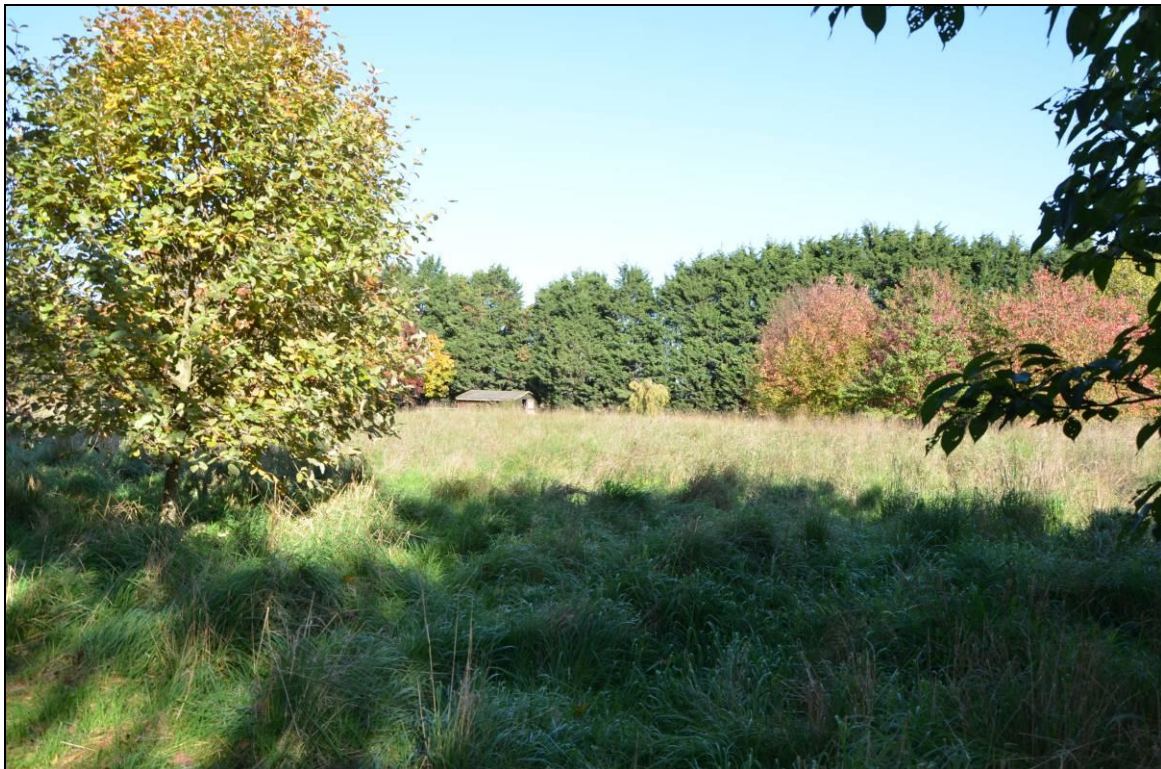
**Figure 3: South east part of site facing north west from driveway**

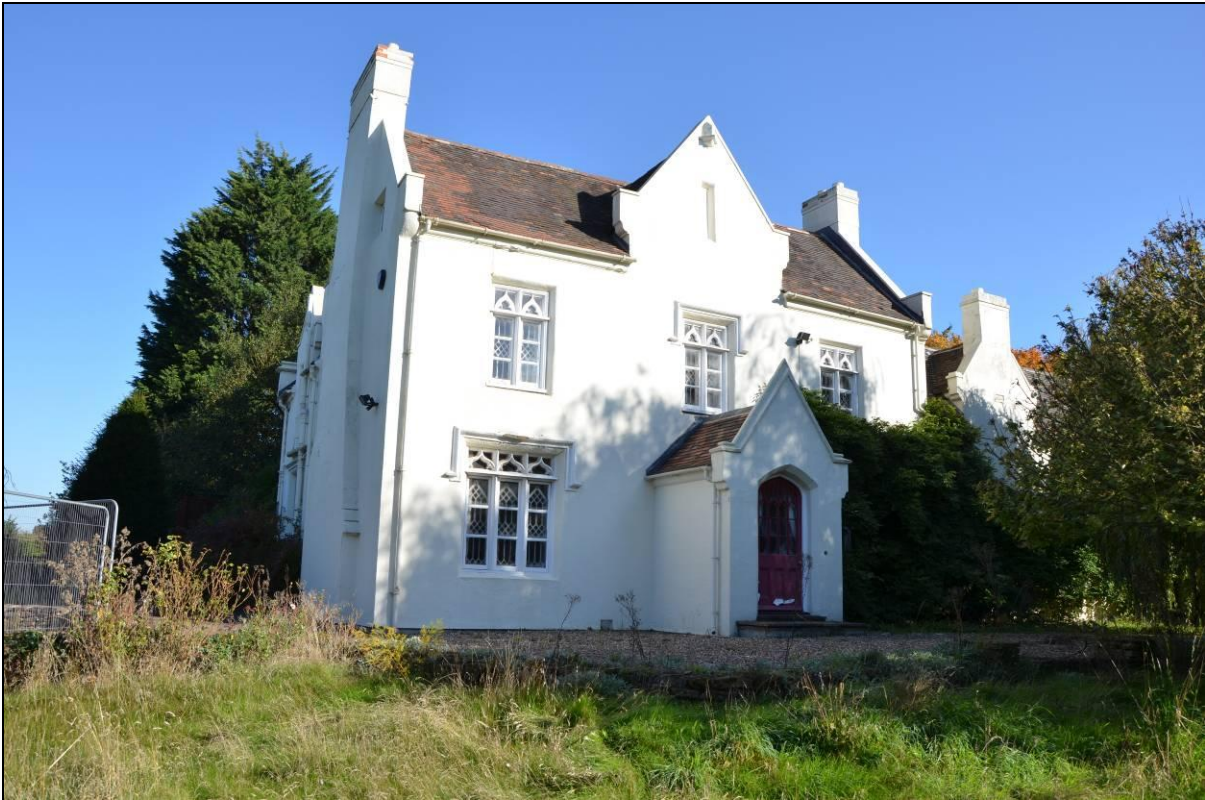
**Figure 4: Aldington Lodge and garden in south west part of site, facing north east**

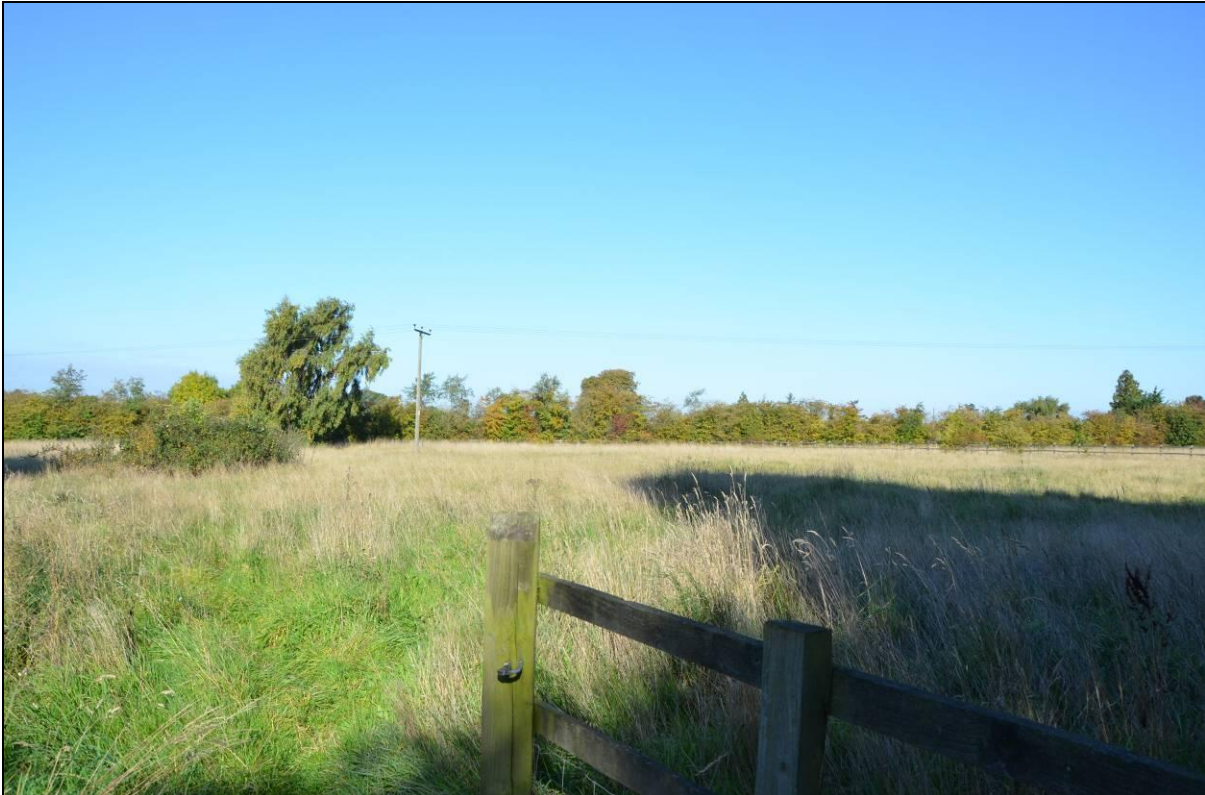
**Figure 5: Pasture in north west part of site, facing north west**

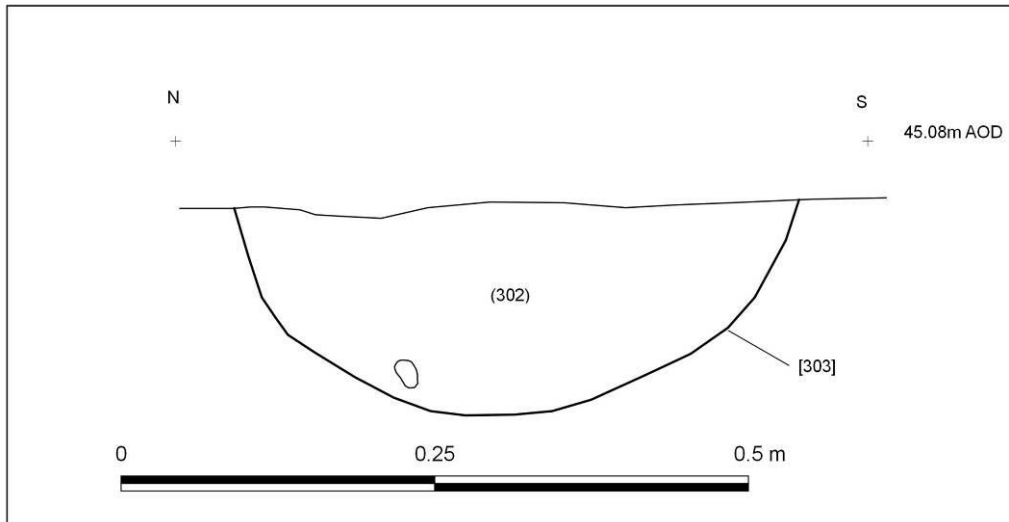
**Figure 12: West facing section, linear feature [303]**

- 7.16 The natural geology was sandy gravel (304).
- 7.17 A single linear feature (cut [303]) was excavated. This measured 0.45m wide and 0.16m deep with an observed length of 1.55m, orientated east-west. The feature was shallow with sloping sides and a flat base, terminating within the trench at its western end (Figure 12, Figure 36). The fill (302) was a mid-grey sandy silt with frequent small pebbles and gravel. An iron nail was found in this context.

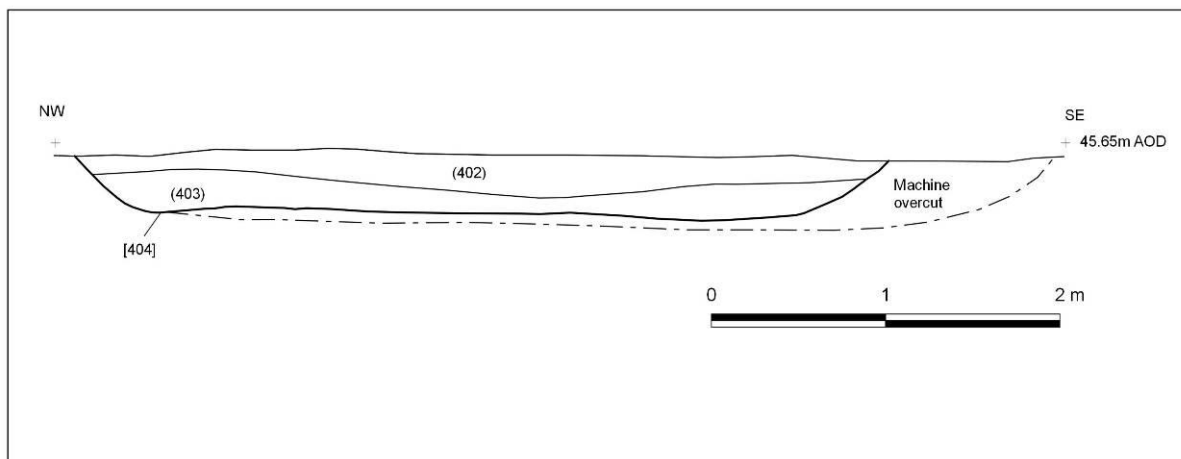
**Figure 13: South west facing section, linear feature [404]**

- 7.21 The natural geology was sandy gravel (401).
- 7.22 A broad linear feature orientated northwest-southeast was exposed in the centre of the trench (Figure 13, Figure 38, Figure 39). The cut [404] had shallow sloping sides and a flat base. It measured 4.6m wide and was 0.4m deep with an observed length within the trench of 1.8m. The basal fill (403) and upper fill (402) comprised mid-brown sandy silt with frequent gravel. (402) was 0.24m thick and (403) was 0.14m thick. Ceramic building material and pottery dated to the 18<sup>th</sup> century, alongside animal bone and an iron nail, was encountered in context (402).

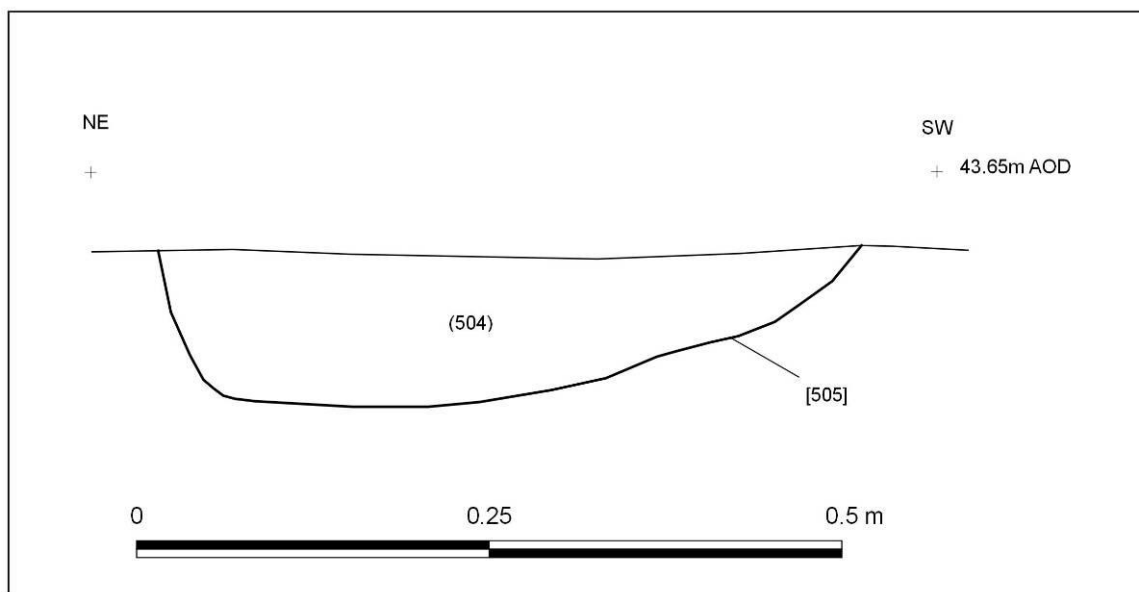
**Figure 15: South east facing section, post hole [505]**

- 7.27 [505] was also oval in plan with steep to shallow sloping sides and a flat to concave base (Figure 15, Figure 42). In plan the post hole measured 0.49 x 0.44m and it was 0.12m deep. The fill (504) was a soft, dark grey sandy silt with occasional pebbles & gravel & moderate charcoal. It was 0.12m thick.

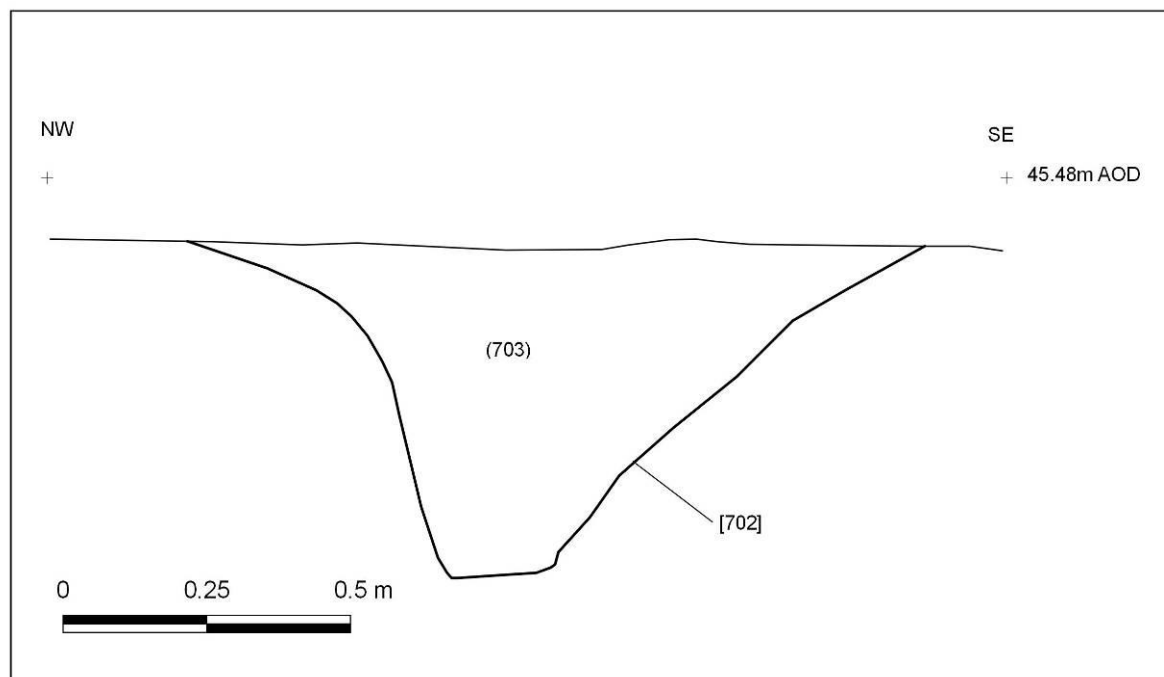
**Figure 16: South west facing section, ditch [702]**

- 7.36 The natural geology (701) was medium orange grey sandy gravel.
- 7.37 Two ditches were identified, [702] and [704], of unknown date. Linear ditch [702] was oriented northeast-southwest with very steep (45°-60°) sides and a V-shaped base (Figure 16, Figure 46). It was 1.7m wide and 0.6m deep with an observed length of 1.8m. The single fill (703) was light brown-grey silty sand with frequent gravel and pebbles.

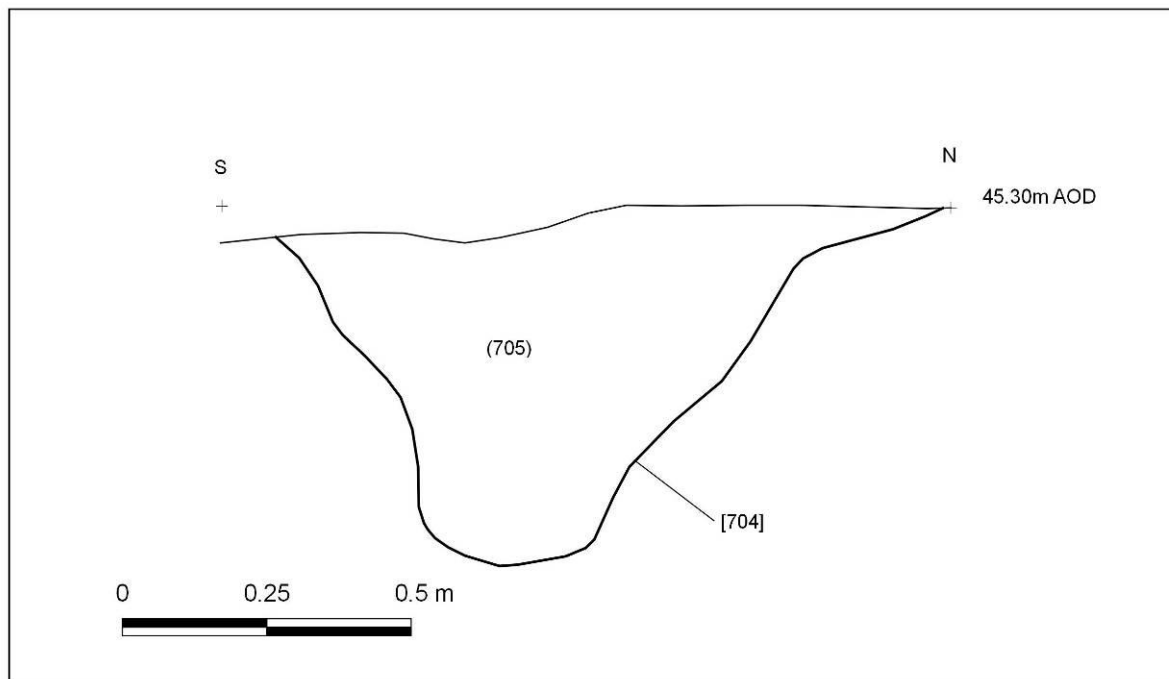
**Figure 17: East facing section, ditch [704]**

- 7.38 Linear ditch [704] was oriented east-west with very steep (45°-60°) sides and a concave base (Figure 17, Figure 47). It was 1.15m wide and 0.6m deep with an observed length of 3m. The fill (705) was light grey-orange silty sand with frequent pebbles.

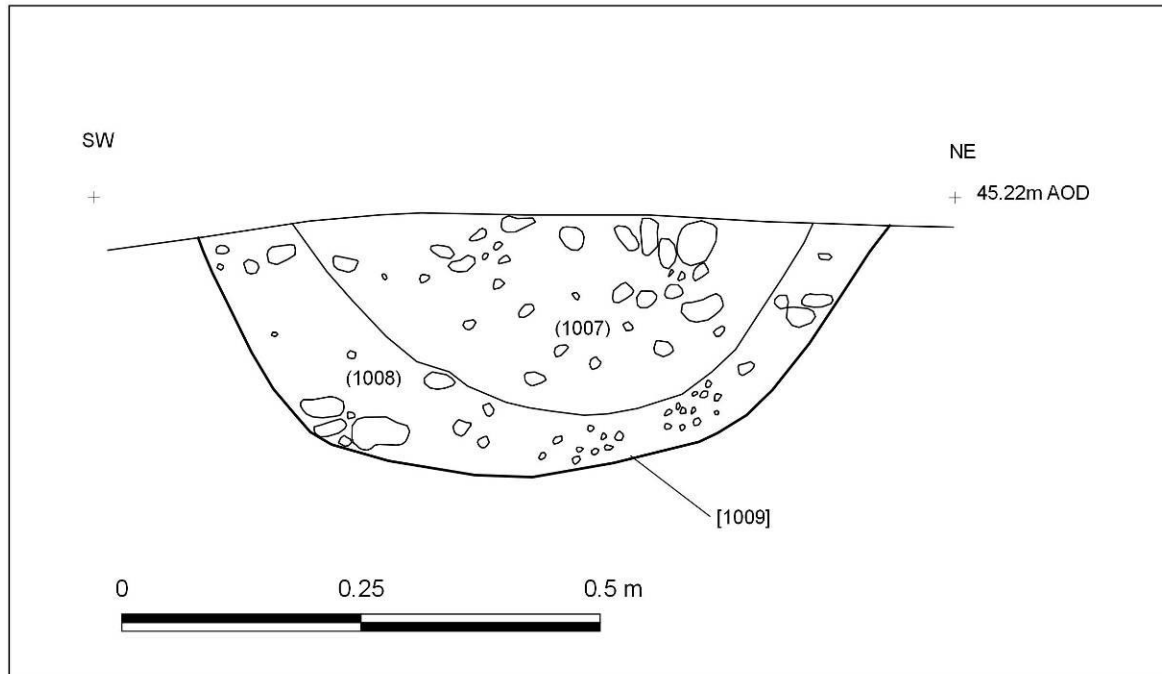
**Figure 19: South east facing section, ditch [1009]**

- 7.51 Trench 10 measured 46.5m in length orientated northeast-southwest, shortened slightly from the planned length due to the presence of a fence in the south west. The trench was excavated to a depth of 0.65m along its length (Figure 52). The trench was positioned to intercept three linear geophysical anomalies at its northern end.
- 7.52 The natural geology (1001) comprised orange/red sandy gravel.
- 7.53 Cut within the natural was a linear ditch [1009] at the northern end of the trench and three intercutting pits ([1002], [1004] and [1006]) towards the centre.
- 7.54 Ditch [1009] was orientated northwest-southeast. The cut was linear in plan, 0.72m wide and 0.27m deep with steep sides and a concave base (Figure 19, Figure 55). The observed length within the trench was 2.1m, extending beyond the trench edges. The

basal fill (1008) was loose, light greyish brown sand with frequent small, medium and large sub-rounded and rounded pebbles. It was up to 60mm thick. The second, upper fill (1010) was loose, dark greyish brown silty sand with frequent small, medium & large sub-rounded and rounded pebbles. This was 0.21m thick. No finds were recovered from the feature.

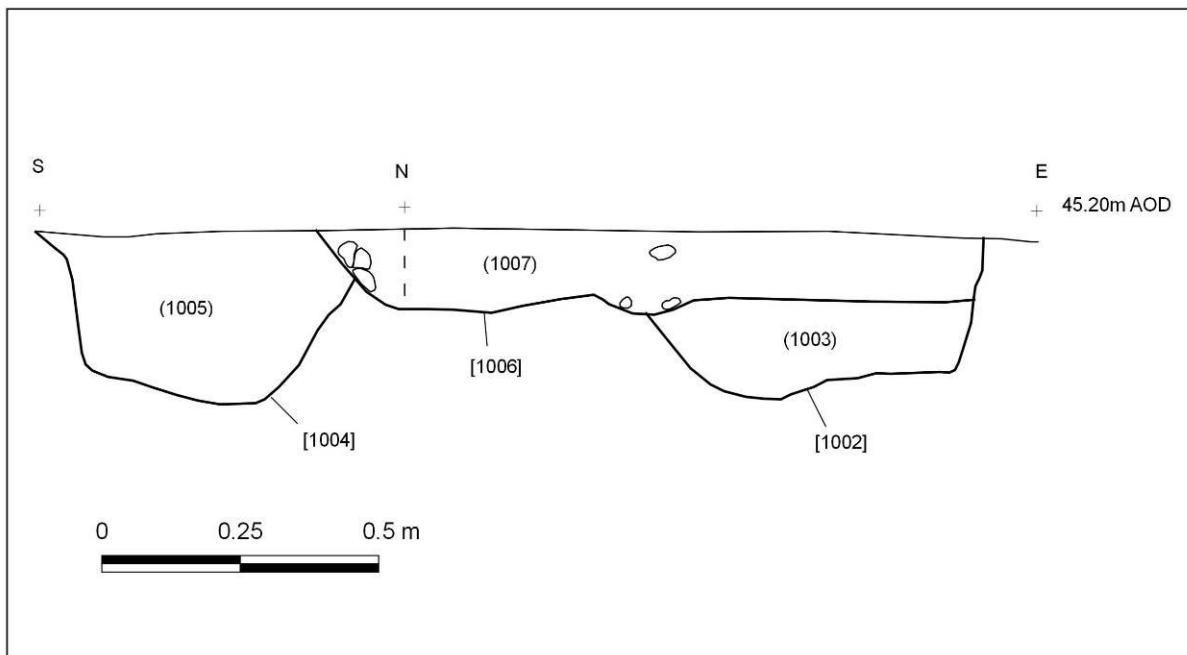
**Figure 20: East/south facing section, intercutting pits [1002], [1004] and [1006]**

- 7.55 The cluster of pits in the centre of the trench comprised two discrete earlier pits [1002] and [1004], both cut into by later pit [1006] (Figure 20, Figure 54):

- 7.58 Pit [1006] was an east-west orientated oval cut with steep (45°-60°) sides and a flattish base. It measured 1.4 x 0.55m and was 0.15m deep. The fill (1007) was dark brown-orange sandy silt with occasional pebbles, charcoal flecks, iron nails and part of a metal bucket handle.

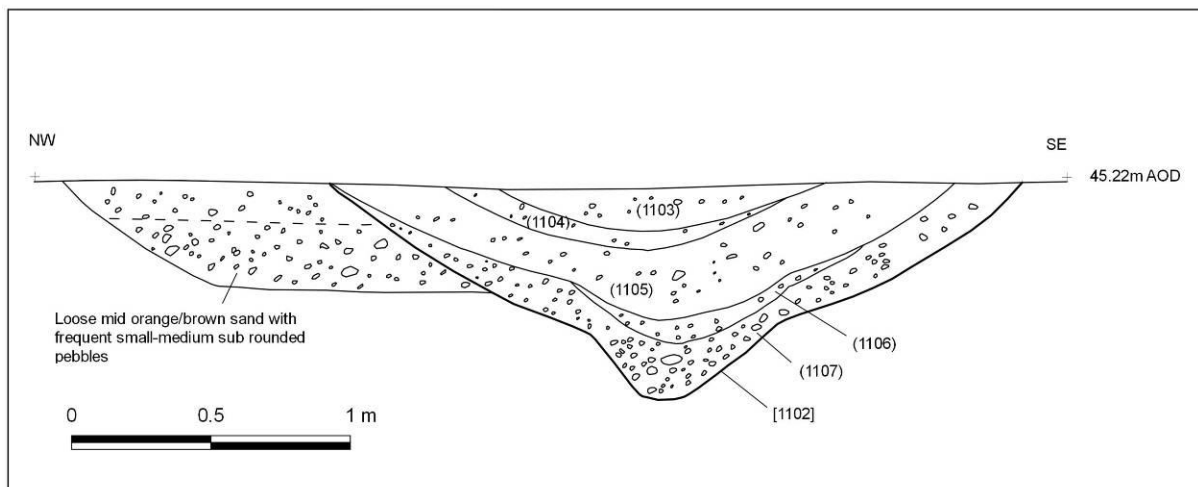
**Figure 21: South west facing section, ditch [1102]**

- 7.64 Ditch [1102] was orientated northeast- southwest. It was a linear cut with gently sloping upper sides (c. 30°) leading to a sharp break becoming steep-sided (c. 45°-60°) with a flat base (Figure 21, Figure 60). The ditch was 2.4m wide and 0.83m deep with an exposed length of 1.8m. The fill was comprised of 5 contexts: (1107), (1106), (1105), (1104) and (1103) from earliest to latest. (1107) was a loose dark/mid greyish brown silty sand 0.22m thick containing frequent charcoal flecks and frequent small, medium, large sub-rounded and rounded pebbles. (1106) was loose dark/mid greyish brown silty sand with frequent charcoal flecks and frequent small, medium and large sub-rounded and rounded pebbles. It measured 0.38m thick. (1105) was mid-light orange grey silty sand with large gravels. It was 0.53m thick. (1104) was soft, mid grey brown silt with burnt stones and charcoal. It was 0.24m thick. (1103) was soft, mid brown silty sand with moderate small, medium and large sub-rounded and rounded pebbles. It was 0.19m thick. The only artefact encountered was a small fragment of very heavily

abraded shell and oolitic limestone-tempered ware pottery, tentatively dated to the pre-Middle Iron Age, in context (1104).

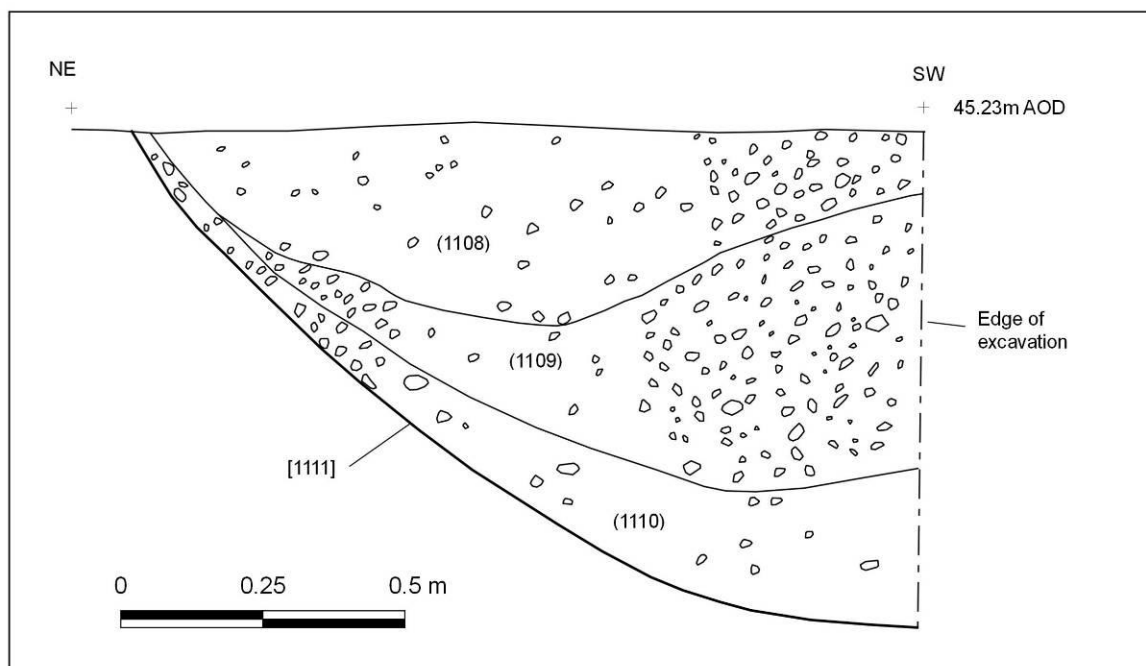
**Figure 22: South west facing section, pit/tree bole [1111]**

- 7.65 Pit/tree bole [1111] was sub-circular in plan with shallow sides becoming steeper towards a concave base (Figure 22, Figure 58). It was 4.65m wide and 0.88m deep, extending beneath the south western trench edge. Basal fill (1110) was loose light orange brown sand with moderate small, medium and large sub-rounded and rounded pebbles, up to 0.28m thick. This was overlain by context (1109), a loose light grey silty sand with moderate small, medium and large sub-rounded and rounded pebbles in the northeast (frequent in the southwest). It measured up to 0.53m thick. The upper fill (1108) was loose, mid greyish brown silty sand with moderate small, medium and large sub-rounded and rounded pebbles in the northeast, (frequent in the southwest), up to 0.36m thick.

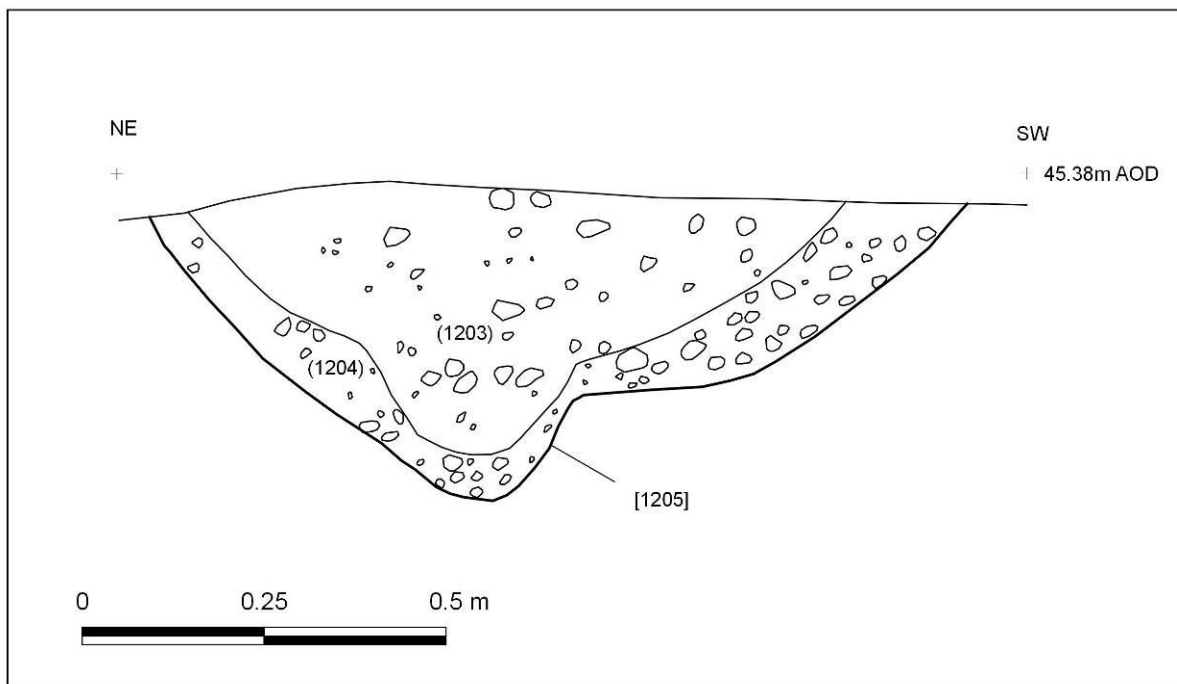
**Figure 24: South east facing section, ditch [1205]**

- 7.71 Ditch [1205] was linear in plan oriented northwest-southeast with a gradual break of slope and gently sloping sides, becoming steep sided towards a flat base (Figure 24, Figure 64). It was 0.9m wide and 0.44m deep with an observed length of 2.6m. The basal fill (1204) was loose light greyish brown sand with frequent small, medium & large pebbles (only occasional in the northeast), up to 80mm thick. The upper fill (1203) was

loose mid-dark brownish grey silty sand with moderate small, medium and large rounded and sub-rounded pebbles, 0.38m thick. The feature contained no finds.

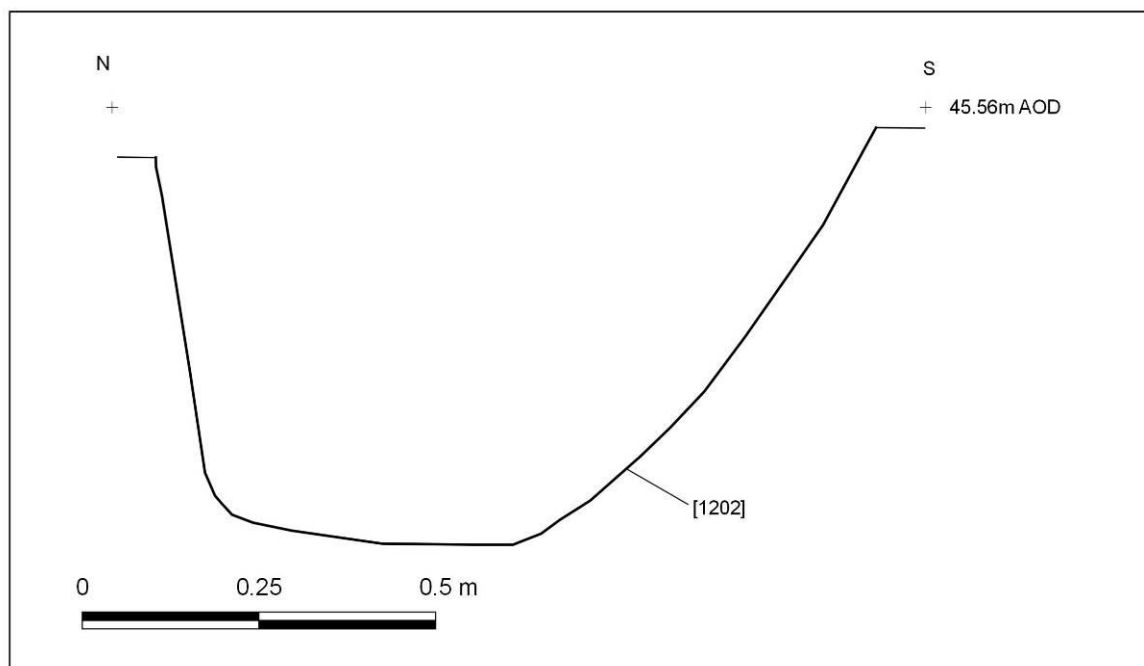
**Figure 26: West facing post-excavation profile, tree bole [1202]**

- 7.73 A tree bole was encountered towards the southern end of the trench. The cut [1202] was oval in plan with very steep (almost vertical) sides except in the southwest (Figure 26, Figure 65). It had a flat irregular base. It measured 1.5x1m in plan and was 0.6m deep. The fill was (1201) was a moderately loose mid yellowish grey sandy silt with frequent small with medium and large rounded and sub-rounded pebbles.

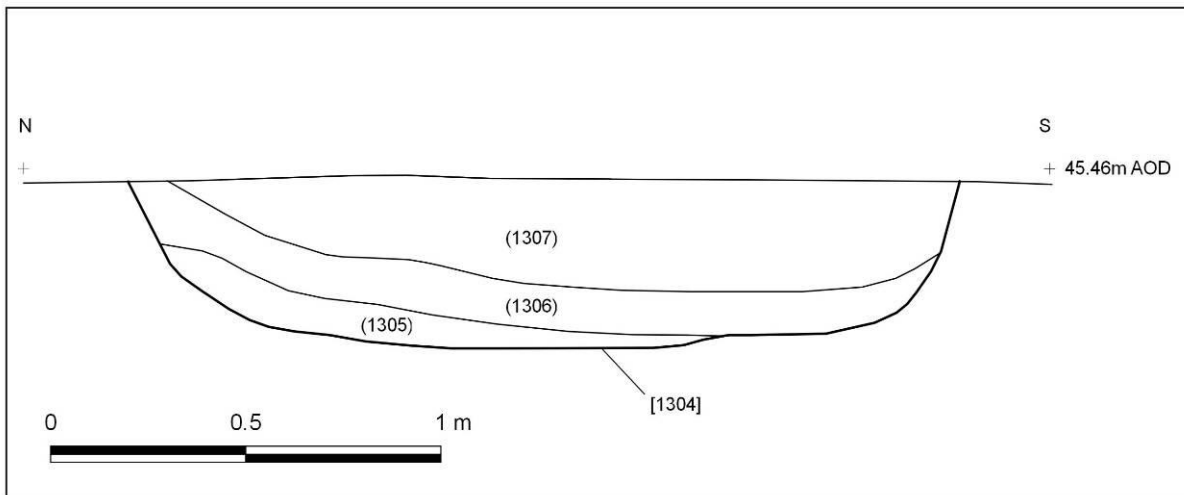
**Figure 28: West facing section, ditch [1304]**

- 7.79 Possible ditch [1304] was linear in plan oriented northwest-southeast, with gently sloping sides and a flattish/ slightly concave base (Figure 28, Figure 68). It measured 2.65m wide, 0.55m deep with an observed length of 1.8m. The basal fill (1305) comprised sandy gravel up to 0.1m thick. This was sealed by fill (1306), a light grey-orange silty sand with gravel, up to 0.15m thick. The upper fill (1307) was a medium brown-orange silty sand with frequent pebbles & gravel, up to 0.1m thick. The location/orientation does not correspond to the continuation of any geophysical anomalies recorded to the west.

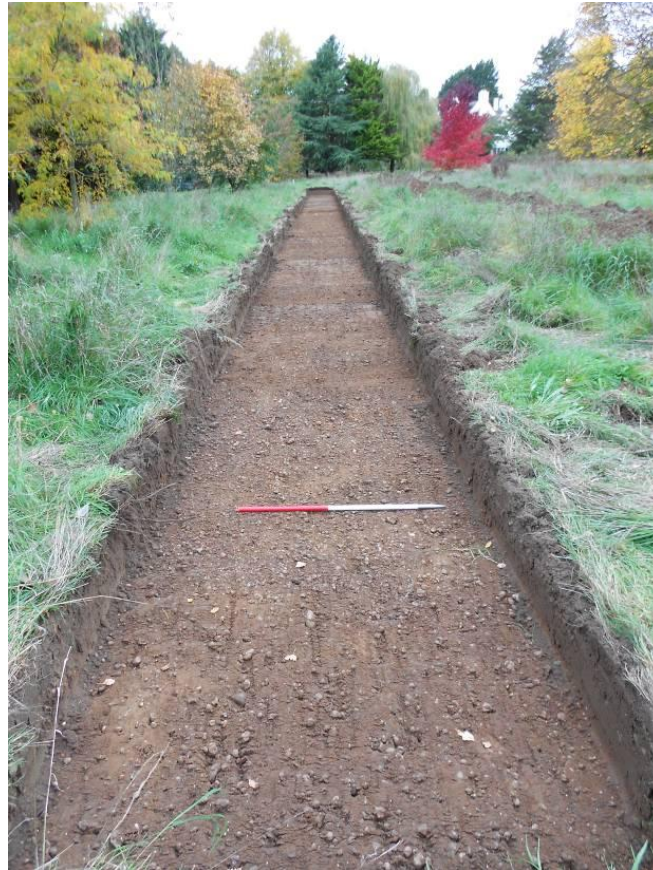
**Figure 32: Trench 2, facing north west**

- 7.11 Trench 2 was shortened in the west due to the presence of services. The trench measured 47m and was excavated to a depth of 0.4m (Figure 32). It was orientated northwest-southeast.
- 7.12 No archaeology was encountered.
- 7.13 The natural geology was sandy gravel (201).
- 7.14 The overlying topsoil (200) was brown sandy silt up to 0.4m deep (Figure 33).

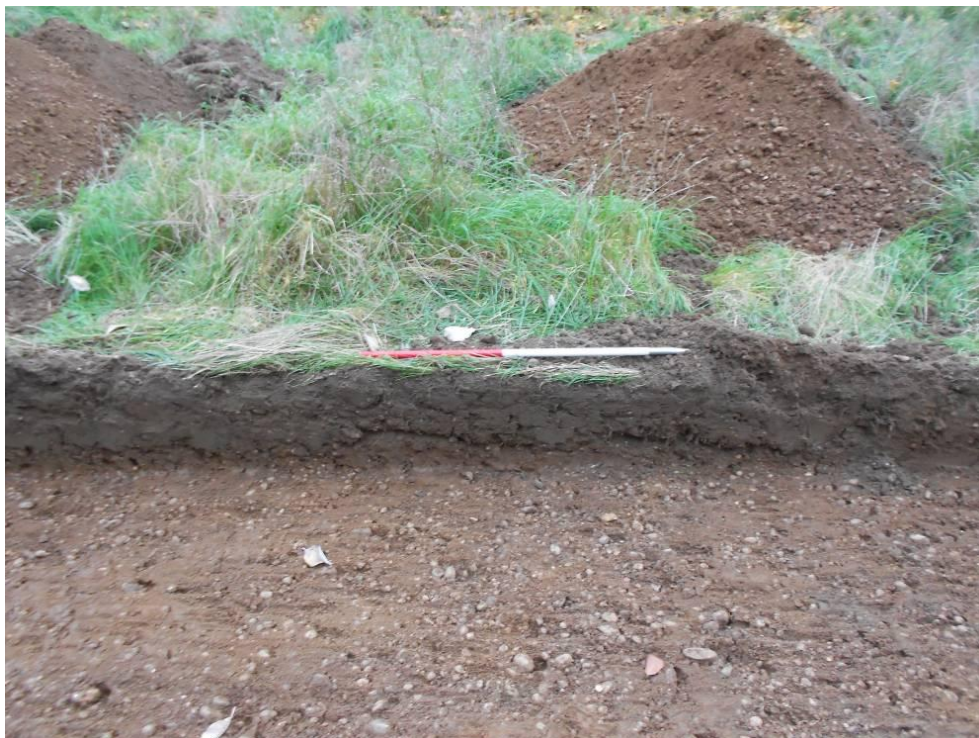
**Figure 33: Trench 2, south facing section**

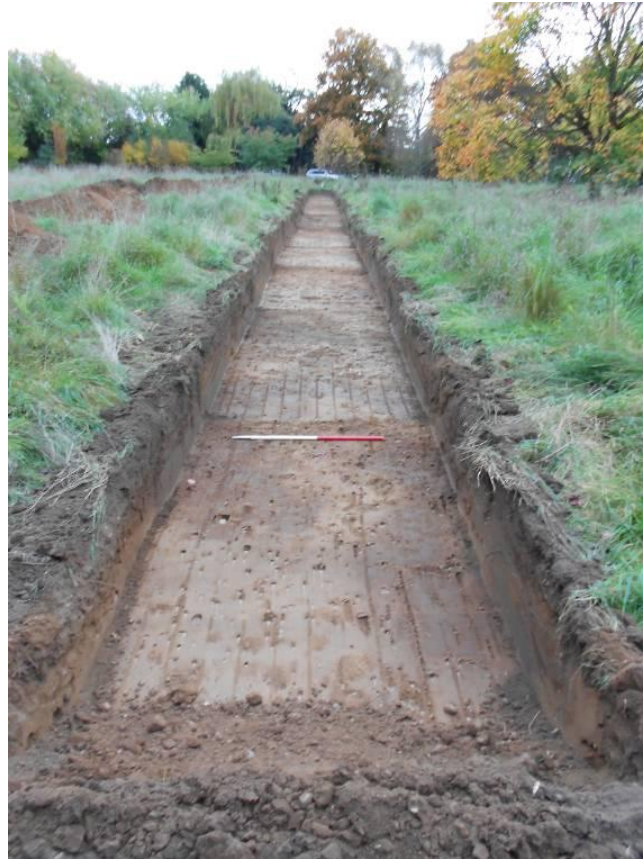
**Figure 34: Trench 3, facing south**

- 7.15 Trench 3 was excavated in its proposed location. The trench was 50m long and was excavated to a depth of 0.55m (Figure 34). It was orientated northwest-southeast.

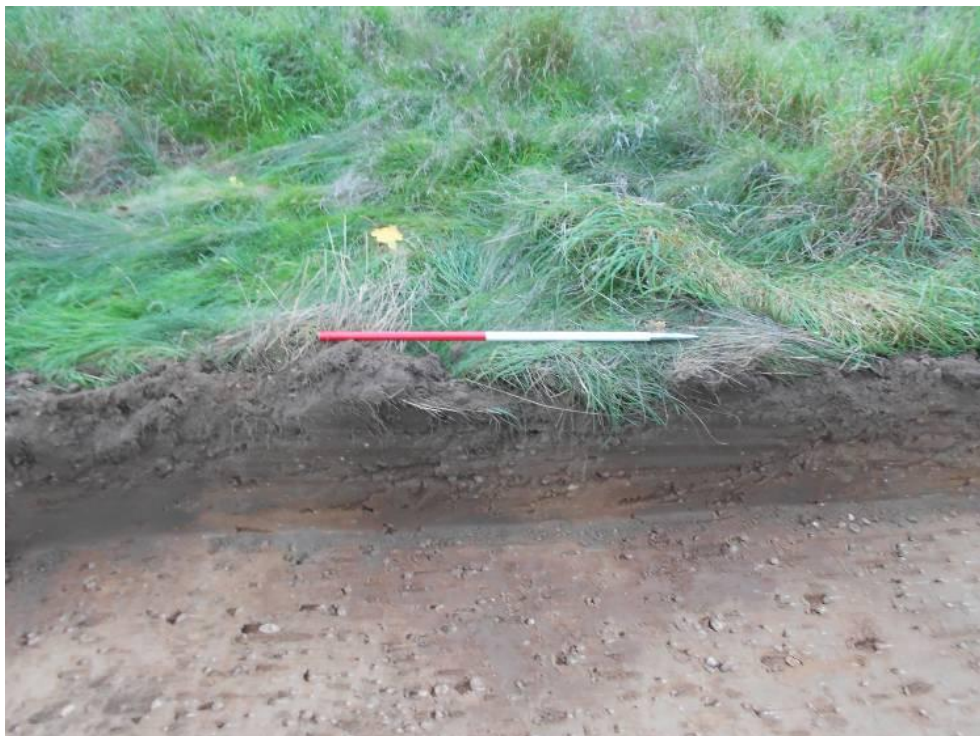
**Figure 35: Trench 3, east facing section**

- 7.18 The overlying topsoil (300) was dark brown sandy silt, 0.3m thick (Figure 35).
- 7.19 Discrete geophysical anomalies detected at this location during the geophysical survey were not encountered within the trench.

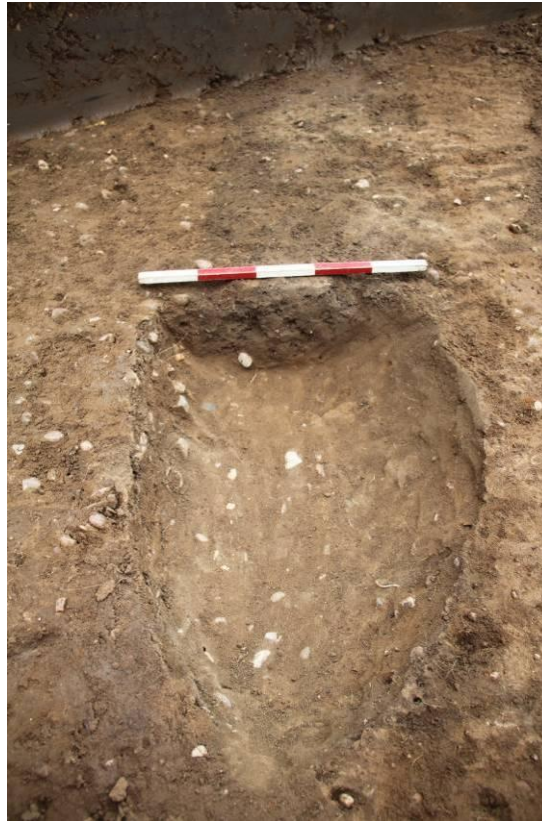
**Figure 36: Trench 3, gully terminus [303] facing south east**

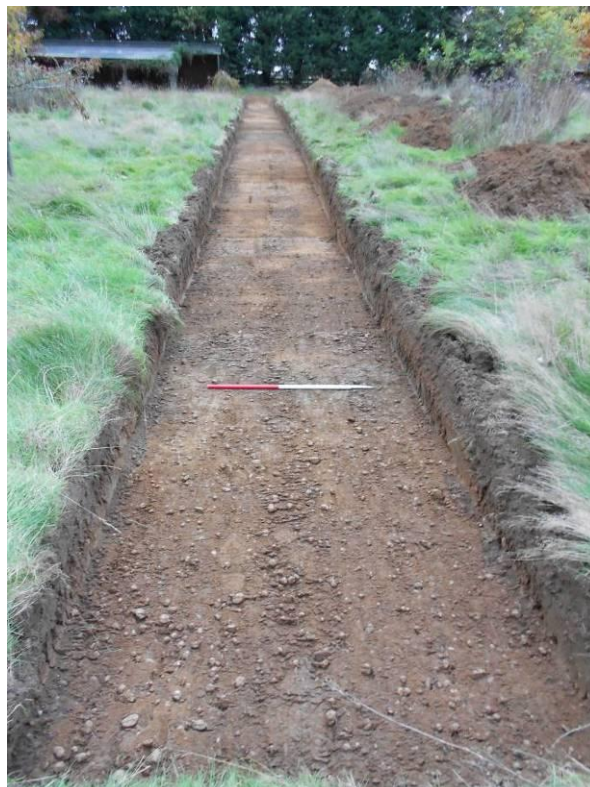
**Figure 37: Trench 4, facing north east**

- 7.20 Trench 4 was shortened and slightly relocated to the east due to the presence of trees in the south, and widened in the centre to investigate a linear feature. It measured 42.4m in length and was excavated to a depth of 0.5-0.8m (Figure 37). It was orientated northeast-southwest.

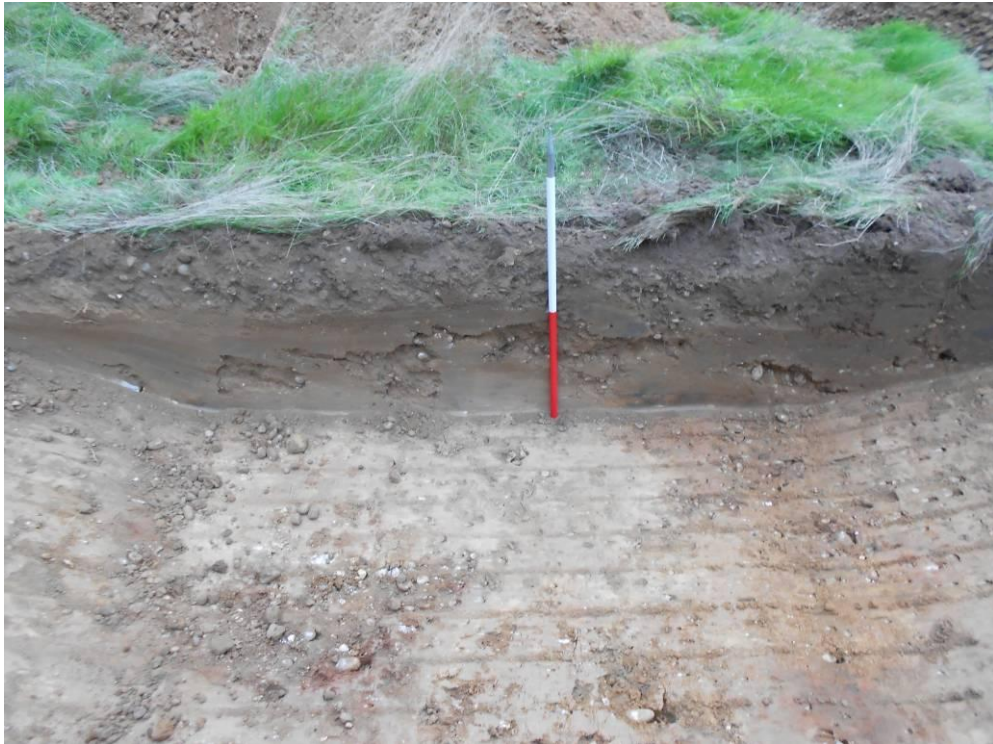
**Figure 38: Trench 4, south east facing section**

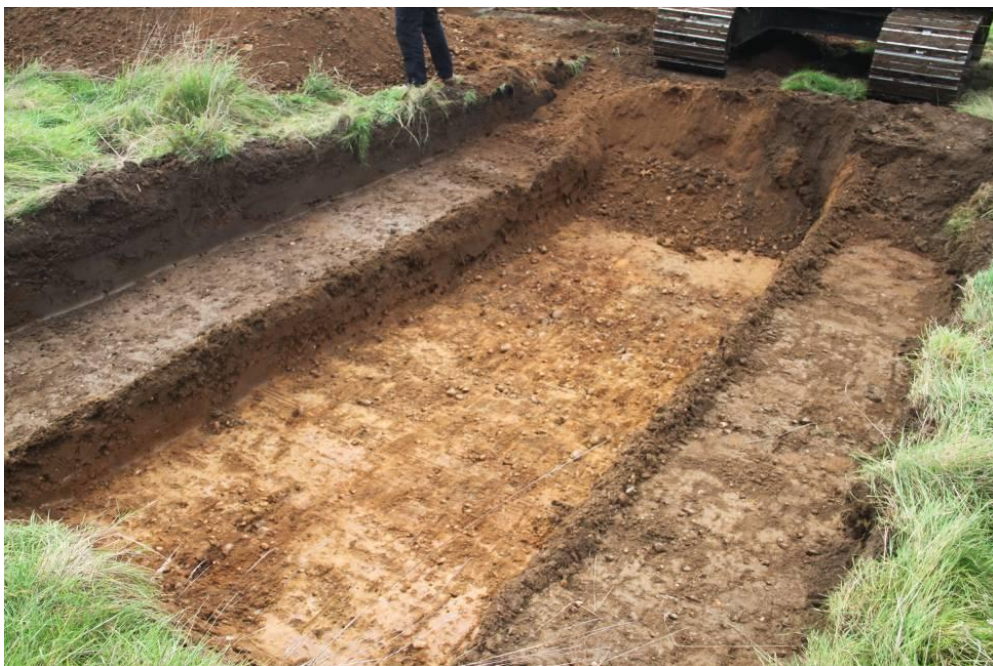
**Figure 39: Trench 4, linear feature [404], looking south east**

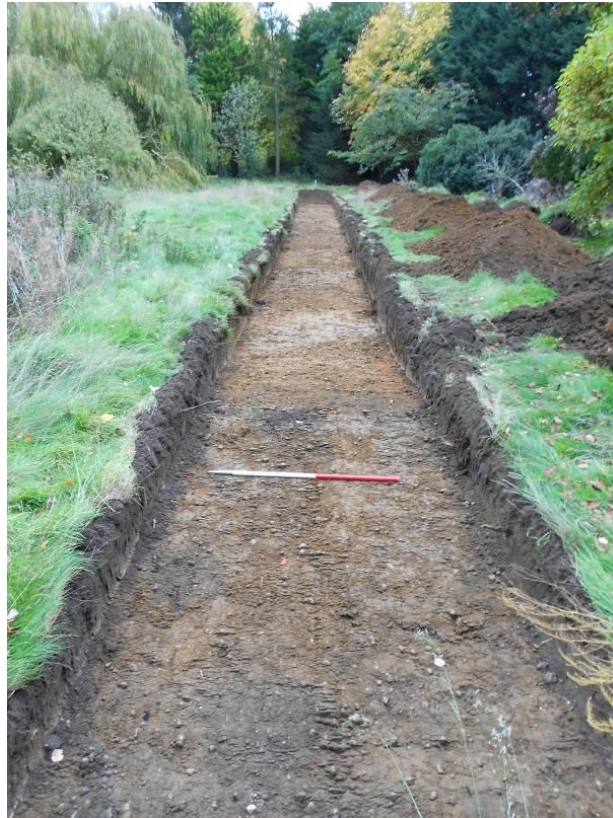
**Figure 40: Trench 5, facing north west**

- 7.24 Trench 5 was excavated in its proposed location but was shortened in the south east because of the presence of trees. The trench measured 35.7m and was excavated to a depth of 0.5m (Figure 40). It was orientated northwest-southeast.

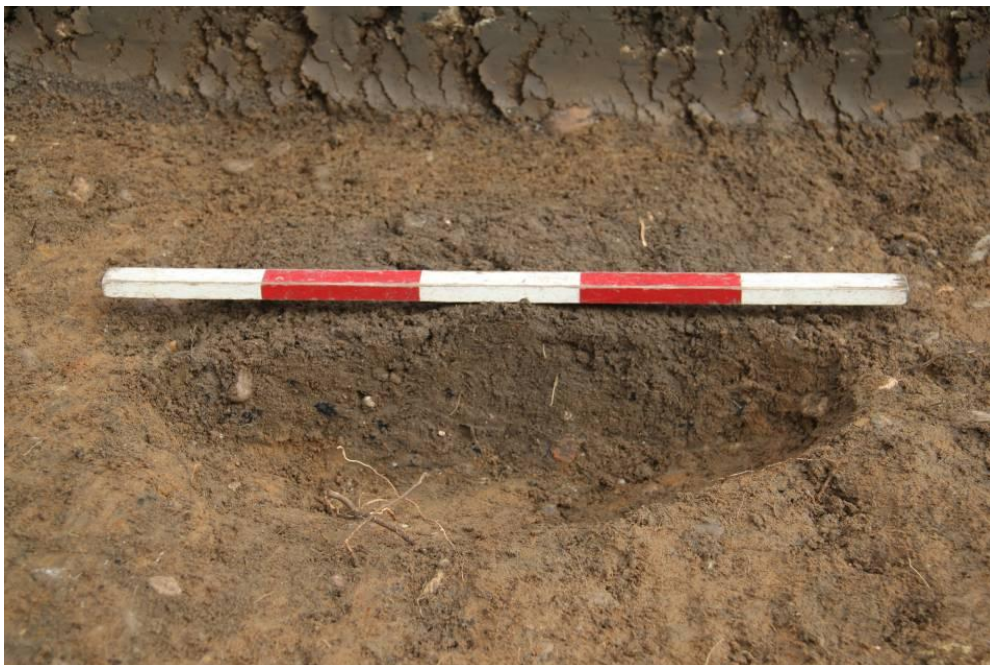
**Figure 41: Trench 5, possible posthole [503], south west facing section**

- 7.25 The natural geology in the trench comprised sandy gravel (506).
- 7.26 Two postholes were encountered in the northwest end of the trench: [503] and [505]. [503] was oval in plan with shallow sloping sides and a concave base (Figure 14, Figure 41). It measured 0.42x0.38m and was 0.1m deep. The fill (502) was a soft, dark, grey sandy silt with occasional pebbles and gravel and moderate charcoal.

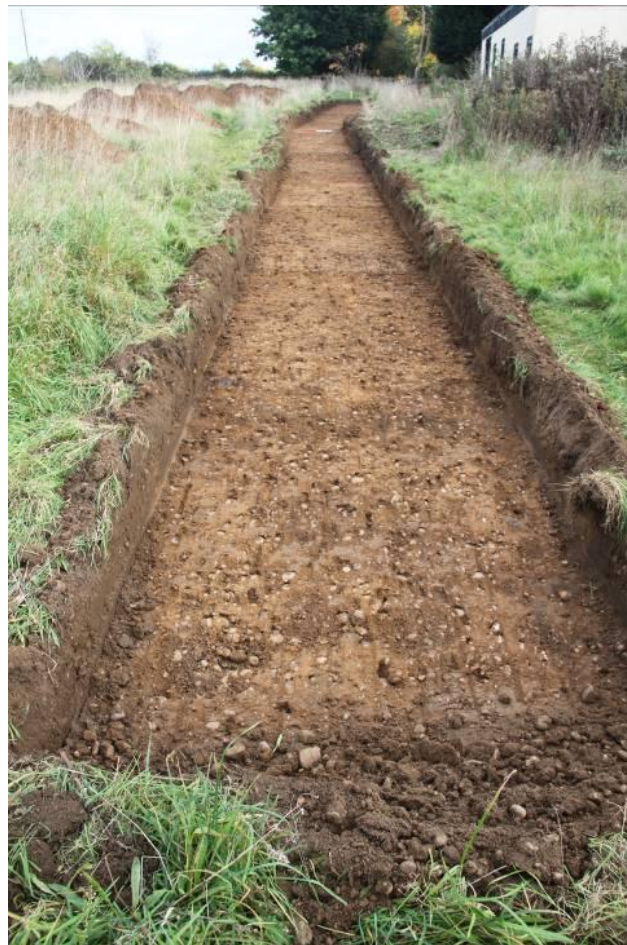
**Figure 43: Trench 6, facing east**

- 7.31 Trench 6 was excavated in the proposed location. The trench measured 50m and was excavated to a depth of 0.32-0.4m (Figure 43). It was orientated northwest-southeast.
- 7.32 No archaeology was encountered.
- 7.33 The natural geology (601) was mid-light orange brown sandy gravel.

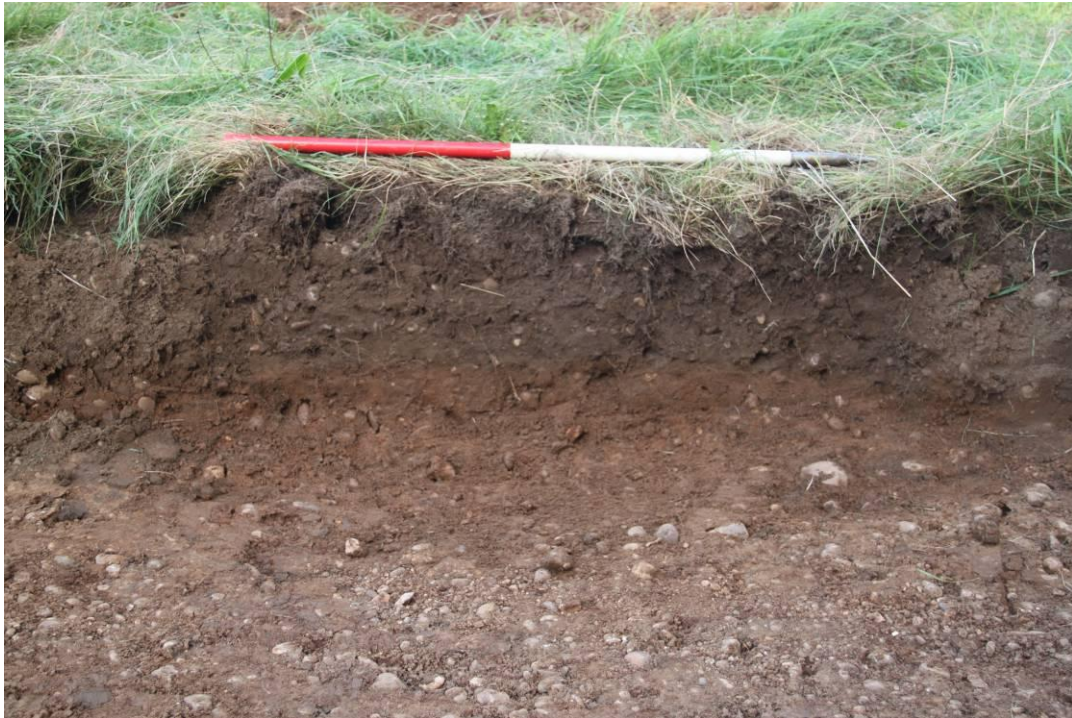
**Figure 44: Trench 6, south facing section**

- 7.34 The topsoil (600) was loose, dark greyish brown silty sand between 0.32-0.4m thick (Figure 44).

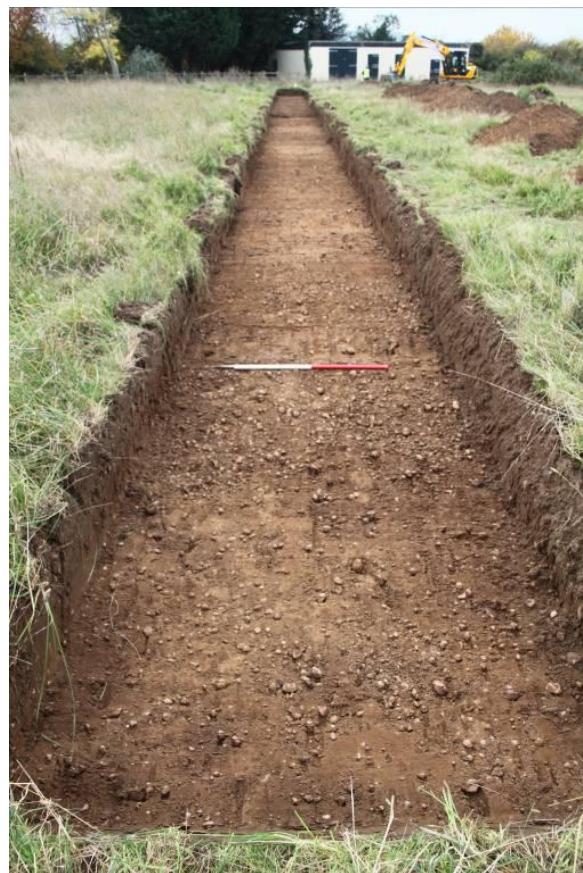
**Figure 45: Trench 7, facing south west**

- 7.35 Trench 7 was excavated in its proposed location. It measured 50m in length and was excavated to a depth of 0.4m, orientated northeast-southwest (Figure 45).
