# Aldington Lodge, Offenham Road, Evesham

Archaeological Evaluation Report

Planning Reference W/13/01289/OU

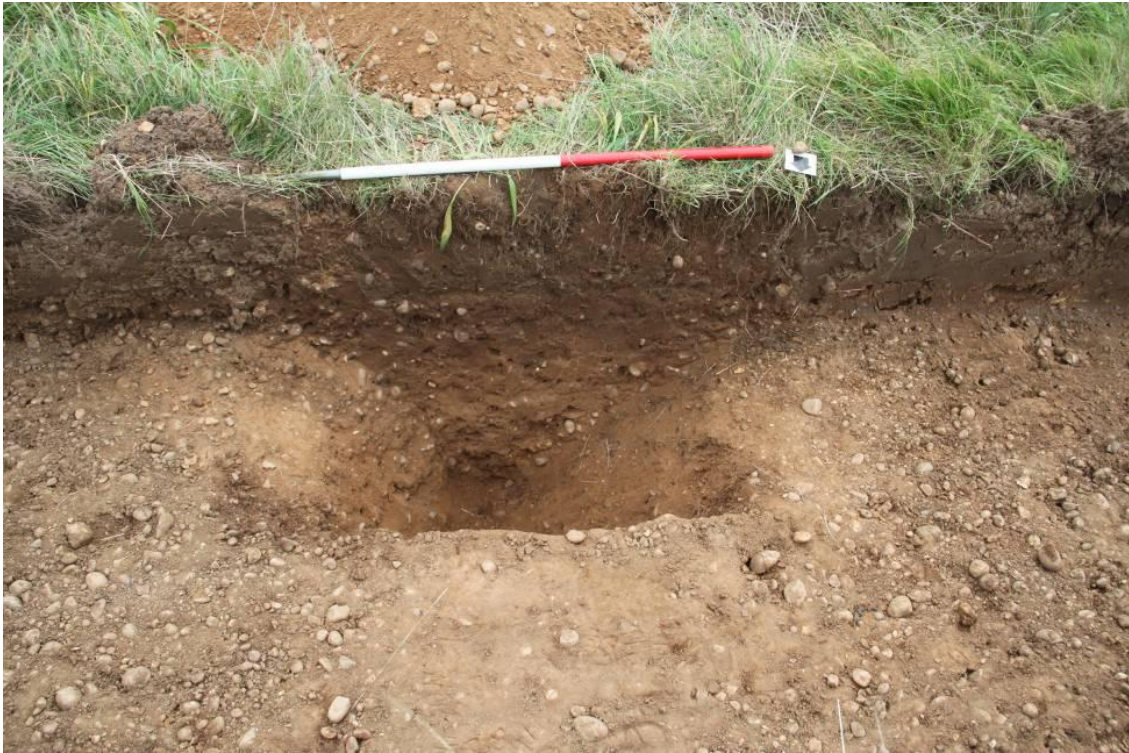
**Figure 46: Trench 7, Ditch [702], north west facing section**

- 7.36 The natural geology (701) was medium orange grey sandy gravel.
- 7.37 Two ditches were identified, [702] and [704], of unknown date. Linear ditch [702] was oriented northeast-southwest with very steep (45°-60°) sides and a V-shaped base (Figure 16, Figure 46). It was 1.7m wide and 0.6m deep with an observed length of 1.8m. The single fill (703) was light brown-grey silty sand with frequent gravel and pebbles.

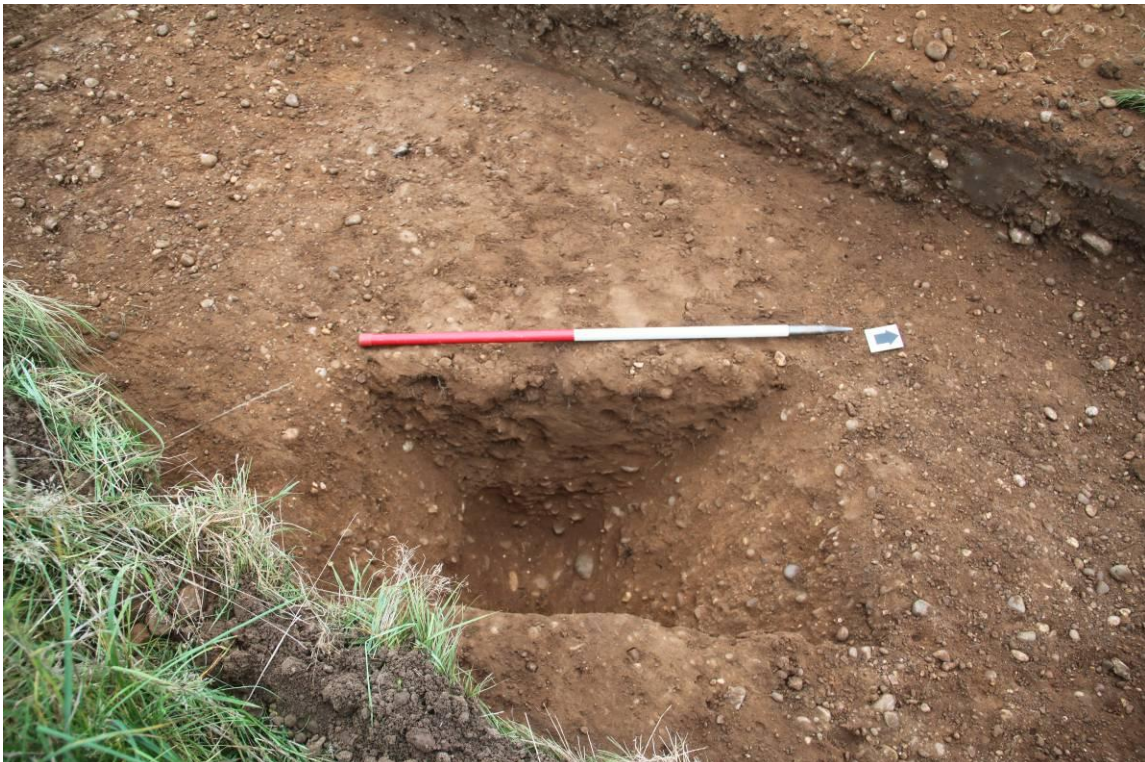
**Figure 47: Trench 7, Ditch [704], east facing section**

- 7.38 Linear ditch [704] was oriented east-west with very steep (45°-60°) sides and a concave base (Figure 17, Figure 47). It was 1.15m wide and 0.6m deep with an observed length of 3m. The fill (705) was light grey-orange silty sand with frequent pebbles.

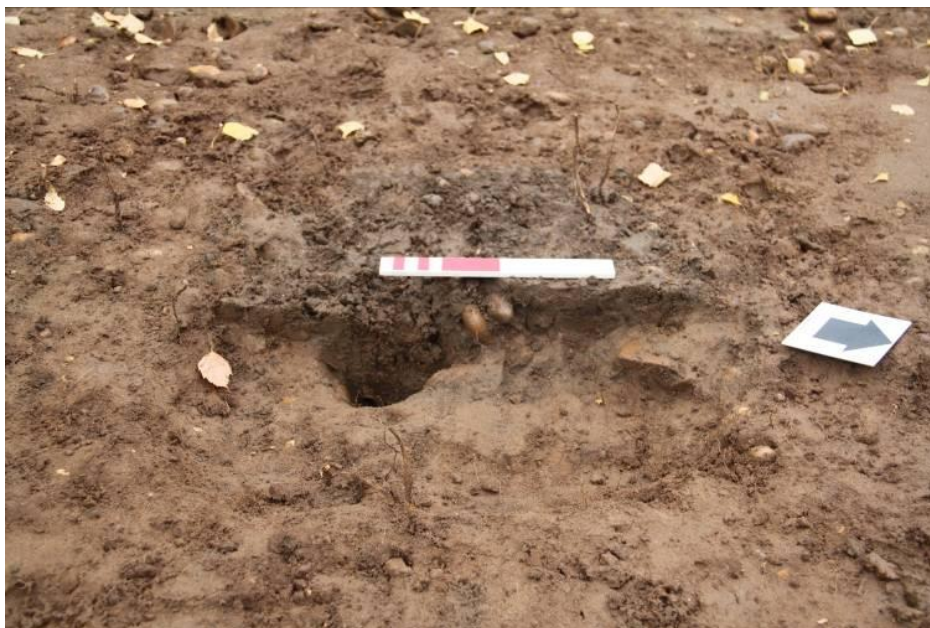
**Figure 49: Trench 8, root hole [803], north east facing section**

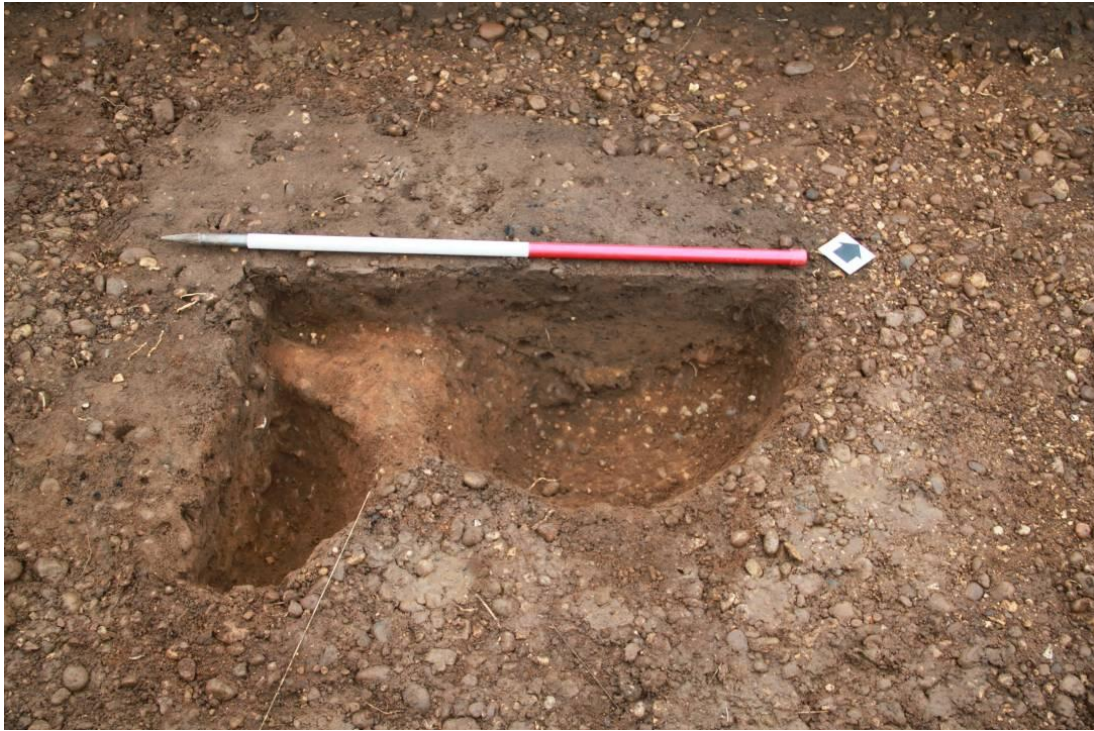
**Figure 54: Trench 10, intercutting pits [1002], [1004] and [1006]. North west facing section**

- 7.55 The cluster of pits in the centre of the trench comprised two discrete earlier pits [1002] and [1004], both cut into by later pit [1006] (Figure 20, Figure 54):

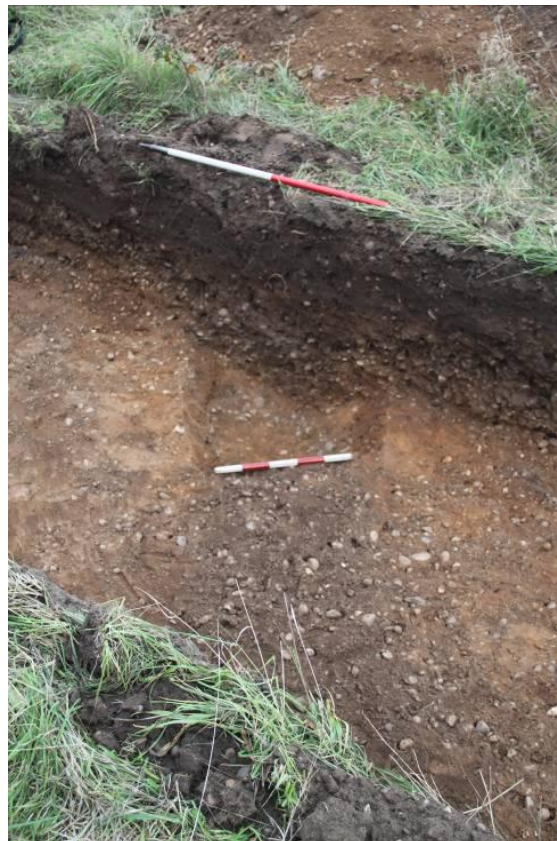
**Figure 55: Trench 10, Ditch [1009]. Facing south east**

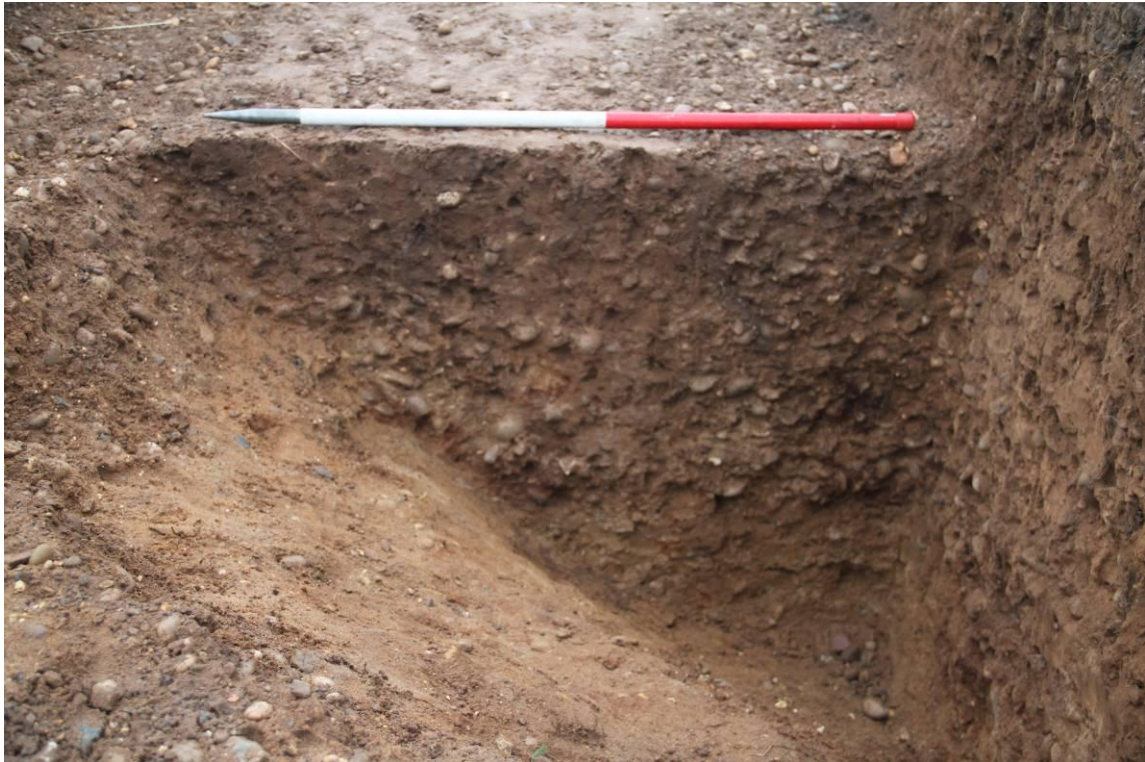
**Figure 58: Trench 11, possible tree bole [1111], north west facing section**

- 7.65 Pit/tree bole [1111] was sub-circular in plan with shallow sides becoming steeper towards a concave base (Figure 22, Figure 58). It was 4.65m wide and 0.88m deep, extending beneath the south western trench edge. Basal fill (1110) was loose light orange brown sand with moderate small, medium and large sub-rounded and rounded pebbles, up to 0.28m thick. This was overlain by context (1109), a loose light grey silty sand with moderate small, medium and large sub-rounded and rounded pebbles in the northeast (frequent in the southwest). It measured up to 0.53m thick. The upper fill (1108) was loose, mid greyish brown silty sand with moderate small, medium and large sub-rounded and rounded pebbles in the northeast, (frequent in the southwest), up to 0.36m thick.

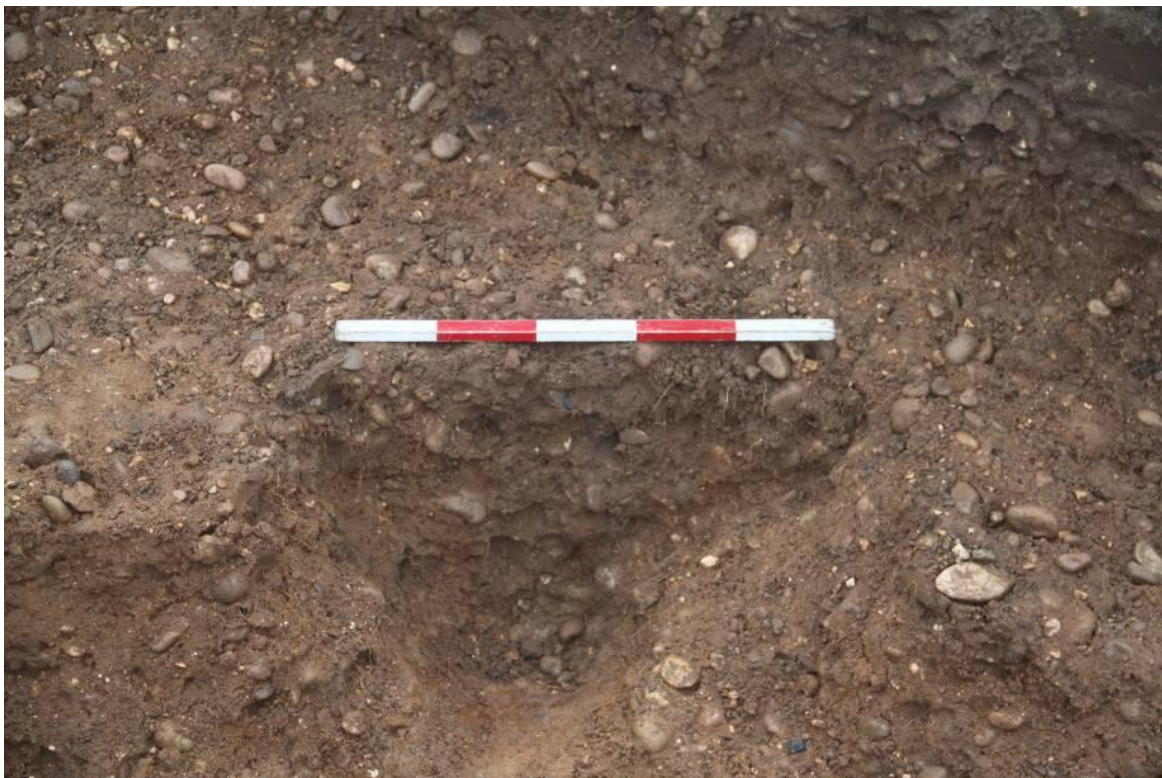
**Figure 59: Trench 11, pit/root disturbance [1113], south facing section**

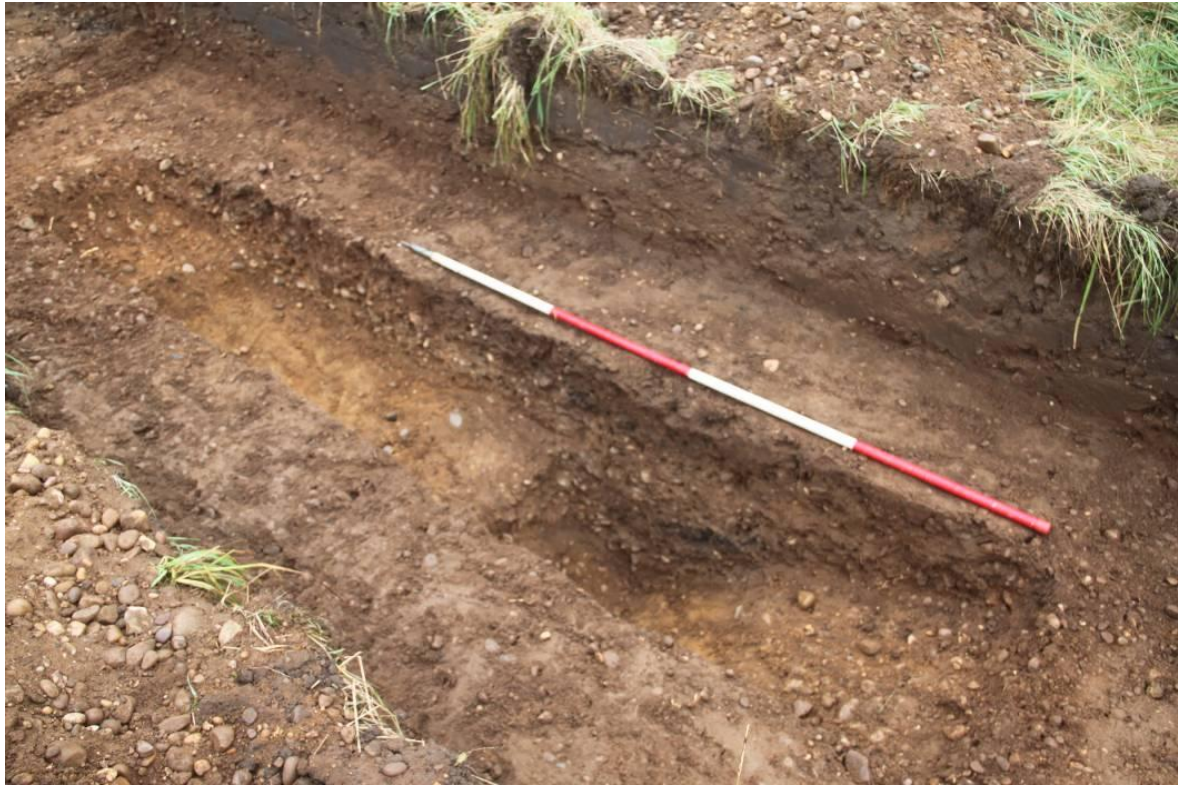
**Figure 60: Trench 11, Ditch [1102], oblique view of south west facing section**

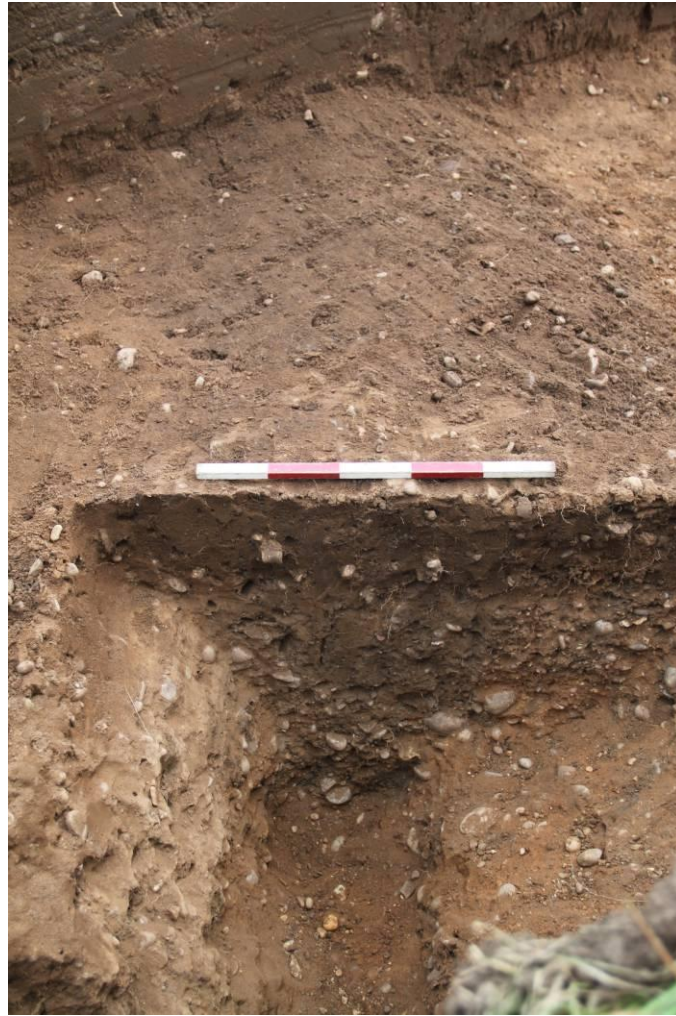
**Figure 62: Trench 12, Ditch [1208], north west facing section**

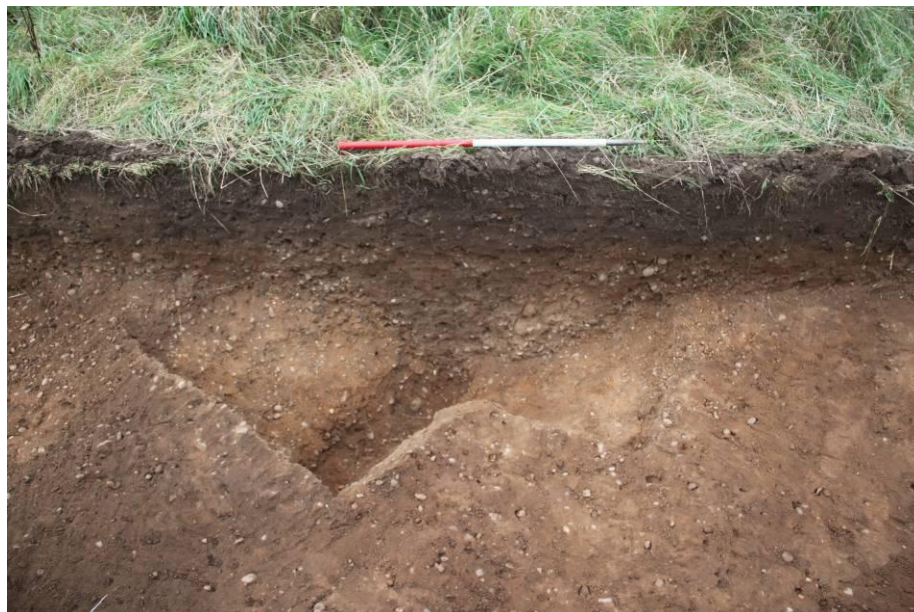
**Figure 63: Trench 12, Ditch [1208] facing west**

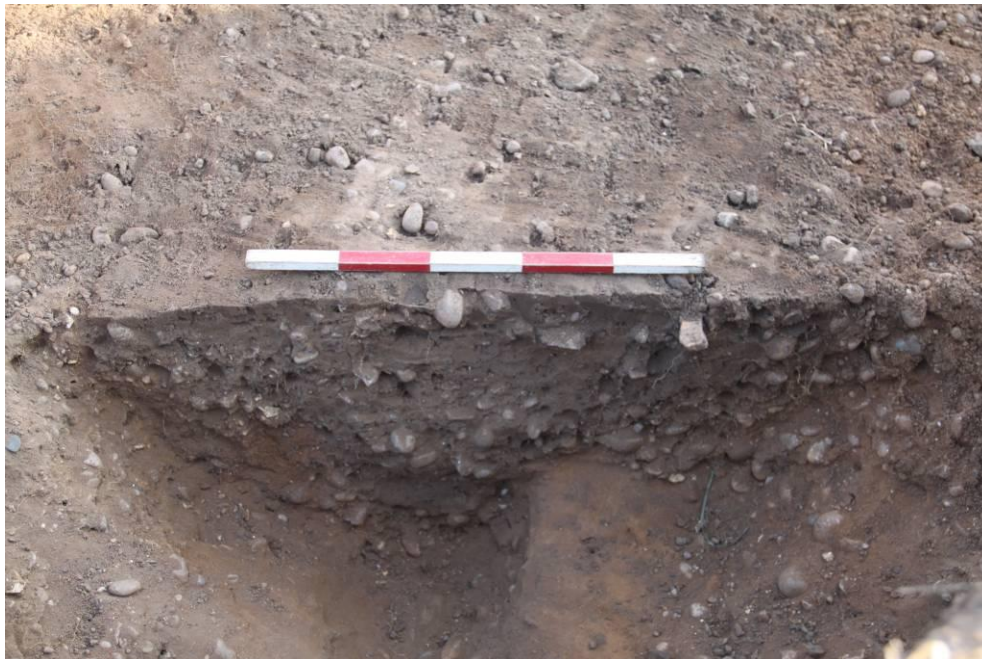
**Figure 64: Trench 12, Ditch [1205], north west facing section**

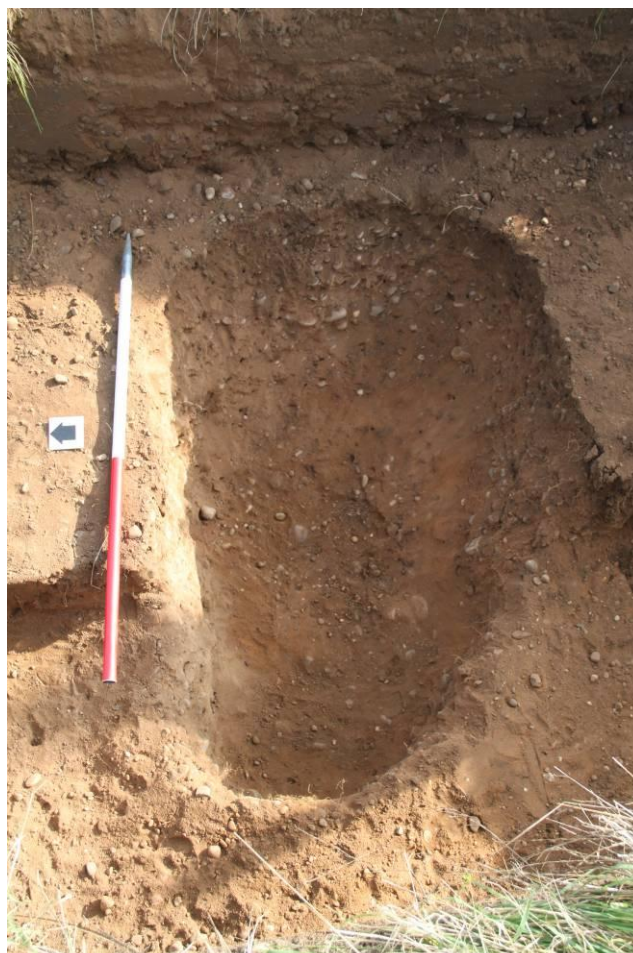
**Figure 65: Trench 12, tree bole [1202], facing east**

- 7.73 A tree bole was encountered towards the southern end of the trench. The cut [1202] was oval in plan with very steep (almost vertical) sides except in the southwest (Figure 26, Figure 65). It had a flat irregular base. It measured 1.5x1m in plan and was 0.6m deep. The fill was (1201) was a moderately loose mid yellowish grey sandy silt with frequent small with medium and large rounded and sub-rounded pebbles.

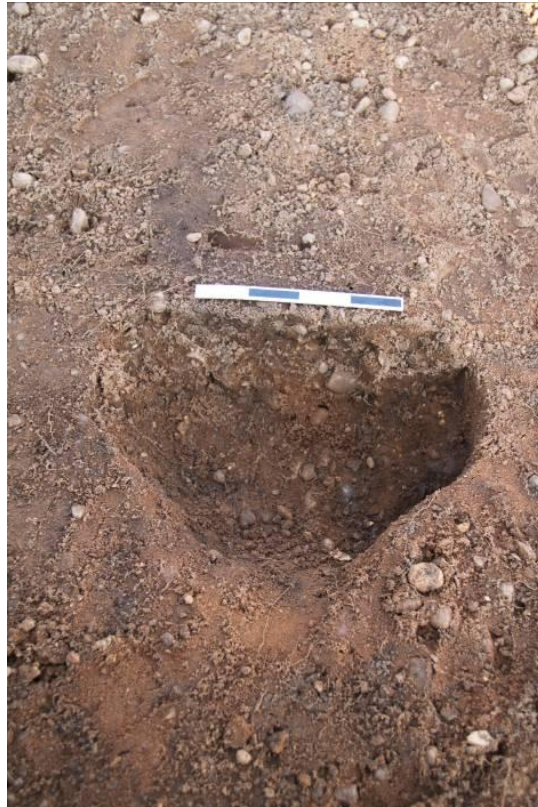
**Figure 66: Trench 12, root bole [1210], south west facing section**

- 7.74 A second possible tree bole [1210] was encountered near to the northern end of the trench, ascribed a likely natural origin. The cut measured 0.45mx0.36m in plan and was 0.12m deep (Figure 27, Figure 66). This was filled by (1209), a loose dark brownish grey silty sand with moderate small, medium and large rounded and sub-rounded pebbles and occasional charcoal flecks.

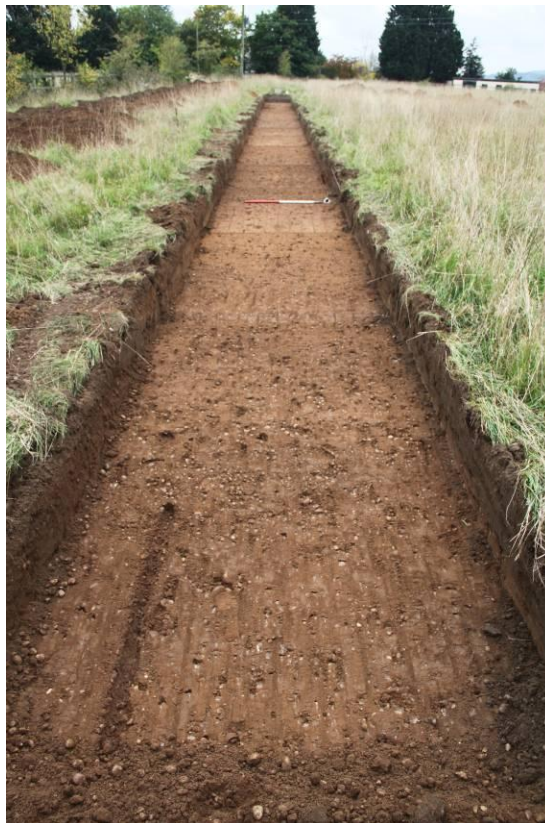
**Figure 67: Trench 13, facing south**

- 7.76 Trench 13 was excavated in its proposed location to 50m length and a depth of 0.4m. It was orientated northeast- southwest (Figure 67). The trench was positioned to target the possible continuation of linear geophysical anomalies observed to the west.

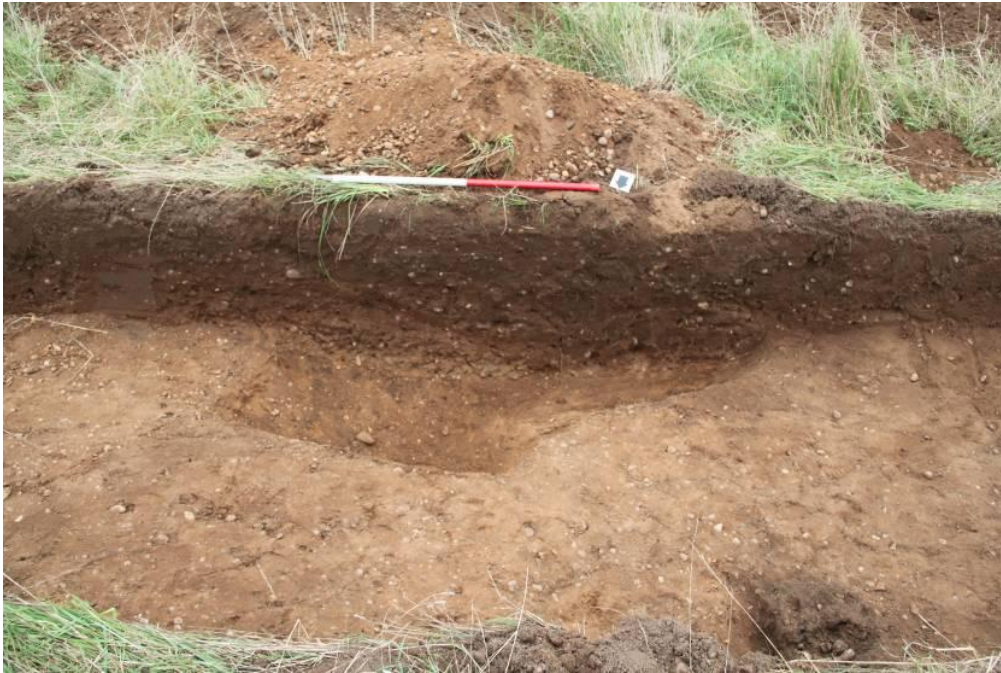
**Figure 68: Trench 13, possible Ditch [1304], facing south east**

- 7.79 Possible ditch [1304] was linear in plan oriented northwest-southeast, with gently sloping sides and a flattish/ slightly concave base (Figure 28, Figure 68). It measured 2.65m wide, 0.55m deep with an observed length of 1.8m. The basal fill (1305) comprised sandy gravel up to 0.1m thick. This was sealed by fill (1306), a light grey-orange silty sand with gravel, up to 0.15m thick. The upper fill (1307) was a medium brown-orange silty sand with frequent pebbles & gravel, up to 0.1m thick. The location/orientation does not correspond to the continuation of any geophysical anomalies recorded to the west.

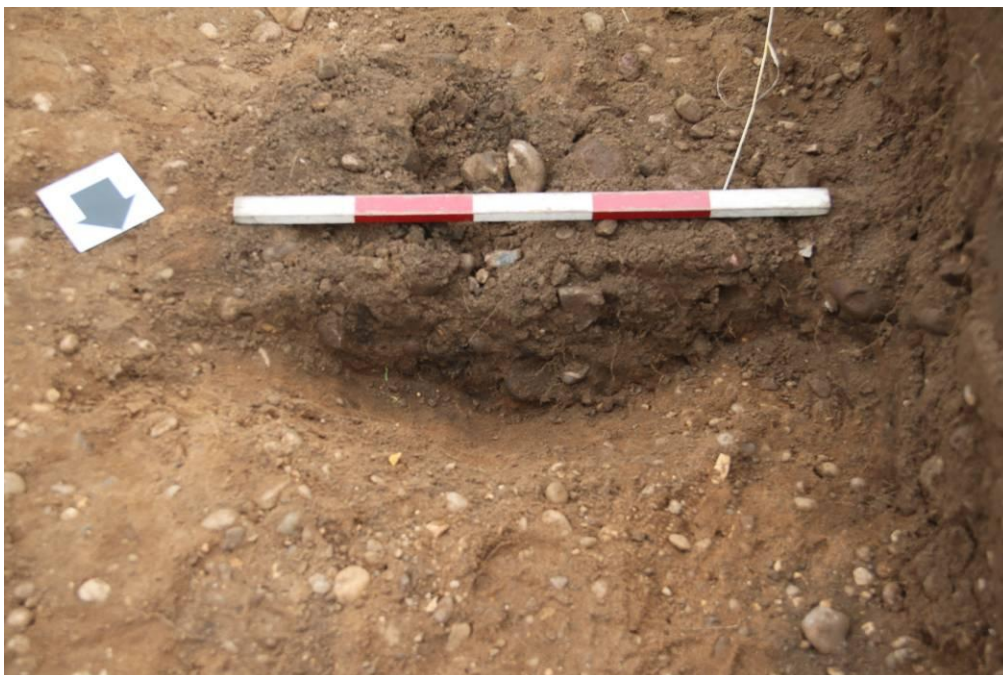
**Figure 69: Trench 13, tree bole [1302], north east facing section**

- 7.81 Cut [1302] was also a tree bole. It was circular in plan with gently sloping sides and a concave base, measuring 0.65m in diameter and 0.14m deep (Figure 69). It was filled by (1303), dark black brown silty sand with frequent medium pebbles.

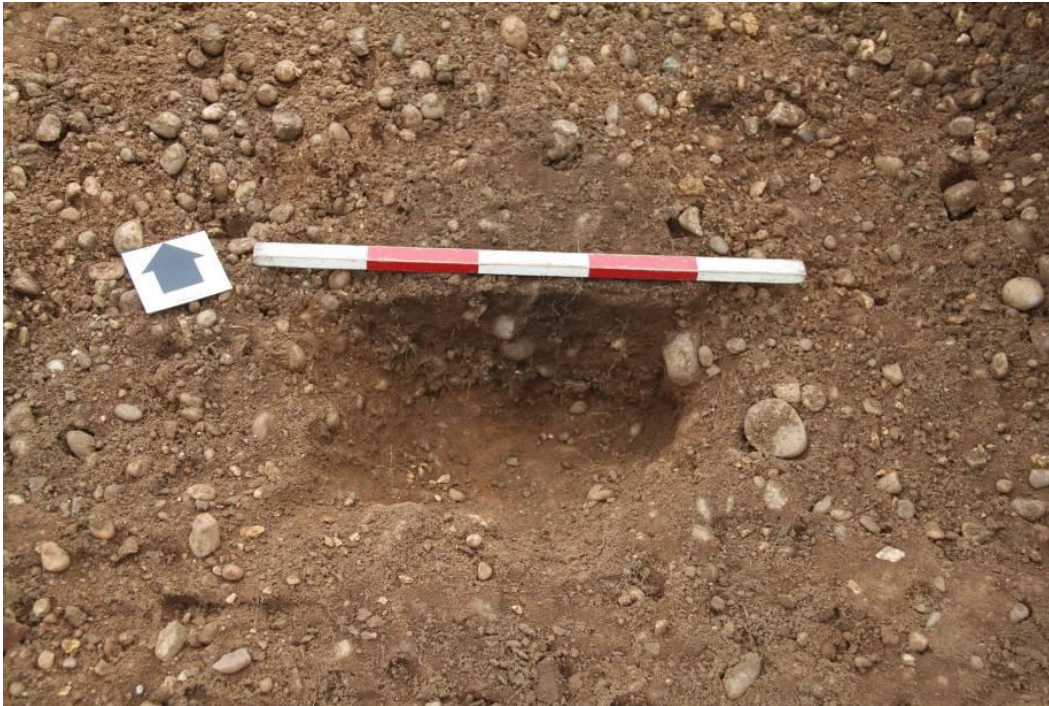
**Figure 70: Trench 13, tree hole [1308], south west facing section**

- 7.80 Tree bole [1308] was circular in plan measuring 0.54m in diameter and 0.16m deep (Figure 29, Figure 70). It was filled by (1309), a medium brown silty sand with frequent pebbles & gravels.
