The Network Rail (Buxton Sidings Extension) Order

Historic Environment Baseline Report

Annex A

JULY 2016

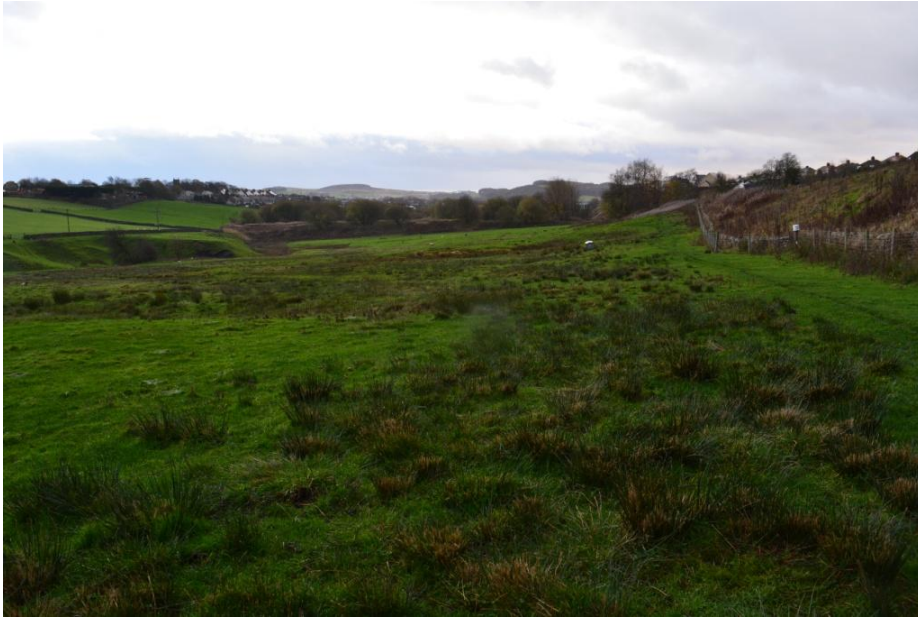
Figure 3.1. General view of Area A, looking south

- 3.2.5 Area A (Figure G1.1), the northern half of the Site, is a single pasture field (unploughed) currently being used to graze sheep. The field is undulating, generally sloping up from Nun Brook in the east towards the railway in the west.

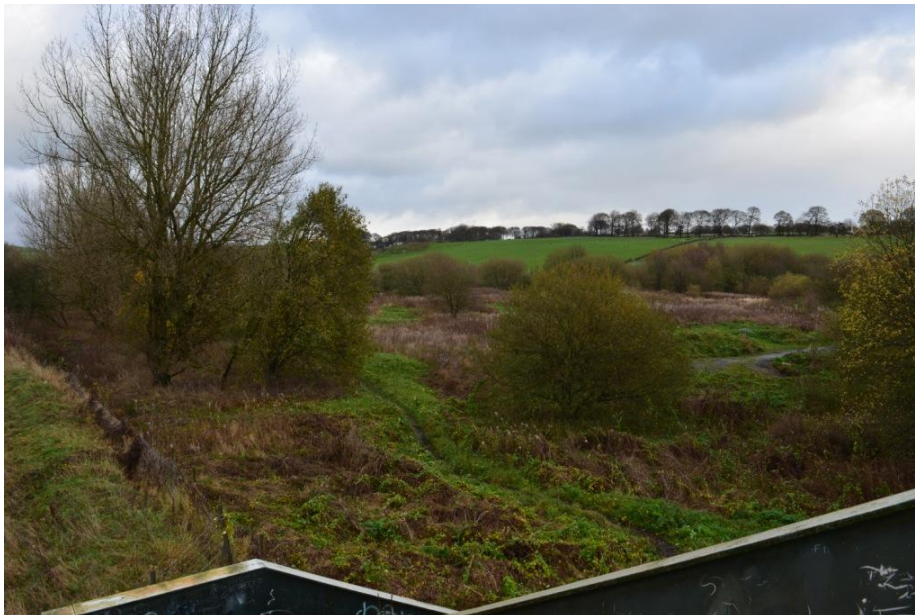
Figure 3.2. View of Area B looking north east from the railway bridge

- 3.2.6 Area B (Figure G1.2) occupies the central part of the site to the south of Area A. This area has previously been used as a tip (now disused). This is depicted by the BGS as 'made ground' (<http://mapapps.bgs.ac.uk>). The area is flat but with a raised ground level relative to the adjacent Area A. There was a lower level of visibility in this area due to existing scrub. No archaeological features were identified.

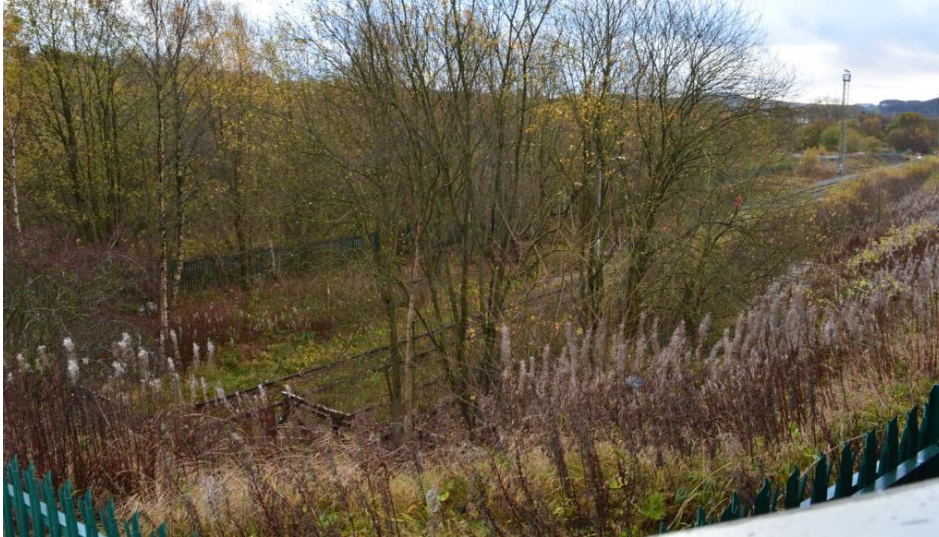
Figure 3.3. Existing sidings with Area C to the east, beyond. Looking south east

- 3.2.7 To the south of Area B and east of the existing railway sidings is Area C (Figure G1.3), the site of former railway sidings. To the south the Site is accessed via an established trackway (shown on historic mapping from 1973). This area has colonised with young birch trees. The land is relatively flat in Area C, likely a consequence of levelling during the construction and de-construction of the railway sidings.

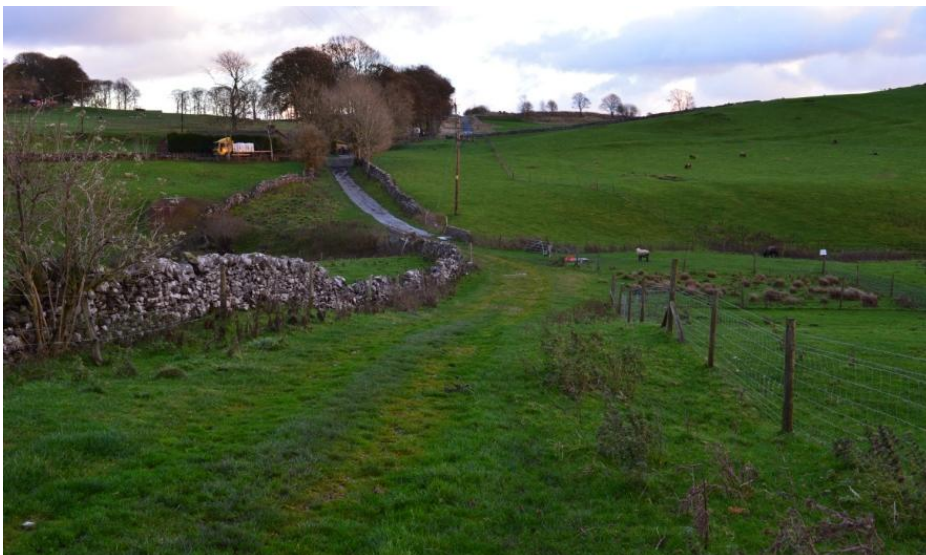
Figure 3.4. Area D, looking east

- 3.2.8 Area D (Figure G1.4) is a current access track which would be utilised to access the Site. It is tarmac in the east and grassed in the west.

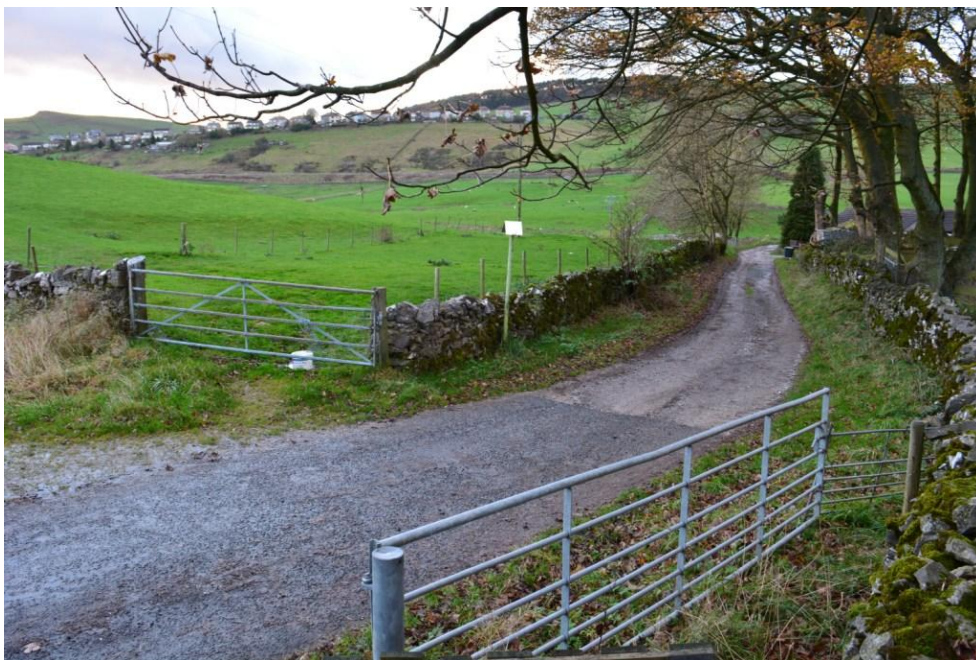
- 4.3.10 No surface evidence of the Roman road (RSK 24) at its purported crossing point with Area D was observed during the site visit, however, the HER records two previous archaeological interventions designed to identify this feature:

Figure 4.1. Intersection of Area D (project proposed access track) and possible Buxton and Melandra Roman road (RSK 24). Looking west

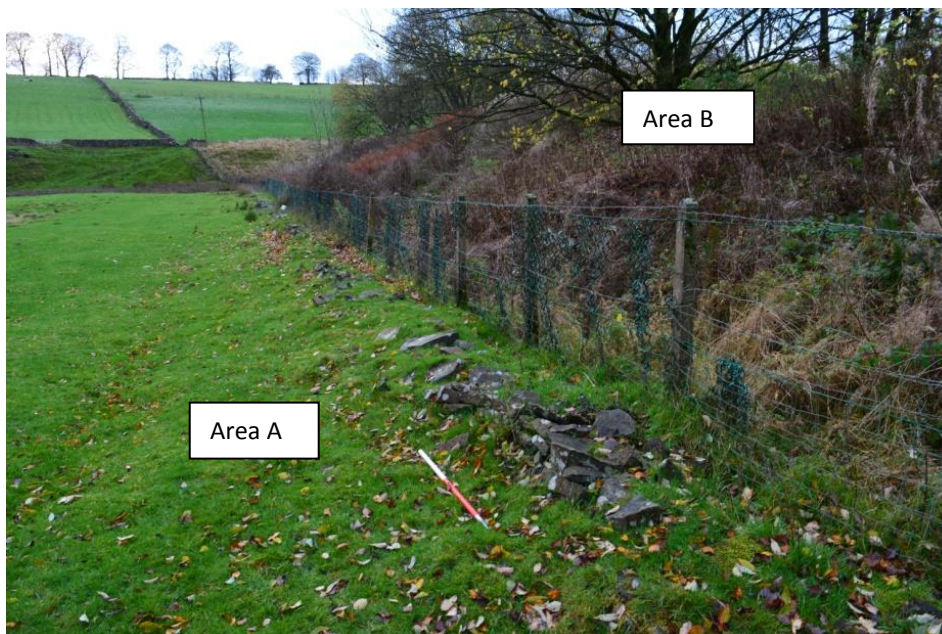
- 4.3.29 With the exception of field boundaries alongside the site access track (Area D, see Figure 5), the only field boundary within the Scheme redline boundary likely to be contemporary with the field system depicted on the 1841 tithe map of Fairfield runs between Areas A and B (Figure G1.7).

Figure 4.3. Disused dry stone wall between Area A and Area B looking east towards Nun Brook. Field boundary is shown on 1841 tithe mapping. (Note difference in ground level between Area A and B (landfill). 1m scale

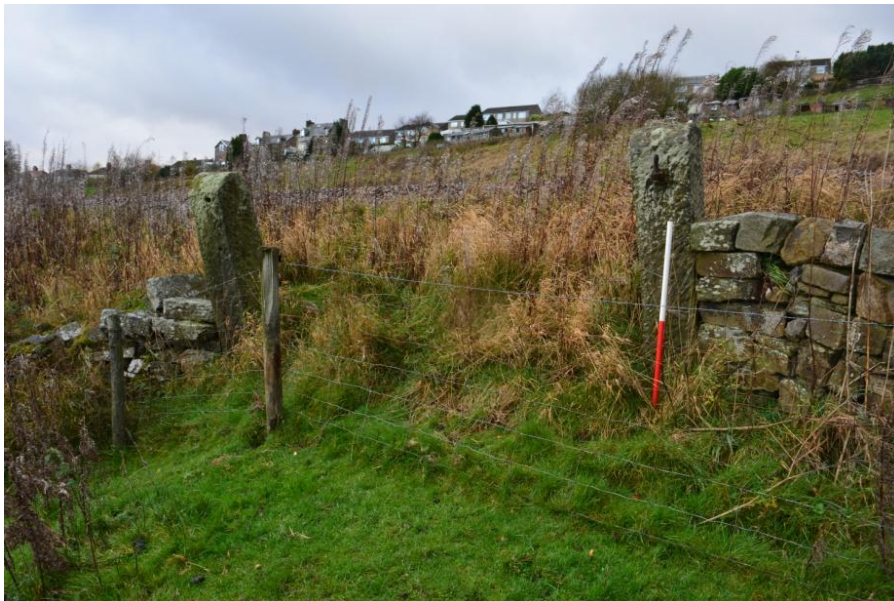
- 4.3.33 The 1879 1:2500 OS map shows the constructed railway which now defines the Scheme redline western boundary. The dry stone boundary wall observed during the site visit is contemporary with the railway, and includes a set of good quality hewn gate posts in Area A (RSK 38) (Figure G1.8). Metal hinges indicate that a gate would have been hung between them. There is no apparent gateway on the other side of the railway that would suggest a crossing, thus this gate must have allowed for access to the railway line itself.

Figure 4.4. Gateposts c.1867 on the western boundary of Area A, looking south west. Beyond the gate is the railway. 1m scale

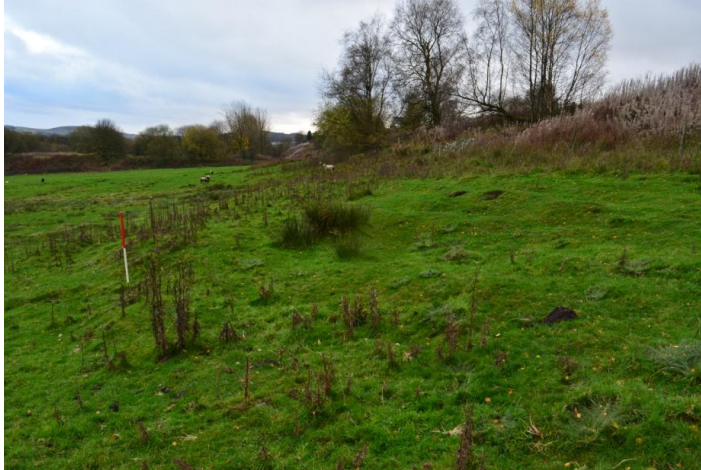
- 4.3.34 During construction of the railway, a significant portion of the site alongside was disturbed (as shown on Figure G1.9).

Figure 4.5. View of Area A looking south along the highest point of the field, showing previous disturbance, likely through construction of the railway (to the west). 1m scale

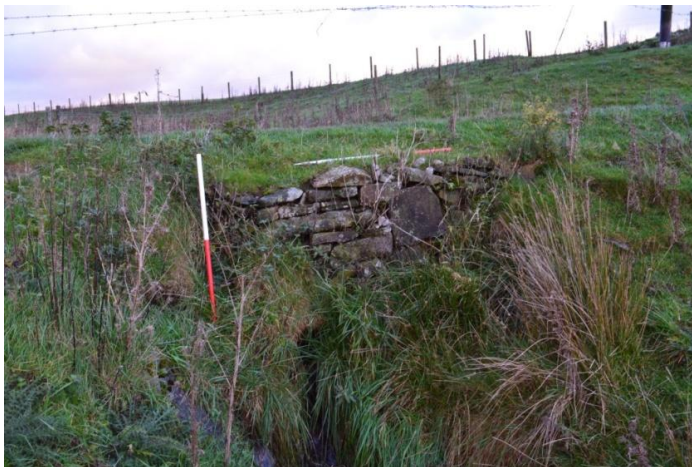
- 4.3.35 By the time the 1879 1:2500 OS map was published the farm access track (Area D) was established and it is likely that the bridge over Nun Brook (RSK 36, Figure G1.11) and the revetted tributary (RSK 37, Figure G1.10) (both added to the gazetteer as a result of the site visit) are contemporary with this period.
- 4.3.36 The 1879 map is not reproduced in this report, however the features are shown on the 1898 map (Figure G1.12).

Figure 4.6. Dry stone revetment of tributary (RSK 37) in Area D. 1m scales

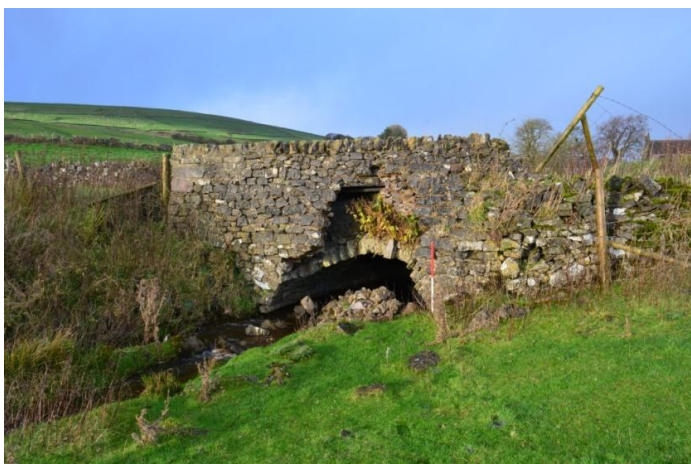
Figure 4.7. Bridge (RSK 36) in Area D over the Nun Brook. 1m scale

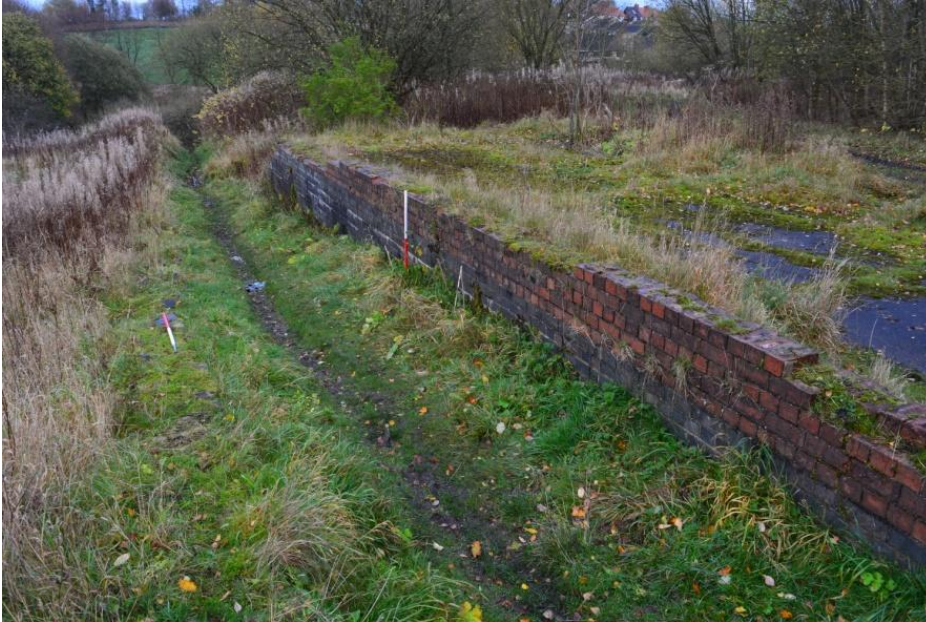
4.3.39 Area C underwent the greatest transformation during the late 19th century, with the development of extensive railway sidings and an associated engine shed (RSK 35, Figures G1.13-15) and turntable (RSK 34, Figure G1.15). No surface evidence for the turntable (RSK 34) was observed during the site visit, however, foundation remains of the engine shed (RSK 35), sidings and sleepers were visible preserved extant.

Figure 4.9. Brick foundations of Engine Shed (RSK 35) shown on 1898 OS map, Area C. Looking south east. 1m scales

- 5.1.4 The assessment has demonstrated that material remains of railway sidings c.1898-1973 including an engine shed (RSK 35) and potentially a turntable (RSK 34) are preserved within the Scheme redline boundary.
- 5.1.5 Area C has limited potential for the survival of archaeological remains predating the 19th century due to the construction of the railway sidings; the foundations are likely to have truncated any previous archaeological deposits.

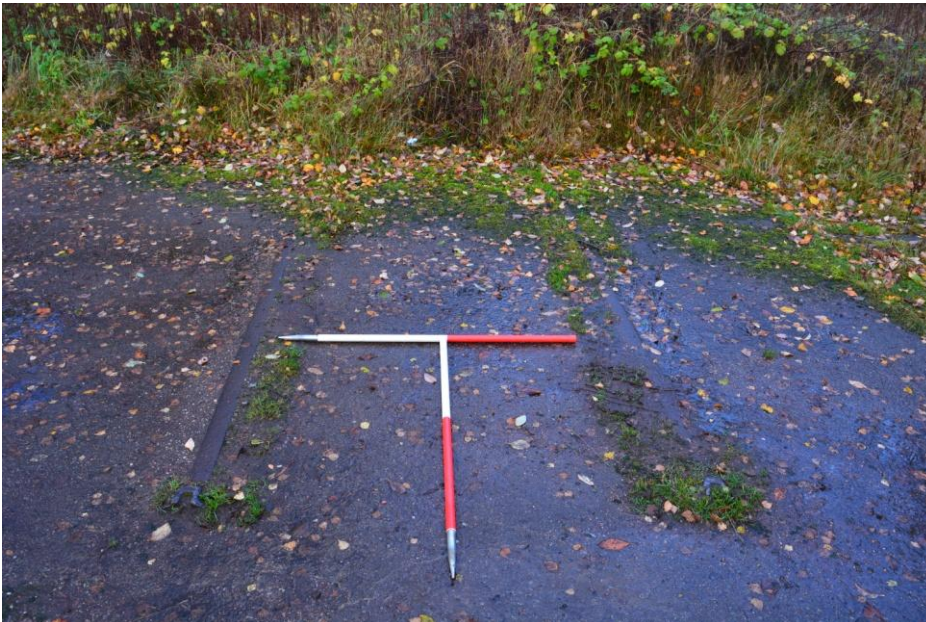
Figure 4.10. Sidings shown on 1898 OS map, Area C. Looking south east. 1m scales

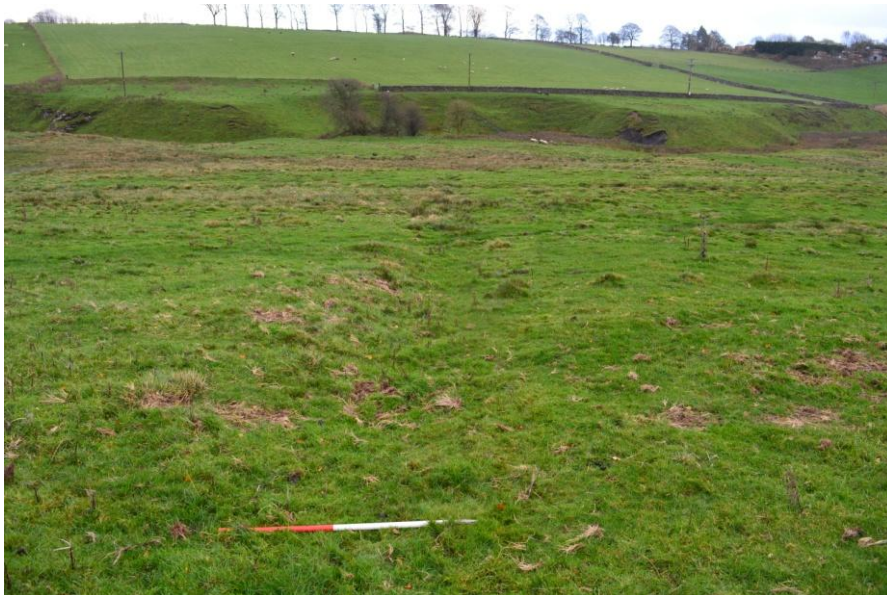
- 4.3.48 Light Detection and Ranging (LiDAR) data assessment for the purposes of the current project found that a slight linear depression thought at the time of the site visit to be a field boundary (Figure G1.16) is actually part of a larger, possible enclosure (Figures G1.17 & G1.18) within the Scheme redline boundary. The feature comprises parallel linear ditches, joined at the ends with a semi-circular ditch. This is cut by a perpendicular linear ditch which may or may not be related.
- 4.3.49 The enclosure appears to have been cut through by the railway and does not equate to any landscape features, such as former fields or trackways, depicted on historic mapping.

Figure 4.2. Linear element of feature RSK 39 (directly beneath scale) in Area A. Looking east. 1m scale

- 4.3.50 The heritage importance of the feature, and potential for associated remains is, at present, uncertain.

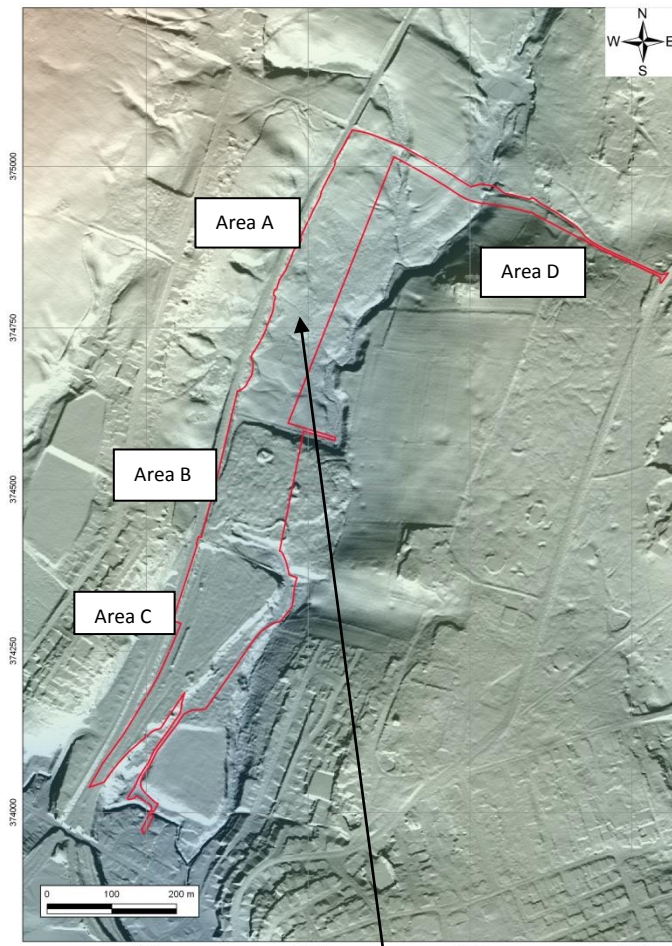
Figure G1.5.
Digital Terrain Model (DTM)
derived from LiDAR data (whole
site boundary)

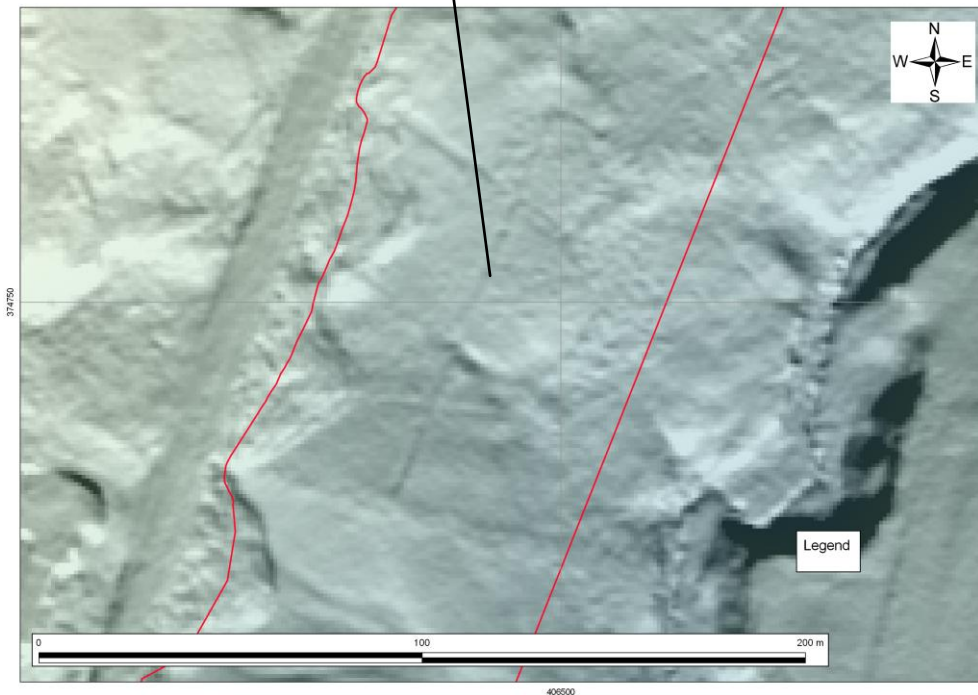
Figure 4.3. DTM LiDAR data – detail of RSK 39 (possible enclosure, uncertain date) © Environment Agency copyright and/or database right 2015. All rights reserved.
