PE Jones (Contractors) Ltd.

# **Moss Farm, Congleton Historic Environment Desk-based Assessment**

660440

SEPTEMBER 2014

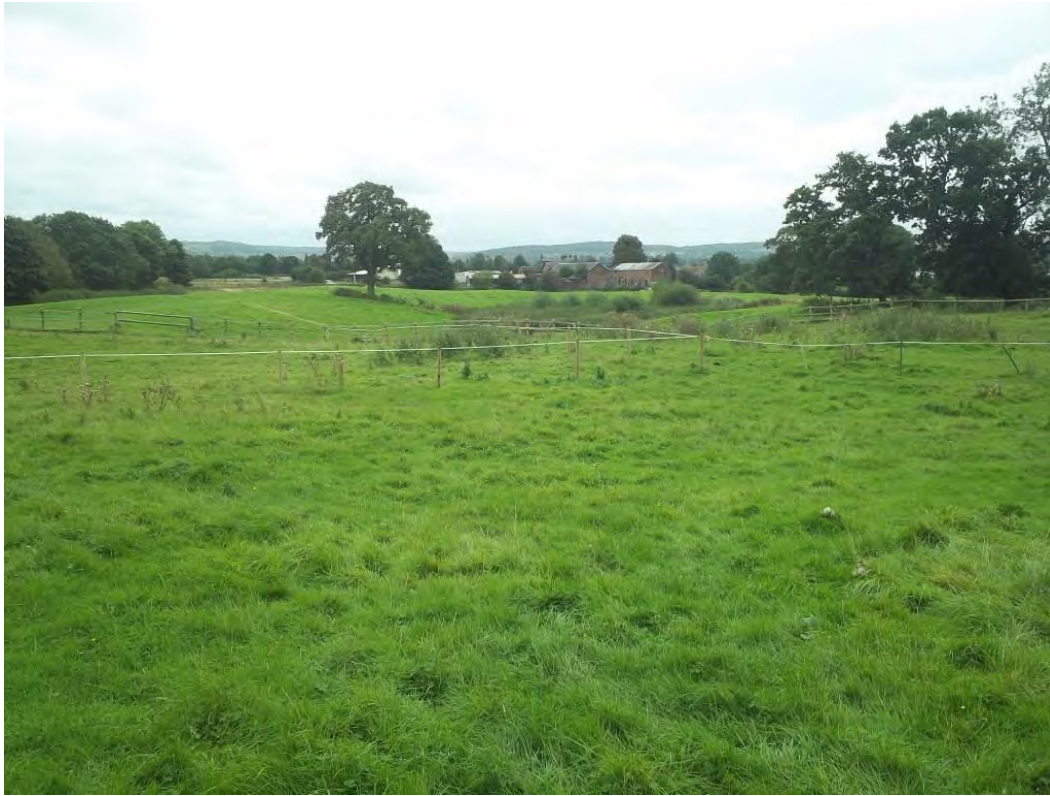
- 4.43 The largest field, bound to the west by Manchester Road and to the east by Moss Lane.
- 4.44 Apparently previously undisturbed, improved pasture (**Photo 1**).

**Photo 1.** General site shot. Looking south from Field A to Field B. Moss Farm (RSK ID 16) in distance.

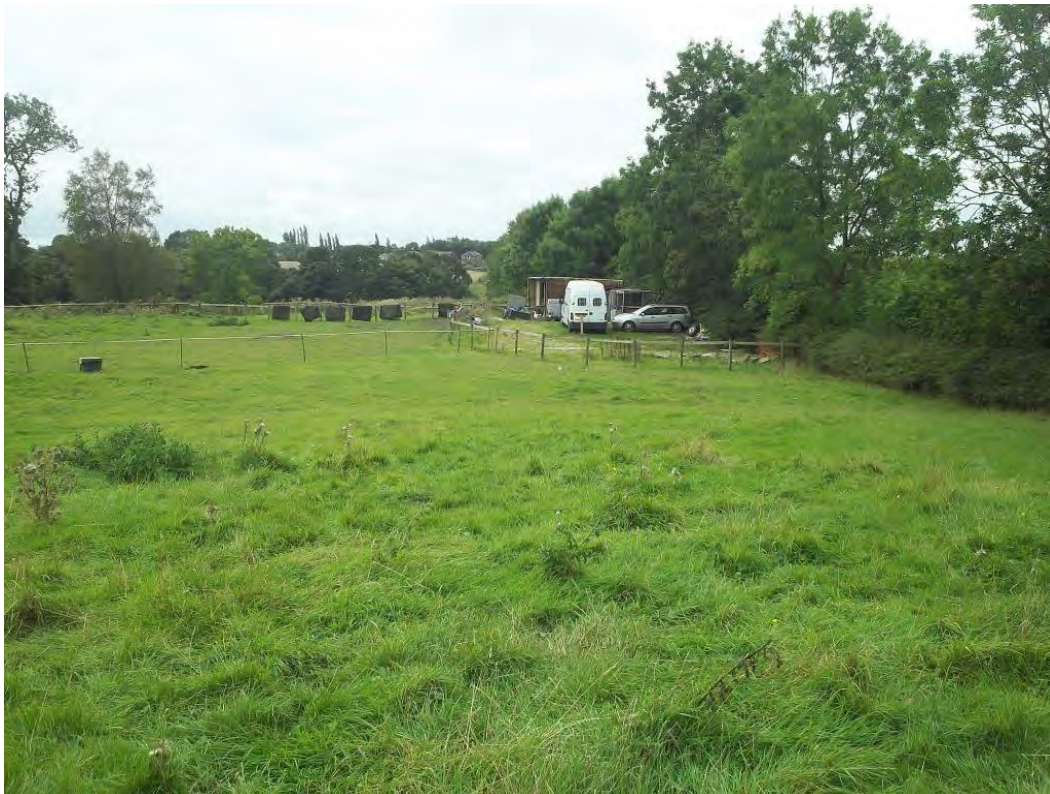
- 4.45 Topography is generally uneven but with a plateau to the north – the former location of Maypole Farm of which no remains exist above-ground at all (**Photo 2**). Some concrete is evident within field boundaries, but it is unlikely this is associated with the former farm.

**Photo 2.** Field A. Location of former Maypole Farm (RSK ID 18). Looking west.

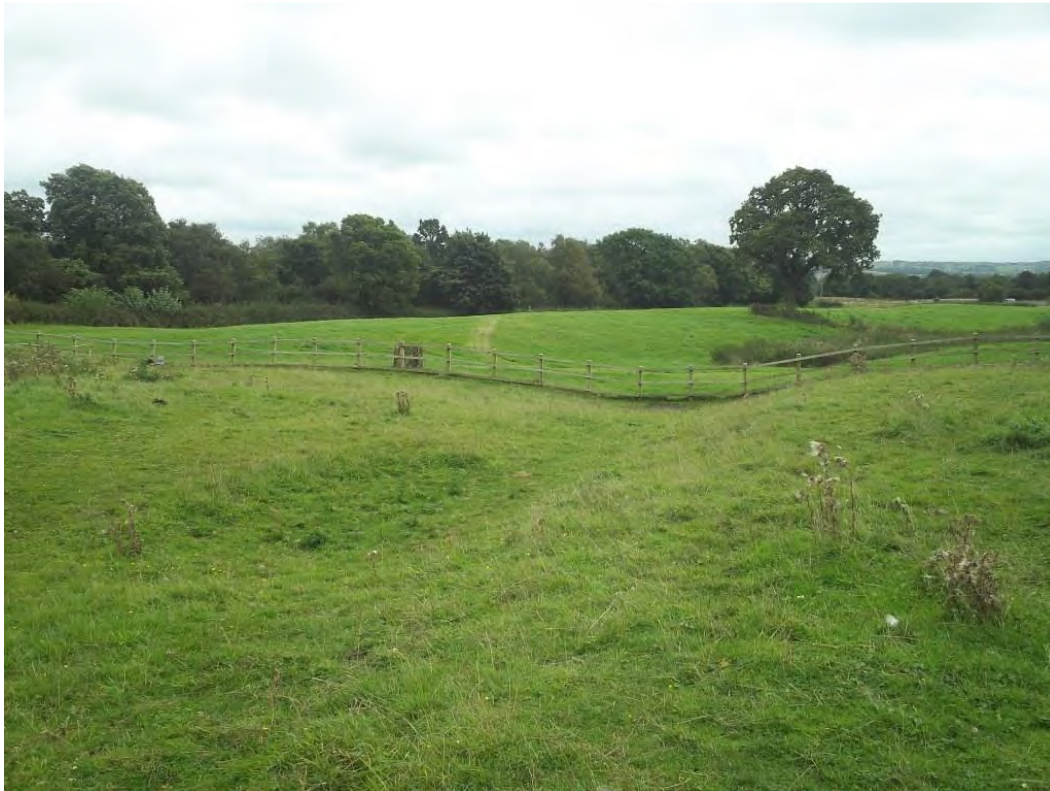
- 4.46 The only features associated with the former farm remaining are a pond (recently cleared out), and a possible hollow-way running towards Field B to the south (**Photo 3**).

**Photo 3.** Field A. Possible Hollow-way. Looking south.

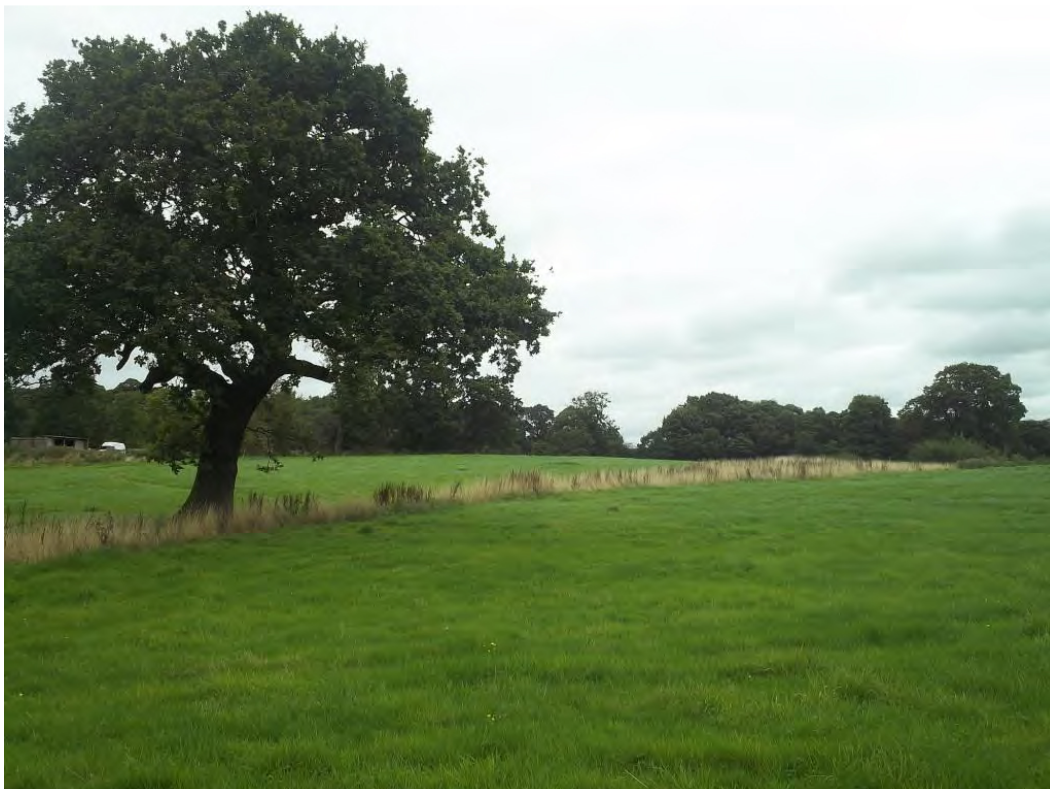
- 4.48 The allocation of 'Field A' coincides with a field on the first edition OS mapping (**Appendix B**). Field boundaries to the east and west are mature hedgerows; that to the south (with Field B) following the line of a boundary shown on historic mapping is set-aside only (no hedge, ditch or bank etc) but includes two mature oak trees which are likely the remnants of a nearby boundary (**Photo 4**).

**Photo 4.** Field B. Former field boundary. Looking north.

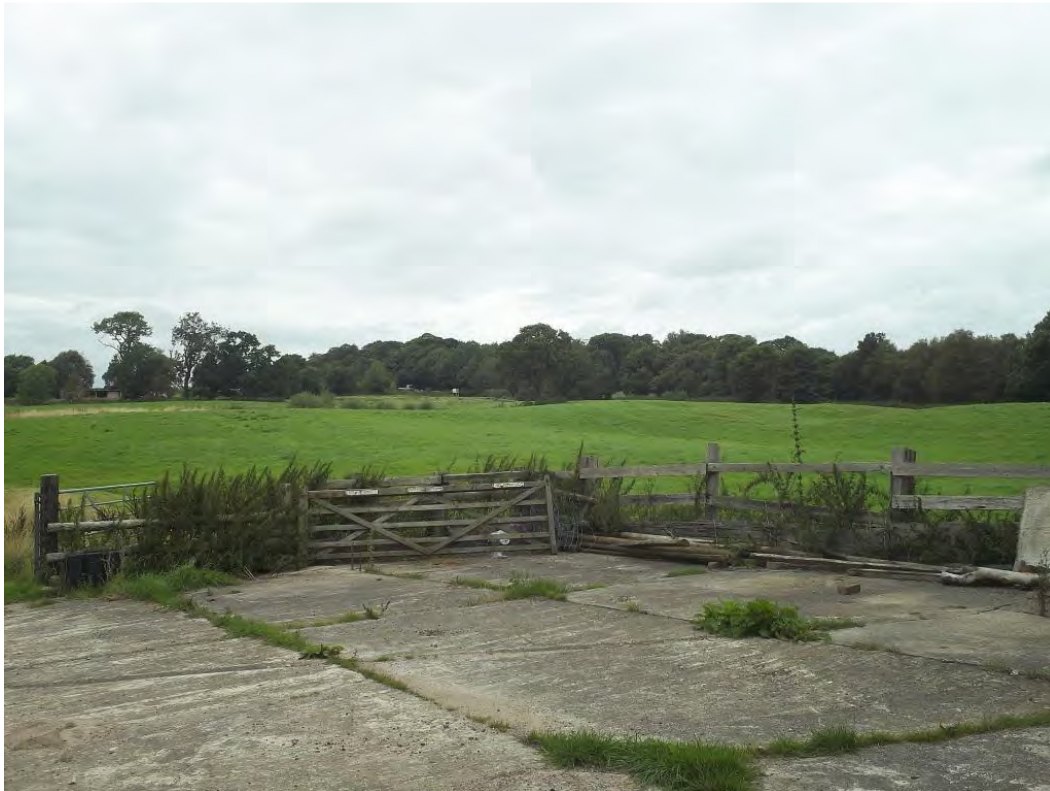
- 4.49 Improved pasture, the field is slightly domed but with generally very uneven topography (**Photo 5**). Along the length of Moss Lane the ground-level drops off steeply and abruptly, forming a linear ridge running roughly between Moss Farm and Maypole Farm (see **Photo 6**). This does not appear man-made; however, regular (i.e. square) imprints within this ridge have been interpreted as possible surface extraction pits (**RSK ID 20**).

**Photo 5.** Looking north from Yard to Field B with variable topography.

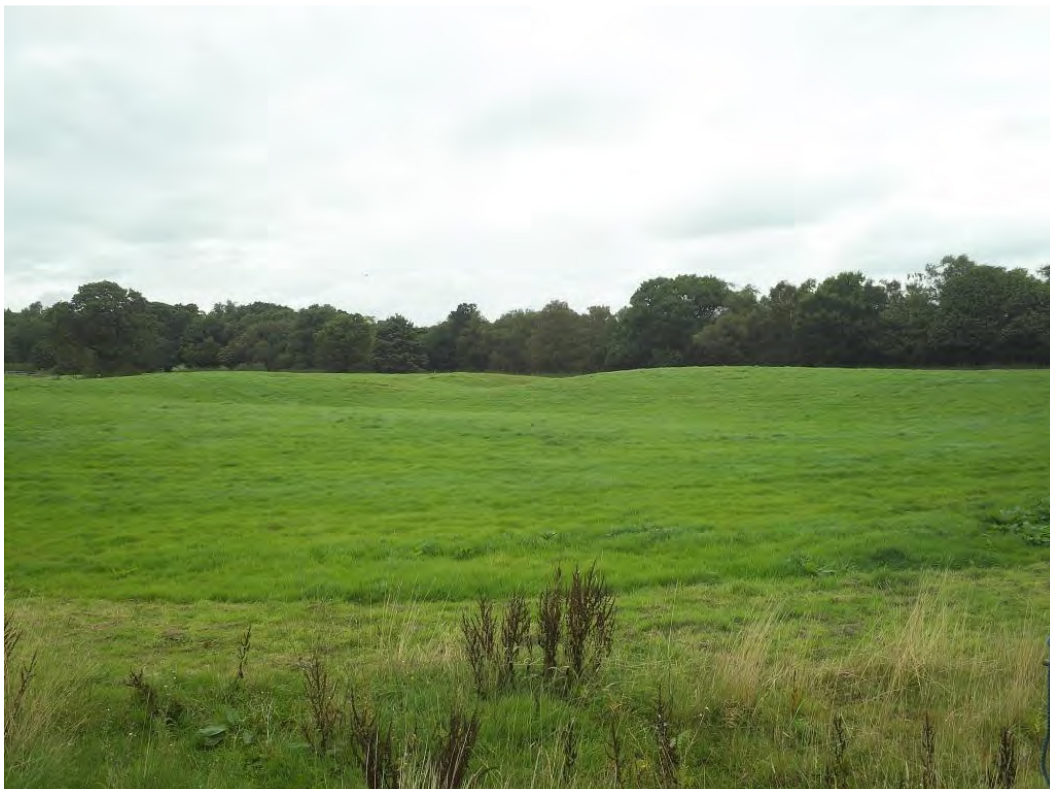
**Photo 6.** Field B. Illustrative of raised ridge running north-south. Looking east.

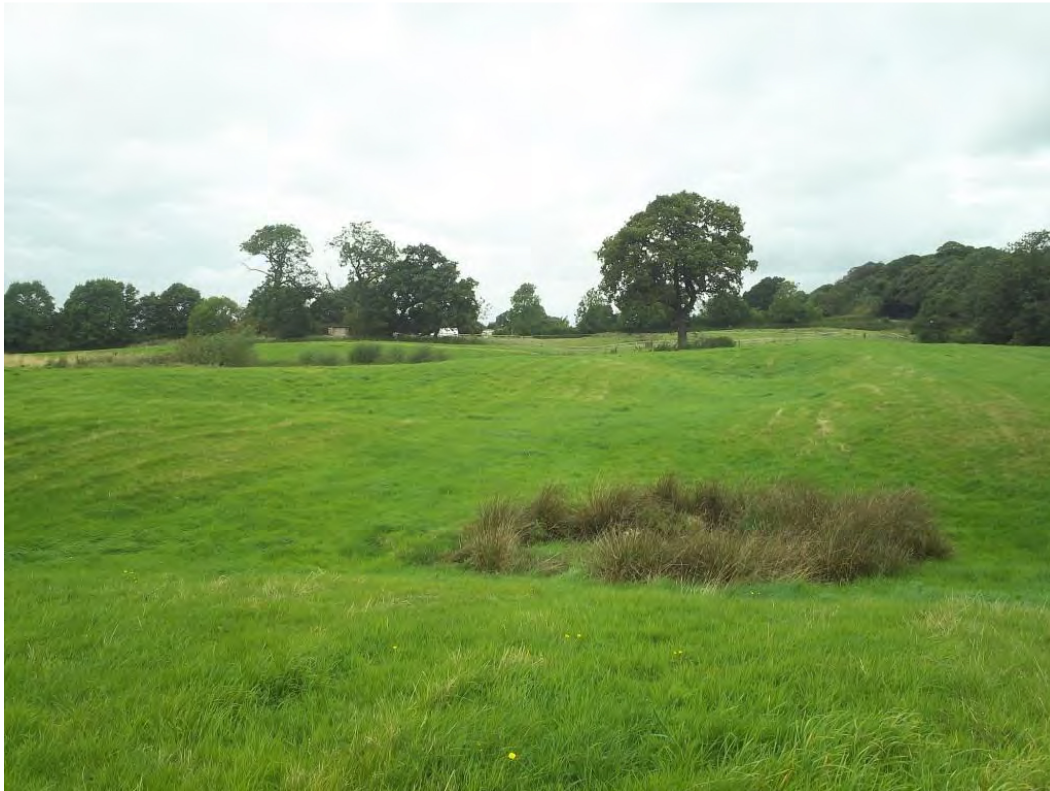
(**Photo 7**). Both the ridge and diggings are clearly visible on modern aerial photographs of the site.

**Photo 7.** Field B. Possible surface extraction pits (RSK ID 20). Looking north.

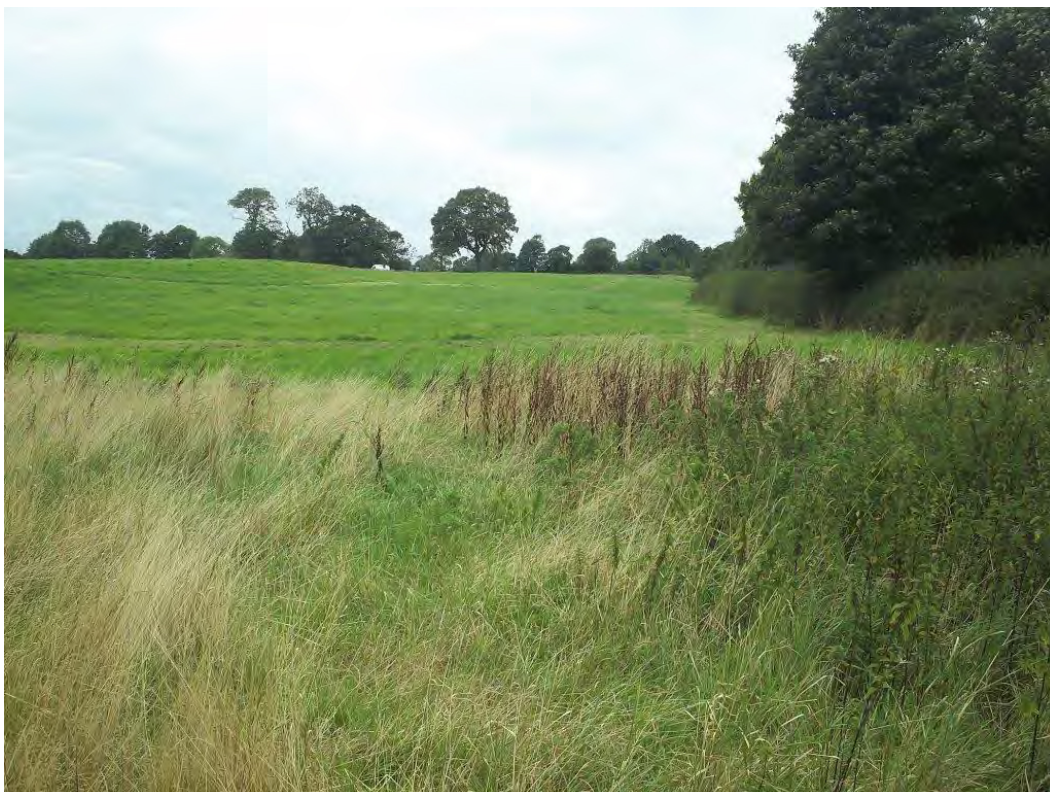
- 4.50 To the south east of Field B there are no surface remains of the dwelling **RSK ID 17** indicated on historic mapping, however, the ground cover is indicative of previous disturbance (**Photo 8**). Additionally, the triangular shape of the property boundary was evidently dictated by the landscape features of the large natural ridge and Moss Lane.
- 4.51 The western part of Field B, currently set-aside, appears disturbed, possibly by animals.

**Photo 8.** Field B. Location of former dwelling (RSK ID 17). Looking north.

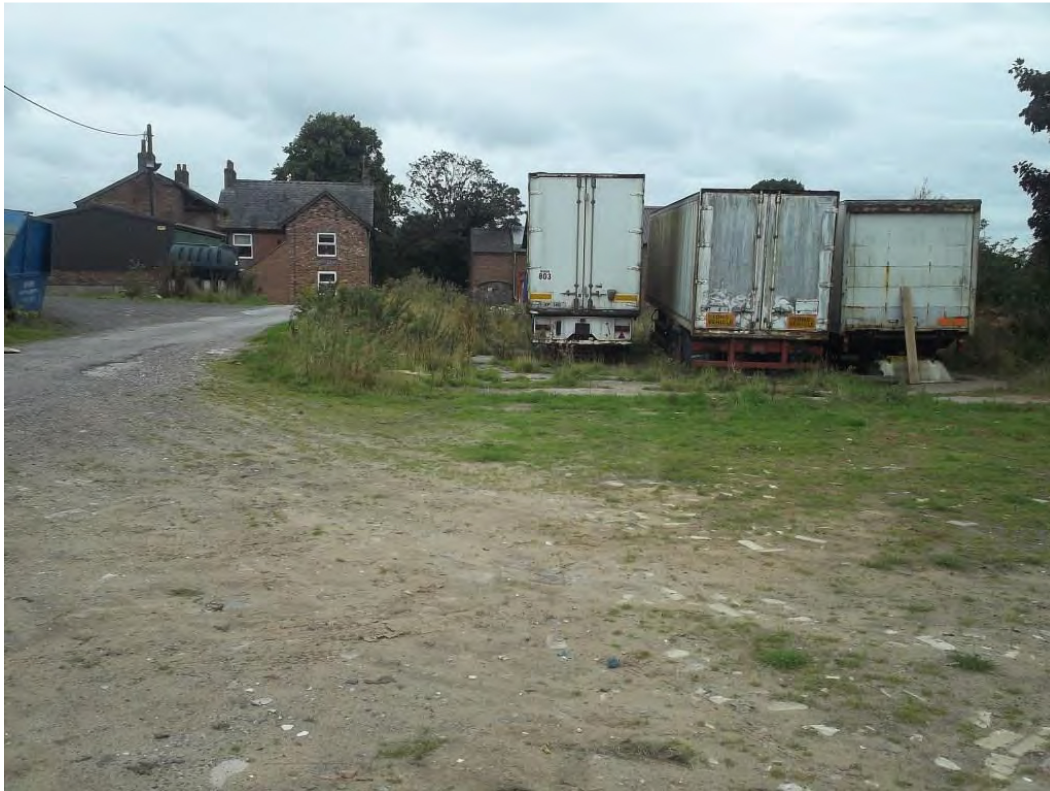
- 4.52 The yards of Moss Farm coincide with land-parcels annotated on tithe mapping which is now hardcore/concrete surfaced (**Photos 5, 9 & 17**).
- 4.53 The track between Moss Lane and Moss Farm has been terraced, cut into the field to the south and built up above the field to the north to counter a slight natural slope.

**Photo 9.** Yard and Moss Farm (RSK ID 16). Looking west.

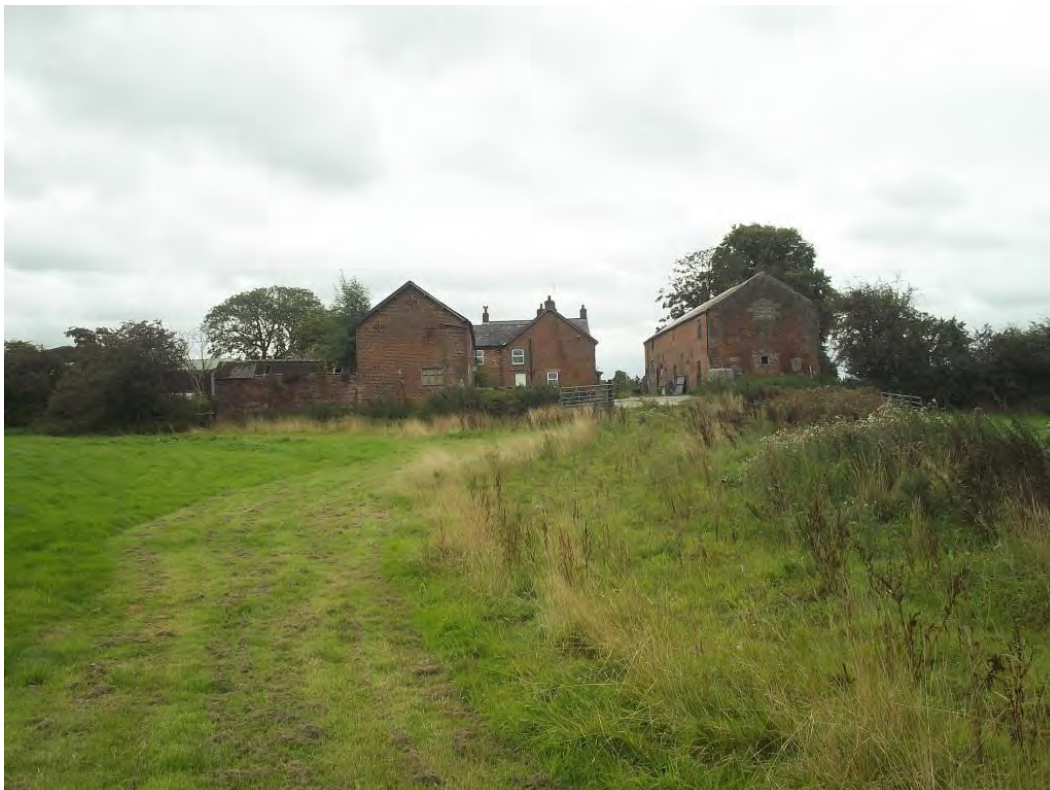
- 4.56 The two red-brick buildings to the south (**Photo 10**), barns/byres, are poorly-preserved but contain original features such as air venting, cross-reinforcement bars and square windows with stone sills (**Photos 14 & 15**). The western barn has been extended to the south and the roof is not original (**Photos 14 & 16**). The eastern barn/byre includes a rear contemporary porch (**Photo 17**). Between the two barns/byres is a partially cobbled surface which may continue beneath a concrete resurface (**Photo 18**).

**Photo 10.** General shot of Moss Farm and associated buildings (RSK ID 16). Looking south.

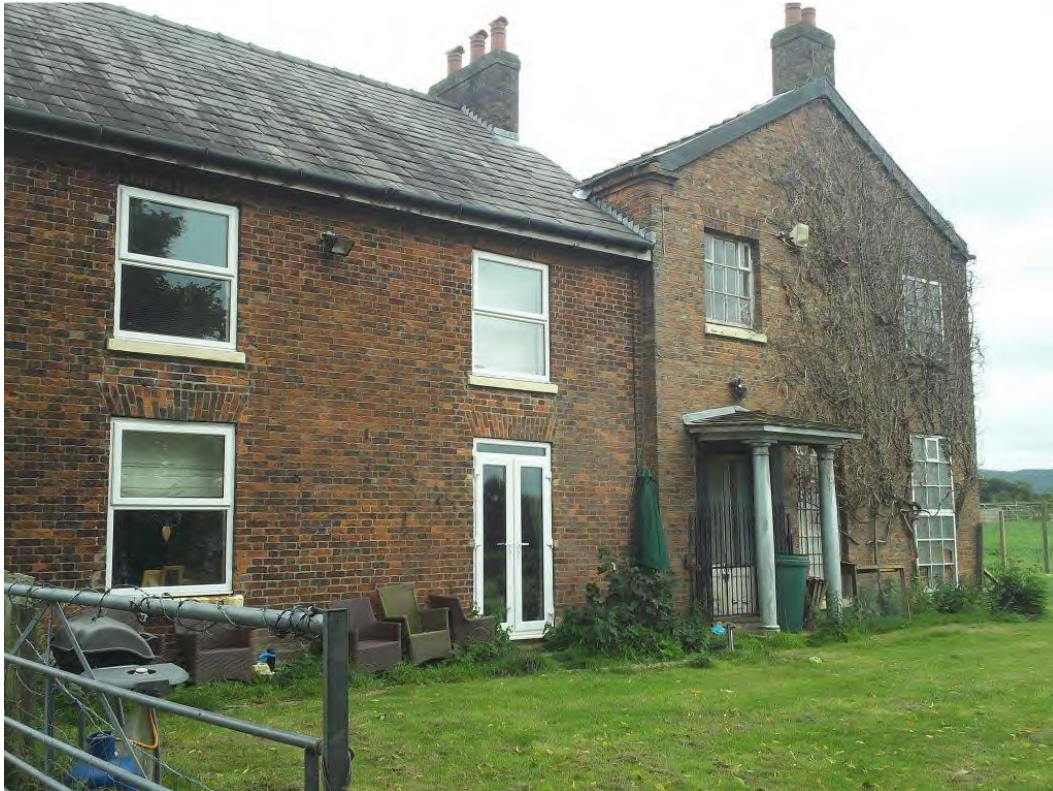
**Photo 11.** Moss Farm (RSK ID 16). Looking south east.

- 4.54 To the south of the track is a massive modern steel shed, and to the north are further breeze-block and steel sheds (see **Photo 17**).
- 4.55 Moss Farm, of red-brick with a slate roof (**Photos 10 – 12**), has been extended to the east and the north (see **Photo 13**).

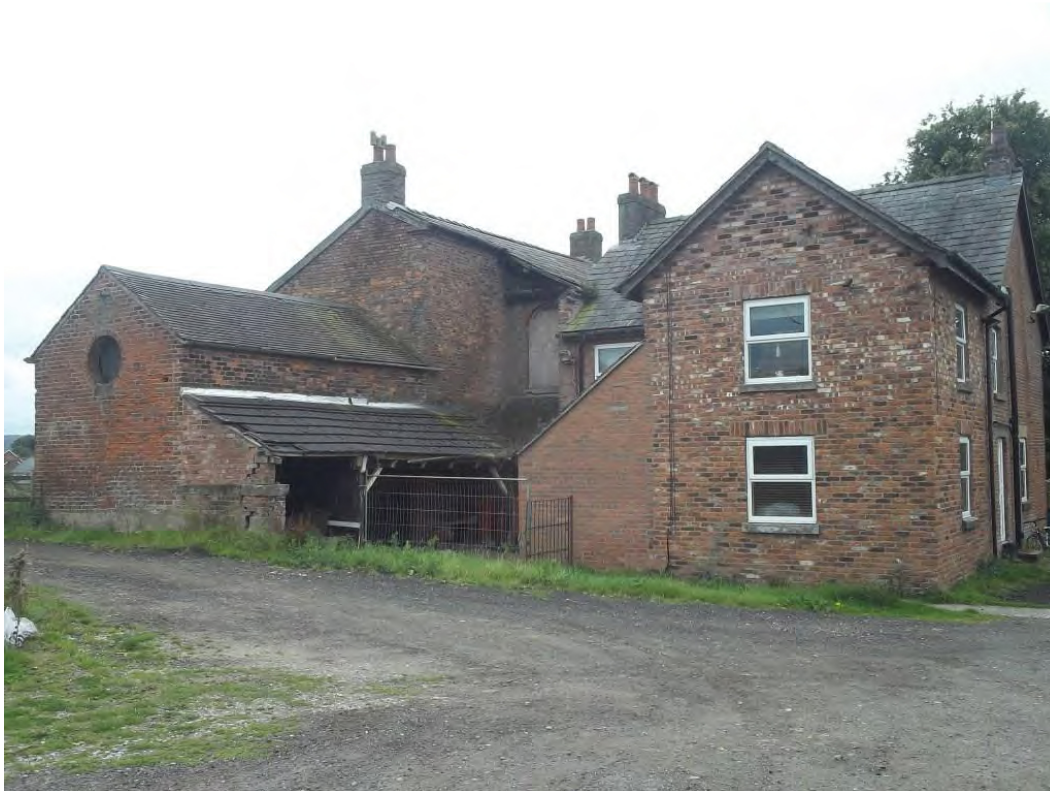
**Photo 13.** Moss Farm (RSK ID 16). Looking south west. Note two phases.

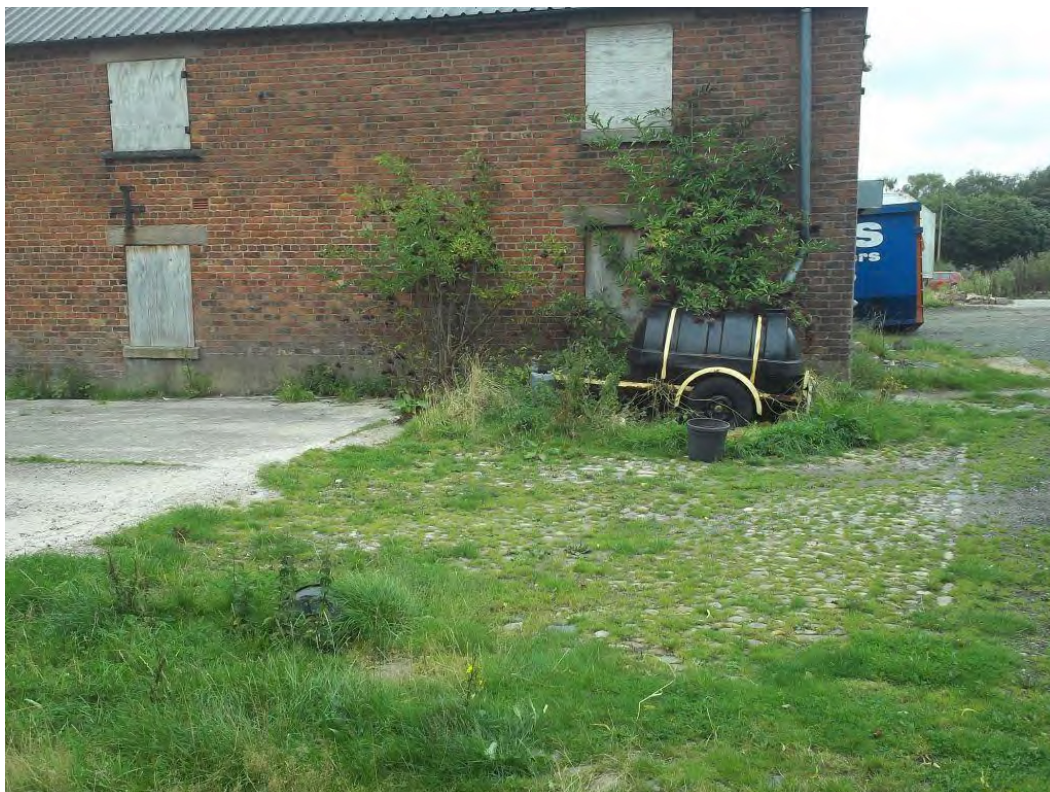
**Photo 18.** Cobbled surface of Moss Farm (RSK ID 16). Looking east.

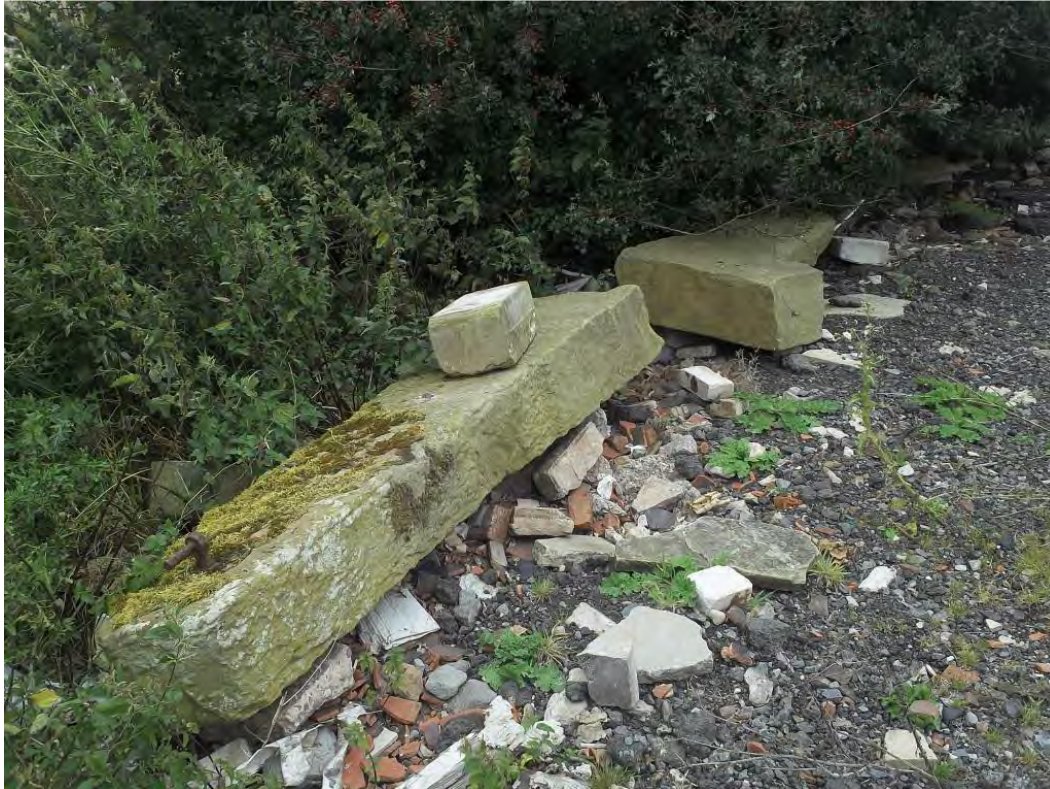
- 4.57 There is no preserved track from the yard to Manchester Road to the west, however an access point from Field H to Manchester Road remains.
- 4.58 Hewn stone gateposts have been moved and remain to one side in the yard (**Photo 19**).

**Photo 19.** Gateposts in yard.

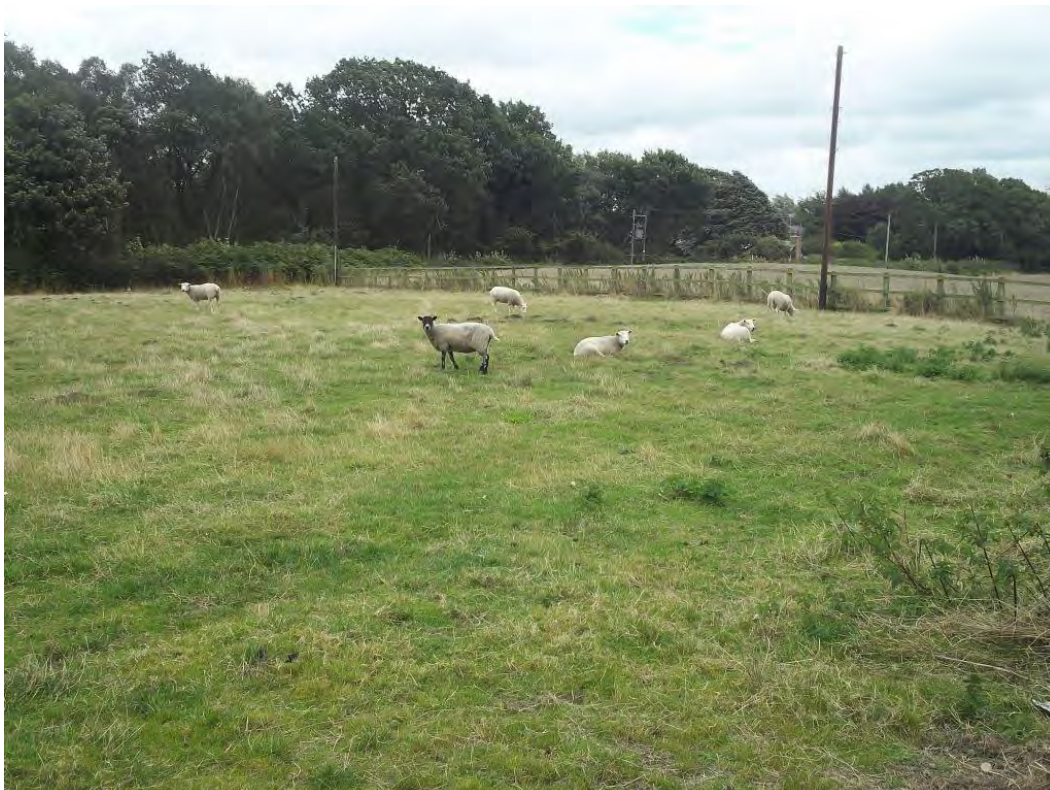
- 4.59 Small, flat, undisturbed paddocks are grazed. Field boundaries are post-and-wire fencing (**Photo 20**).

**Photo 20.** Field C. Looking south east.

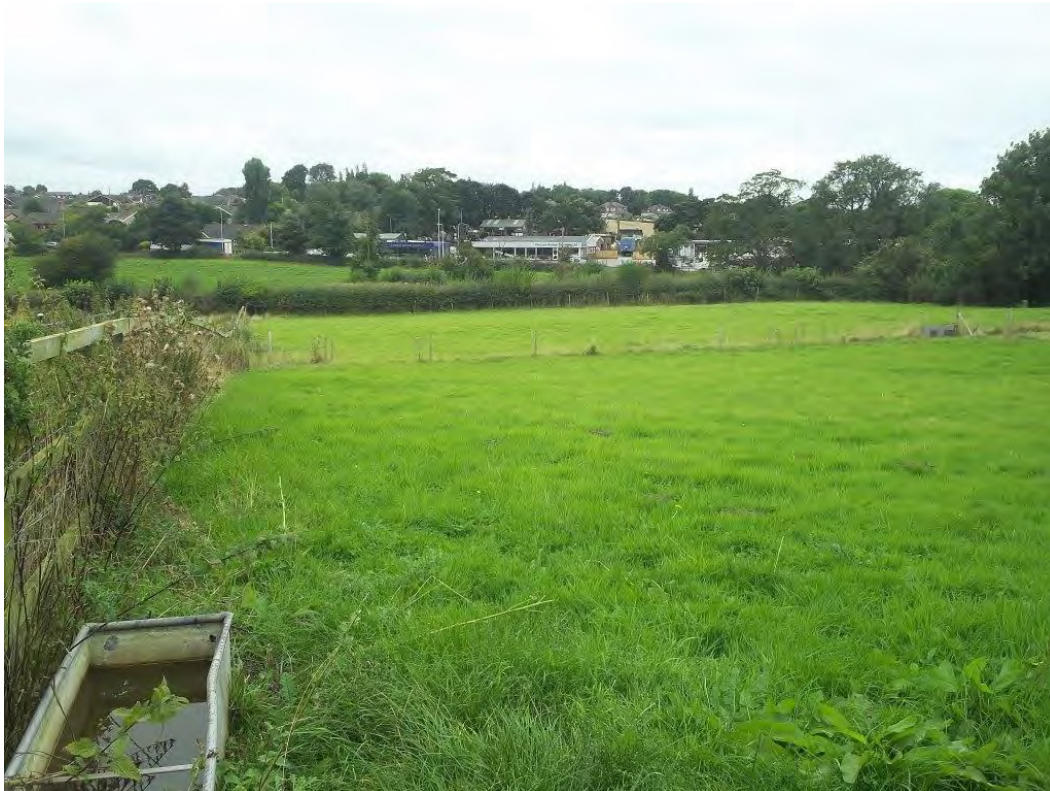
- 4.60 Garden pasture, slope down slightly to the west. Field boundaries are post-and-wire fencing (**Photo 21**). Open with good views to the south and east.

**Photo 21.** Fields D & E. Looking west.

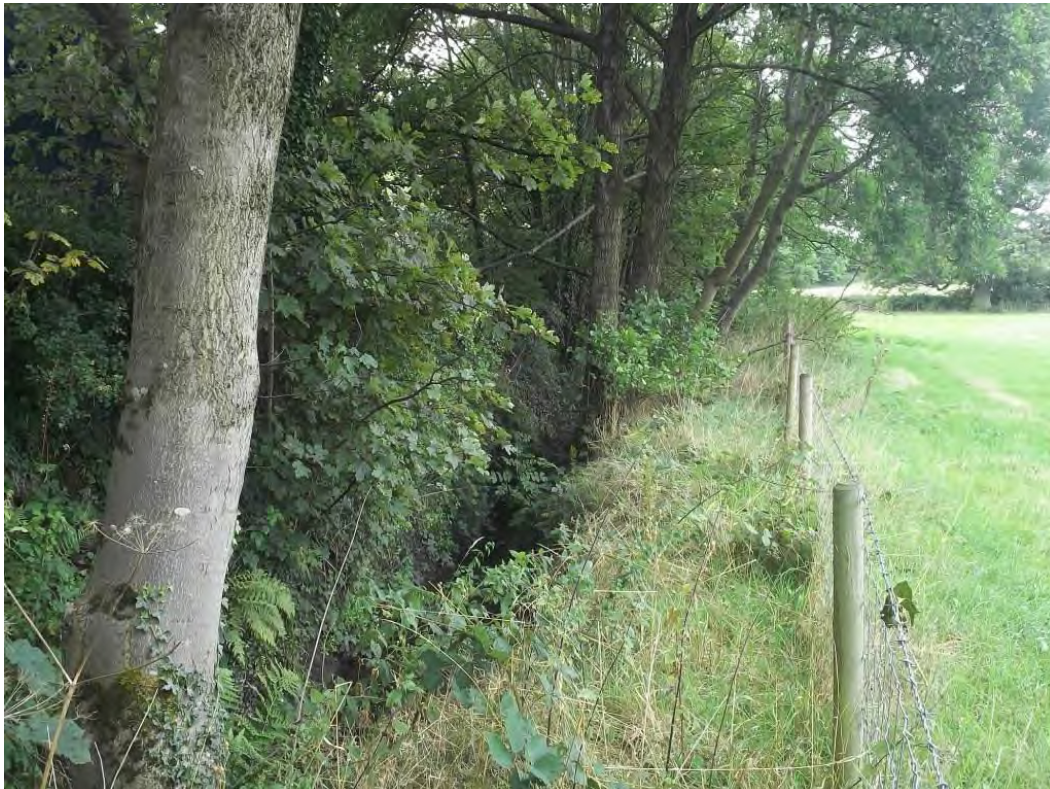
**Photo 22.** Union and Municipal and Borough boundary. Boundary to Fields G & H. Looking north in Field H

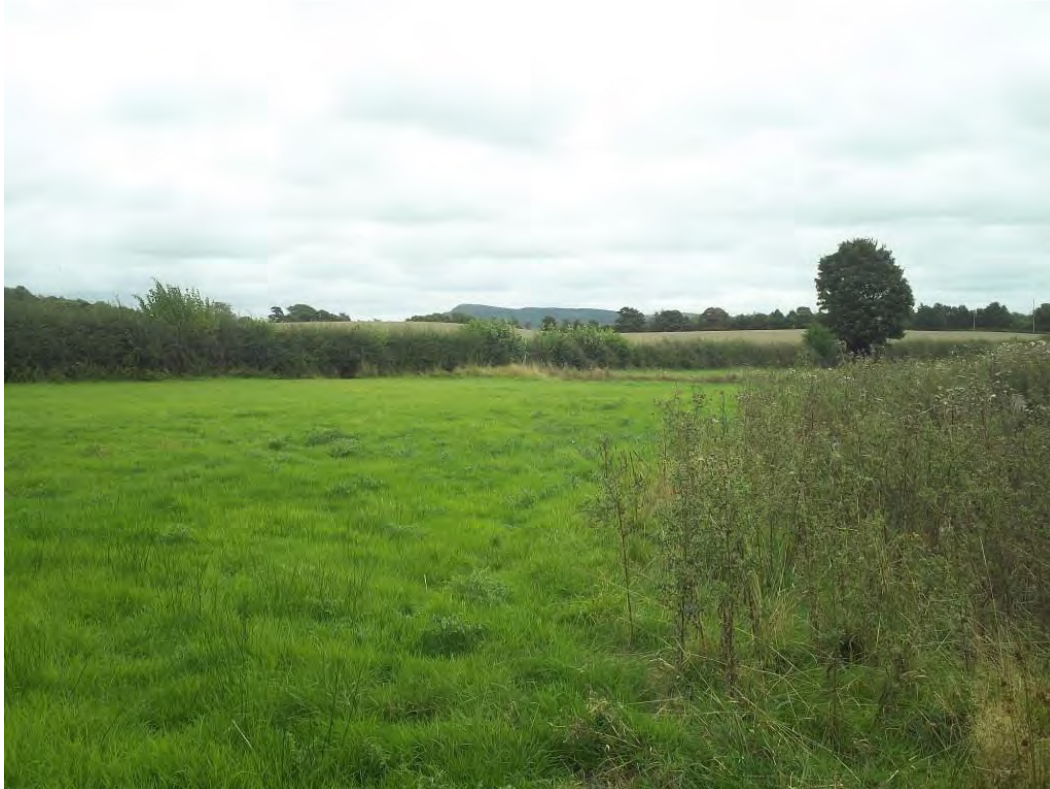
4.64 Good views to the south and east, as far as the Cloud, a natural scarp and Iron Age enclosure (**Photo 23**).

**Photo 23.** Field G. Looking south east. Note the Cloud in distance.

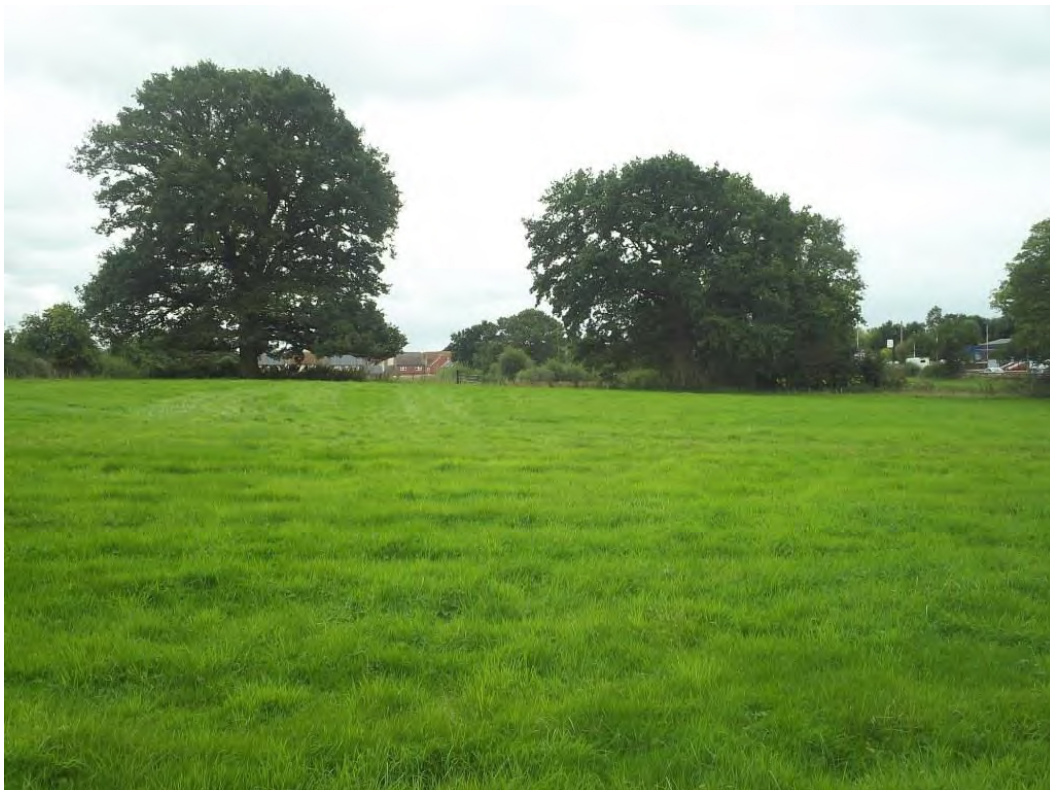
**Photo 24.** Field H. Looking south.

4.65 Improved pasture, sloping down slightly to the west. Previously undisturbed. Includes mature oak trees within the field which are shown on first edition OS mapping (**Photo 24**).
