TITLE
CONDITION SURVEY
AND TREATMENT

PROJECT
PETERBOROUGH CATHEDRAL
Restoration of Fire Damage
July-October 2002

AREA
SOUTH TRANSEPT
CEILING
Rows: A B C D

PETERBOROUGH CATHEDRAL South Transept ceiling plan from above

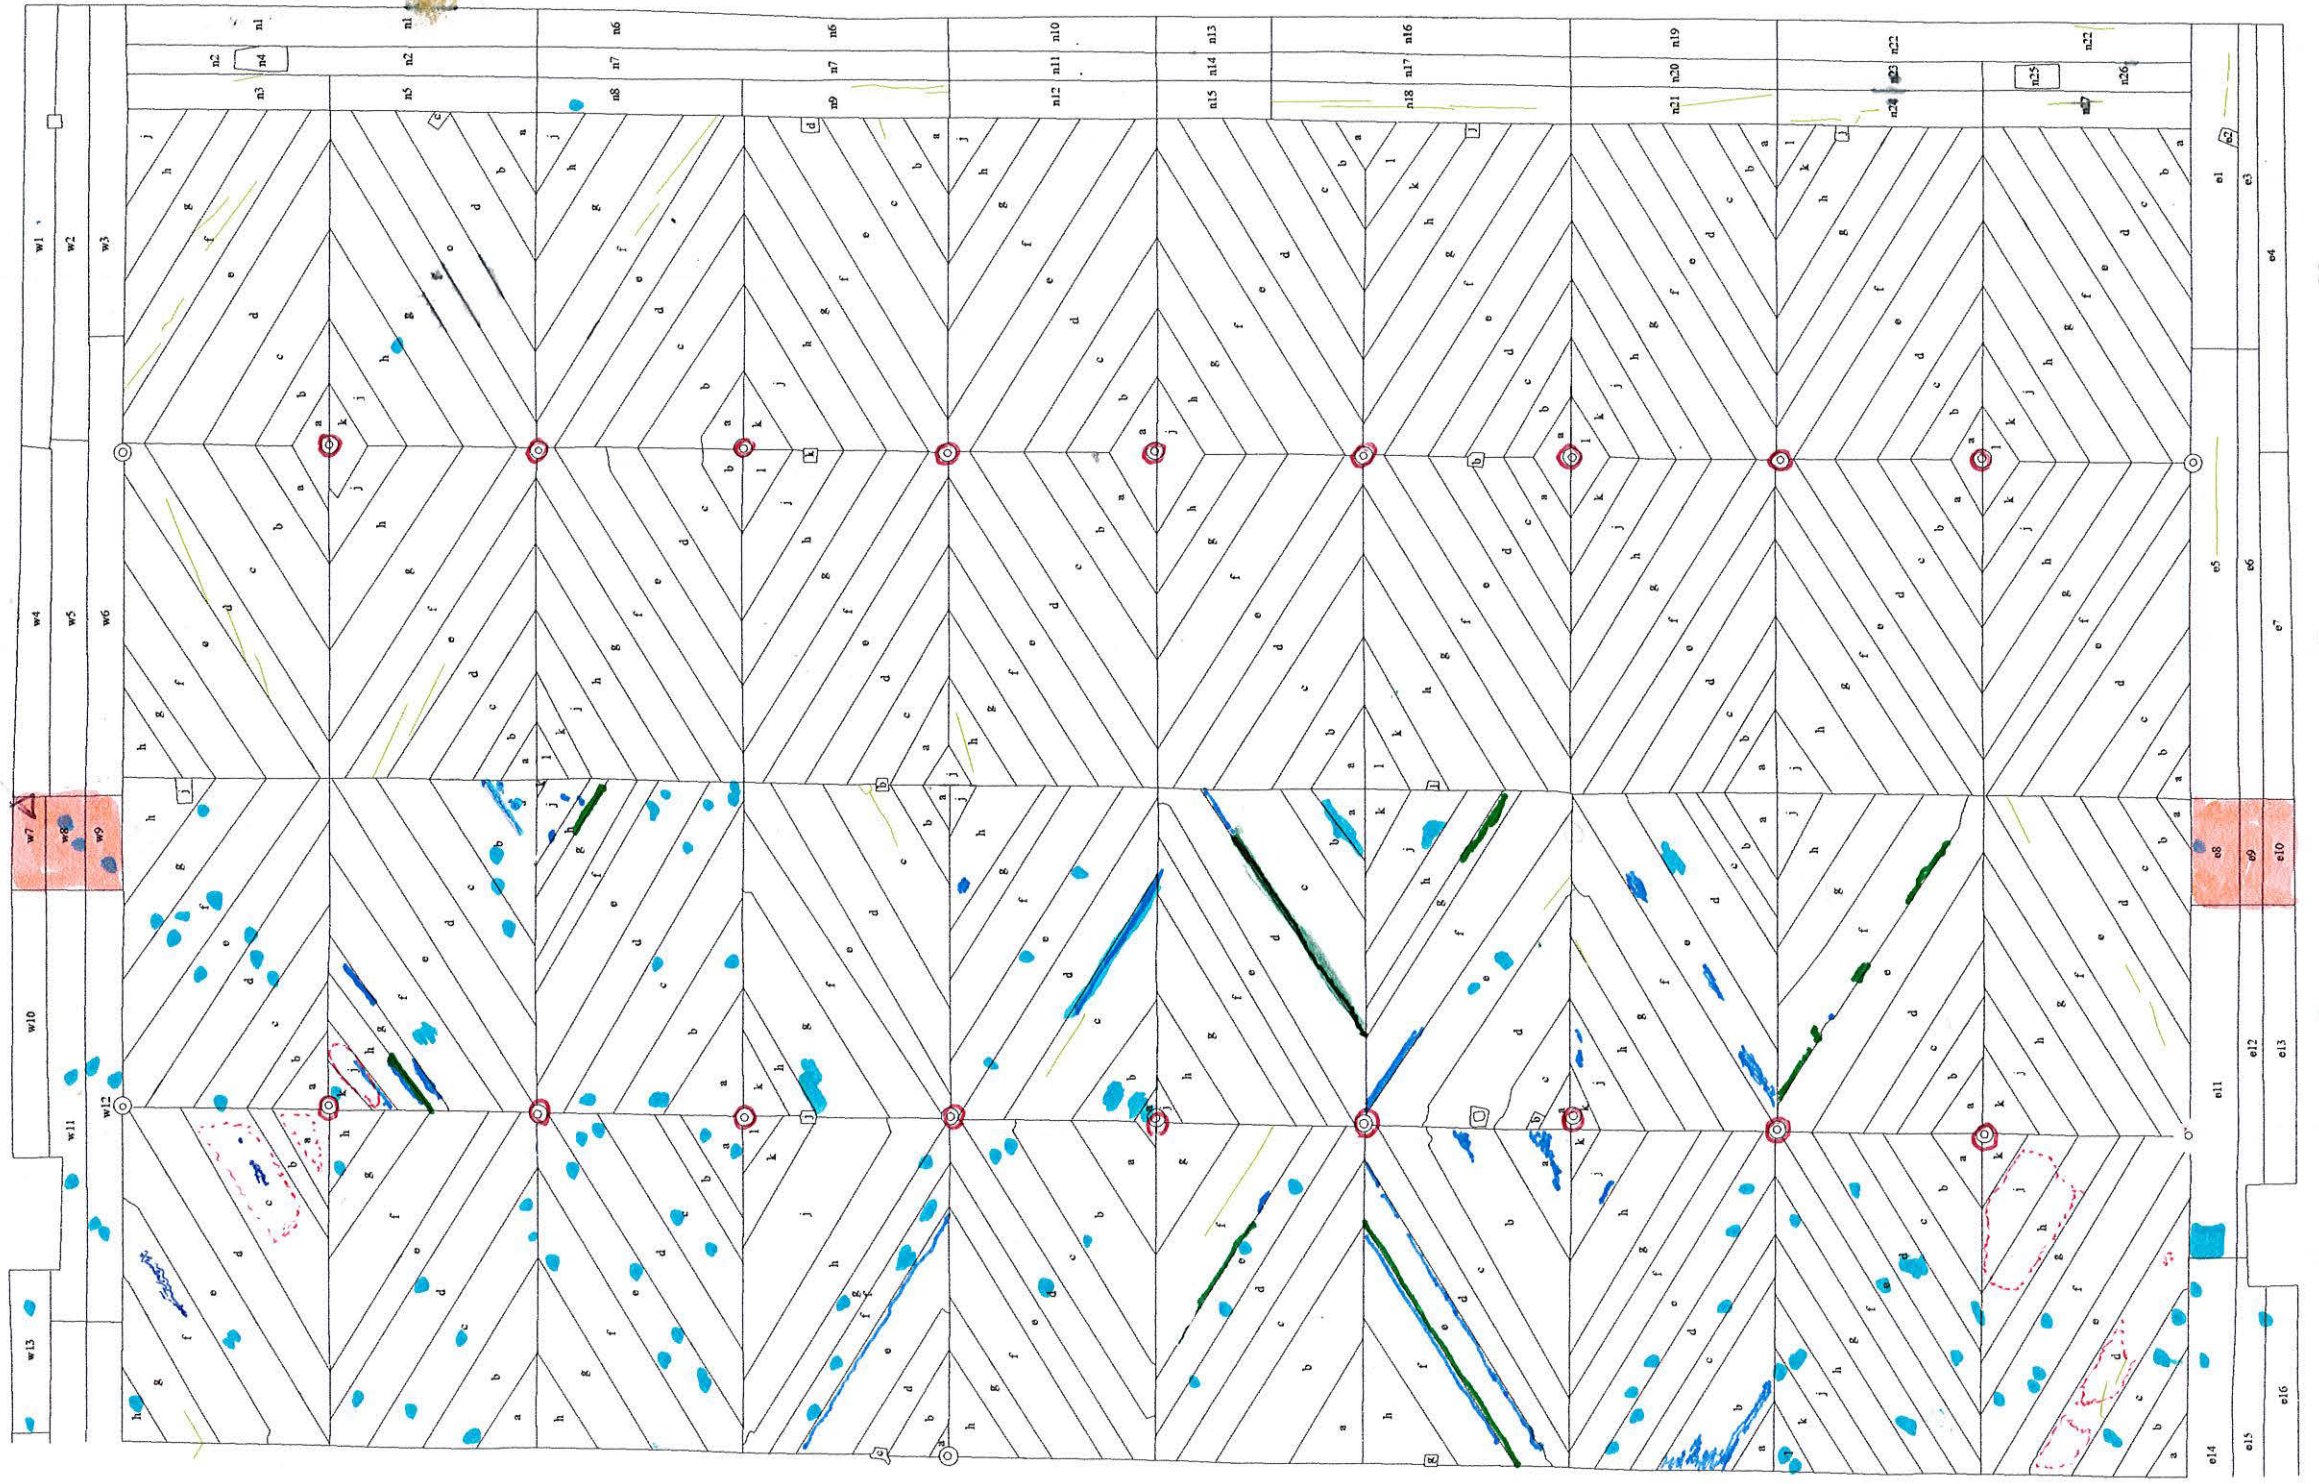
KEY ○ Bolts lowered plastagate washers

INSECT
GUN SHOT
WET ROT

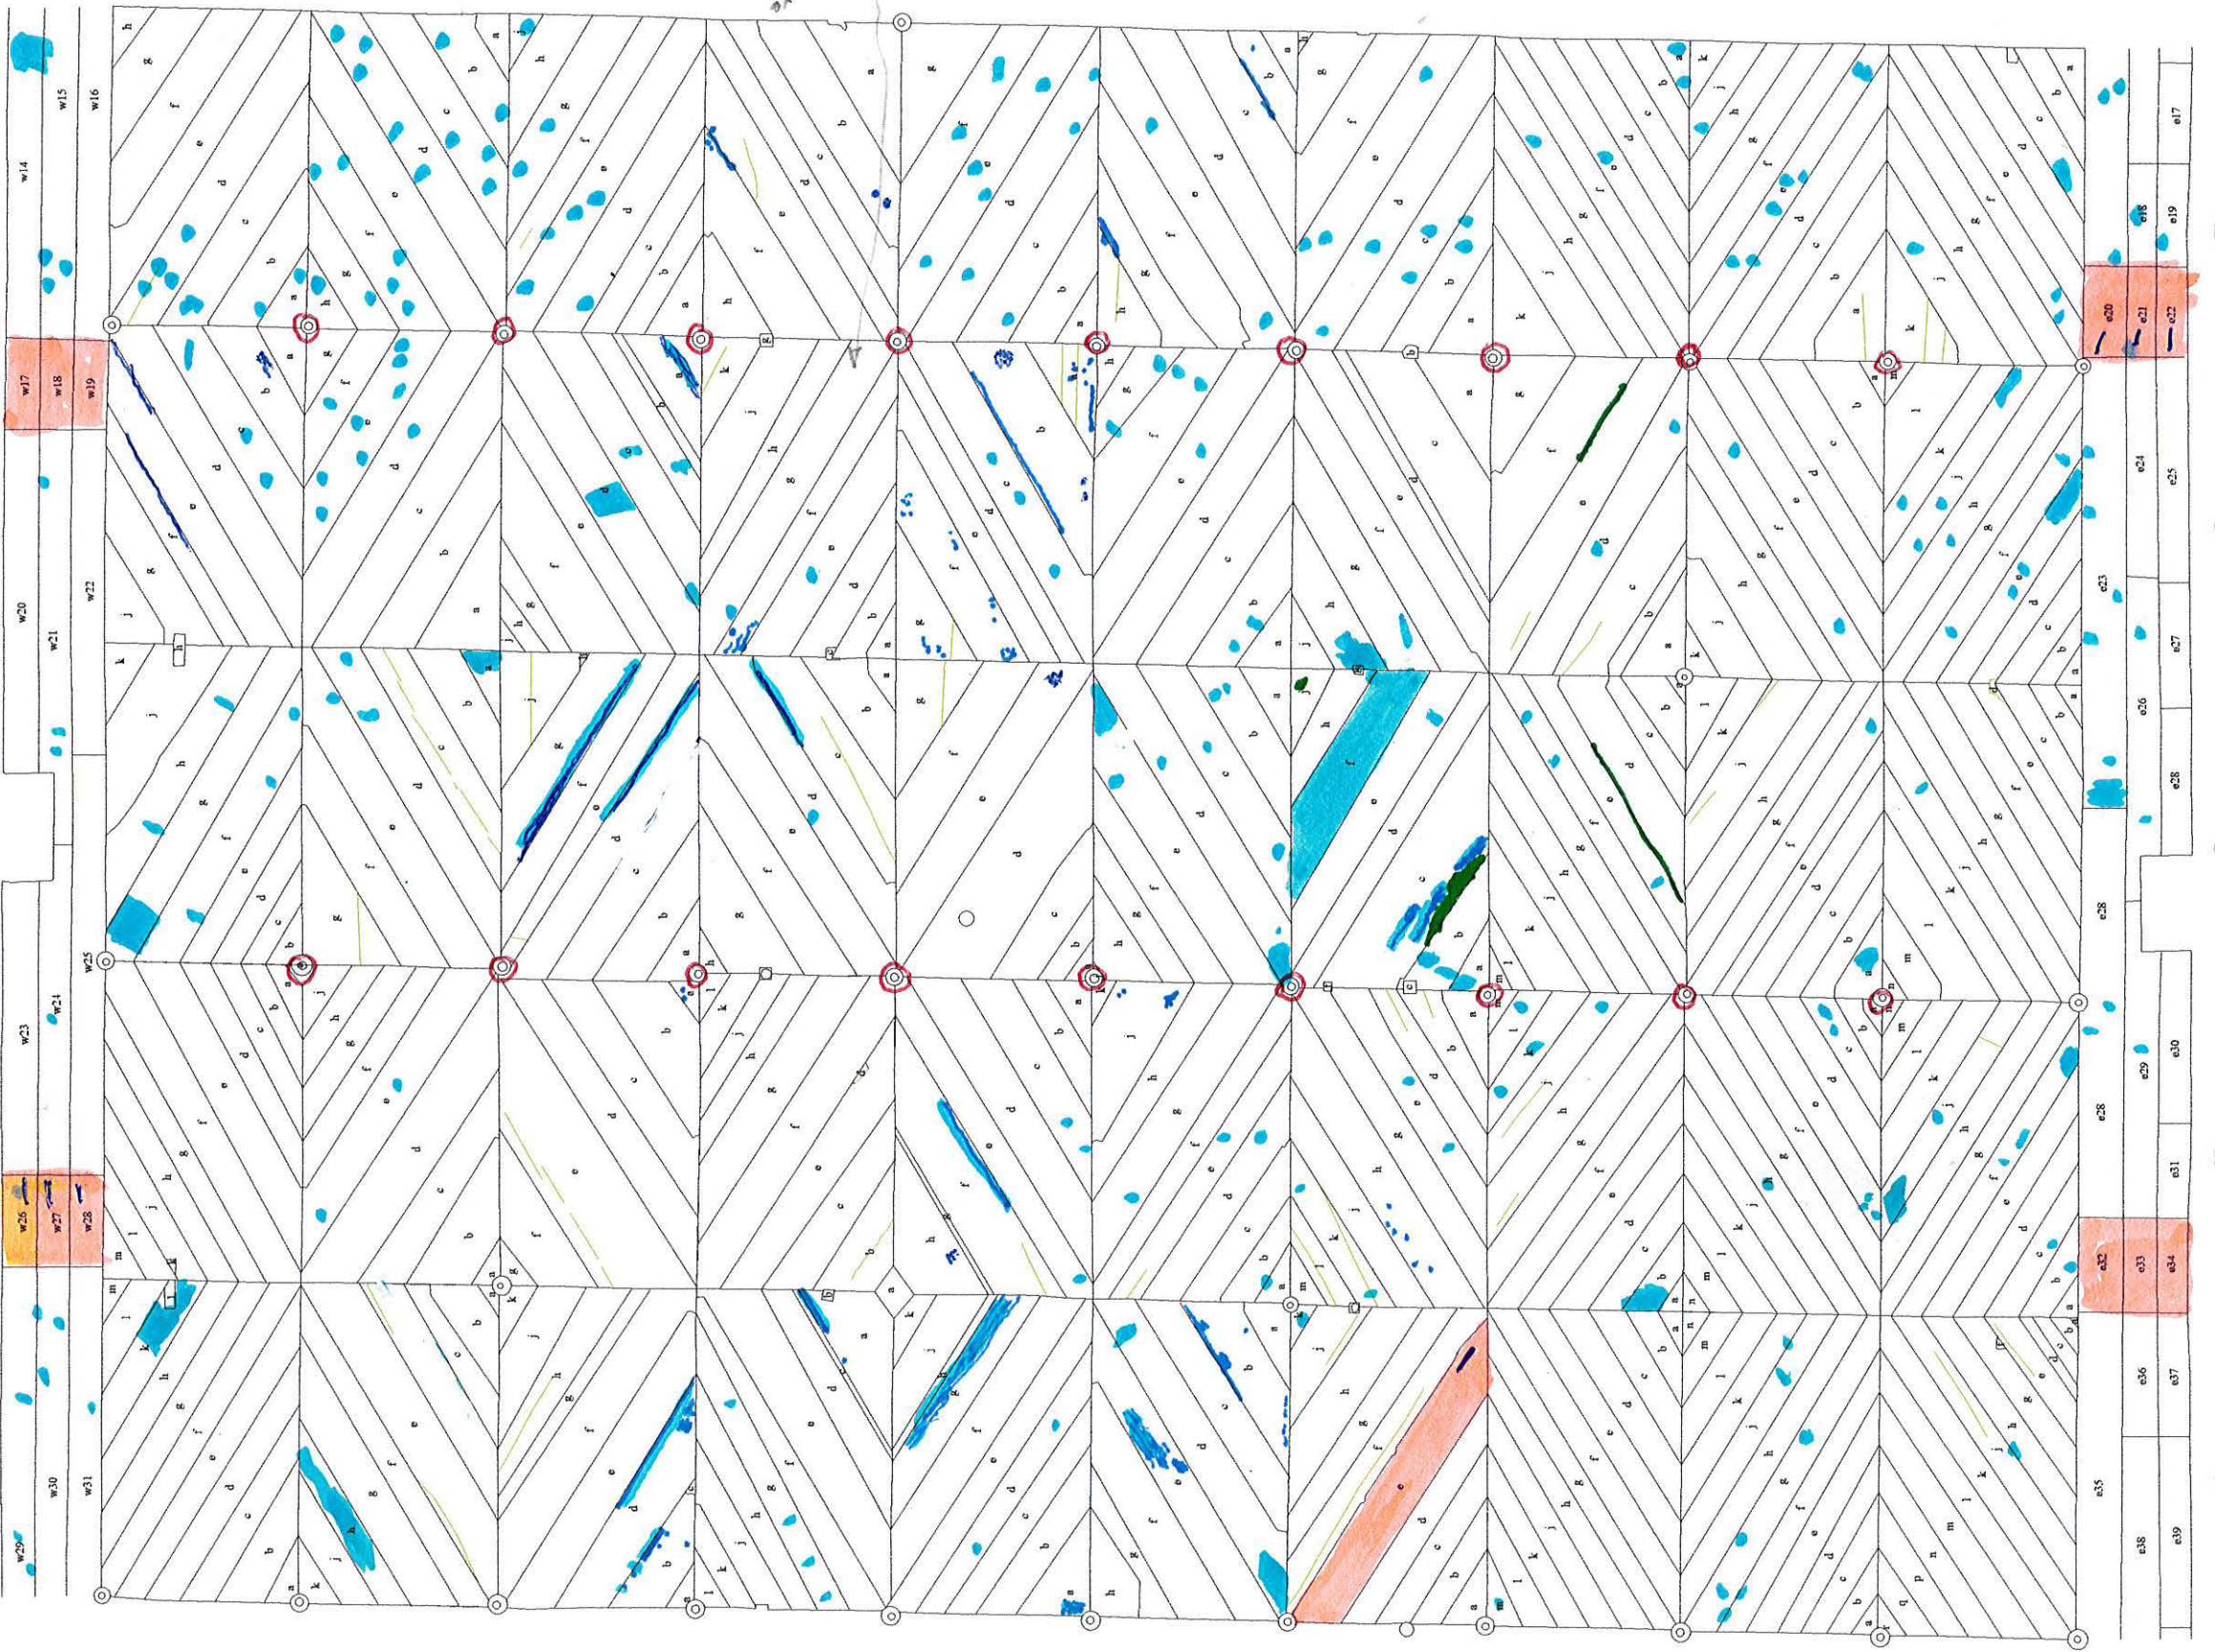
DRAWING:	TITLE	PROJECT	AREA			SCALE 1:35	Photogrammetry by: The Downland Partnership Lychgate House, Ramsbury Wiltshire SN8 2PB	POSITION
	CONDITION SURVEY AND TREATMENT	PETERBOROUGH CATHEDRAL Restoration of Fire Damage July-October 2002	SOUTH TRANSEPT CEILING Rows: E F G H J

KEY
 BOARDS REMOVED FOR DENDRO
 BOARDS USED FOR DENDRO

INSECT
GUN SHOT
WET ROT

Bolts lowered
Plactagote Washers

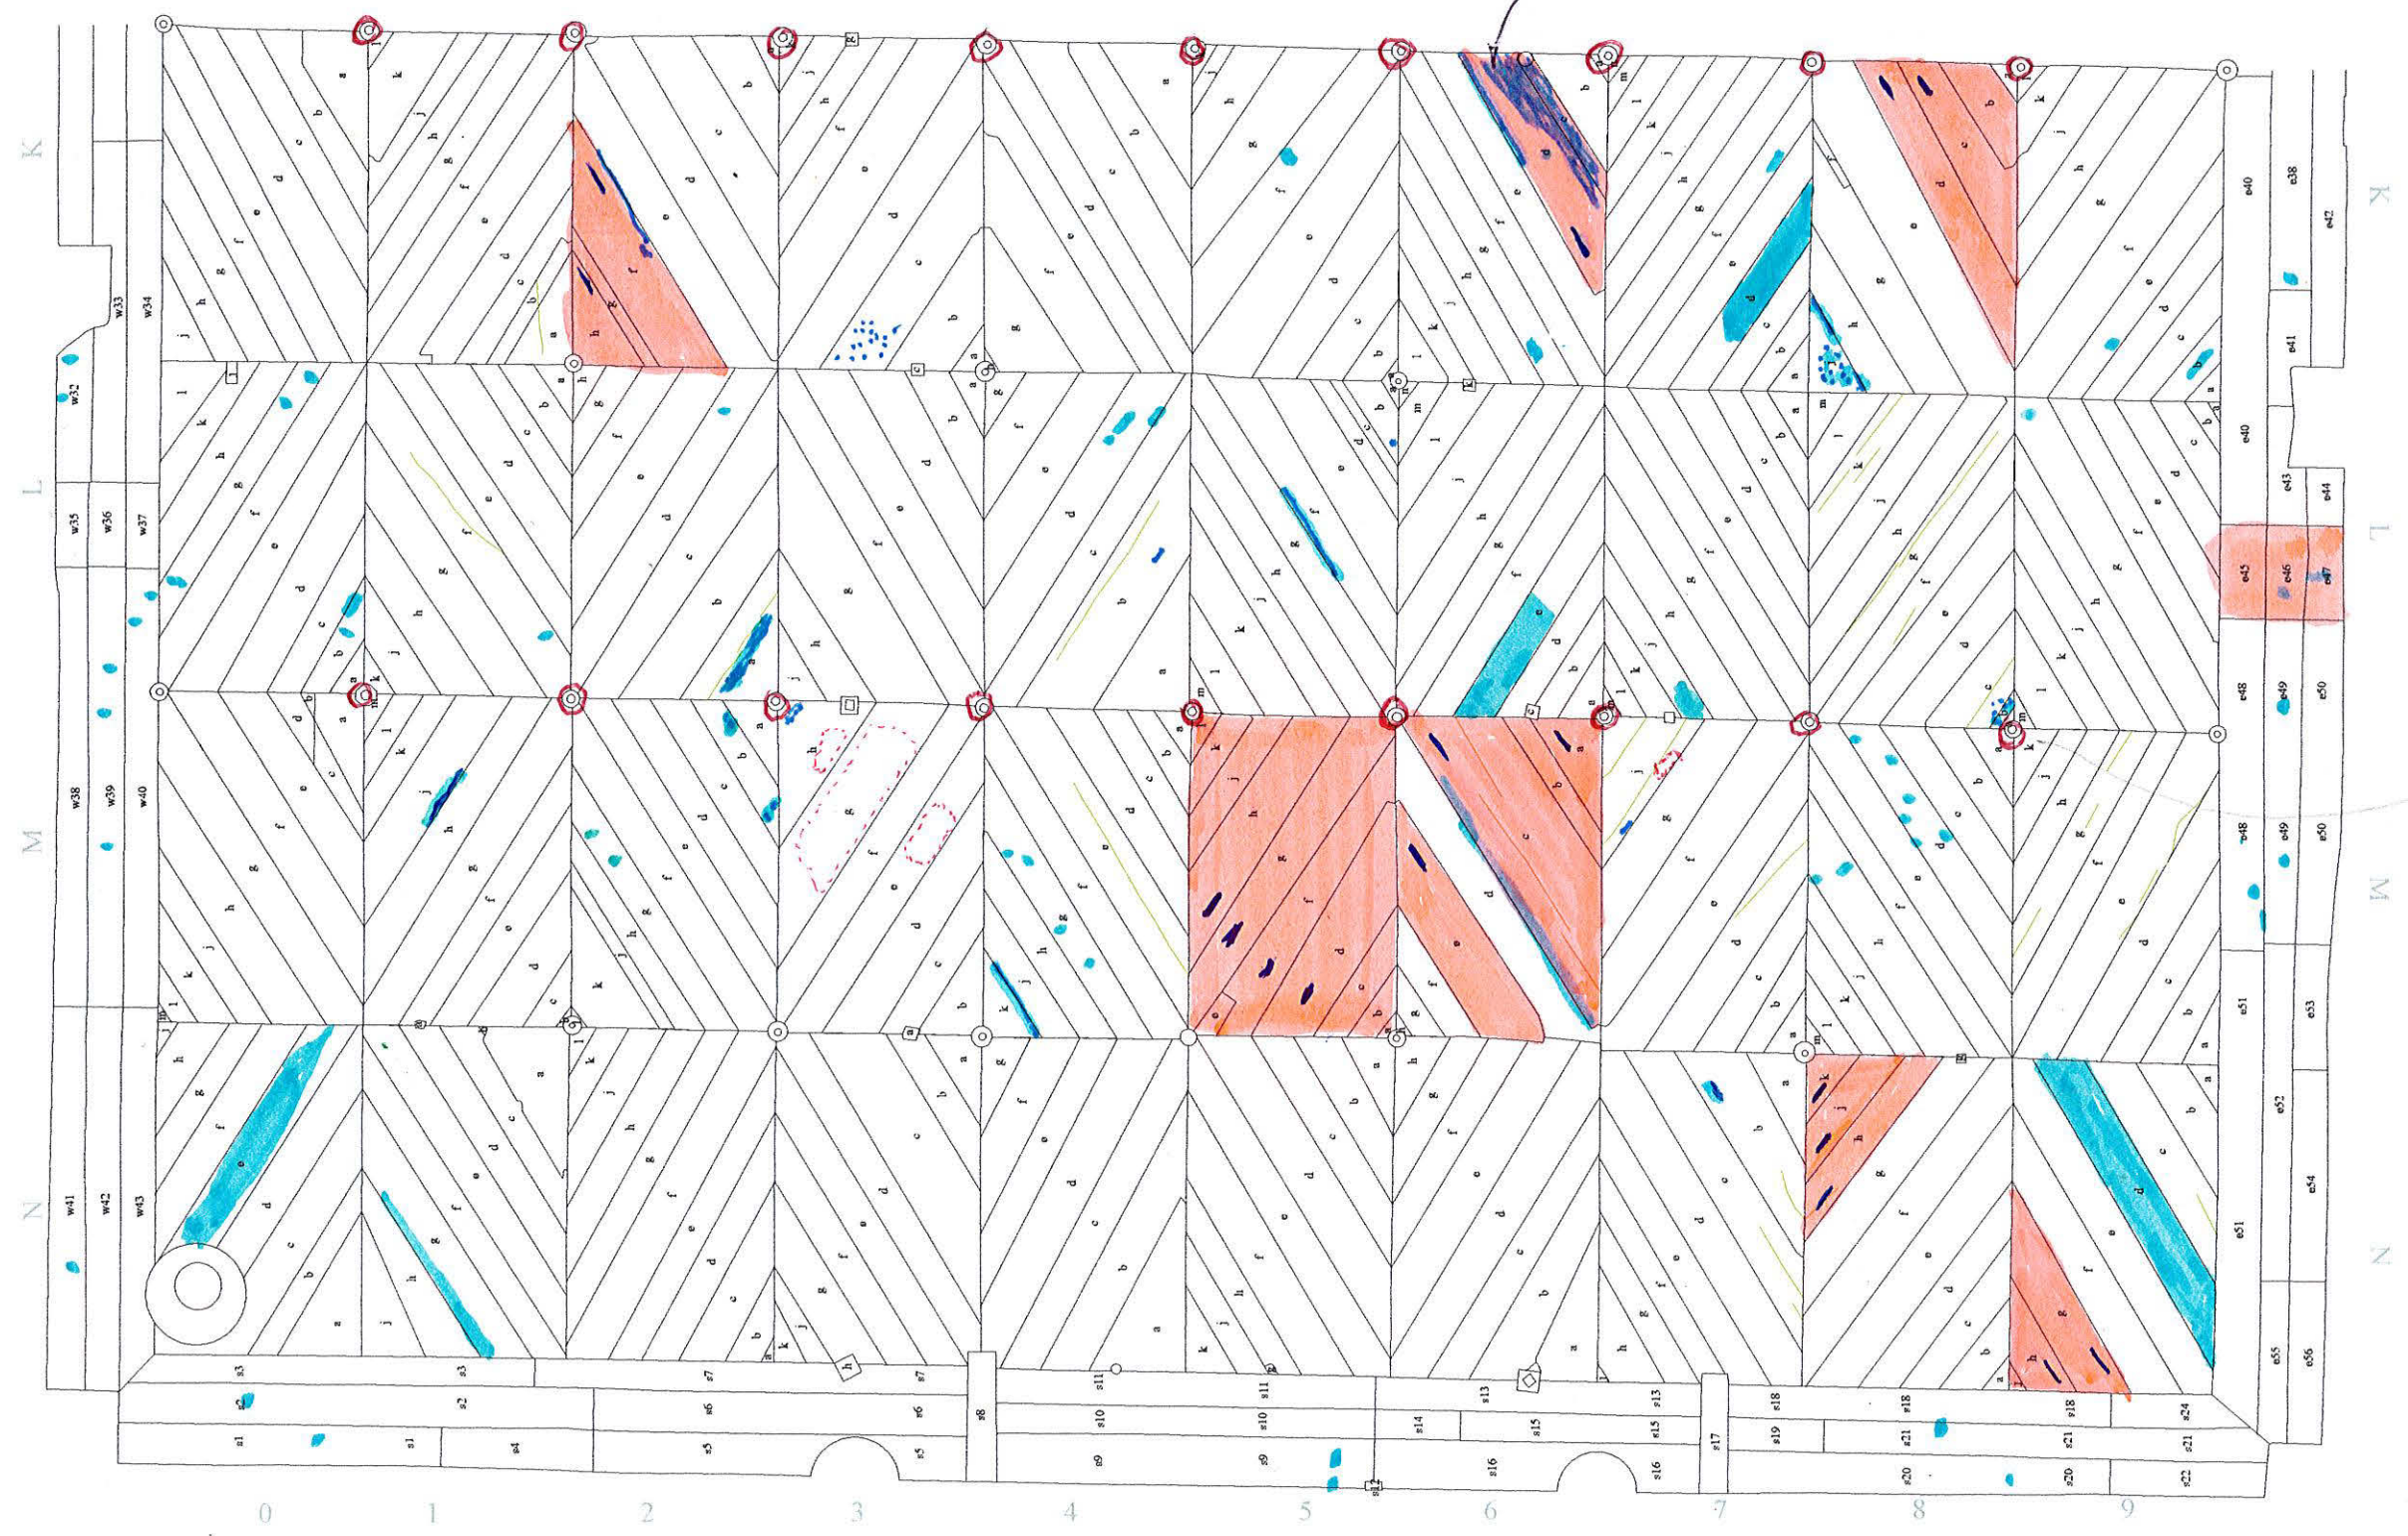
AREA SOUTH TRANSEPT
CEILING
Rows: K L M N

MAY HAVE BEEN MISTAKEN FOR KB

BOARDS REMOVED FOR DEVAIRO

BOARDS USED FOR DEVAIRO

INSECT

GUN SHOT

WET ROT

54 O Belts lowered Plastazote Washers
